Document Version 1  
Survey Date 13/08/2025  
Suggested Review Date 13/08/2030

# FIRE RISK APPRAISAL EXTERNAL WALLS

## 65-96 HORTON STREET

Great Bridge  
DY4 7JW

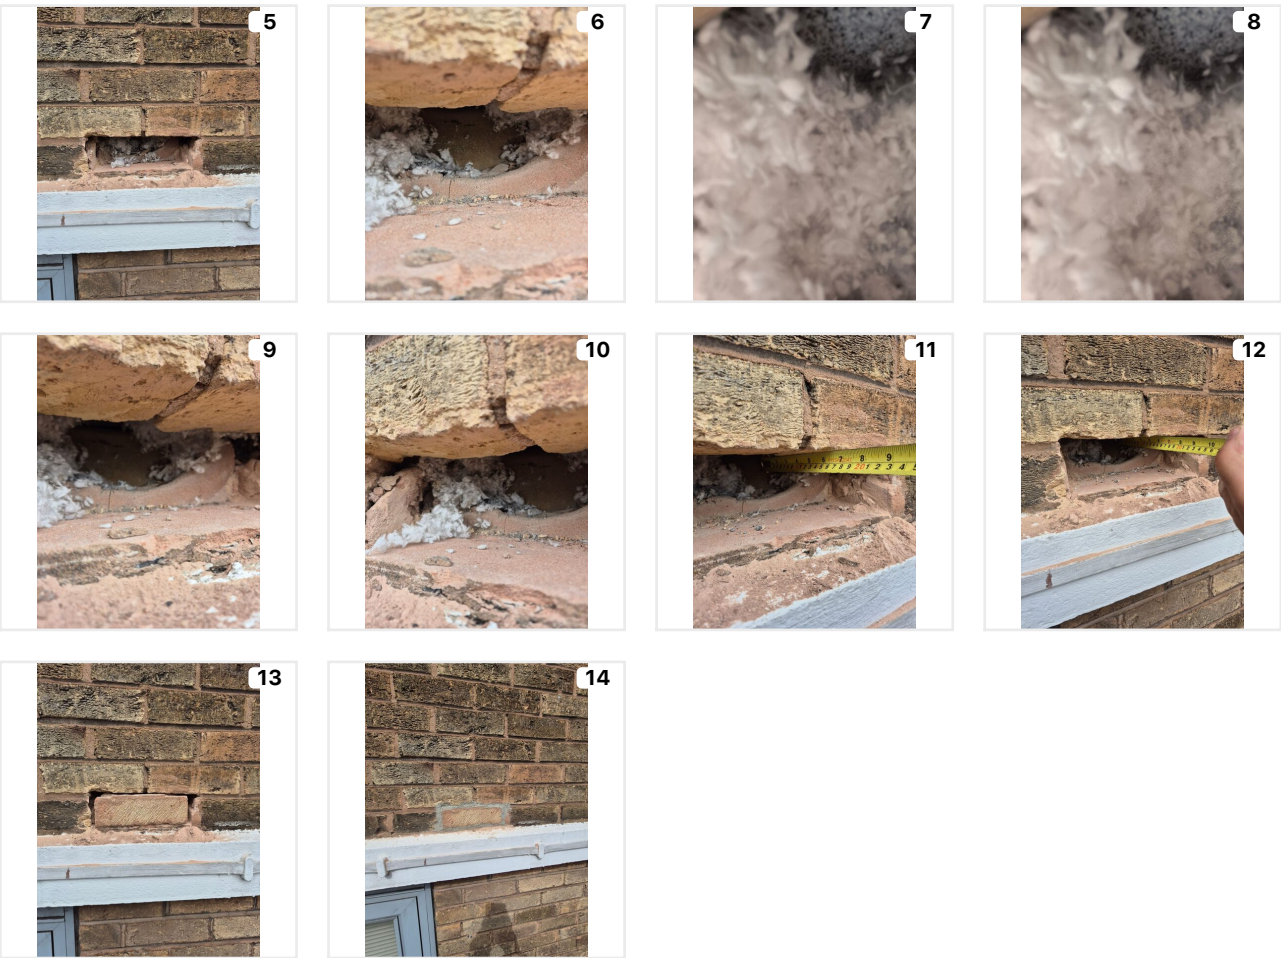
# Inspection Photos

Backing Wall Sits On The Floor Slab

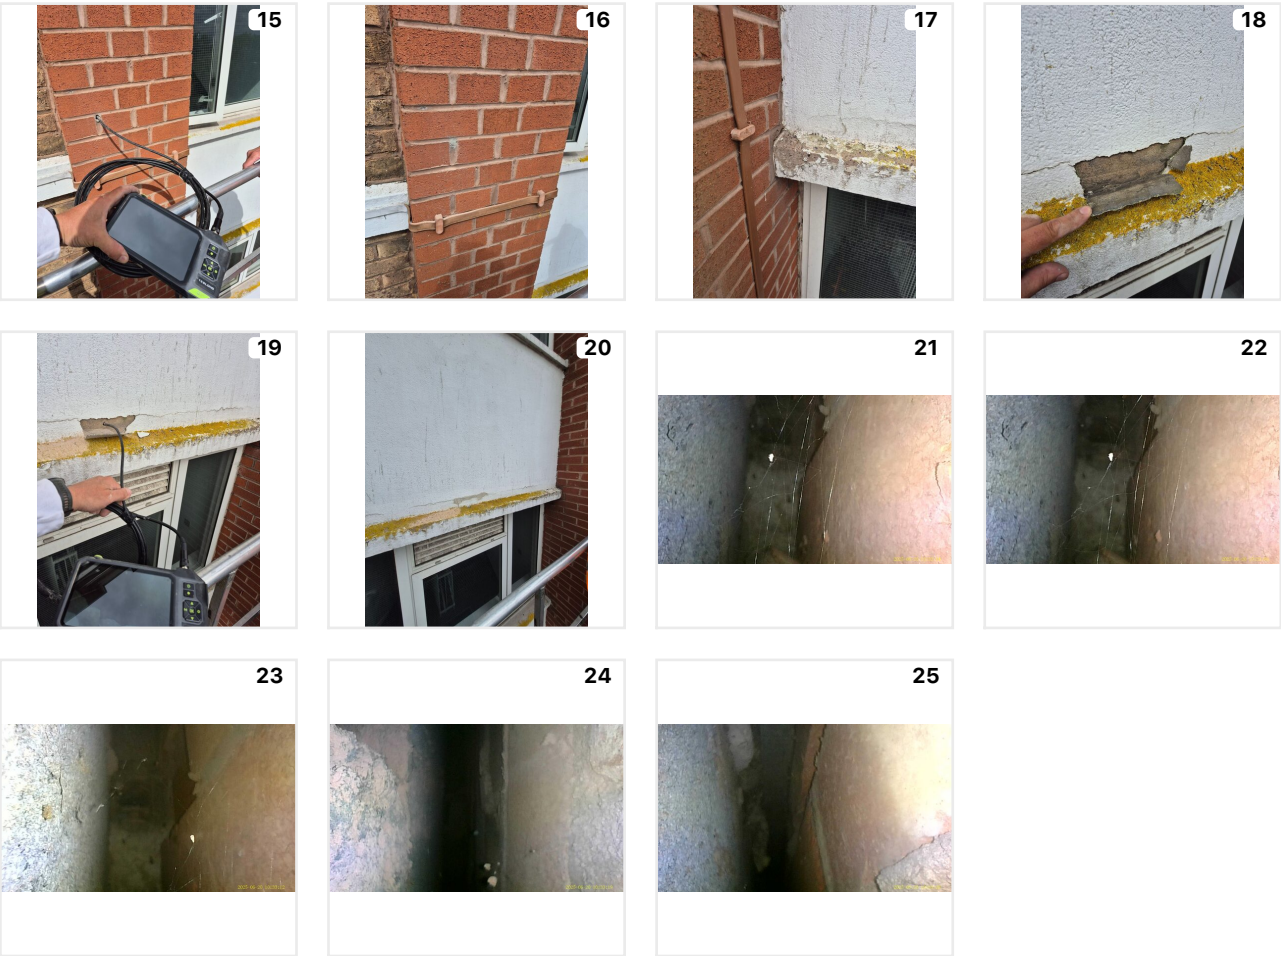
# Inspection Photos

Backing Wall Sits On The Floor Slab

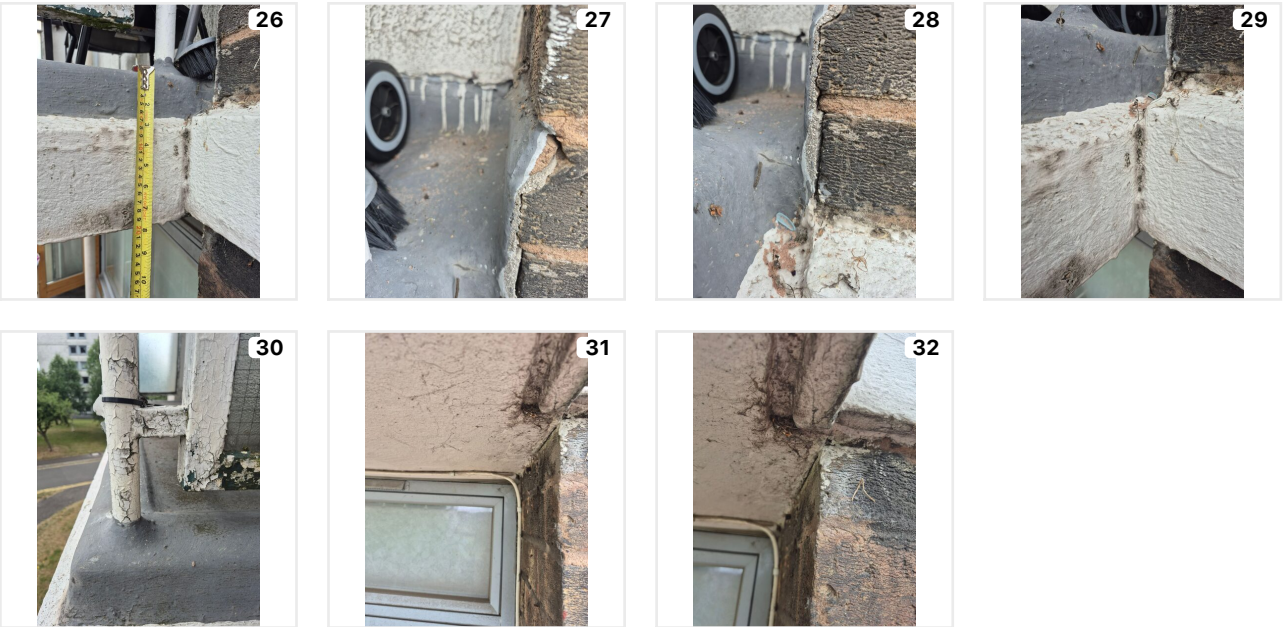
## Inspection Photos

Reinforced concrete

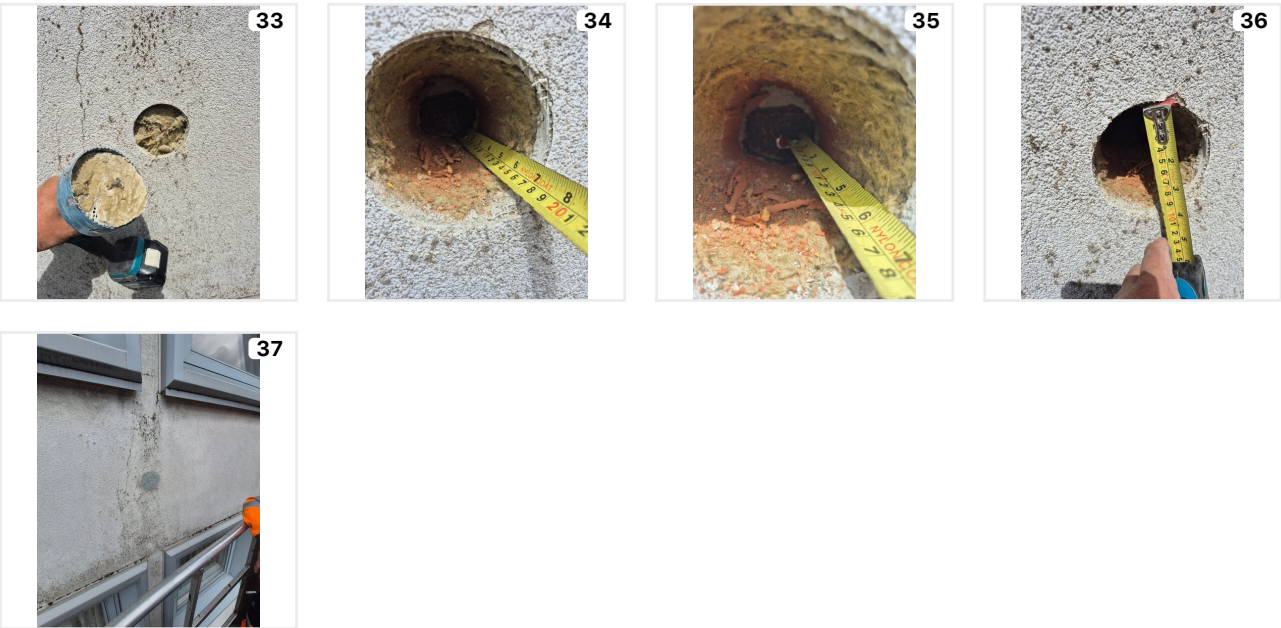
Inspection Photos

Backing Wall Sits On The Floor Slab
