Document Version 1  
Survey Date 23/07/2025  
Suggested Review Date 23/07/2030

# EXTERNAL WALL SURVEY

## KYNASTON HOUSE

Kynaston House  
Rydding Lane  
West Brom  
B71 2HD

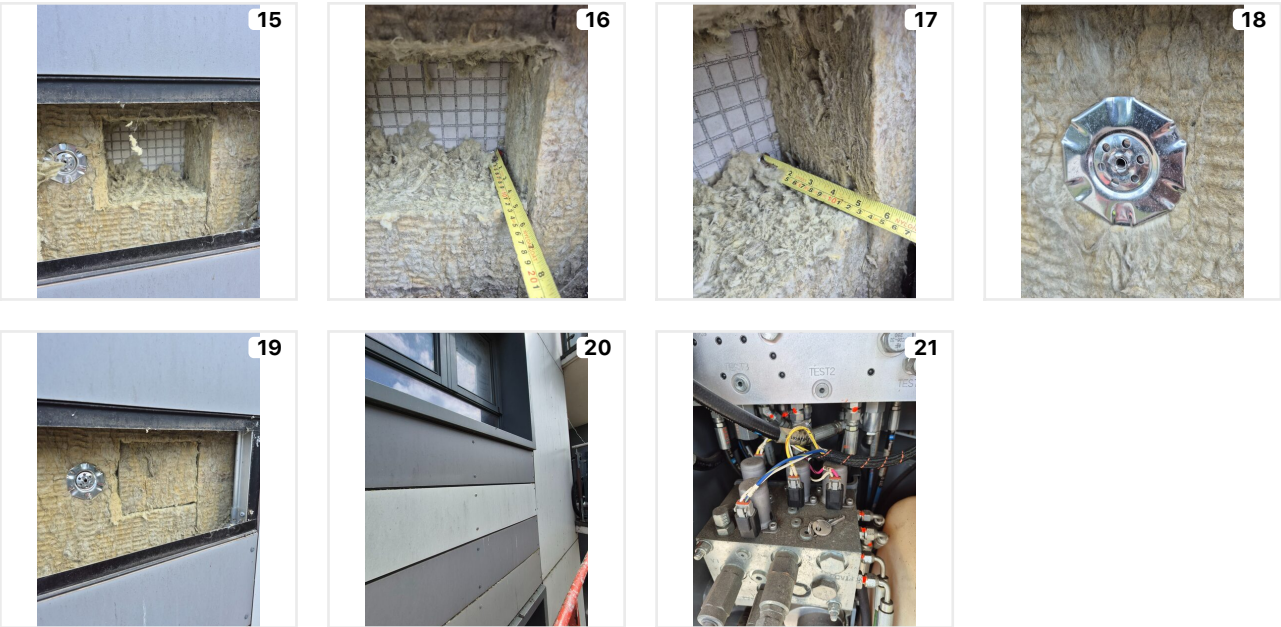
# Inspection: 7YDYAM

Elevation • Location  
East Elevation • Balcony Inspection

Backing Wall Sits On The Floor Slab

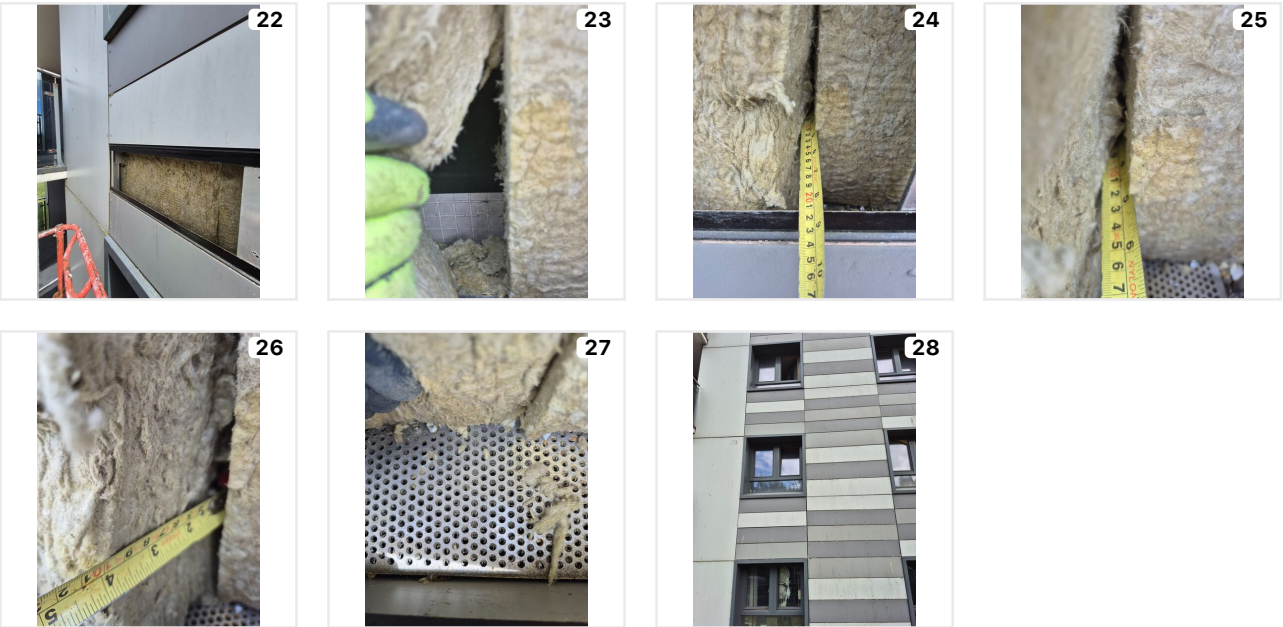
# Inspection: C1FK33

Elevation • Location  
East Elevation • Compartment Floor and Wall Junction Interface

Backing Wall Sits On The Floor Slab
