Document Version 3  
Survey Date 04/11/2024  
Suggested Review Date 04/11/2029

# EXTERNAL WALL SURVEY

## LANCASTER HOUSE

Lancaster House  
Oldbury Road  
Oldbury  
West Midlands  
B65 0QE

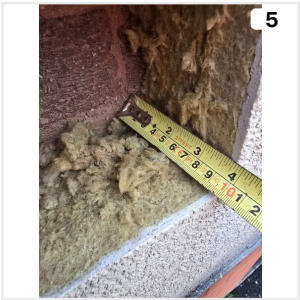
# Inspection: GMTNJF

Wall Type 1 - render over mineral wool insulation

| 3 Elements | Thickness/Depth | Material | Photo Ref. | Rating (BS EN13501) |
|---|---|---|---|---|
| Surface Finish | 6mm | Render | | A2 - Limited Combustibility |
| Insulation | 100mm | Mineral Wool Insulation | | A1 - Non-Combustible |
| Inner Leaf Support (Backing Wall) | 102mm | Original brickwork | | A1 - Non-Combustible |

There is no external wall cavity

Backing Wall Sits On The Floor Slab

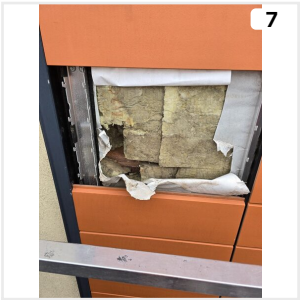
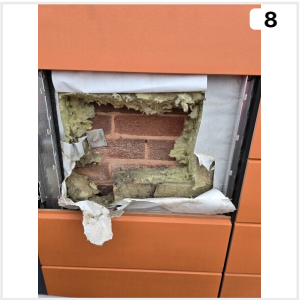
# Inspection: J766CE

Wall Type 2 - Terracotta over mineral wool

| 4 Elements | Thickness/Depth | Material | Photo Ref. | Rating (BS EN13501) |
|---|---|---|---|---|
| Surface Finish | 15mm | Terracotta Tile | | A1 - Non-Combustible |
| Cavity | 30mm | | | |
| Insulation | 100mm | Mineral Wool Insulation | | A1 - Non-Combustible |
| Inner Leaf<br>Support (Backing<br>Wall) | 102mm | Original brickwork | | A1 - Non-Combustible |

None

Backing Wall Sits On The Floor Slab

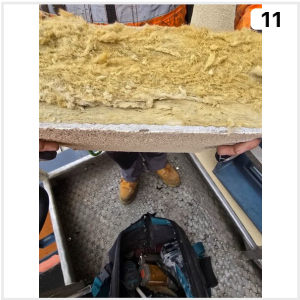
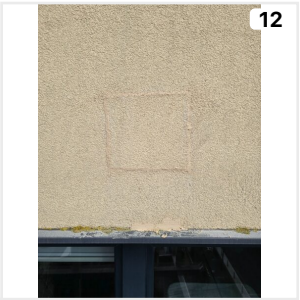
# Inspection: QM6QF9

Wall Type 1 - render over mineral wool

| 3 Elements | Thickness/Depth | Material | Photo Ref. | Rating (BS EN13501) |
|---|---|---|---|---|
| Surface Finish | 6mm | Render | | A2 - Limited Combustibility |
| Insulation | 100mm | Mineral Wool Insulation | | A1 - Non-Combustible |
| Inner Leaf Support (Backing Wall) | 102mm | | | A1 - Non-Combustible |

There is no external wall cavity

Backing Wall Sits On The Floor Slab
