# FIRE RISK APPRAISAL EXTERNAL WALLS

## KYNASTON HOUSE

Kynaston House  
Rydding Lane  
West Brom  
B71 2HD

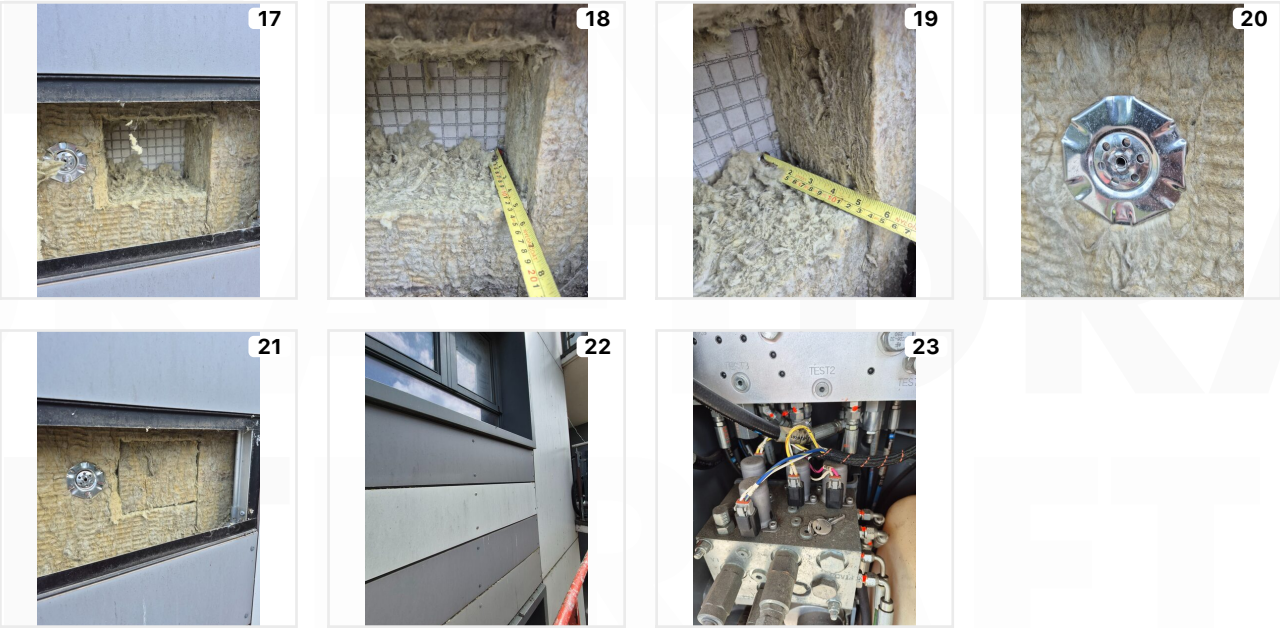
Backing Wall Sits On The Floor Slab

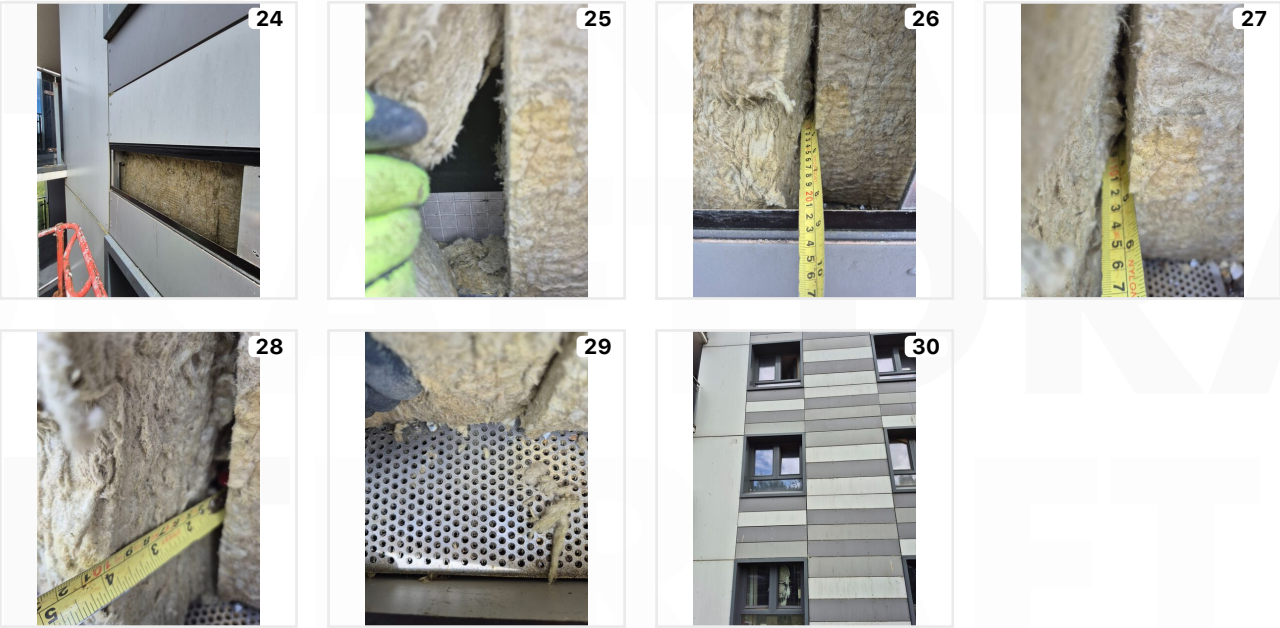
# Inspection: C1FK33

Backing Wall Sits On The Floor Slab

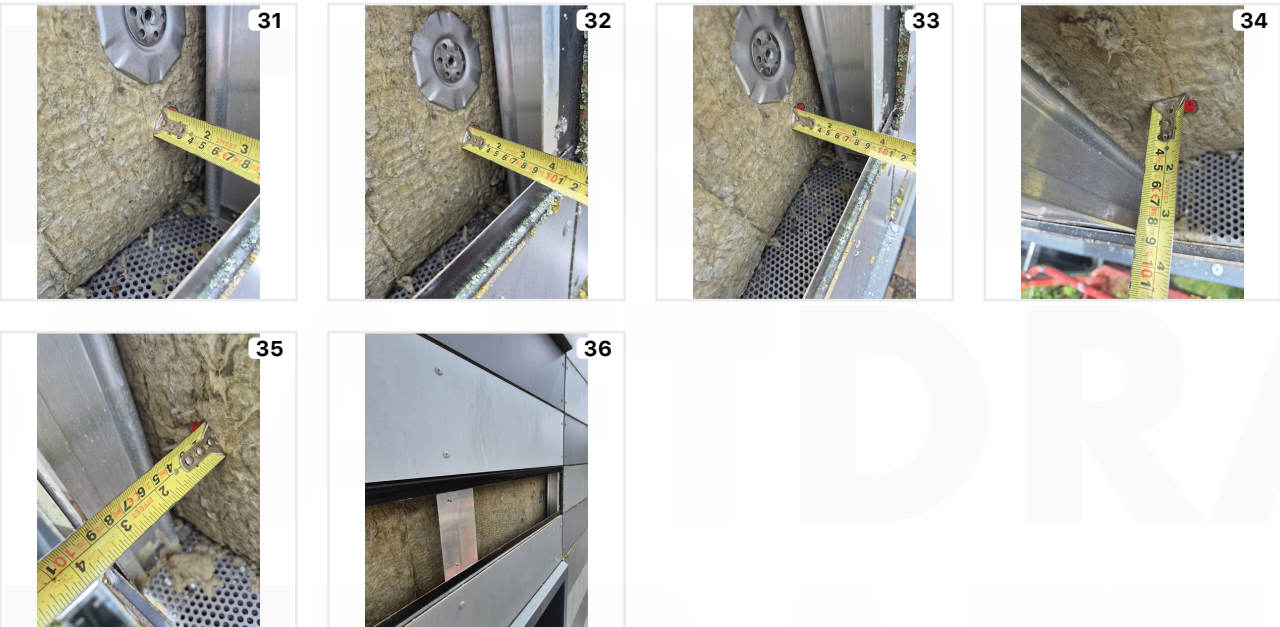
# Inspection: S2U43U

Backing Wall Sits On The Floor Slab

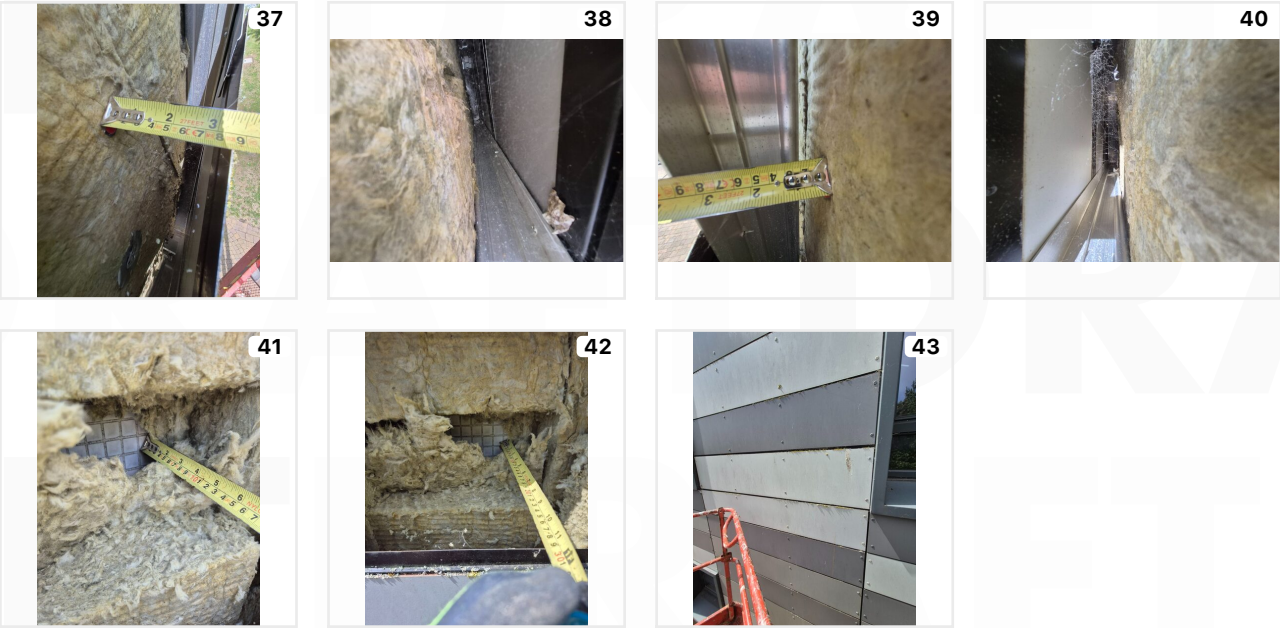
# Inspection: WTSDS6

Backing Wall Sits On The Floor Slab

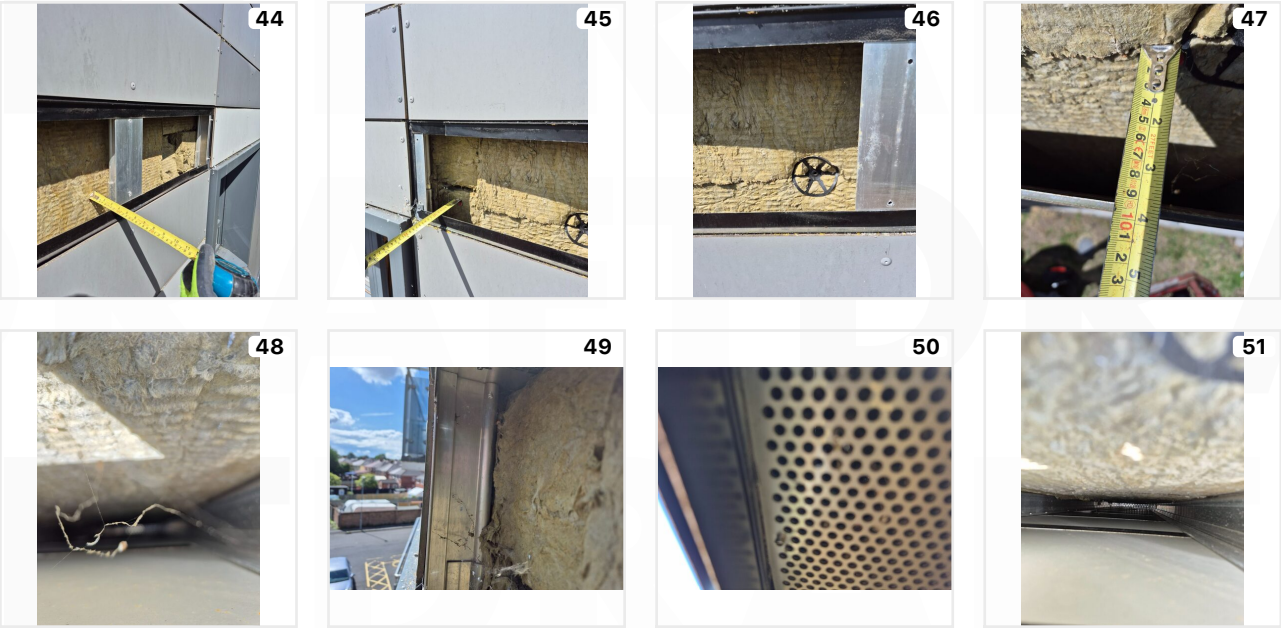
# Inspection: BDKFS3

Backing Wall Sits On The Floor Slab
