Document Version 5  
Survey Date 25/11/2024  
Suggested Review Date 25/11/2029

# FIRE RISK APPRAISAL EXTERNAL WALLS

## LANCASTER HOUSE

Lancaster House  
Oldbury Road  
Oldbury  
West Midlands  
B65 0QE

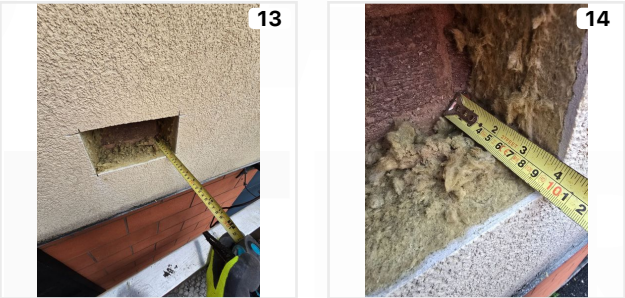
No external cavity

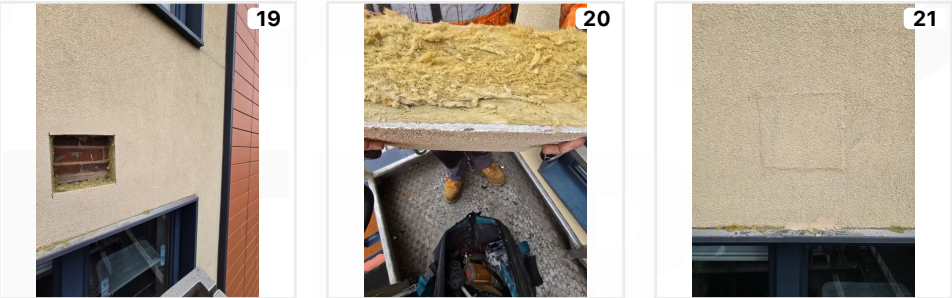
No external cavity
