**FIRNTEC**  
BUILDING COMPLIANCE

# EXTERNAL WALL SURVEY

## LAWRENCE COURT

Kingsway  
Brandhall  
B68 0HB

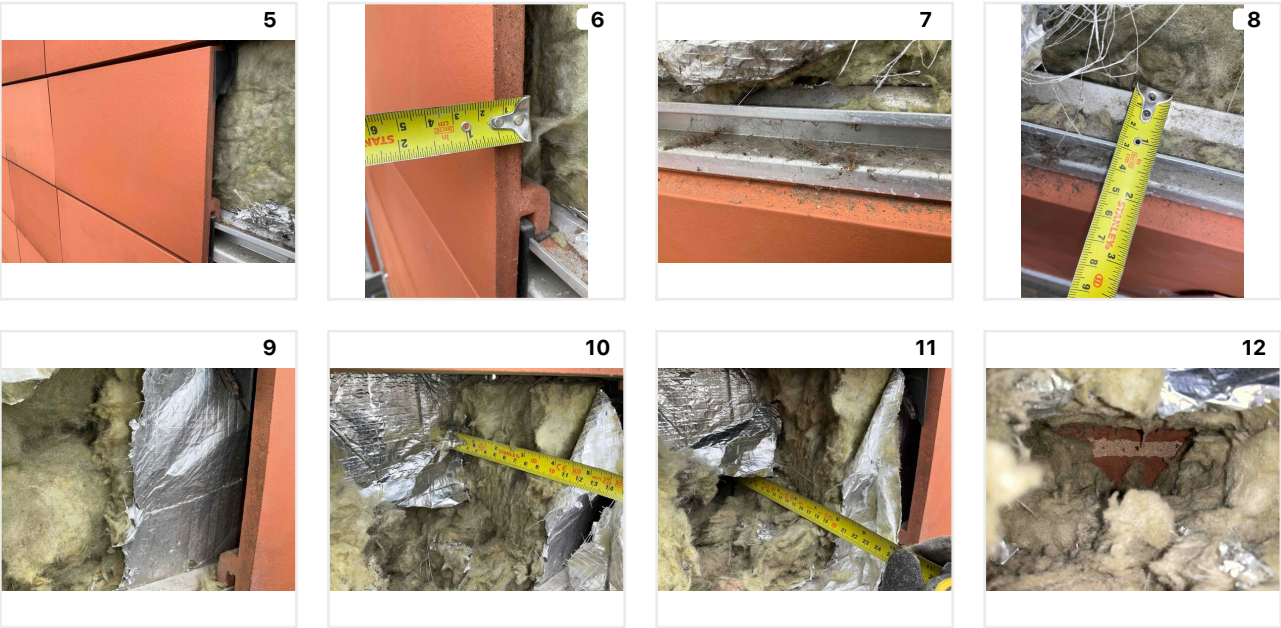
# Inspection: W4GKY2

| 4 Elements | Thickness/Depth | Material | Photo Ref. | Rating (BS EN13501) |
|---|---|---|---|---|
| External Surface Material | 14mm | Terracotta Tile | 5, 6 | A1 - Non-Combustible |
| Framework | 30mm | Aluminium L/T Rail | 7, 8 | A2 - Limited Combustibility |
| Insulation | | Mineral Wool Insulation | 9, 10, 11 | A1 - Non-Combustible |
| Substrate | | Original brickwork | 12 | A1 - Non-Combustible |

| 1 Cavity Barrier | Material | Photo Ref. |
|---|---|---|
| Horizontal Cavity Barrier | Stonewool core, aluminium foil faces | 11 |

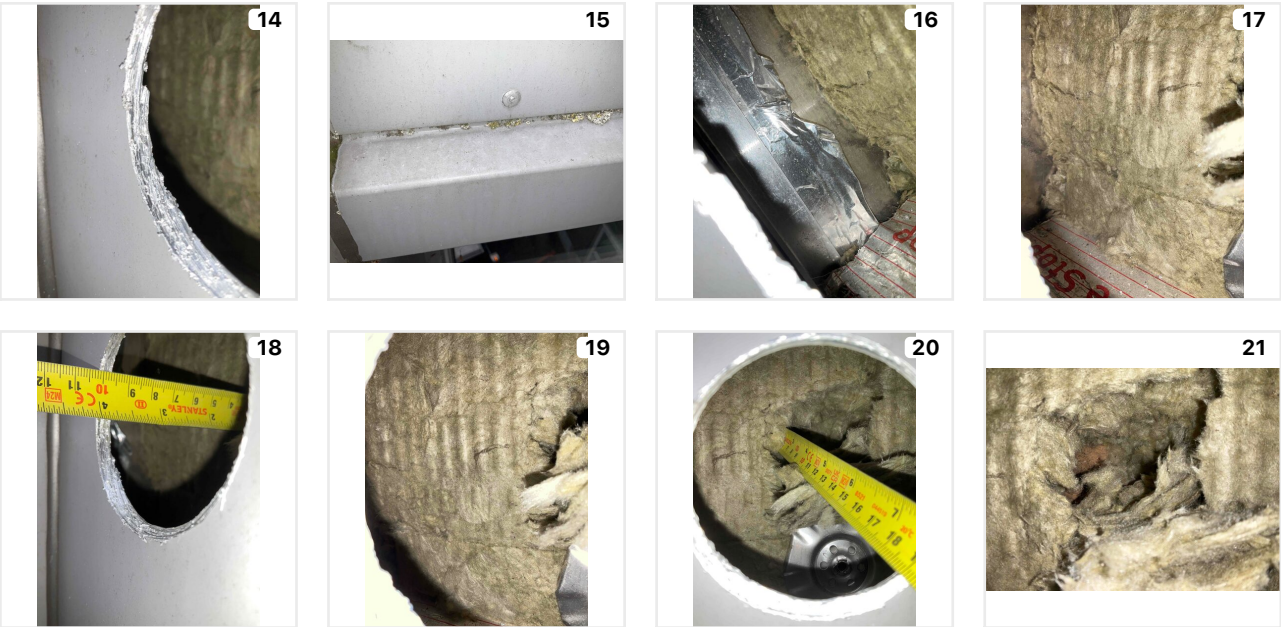
# Inspection: EM4M1L

| 5 Elements | Thickness/Depth | Material | Photo Ref. | Rating (BS EN13501) |
|---|---|---|---|---|
| External Surface Material | 3mm | Aluminium Panel | 14 | A2 - Limited Combustibility |
| Framework | | Aluminium L/T Rail | 15, 16 | A2 - Limited Combustibility |
| Cavity | 98mm | | 17, 18 | |
| Insulation | 100mm | Mineral Wool Insulation | 19, 20 | A1 - Non-Combustible |
| Substrate | | Original brickwork | 21 | A1 - Non-Combustible |

| 1 Cavity Barrier | Material | Photo Ref. |
|---|---|---|
| Horizontal Cavity Barrier | Stonewool core, aluminium foil faces<br>Material Brand: Rockwool | 22, 23 |

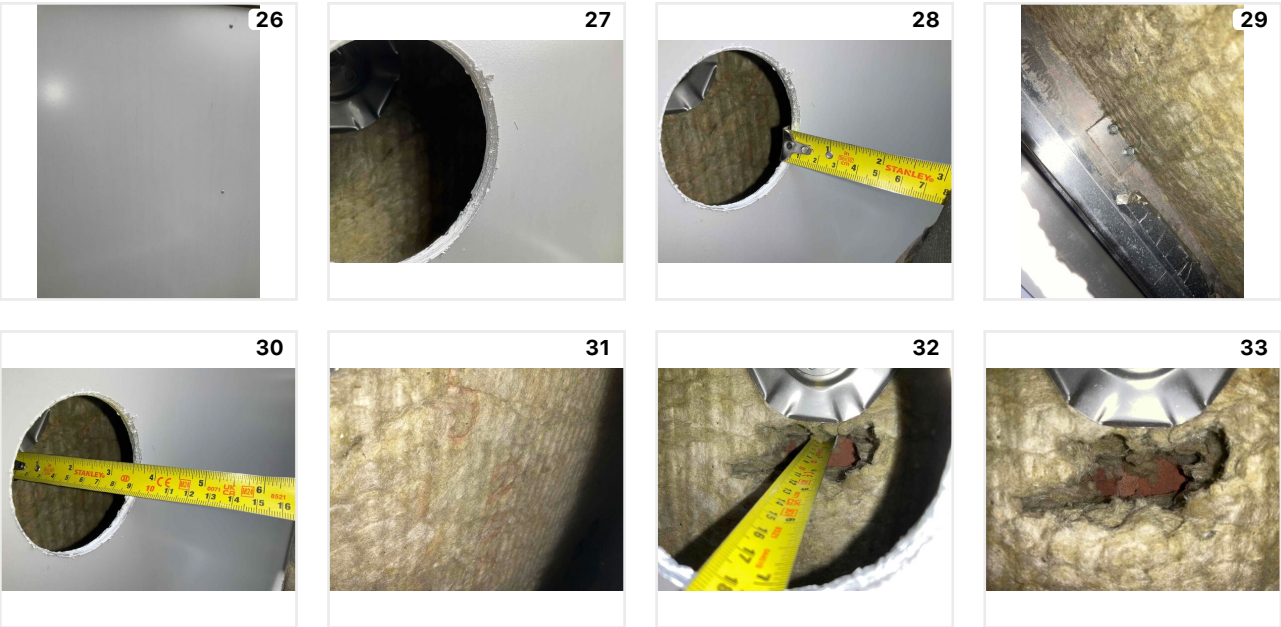
# Inspection: NBKJBS

| 5 Elements | Thickness/Depth | Material | Photo Ref. | Rating (BS EN13501) |
|---|---|---|---|---|
| External Surface Material | 3mm | Aluminium Panel | 26, 27, 28 | A2 - Limited Combustibility |
| Framework | | Aluminium L/T Rail | 29 | A2 - Limited Combustibility |
| Cavity | 85mm | | 30 | |
| Insulation | 100mm | Mineral Wool Insulation | 31, 32 | A1 - Non-Combustible |
| Substrate | | Original brickwork | 33 | A1 - Non-Combustible |

| 1 Cavity Barrier | Material | Photo Ref. |
|---|---|---|
| Horizontal Cavity Barrier | Stonewool core, aluminium foil faces | 34 |

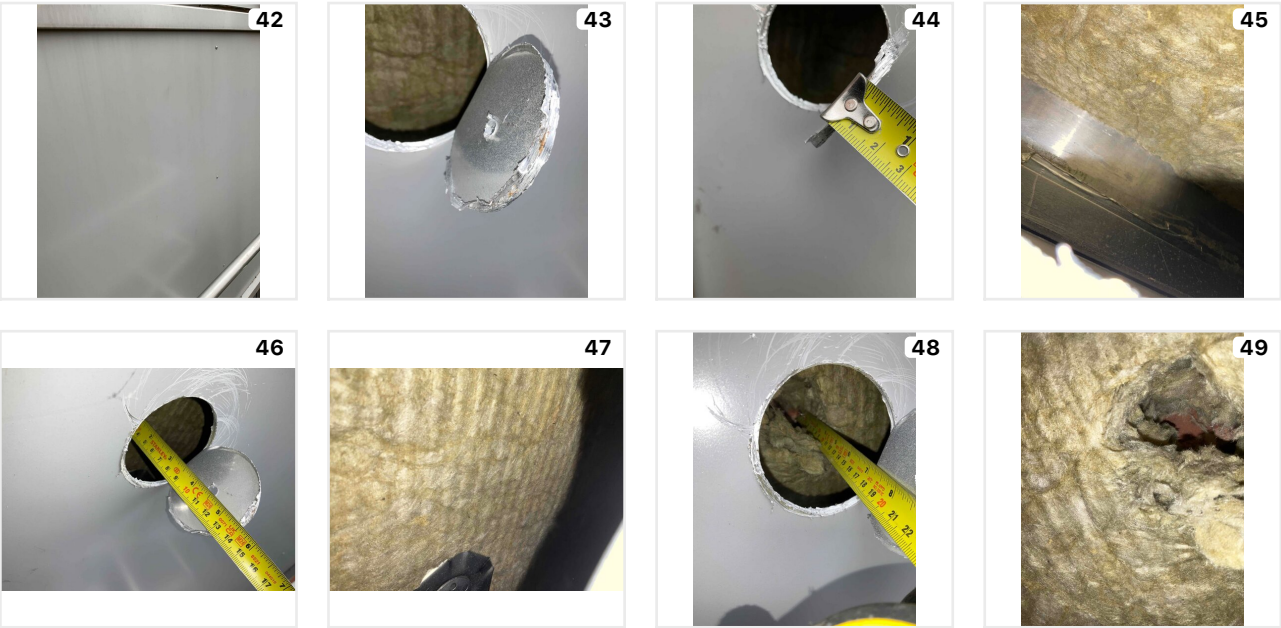
# Inspection: 2BC9YL

| 5 Elements | Thickness/Depth | Material | Photo Ref. | Rating (BS EN13501) |
|---|---|---|---|---|
| External Surface Material | 3mm | Aluminium Panel | 42, 43, 44 | A2 - Limited Combustibility |
| Framework | | Aluminium L/T Rail | 45 | A2 - Limited Combustibility |
| Cavity | 82mm | | 46 | |
| Insulation | 100mm | Mineral Wool Insulation | 47, 48 | A1 - Non-Combustible |
| Substrate | | Original brickwork | 49 | A1 - Non-Combustible |
