Document Version 1  
Survey Date 15/09/2025  
Suggested Review Date 15/09/2030

# FIRE RISK APPRAISAL EXTERNAL WALLS

## LAWRENCE COURT

Kingsway  
Brandhall  
B68 0HB

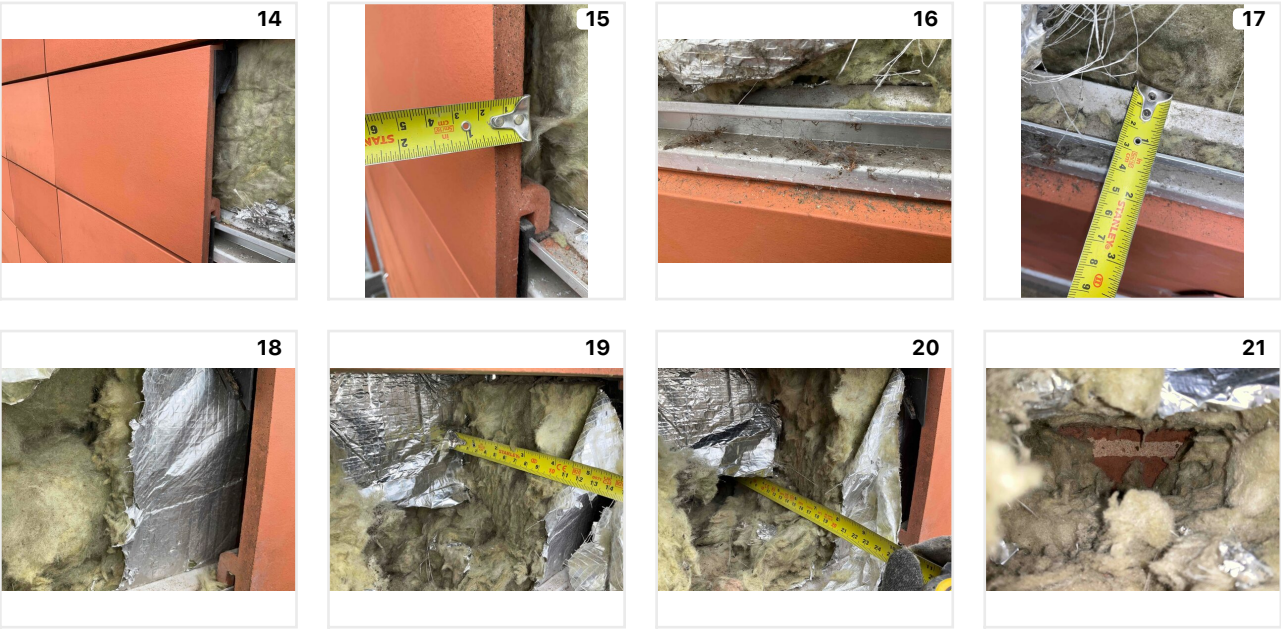
Build-up Photos

Reinforced concrete

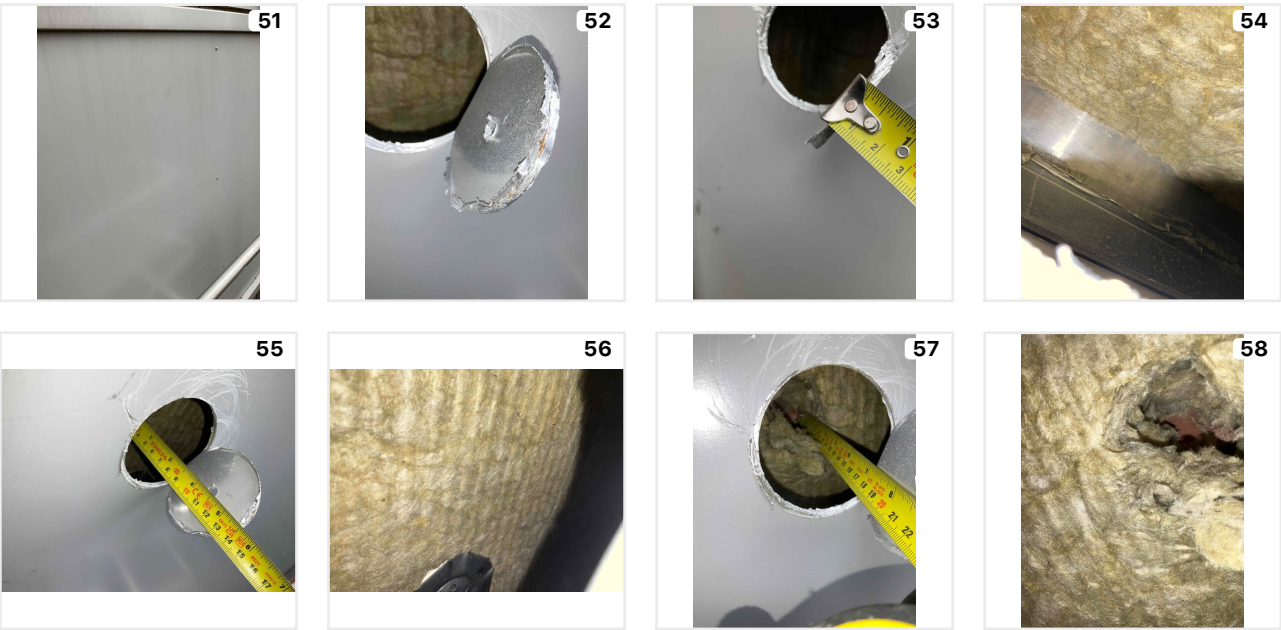
Build-up Photos

Backing Wall Sits On The Floor Slab
