**FIRNTEC**  
BUILDING COMPLIANCE

# EXTERNAL WALL SURVEY

## MACAULAY HOUSE

Macaulay House  
Glover Street  
West Brom  
B70 6DY

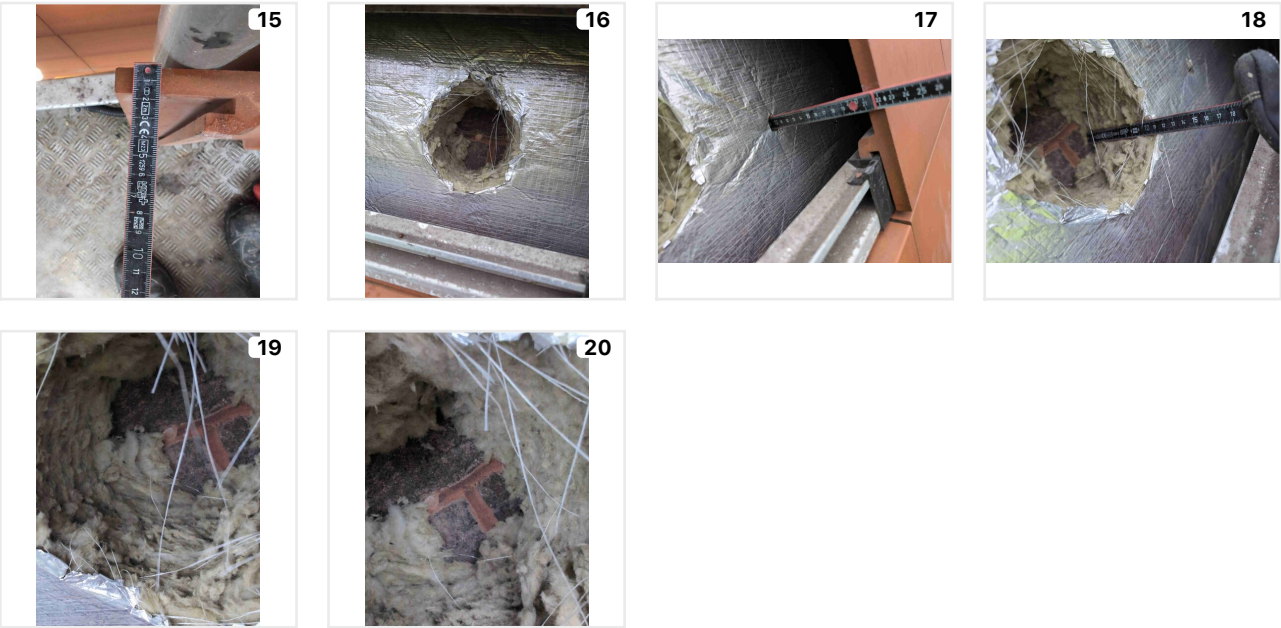
| 4 Elements | Thickness/Depth | Material | Photo Ref. | Rating (BS EN13501) |
|---|---|---|---|---|
| Surface Finish | 16mm | Terracotta tile | 15 | A1 - Non-Combustible |
| Cavity | 210mm | | 16, 17 | |
| Insulation | 100mm | Mineral Wool Insulation | 18, 19 | A1 - Non-Combustible |

| 1 Cavity Barrier | Material | Photo Ref. |
|---|---|---|
| Horizontal Cavity Barrier | Stonewool core, aluminium foil faces | 16 |

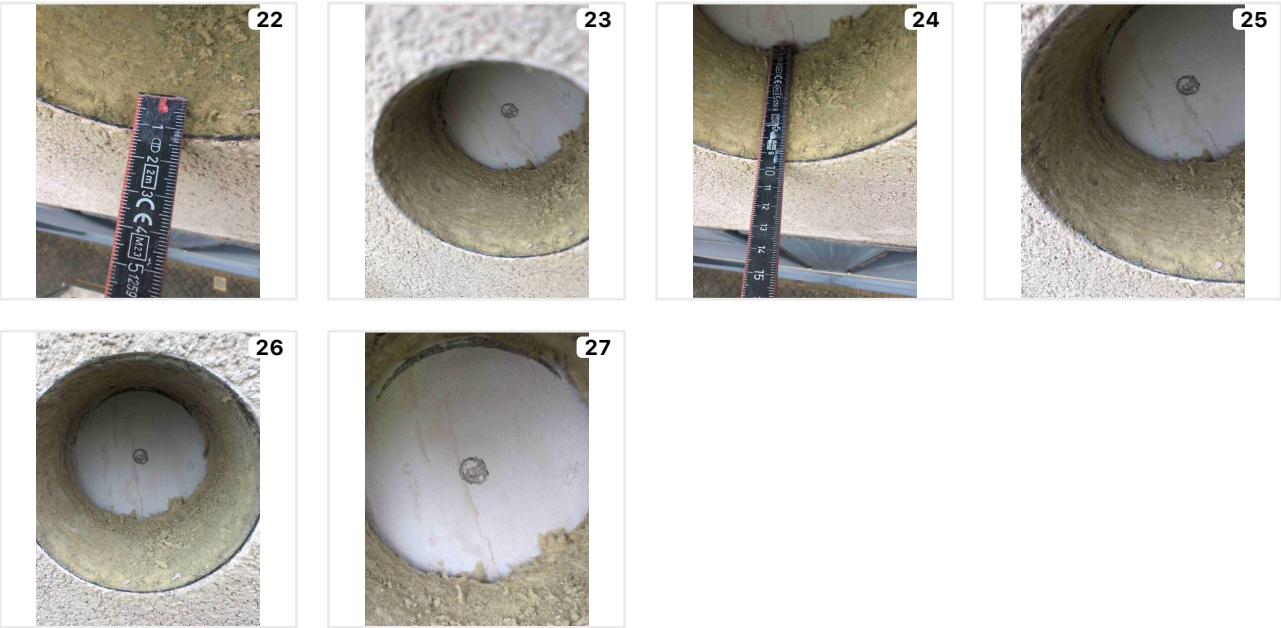
Render on to slab

| 3 Elements | Thickness/Depth | Material | Photo Ref. | Rating (BS EN13501) |
|---|---|---|---|---|
| Surface Finish | 4mm | Sto render | 22, 23 | A1 - Non-Combustible |
| Insulation | 90mm | Mineral Wool Insulation | 24, 25 | A1 - Non-Combustible |
| Inner Leaf | | Reinforced concrete<br>Material Brand:<br>Concrete | 26, 27 | A1 - Non-Combustible |

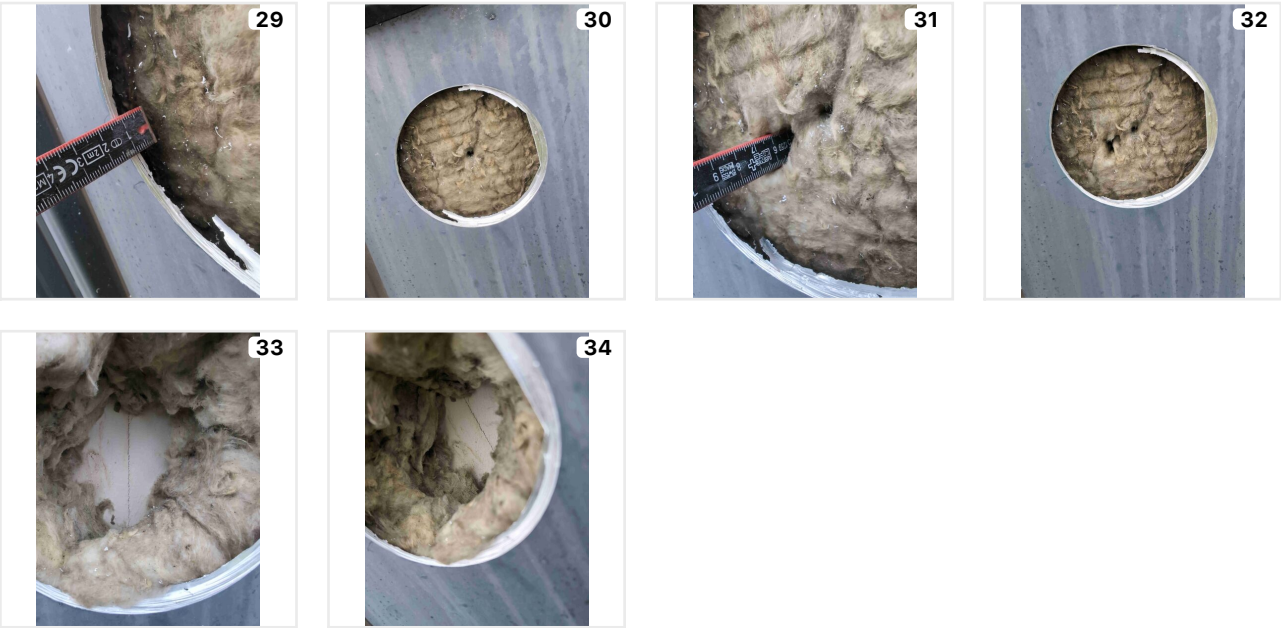
| 3 Elements | Thickness/Depth | Material | Photo Ref. | Rating (BS EN13501) |
|---|---|---|---|---|
| Surface Finish | 4mm | Aluminium panel | 29, 30 | A1 - Non-Combustible |
| Insulation | 60mm | Mineral Wool Insulation | 31, 32 | A1 - Non-Combustible |
| Inner Leaf | | Reinforced concrete | 33, 34 | A1 - Non-Combustible |

| 1 Cavity Barrier | Material | Photo Ref. |
|---|---|---|
| Horizontal Cavity Barrier | Solid State Mineral Wool | 30 |

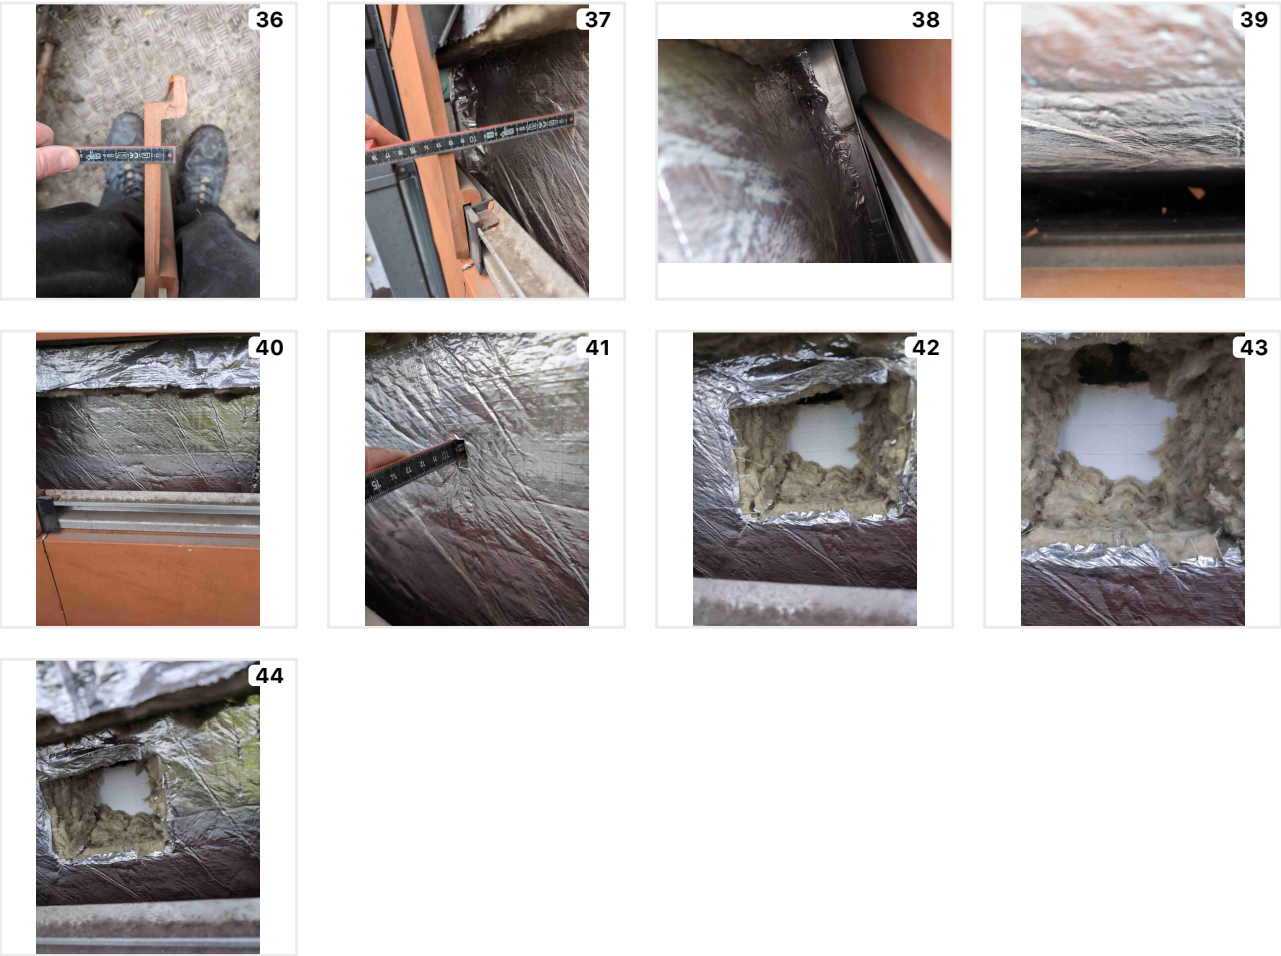
| 4 Elements | Thickness/Depth | Material | Photo Ref. | Rating (BS EN13501) |
|---|---|---|---|---|
| Surface Finish | 16mm | Terracotta tile | 36 | A1 - Non-Combustible |
| Cavity | 120mm | | 37, 38, 39 | |
| Insulation | 90mm | Mineral Wool Insulation | 40, 41, 42 | A1 - Non-Combustible |
| Inner Leaf | | Reinforced concrete | 43, 44 | A1 - Non-Combustible |

| 1 Cavity Barrier | Material | Photo Ref. |
|---|---|---|
| Horizontal Cavity Barrier | Stonewool core, aluminium foil faces | 45 |

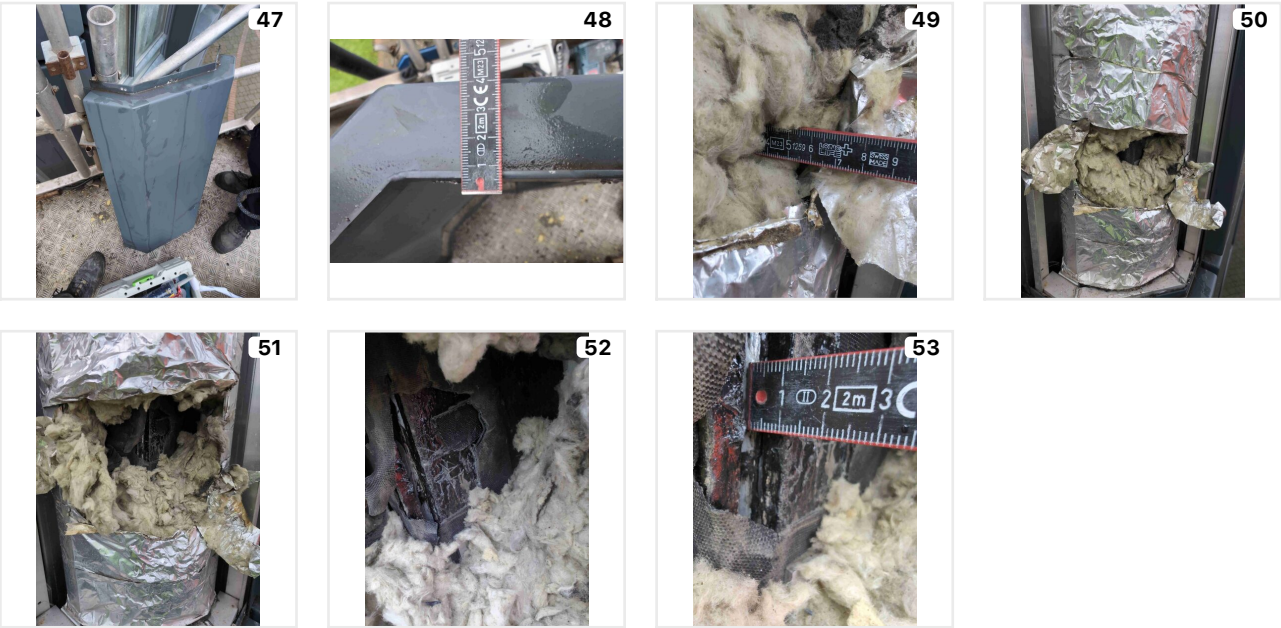
| 3 Elements | Thickness/Depth | Material | Photo Ref. | Rating (BS EN13501) |
|---|---|---|---|---|
| Surface Finish | 3mm | Aluminium panel | 47, 48 | A1 - Non-Combustible |
| Insulation | 40mm | Mineral Wool Insulation | 49, 50 | A1 - Non-Combustible |
| Inner Leaf | 10mm | Reinforced concrete | 51, 52, 53 | A1 - Non-Combustible |

Concrete wall with steel beam.
