Document Version 3  
Survey Date 13/02/2025  
Suggested Review Date 13/02/2030

# EXTERNAL WALL SURVEY

## ASPEN HOUSE

Aspen House  
Meadow Avenue  
West Brom  
B71 3EN

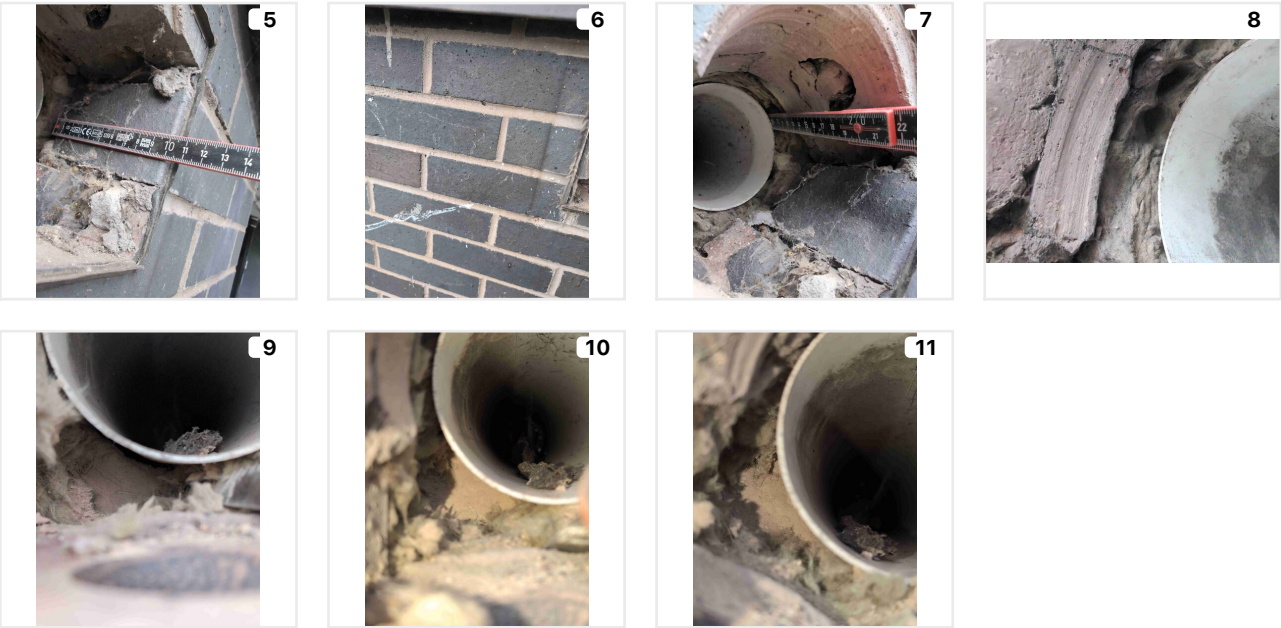
# Inspection: YMZNXE

BRICKWORK - WEST ELEVATION

| 3 Elements | Thickness/Depth | Material | Photo Ref. | Rating (BS EN13501) |
|---|---|---|---|---|
| Surface Finish | 100mm | Brickwork | 5, 6 | A1 - Non-Combustible |
| Insulation | 90mm | Mineral Wool Insulation | 7, 8 | A1 - Non-Combustible |
| Inner Leaf<br>Support (Backing<br>Wall) | | Concrete slab | 9, 10, 11 | |

| 1 Cavity Barrier | Material | Photo Ref. |
|---|---|---|
| Horizontal Cavity Barrier | Solid State Mineral Wool | |

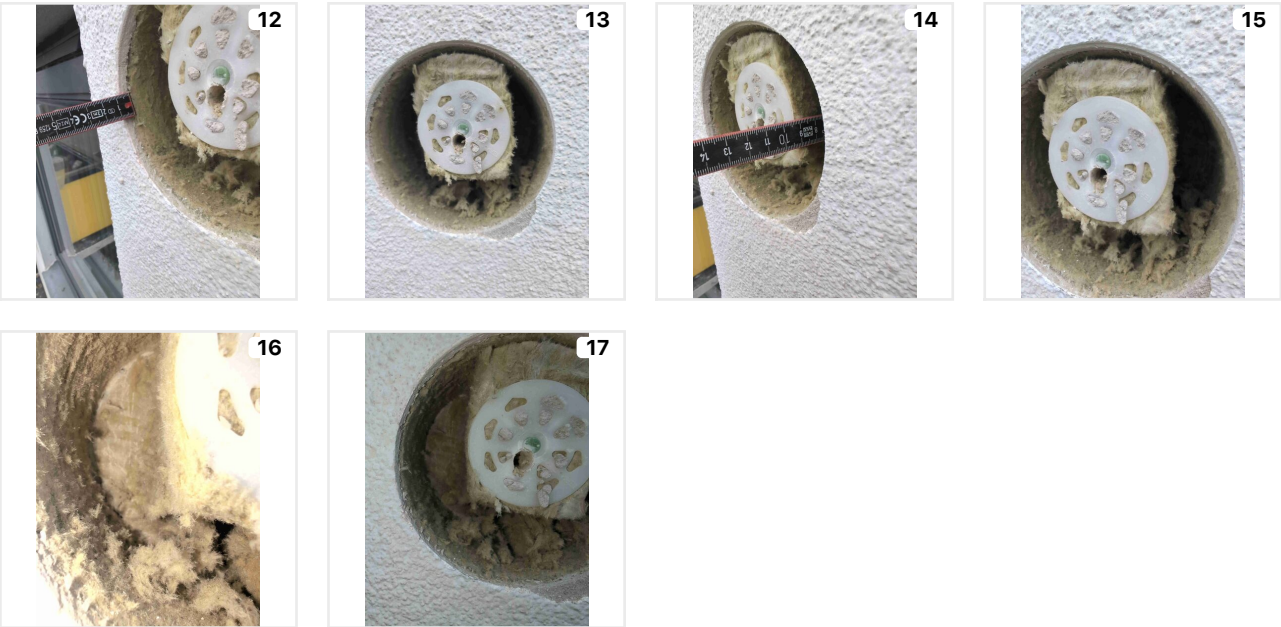
# Inspection: FQTR57

RENDER SYSTEM - WEST ELEVATION

Location moved due to restricted access on mewt.

| 3 Elements | Thickness/Depth | Material | Photo Ref. | Rating (BS EN13501) |
|---|---|---|---|---|
| Surface Finish | 9mm | Sto render | 12, 13 | A1 - Non-Combustible |
| Insulation | 90mm | Mineral Wool Insulation | 14, 15 | A1 - Non-Combustible |
| Inner Leaf<br>Support (Backing<br>Wall) | | Concrete wall | 16, 17 | A1 - Non-Combustible |

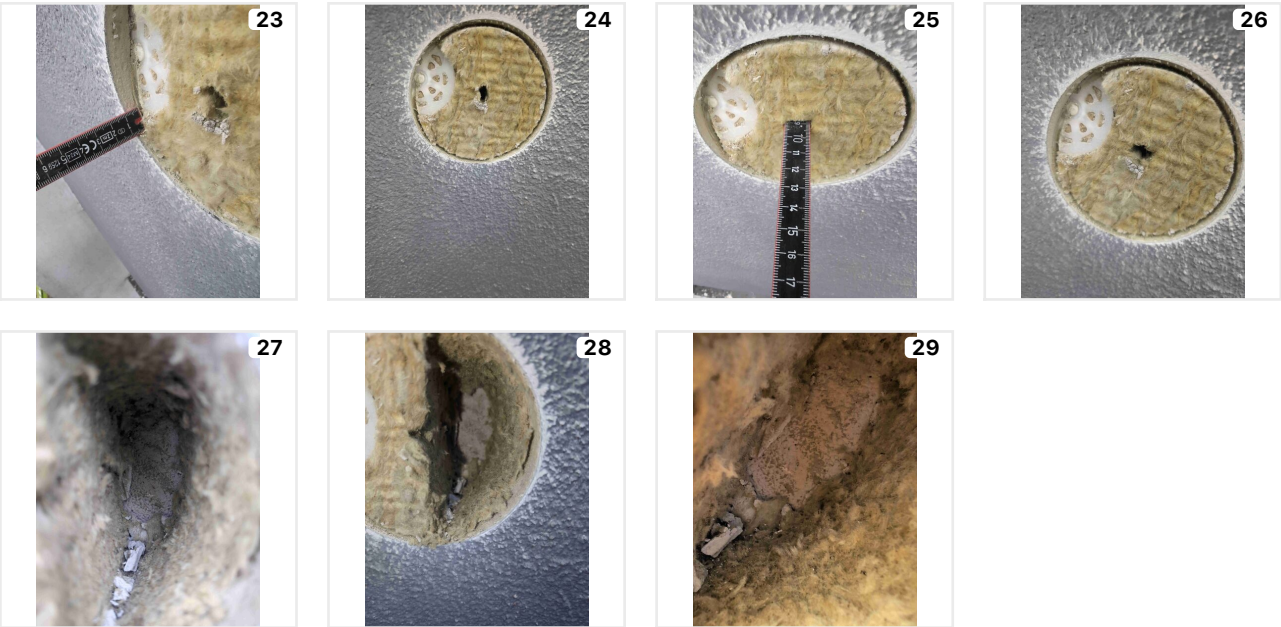
# Inspection: 9YWVZM

Render section under window

Render not spandrel.

| 3 Elements | Thickness/Depth | Material | Photo Ref. | Rating (BS EN13501) |
|---|---|---|---|---|
| Surface Finish | 9mm | Sto render | 23, 24 | A1 - Non-Combustible |
| Insulation | 90mm | Mineral Wool Insulation | 25, 26 | A1 - Non-Combustible |
| Inner Leaf<br>Support (Backing<br>Wall) | | Reinforced concrete | 27, 28, 29 | A1 - Non-Combustible |

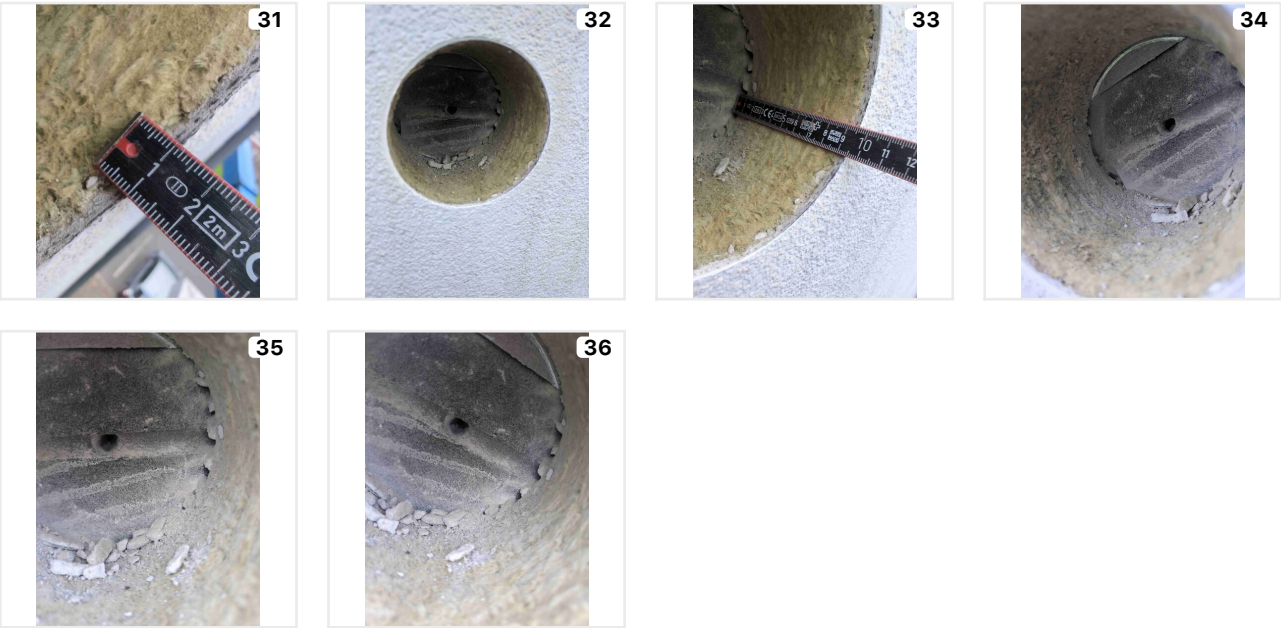
# Inspection: WNPW8C

RENDER SYSTEM - NORTH ELEVATION

| 3 Elements | Thickness/Depth | Material | Photo Ref. | Rating (BS EN13501) |
|---|---|---|---|---|
| Surface Finish | 9mm | Sto render | 31, 32 | A1 - Non-Combustible |
| Insulation | 90mm | Mineral Wool Insulation | 33, 34 | A1 - Non-Combustible |
| Inner Leaf<br>Support (Backing<br>Wall) | | Reinforced concrete | 35, 36 | A1 - Non-Combustible |

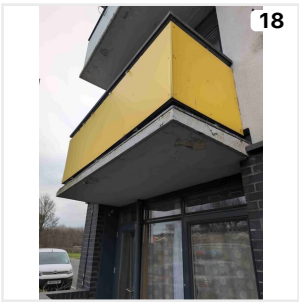
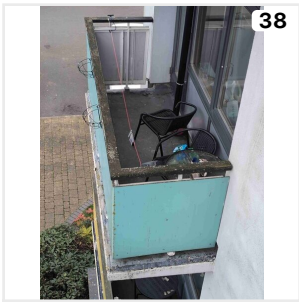
# Attachment: Cantilever Balcony

Reinforced concrete framework extension of the floor slab

Steel handrail and balusters with suspected HPL panels

Trespa HPL panels to balconies. Fire classification B-s1, d0.
