Document Version 2  
Survey Date 26/03/2025  
Suggested Review Date 26/03/2030

# FIRE RISK APPRAISAL EXTERNAL WALLS

## ASPEN HOUSE

Aspen House  
Meadow Avenue  
West Brom  
B71 3EN

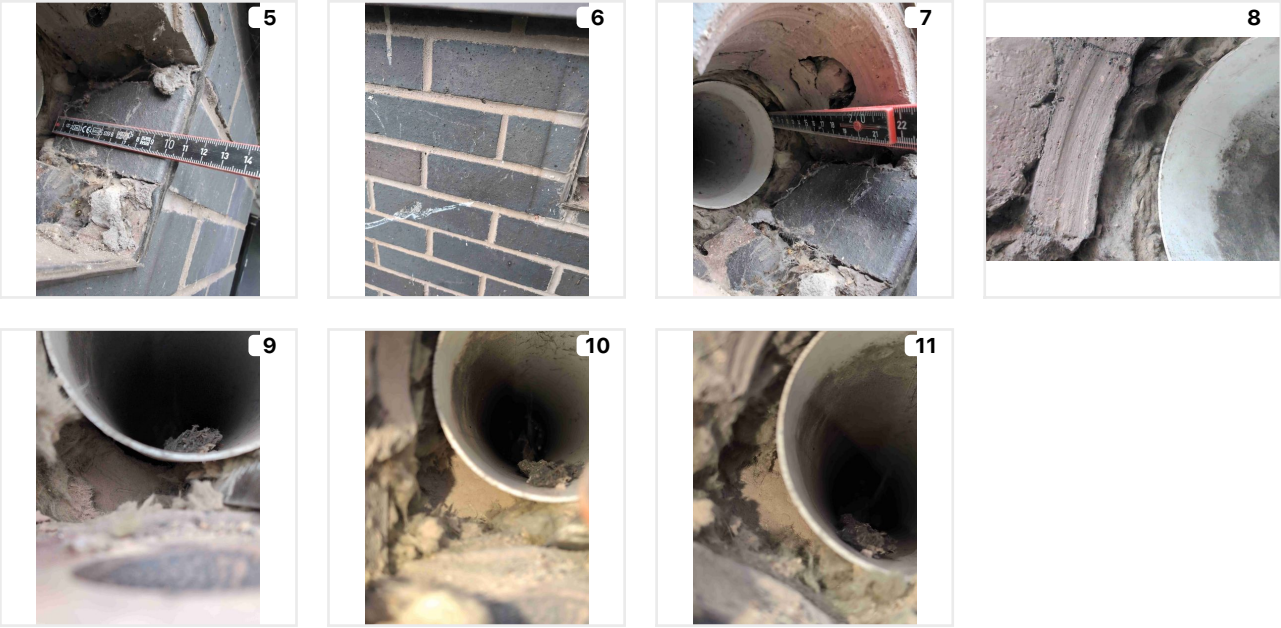
Cut out 3/4 bricks to expose construction behind.  
Inspect the construction, cavity, insulation, junction with compartment floor slab, junction at compartment wall and window opening.  
Replace any insulation removed with new.  
Replace bricks with existing or new as required and mortar. We will match existing bricks and mortar as best as possible but cannot guarantee a perfect match. Access provided by lorry mounted cherry picker 21m height capacity by Firntec.

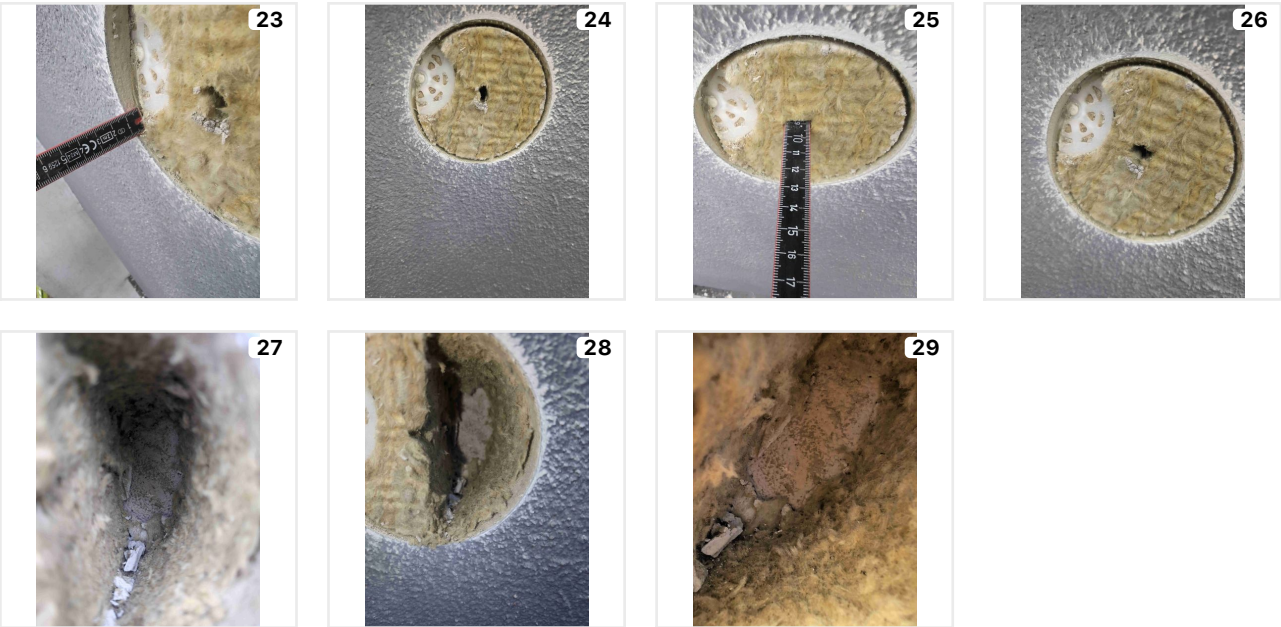
Elevation • Location  
WEST 2 • Balcony soffit

PANELS/SOFFIT  
Remove panel to expose the construction behind.  
Inspect the construction, cavity, insulation and inner skin.  
Replace any insulation removed with existing or new if required.  
Replace panel.

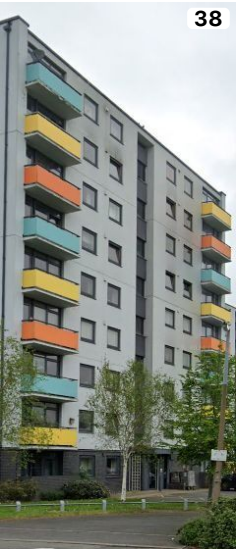
**Cantilever Balcony (UEK477)**

| 6 Items | Effect | Risk |
|---|---|---|
| Attachment<br>Cantilever Balcony (UEK477) | Neutral | Medium |

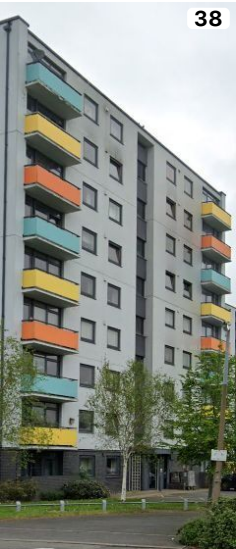
Top, Mid, Side Hung Casements (NQ8M5D)

Windows are A1 aluminium framework, aluminium is a soft metal that has a low melting point. As such this material is able to perform in temperatures between 400°C and 600°C, after which the metal will start to melt. Although it will not combust it will form molten droplets which may fall and ignite combustible materials below to cause secondary fires.
