Survey Date 01/05/2025

# EXTERNAL WALL SURVEY

## BEECH HOUSE

Meadow Avenue  
West Brom  
B71 3EJ

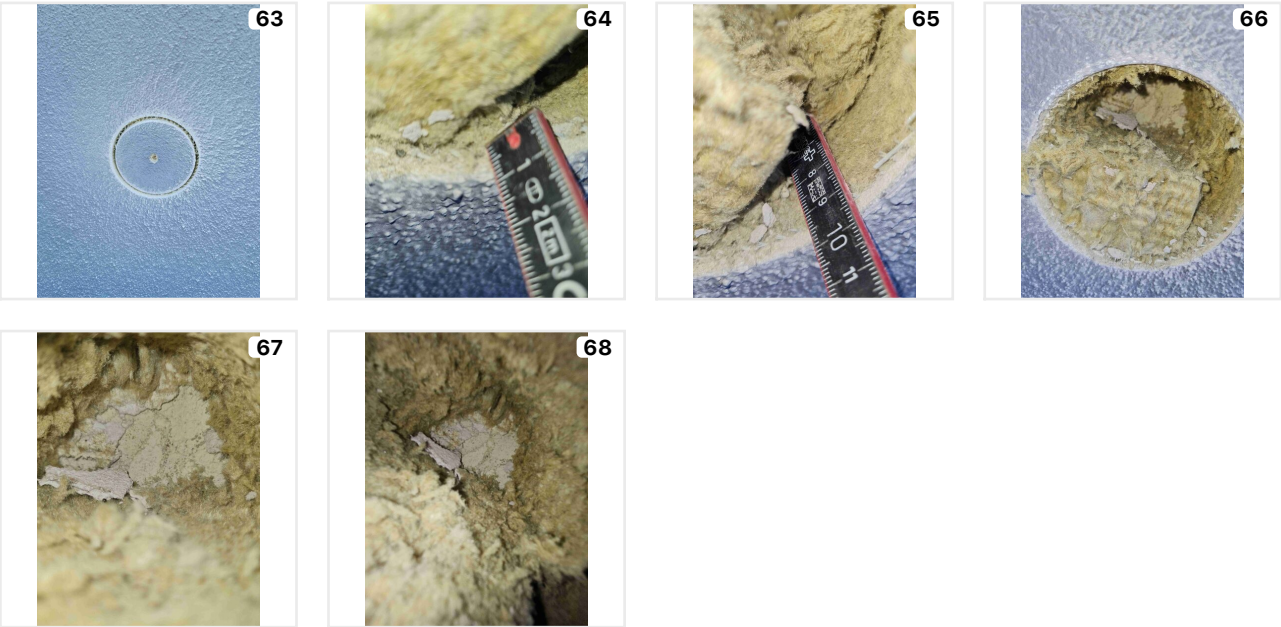
# Inspection: MW8XHL

| 3 Elements | Thickness/Depth | Material | Photo Ref. |
|---|---|---|---|
| Surface Finish | 9mm | Sto render | 63, 64 |
| Insulation | 90mm | Mineral wool | 65, 66 |
| Inner Leaf | | Concrete wall | 67, 68 |

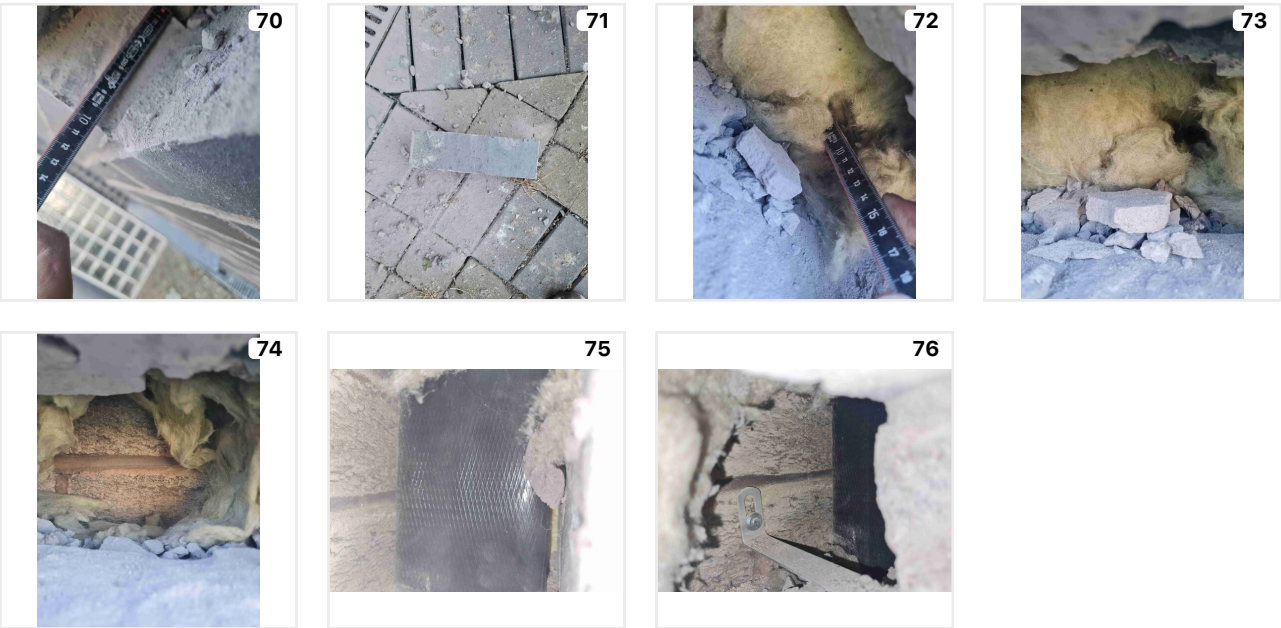
# Inspection: Q8W9CL

| 3 Elements | Thickness/Depth | Material | Photo Ref. |
|---|---|---|---|
| Surface Finish | 100mm | Brickwork | 70, 71 |
| Insulation | 90mm | Mineral wool | 72, 73 |
| Inner Leaf | | Blockwork | 74, 75, 76 |

Black membrane around window

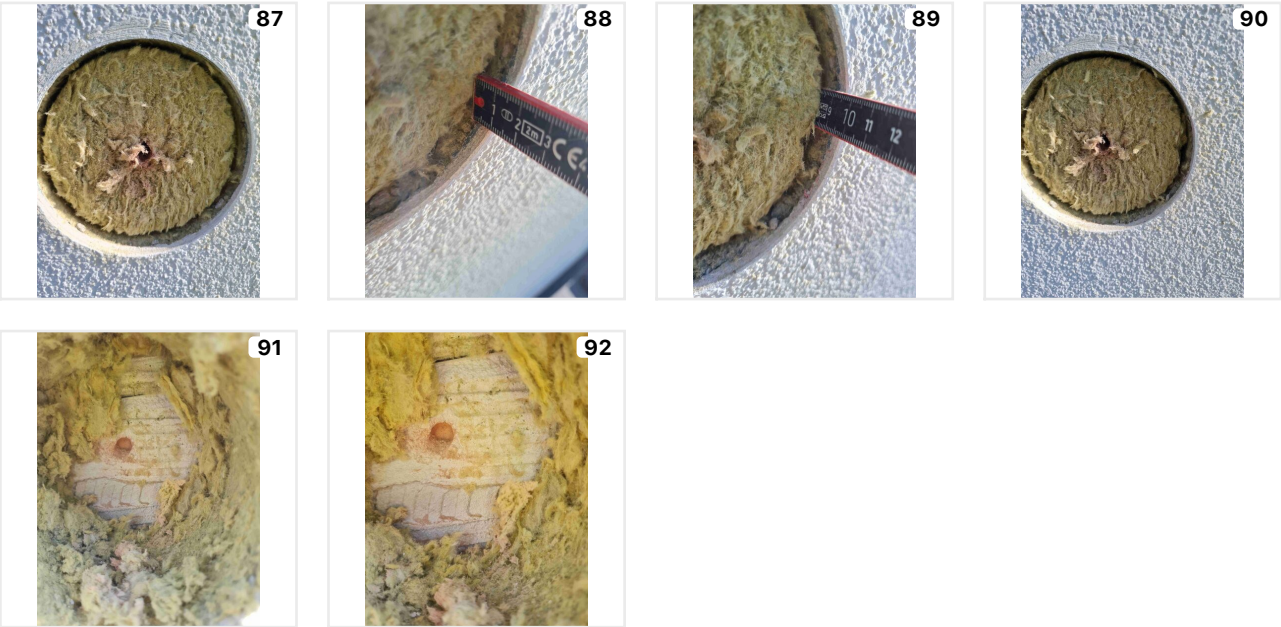
# Inspection: 1I9RT3

| 3 Elements | Thickness/Depth | Material | Photo Ref. |
|---|---|---|---|
| Surface Finish | 9mm | Sto render | 87, 88 |
| Insulation | 90mm | Mineral wool | 89, 90 |
| Inner Leaf | | Concrete wall | 91, 92 |

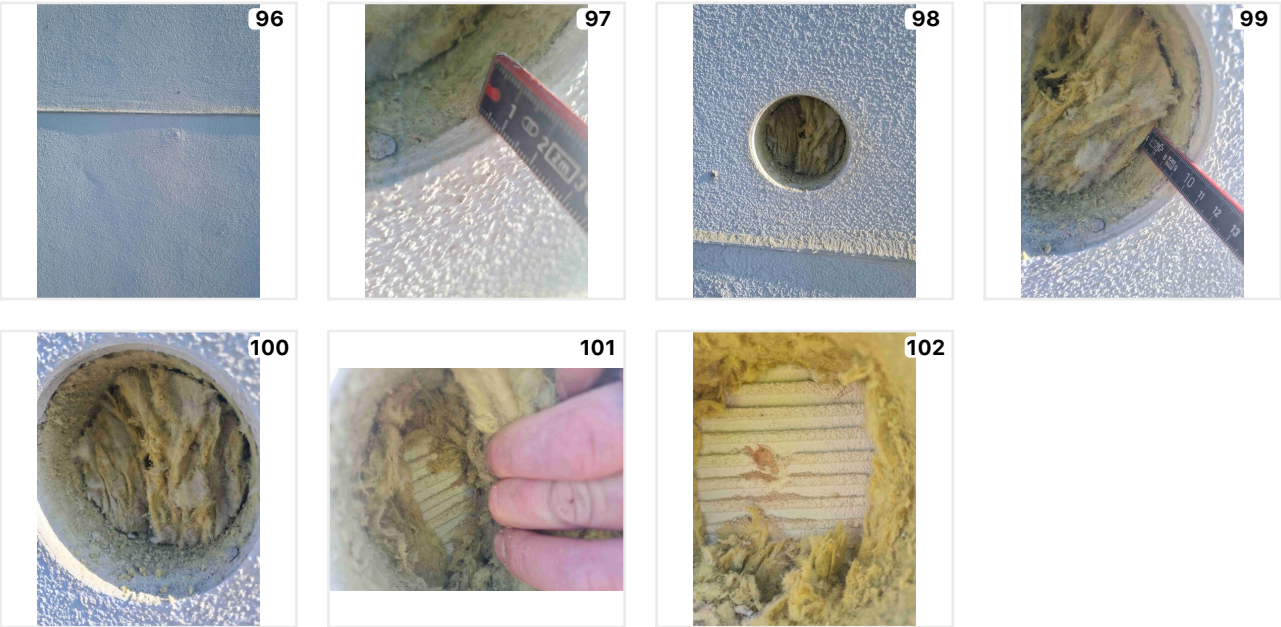
# Inspection: XJ5ANA

| 3 Elements | Thickness/Depth | Material | Photo Ref. |
|---|---|---|---|
| Surface Finish | | Sto render | 96, 97, 98 |
| Insulation | 90mm | Mineral wool | 99, 100 |
| Inner Leaf | | Concrete wall | 101, 102 |
