Survey Date 01/05/2025

# EXTERNAL WALL SURVEY

## WILLOW HOUSE

Meadow Avenue  
West Brom  
B71 3EN

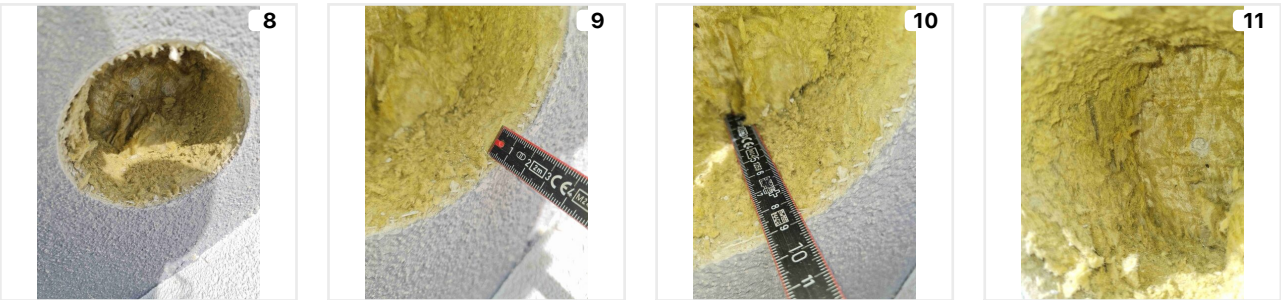
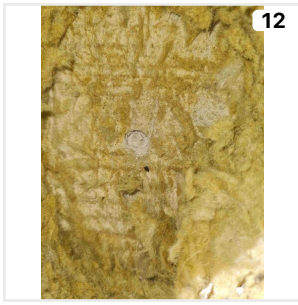
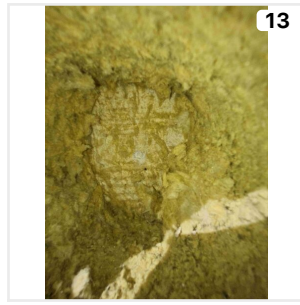
# Inspection: SM4SVF

Rainscreen

No access due to cars o  
Parked at front of the building

| 3 Elements | Thickness/Depth | Material | Photo Ref. |
|---|---|---|---|
| Surface Finish | 9mm | Sto render | 8, 9 |
| Insulation | 90mm | Mineral wool | 10, 11 |
| Inner Leaf | | Concrete wall | 12, 13 |

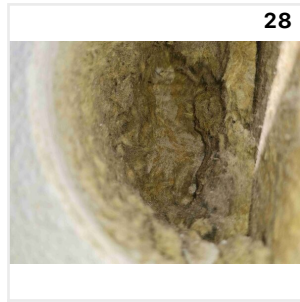
# Inspection: J6VZDA

Render

No access due to cars parked at the front of the building

| 3 Elements | Thickness/Depth | Material | Photo Ref. |
|---|---|---|---|
| Surface Finish | 9mm | Sto render | 23, 24 |
| Insulation | 90mm | Mineral wool | 25, 26 |
| Inner Leaf | | Concrete wall | 27, 28 |

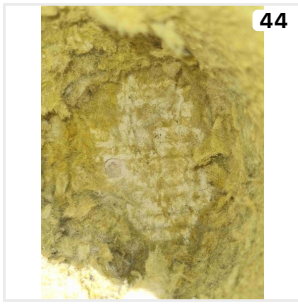
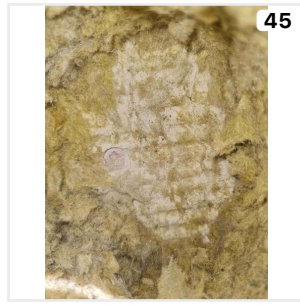
# Inspection: 62EZ23

Render

No access to elevation with mewt due yo garages

| 3 Elements | Thickness/Depth | Material | Photo Ref. |
|---|---|---|---|
| Surface Finish | 9mm | Sto render | 40, 41 |
| Insulation | 90mm | Mineral wool | 42, 43 |
| Inner Leaf | | Concrete wall | 44, 45 |

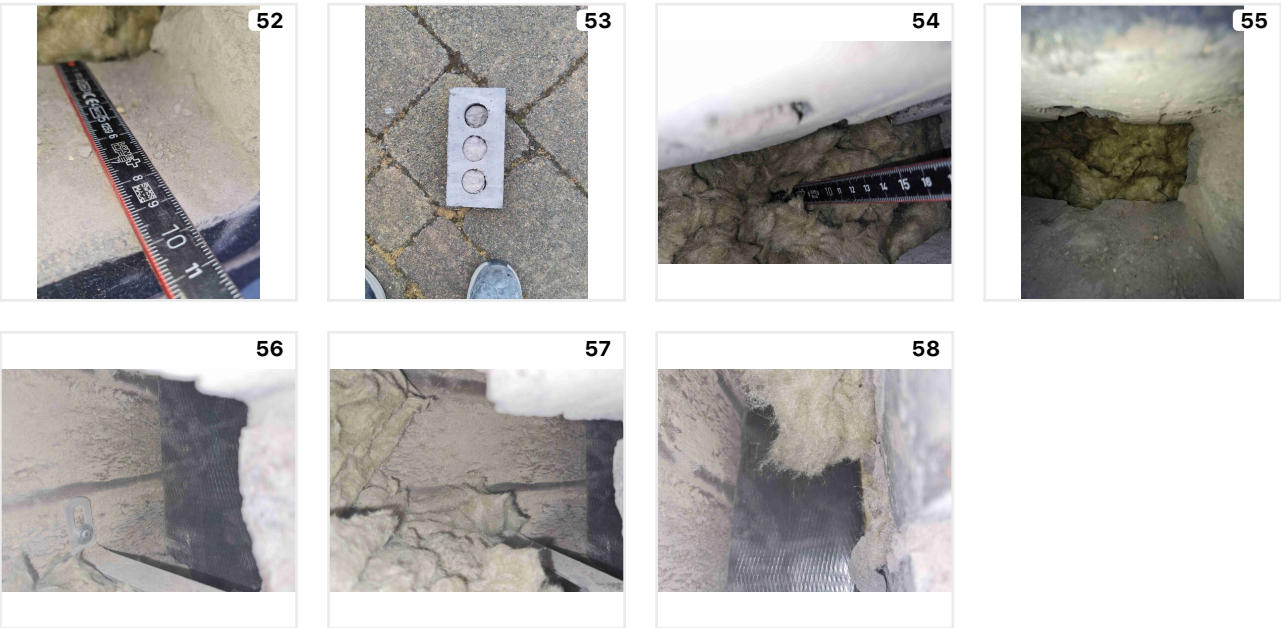
# Inspection: LXBR7S

Masonry

| 3 Elements | Thickness/Depth | Material | Photo Ref. |
|---|---|---|---|
| Surface Finish | 100mm | Brick | 52, 53 |
| Insulation | 90mm | Mineral wool | 54, 55 |
| Inner Leaf | | Concrete wall | 56, 57, 58 |

Membrane around window
