**FIRNTEC**  
BUILDING COMPLIANCE

# FIRE RISK APPRAISAL EXTERNAL WALLS

## WILLOW HOUSE

Meadow Avenue  
West Brom  
B71 3EN

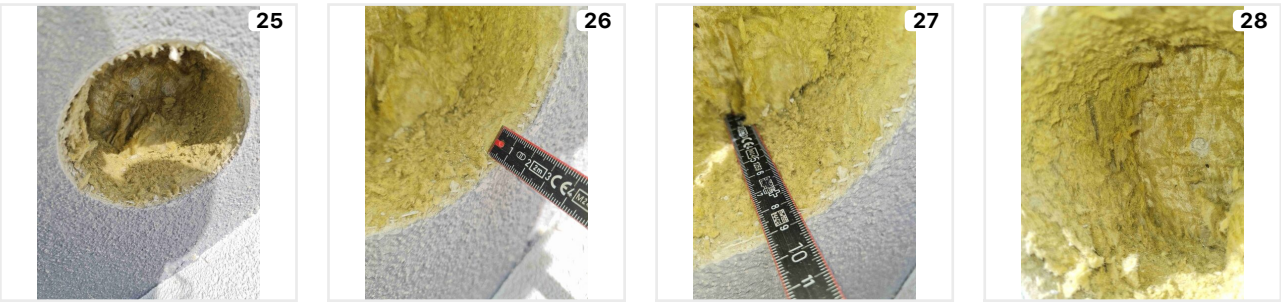
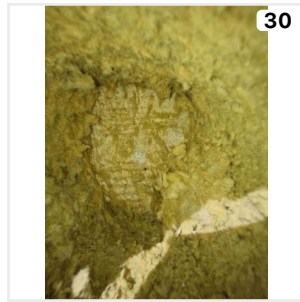
## Build-up Photos

| 3 Elements | Thickness/Depth | Material | Photo Ref. | Rating (BS EN13501) |
|---|---|---|---|---|
| Inner Leaf | | Concrete wall | 29, 30 | A1 - Non-Combustible |

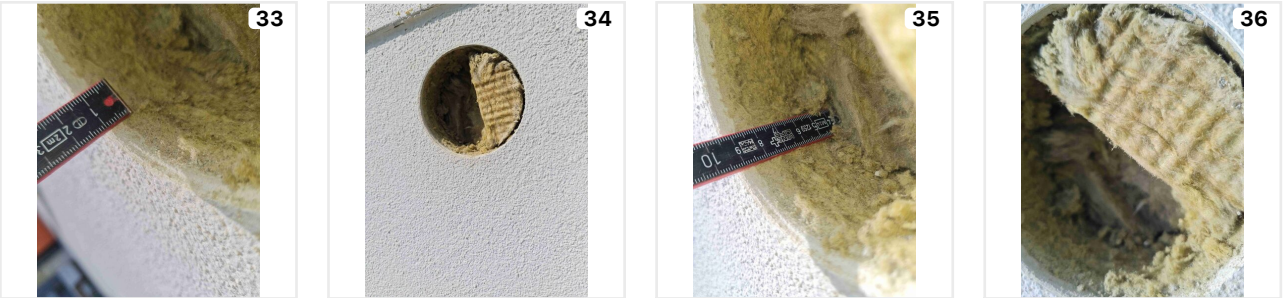
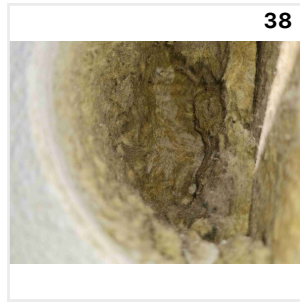
## Build-up Photos

Elevation • Location  
Wall Inspection • Ventilation Outlet and floor slab

| 3 Elements | Thickness/Depth | Material | Photo Ref. | Rating (BS EN13501) |
|---|---|---|---|---|
| Inner Leaf | | Concrete wall | 37, 38 | A1 - Non-Combustible |

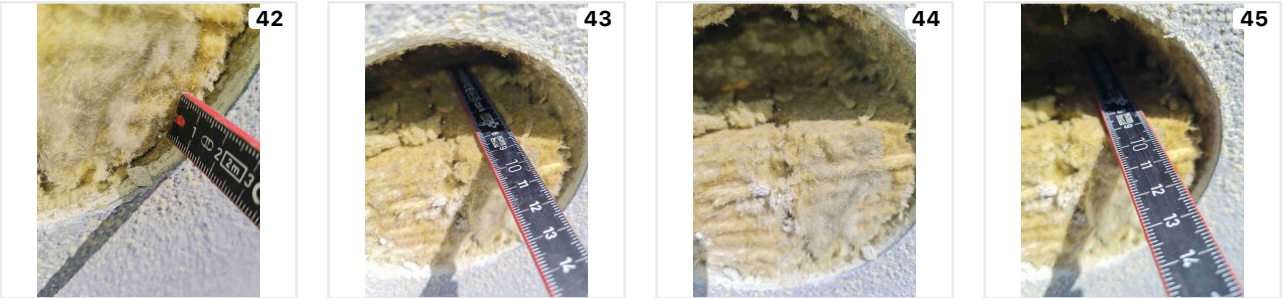
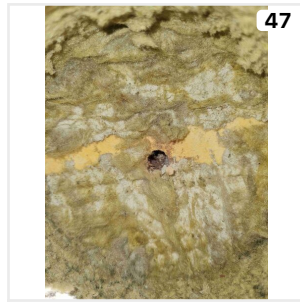
## Build-up Photos

Elevation • Location  
Wall Inspection • Compartment Floor Junction

| 3 Elements | Thickness/Depth | Material | Photo Ref. | Rating (BS EN13501) |
|---|---|---|---|---|
| Inner Leaf | | Concrete wall | 46, 47 | A1 - Non-Combustible |

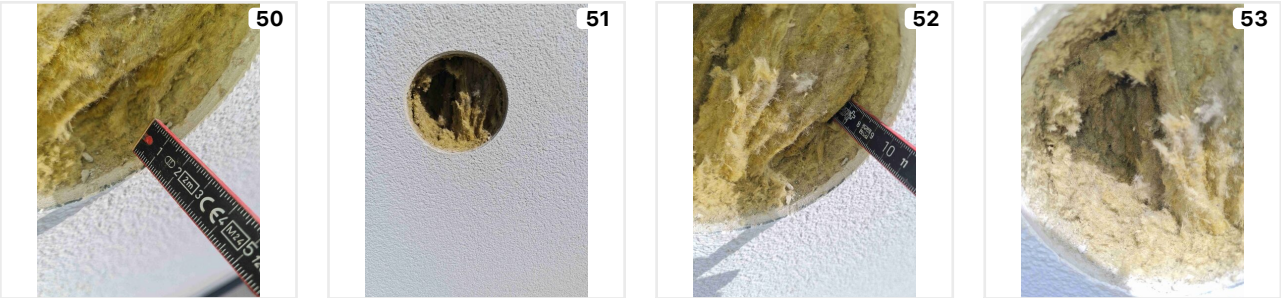
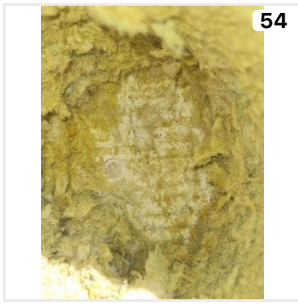
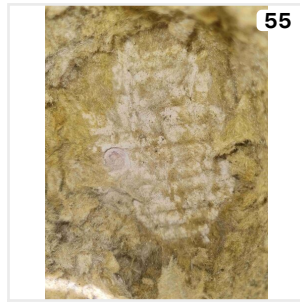
## Build-up Photos

| 3 Elements | Thickness/Depth | Material | Photo Ref. | Rating (BS EN13501) |
|---|---|---|---|---|
| Inner Leaf | | Concrete wall | 54, 55 | A1 - Non-Combustible |

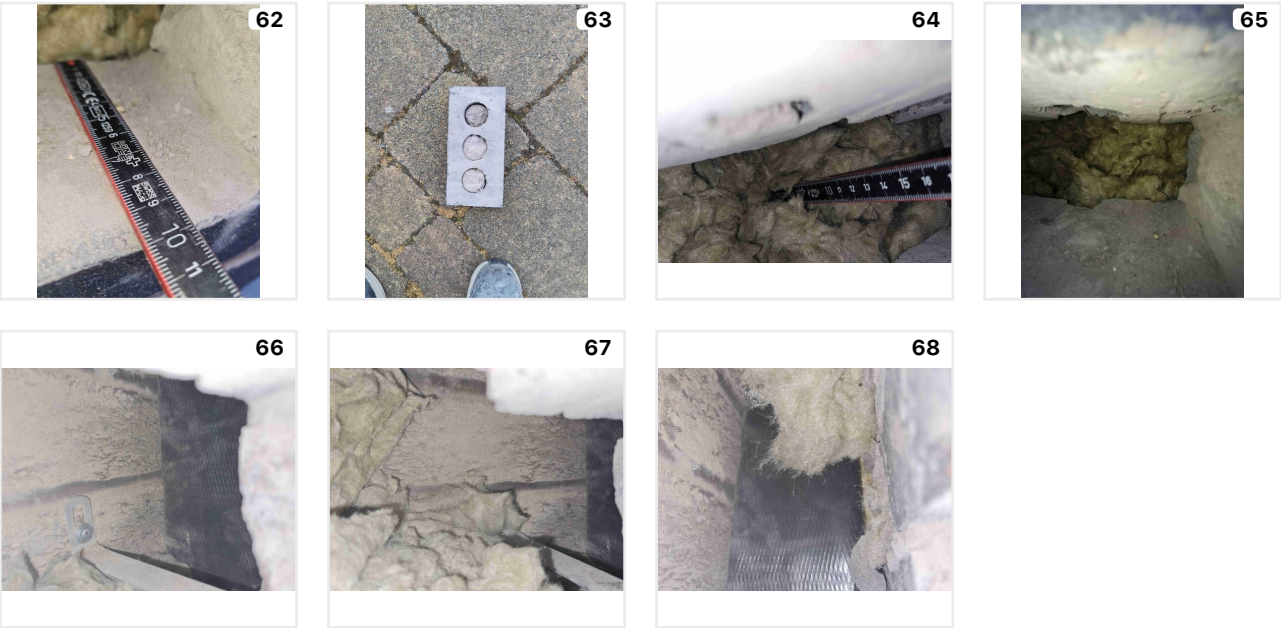
# Build-up Photos

Membrane around window
