Document Version 1  
Survey Date 19/06/2025  
Suggested Review Date 19/06/2030

# EXTERNAL WALL SURVEY

## NELSON HOUSE

Upper Church Lane  
Tipton  
DY4 7TU

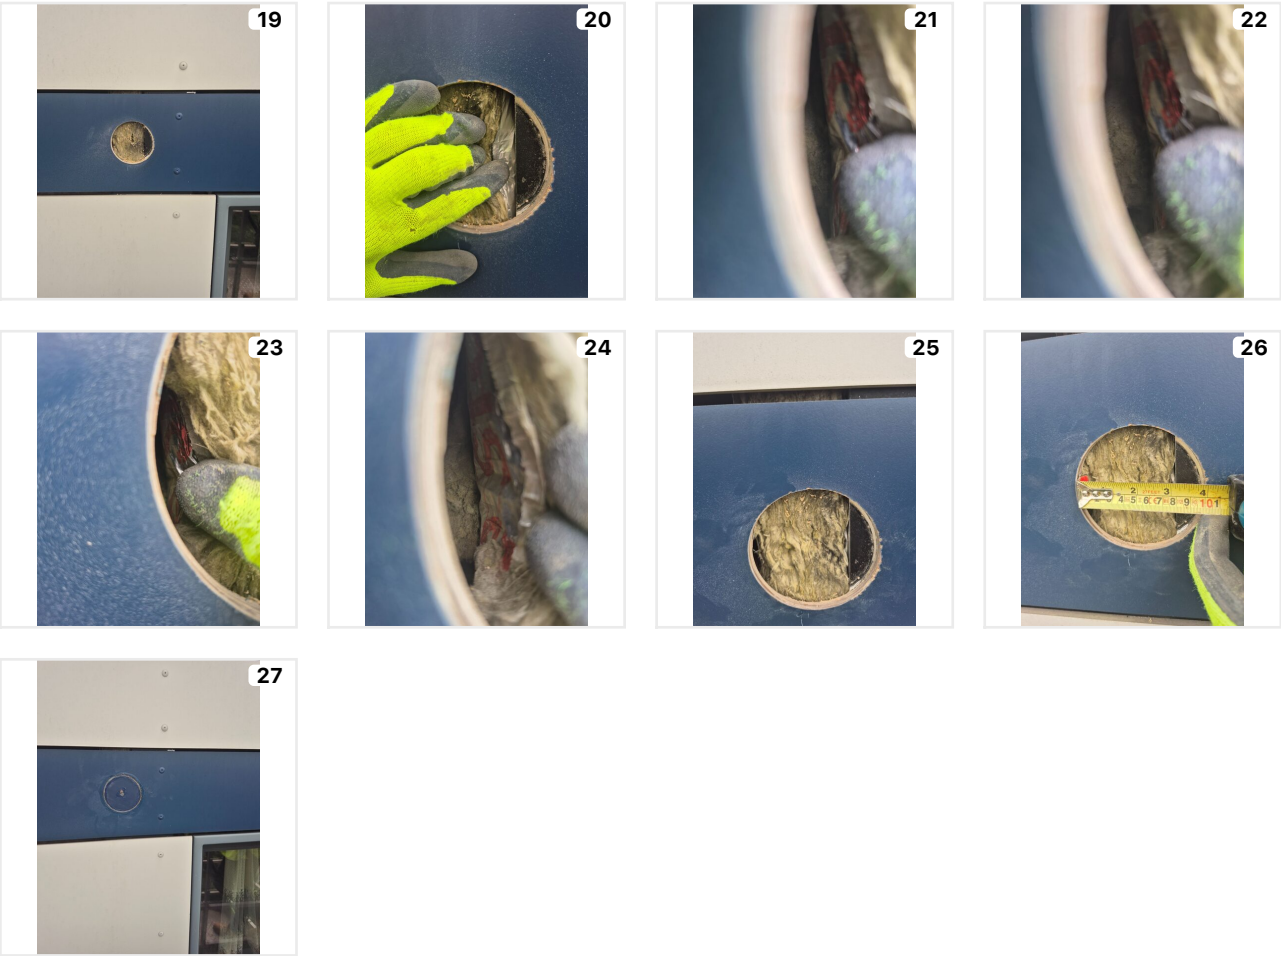
# Inspection: UL45AL

Elevation • Location  
East Elevation • Aperture Opening

HPL Bauclad High Pressure Laminate (HPL) panels by Euro Clad Ltd.

| 4 Elements | Thickness/Depth | Material | Photo Ref. | Rating (BS EN13501) |
| External Surface Material | 8mm | High Pressure Laminate (HPL) Panel | | B - Combustible |
| Insulation | 100mm | Mineral Wool Insulation | | A1 - Non-Combustible |
| Inner Leaf | 100mm | Brickwork | | A1 - Non-Combustible |

| 1 Cavity Barrier | Material | Photo Ref. |
|---|---|---|
| Vertical Cavity Barrier | Solid State Mineral Wool | |

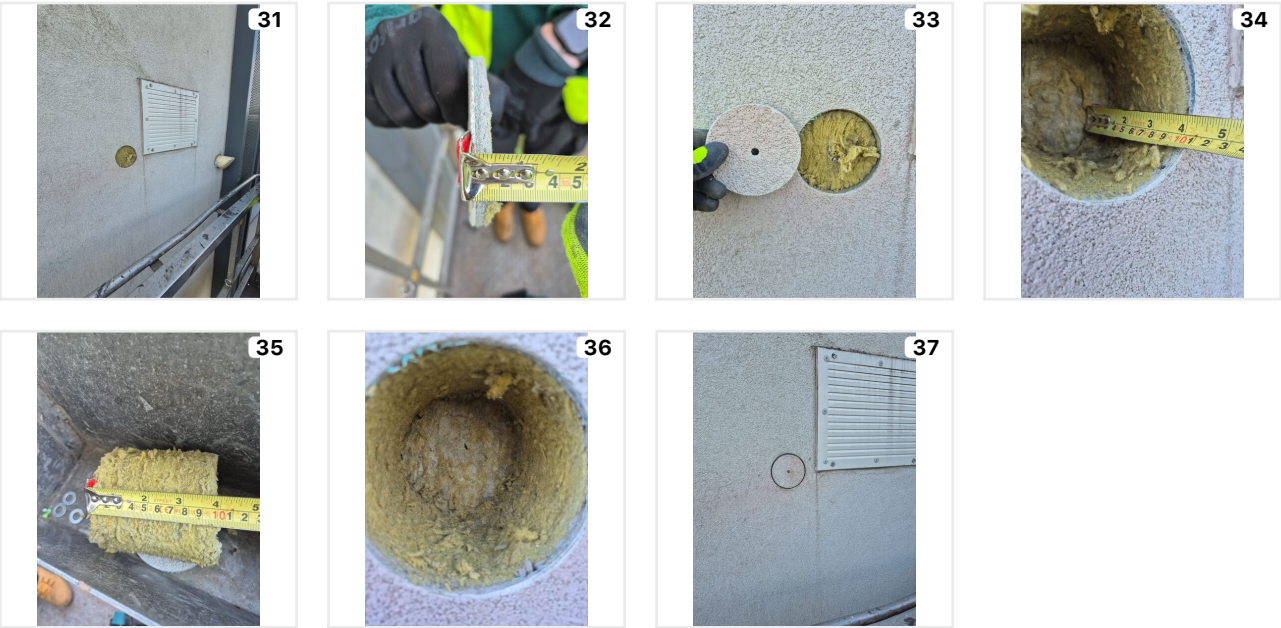
# Inspection: J6QY61

Elevation • Location  
South Elevation • Compartment Floor and Wall Junction Interface

Render (White) Wetherby External Wall Insulation (EWI) render system.

| 3 Elements | Thickness/Depth | Material | Photo Ref. | Rating (BS EN13501) |
|---|---|---|---|---|
| External Surface Material | 6mm | Render | | A2 - Limited Combustibility |
| Insulation | 100mm | Mineral Wool Insulation | | A1 - Non-Combustible |

No external cavity

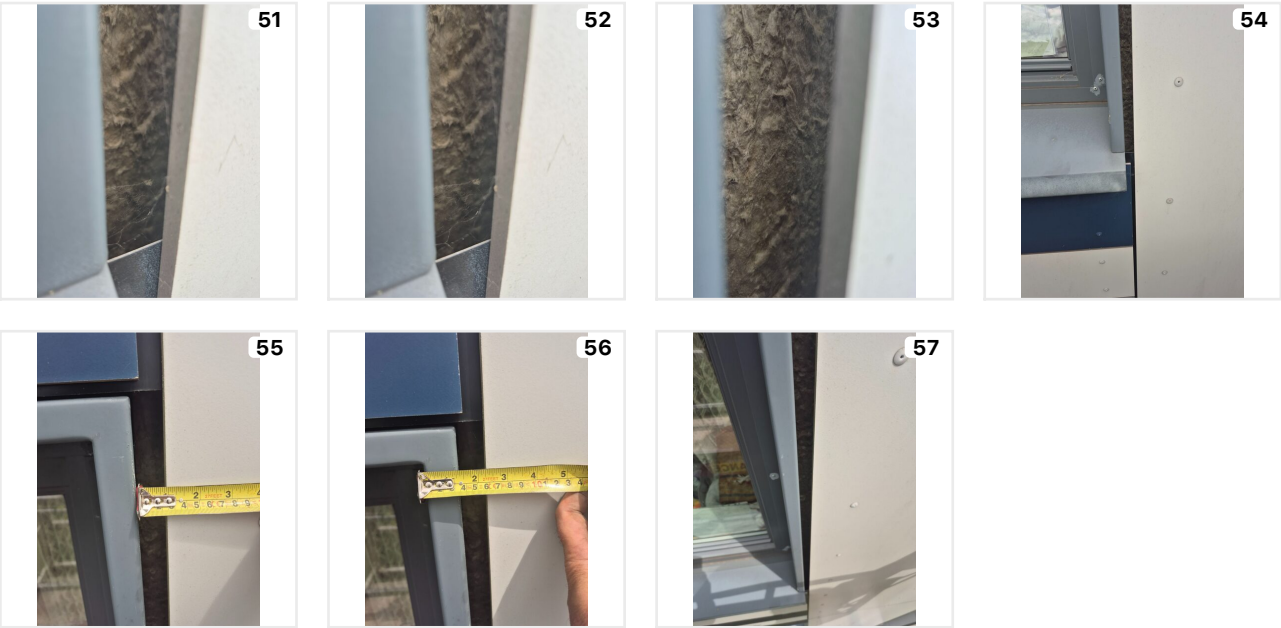
# Inspection: F1JNE1

Elevation • Location  
South Elevation • Aperture Opening

Render (Grey)Wetherby External Wall Insulation (EWI) render system.

| 3 Elements | Thickness/Depth | Material | Photo Ref. | Rating (BS EN13501) |
|---|---|---|---|---|
| External Surface Material | 6mm | Render | | A2 - Limited Combustibility |
| Insulation | 100mm | Mineral Wool Insulation | | A1 - Non-Combustible |
