**FIRNTEC**  
BUILDING COMPLIANCE

# FIRE RISK APPRAISAL EXTERNAL WALLS

## NELSON HOUSE

Upper Church Lane  
Tipton  
DY4 7TU

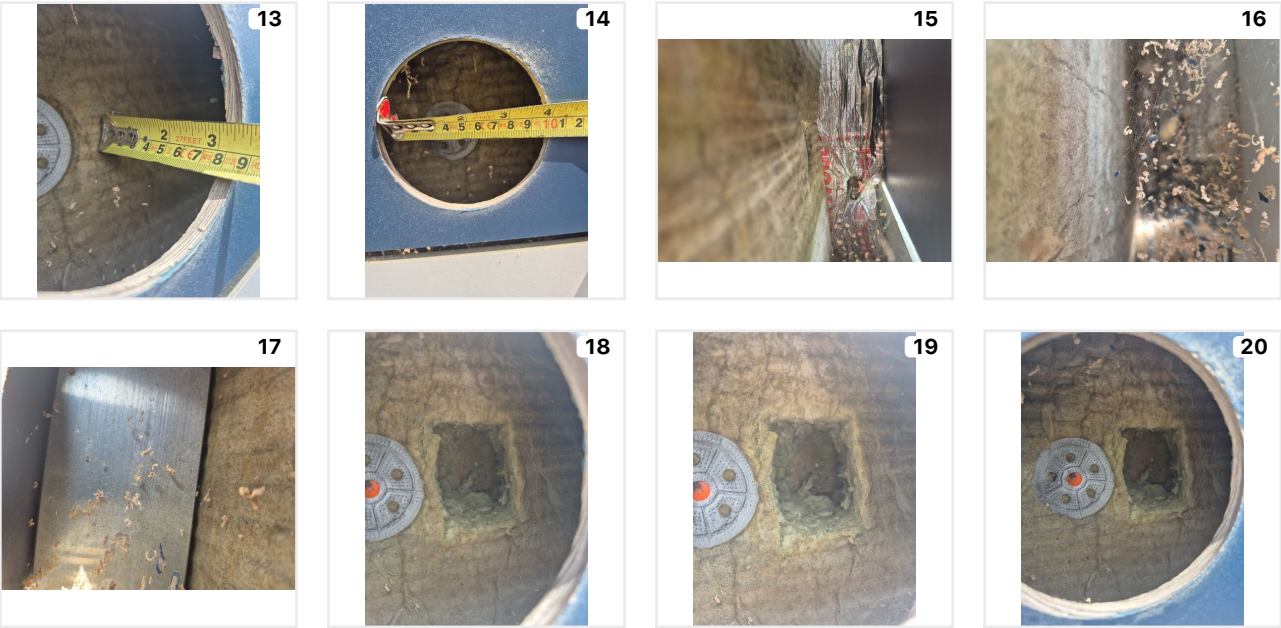
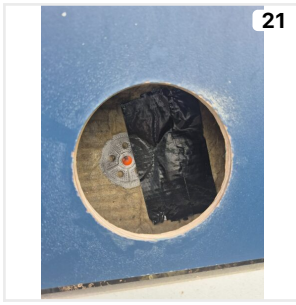
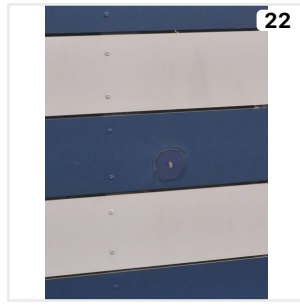
Inspection Photos

Backing Wall Sits On The Floor Slab

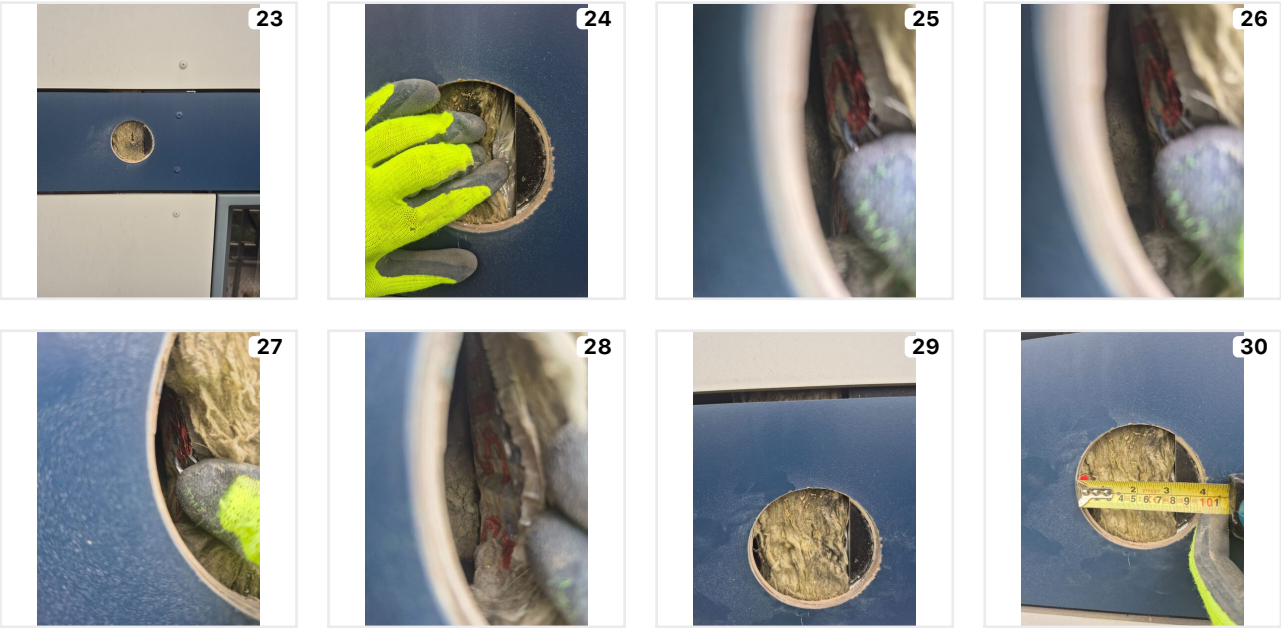
Inspection Photos

Backing Wall Sits On The Floor Slab

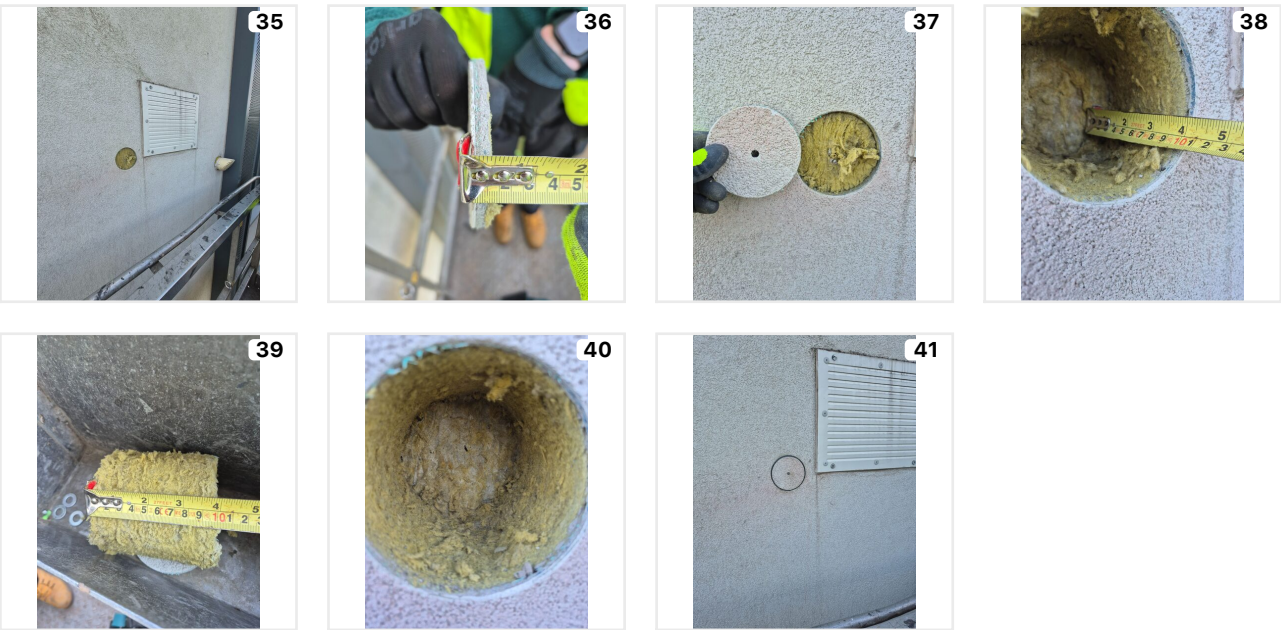
## Inspection Photos

Backing Wall Sits On The Floor Slab

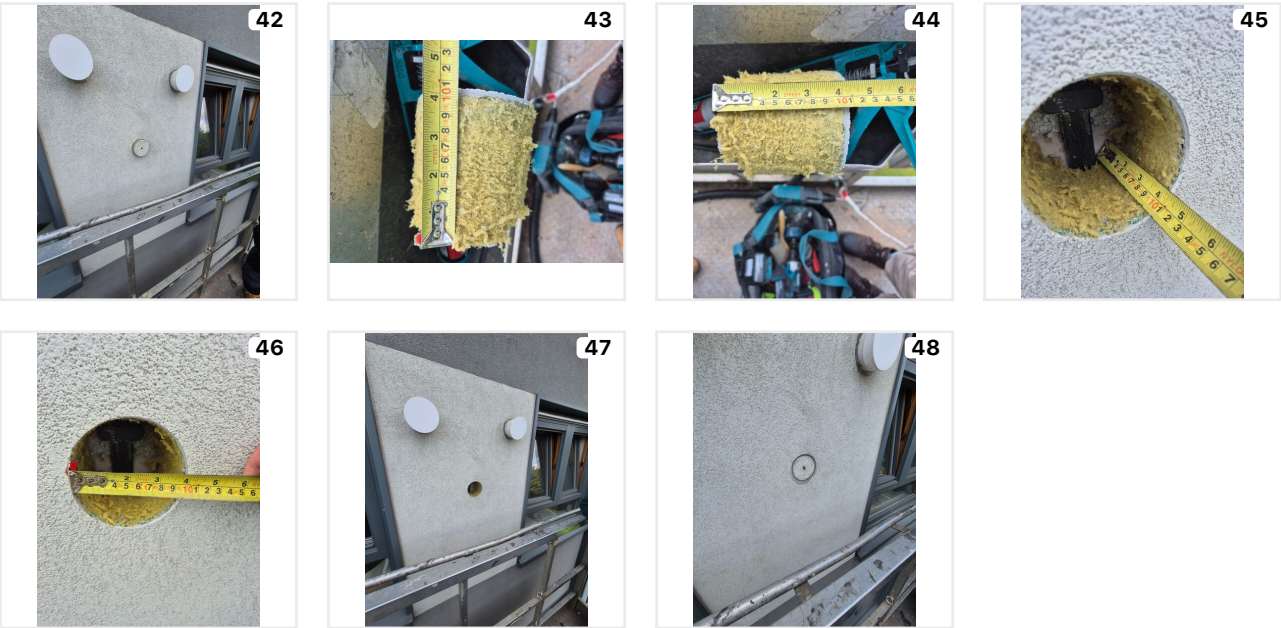
## Inspection Photos

Backing Wall Sits On The Floor Slab

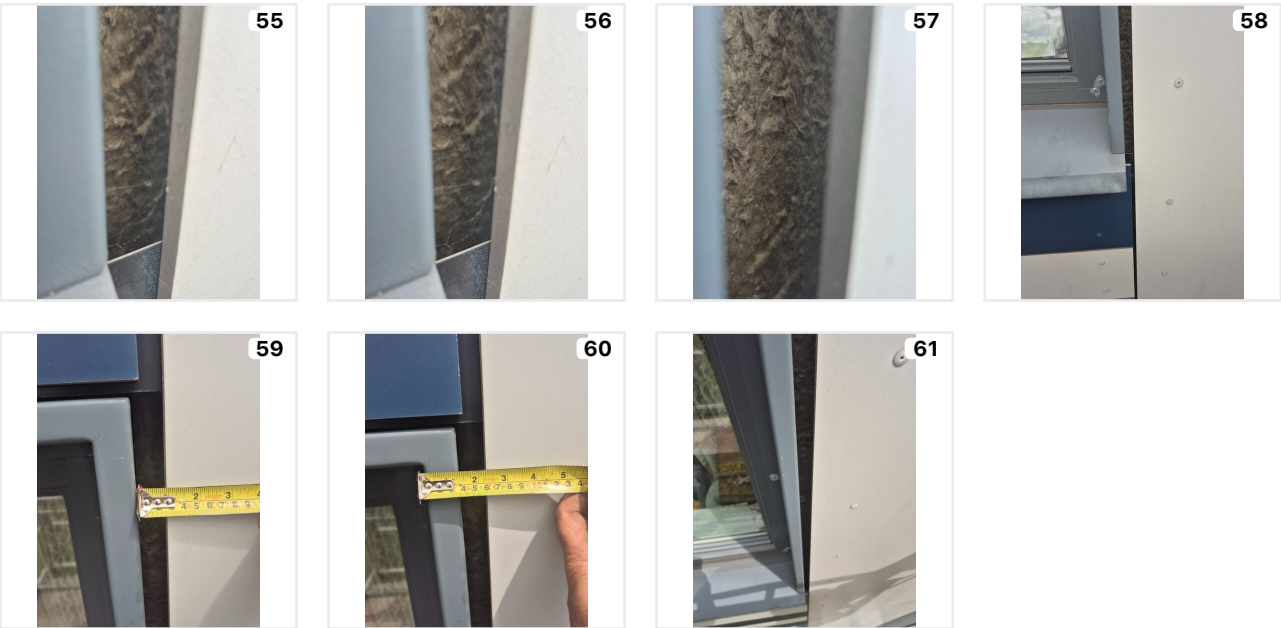
Inspection Photos

Backing Wall Sits On The Floor Slab
