# EXTERNAL WALL SURVEY

## SCOTT HOUSE

Coniston Crescent  
Hamstead  
B43 5RD

RB-N77RBB

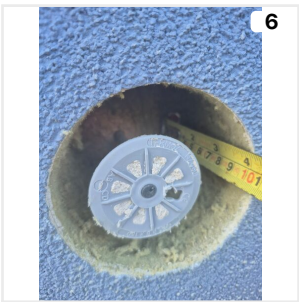
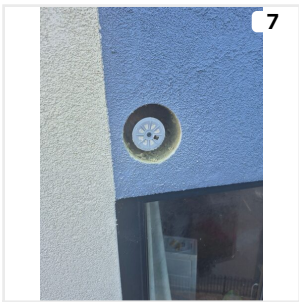
Backing Wall Sits On The Floor Slab

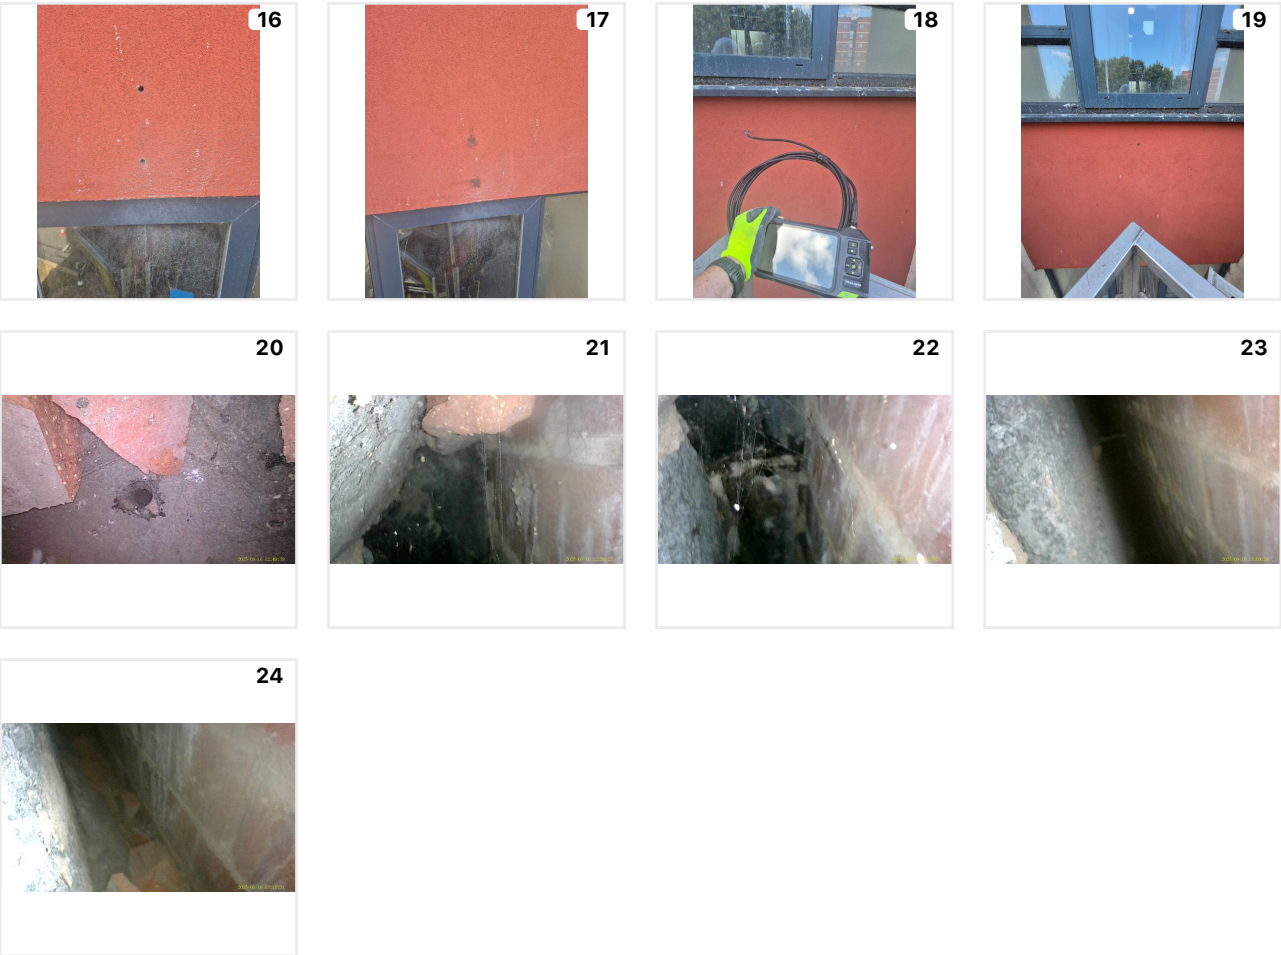
Backing Wall Sits On The Floor Slab

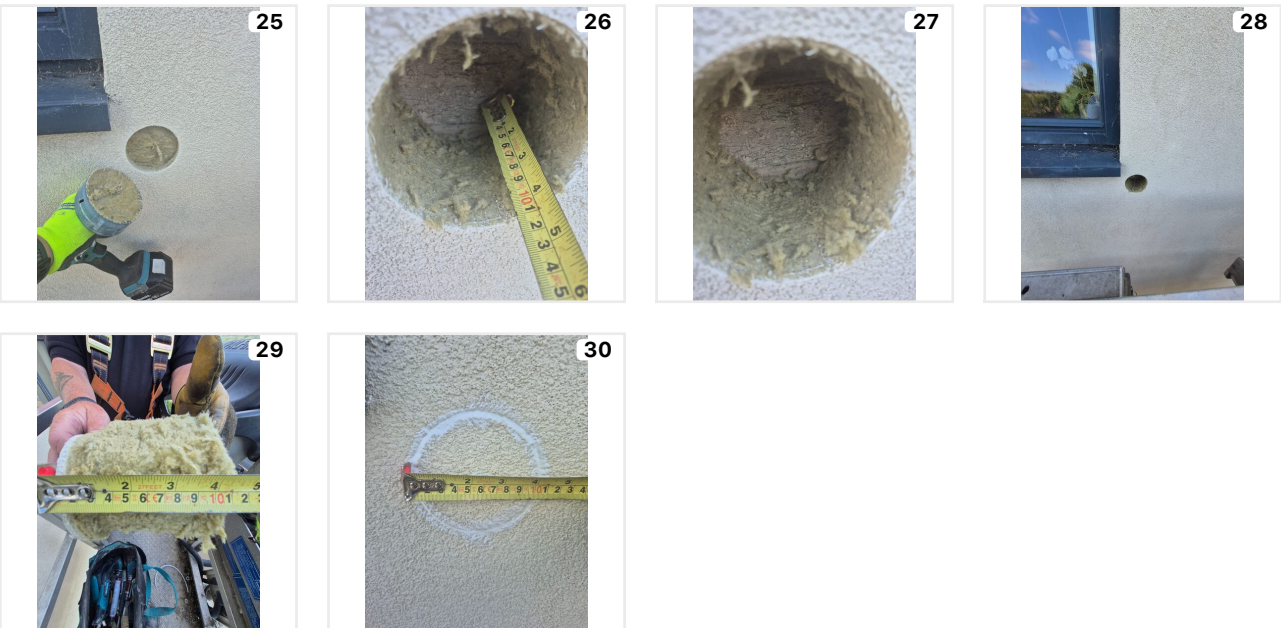
# Inspection: HU6R5L

Mineral wool insulation is non-combustible, typically classified as A1 or A2-s1,d0, satisfying high fire performance criteria under BS EN 13501-1. Based on visible construction and prior refurbishment records (2008), this EWI system is low-risk with respect to fire spread, assuming: Cavity barriers are not required due to direct-to-substrate application System is fully bonded without open cavities No evidence of PIR or PF in this area; previously noted combustible rigid insulation appears confined to side elevations (brick cavity walls) only.

The EWI system is confirmed as a non-combustible mineral wool render system, mechanically fixed to brick masonry substrate. No elevated fire risk is introduced by this build-up, and it supports the existing Stay Put – Unless Affected strategy without further remediation. Observation aligns with FRA description and PAS 9980 Step 1 classification of “Low risk” façade condition for these elevations.

Backing Wall Sits On The Floor Slab

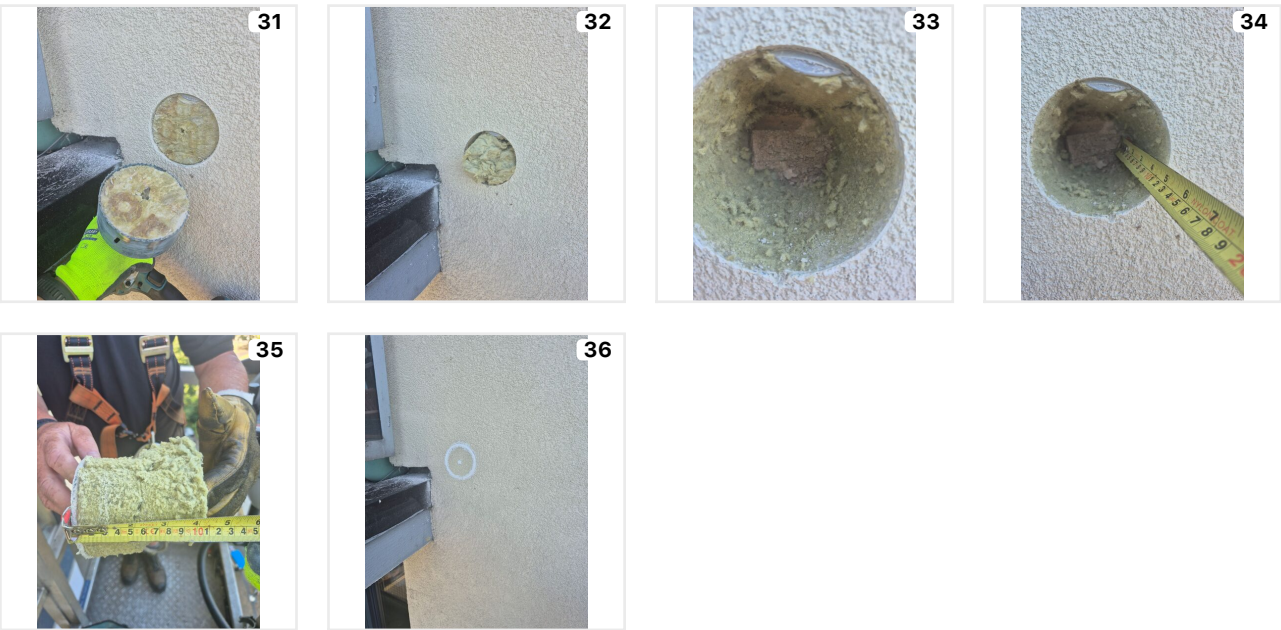
# Inspection: 8KU54T

Mineral wool insulation is non-combustible, typically classified as A1 or A2-s1,d0, satisfying high fire performance criteria under BS EN 13501-1. Based on visible construction and prior refurbishment records (2008), this EWI system is low-risk with respect to fire spread, assuming: Cavity barriers are not required due to direct-to-substrate application System is fully bonded without open cavities No evidence of PIR or PF in this area; previously noted combustible rigid insulation appears confined to side elevations (brick cavity walls) only.

The EWI system is confirmed as a non-combustible mineral wool render system, mechanically fixed to brick masonry substrate. No elevated fire risk is introduced by this build-up, and it supports the existing Stay Put – Unless Affected strategy without further remediation. Observation aligns with FRA description and PAS 9980 Step 1 classification of “Low risk” façade condition for these elevations.

Backing Wall Sits On The Floor Slab

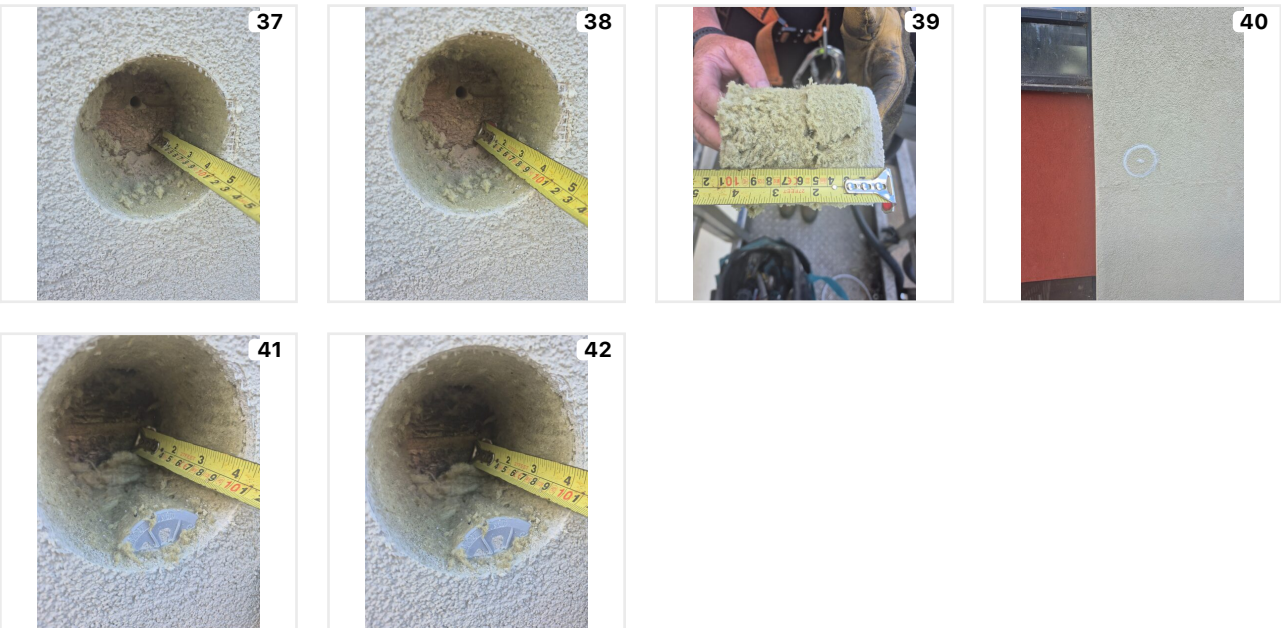
# Inspection: 3SIKLD

Mineral wool insulation is non-combustible, typically classified as A1 or A2-s1,d0, satisfying high fire performance criteria under BS EN 13501-1. Based on visible construction and prior refurbishment records (2008), this EWI system is low-risk with respect to fire spread, assuming: Cavity barriers are not required due to direct-to-substrate application System is fully bonded without open cavities No evidence of PIR or PF in this area; previously noted combustible rigid insulation appears confined to side elevations (brick cavity walls) only.

The EWI system is confirmed as a non-combustible mineral wool render system, mechanically fixed to brick masonry substrate. No elevated fire risk is introduced by this build-up, and it supports the existing Stay Put – Unless Affected strategy without further remediation. Observation aligns with FRA description and PAS 9980 Step 1 classification of “Low risk” façade condition for these elevations.

Backing Wall Sits On The Floor Slab

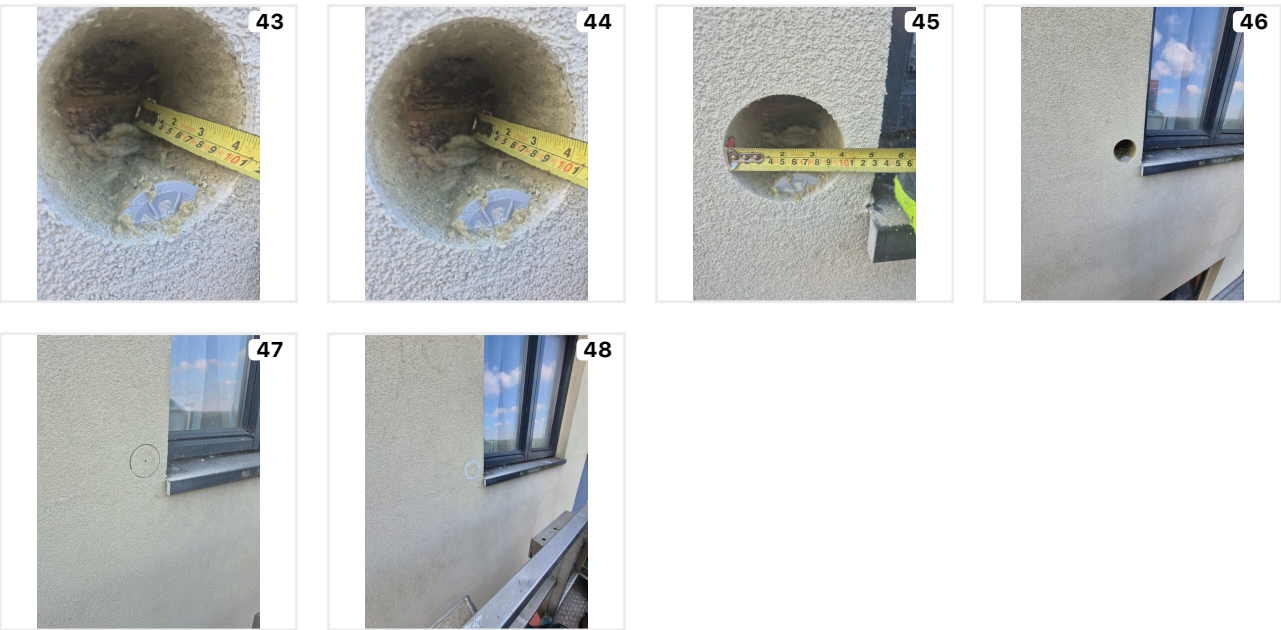
# Inspection: 9DT1QT

Mineral wool insulation is non-combustible, typically classified as A1 or A2-s1,d0, satisfying high fire performance criteria under BS EN 13501-1. Based on visible construction and prior refurbishment records (2008), this EWI system is low-risk with respect to fire spread, assuming: Cavity barriers are not required due to direct-to-substrate application System is fully bonded without open cavities No evidence of PIR or PF in this area; previously noted combustible rigid insulation appears confined to side elevations (brick cavity walls) only.

The EWI system is confirmed as a non-combustible mineral wool render system, mechanically fixed to brick masonry substrate. No elevated fire risk is introduced by this build-up, and it supports the existing Stay Put – Unless Affected strategy without further remediation. Observation aligns with FRA description and PAS 9980 Step 1 classification of “Low risk” façade condition for these elevations.

Backing Wall Sits On The Floor Slab

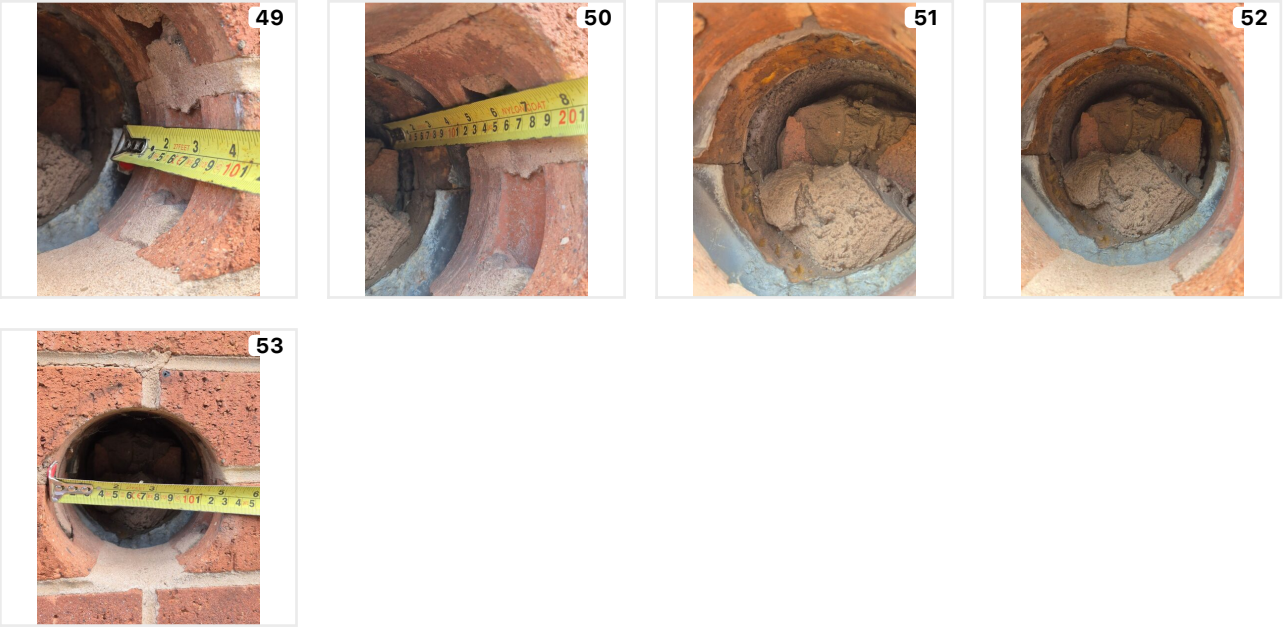
# Inspection: 1PKAAJ

Flank (Side) Elevations  
The flank (side) elevations comprise traditional cavity wall construction with an external leaf of clay brickwork and an internal concrete blockwork leaf, separated by a cavity containing partial-fill rigid phenolic (PF) insulation boards. Intrusive investigations confirmed the insulation is foil-faced and combustible, consistent with mid-2000s partial-fill retrofit practice. No render or cladding system is present, and the insulation appears loosely placed directly within the cavity. There is no evidence of horizontal or vertical cavity barriers at floor levels or around openings.

Backing Wall Sits On The Floor Slab
