Document Version 4  
Survey Date 14/01/2025  
Suggested Review Date 14/01/2030

# EXTERNAL WALL SURVEY

## SHEAPCOATE HOUSE

Sheapecoate House  
Beconview Road  
West Brom  
B71 3PP

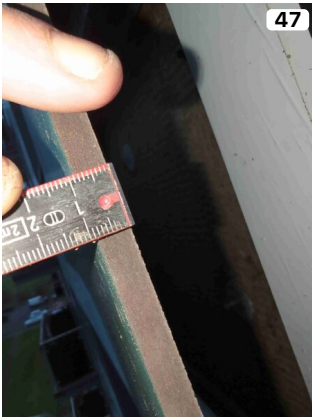
| 4 Elements | Thickness/Depth | Material | Photo Ref. | Rating (BS EN13501) |
|---|---|---|---|---|
| Surface Finish | 8mm | Suspected High Pressure Laminate (HPL) Panel<br>Material Brand: TREPSA | 46, 47 | D - Highly Combustible |

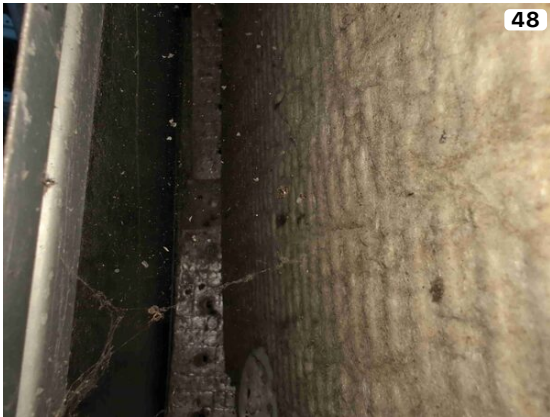
48

| 4 Elements | Thickness/Depth | Material | Photo Ref. | Rating (BS EN13501) |
|---|---|---|---|---|
| Cavity | 80mm | | 48, 49, 50, 51 | |

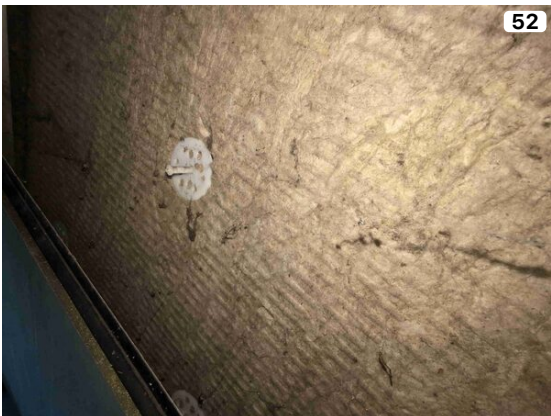
52

| 4 Elements | Thickness/Depth | Material | Photo Ref. | Rating (BS EN13501) |
|---|---|---|---|---|
| Insulation | 90mm | Mineral Wool Insulation | 52, 53 | A1 - Non-Combustible |

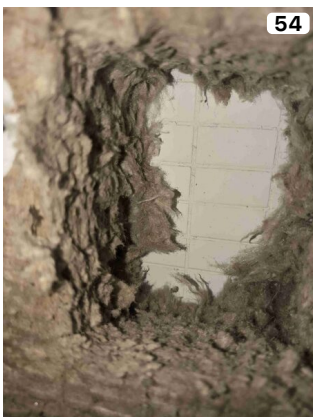
54

| 4 Elements | Thickness/Depth | Material | Photo Ref. | Rating (BS EN13501) |
|---|---|---|---|---|
| Inner Leaf | | Reinforced concrete | 54, 55 | A1 - Non-Combustible |
