**FIRNTEC**  
BUILDING COMPLIANCE

# EXTERNAL WALL SURVEY

## ST CLEMENTS

St Clements house  
Hallam Street  
West Brom  
B71 4HB

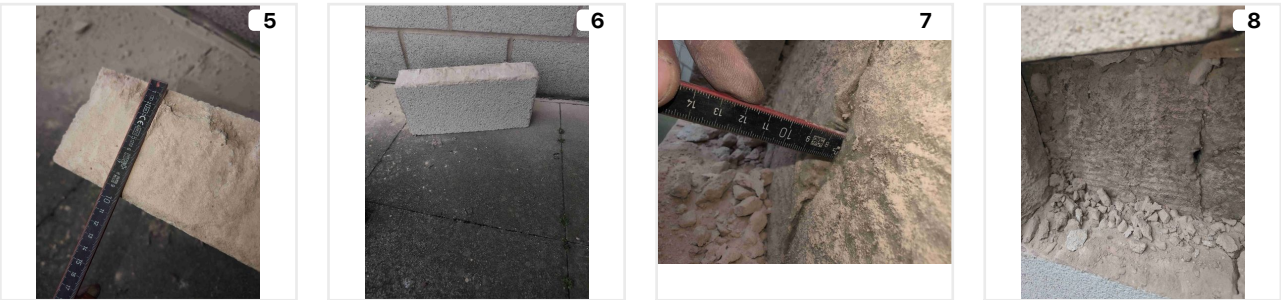
# Inspection: 5K3PD9

Elevation • Location  
Wall Inspection • Compartment Wall Junction

Masonry blockwork

| 3 Elements | Thickness/Depth | Material | Photo Ref. | Rating (BS EN13501) |
|---|---|---|---|---|
| Surface Finish | 100mm | Masonry blockwork | 5, 6 | A1 - Non-Combustible |
| Insulation | 80mm | Mineral Wool Insulation | 7, 8 | A1 - Non-Combustible |
| Inner Leaf | 100mm | Blockwork | 9, 10 | A1 - Non-Combustible |

| 1 Cavity Barrier | Material | Photo Ref. |
|---|---|---|
| Vertical Cavity Barrier | Solid State Mineral Wool | |

fully fills cavity

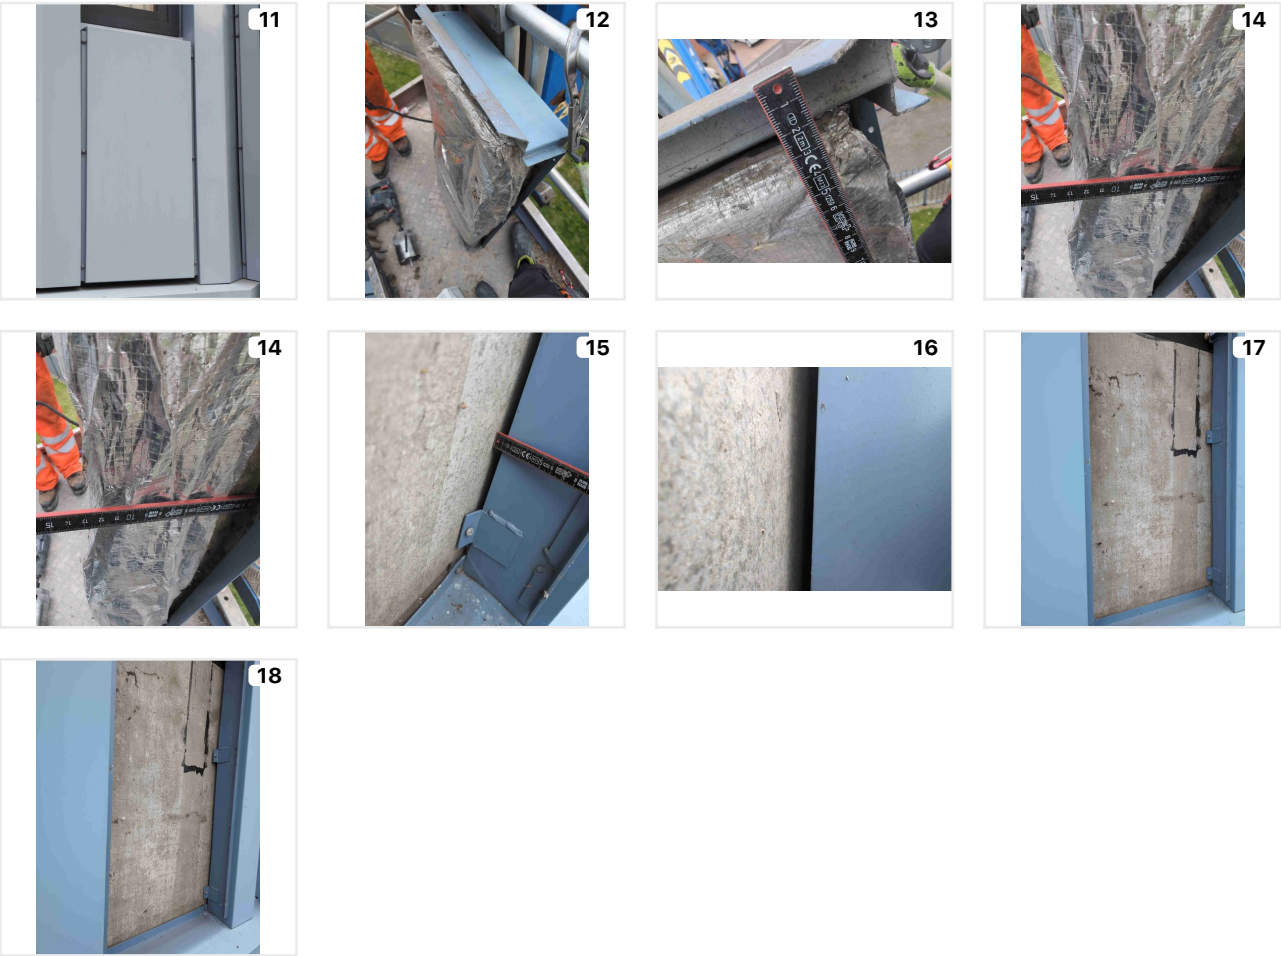
# Inspection: CJBIGZ

Elevation • Location  
Wall Inspection • Aperture Opening

Rainscreen cladding

| 5 Elements | Thickness/Depth | Material | Photo Ref. | Rating (BS EN13501) |
|---|---|---|---|---|
| Surface Finish | 3mm | Aluminium Panel | 11, 12, 13, 14 | A2 - Limited Combustibility |
| Insulation | | Mineral Wool Insulation enclosed in foil | 14 | A1 - Non-Combustible |
| Cavity | 10mm | | 15, 16 | |
| Inner Leaf | | Reinforced concrete | 17, 18 | A1 - Non-Combustible |

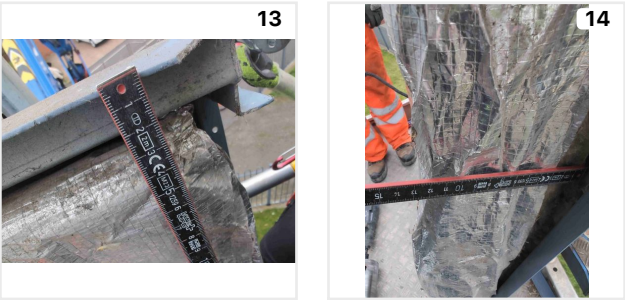
# Cavity Barrier Photos

| 1 Cavity Barrier | Material | Photo Ref. |
|---|---|---|
| Window Aperture | Stonewool core, aluminium foil faces | 13, 14 |

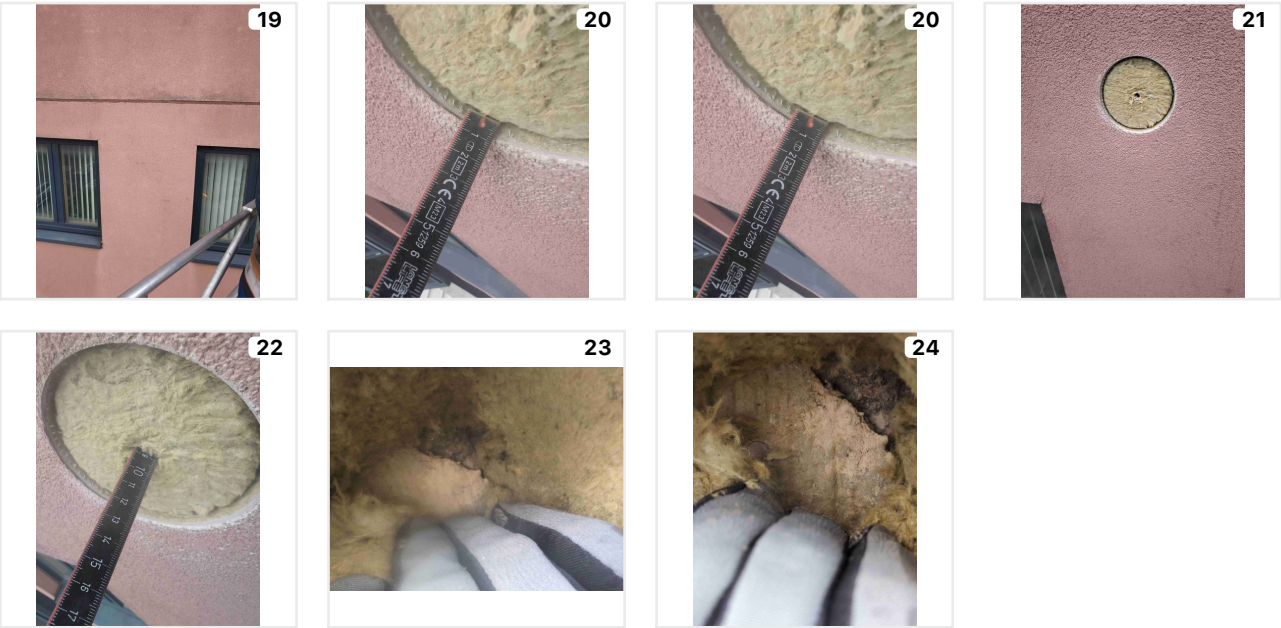
# Inspection: BXLNTB

Elevation • Location  
Wall Inspection • Compartment Floor and Wall Junction Interface

Render section

| 4 Elements | Thickness/Depth | Material | Photo Ref. | Rating (BS EN13501) |
|---|---|---|---|---|
| Surface Finish | 5mm | Sto render | 19, 20 | A1 - Non-Combustible |
| Outer leaf | 5mm | | 20 | A1 - Non-Combustible |
| Insulation | 95mm | Mineral Wool Insulation | 21, 22 | A1 - Non-Combustible |
| Inner Leaf | 100mm | Blockwork | 23, 24 | A1 - Non-Combustible |

| 1 Cavity Barrier | Material | Photo Ref. |
|---|---|---|
| Horizontal Cavity Barrier | Solid State Mineral Wool | |

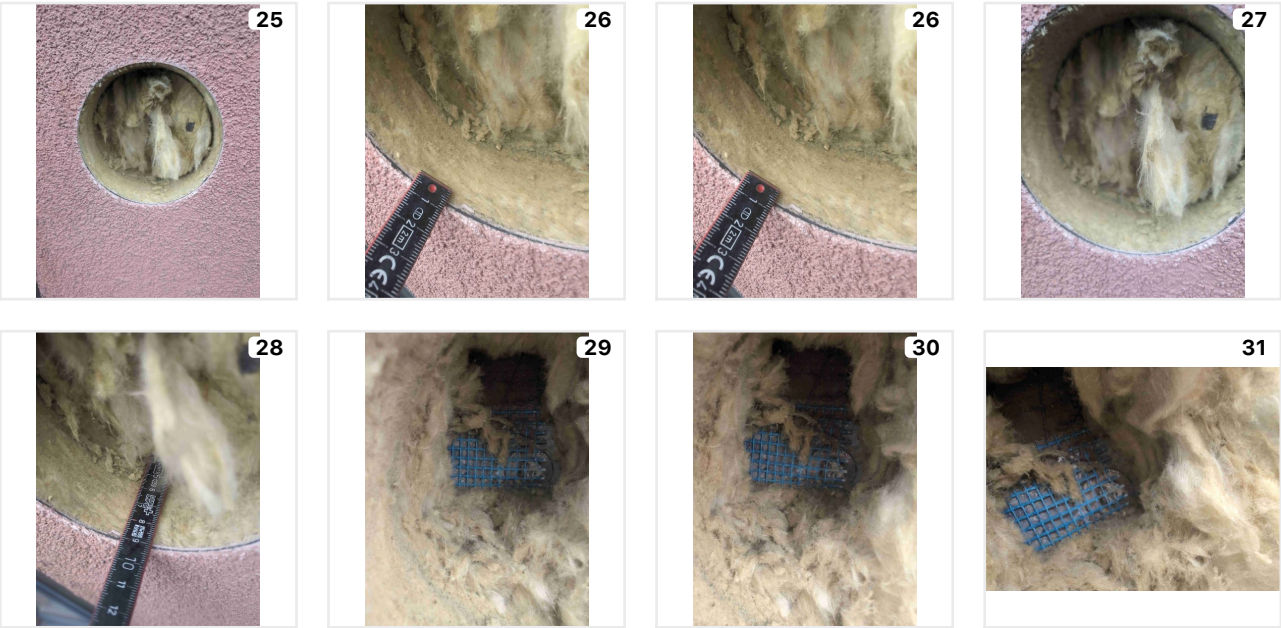
# Inspection: PY76U1

Elevation • Location  
Wall Inspection • Aperture Opening

Render section

| 5 Elements | Thickness/Depth | Material | Photo Ref. | Rating (BS EN13501) |
|---|---|---|---|---|
| Surface Finish | 5mm | Sto | 25, 26 | A1 - Non-Combustible |
| Outer leaf | 5mm | | 26 | A1 - Non-Combustible |
| Insulation | 90mm | Mineral Wool Insulation | 27, 28 | A1 - Non-Combustible |
| Other | 2mm | Mesh | 29 | E - Highly Combustible |
| Inner Leaf<br>Support (Backing<br>Wall) | | Concrete wall | 30, 31 | A1 - Non-Combustible |

| 1 Cavity Barrier | Material | Photo Ref. |
|---|---|---|
| Horizontal Cavity Barrier | Solid State Mineral Wool | |
