Document Version 2  
Survey Date 16/05/2025  
Suggested Review Date 16/05/2030

# FIRE RISK APPRAISAL EXTERNAL WALLS

## ST CLEMENTS

St Clements house  
Hallam Street  
West Brom  
B71 4HB

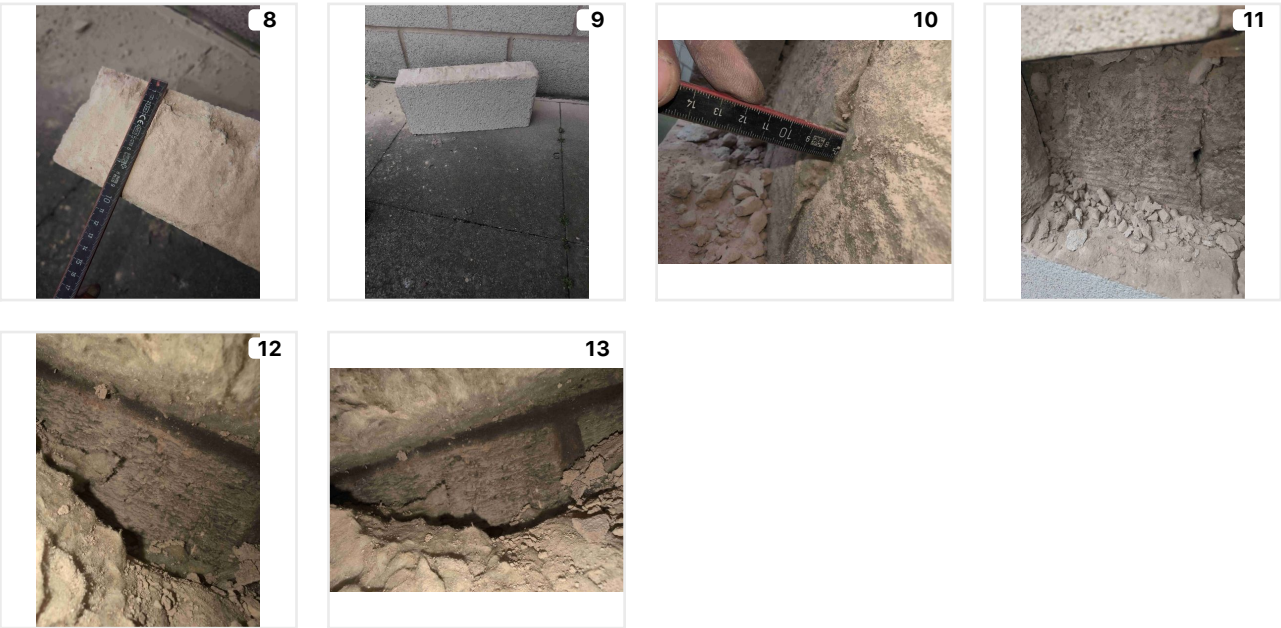
## Build-up Photos

| 1 Cavity Barrier | Material | Photo Ref. |
|---|---|---|
| fully fills cavity | | |

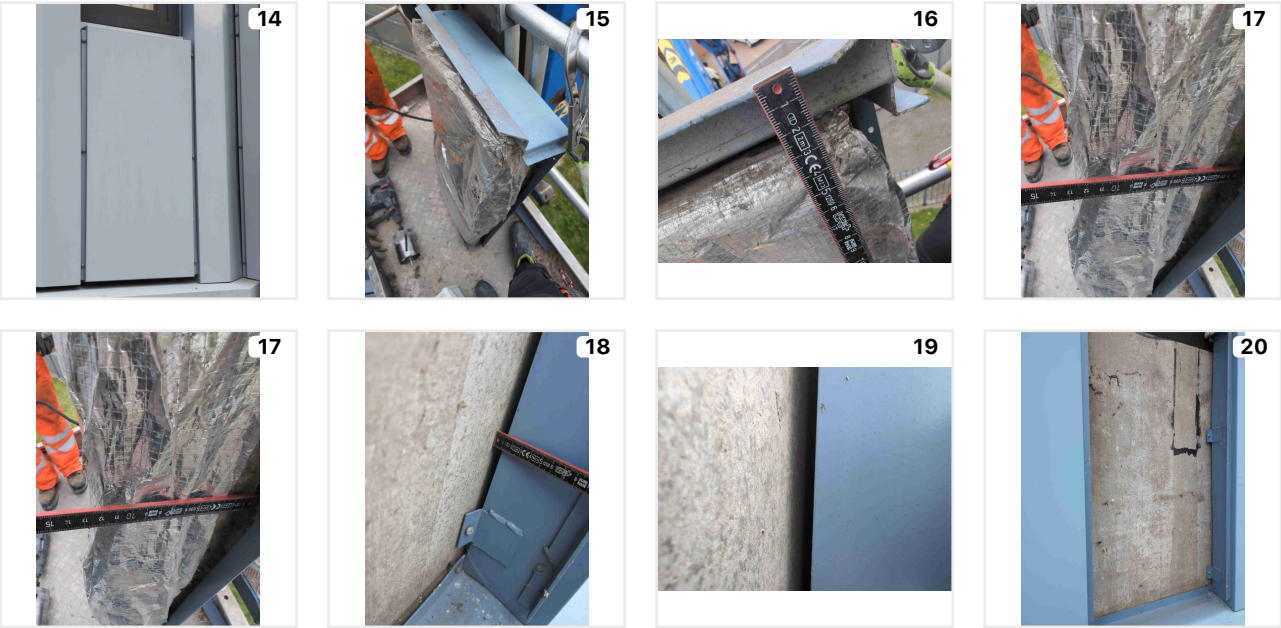
Build-up Photos

Reinforced concrete

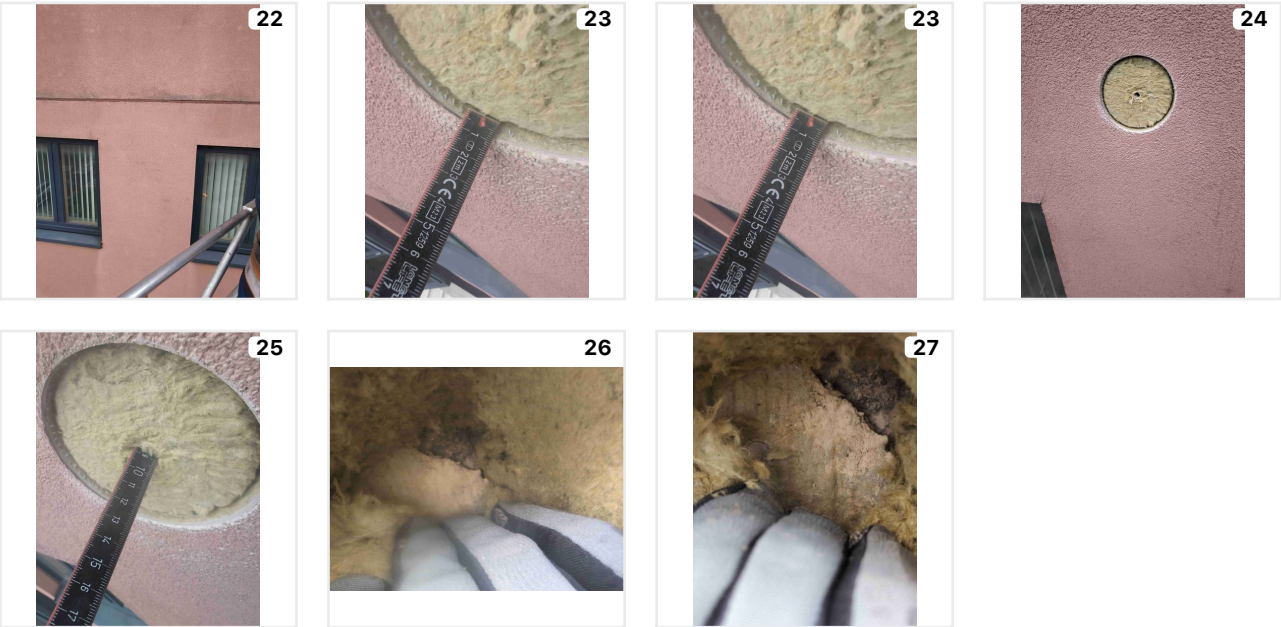
## Build-up Photos

Reinforced concrete

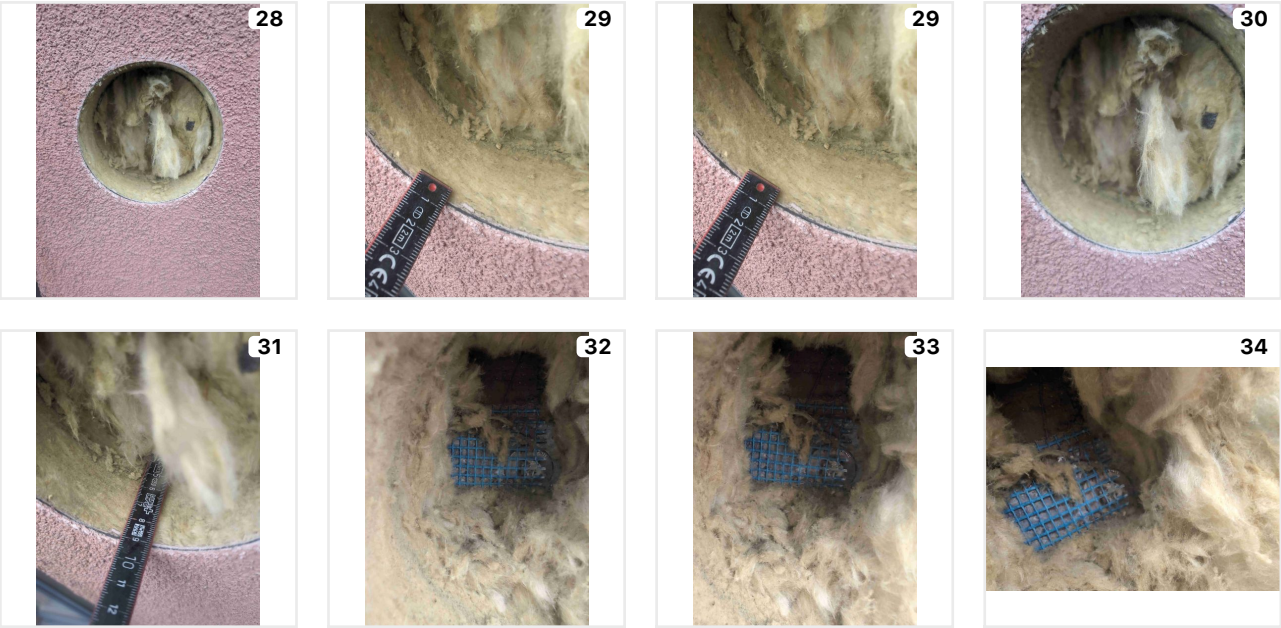
## Build-up Photos

| 1 Cavity Barrier | Material | Photo Ref. |
|---|---|---|
| Horizontal Cavity Barrier | Solid State Mineral Wool | |

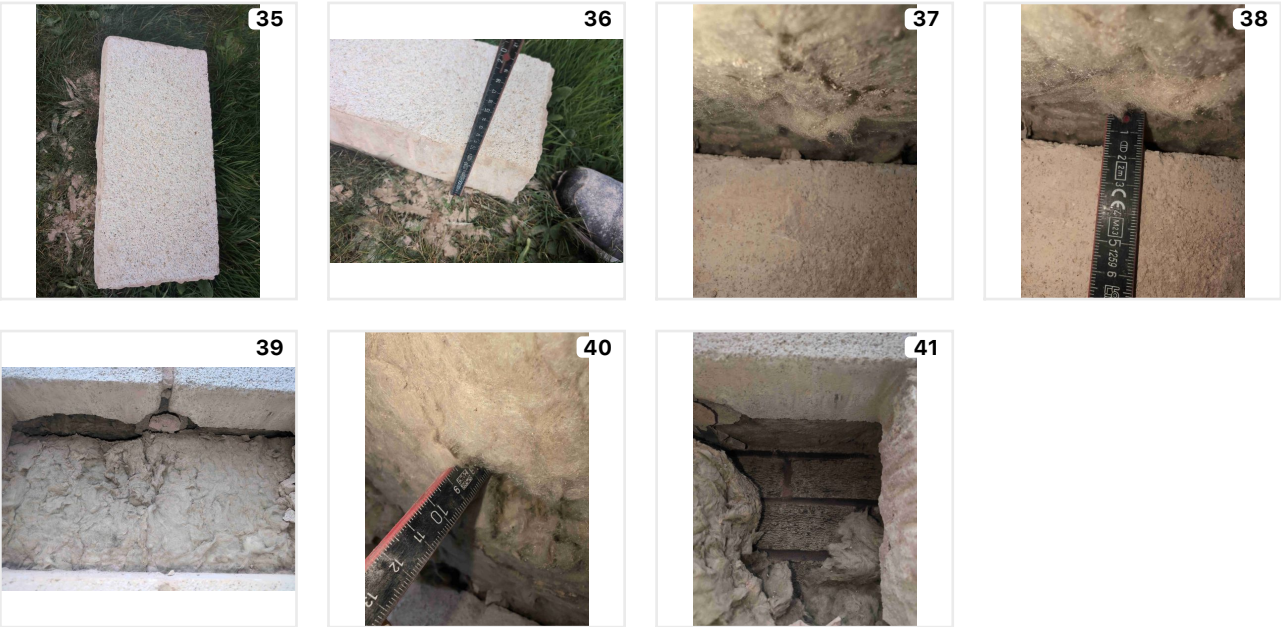
## Build-up Photos

Reinforced concrete

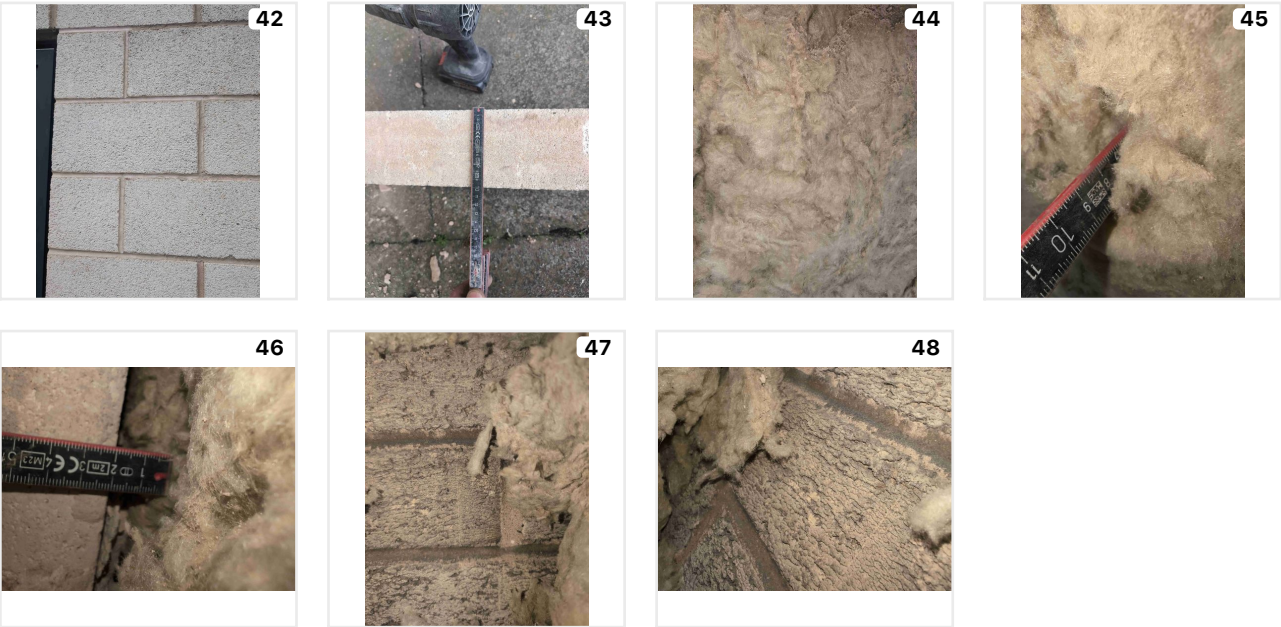
## Build-up Photos

Backing Wall Sits On The Floor Slab

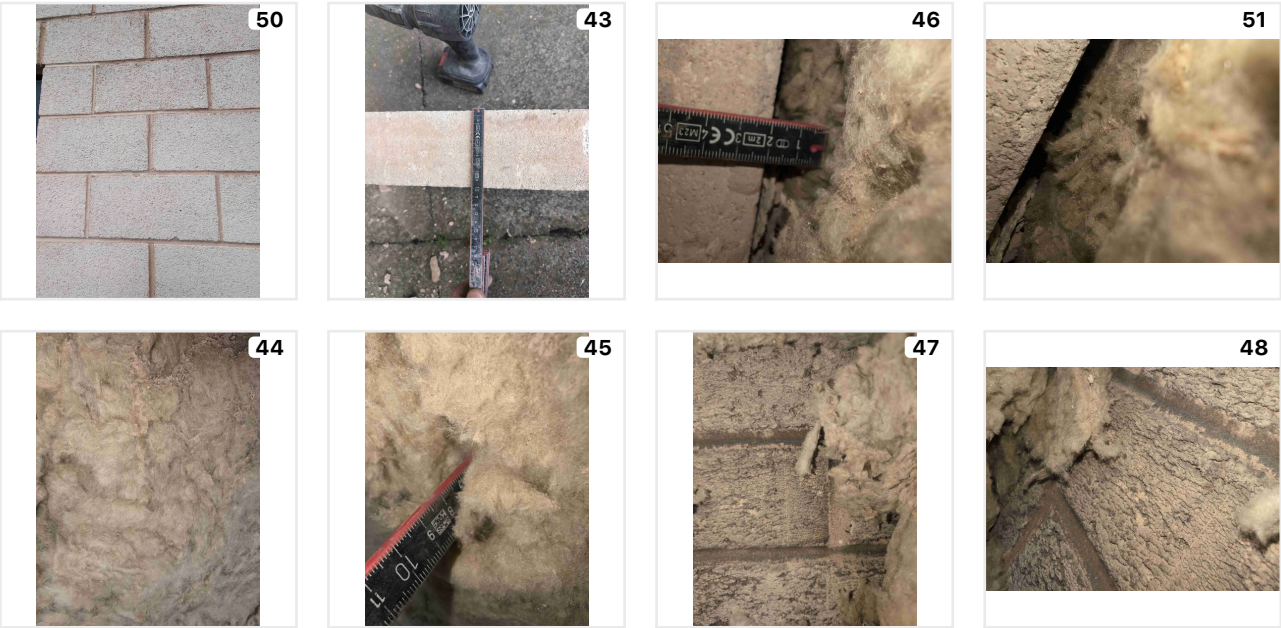
# Build-up Photos

| 4 Elements | Thickness/Depth | Material | Photo Ref. | Rating (BS EN13501) |
|---|---|---|---|---|
| Inner Leaf | | Brickwork | 47, 48 | A1 - Non-Combustible |
