# EXTERNAL WALL SURVEY

## STANTON HOUSE

Stanton House  
Beaconview Road  
West Brom  
B71 3PW

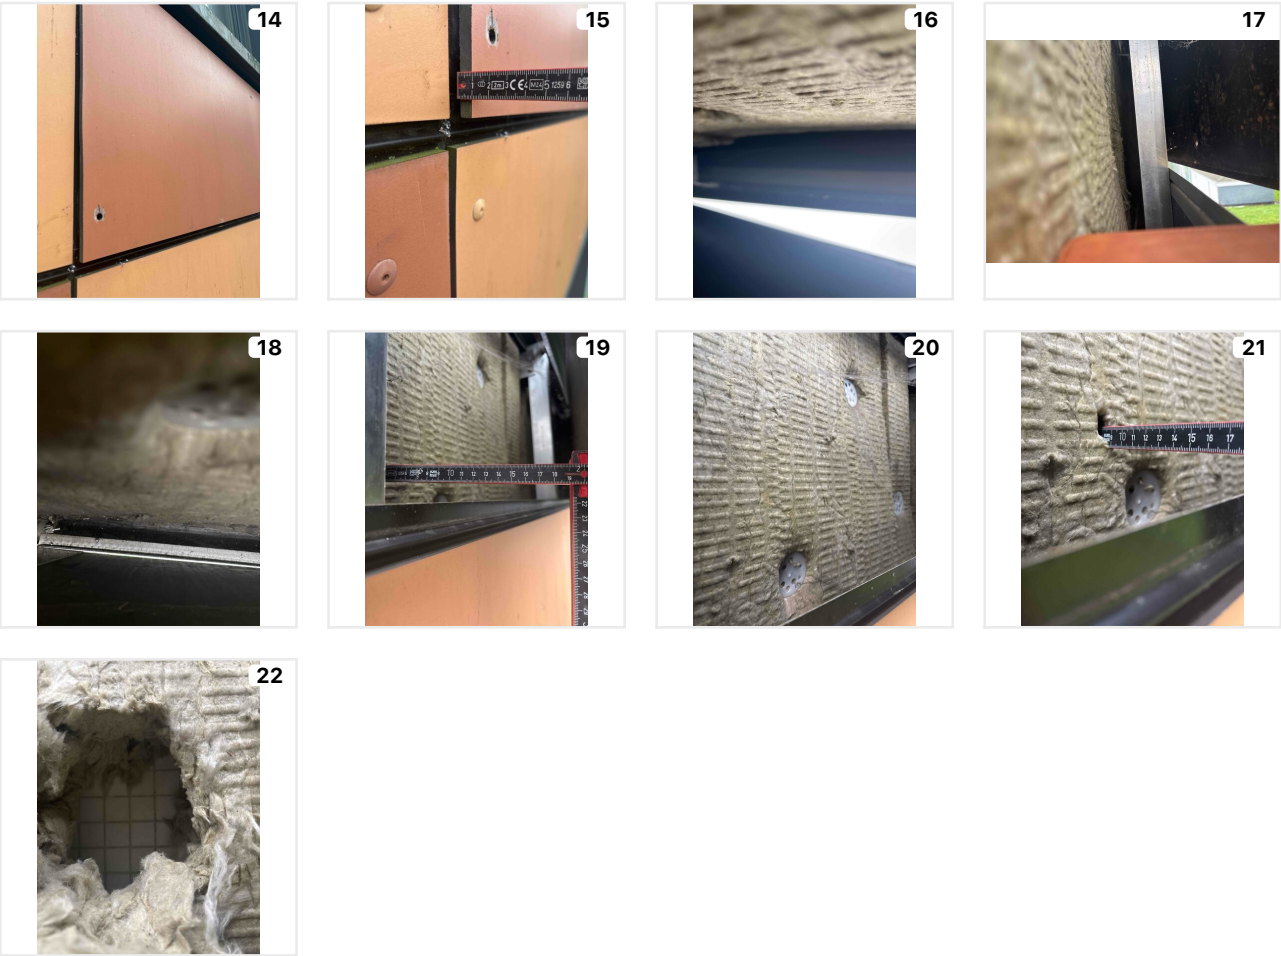
| 4 Elements | Thickness/Depth | Material | Photo Ref. | Rating (BS EN13501) |
|---|---|---|---|---|
| Surface Finish | 10mm | Suspected High Pressure Laminate (HPL) Panel<br>Material Brand: TRESPA | 14, 15 | D - Highly Combustible |
| Cavity | 90mm | | 16, 17, 18, 19 | |
| Insulation | 90mm | Mineral Wool Insulation | 20, 21 | A1 - Non-Combustible |
| Inner Leaf<br>Support (Backing Wall) | | Concrete wall | 22 | A1 - Non-Combustible |

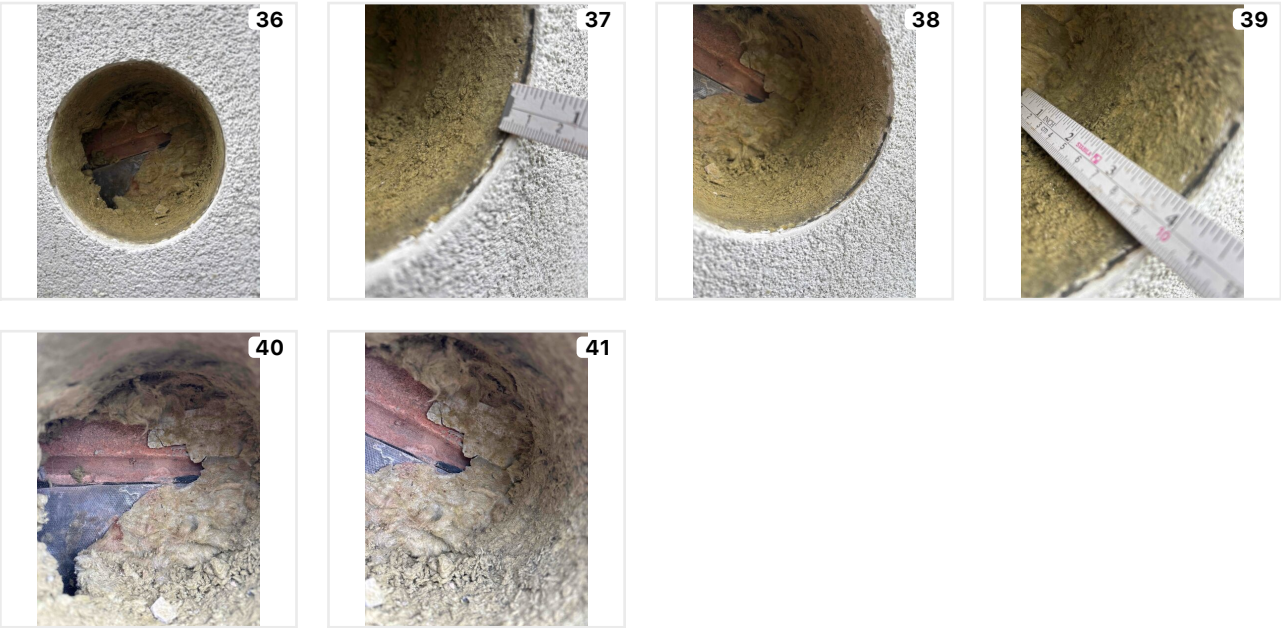
| 3 Elements | Thickness/Depth | Material | Photo Ref. | Rating (BS EN13501) |
|---|---|---|---|---|
| Surface Finish | 9mm | Sto render | 36, 37 | A1 - Non-Combustible |
| Insulation | | Mineral Wool Insulation | 38, 39 | A1 - Non-Combustible |
| Inner Leaf<br>Support (Backing<br>Wall) | | Concrete wall | 40, 41 | A1 - Non-Combustible |
