Document Version 2  
Survey Date 21/03/2025  
Suggested Review Date 21/03/2030

# FIRE RISK APPRAISAL EXTERNAL WALLS

## STANTON HOUSE

Stanton House  
Beaconview Road  
West Brom  
B71 3PW

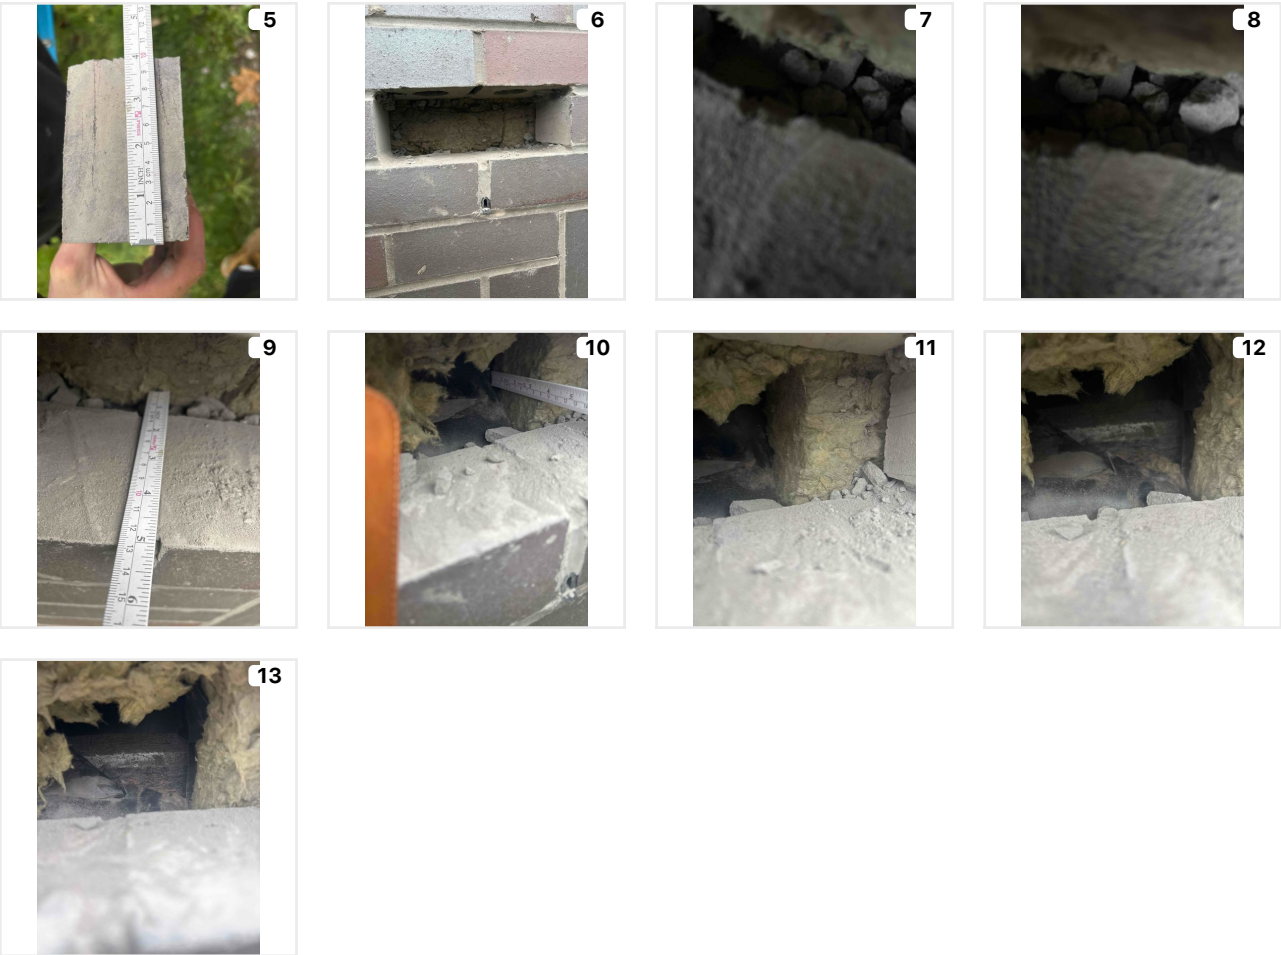
Backing Wall Sits On The Floor Slab

Cut out 3/4 bricks to expose construction behind.  
Inspect the construction, cavity, insulation, junction with compartment floor slab, junction at compartment wall and window opening.  
Replace any insulation removed with new.  
Replace bricks with existing or new as required and mortar. We will match existing bricks and mortar as best as possible but cannot guarantee a perfect match. Access provided by lorry mounted cherry picker 21m height capacity by Firntec.

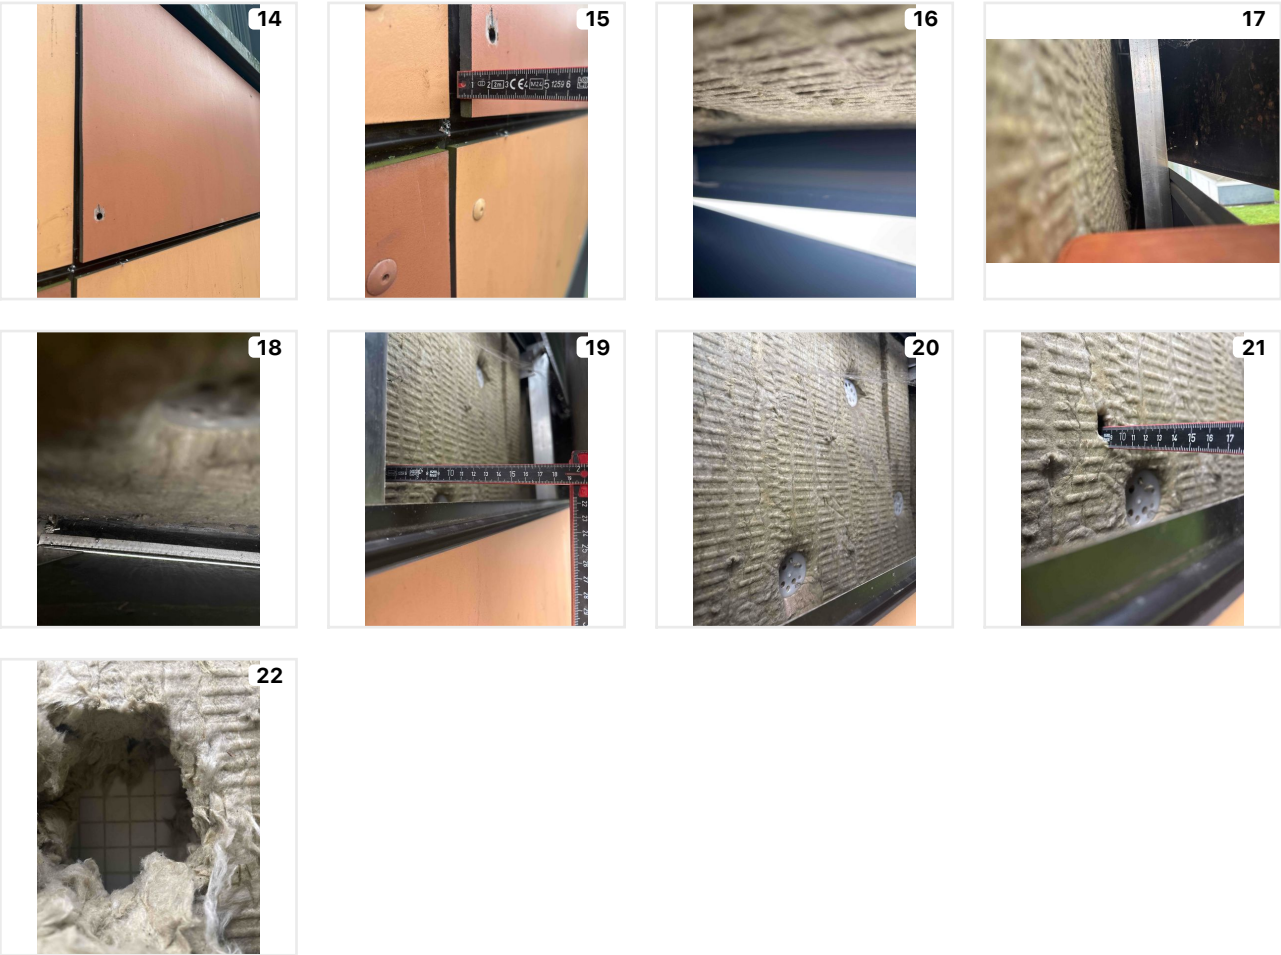
Elevation • Location  
WEST • JUNCTION WITH OTHER FACADE TYPES

Reinforced concrete

- Panel Inspection options
1. Remove panel if possible or conduct a core hole removal of external surface material  
Assess material making up the wall type  
Reinstate to a weathertight condition
  2. If panel cannot be removed. Cut a 250mm core hole  
Assess material making up the wall type  
Reinstate to a weathertight condition
  3. If access is restricted externally-From internal-  
Cut out 200mm x 200mm inspection panel through internal plaster / plasterboard to expose construction behind.  
Inspect the construction, cavity, insulation and junction with compartment floor slab, compartment wall and window opening  
Replace any insulation removed with new  
Replace plasterboard with existing / new as required fixing to a timber batten  
Redecoration by the Building Management

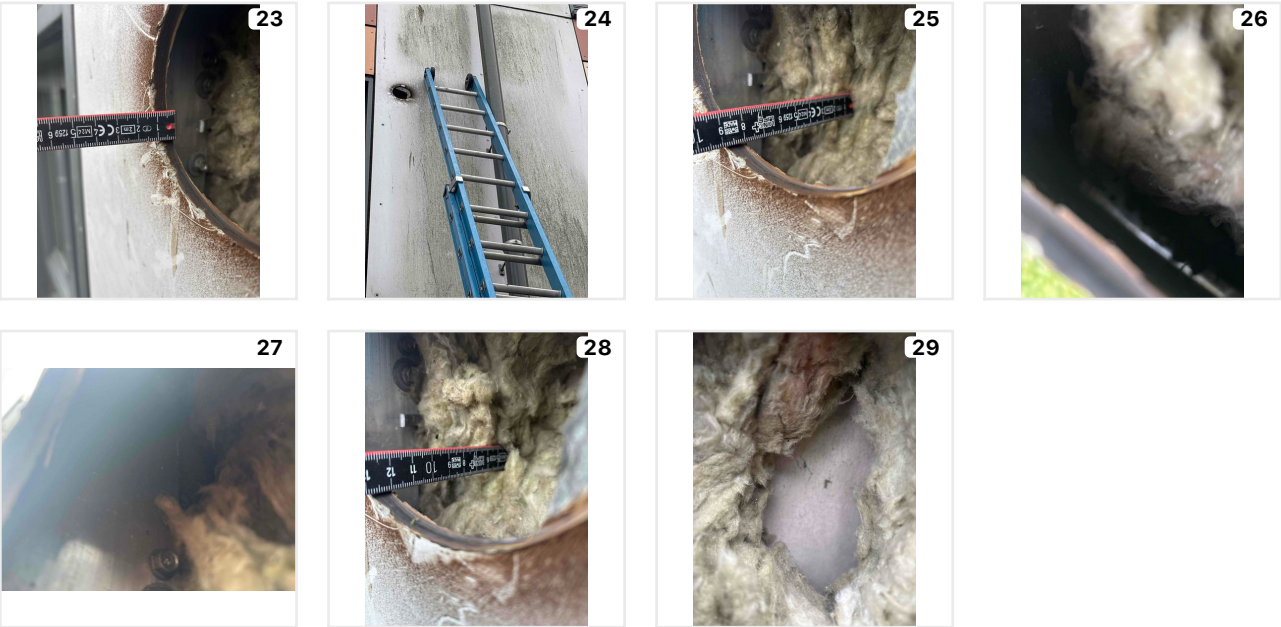
Elevation • Location  
WEST • PANEL BUILD UP -PLUS JUNCTION WITH OTHER FACADE TYPES

Reinforced concrete

- Panel Inspection options
1. Remove panel if possible or conduct a core hole removal of external surface material  
Assess material making up the wall type  
Reinstate to a weathertight condition
  2. If panel cannot be removed. Cut a 250mm core hole  
Assess material making up the wall type  
Reinstate to a weathertight condition
  3. If access is restricted externally-From internal-  
Cut out 200mm x 200mm inspection panel through internal plaster / plasterboard to expose construction behind.  
Inspect the construction, cavity, insulation and junction with compartment floor slab, compartment wall and window opening  
Replace any insulation removed with new  
Replace plasterboard with existing / new as required fixing to a timber batten  
Redecoration by the Building Management

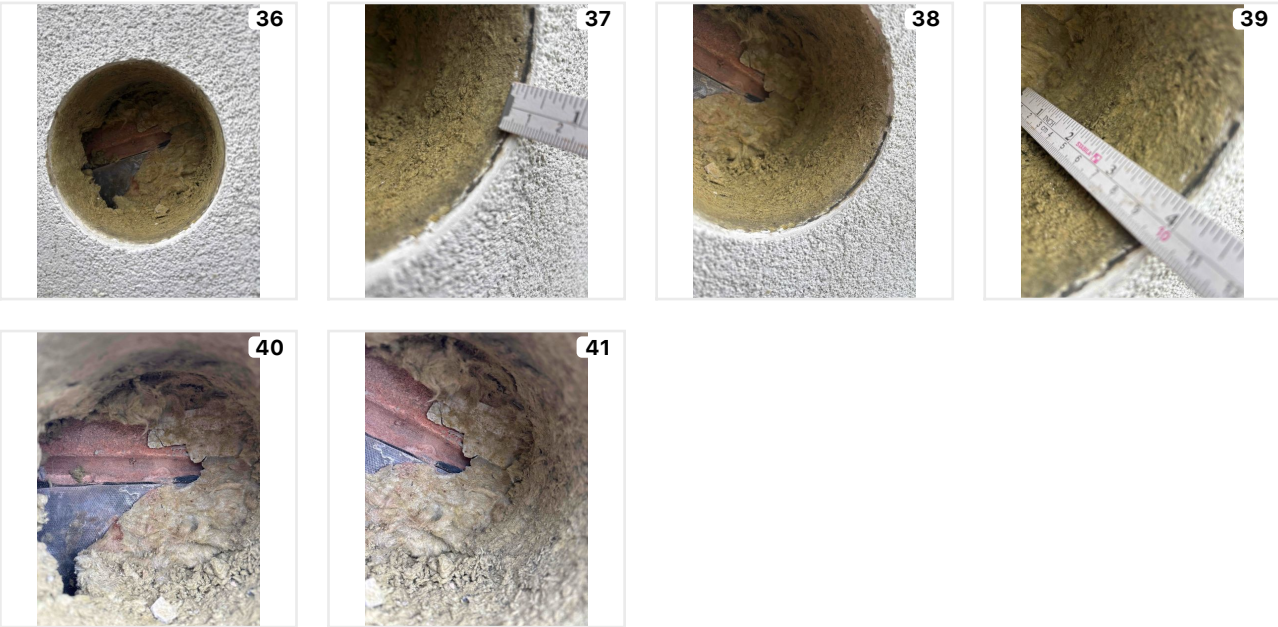
Reinforced concrete

1. Remove panel if possible or conduct a core hole removal of external surface material  
Assess material making up the wall type  
Reinstate to a weathertight condition
2. If panel cannot be removed. Cut a 250mm core hole  
Assess material making up the wall type  
Reinstate to a weathertight condition
3. If access is restricted externally-From internal-  
Cut out 200mm x 200mm inspection panel through internal plaster / plasterboard to expose construction behind.  
Inspect the construction, cavity, insulation and junction with compartment floor slab, compartment wall and window opening  
Replace any insulation removed with new  
Replace plasterboard with existing / new as required fixing to a timber batten  
Redecoration by the Building Management
