Document Version 3  
Survey Date 05/11/2024  
Suggested Review Date 05/11/2029

# EXTERNAL WALL SURVEY

## WALLACE HOUSE

Wallace House  
Badsey Road  
Oldbury  
West Midlands  
B69 1ER

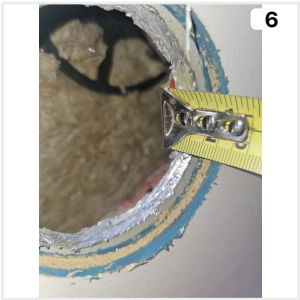
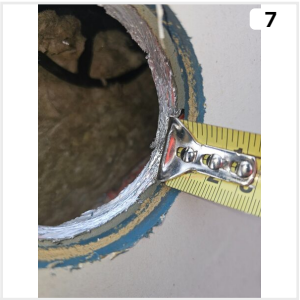
# Inspection: PGX519

Wall Type 1 - Rainscreen cladding

| 4 Elements | Thickness/Depth | Material | Photo Ref. | Rating (BS EN13501) |
|---|---|---|---|---|
| Surface Finish | 10mm | A1 rated rainscreen mineral based panel<br>Material Brand: Rockwool | | A1 - Non-Combustible |

| 1 Cavity Barrier | Material | Photo Ref. |
|---|---|---|
| Horizontal Cavity Barrier | Open State Cavity Barrier | |

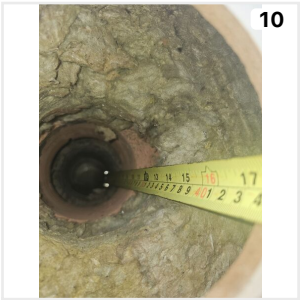
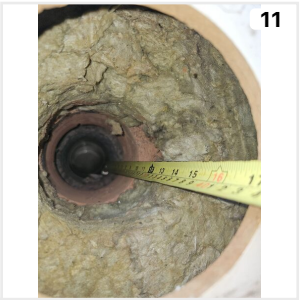
# Inspection: VF1MET

Wall Type 1 - Rainscreen cladding

| 4 Elements | Thickness/Depth | Material | Photo Ref. | Rating (BS EN13501) |
|---|---|---|---|---|
| Surface Finish | 10mm | A1 rated rainscreen mineral based panel<br>Material Brand: Rockwool | | A1 - Non-Combustible |

| 1 Cavity Barrier | Material | Photo Ref. |
|---|---|---|
| Horizontal Cavity Barrier | Open State Cavity Barrier | |

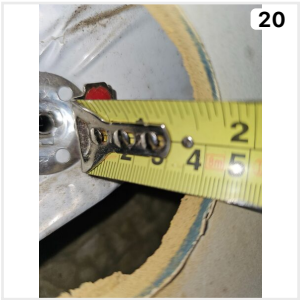
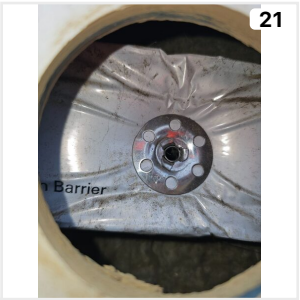
# Inspection: 7TNGLI

Wall Type 1 - Rainscreen cladding

| 4 Elements | Thickness/Depth | Material | Photo Ref. | Rating (BS EN13501) |
|---|---|---|---|---|
| Surface Finish | 10mm | A1 rated rainscreen mineral based panel<br>Material Brand: Rockwool | | A1 - Non-Combustible |

Horizontal Cavity Barrier

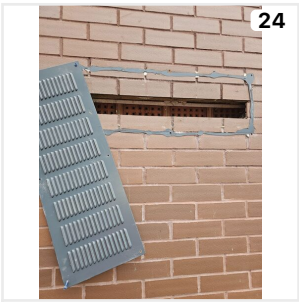
# Inspection: UQFWP3

Wall Type 2 - Brick slip system over mineral wool insulation

| 2 Elements | Thickness/Depth | Material | Photo Ref. | Rating (BS EN13501) |
|---|---|---|---|---|
| Surface Finish | 15mm | Brick Slip / Brick Tile | | A1 - Non-Combustible |

There is no external wall cavity
