Document Version 2  
Survey Date 13/03/2025  
Suggested Review Date 13/03/2030

# EXTERNAL WALL SURVEY

## WIMBERGER HOUSE

Wimberger House  
Hallam Street  
West Brom  
B71 4HA

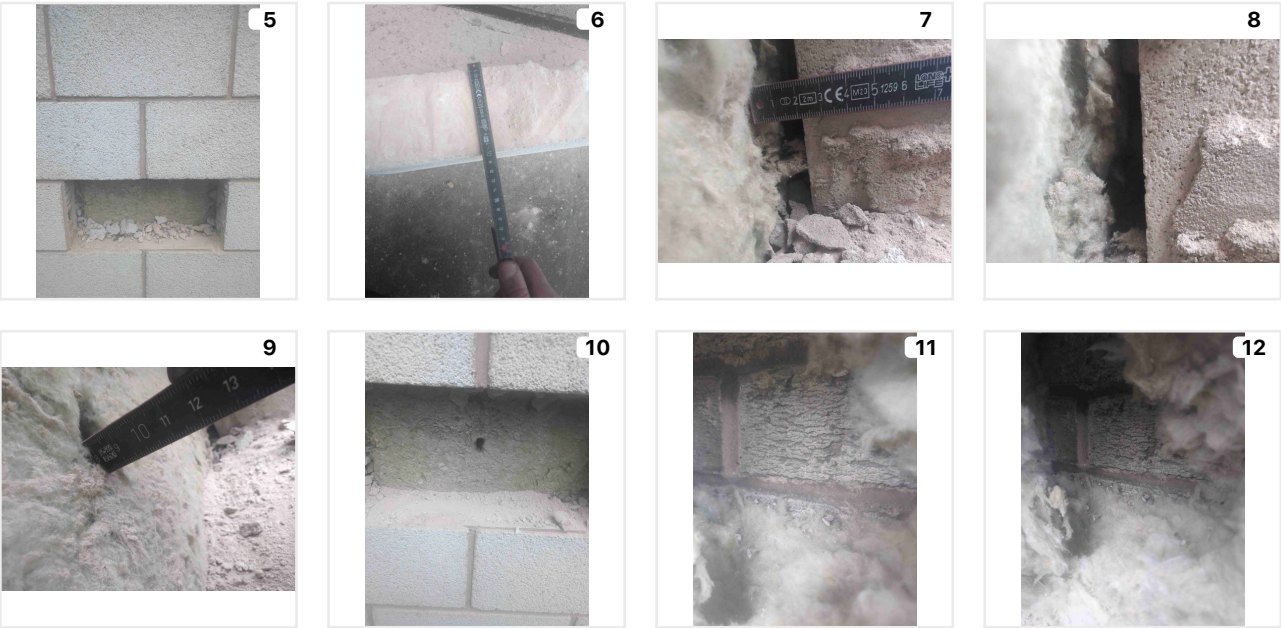
# Inspection: 1RFH4K

| 4 Elements | Thickness/Depth | Material | Photo Ref. | Rating (BS EN13501) |
|---|---|---|---|---|
| Surface Finish | 100mm | Masonry blockwork | 5, 6 | A1 - Non-Combustible |
| Cavity | 20mm | | 7, 8 | |
| Insulation | 90mm | Mineral Wool Insulation | 9, 10 | A1 - Non-Combustible |
| Inner Leaf | 102mm | Brickwork | 11, 12 | A1 - Non-Combustible |

| 1 Cavity Barrier | Material | Photo Ref. |
|---|---|---|
| Horizontal Cavity Barrier | Solid State Mineral Wool | 10 |

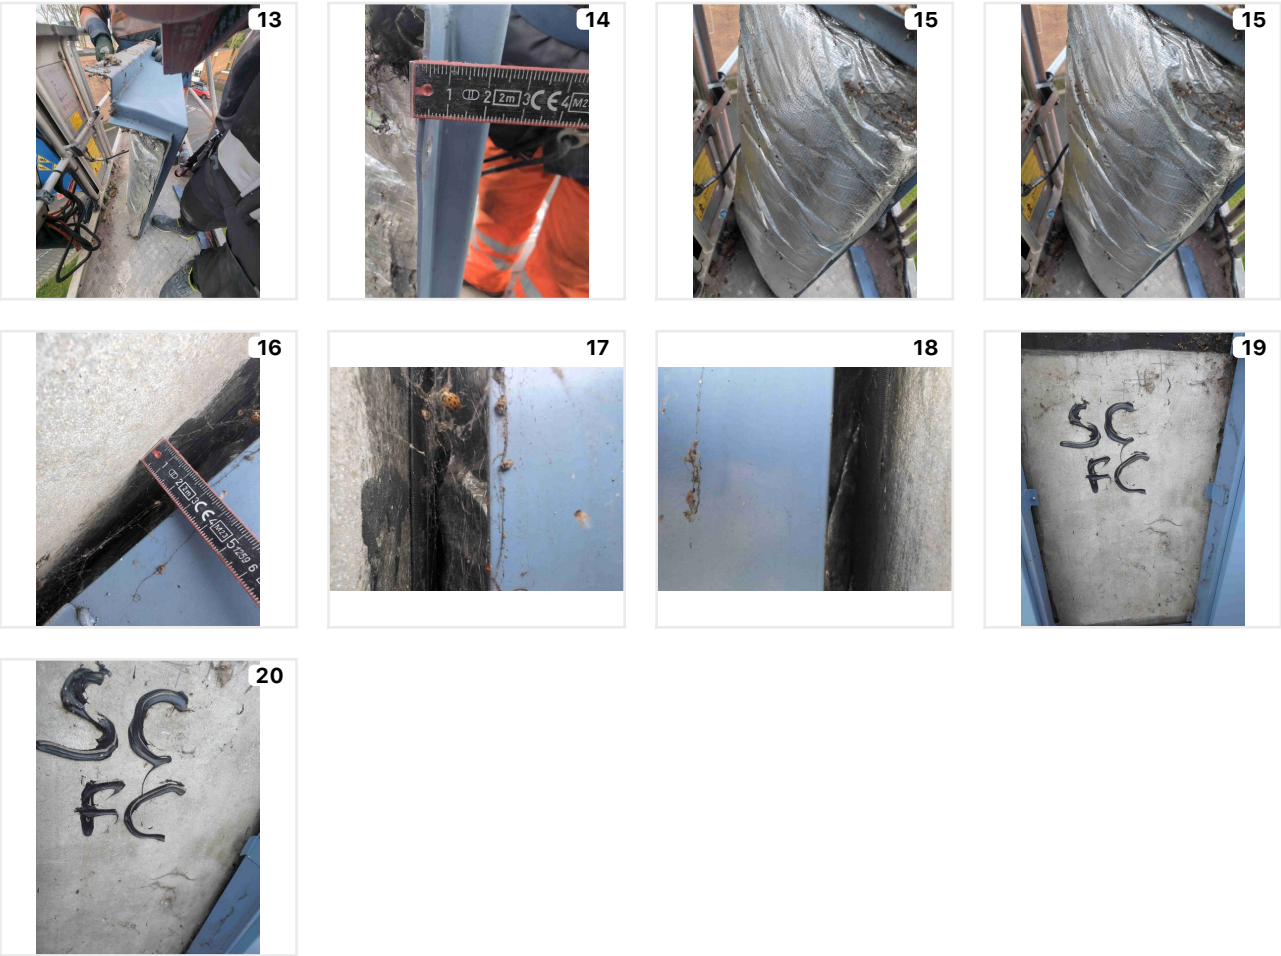
# Inspection: 4RUIUE

| 4 Elements | Thickness/Depth | Material | Photo Ref. | Rating (BS EN13501) |
|---|---|---|---|---|
| Surface Finish | 3mm | Aluminium Panel | 13, 14, 15 | A2 - Limited Combustibility |
| Insulation | 100mm | Mineral Wool Insulation<br>enclose in foil | 15 | A1 - Non-Combustible |
| Cavity | 30mm | | 16, 17, 18 | |
| Inner Leaf | | Reinforced concrete<br>Material Brand:<br>Concrete wall | 19, 20 | A1 - Non-Combustible |

| 1 Cavity Barrier | Material | Photo Ref. |
|---|---|---|
| Window Aperture | Stonewool core, aluminium foil faces | 21 |

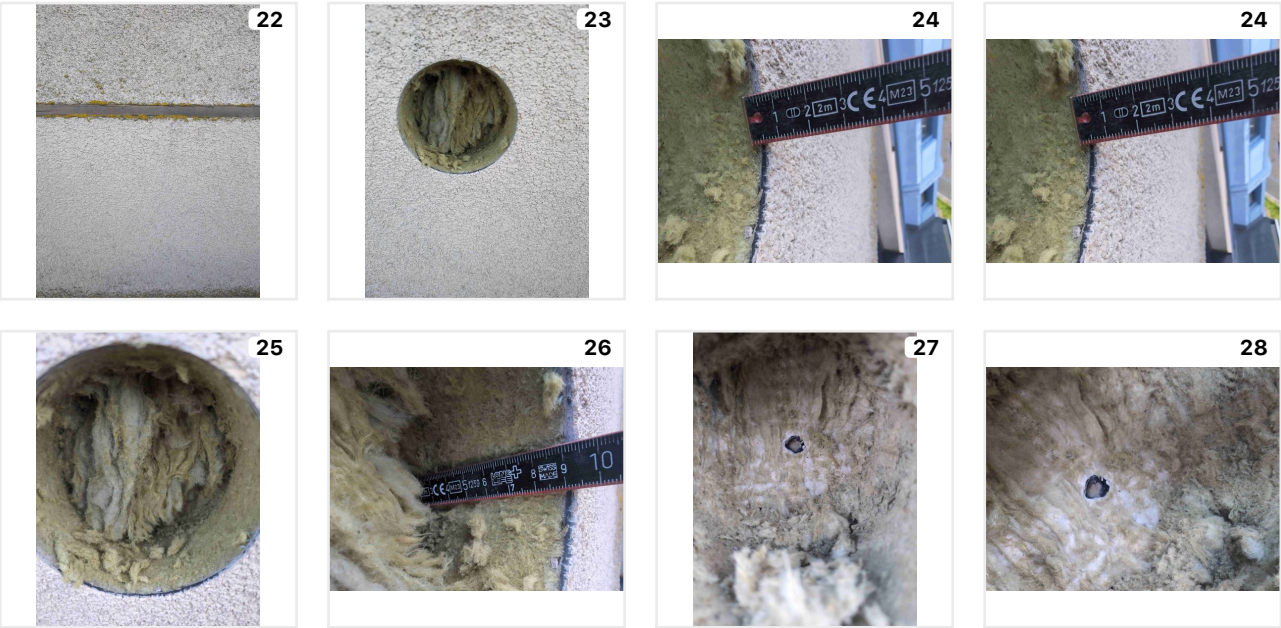
# Inspection: UB1FR1

| 4 Elements | Thickness/Depth | Material | Photo Ref. | Rating (BS EN13501) |
|---|---|---|---|---|
| Surface Finish | 5mm | Sto render | 22, 23, 24 | A1 - Non-Combustible |
| Insulation | 90mm | Mineral Wool Insulation | 25, 26 | A1 - Non-Combustible |
| Inner Leaf | | Blockwork | 27, 28 | A1 - Non-Combustible |

| 1 Cavity Barrier | Material | Photo Ref. |
|---|---|---|
| Horizontal Cavity Barrier | Solid State Mineral Wool | 25 |

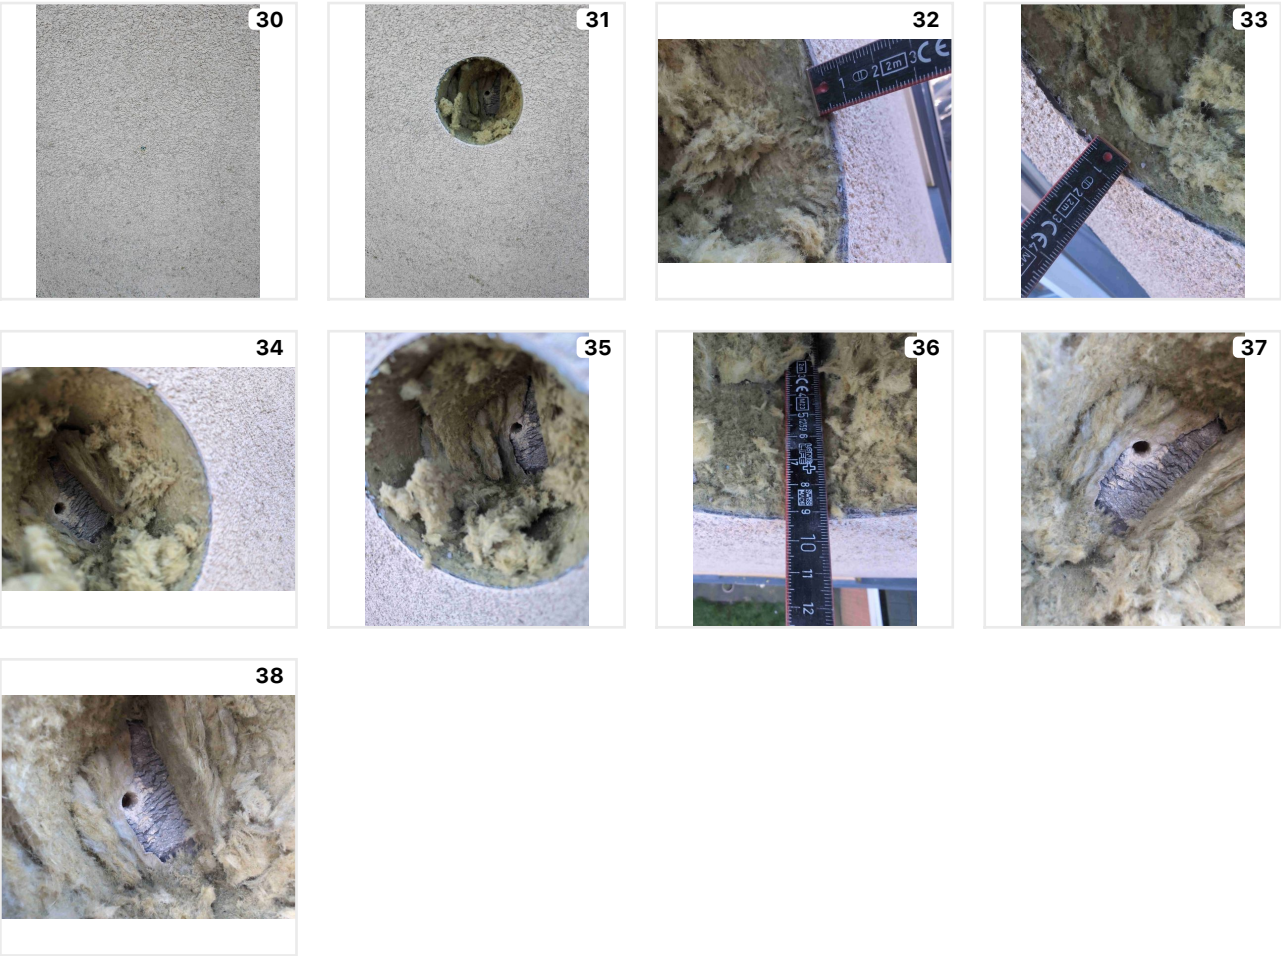
# Inspection: D4B6IJ

| 4 Elements | Thickness/Depth | Material | Photo Ref. | Rating (BS EN13501) |
|---|---|---|---|---|
| Surface Finish | 5mm | Sto render | 30, 31, 32 | A1 - Non-Combustible |
| Outer leaf | 5mm | | 33 | A1 - Non-Combustible |
| Insulation | 90mm | Mineral Wool Insulation | 34, 35, 36 | A1 - Non-Combustible |
| Inner Leaf | | Blockwork | 37, 38 | A1 - Non-Combustible |

| 1 Cavity Barrier | Material | Photo Ref. |
|---|---|---|
| Horizontal Cavity Barrier | Solid State Mineral Wool | 39 |

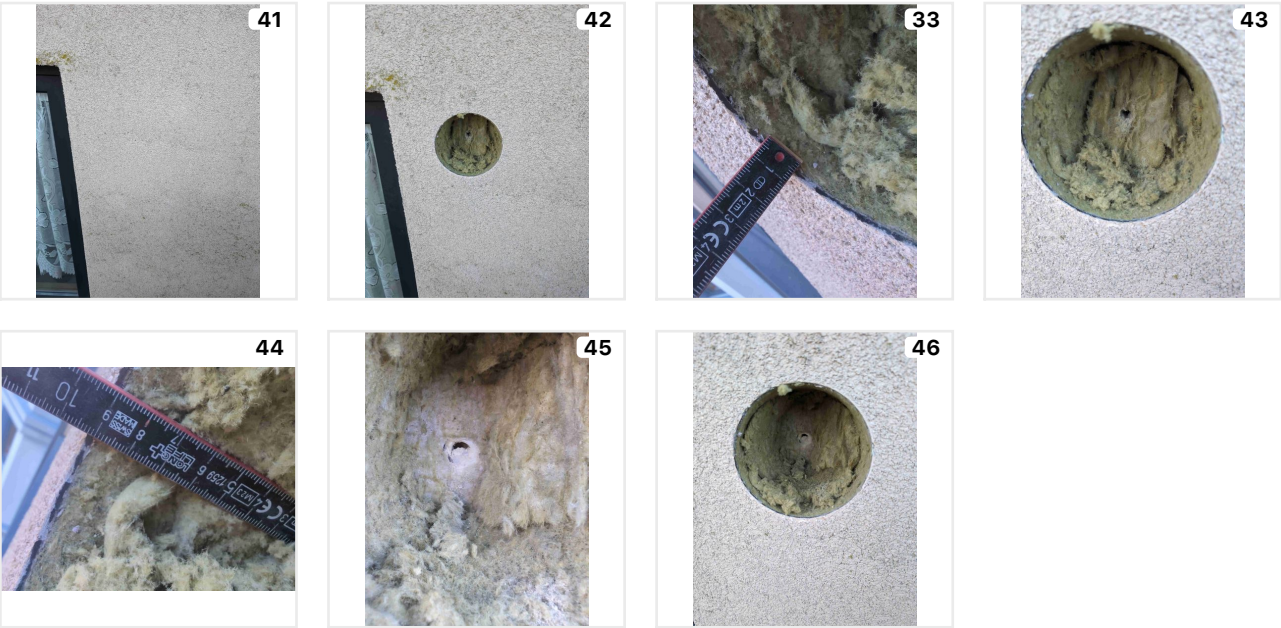
# Inspection: SJKBS

| 4 Elements | Thickness/Depth | Material | Photo Ref. | Rating (BS EN13501) |
|---|---|---|---|---|
| Surface Finish | 5mm | Sto render | 41, 42, 33 | A1 - Non-Combustible |
| Insulation | 90mm | Mineral Wool Insulation | 43, 44 | A1 - Non-Combustible |
| Inner Leaf | | Blockwork | 45, 46 | A1 - Non-Combustible |

| 1 Cavity Barrier | Material | Photo Ref. |
|---|---|---|
| Window Aperture | Solid State Mineral Wool | 46 |

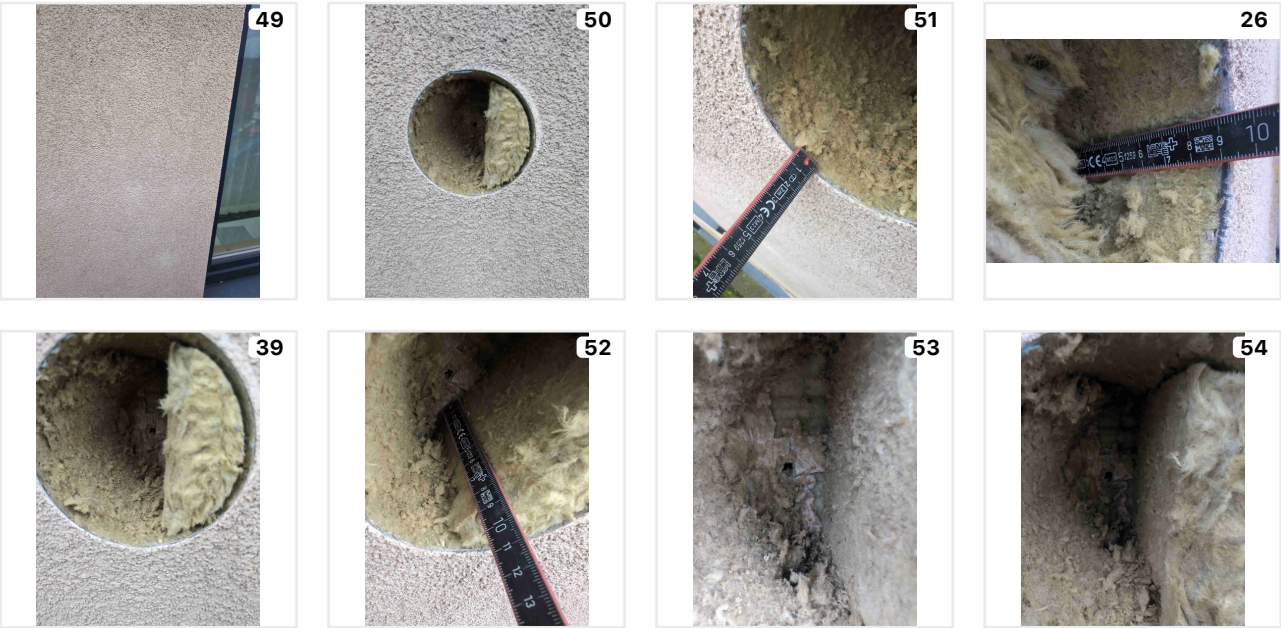
# Inspection: 781DSZ

| 4 Elements | Thickness/Depth | Material | Photo Ref. | Rating (BS EN13501) |
|---|---|---|---|---|
| Surface Finish | 5mm | Sto render | 49, 50, 51 | A1 - Non-Combustible |
