Document Version 3  
Survey Date 27/03/2025  
Suggested Review Date 27/03/2030

# FIRE RISK APPRAISAL EXTERNAL WALLS

## WIMBERGER HOUSE

Wimberger House  
Hallam Street  
West Brom  
B71 4HA

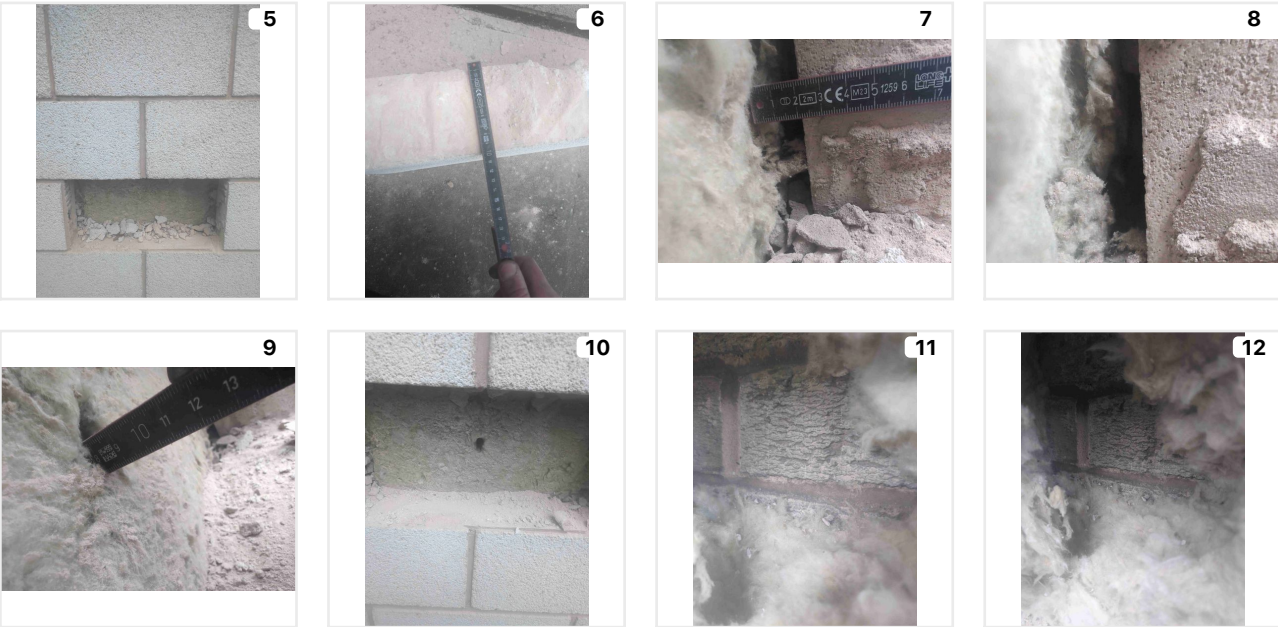
## Build-up Photos

Backing Wall Sits On The Floor Slab

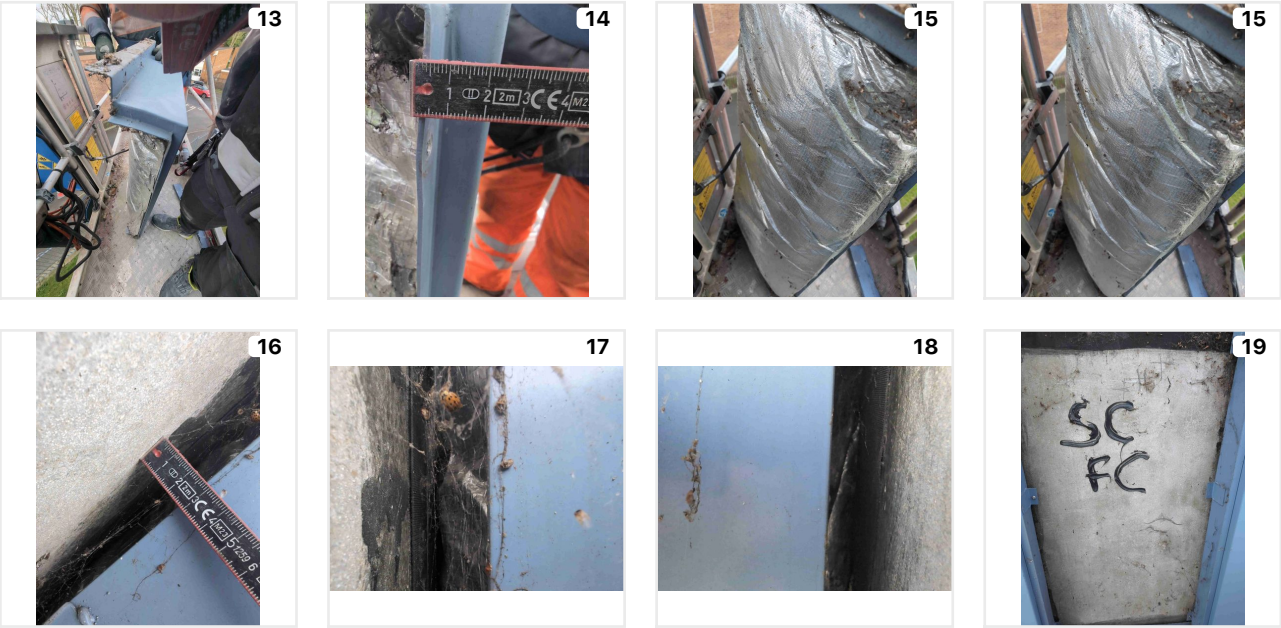
Build-up Photos

Reinforced concrete

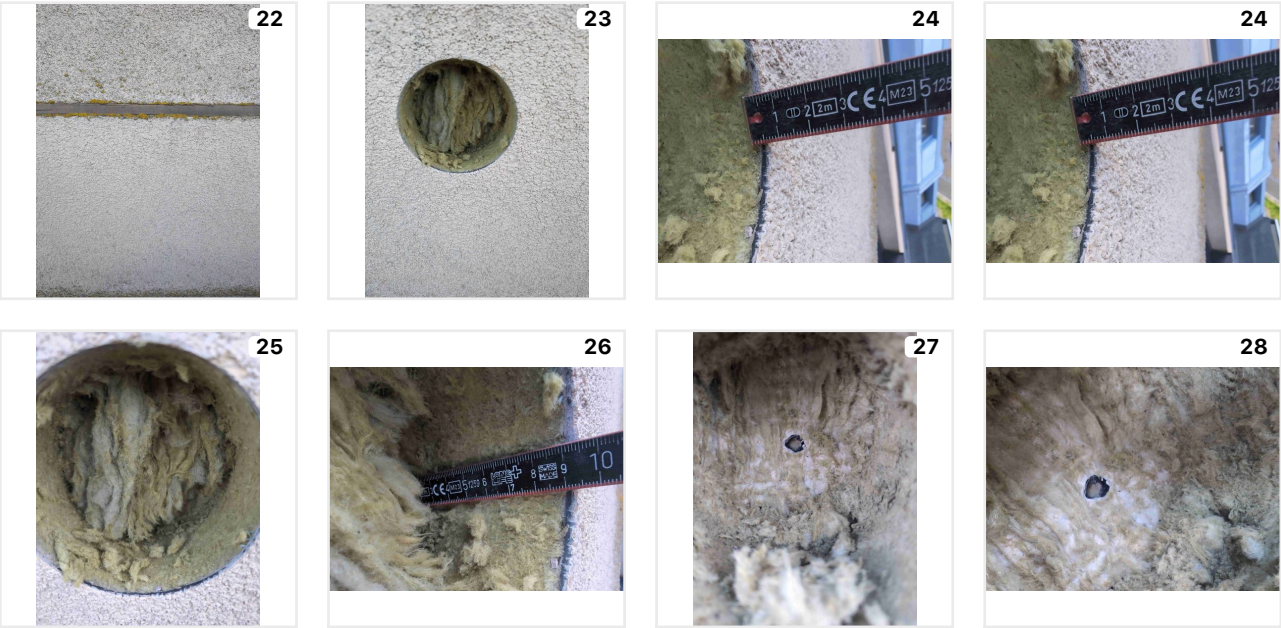
Build-up Photos

Backing Wall Sits On The Floor Slab

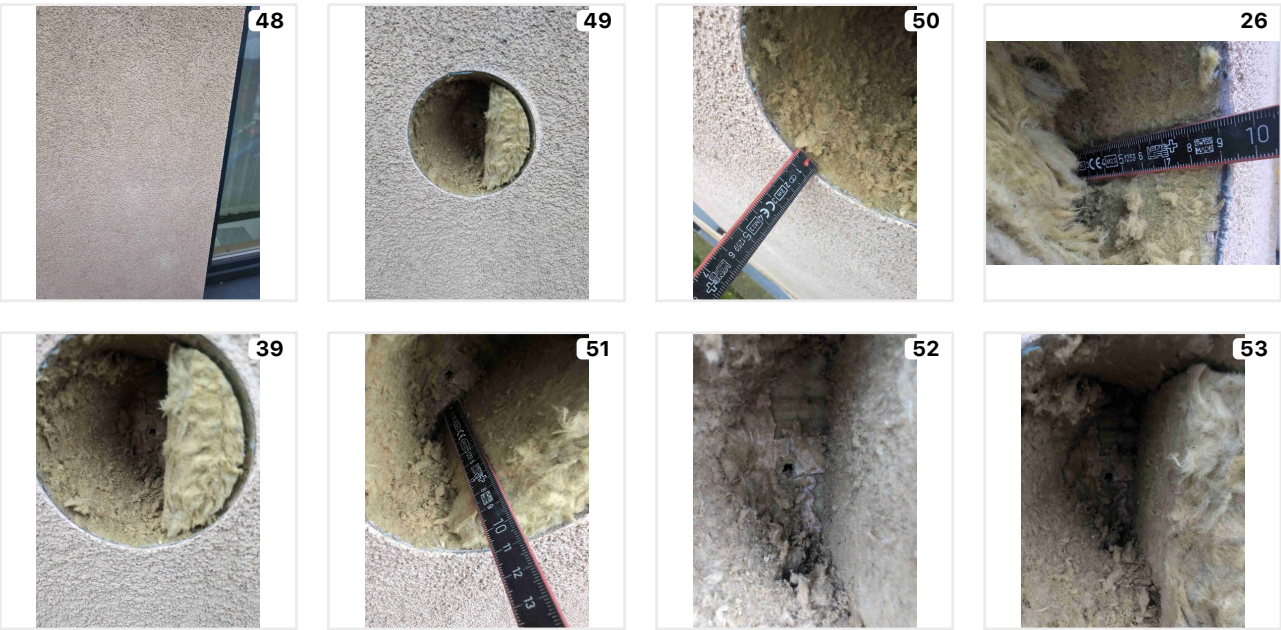
## Build-up Photos

Backing Wall Sits On The Floor Slab

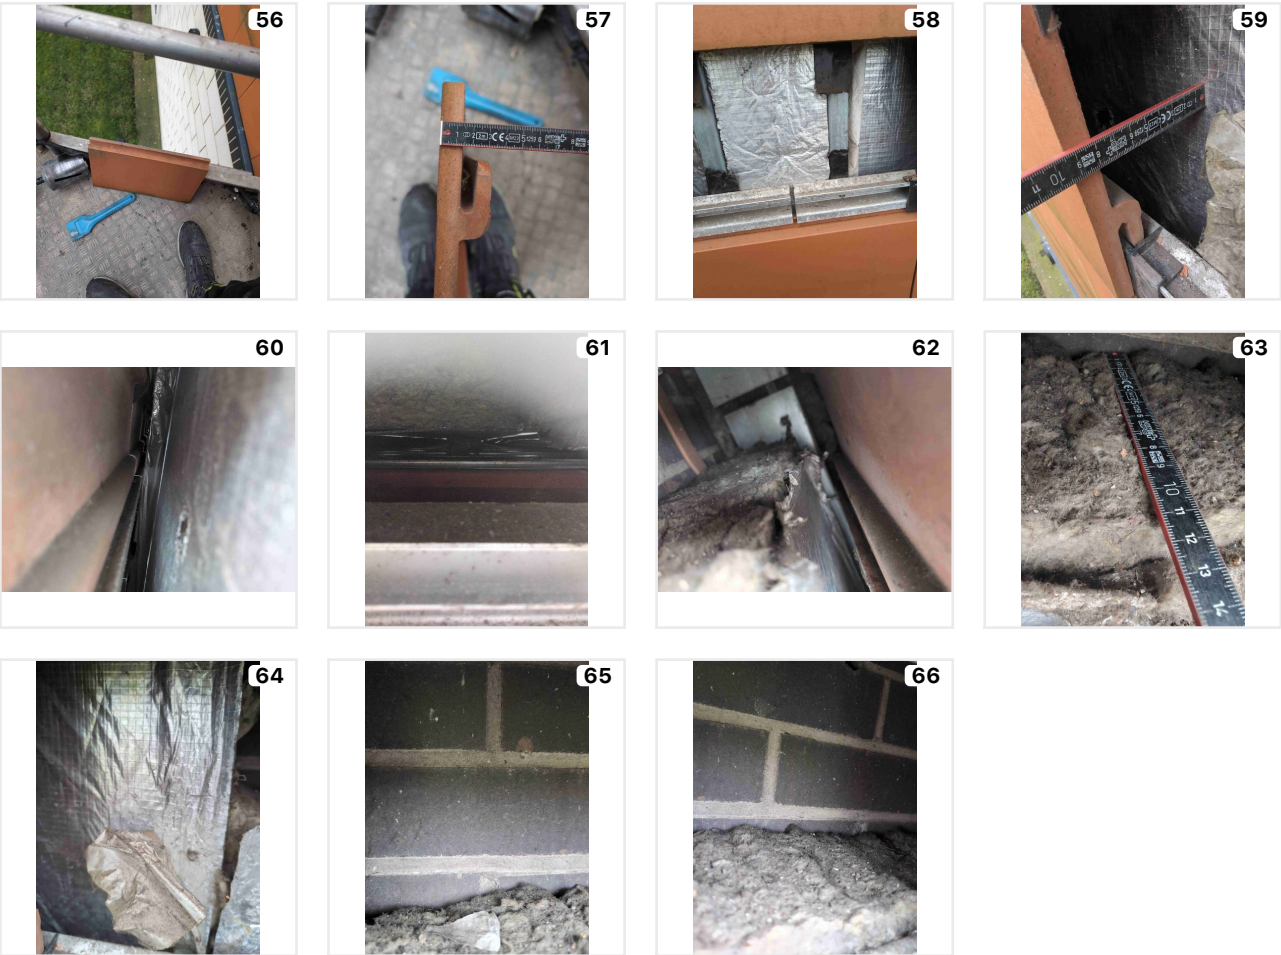
## Build-up Photos

Backing Wall Sits On The Floor Slab

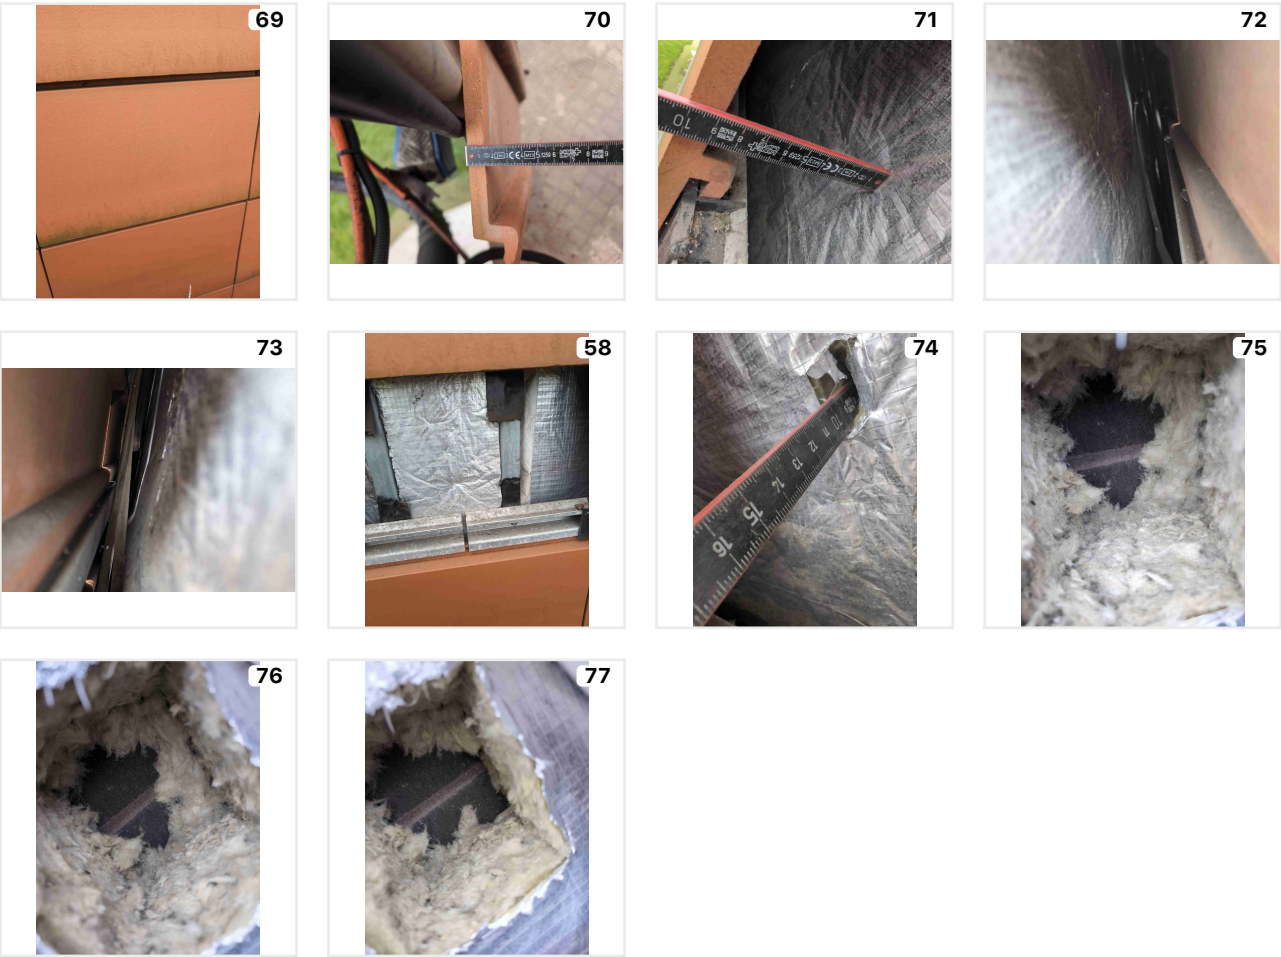
## Build-up Photos

| 1 Cavity Barrier | Material | Photo Ref. |
|---|---|---|
| Horizontal Cavity Barrier | Stonewool core, aluminium foil faces | |

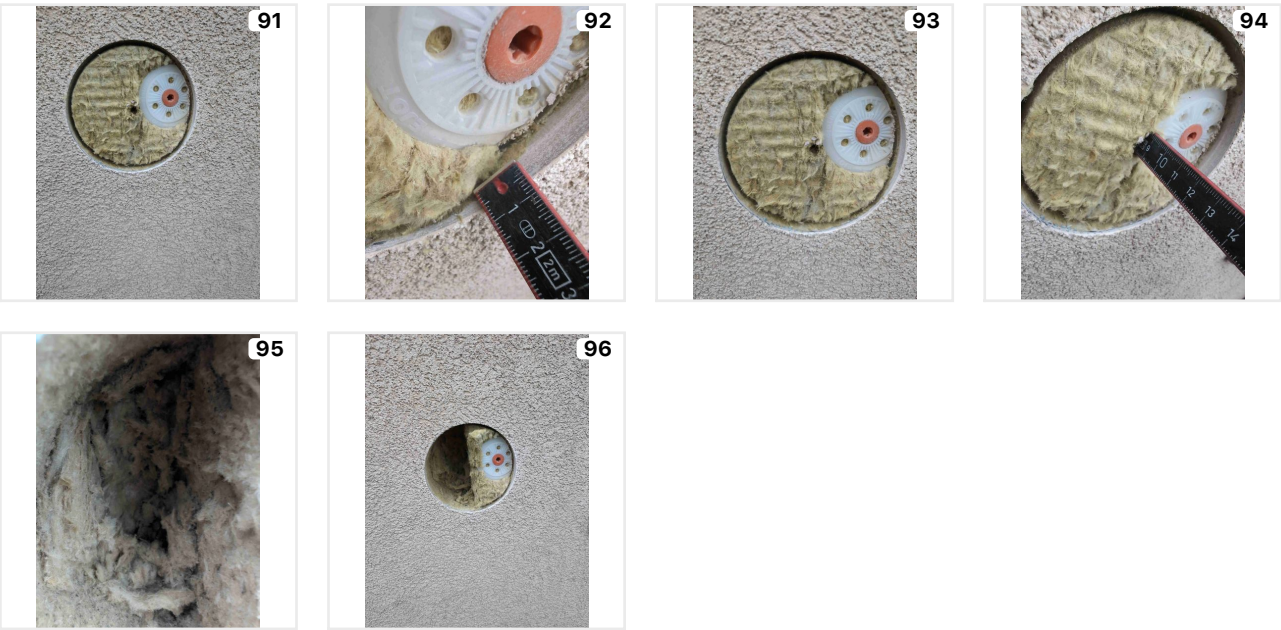
Build-up Photos

Backing Wall Sits On The Floor Slab
