Document Version 4  
Survey Date 20/02/2025  
Suggested Review Date 20/02/2030

# EXTERNAL WALL SURVEY

## WYNDMILL CRESCENT

51-121 Wyndmill Crescent  
West Brom  
West Midlands  
B71 3QZ

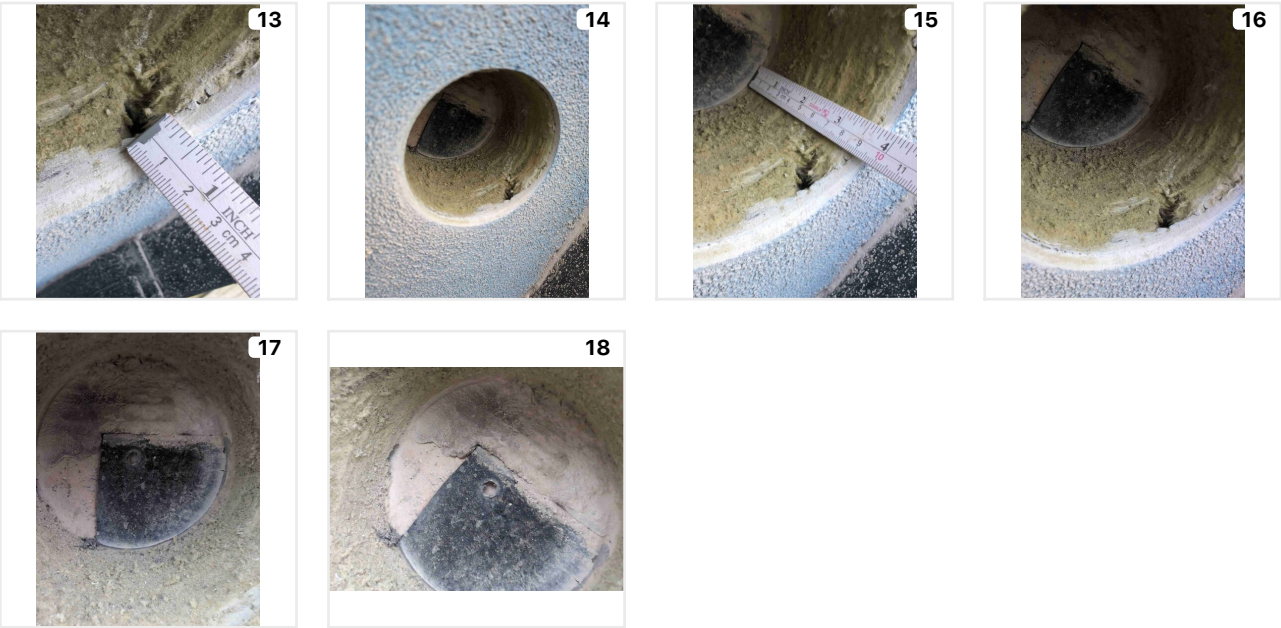
# Inspection: XQ1WFL

RENDER SYSTEM - EAST ELEVATION

| 3 Elements | Thickness/Depth | Material | Photo Ref. | Rating (BS EN13501) |
|---|---|---|---|---|
| Surface Finish | 9mm | Sto render | 13, 14 | A1 - Non-Combustible |
| Insulation | 90mm | Mineral Wool Insulation | 15, 16 | A1 - Non-Combustible |
| Inner Leaf<br>Support (Backing<br>Wall) | | Concrete wall | 17, 18 | A1 - Non-Combustible |

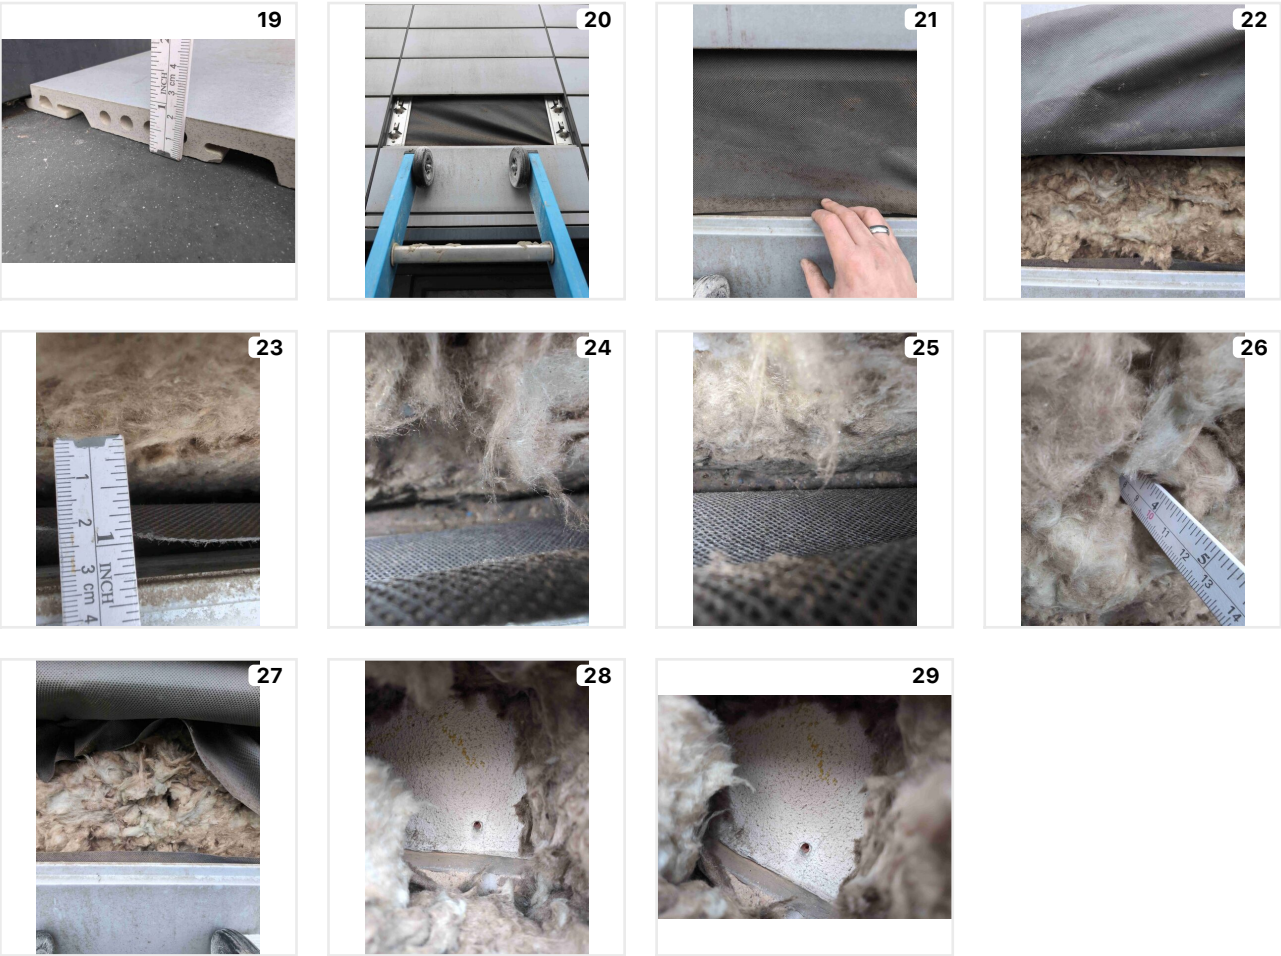
# Inspection: PIAD94

PANEL SYSTEM - EAST ELEVATION

| 5 Elements | Thickness/Depth | Material | Photo Ref. | Rating (BS EN13501) |
|---|---|---|---|---|
| Surface Finish | 20mm | Stone tile | 19, 20 | A1 - Non-Combustible |
| Breather Membrane | 1mm | | 21, 22 | E - Highly Combustible |
| Cavity | 30mm | | 23, 24, 25 | |
| Insulation | 90mm | Mineral Wool Insulation | 26, 27 | A1 - Non-Combustible |
| Inner Leaf Support (Backing Wall) | | Concrete wall | 28, 29 | A1 - Non-Combustible |

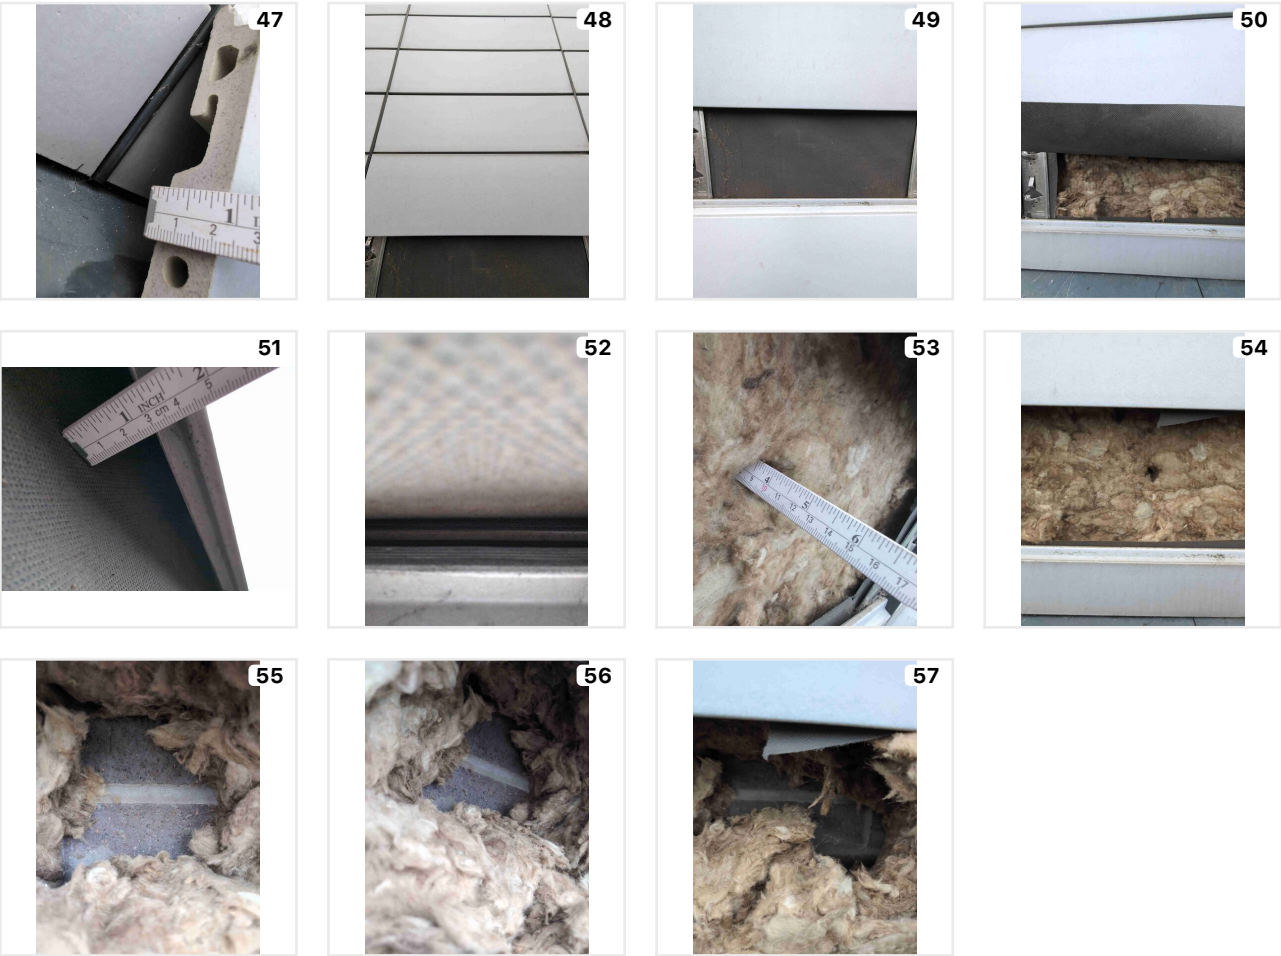
# Inspection: HTH9JA

PANEL SYSTEM - NORTH ELEVATION

| 5 Elements | Thickness/Depth | Material | Photo Ref. | Rating (BS EN13501) |
|---|---|---|---|---|
| Surface Finish | 20mm | Stone tile | 47, 48 | A1 - Non-Combustible |
| Breather Membrane | 1mm | | 49, 50 | E - Highly Combustible |
| Cavity | 30mm | | 51, 52 | |
| Insulation | 90mm | Mineral Wool Insulation | 53, 54 | A1 - Non-Combustible |
| Inner Leaf Support (Backing Wall) | | Original blockwork | 55, 56, 57 | A1 - Non-Combustible |
