# FIRE RISK APPRAISAL EXTERNAL WALLS

## WYRLEY HOUSE

Sedgeley Road East  
Tipton  
DY4 7TT

## Fire Risk Appraisal External Walls

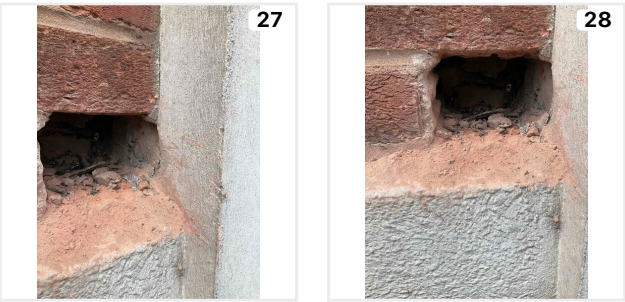
# Cavity Barrier Photos

| 2 Cavity Barriers | Material | Photo Ref. |
|---|---|---|
| Cavity closed horizontally by the concrete floor slab | | |

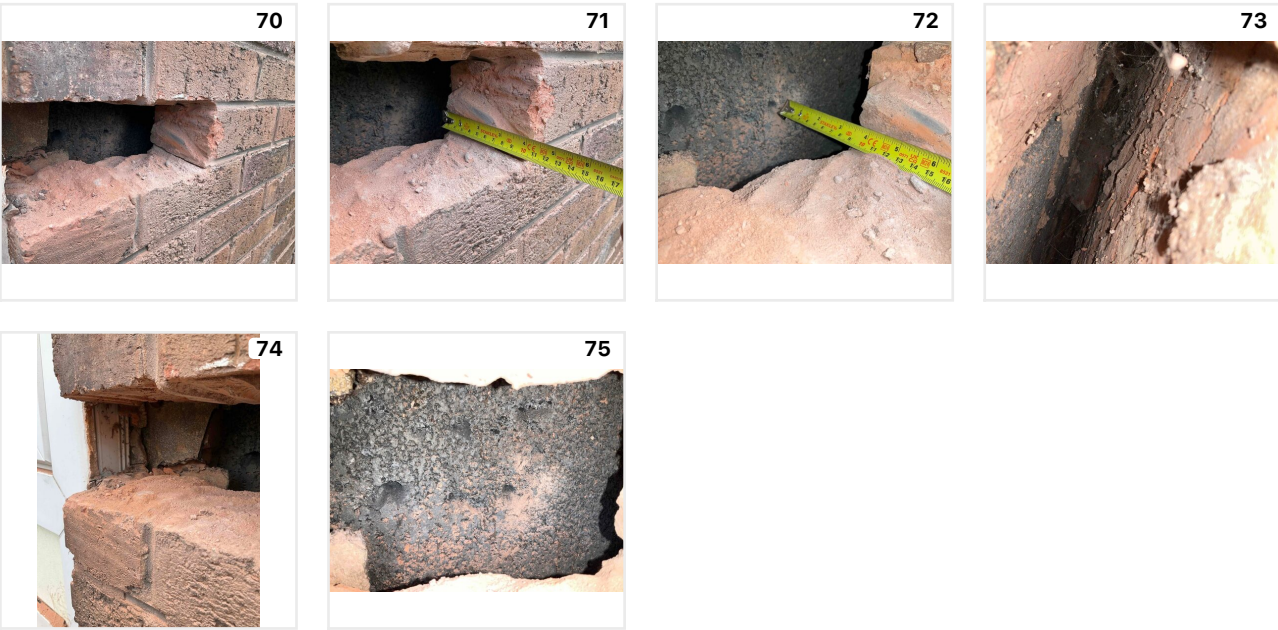
# Build-up Photos

Reinforced concrete
