Document Version 1  
Survey Date 01/07/2025  
Suggested Review Date 01/07/2030

# EXTERNAL WALL SURVEY

## WYRLEY HOUSE

Sedgeley Road East  
Tipton  
DY4 7TT

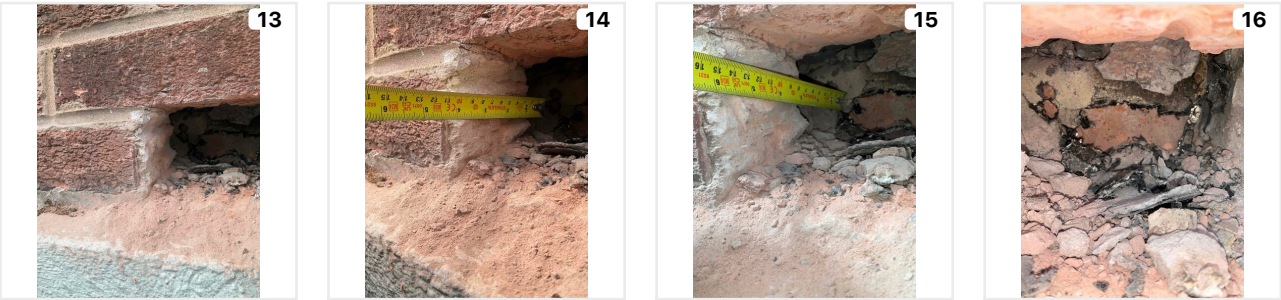
# Build-up Photos

| 3 Elements | Thickness/Depth | Material | Photo Ref. | Rating (BS EN13501) |
|---|---|---|---|---|
| External Surface Material | 102mm | Brickwork | 13, 14 | A1 - Non-Combustible |
| Cavity | 70mm | | 15 | |
| Substrate | | Original brickwork | 16 | A1 - Non-Combustible |

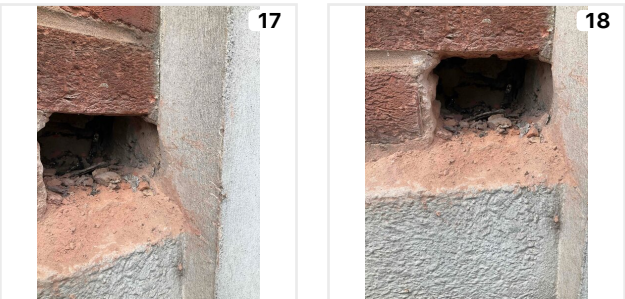
# Cavity Barrier Photos

| 2 Cavity Barriers | Material | Photo Ref. |
|---|---|---|
| Vertical Cavity Barrier | Concrete | 17 |
| Cavity closed at compartmentation wall | | |
| Horizontal Cavity Barrier | Concrete | 18 |

Cavity closed horizontally by the concrete floor slab
