VISUAL STRUCTURAL APPRAISAL

Addenbrooke Court

Southbank Road  
Oldbury  
B64 6LJ

29<sup>th</sup> November 2024

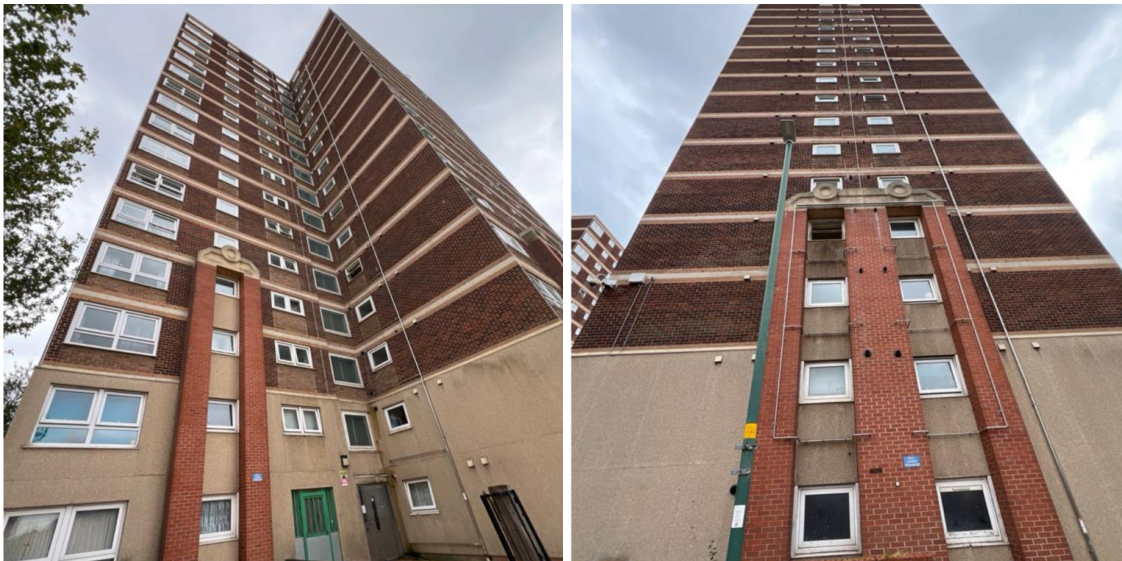
Figure 9 and 10: Front and side Elevations

The exterior elevations were generally in ok condition and no significant structural defects were noted to the infill panels. There were no significant cracks or tell-tale signs of any significant structural movement noted at the time of our inspection.

There were Resin-Stenni panels to ground and first floor. The remaining upper levels are constructed as a cavity wall, with a stretcher bond to the outer leaf. We were unable to see within the wall cavity to confirm whether there are ties or masonry supports present. The exterior walls were noted to be plumb with no signs of significant bowing, bulging or leaning noted to the cavity walls indicating failed fixings, however their presence and condition cannot be confirmed.

The exterior panels were noted to be plumb with no signs of significant bowing, bulging or leaning noted to the panels indicating failed fixings however their presence and condition cannot be confirmed.

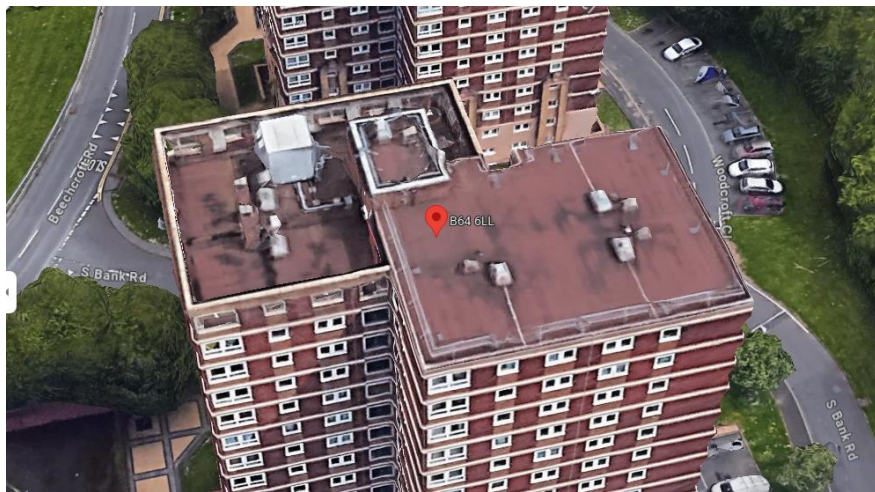
Figure 11: Roof Level

The roof was not accessible at the time of our inspection. However from satellite images it appears to be a flat roof structure with a reinforced concrete cast slab with perimeter RC parapet wall allowing safe access. There is an enclosure which partially covers the roof area likely comprising the lift plant, stair core and water tank. This structure is formed of block and masonry walls with cast in-situ RC slab covering.

The exact build-up of the roof finishes were not accessible at the time of inspection. It is recommended an intrusive survey of the roof finishes is completed by a specialist surveyor to assess the condition of the roof covering.

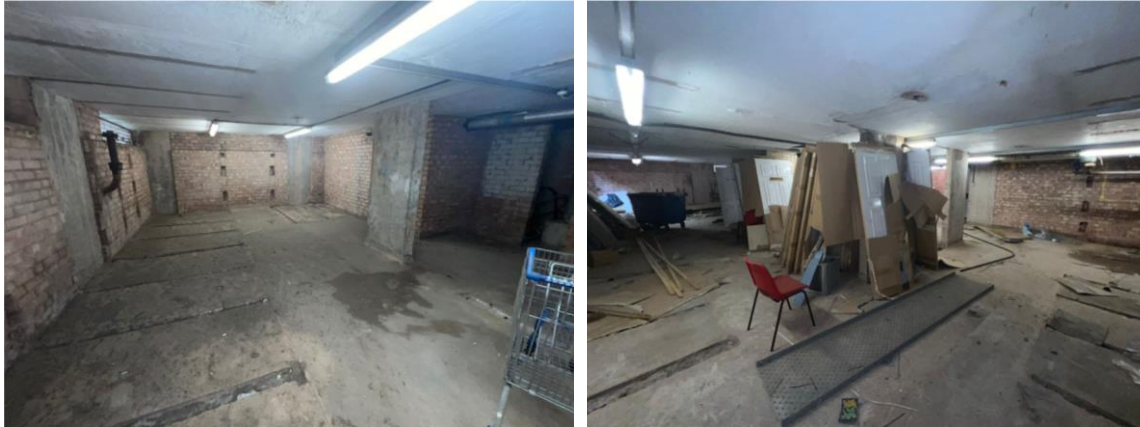
Figure 12 and 13: Vertical RC Structure Visible

The interior of the stair core walls were checked and were plumb and in line with observations made to the exterior – no significant signs of leaning or movement noted. The concrete appeared in fair condition with few BRE category 1 cracks but no structurally significant defects were noted.

There is a basement across the footprint of the building with the RC layout visible. The slabs are providing compartmentation to the building and therefore should meet the fire requirements. A cover meter survey is required to estimate the fire resistance of the floor slabs.

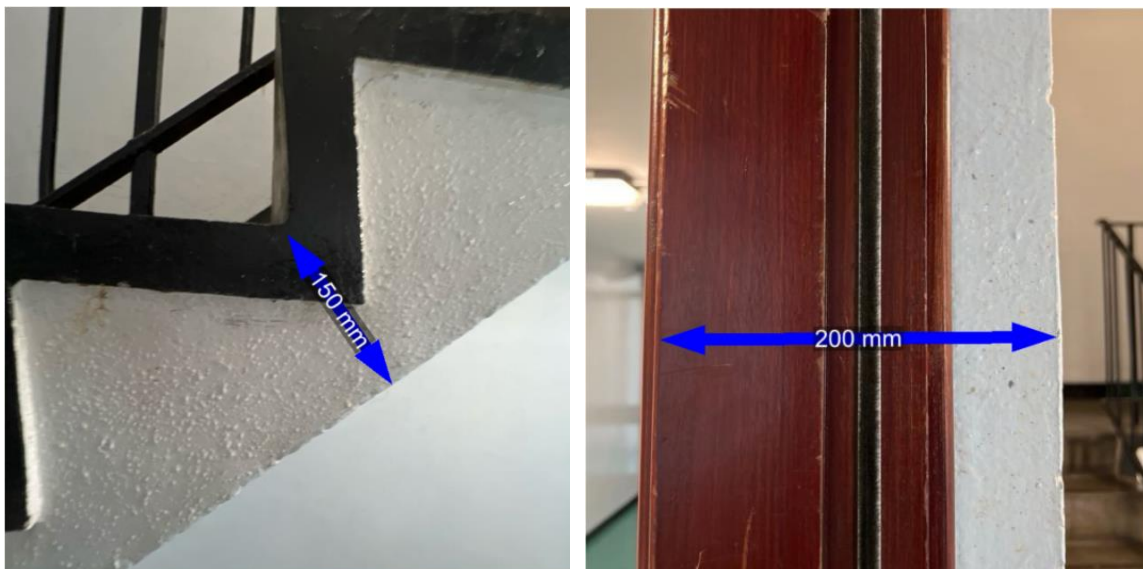
Figure 14 and 15: Staircase Stringer and shear wall

The stair stringer was noted to be 150mm thick, a cover test is required to check the resistance of the concrete section in the event of a fire.

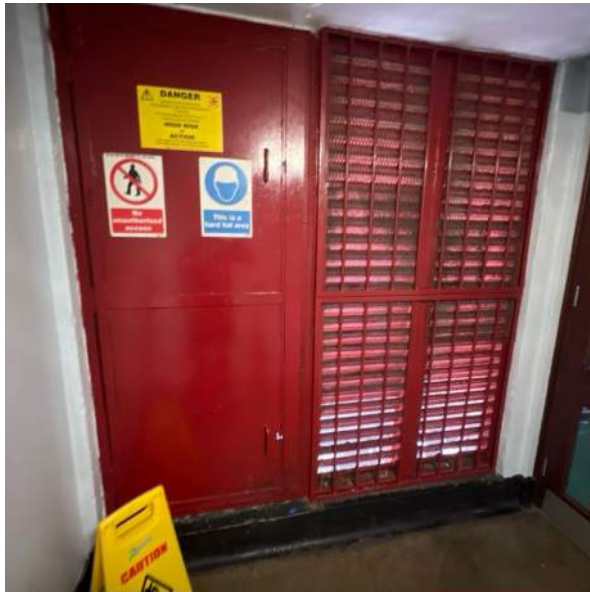
## Main Roof

Comments: Access via 15th floor full height metal door. Restricted access during inspection and therefore not accessed.

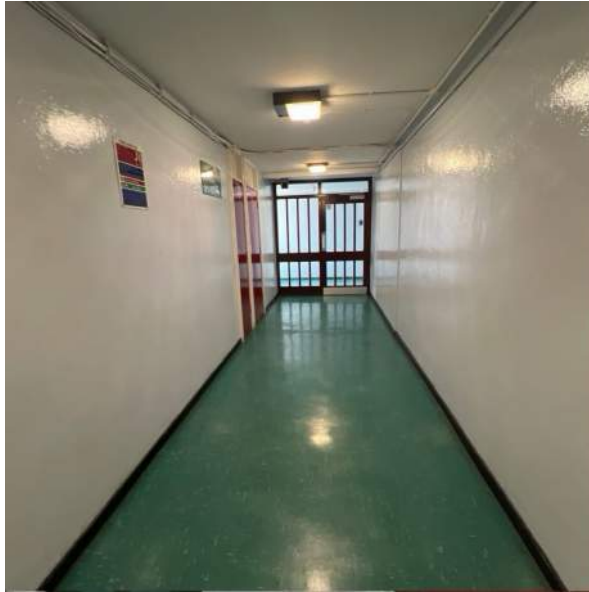
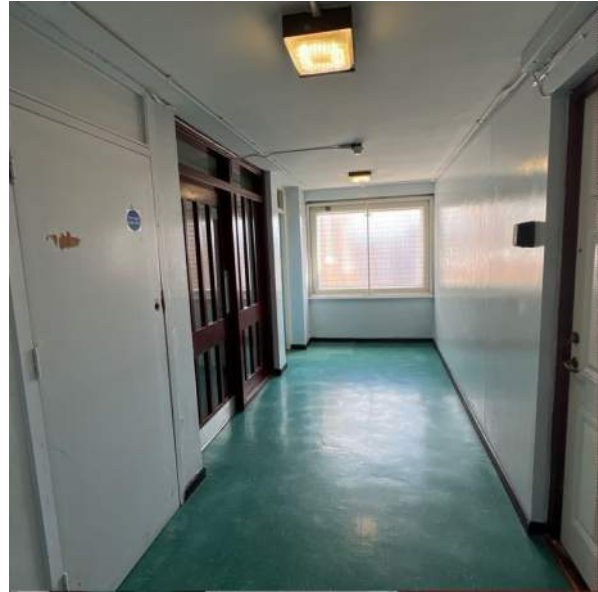
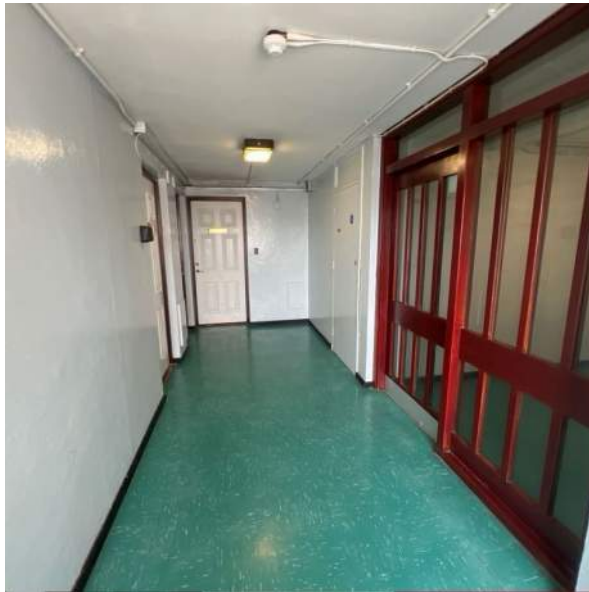
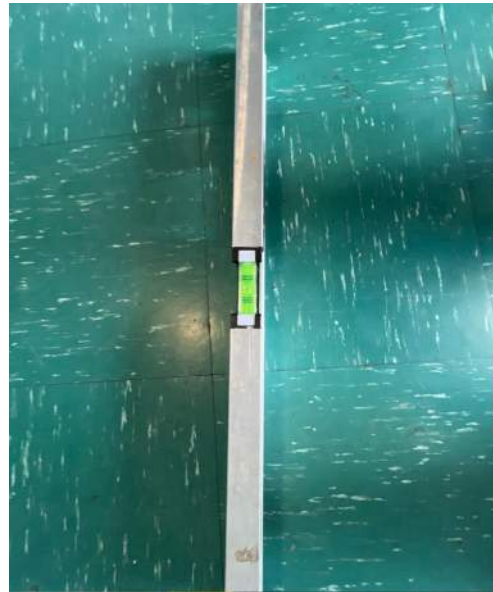
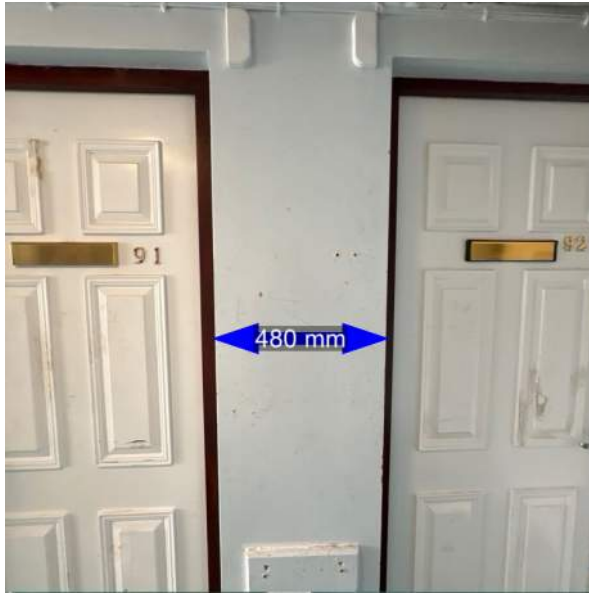
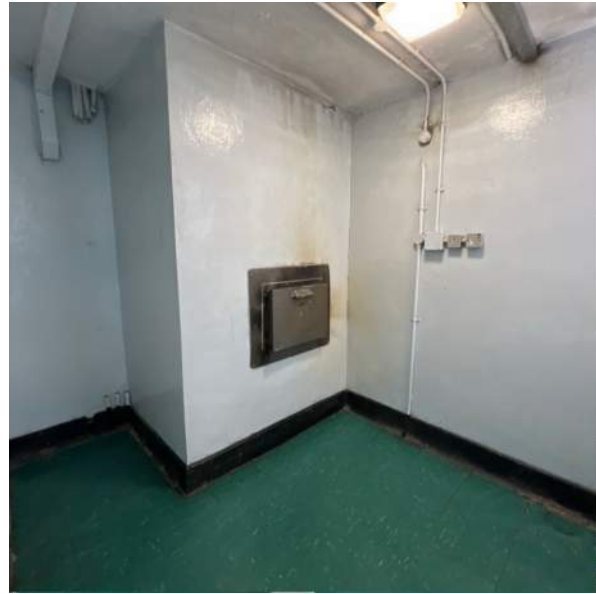
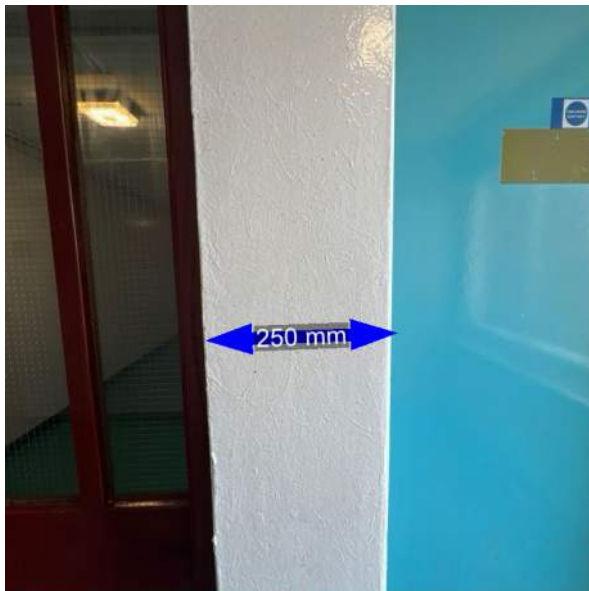
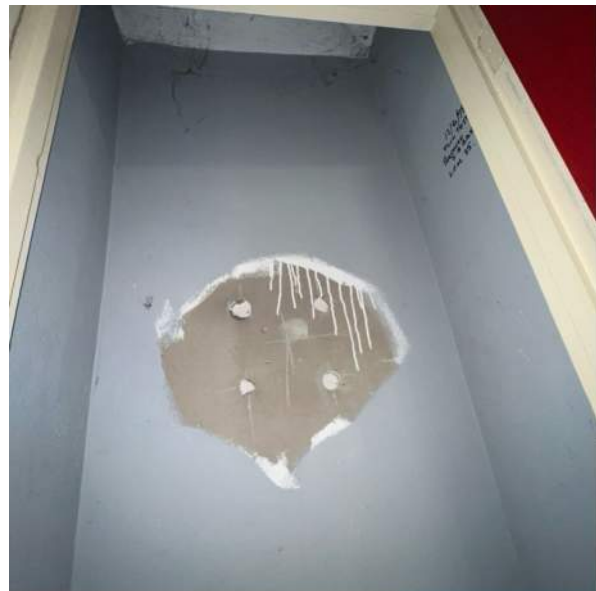
## 15th Floor Hallway

Comments: No jams or distortions noted to hallway doors to indicate any serviceability issues. Generally walls covered with finishes in hallway, likely to consist a mixture of concrete shear walls, embedded columns and block infill walls. Limited structur exposed.

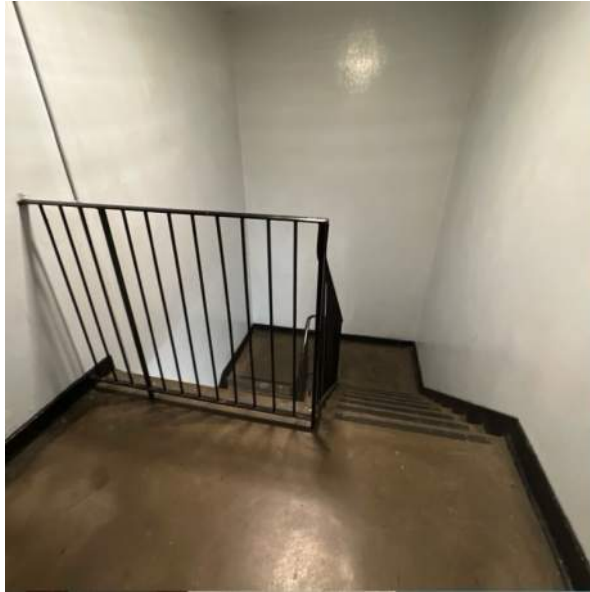
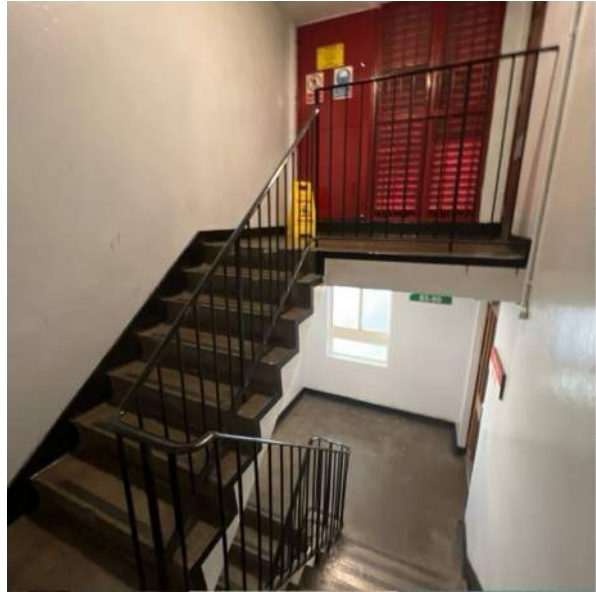
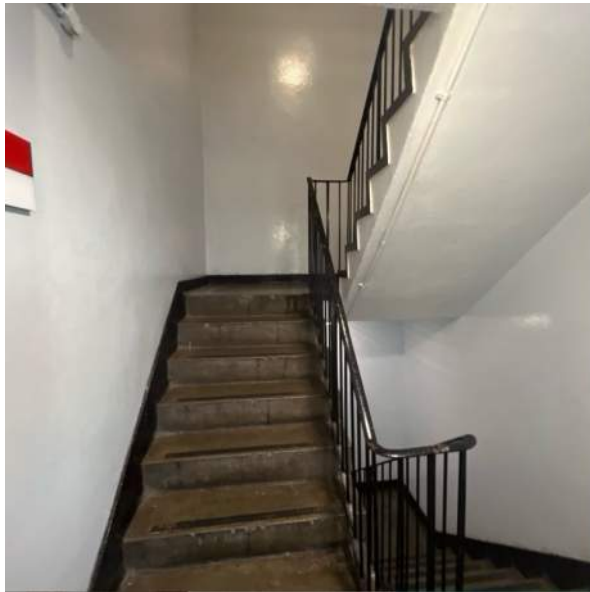
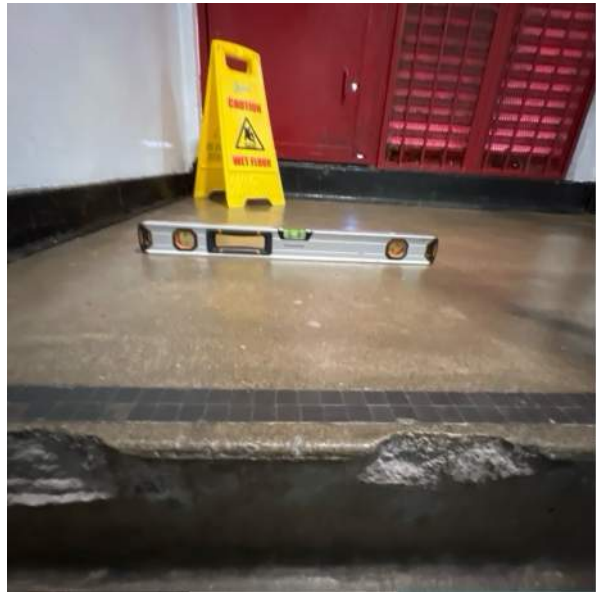
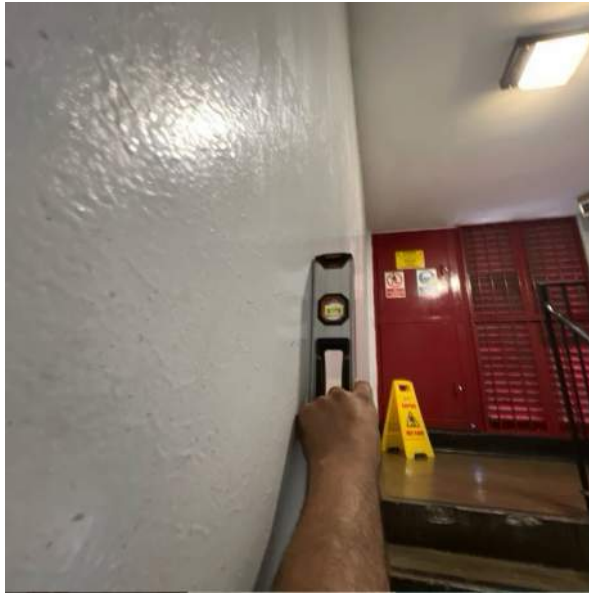
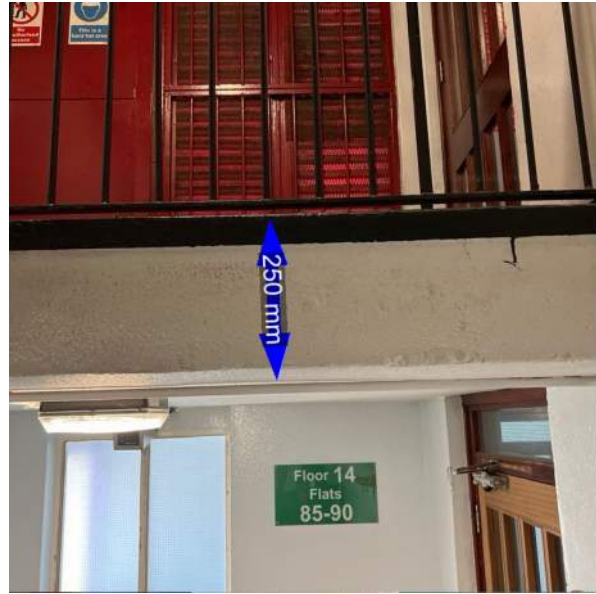
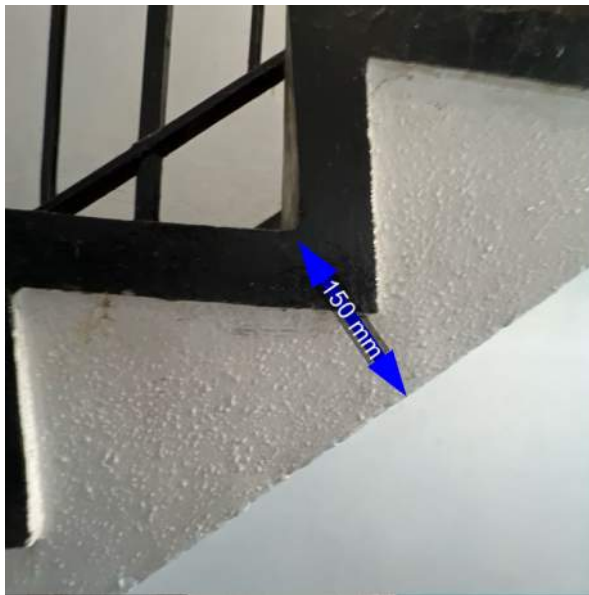
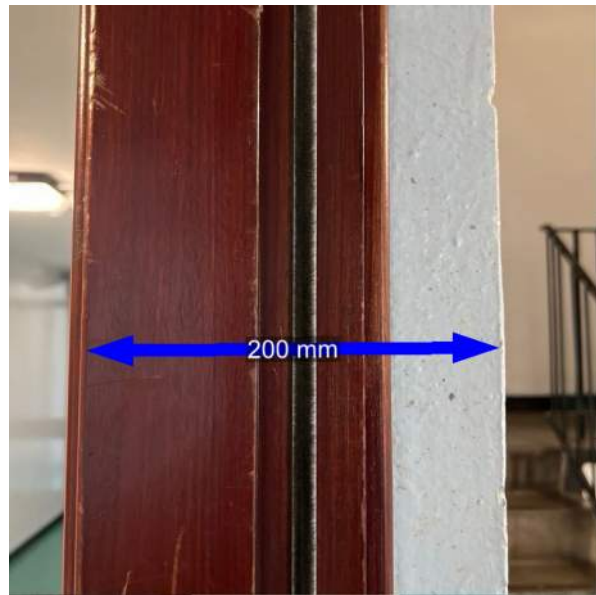
## 15th Floor Staircase

In situ concrete stairs with steel hand railing fixed to stairs. Walls and floors appear to be fairly level.

Stair walls covered with finishes however these would likely form the main concrete shear core walls. Stair walls approx. 200mm thick.

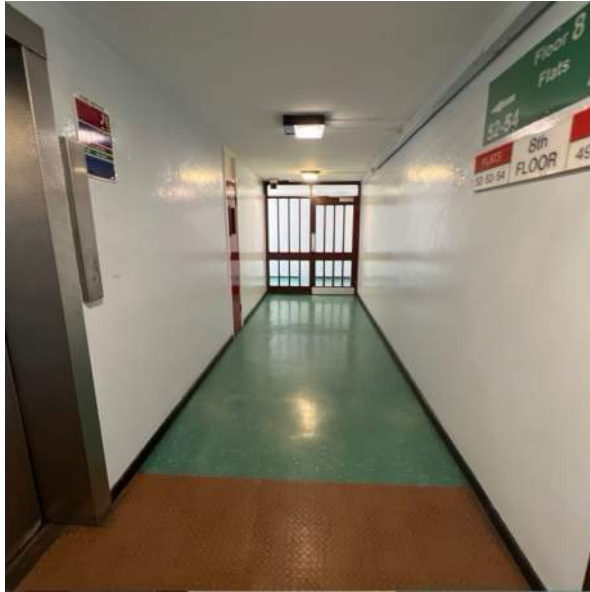
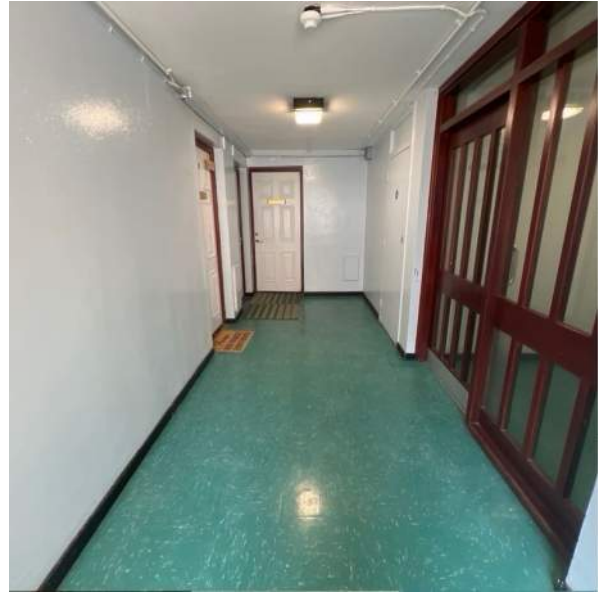
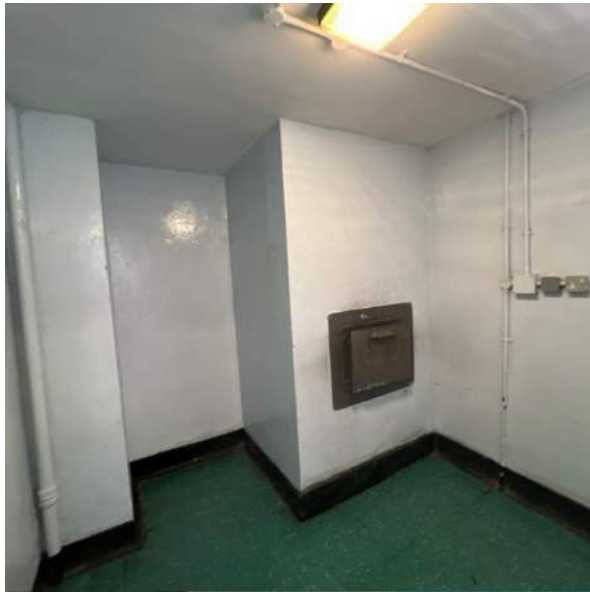
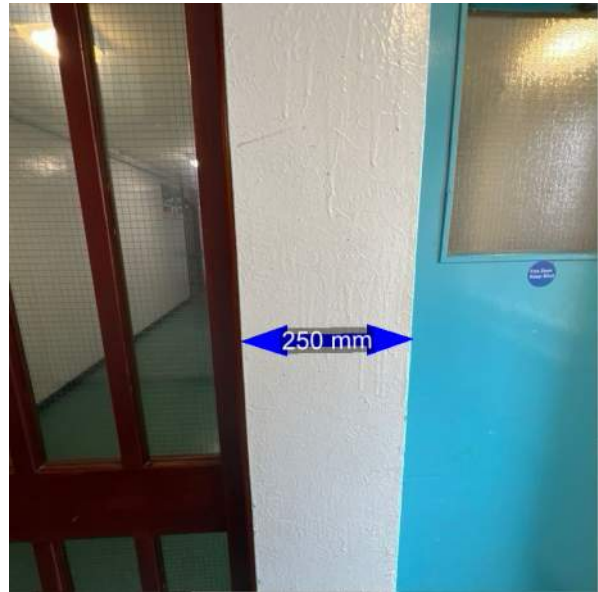
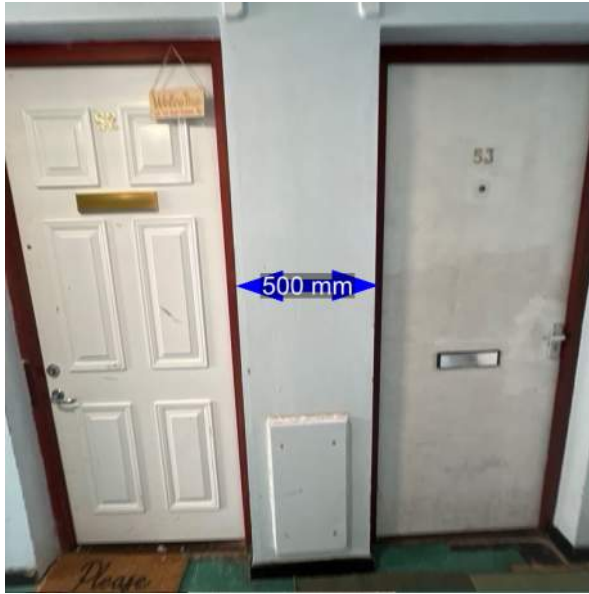
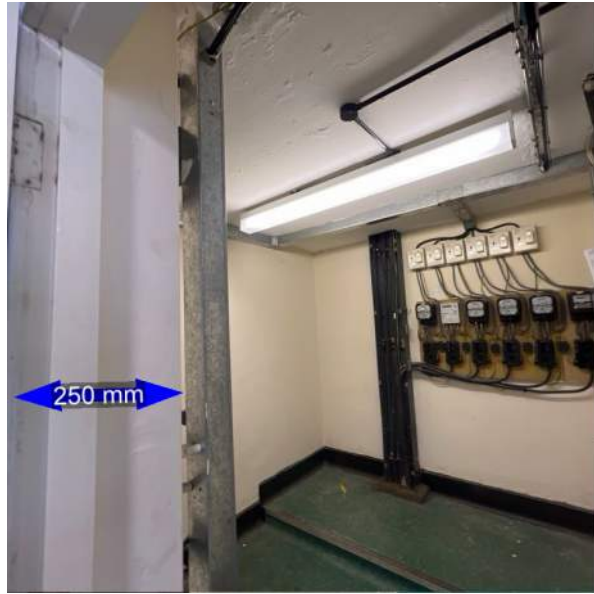
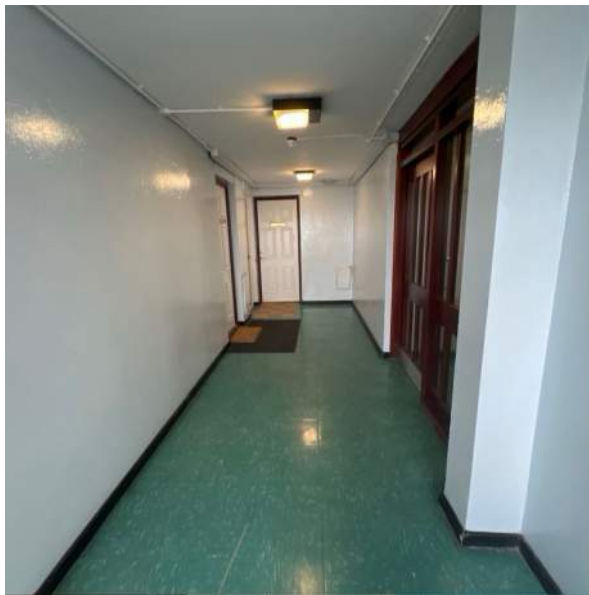
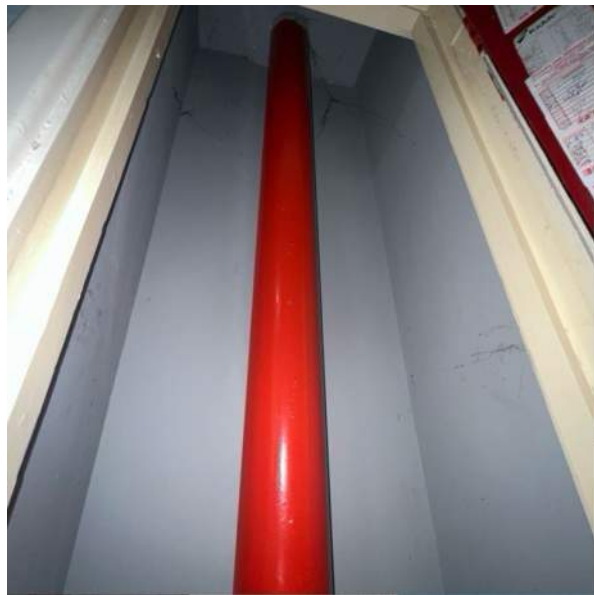
## 8th Floor Hallway

Comments: No jams or distortions noted to hallway doors to indicate any serviceability issues. Generally walls covered with finishes in hallway, likely to consist a mixture of concrete shear walls, embedded columns and block infill walls. Limited structure exposed.

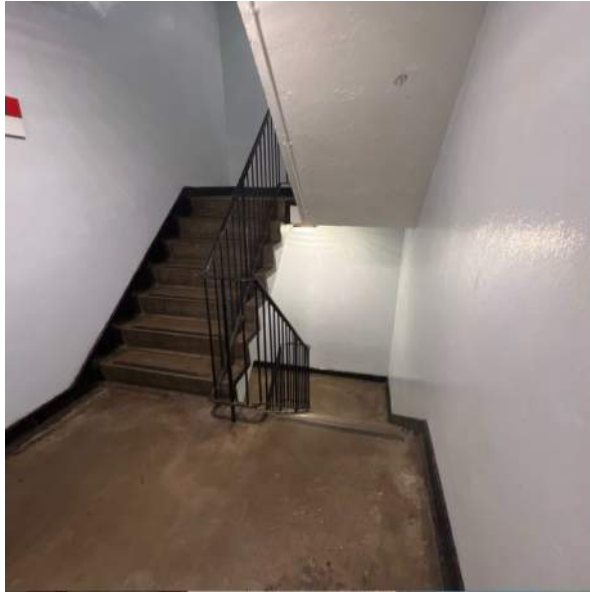
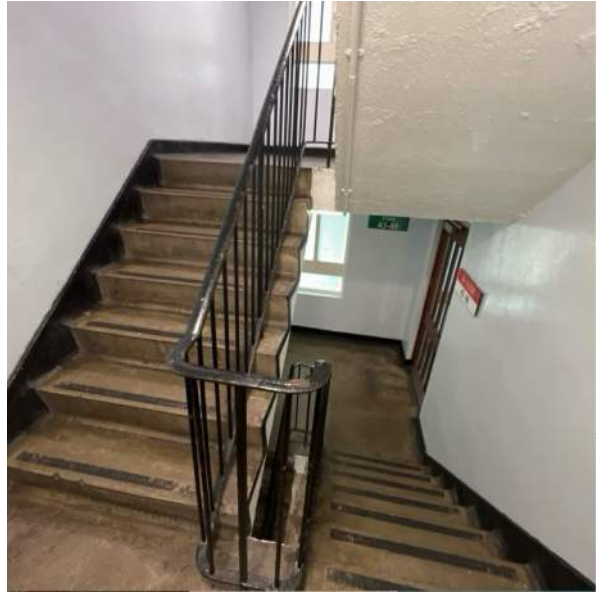
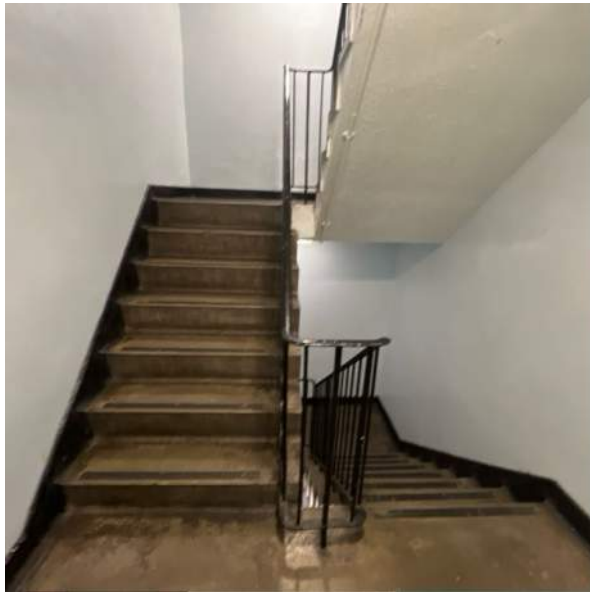
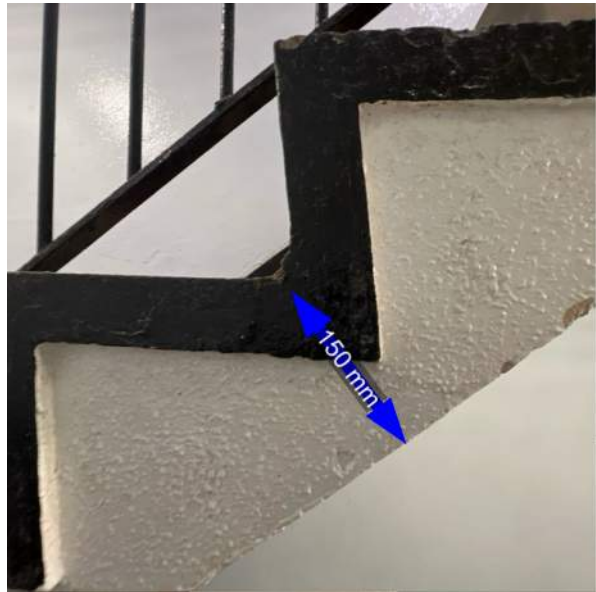
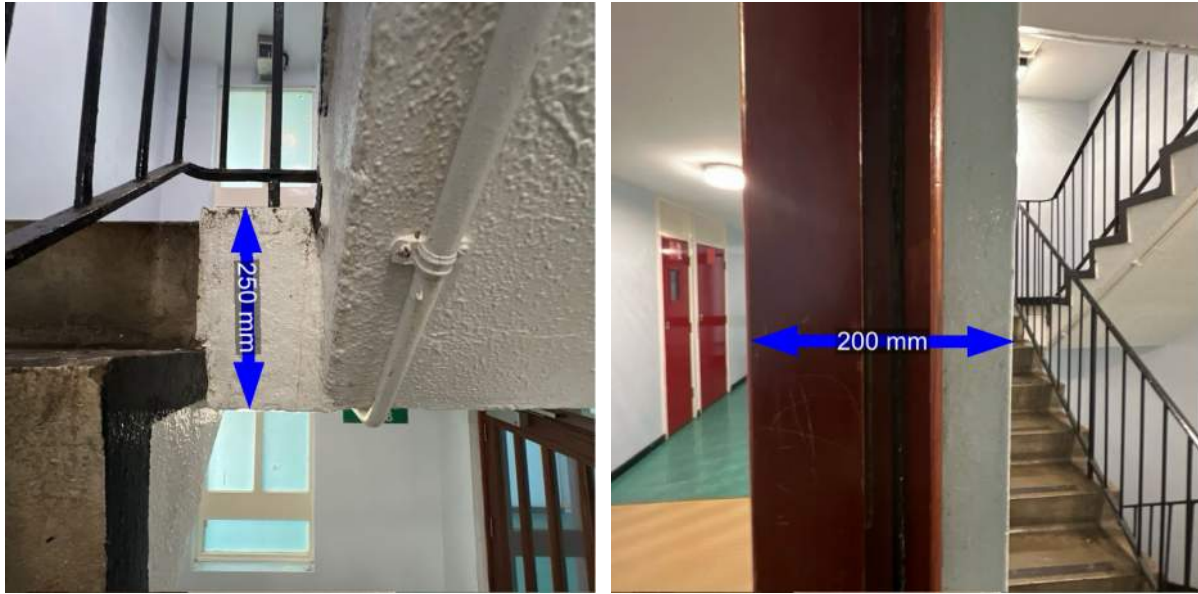
## 8th Floor Staircase

Comments: Insitu concrete stairs with steel hand railing fixed to stairs. Walls and floors appear to be fairly level.  
Stair walls covered with finishes however these would likely form the main concrete shear core walls. Stair walls approx. 200mm thick.

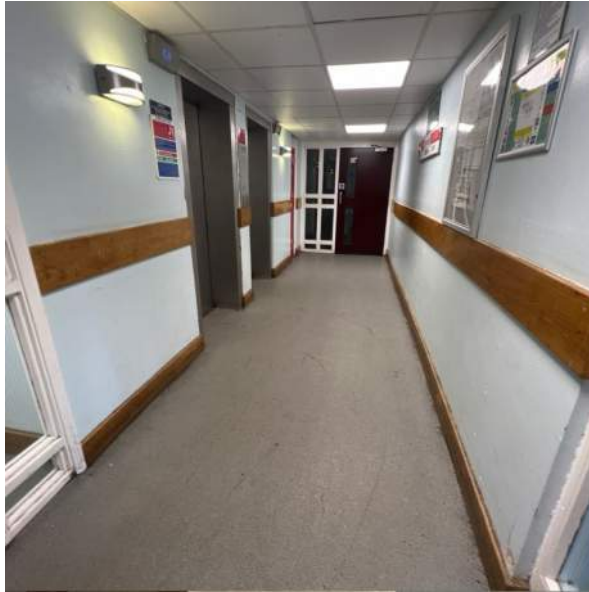
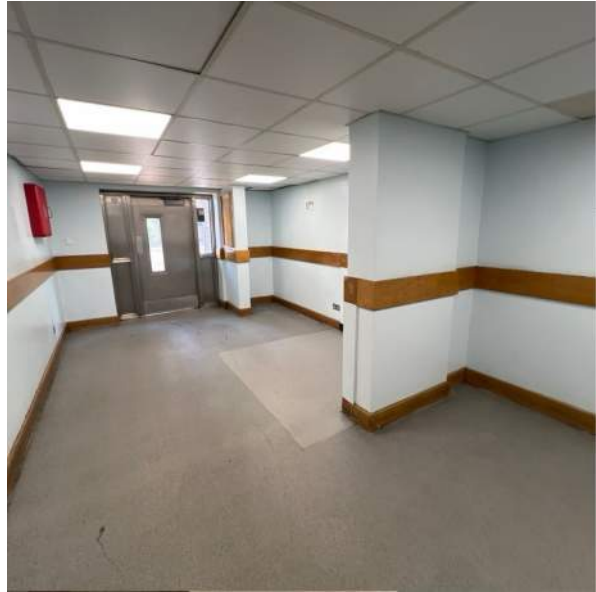
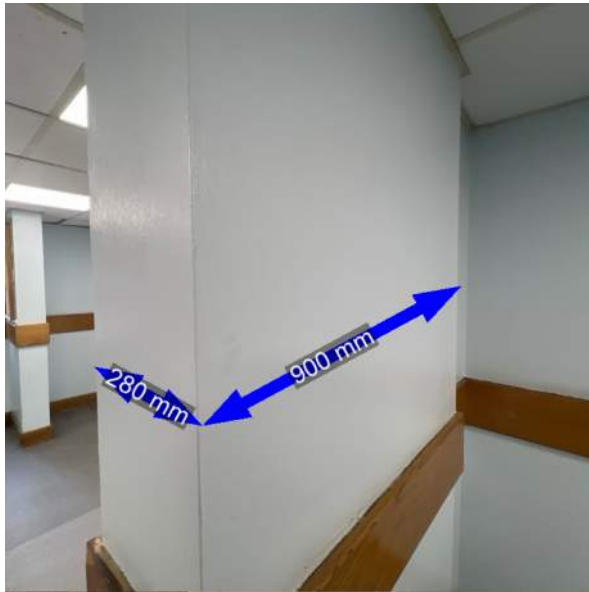
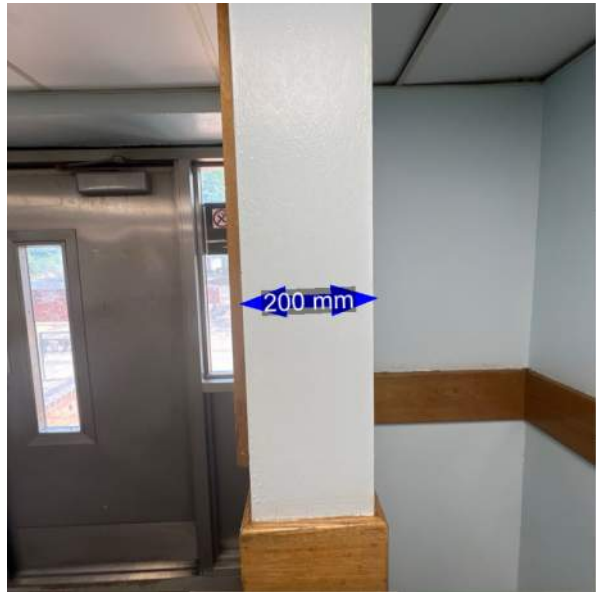
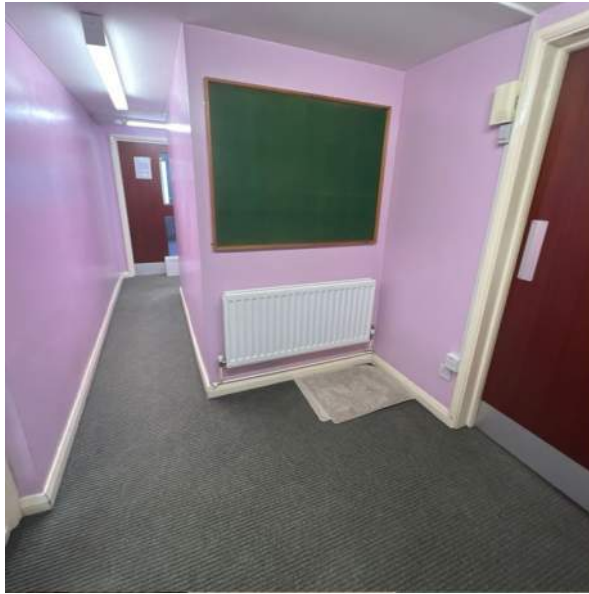
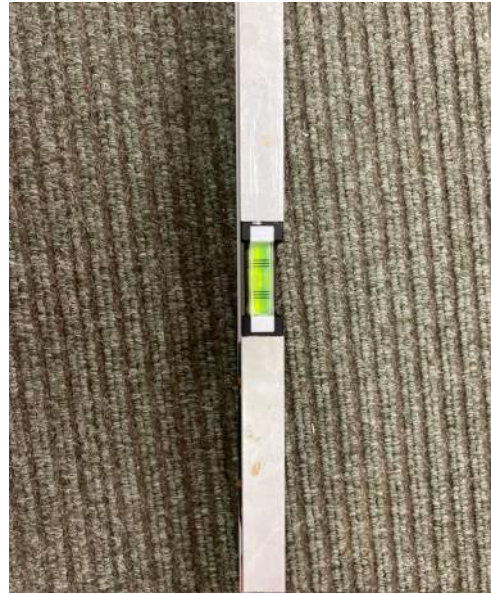
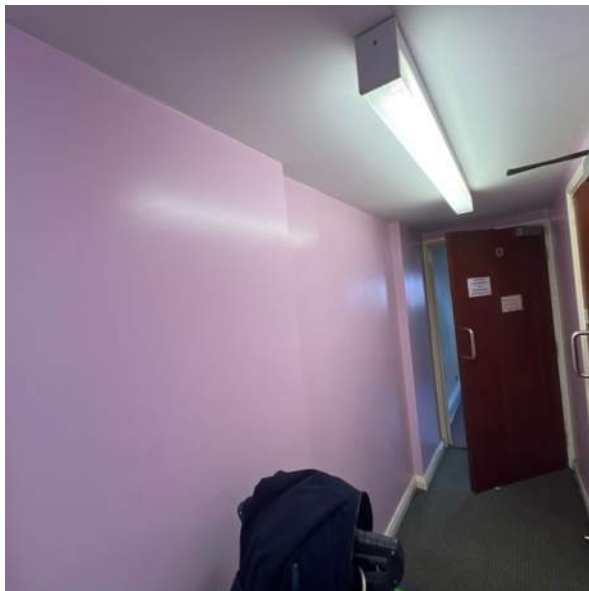
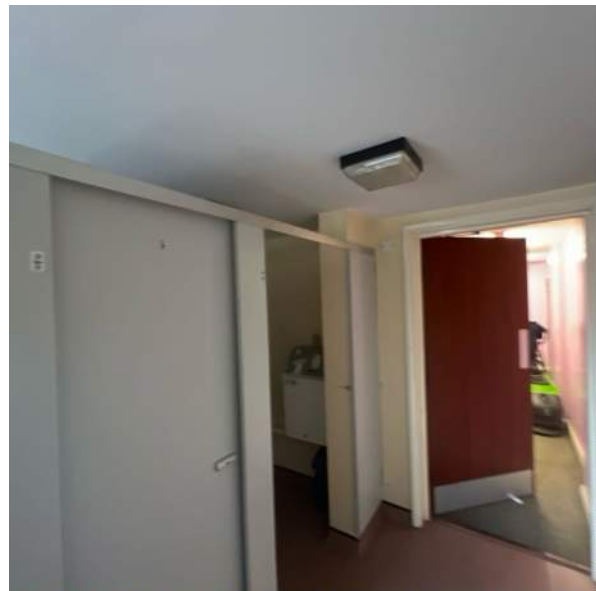
## Ground Floor Hallway

Comments: No jams or distortions noted to hallway doors to indicate any serviceability issues. Generally walls covered with finishes in hallway, likely to consist a mixture of concrete shear walls, embedded columns and block infill walls. Columns noted in hallway area.

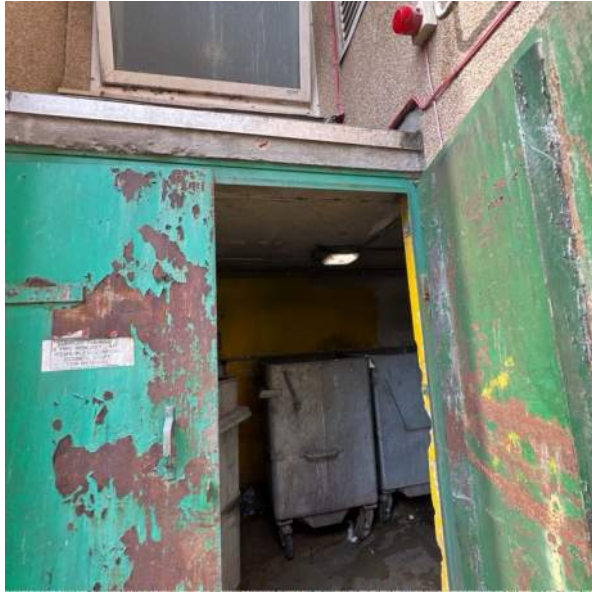
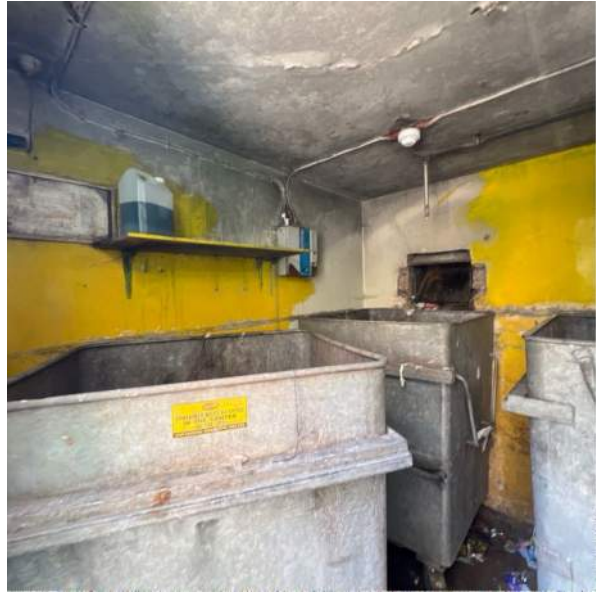
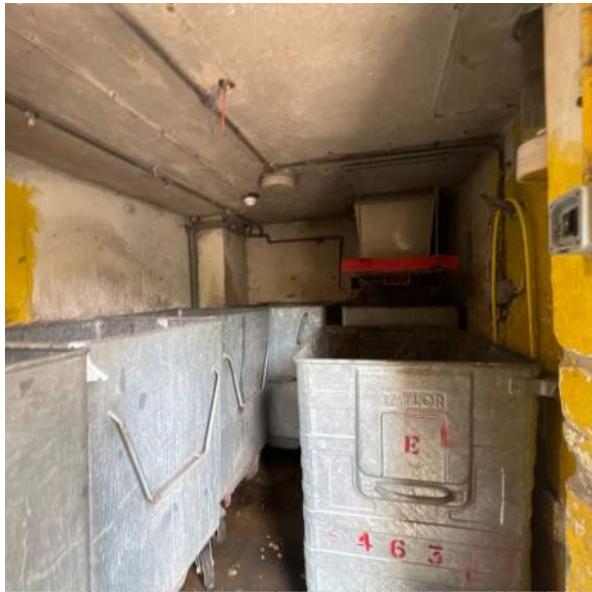
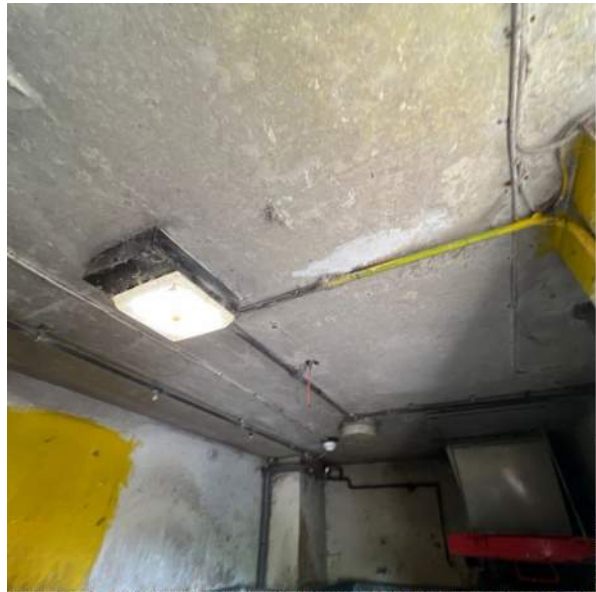
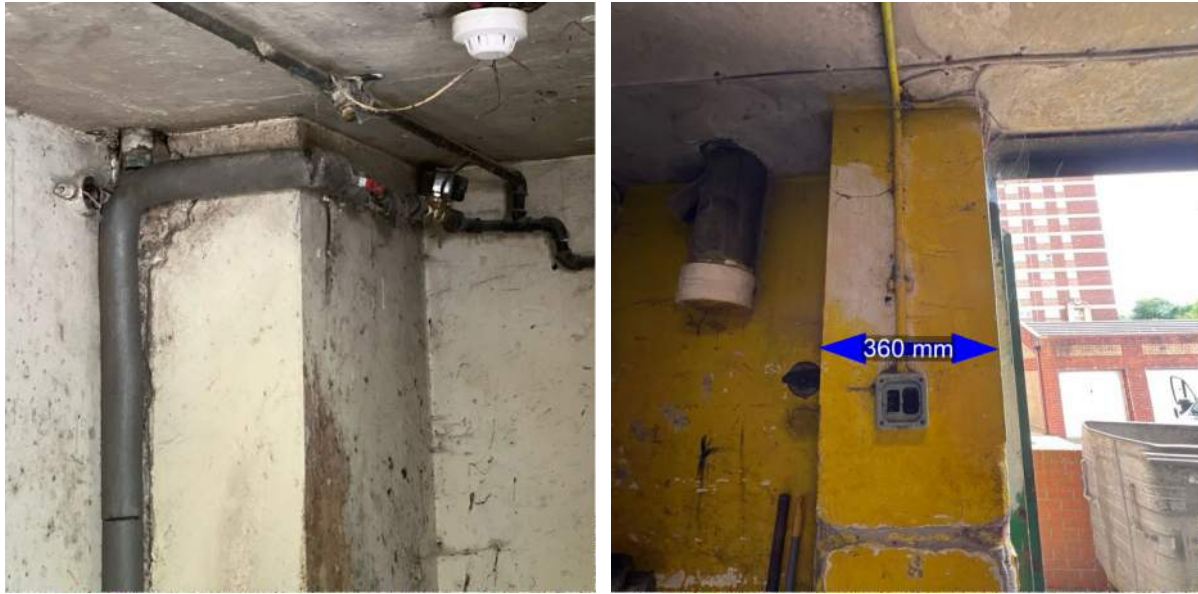
## Bin Store

Comments: Concrete elements mainly covered, RC column noted, approx 360mm wide.

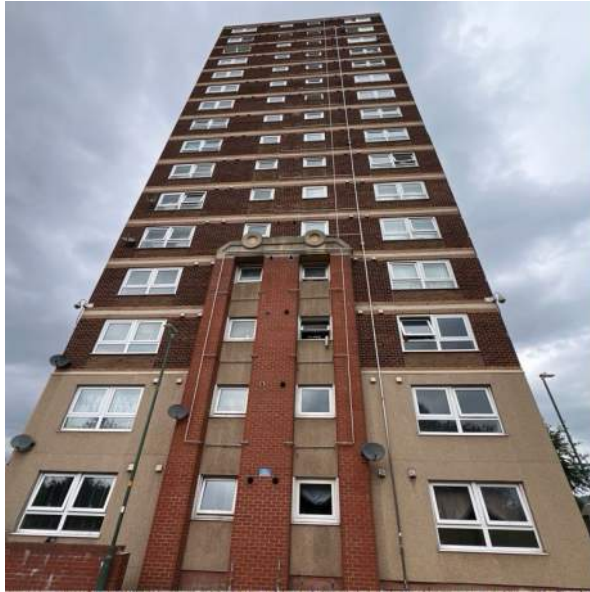
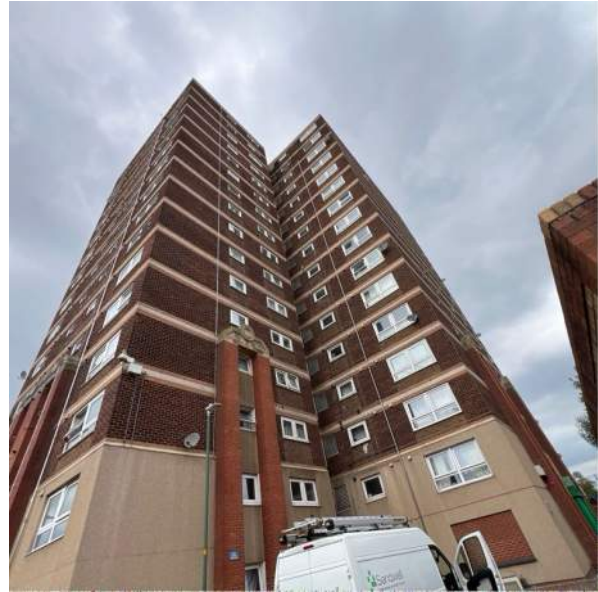
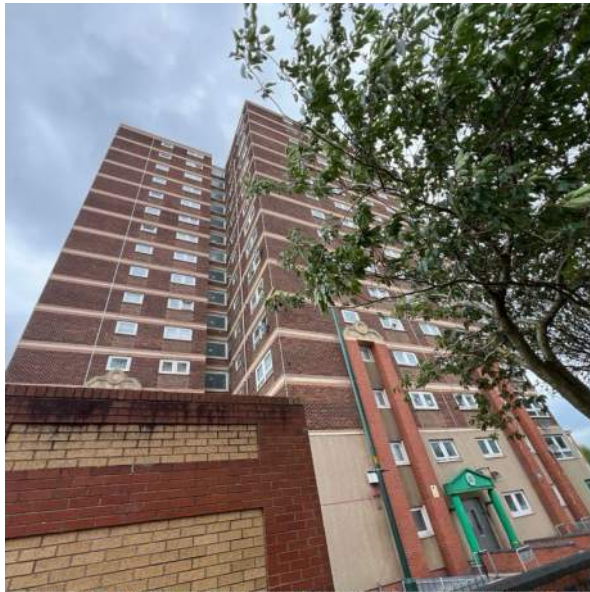
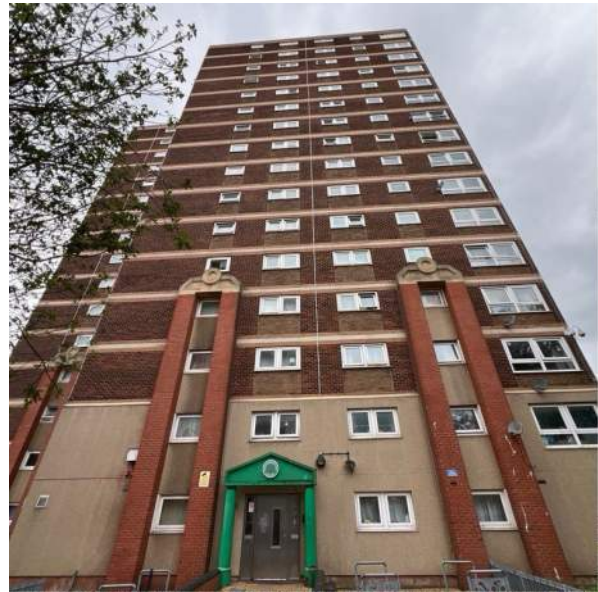
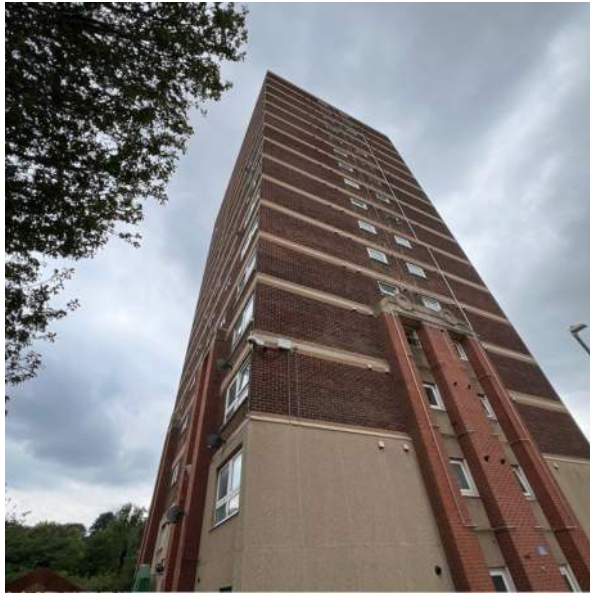
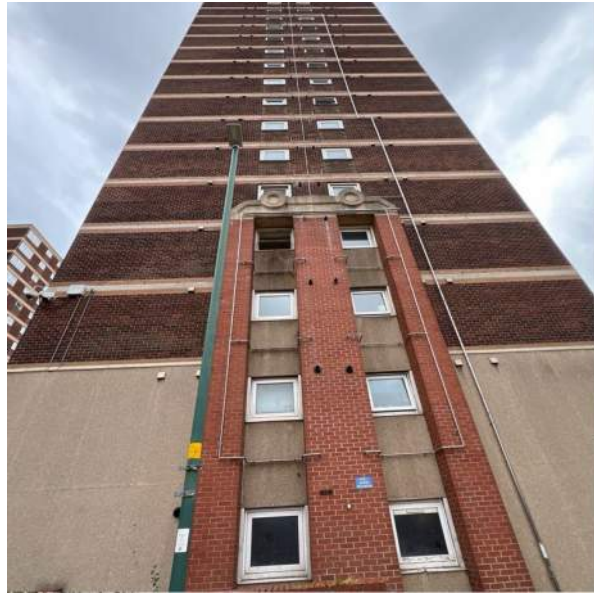
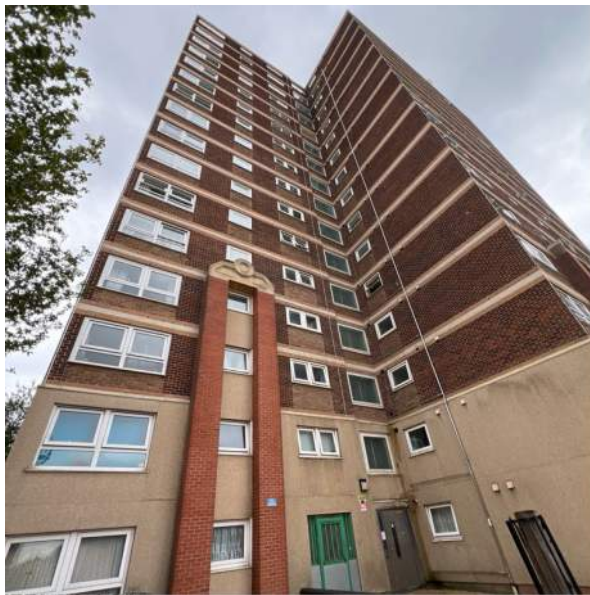
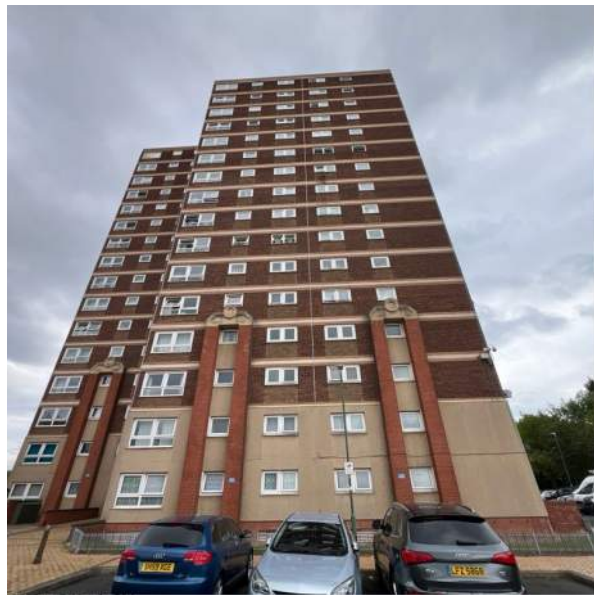
## Elevations

Comments: Ground and first floors of elevations noted to be rendered. Remaining floors consist of infill masonry (brickwork) appear to be supported off the RC slab at each level.
