VISUAL STRUCTURAL APPRAISAL

Addenbrooke Court

Southbank Road  
Oldbury  
B64 6LJ

29<sup>th</sup> November 2024

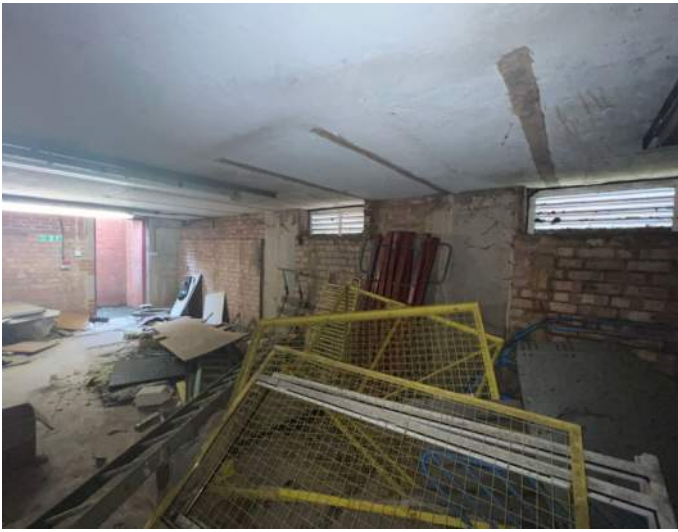
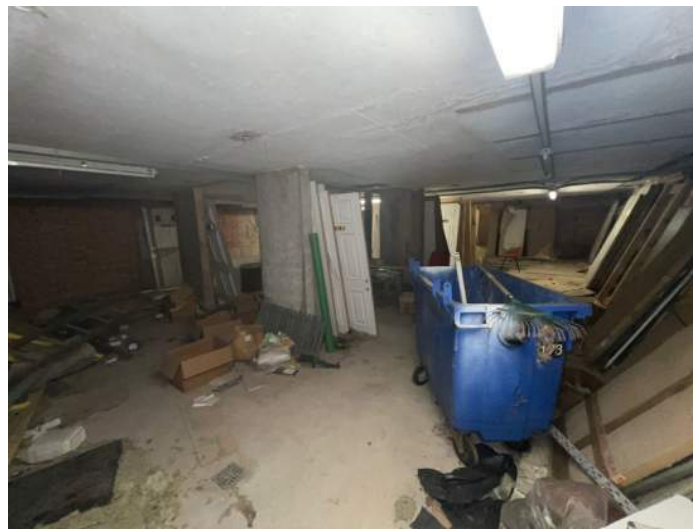
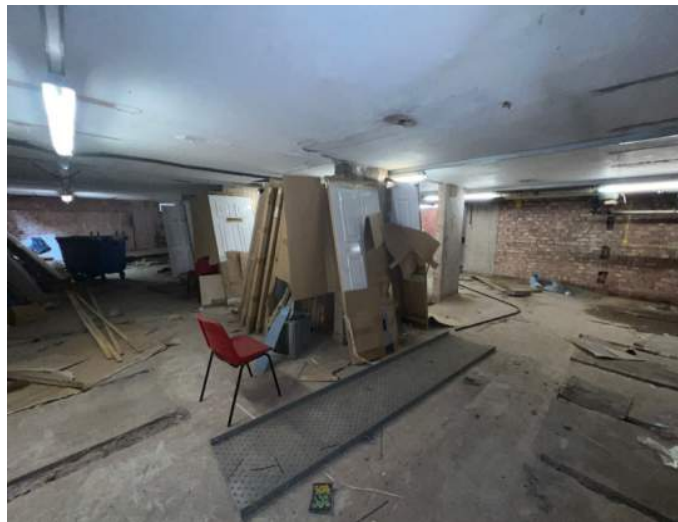
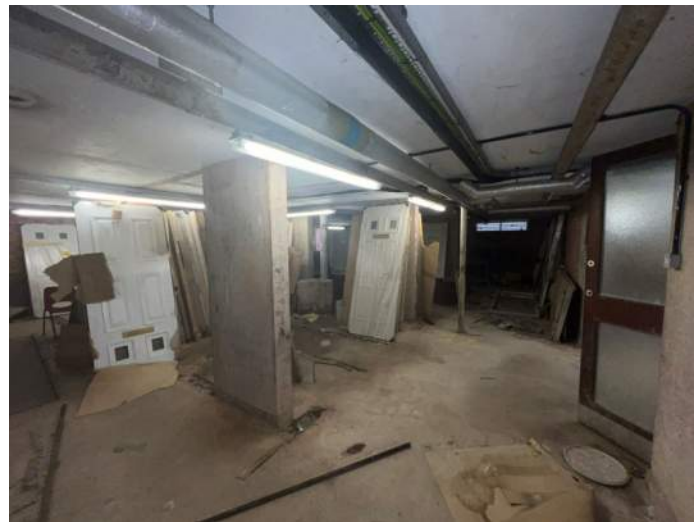
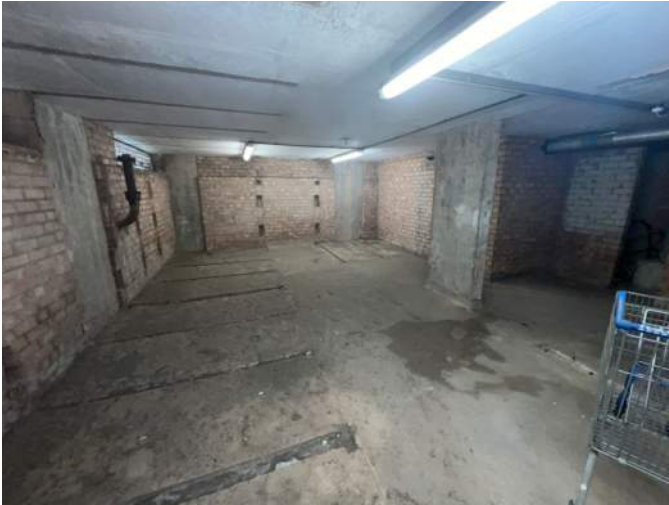
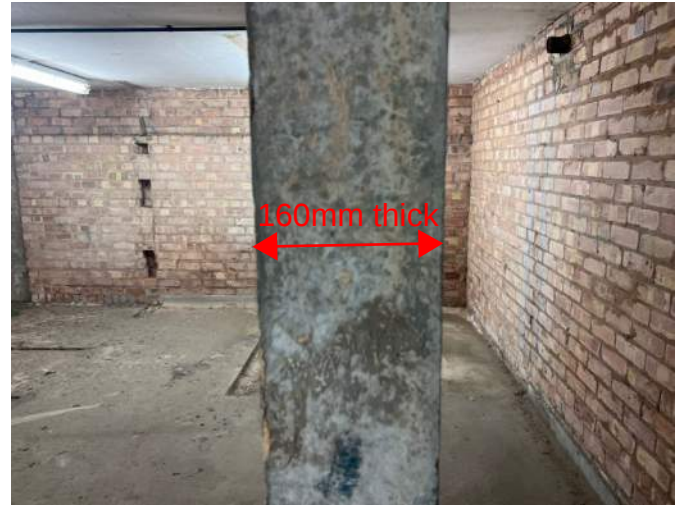
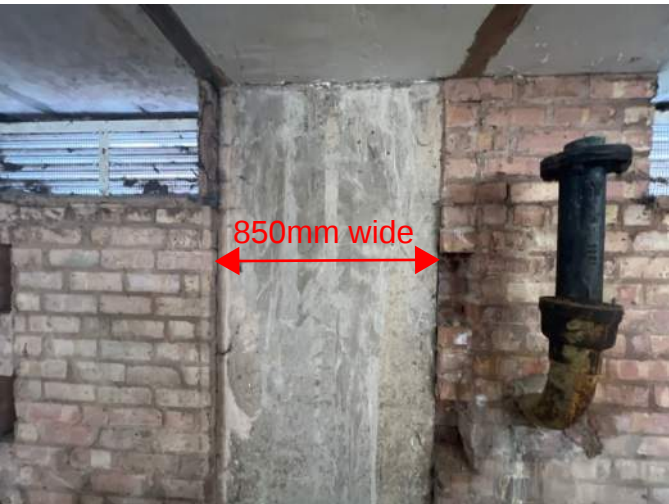
## Basement

RC structure exposed. A series of internal and perimeter columns noted forming the primary structural elements of the structure.
