**FIRNTEC**  
BUILDING COMPLIANCE

VISUAL STRUCTURAL APPRAISAL

Allen House  
West Road  
Hamstead  
B43 5PS

24<sup>th</sup> June 2025

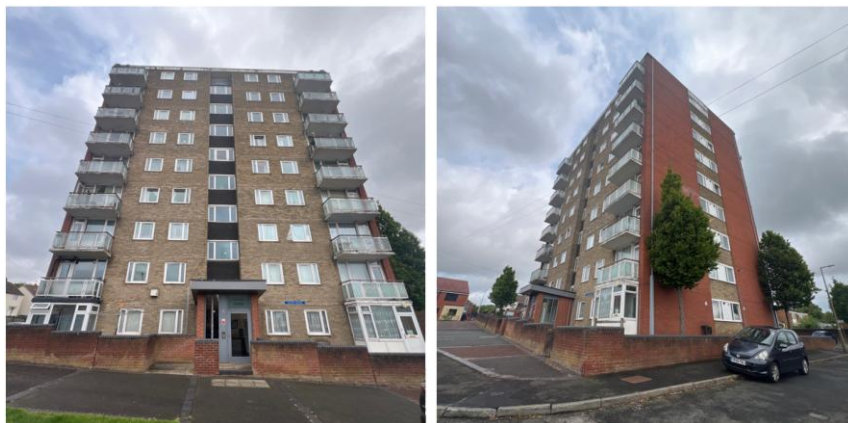
Figure 9 and 10: Building Elevations

The exterior elevations were generally in ok condition and no significant structural defects were noted to the infill panels. There were no significant cracks or tell-tale signs of any significant structural movement noted at the time of our inspection.

The exterior panels were noted to be plumb with no signs of significant bowing, bulging or leaning noted to the panels indicating failed fixings however their presence and condition cannot be confirmed.

There are balconies at each level which are formed of cantilevered RC slabs tied into the main frame. The balconies would benefit from a refurbishment with widespread failed coatings throughout. The cantilevered slabs should be checked for internal corrosion potential at the benchmark inspections.

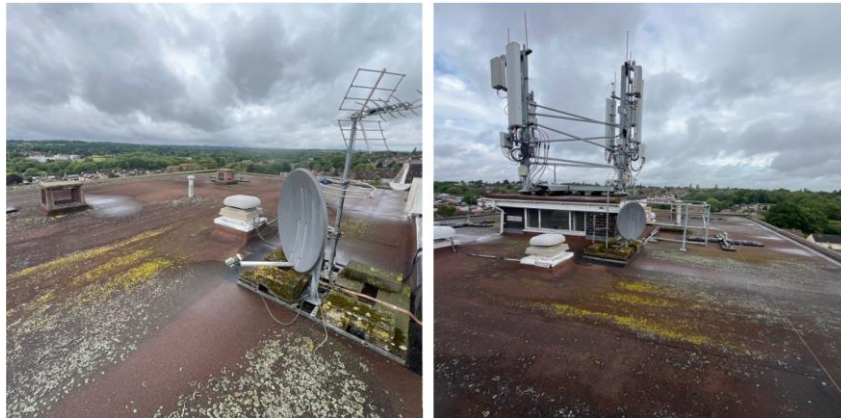
Figure 11 and 12: Roof Level

There were no tell-tale signs of any significant structural movement noted at the time of our inspection.

The roof has a felted waterproofing system. The exact build-up of the roof finishes were not accessible at the time of inspection. It is recommended an intrusive survey of the roof finishes is completed by a specialist surveyor to assess the condition of the roof covering although they were noted in good condition with no known water ingress issues and therefore a low risk element.

There were signs of moss growth to the roof level which should be cleared as part of the regular regimen of maintenance.

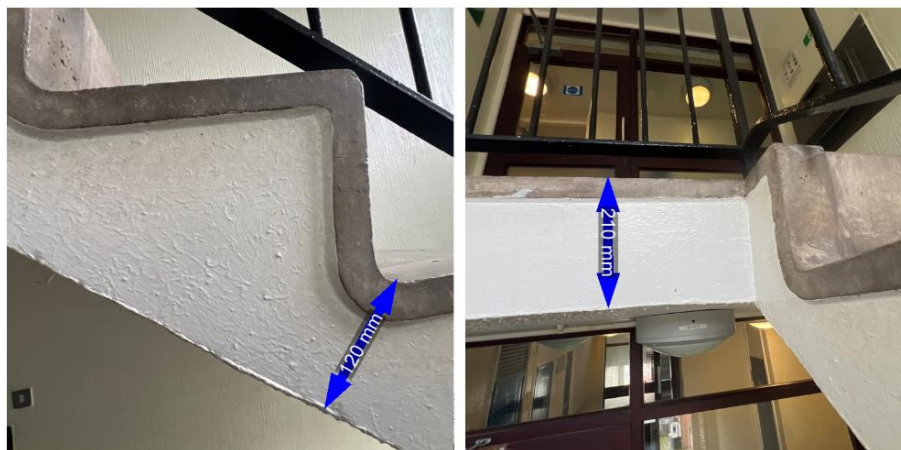
Figure 14 and 15: Slab edge and stair stringer

The interior of the stair core walls were checked and were plumb and in line with observations made to the exterior – no significant signs of leaning or movement noted. The concrete appeared in fair condition with few BRE category 1 cracks but no structurally significant defects were noted.

The stair stringer was noted to be 120mm thick which seems slim, certainly short of modern standards. A cover test is required to check the resistance of the concrete section in the event of a fire.

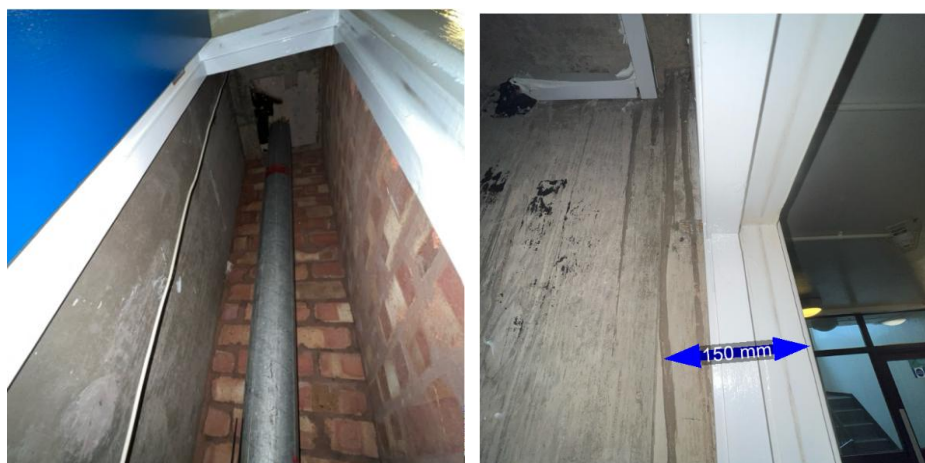
Figure 16 and 17: RC internal elements

There were vertical concrete walls supporting the floor plates at every level. The elements visible matched the floor layout in Figure 6. The walls appear continuous from ground to roof with no transfer structure. The overall condition of the structure observed is good.

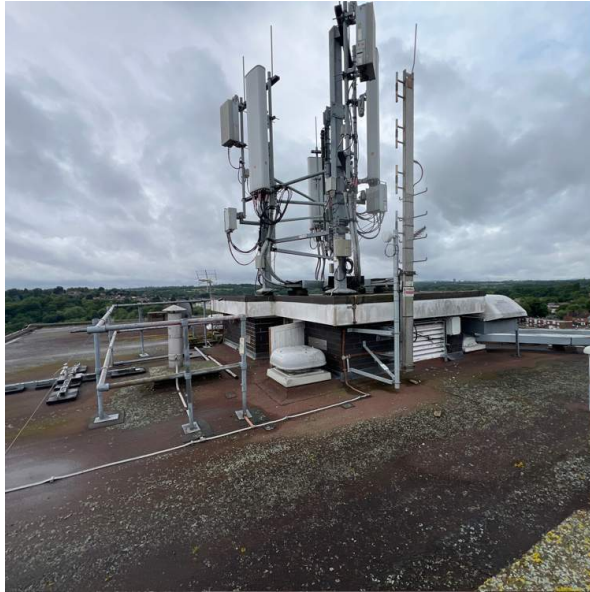
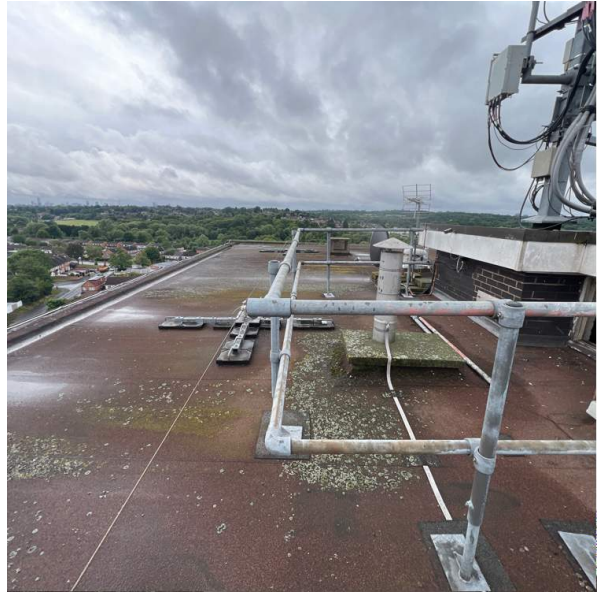
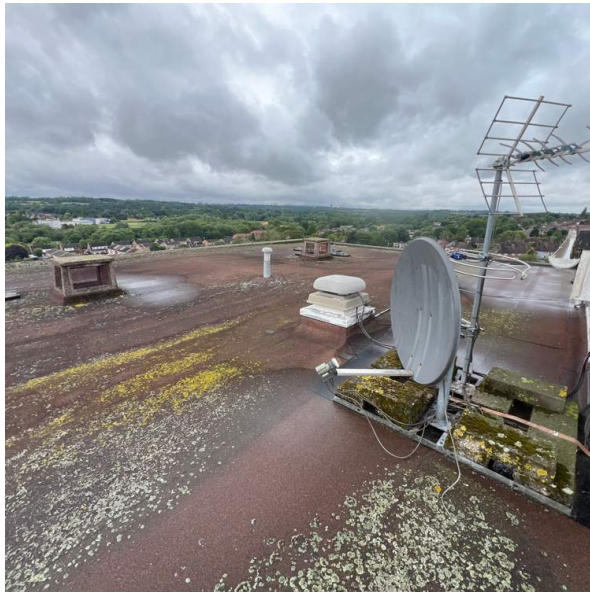
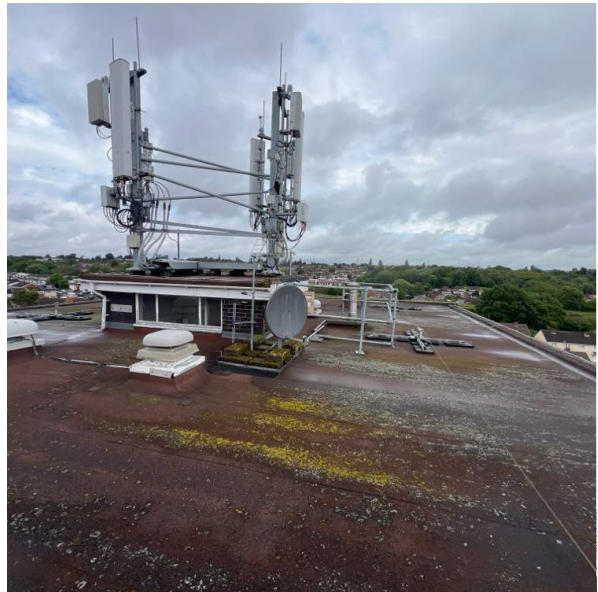
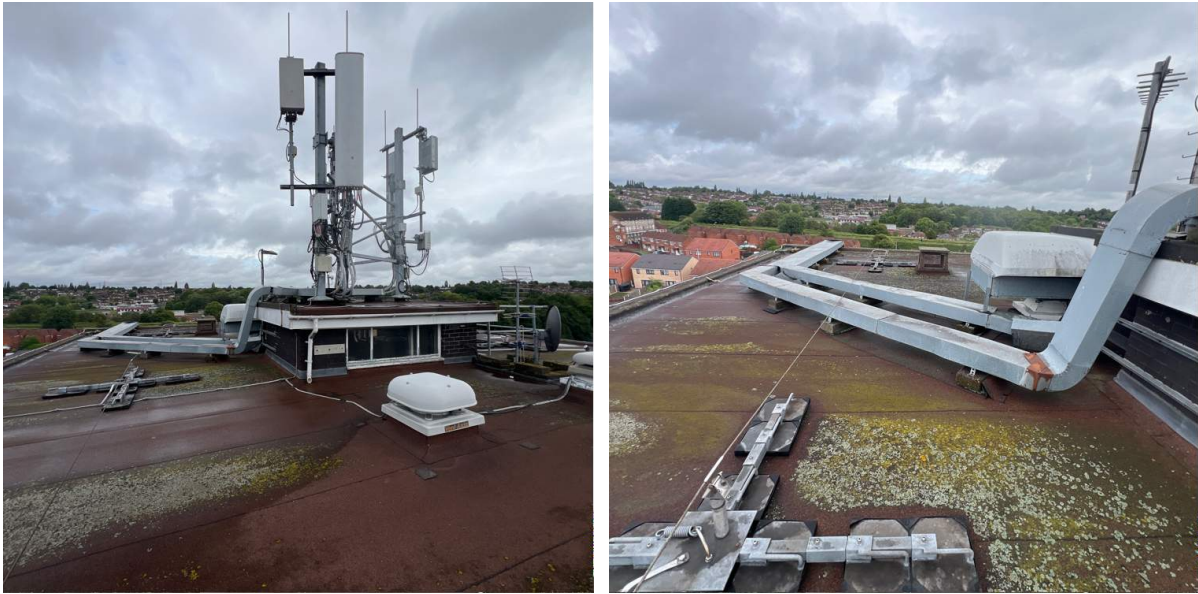
## Main Roof

Comments: Flat roof, RC concrete slab with insulated PIR board and felt coverings.  
Telecoms equipment fitted to roof structure.

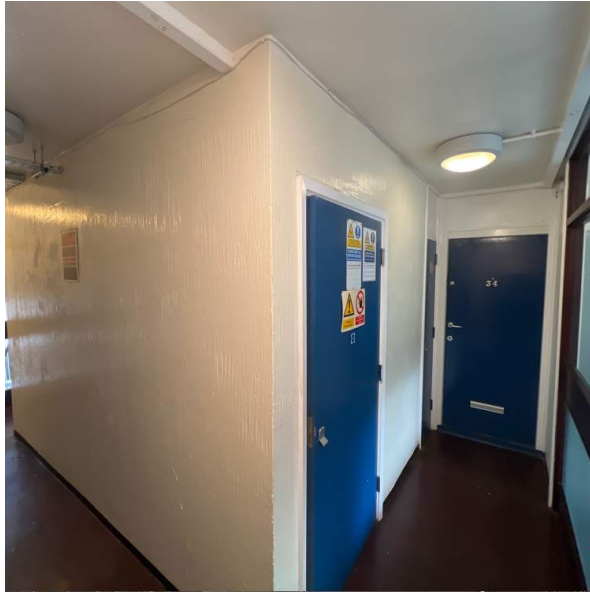
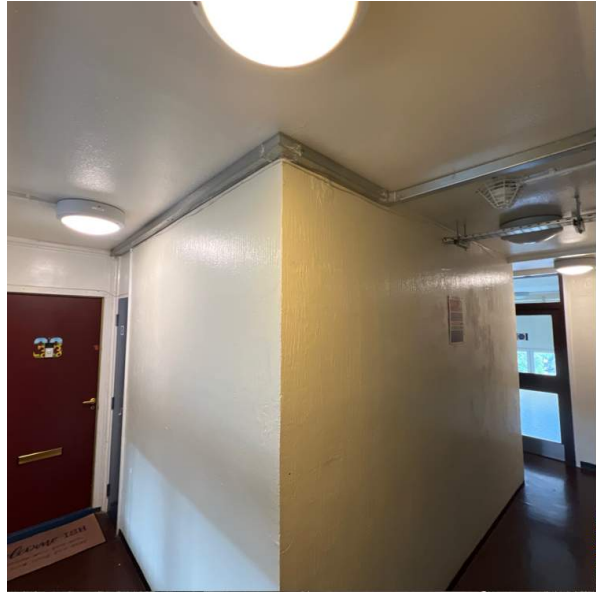
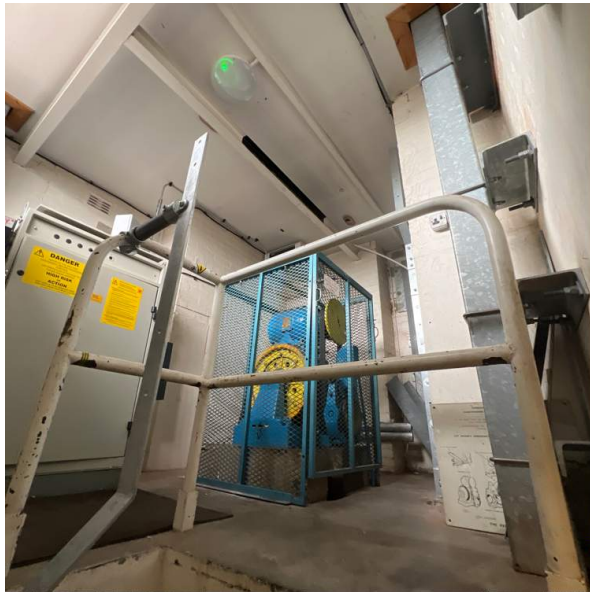
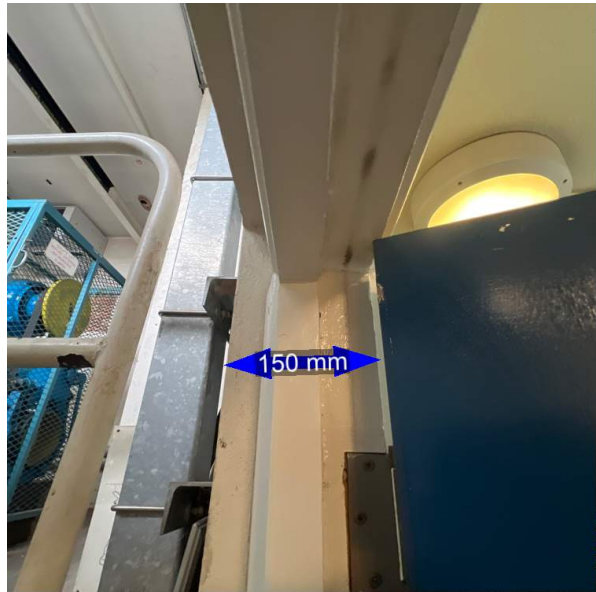
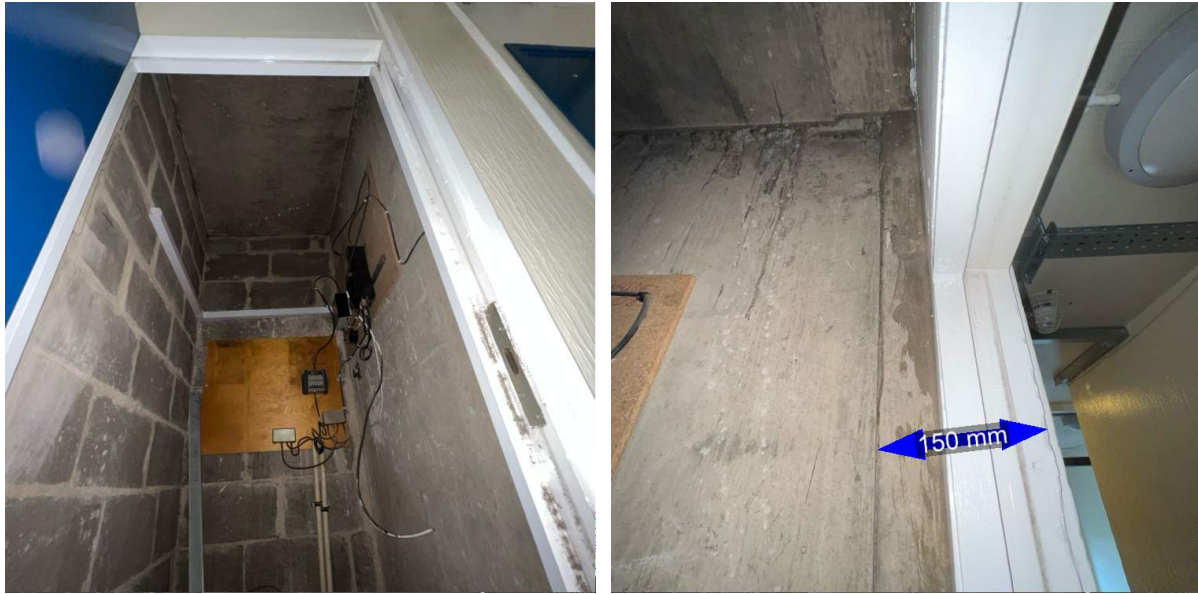
## 8th Floor Hallway

Comments: No jams or distortions noted to hallway doors to indicate any serviceability issues. Generally walls covered with finishes in hallway, likely to consist a mixture of concrete shear walls, embedded columns and masonry infill walls. Limited structure exposed. Concrete walls and infill masonry (non-load bearing) walls noted in riser cupboards.

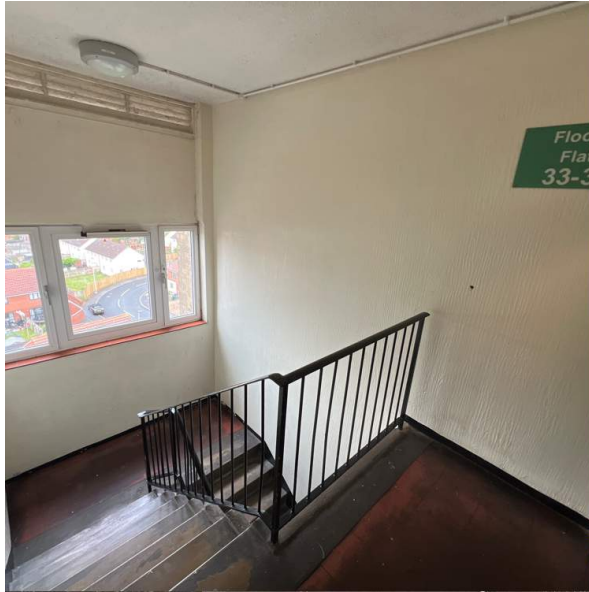
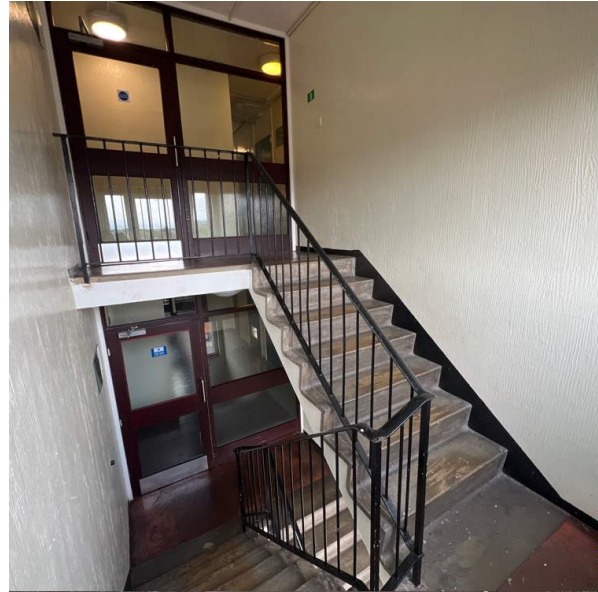
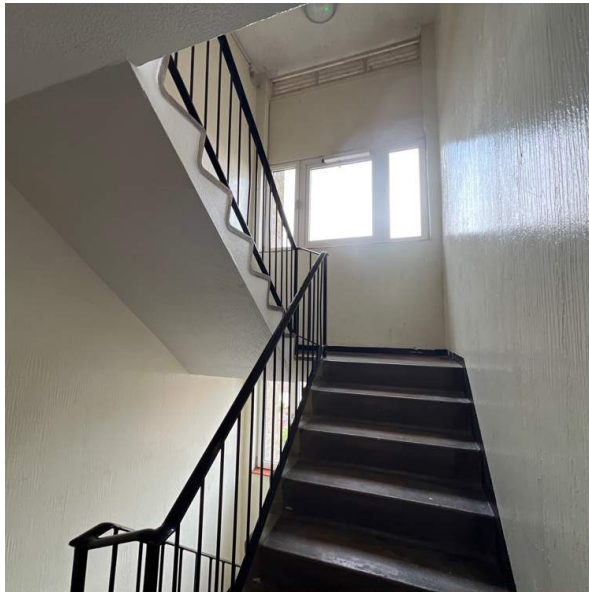
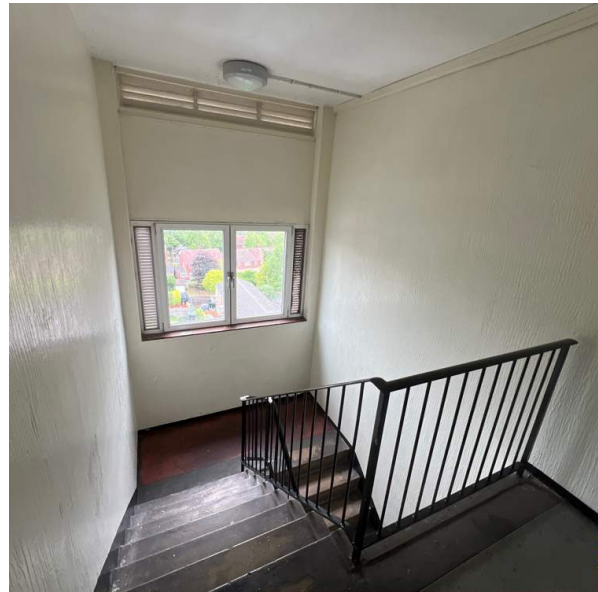
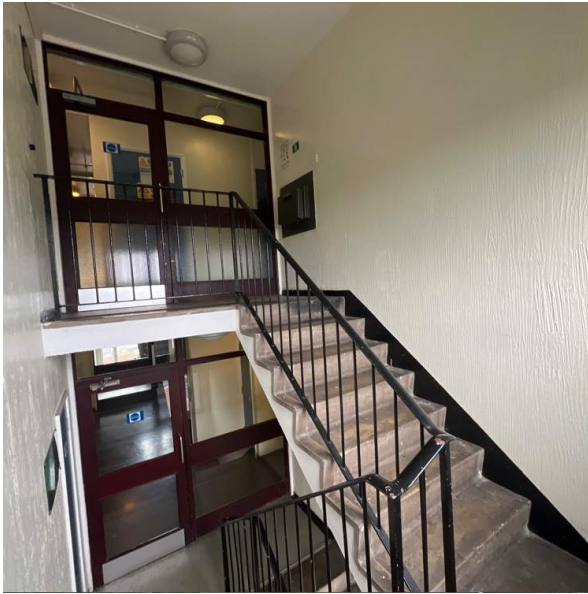
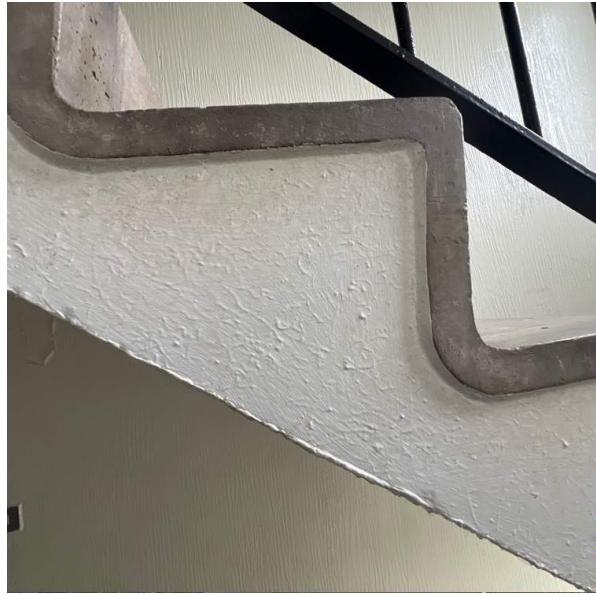
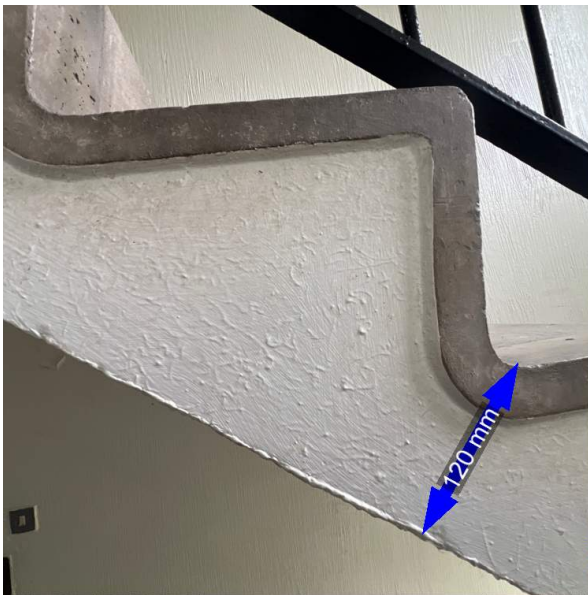
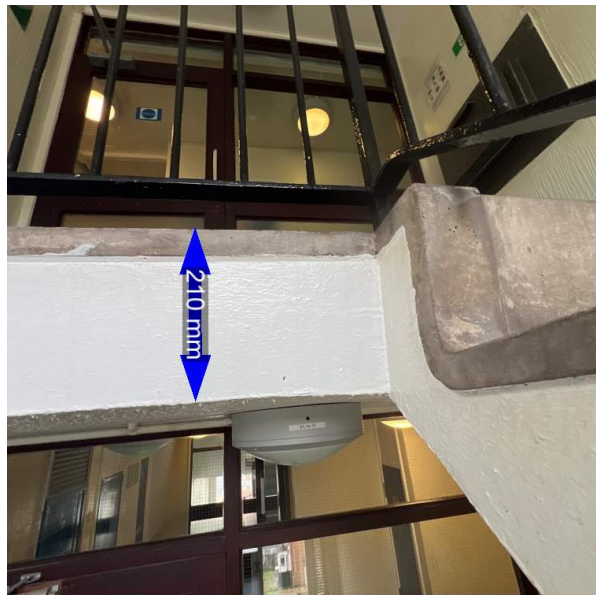
## 8th Floor Staircases

Comments: Insitu concrete stairs with steel hand railing fixed to stairs. Walls and floors appear to be fairly level.  
Stair walls covered with finishes however these would likely form the main concrete shear core walls.

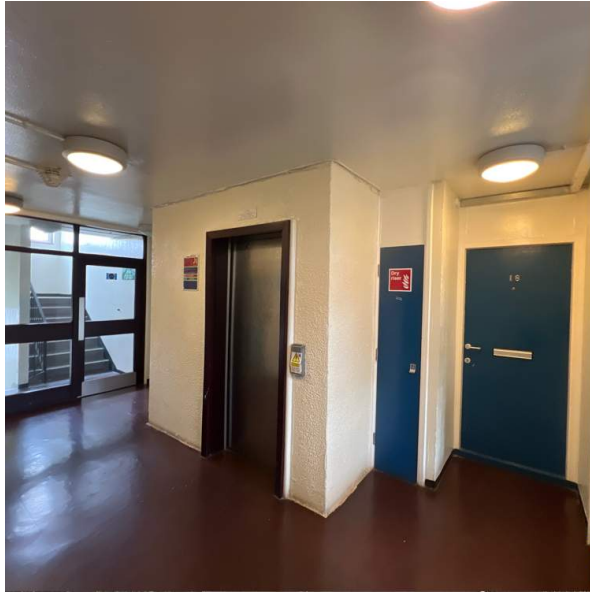
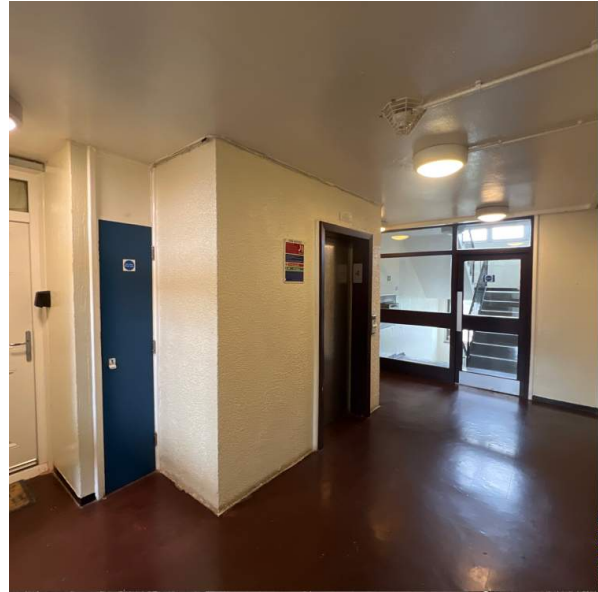
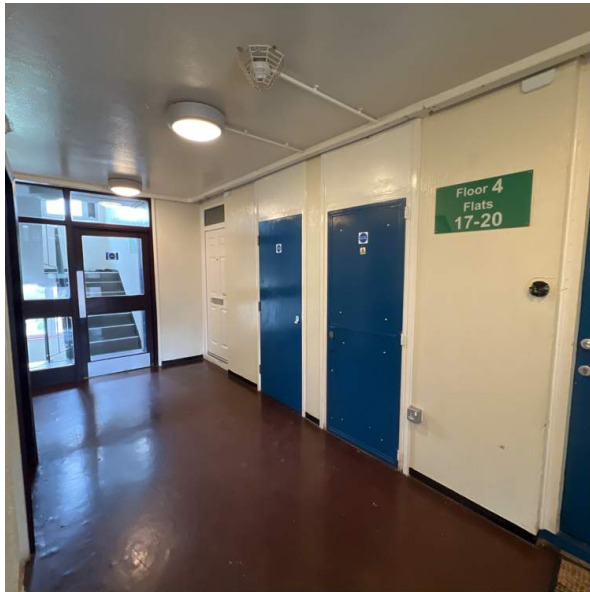
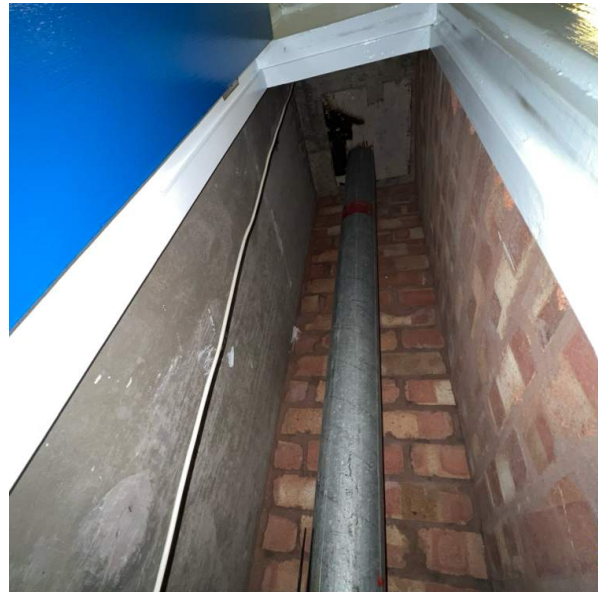
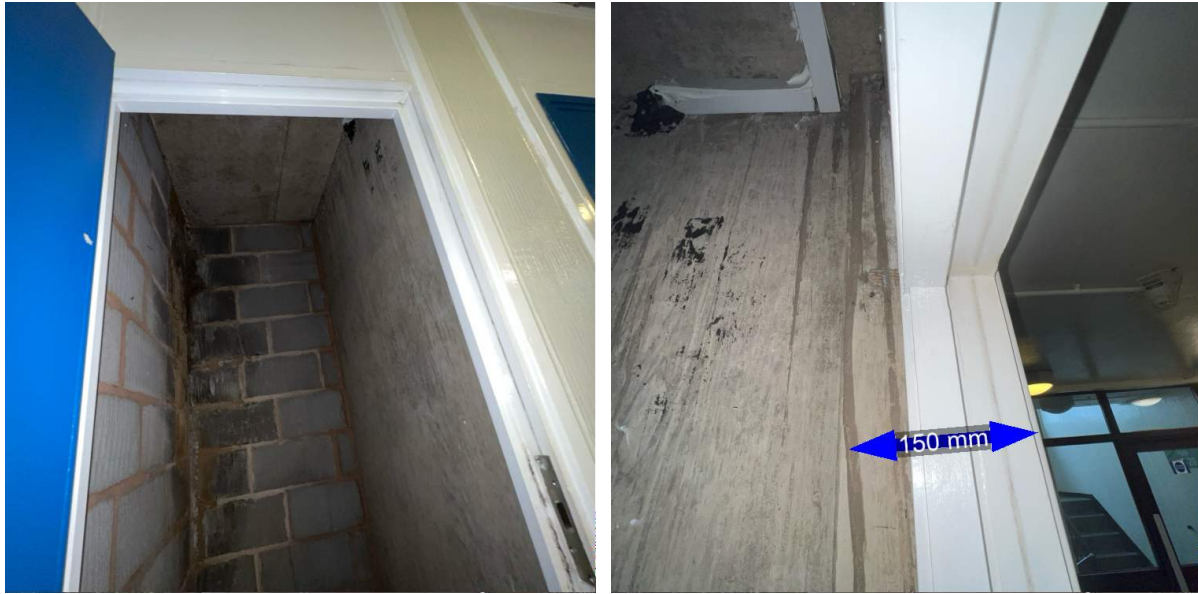
## 4th Floor Hallway

Comments: No jams or distortions noted to hallway doors to indicate any serviceability issues. Generally walls covered with finishes in hallway, likely to consist a mixture of concrete shear walls, embedded columns and masonry infill walls. Limited structure exposed. Concrete walls and infill masonry (non-load bearing) walls noted in riser cupboards.

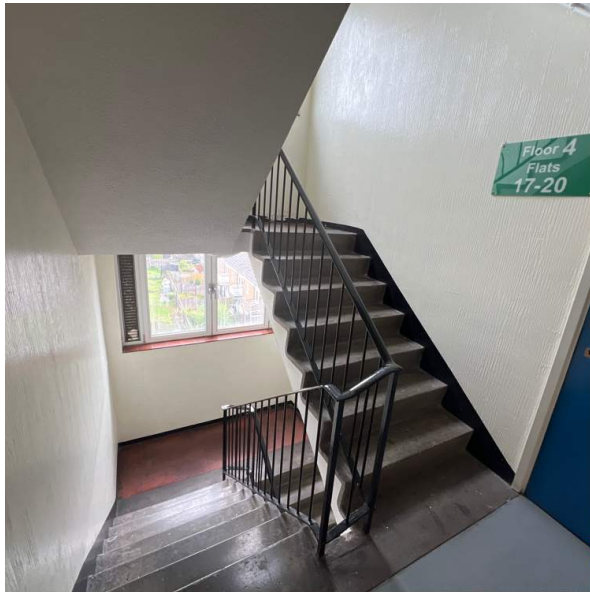
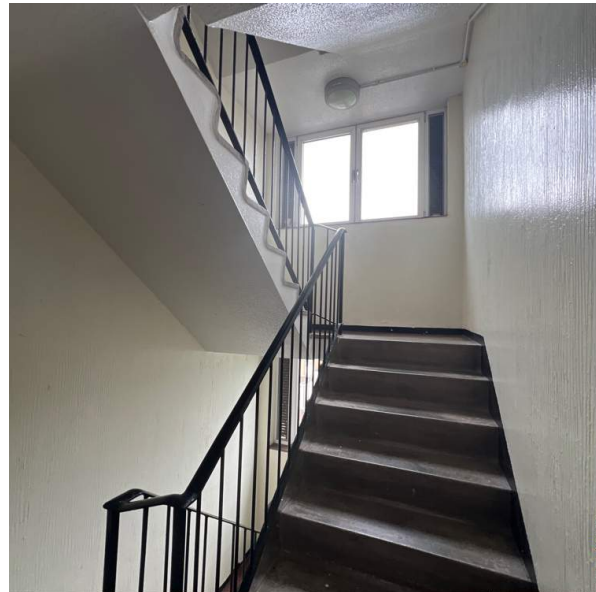
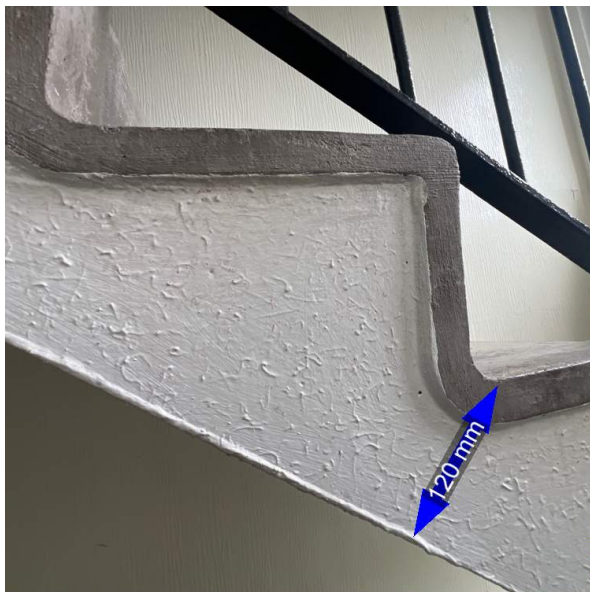
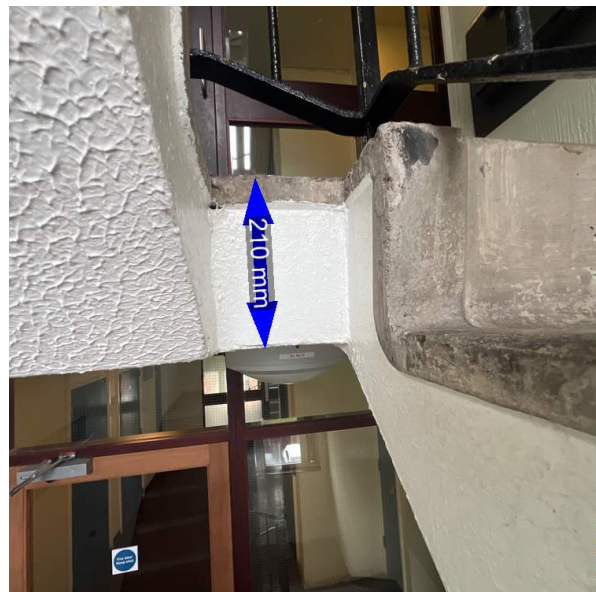
## 4th Floor Staircases

Comments: Insitu concrete stairs with steel hand railing fixed to stairs. Walls and floors appear to be fairly level.  
Stair walls covered with finishes however these would likely form the main concrete shear core walls.

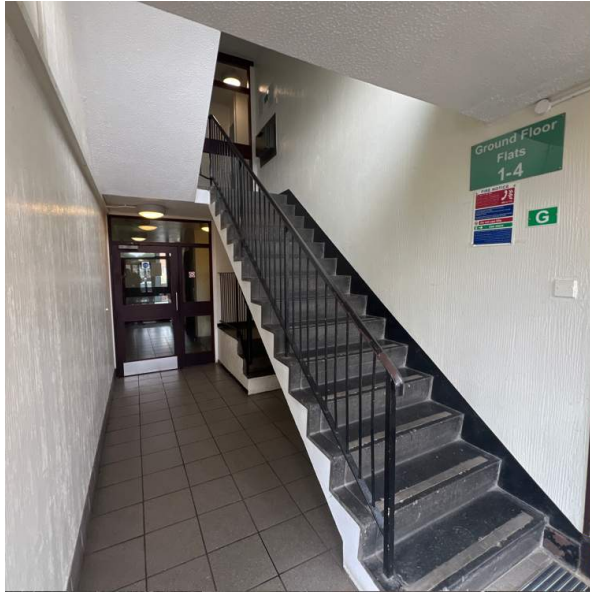
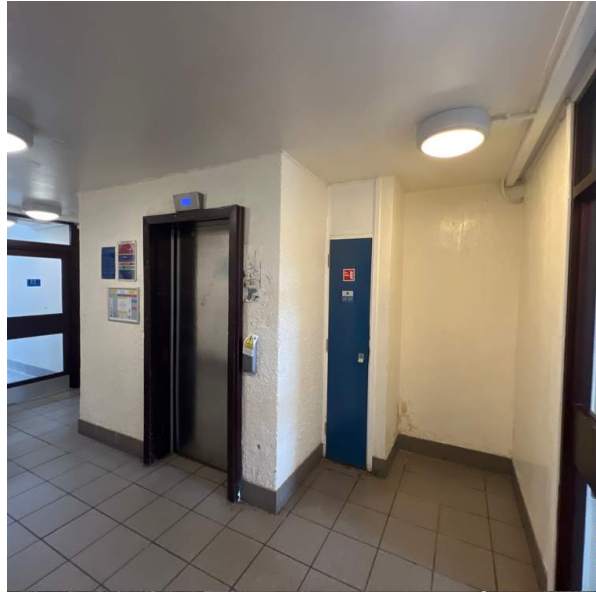
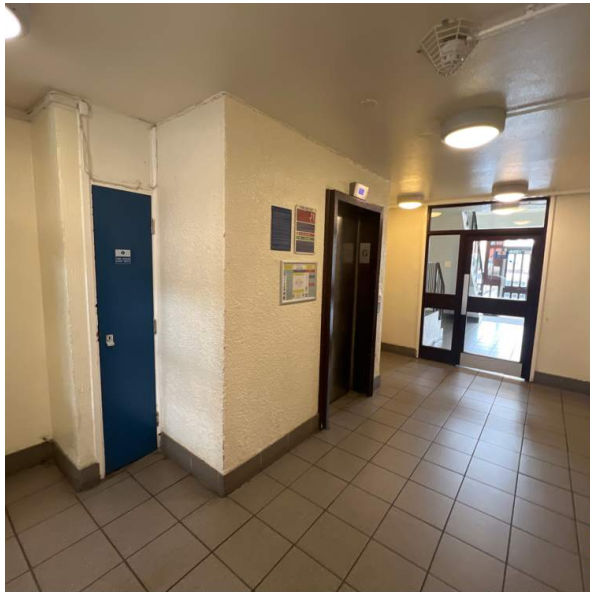
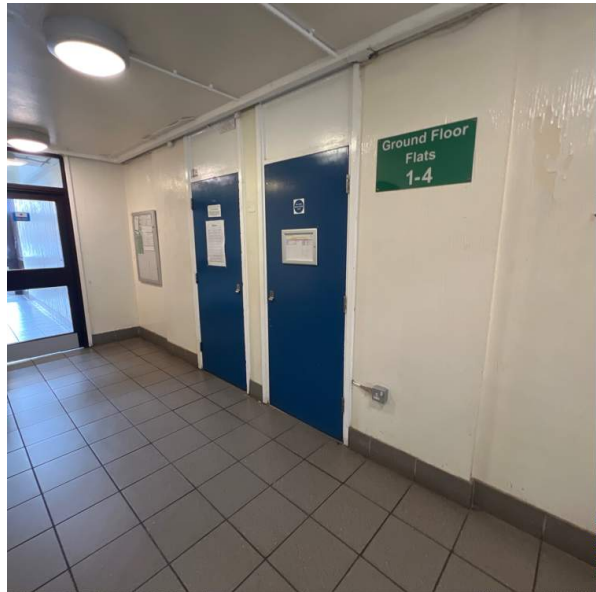
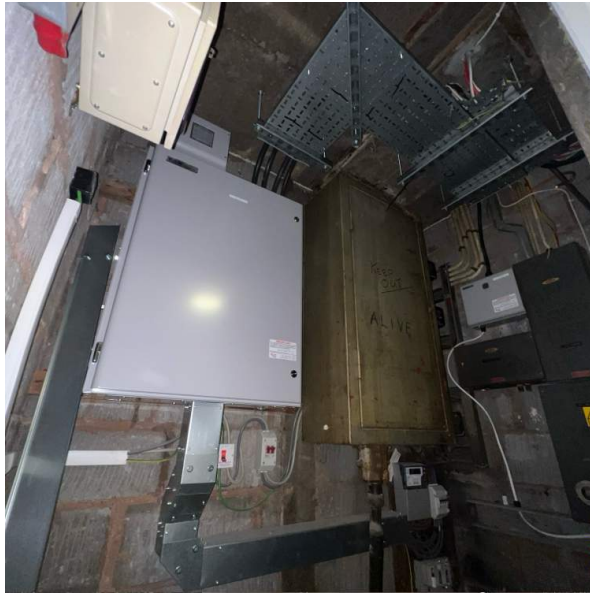
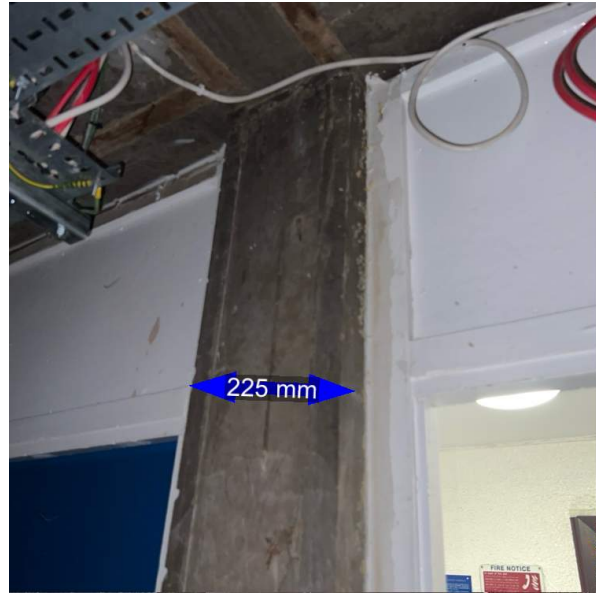
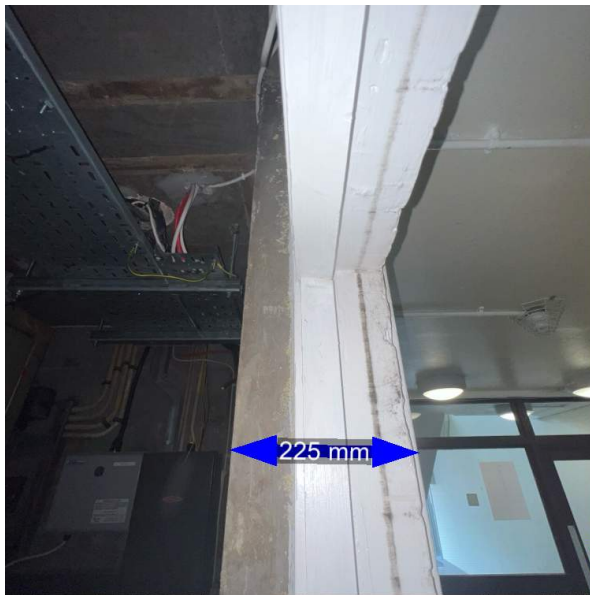
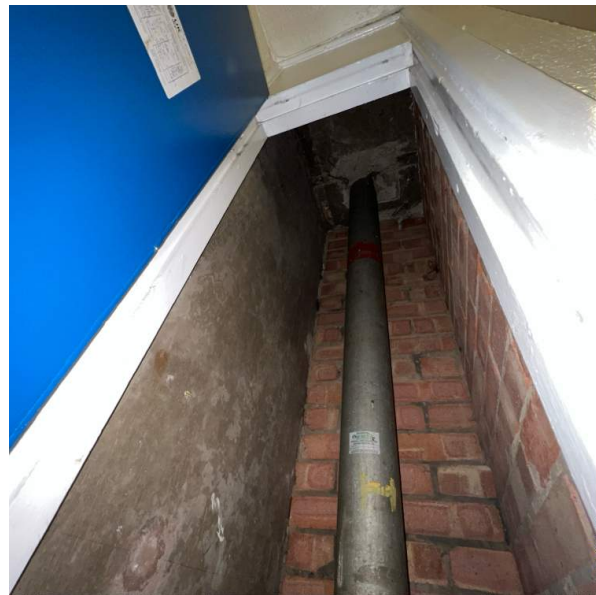
## Ground Floor Hallway

Comments: No jams or distortions noted to hallway doors to indicate any serviceability issues. Generally walls covered with finishes in hallway, likely to consist a mixture of concrete shear walls, embedded columns and masonry infill walls. Limited structure exposed. Concrete walls and infill masonry (non-load bearing) walls noted in riser cupboards.

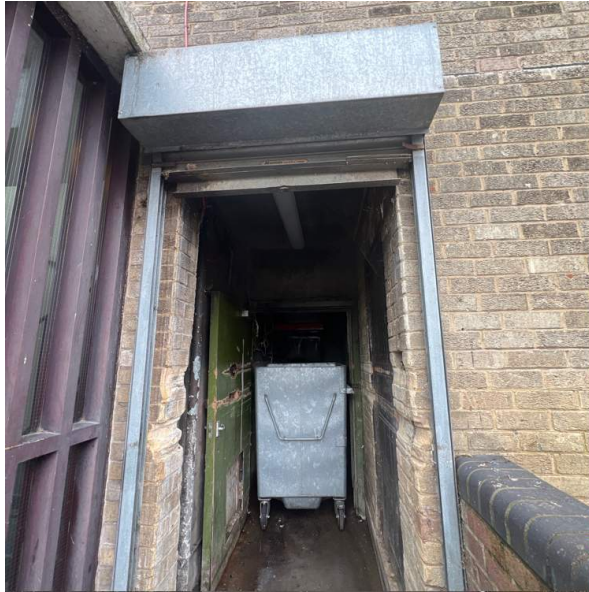
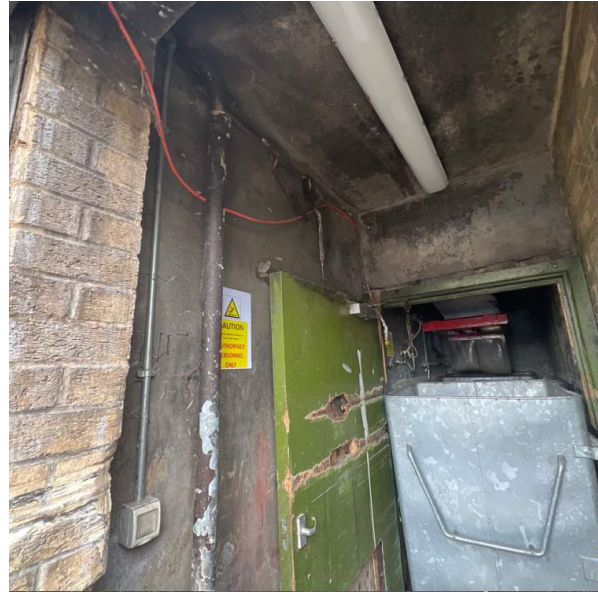
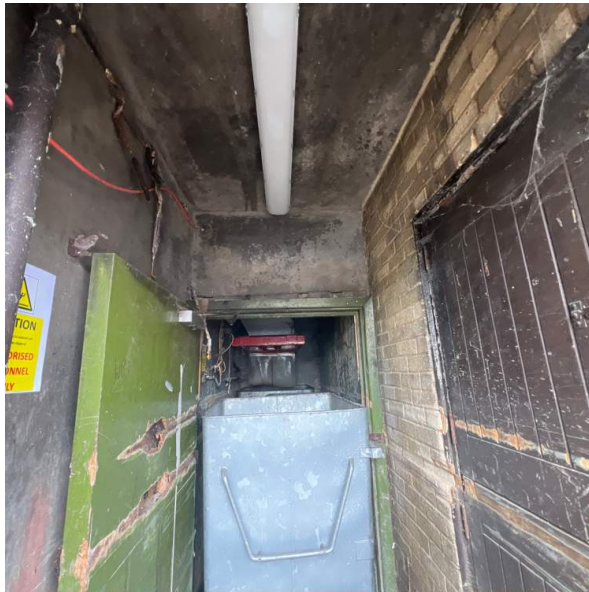
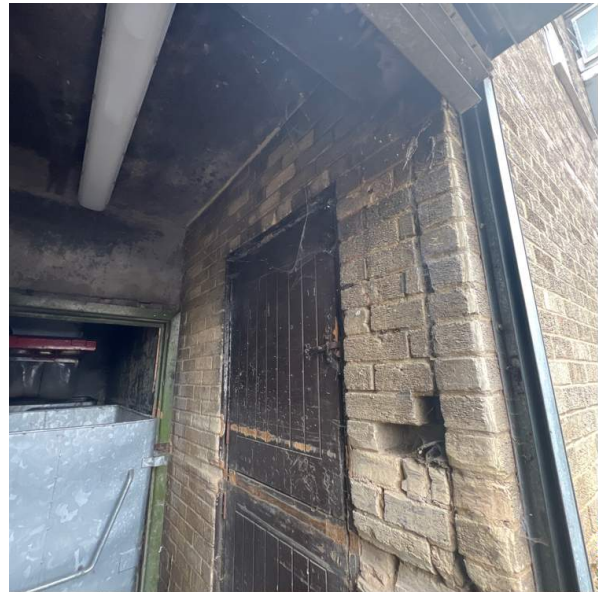
## Bin Store

Comments: RC concrete walls noted in bin store.

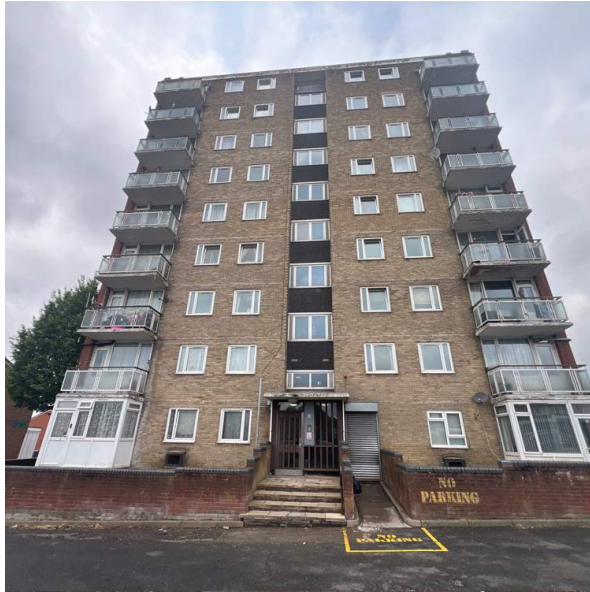
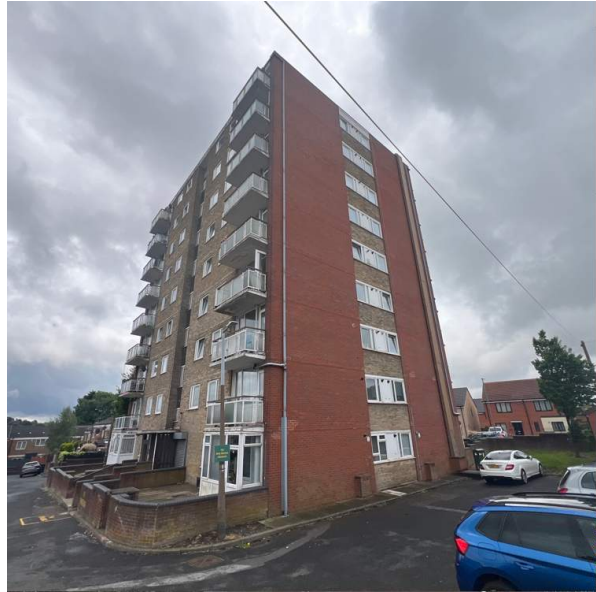
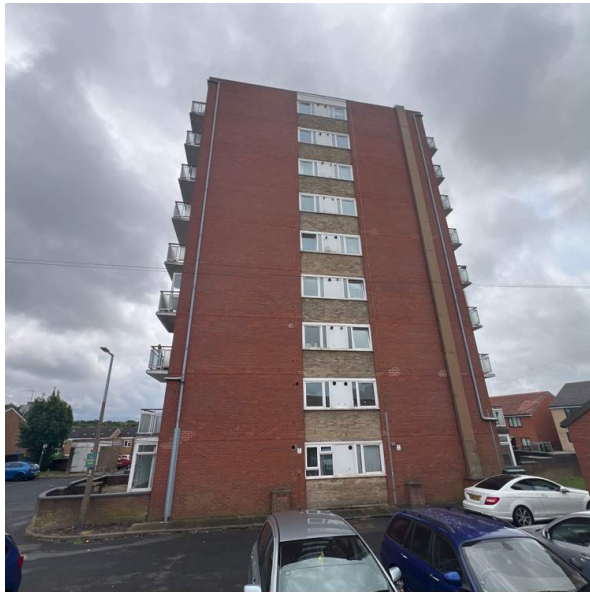
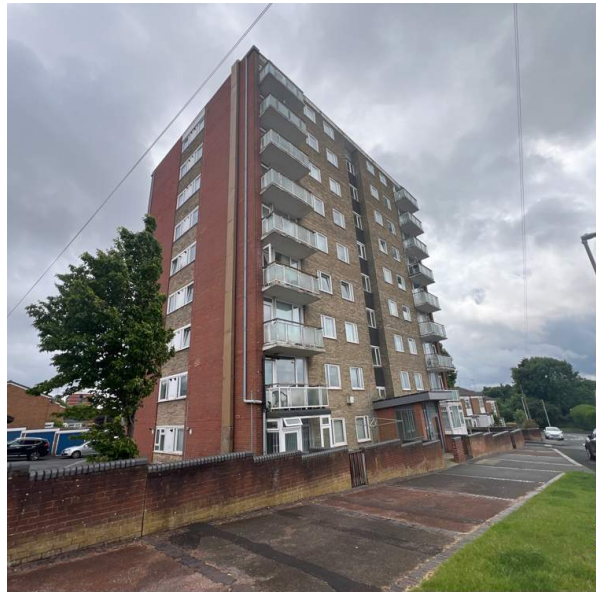
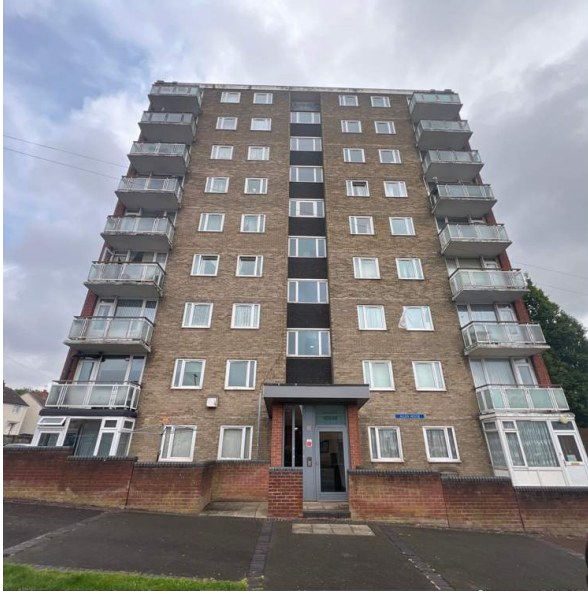
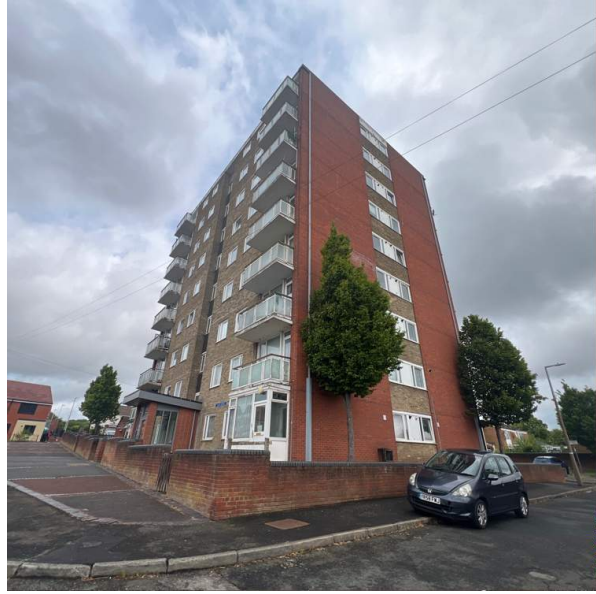
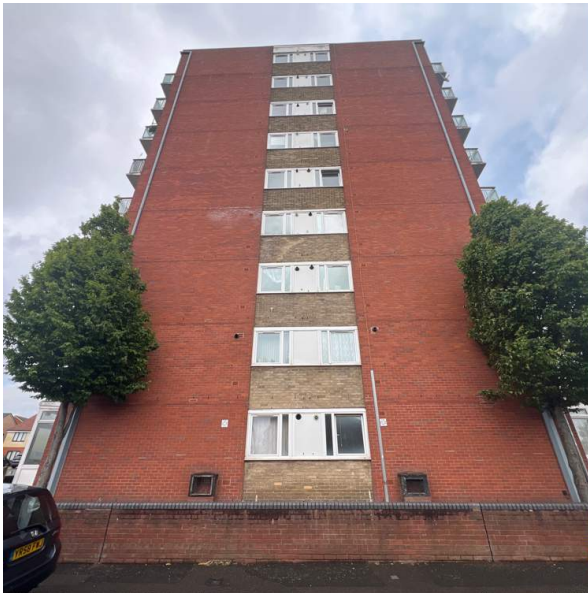
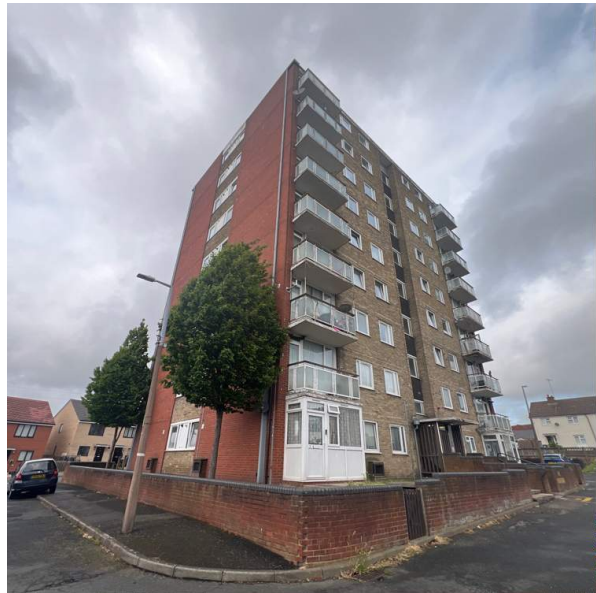
## Elevations

Comments: External facade consists of brick work on all levels for all elevations with cantilevered balconies situated on corners.
