VISUAL STRUCTURAL APPRAISAL

1-90 Ashcroft

Windmill Lane  
West Bromwich  
B66 3JP

29<sup>th</sup> November 2024

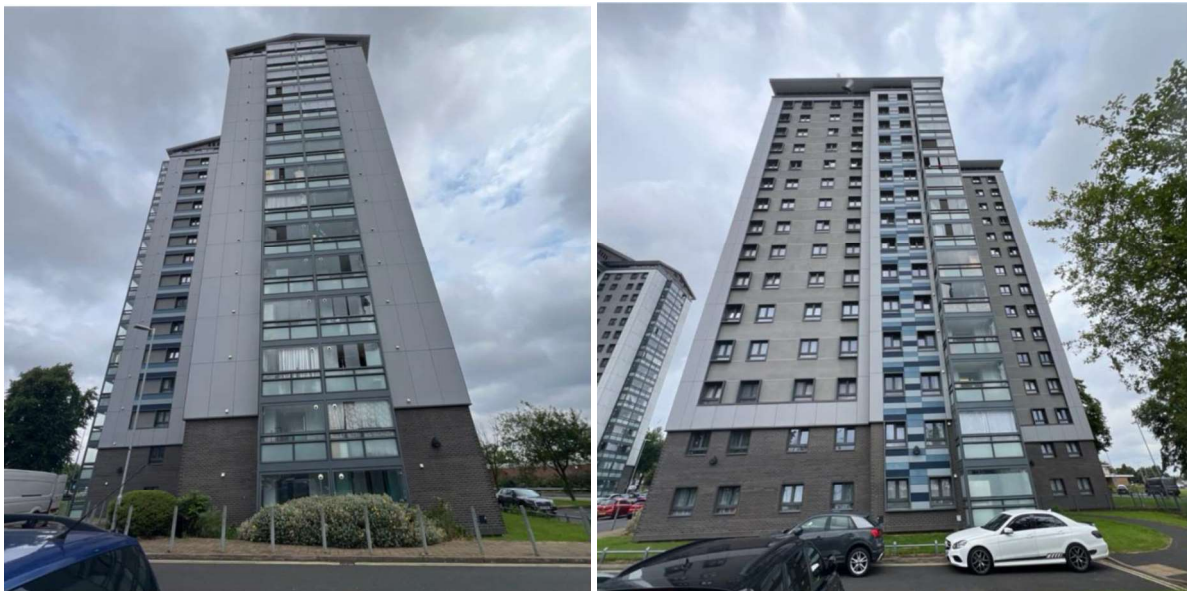
Figure 9 and 10: Building Elevations

The exterior elevations were generally in ok condition and no significant structural defects were noted to the cladding panels. There were no significant cracks or tell-tale signs of any significant structural movement noted at the time of our inspection.

The exterior panels were noted to be plumb with no signs of significant bowing, bulging or leaning noted to the panels indicating failed fixings however their presence and condition cannot be confirmed.

There are balconies at each level which are formed of cantilevered RC slabs tied into the main frame. During the 2016 refurbishment they were transformed into winter gardens by installing glazing around the perimeter of the balcony.

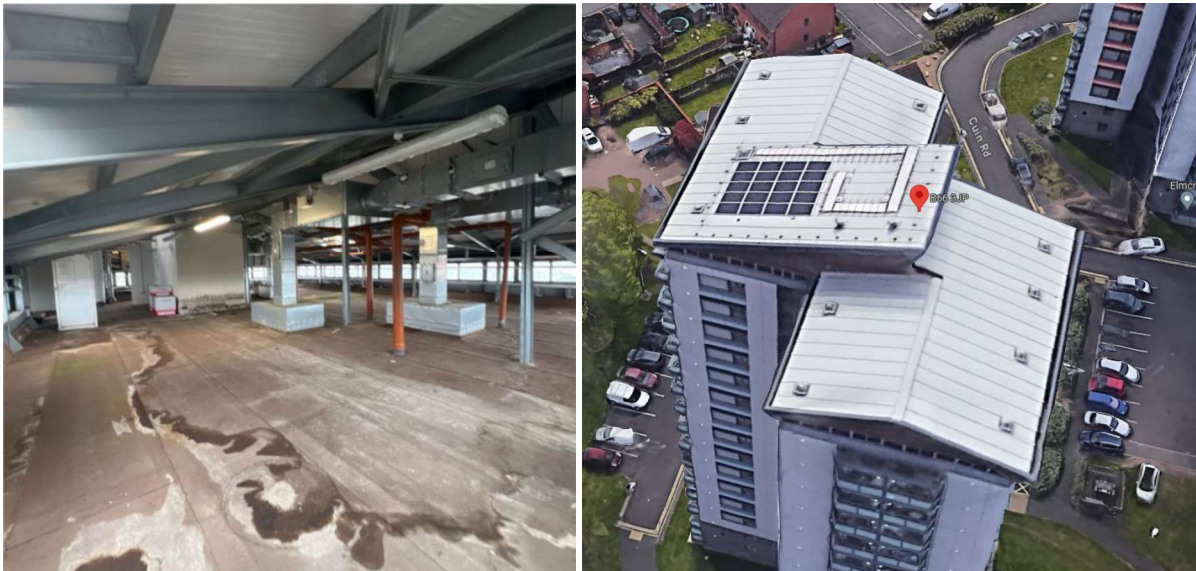
Figure 11 and 12: Roof Level

There were no tell-tale signs of any significant structural movement noted at the time of our inspection. The exterior walls were noted to be plumb with no signs of significant bowing, bulging or leaning noted to the masonry walls.

The roof has subsequently been covered with a new waterproofing covering formed of a steel frame installed to the existing roof which supports pitched corrugated sheets. This roof is not insulated and therefore acts purely as a weather barrier. The fire protection of the steel is unclear as the beams do not appear to be unprotected. Details of this frame should be requested from the contractor who completed the works in 2016.

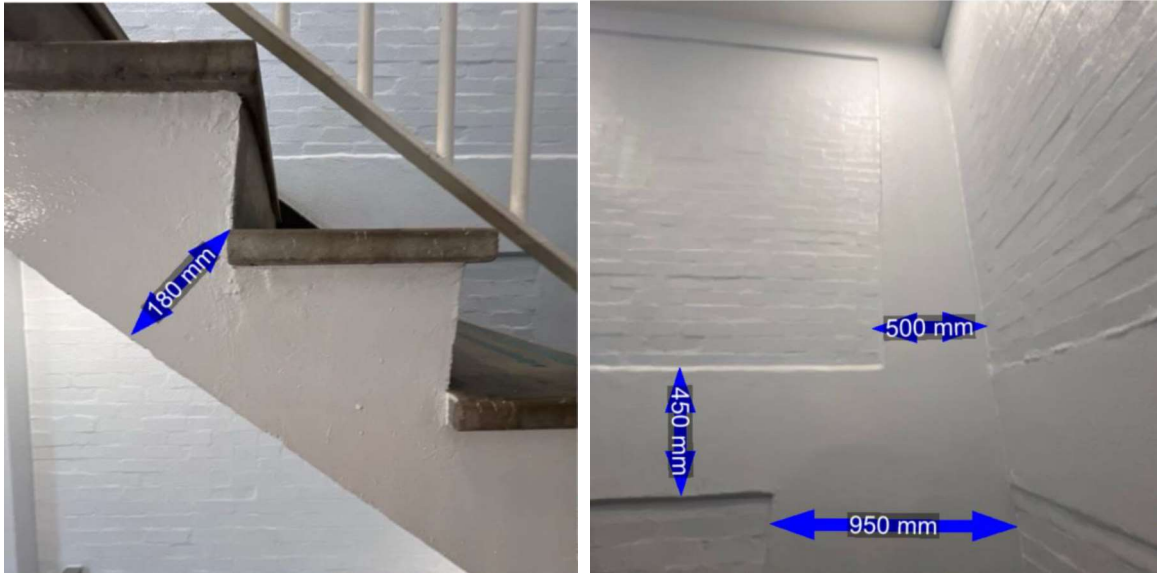
Figure 13 and 14: Stair stringer and concrete frame

The interior of the stair core walls were checked and were plumb and in line with observations made to the exterior – no significant signs of leaning or movement noted. The

concrete appeared in fair condition with few BRE category 1 cracks but no structurally significant defects were noted.

The stair stringer was noted to be 180mm thick which seems reasonable, albeit short of modern standards. A cover test is required to check the resistance of the concrete section in the event of a fire.

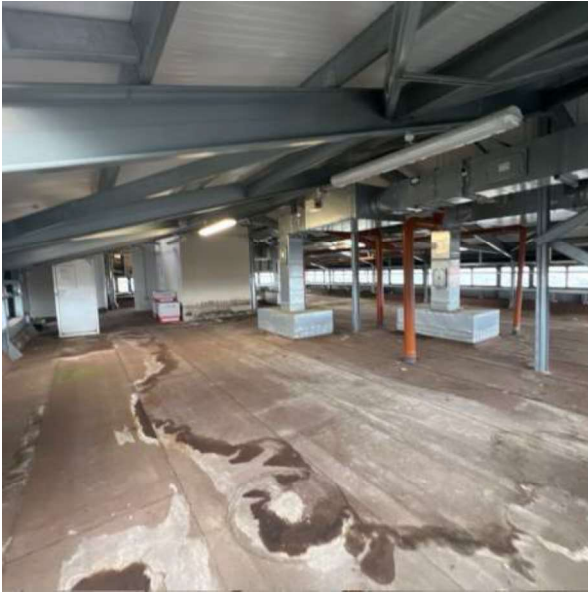
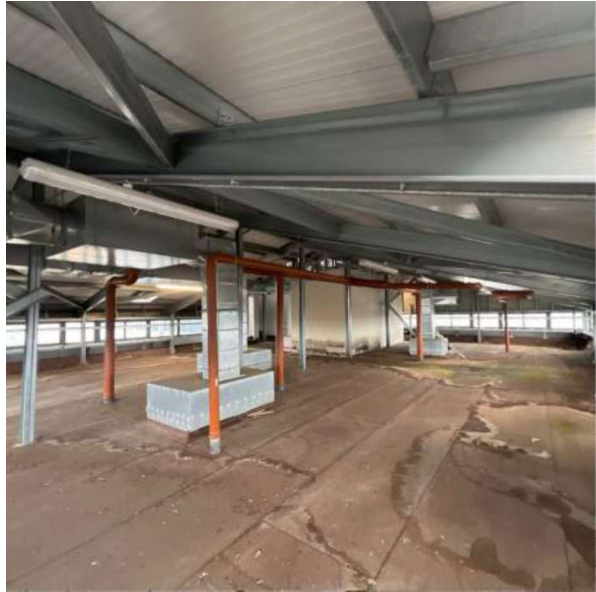
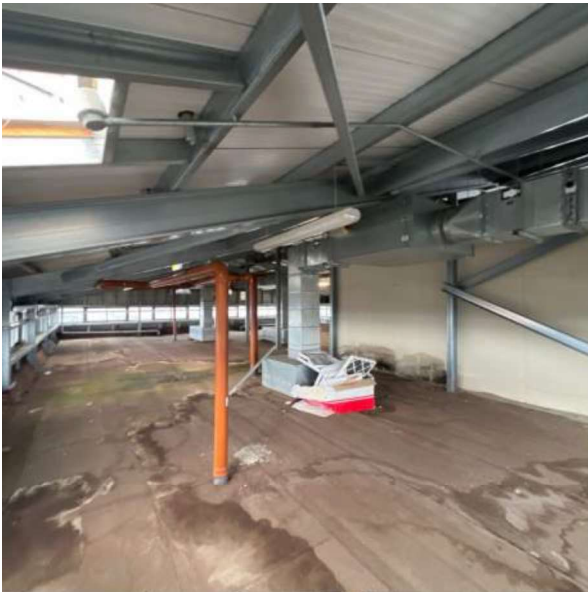
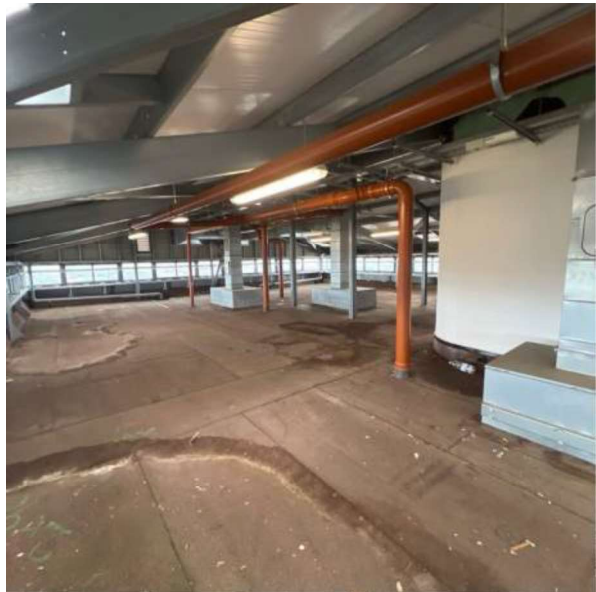
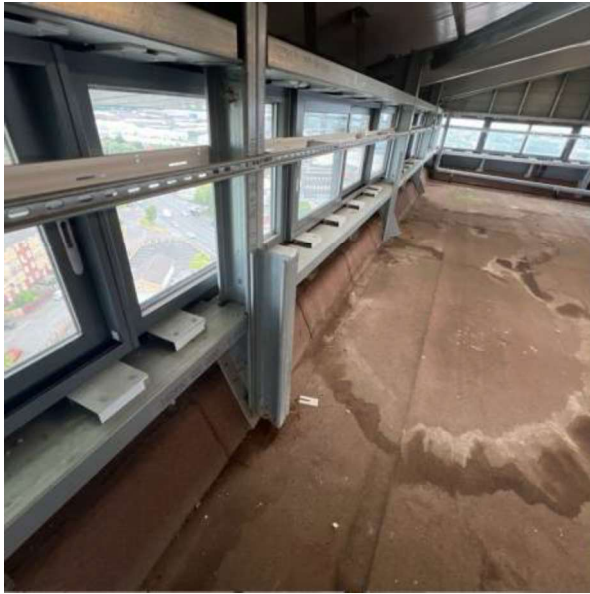
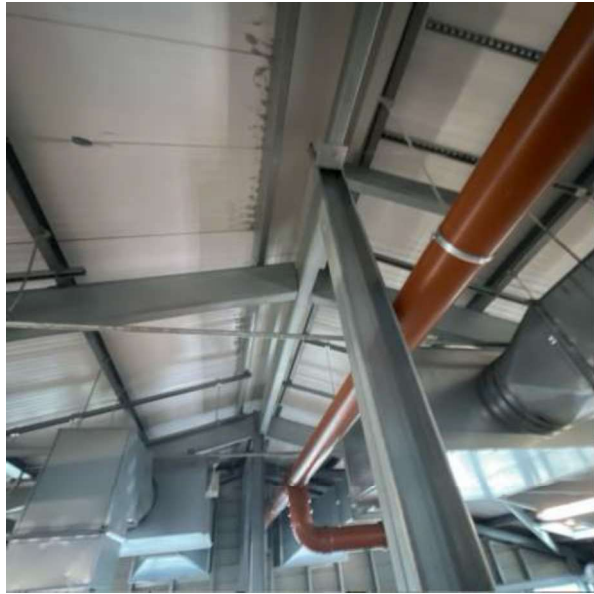
## Main Roof

Comments: Roof structure is formed of a concrete slab with a Lightweight frame (appears to be cold rolled) with a pitched roof fixed on to main roof structure. Frame columns fixed to perimeter of roof.  
Some historical staining to roof coverings noted however no tell tale signs of leaks noted to pitched roof coverings.

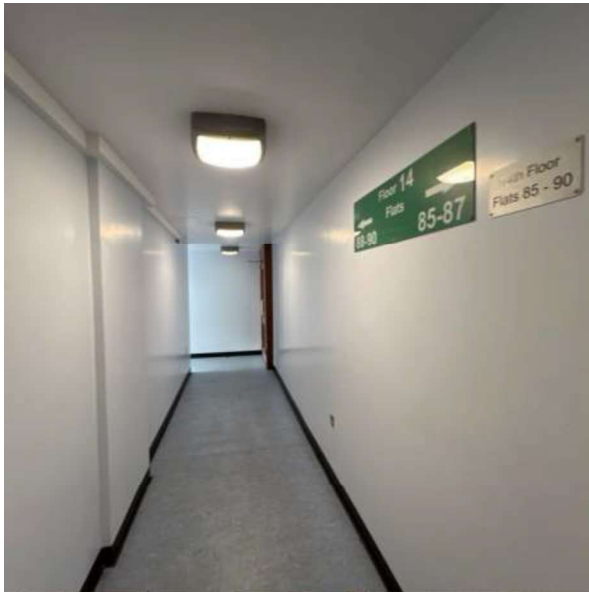
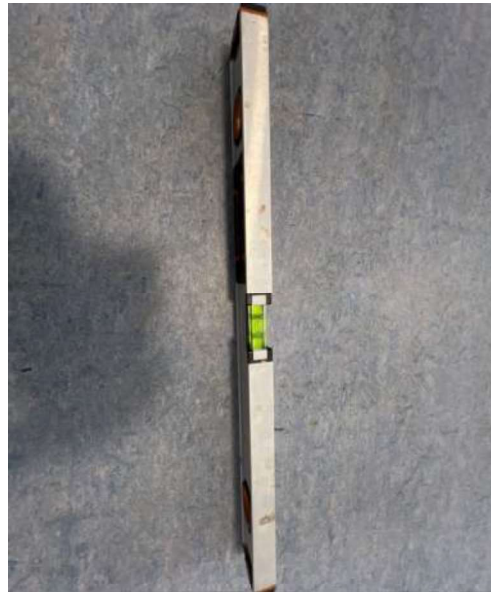
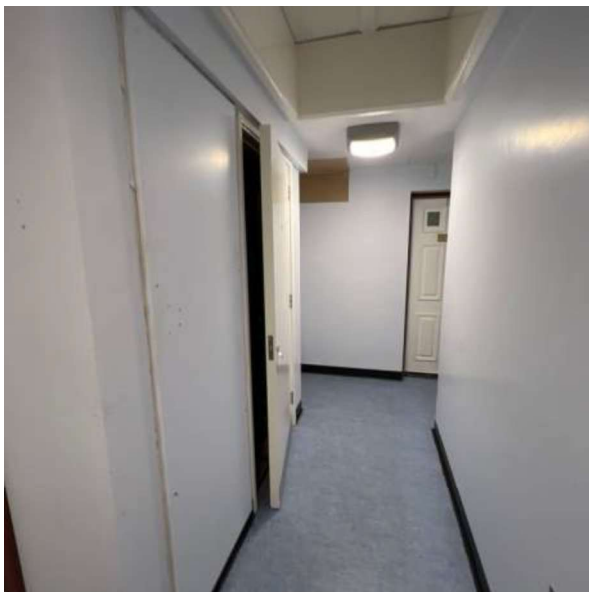
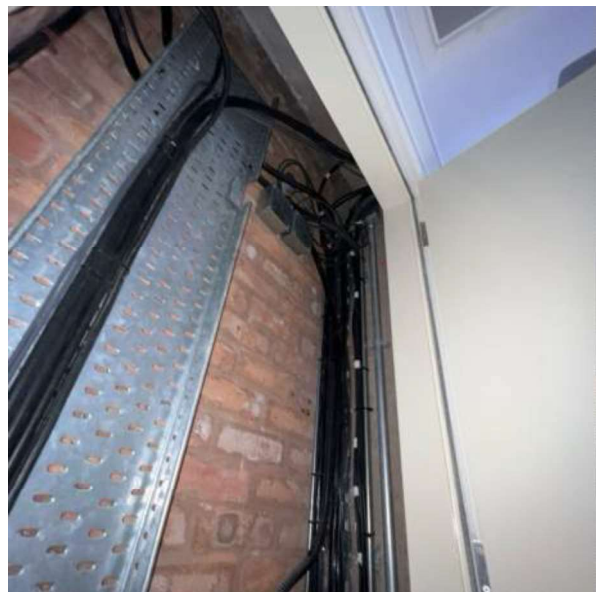
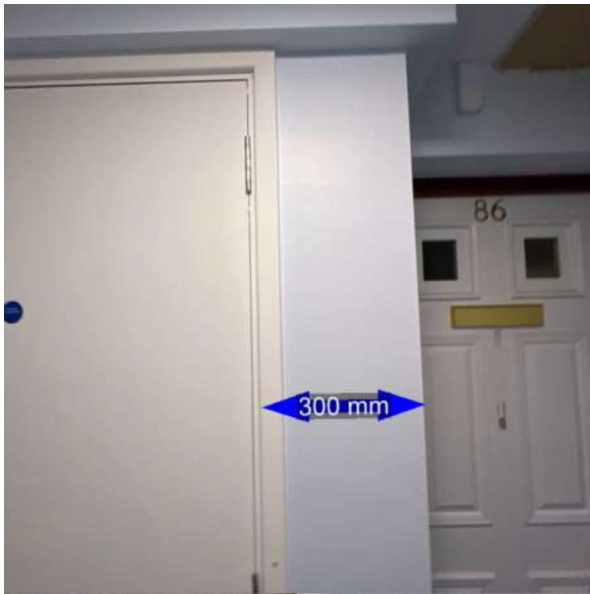
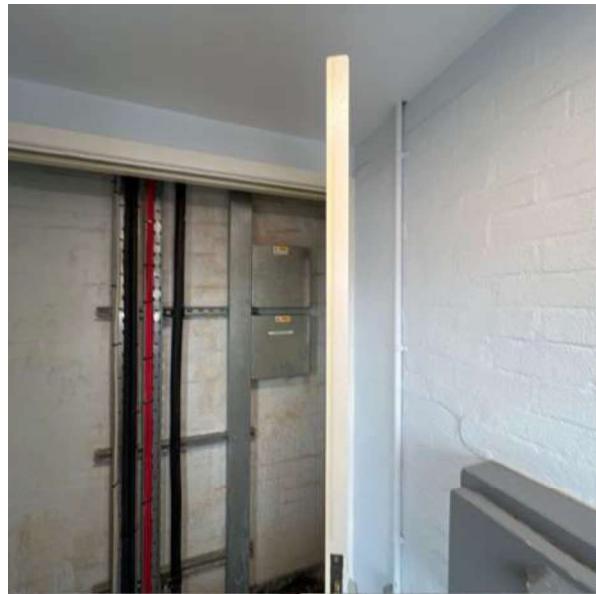
## 14th Floor Hallway

Comments: No jams or distortions noted to hallway doors to indicate any serviceability issues. Generally walls covered with finishes in hallway, likely to consist a mixture of concrete shear walls and embedded columns with internal partition walls. Riser cupboard shows infill masonry walls with a partially exposed concrete element likely an RC Column.

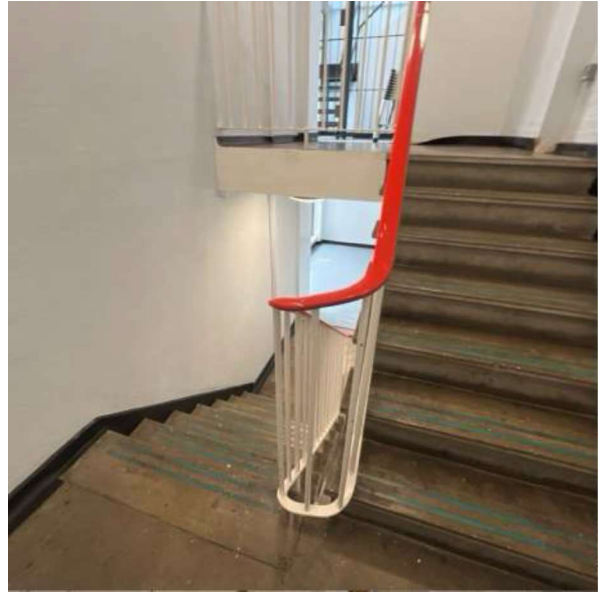
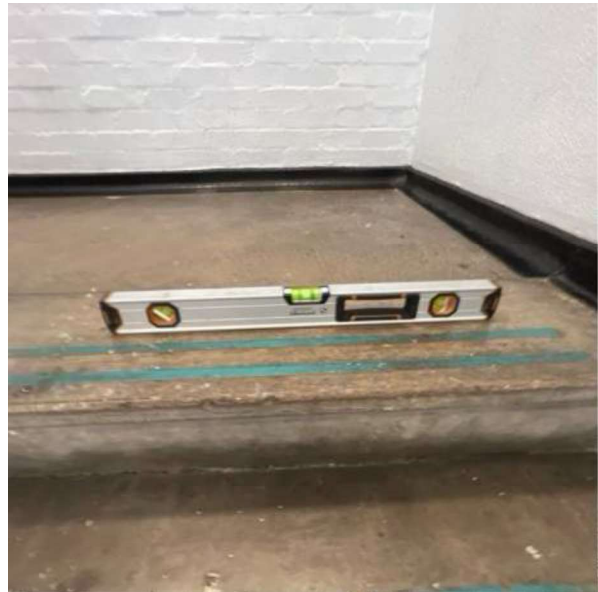
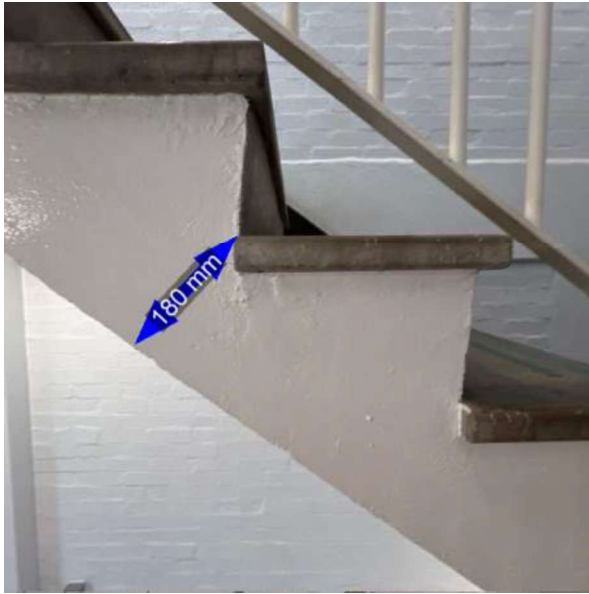
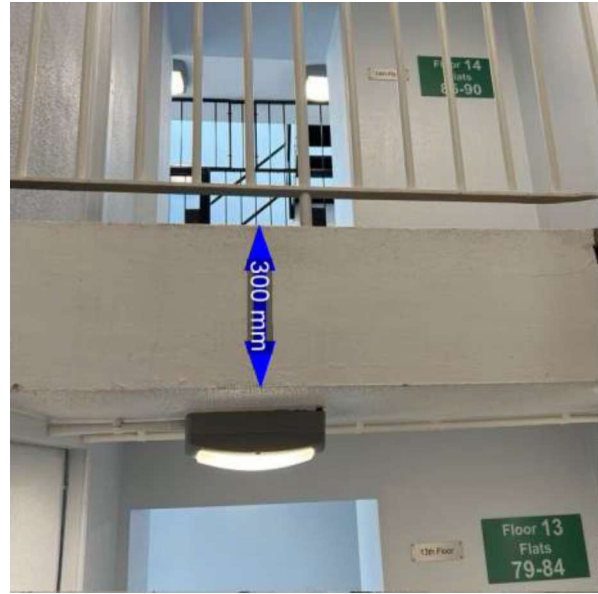
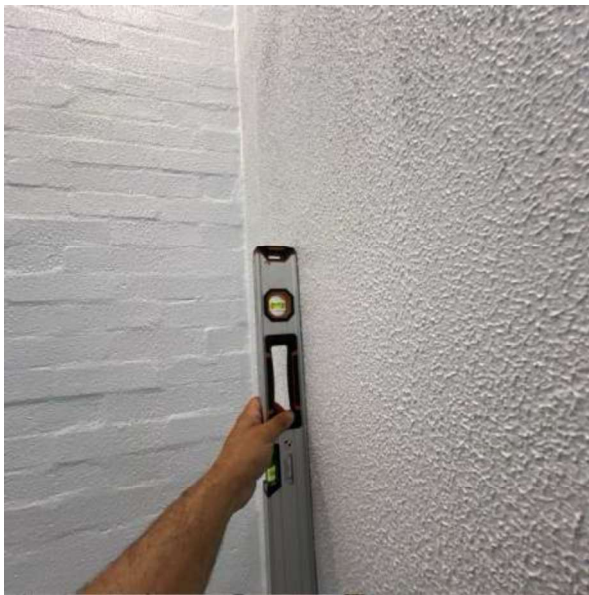
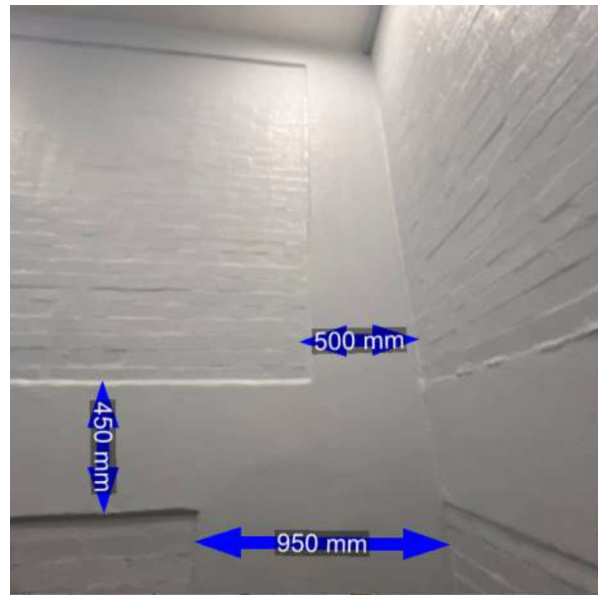
## 14th Floor Staircase

Insitu concrete stairs with steel hand railing fixed to stairs. Walls and floors appear to be fairly level.

Stair walls partly exposed showing infill masonry walls (non-load bearing) and embedded RC Concrete beams and columns noted.

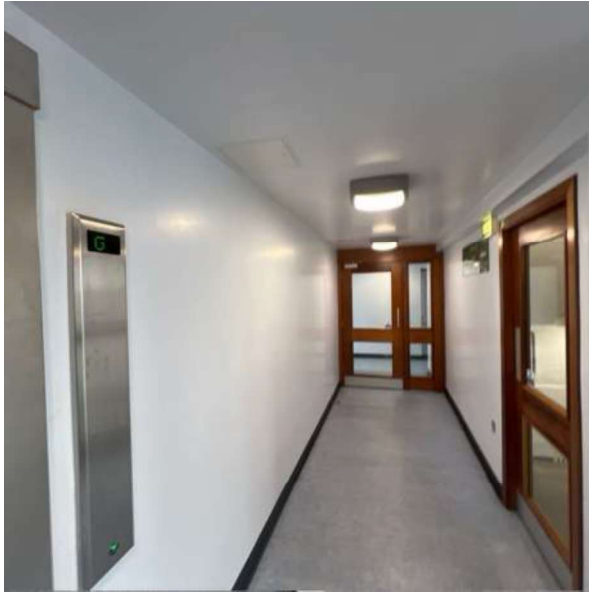
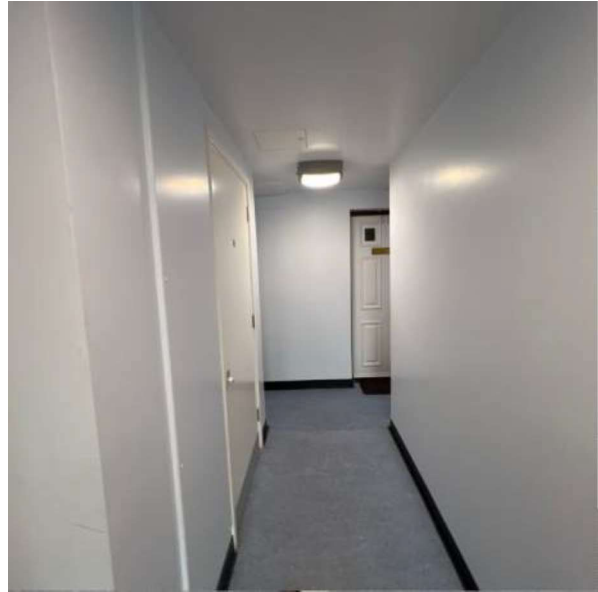
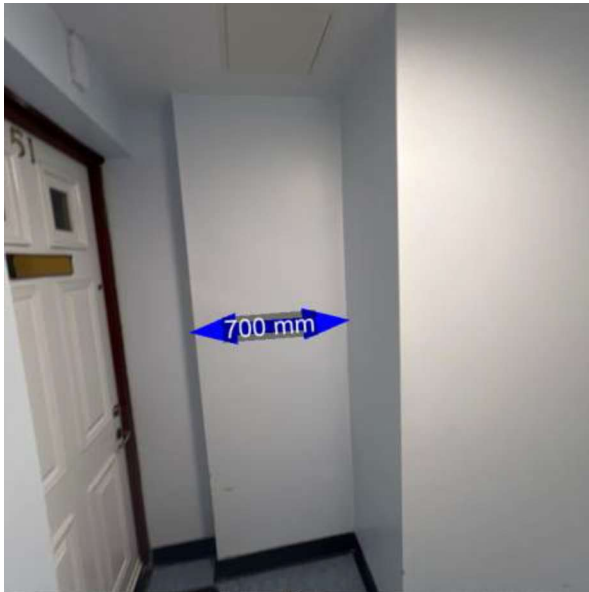
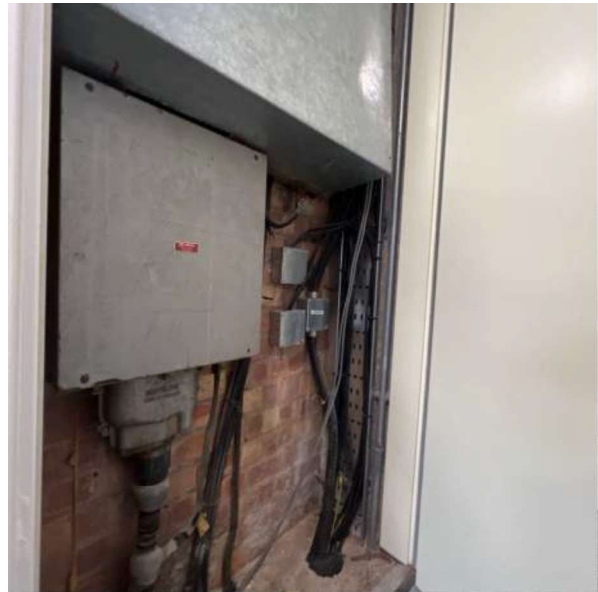
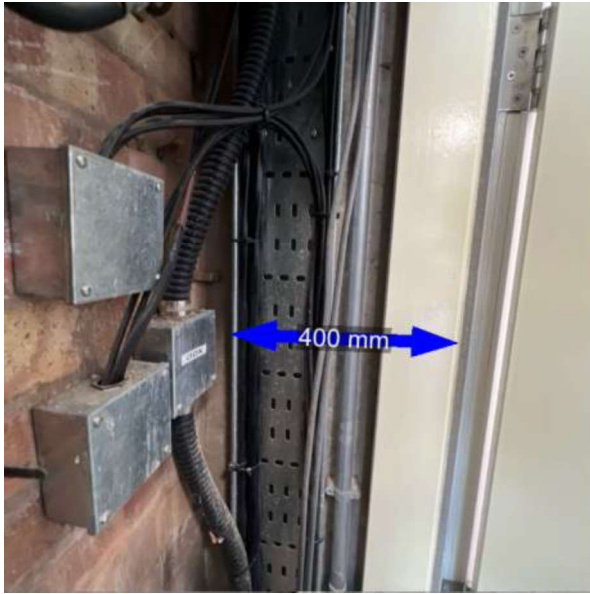
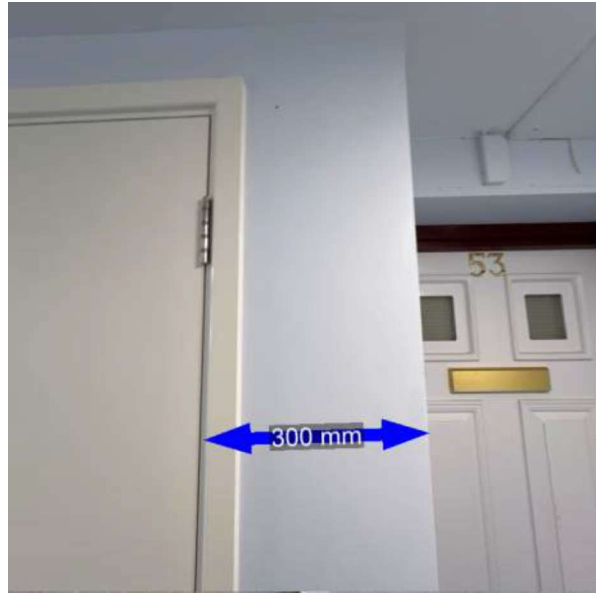
## 8th Floor Hallway

Comments: No jams or distortions noted to hallway doors to indicate any serviceability issues. Generally walls covered with finishes in hallway, likely to consist a mixture of concrete shear walls and embedded columns with internal partition walls. Riser cupboard shows infill masonry walls with a partially exposed concrete element likely an RC Column. Concrete floor slab measured through void in service cupboard noted to be approx. 160mm thick.

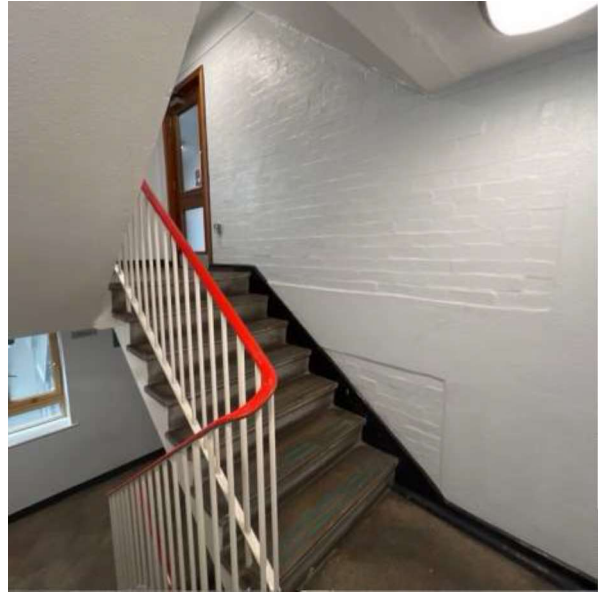
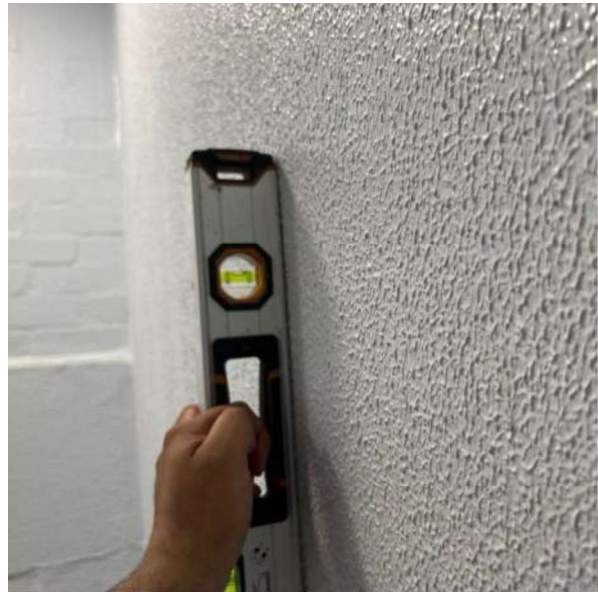
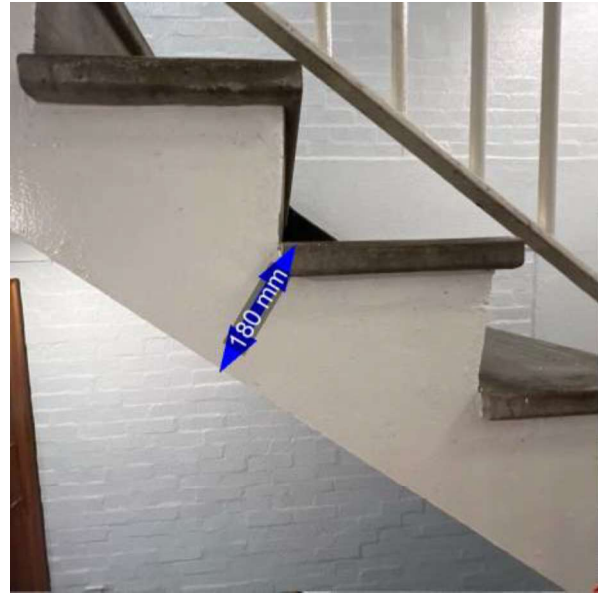
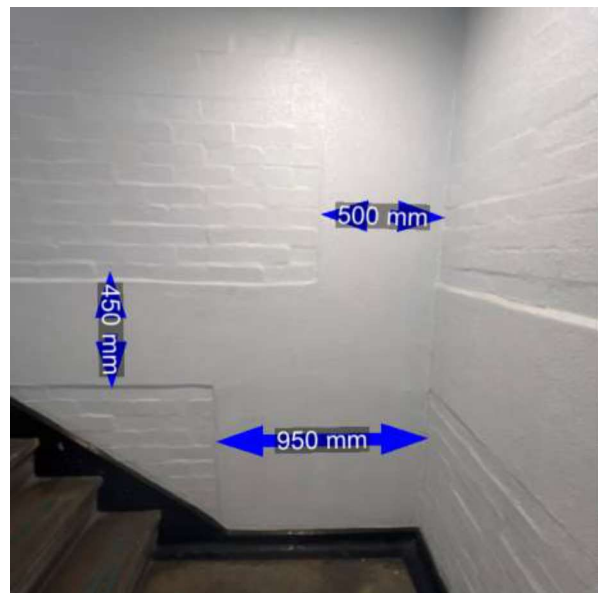
## 8th Floor Staircase

Insitu concrete stairs with steel hand railing fixed to stairs. Walls and floors appear to be fairly level.

Stair walls partly exposed showing infill masonry walls (non-load bearing) and embedded RC Concrete beams and columns noted.

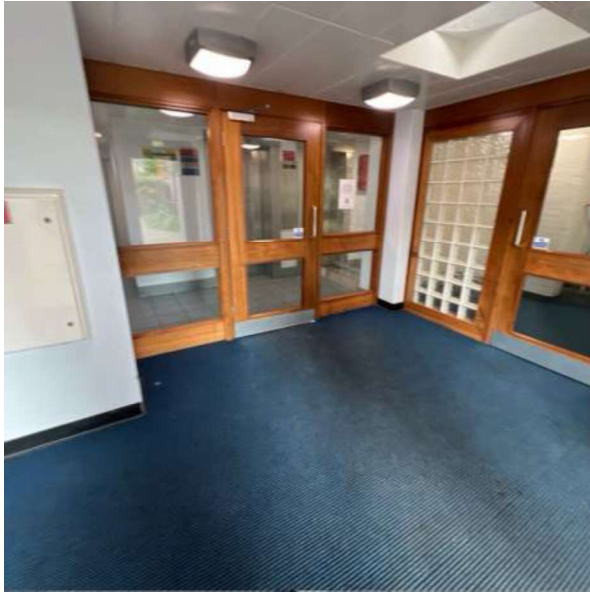
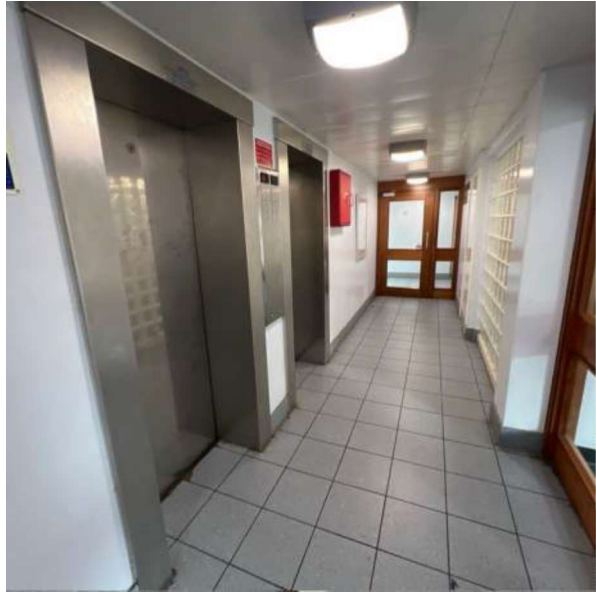
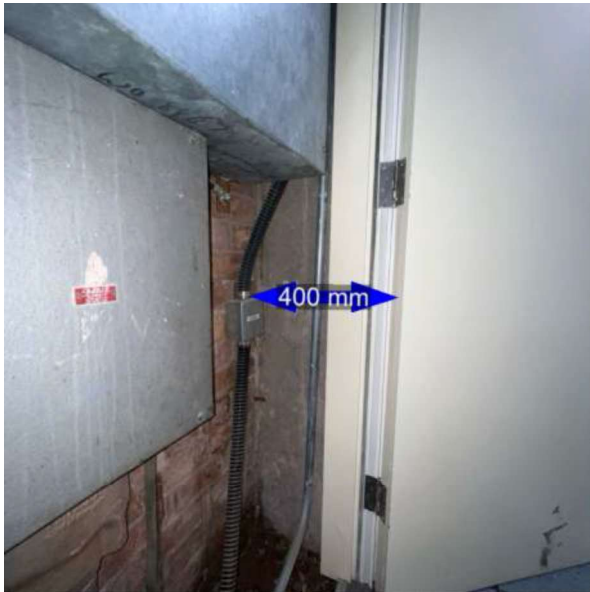
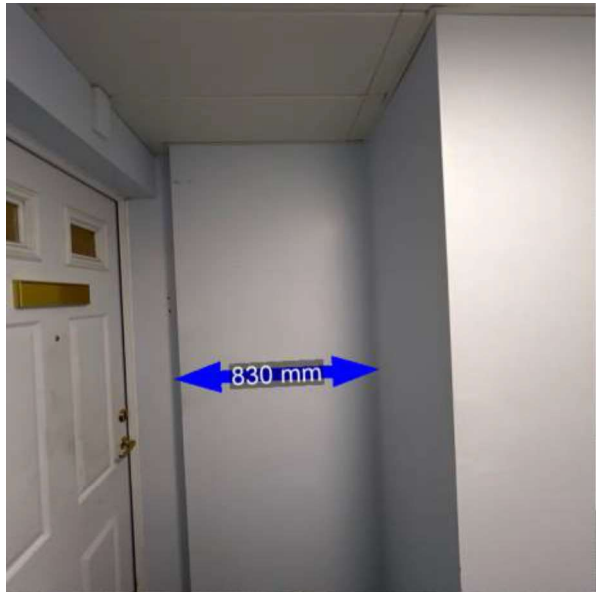
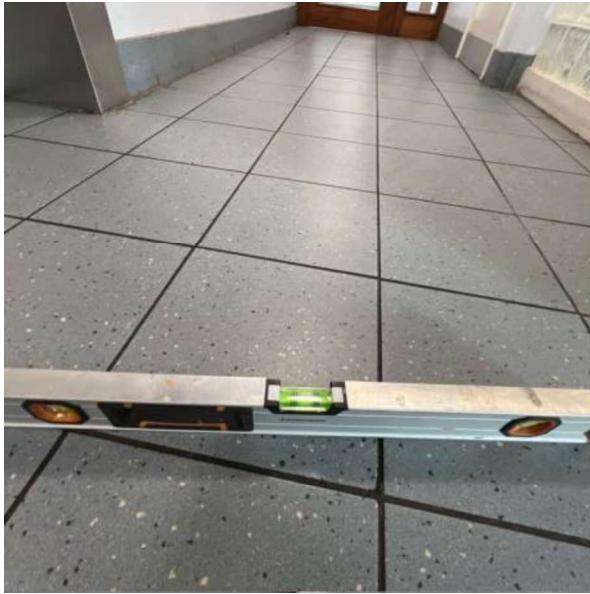
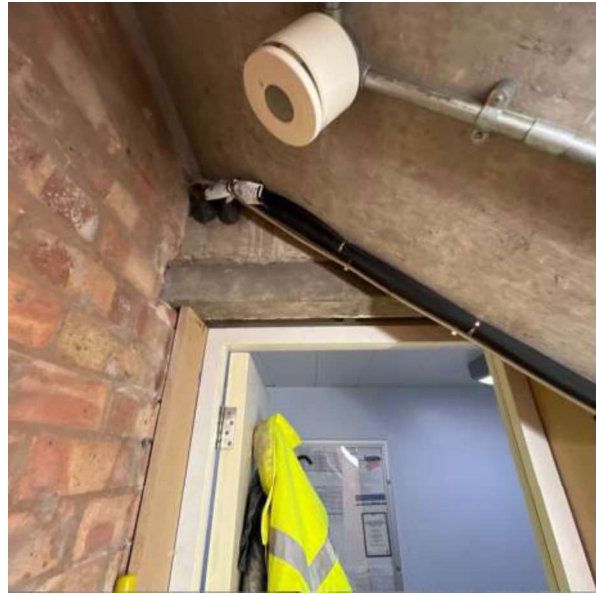
## Ground Floor Hallway

No jams or distortions noted to hallway doors to indicate any serviceability issues. Generally walls covered with finishes in hallway, likely to consist a mixture of concrete shear walls and embedded columns with internal partition walls. Riser cupboard shows infill masonry walls with a partially exposed concrete element likely an RC Column. Storage room under ground floor staircase shows embedded RC concrete beam and column in infill masonry walls. One side of stair wall noted to be an RC concrete wall likely forming a shear core wall of the structure.

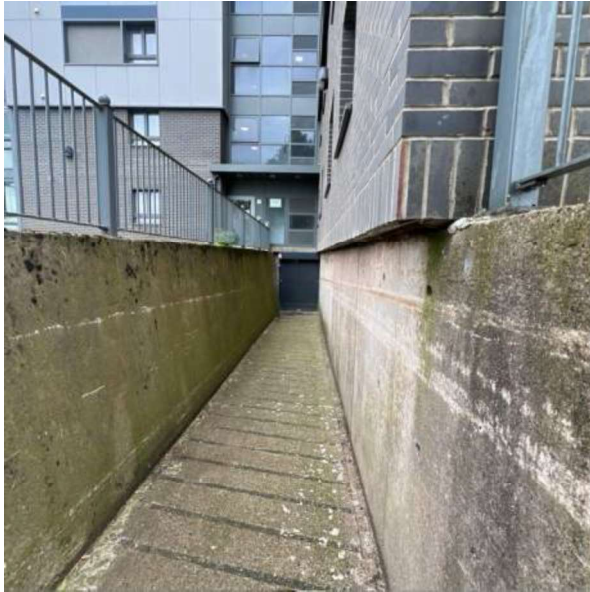
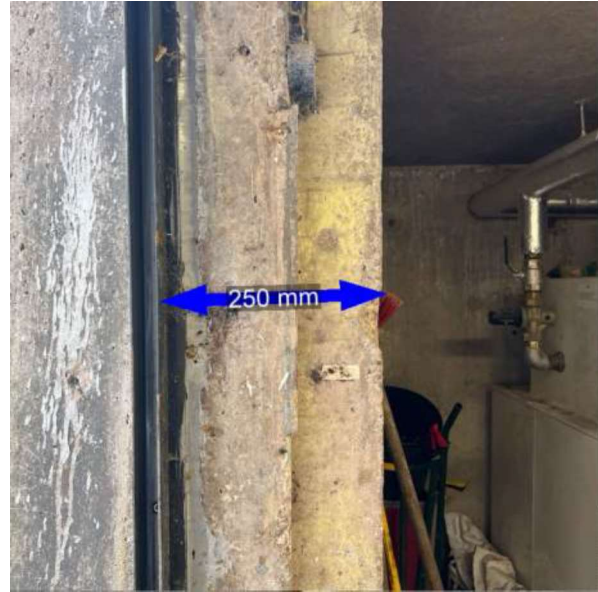
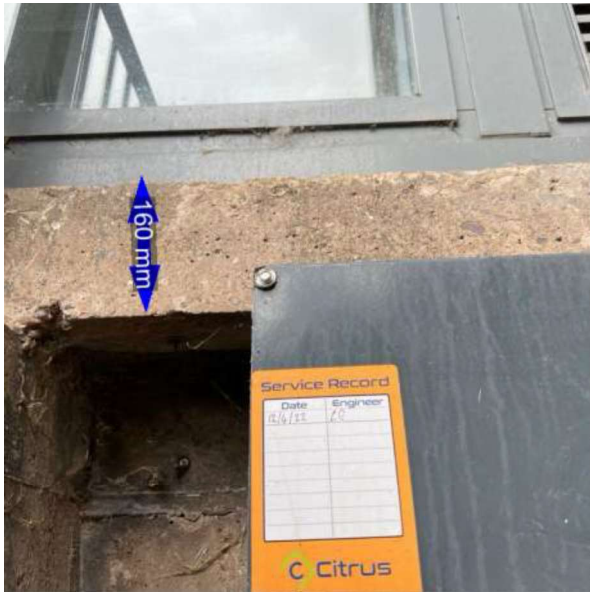
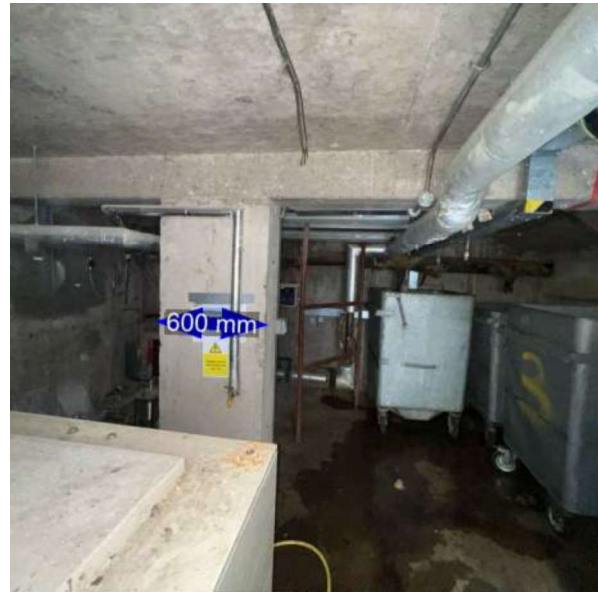
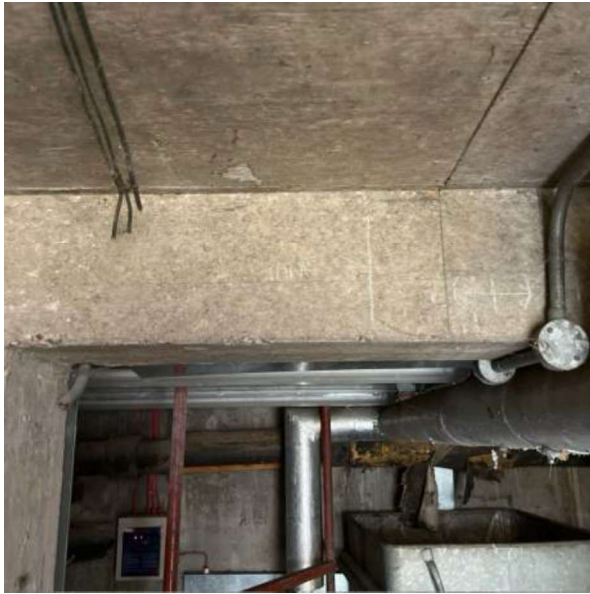
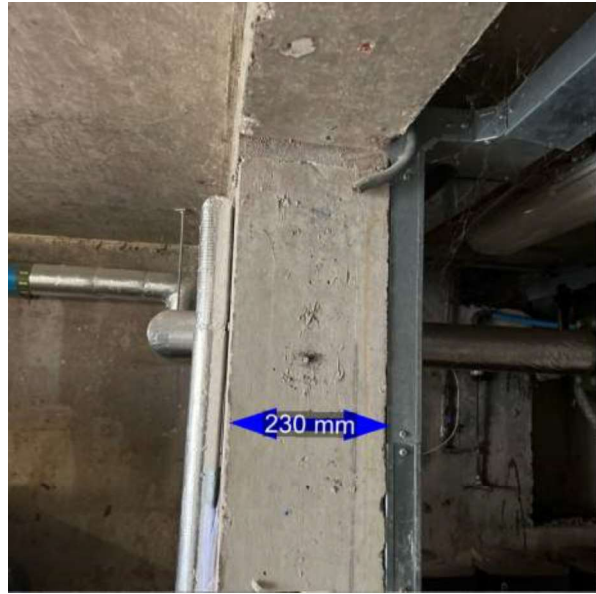
## Bin Store

Bin store located at basement level with a retaining wall leading up to bin store entrance. RC frame structure exposed forming of concrete beams, columns (230x600mm) and shear walls.

Floor slab measured from bin store entrance noted to be approx. 160mm dp.

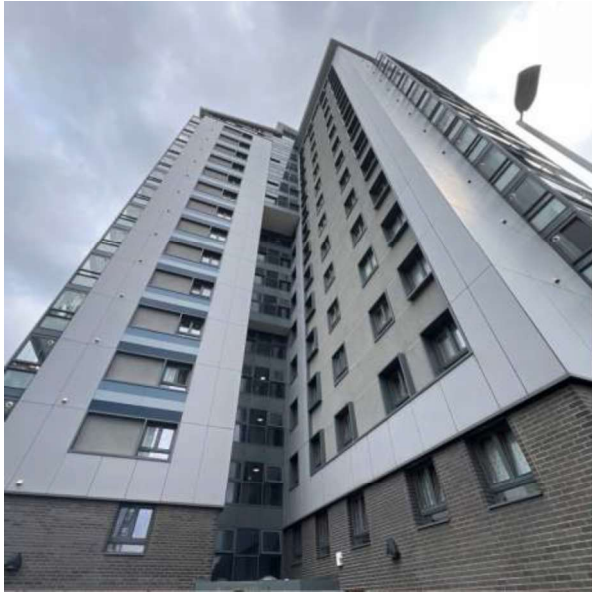
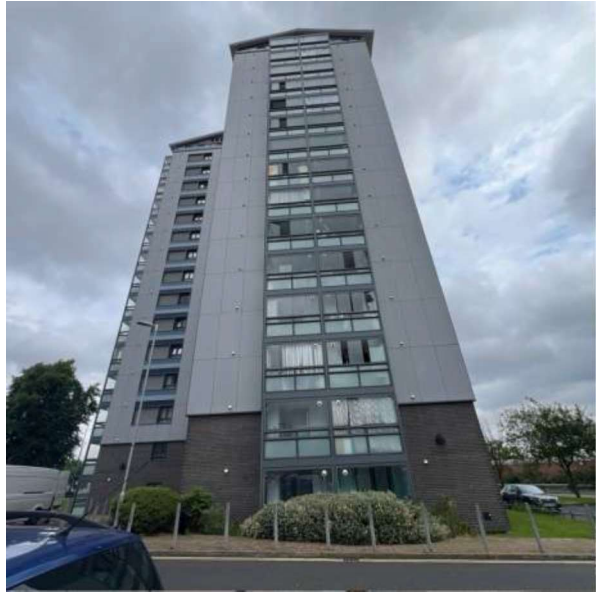
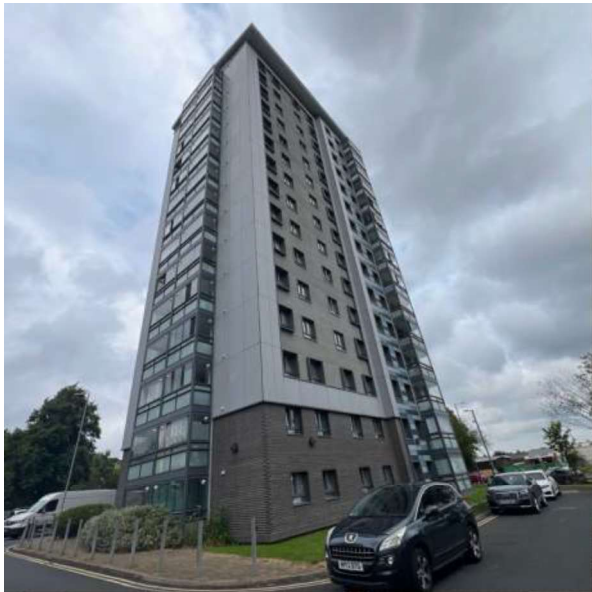
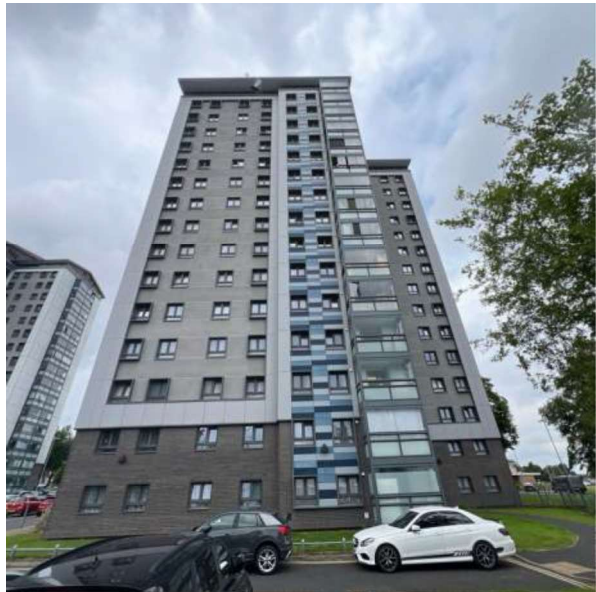
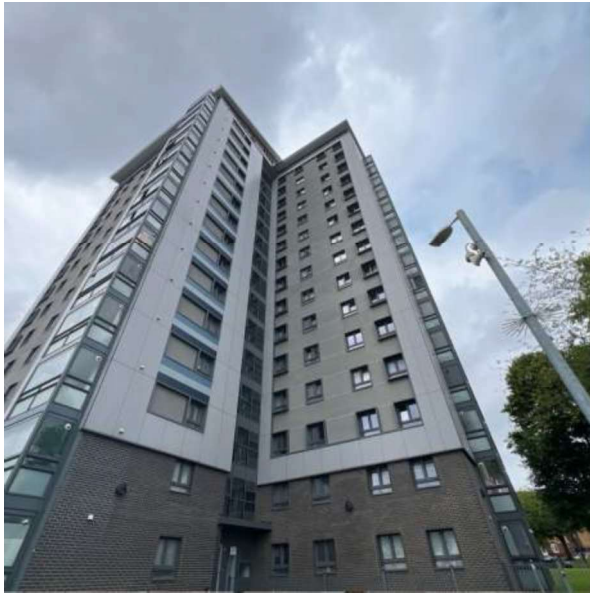
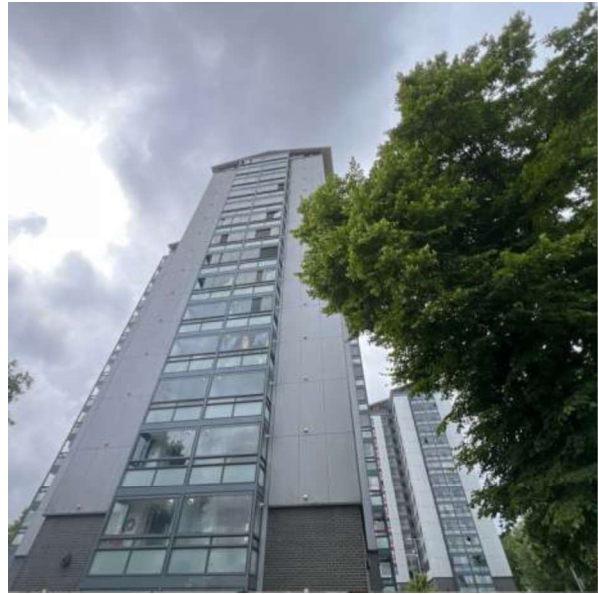
## Elevations

External ground and first floor levels consists of brick work to all elevations.  
Upper floors noted to have cladded facaded.
