**FIRNTEC**  
BUILDING COMPLIANCE

VISUAL STRUCTURAL APPRAISAL

1 -48 Astbury Cout

Kingsway  
Brandhall  
B68 0QG

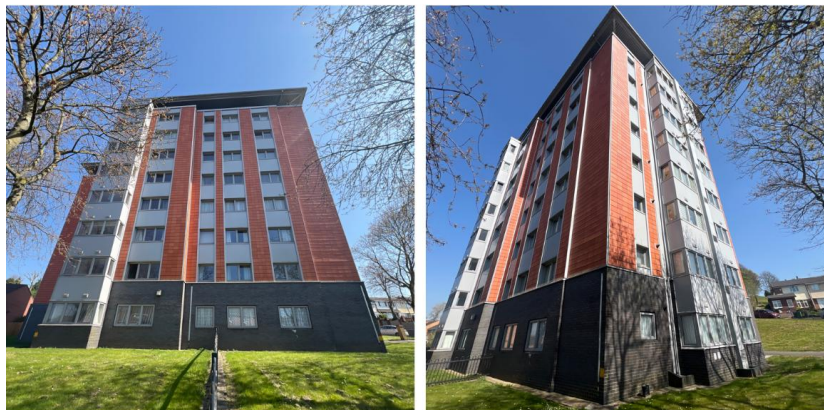
Figure 9 and 10: Building Elevations

The exterior elevations were generally in ok condition and no significant structural defects were noted to the cladding panels. There were no significant cracks or tell-tale signs of any significant structural movement noted at the time of our inspection.

The exterior panels were noted to be plumb with no signs of significant bowing, bulging or leaning noted to the panels indicating failed fixings however their presence and condition cannot be confirmed.

There are balconies at each level which are formed of cantilevered RC slabs tied into the main frame. During the 2018 refurbishment they were enclosed with aluminium panelling.

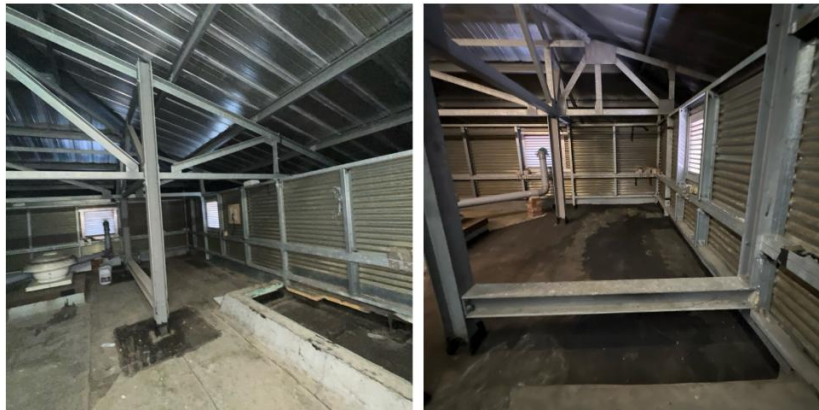
Figure 11 and 12: Roof Level

There were no tell-tale signs of any significant structural movement noted at the time of our inspection. The exterior walls were noted to be plumb with no signs of significant bowing, bulging or leaning noted to the masonry walls.

The roof has subsequently been covered with a new waterproofing covering formed of a steel frame installed to the existing roof which supports pitched corrugated sheets. This roof is not insulated and therefore acts purely as a weather barrier. The fire protection of the steel is unclear as the beams do not appear to be protected. Details of this frame should be requested from the contractor who completed the works in 2018. No signs of water ingress of that the roof is not performing as intended.

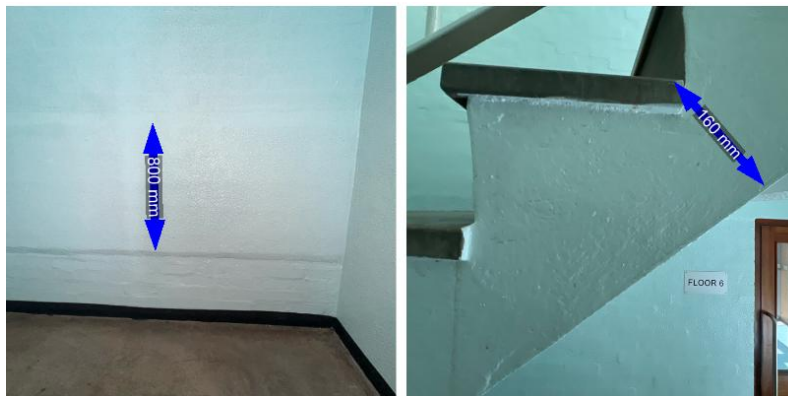
Figure 14 and 15: Stair stringer and concrete element

The interior of the stair core walls were checked and were plumb and in line with observations made to the exterior – no significant signs of leaning or movement noted. The concrete appeared in fair condition with few BRE category 1 cracks but no structurally significant defects were noted.

The stair stringer was noted to be 160mm thick which is what we would expect. A cover test is required to check the resistance of the concrete section in the event of a fire.

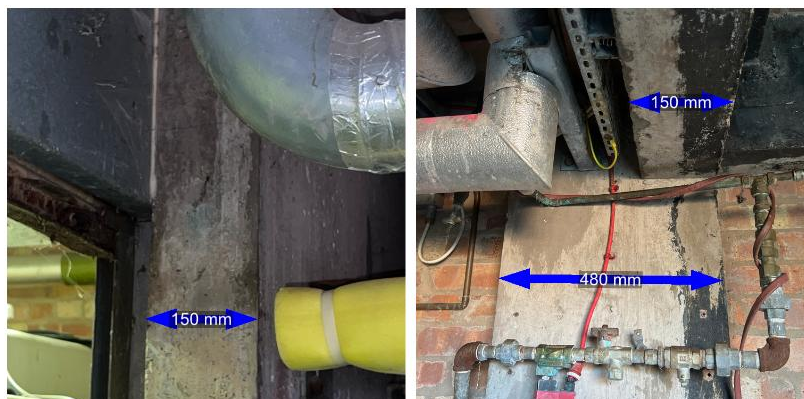
Figure 16 and 17: RC Elements visible at ground floor

There were vertical concrete walls supporting the floor plates at every level. The elements visible matched the floor layout in Figure 6. The walls appear continuous from ground to roof with no transfer structure. The overall condition of the structure observed is good.

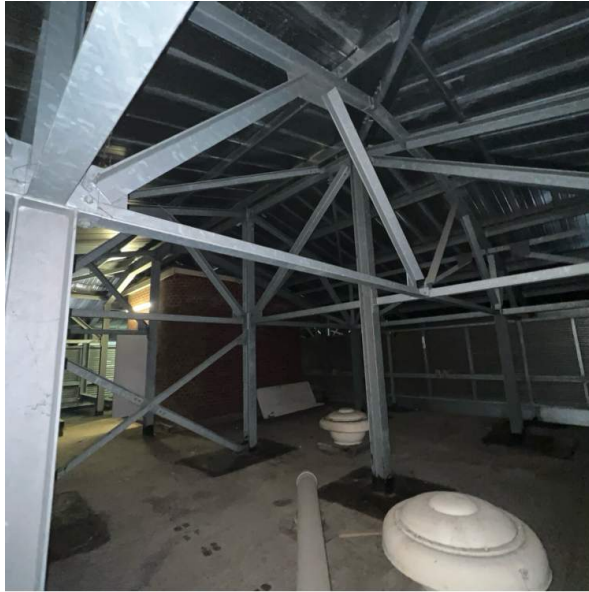
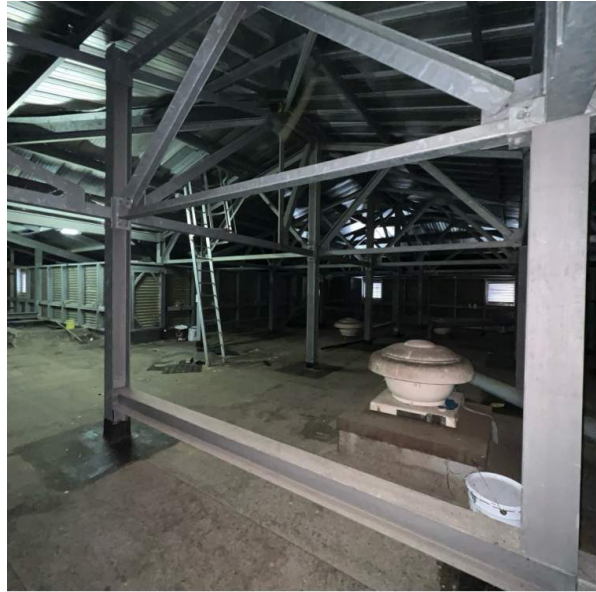
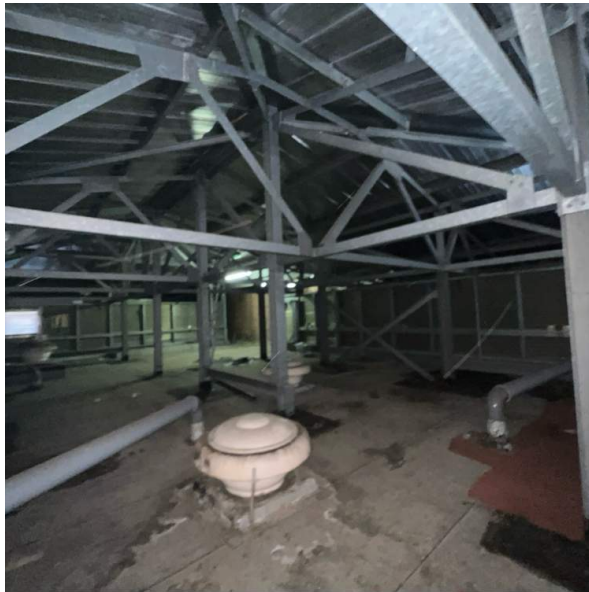
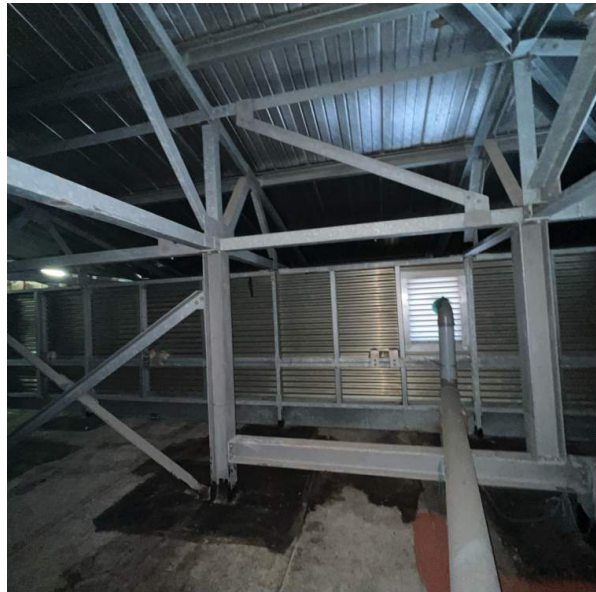
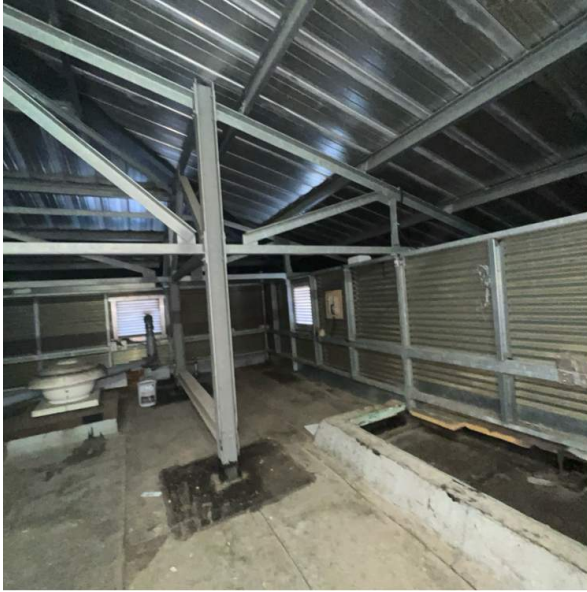
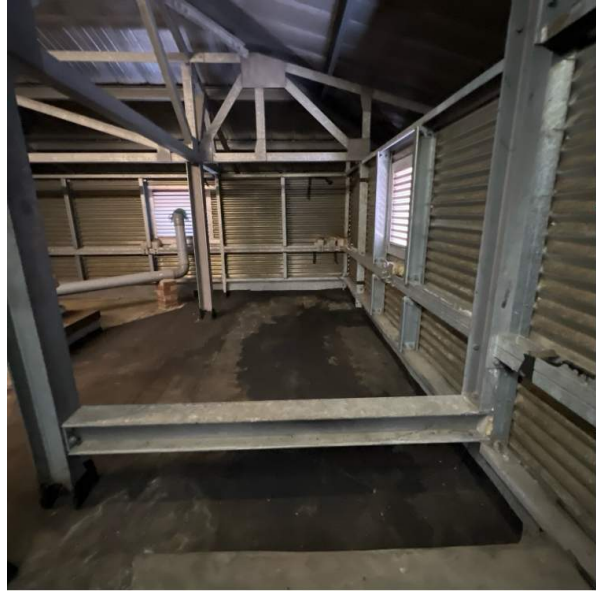
## Main Roof

Comments: A pitched roof constructed above existing original flat roof slab. Steel frame supporting purlins with aluminium standing / mineral wool core profiled panels.  
Masonry walls noted for motor room.

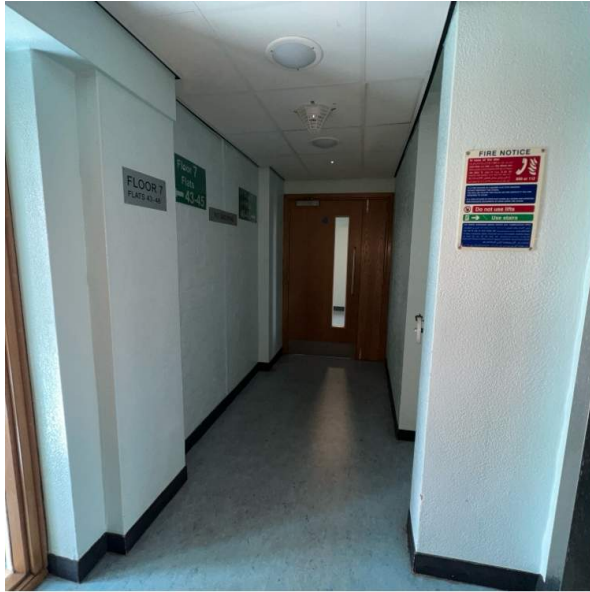
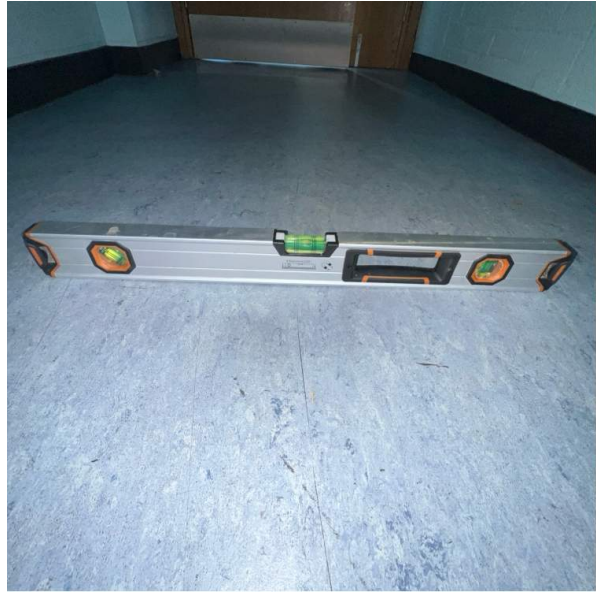
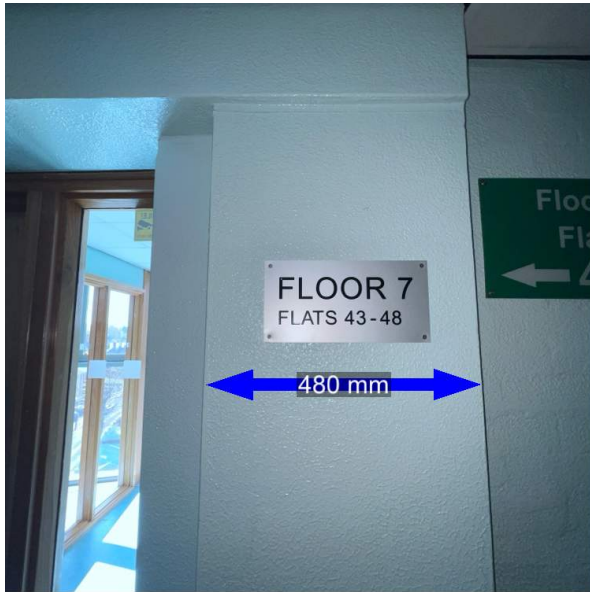
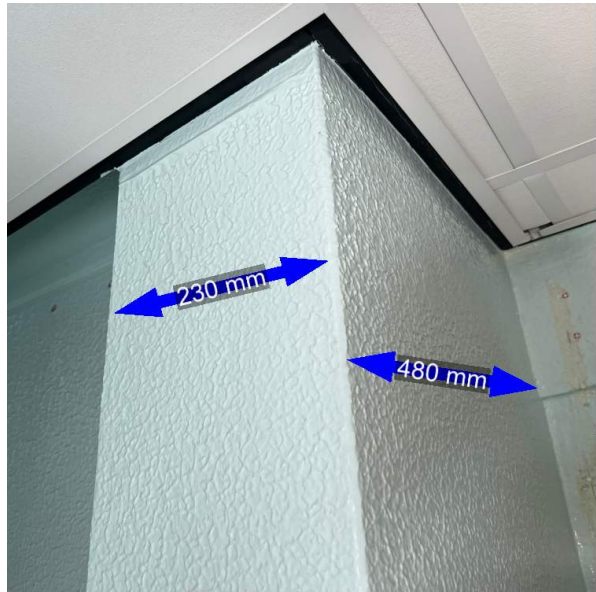
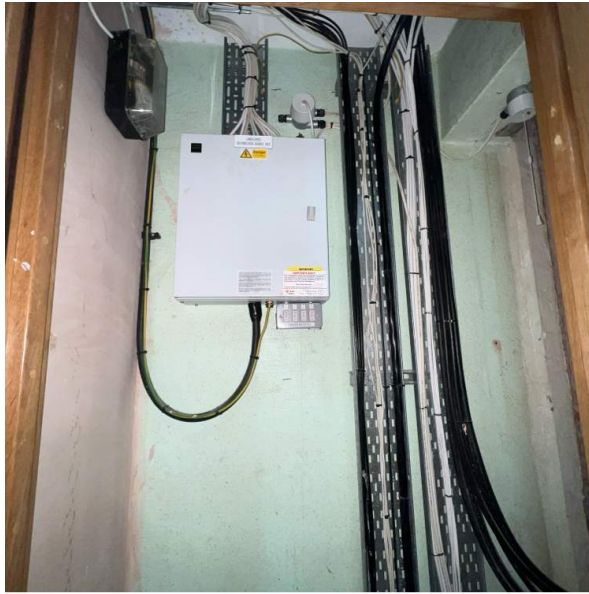
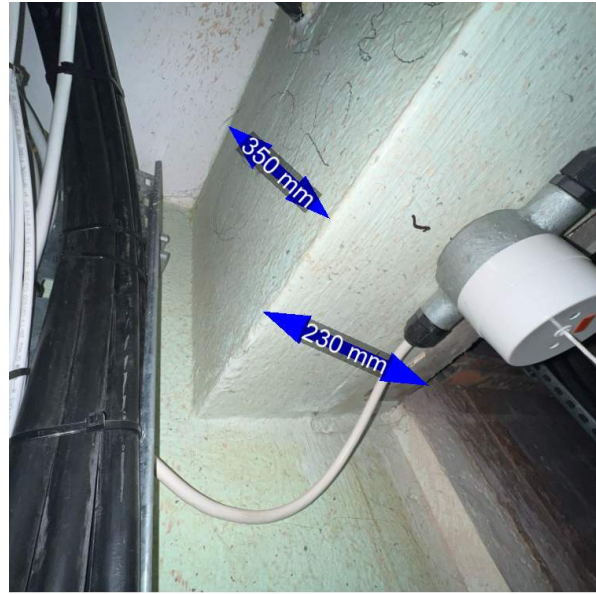
## 7th Floor Hallway

Comments: Hallway walls noted to comprise of a mixture of RC walls/columns and infill (non-load bearing) masonry walls. Concrete walls/columns noted via riser cupboards.

No jams or distortions noted to hallway doors to indicate any serviceability issues.

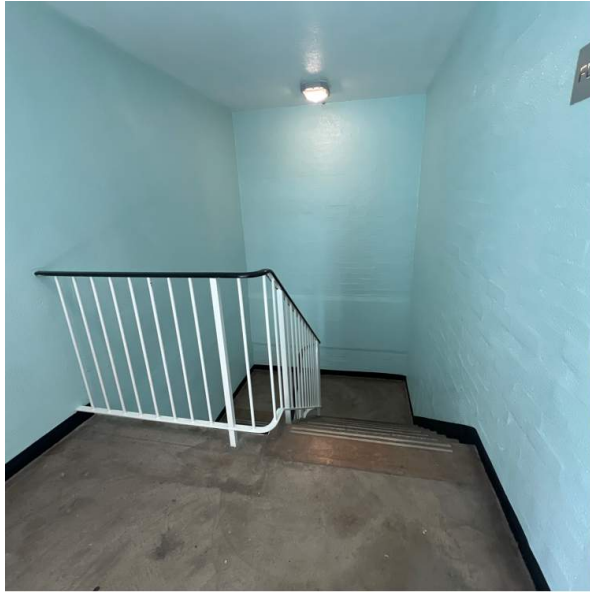
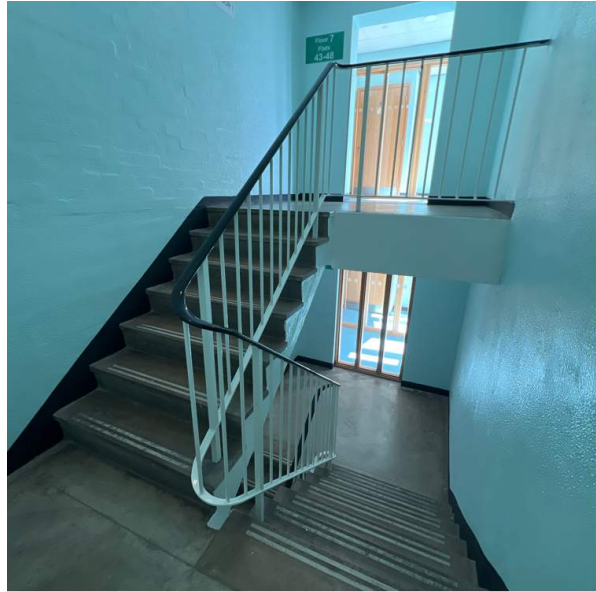
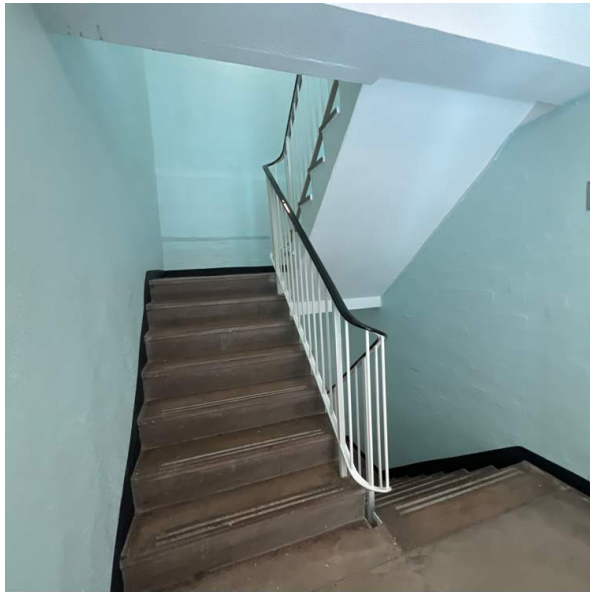
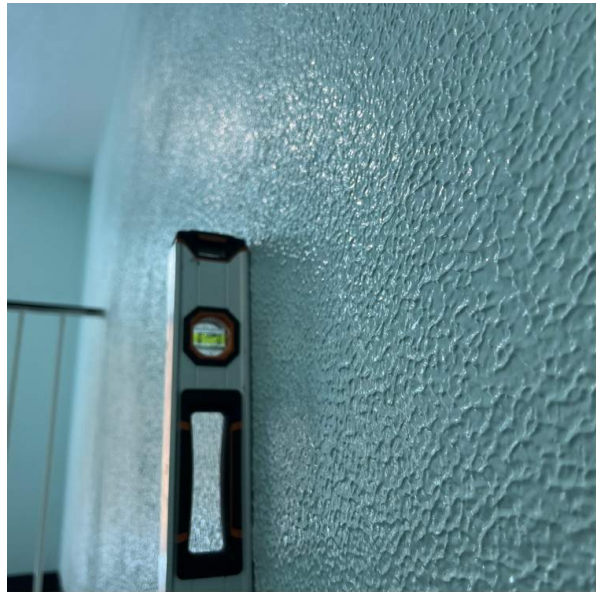
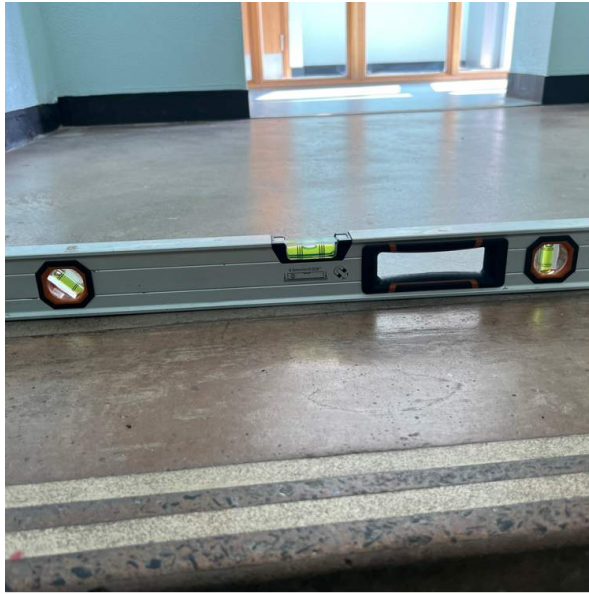
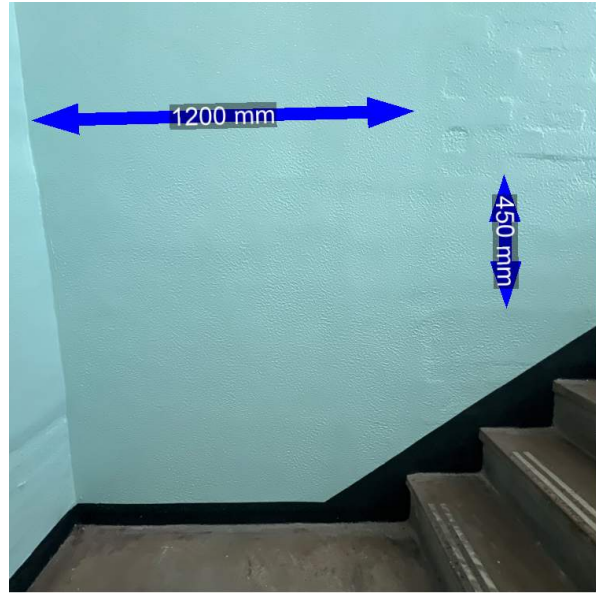
## 7th Floor Staircase

Comments: Insitu concrete stairs with steel hand railing fixed to stairs. Walls and floors appear to be fairly level.  
One side stair walls consist of a RC shear core wall. Other sides embedded with RC wall/column and beam with infill (non-load bearing) masonry.

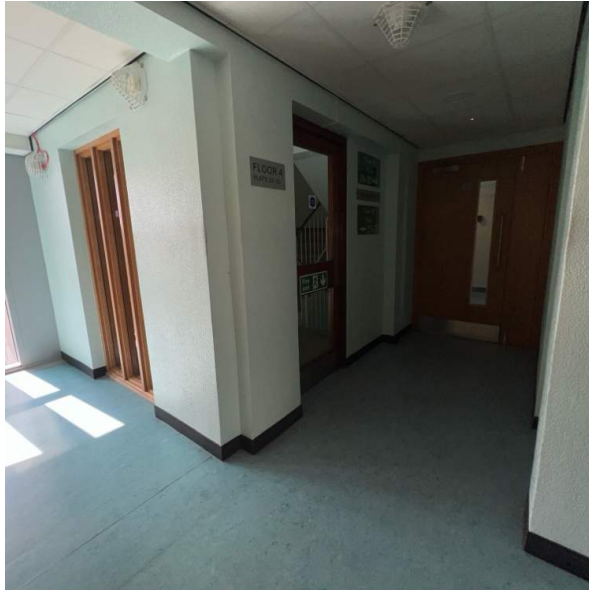
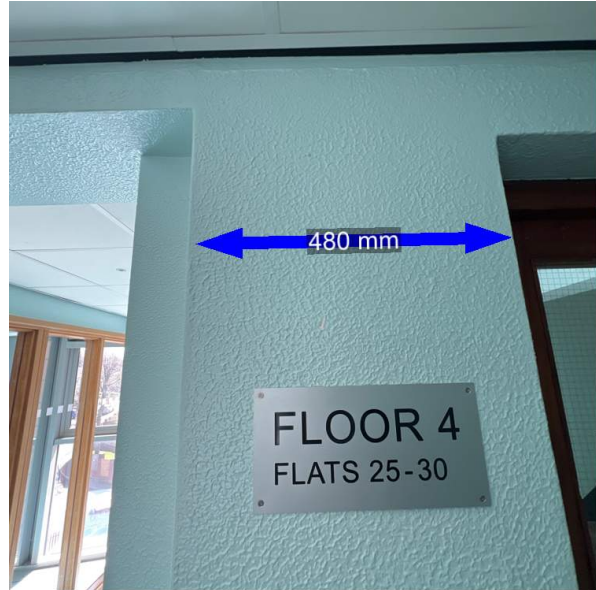
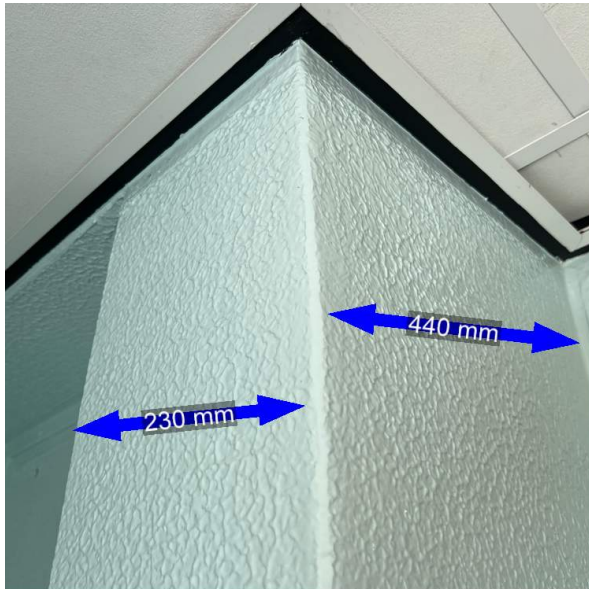
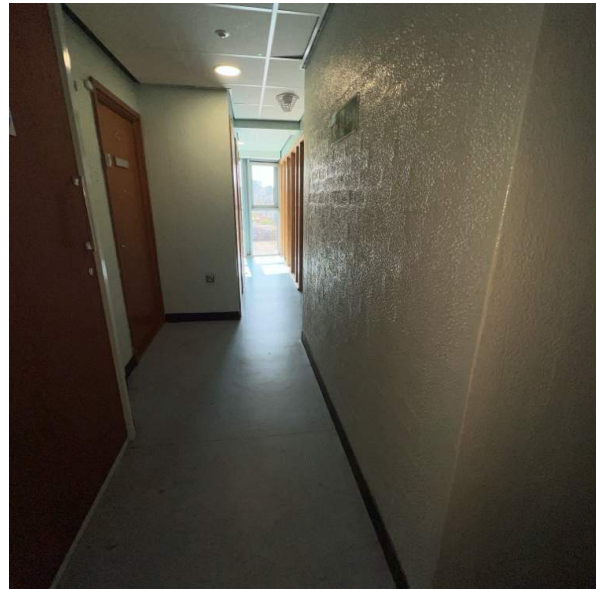
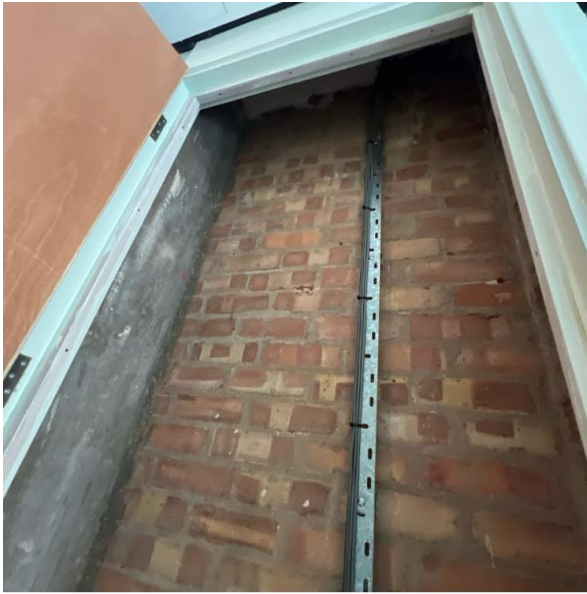
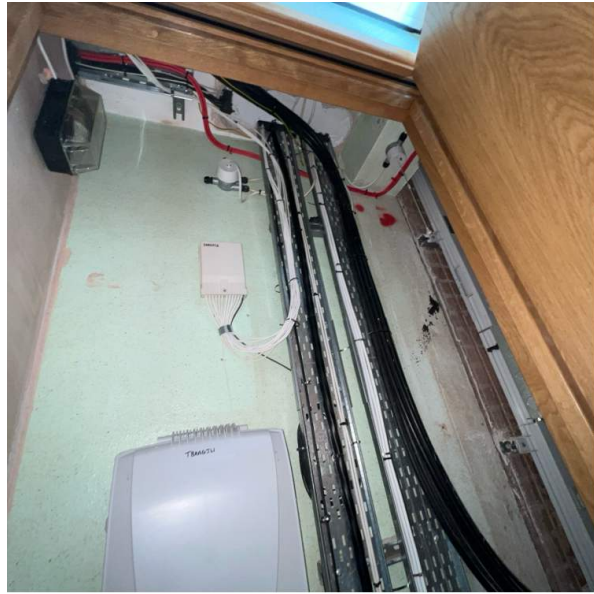
## 4th Floor Hallway

Comments: Hallway walls noted to comprise of a mixture of RC walls/columns and infill (non-load bearing) masonry walls. Concrete walls/columns noted via riser cupboards.

No jams or distortions noted to hallway doors to indicate any serviceability issues.

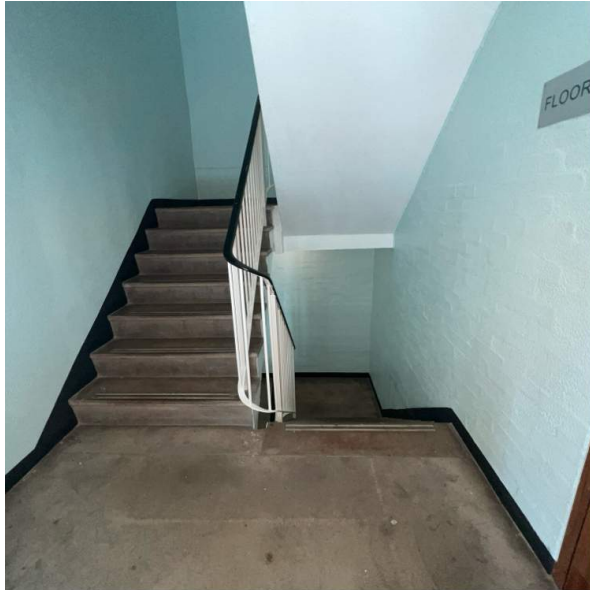
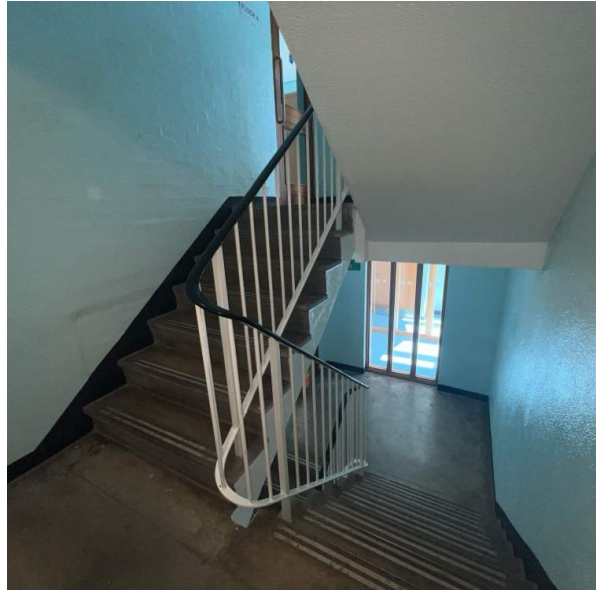
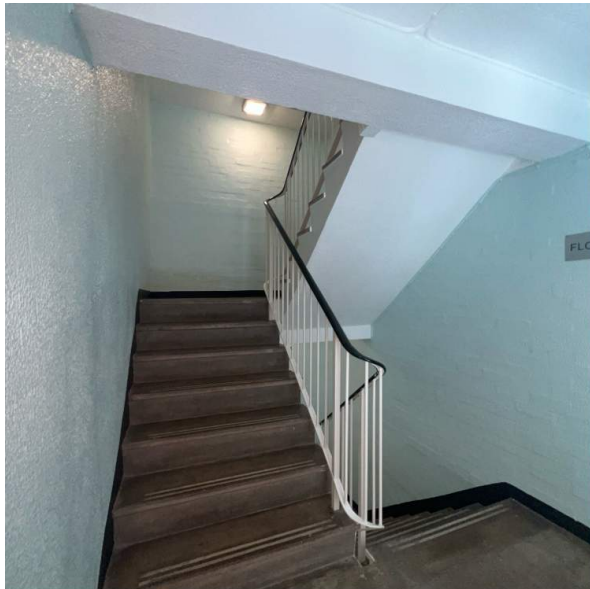
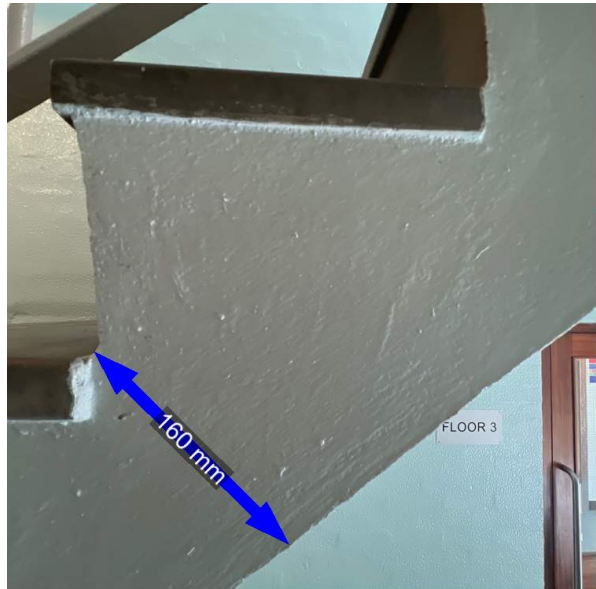
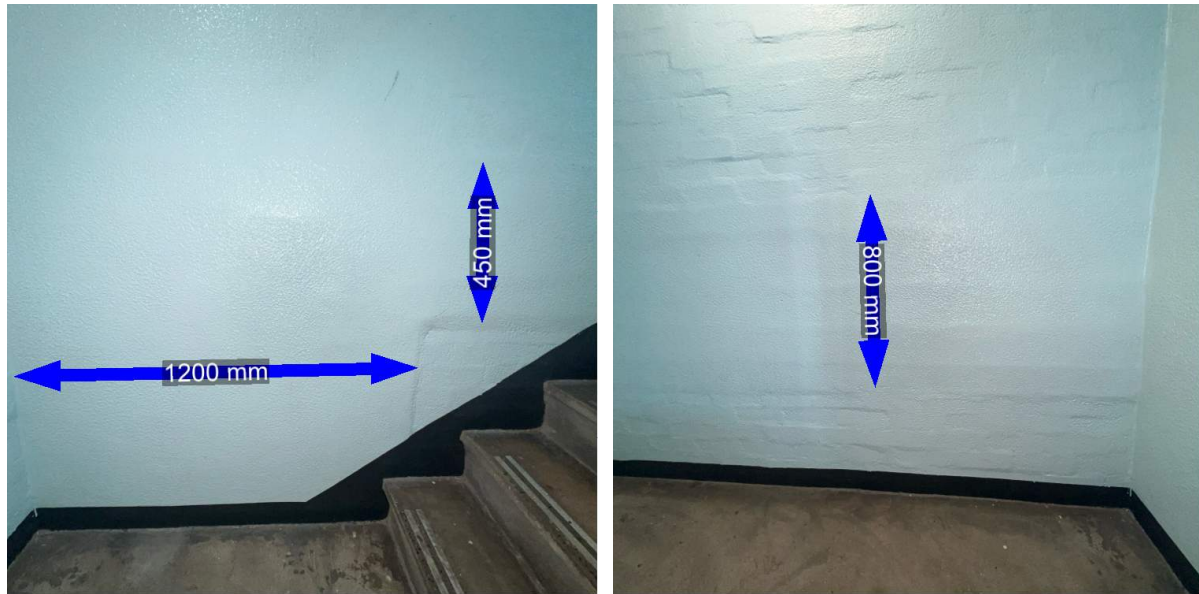
## 4th Floor Staircase

Comments: Insitu concrete stairs with steel hand railing fixed to stairs. Walls and floors appear to be fairly level.  
One side stair walls consist of a RC shear core wall. Other sides embedded with RC wall/column and beam with infill (non-load bearing) masonry.

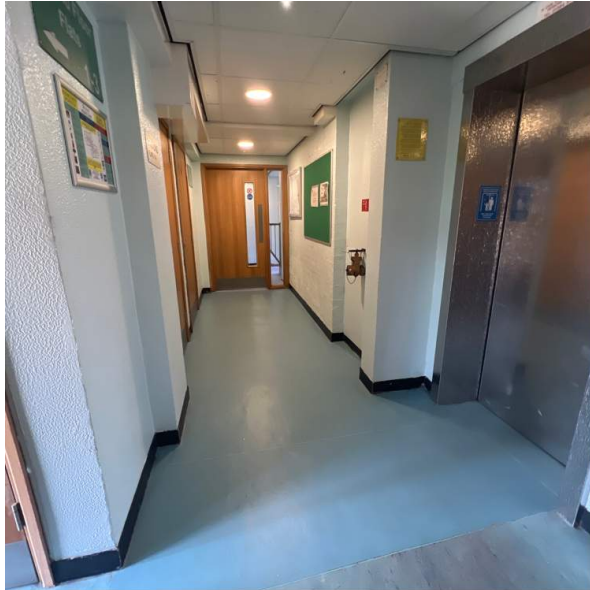
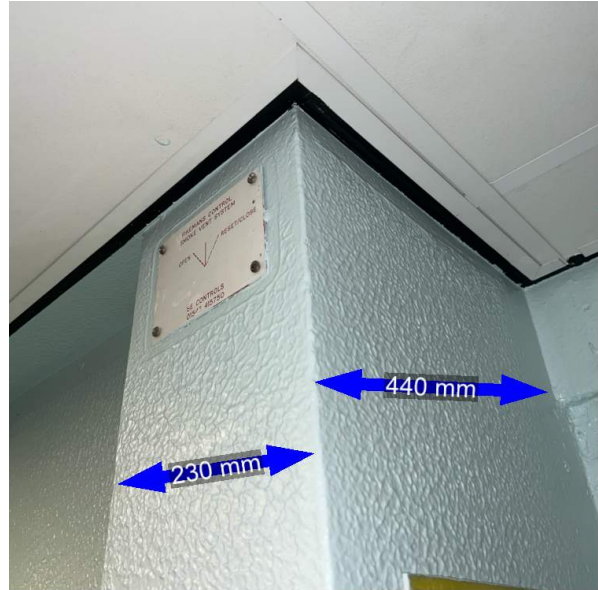
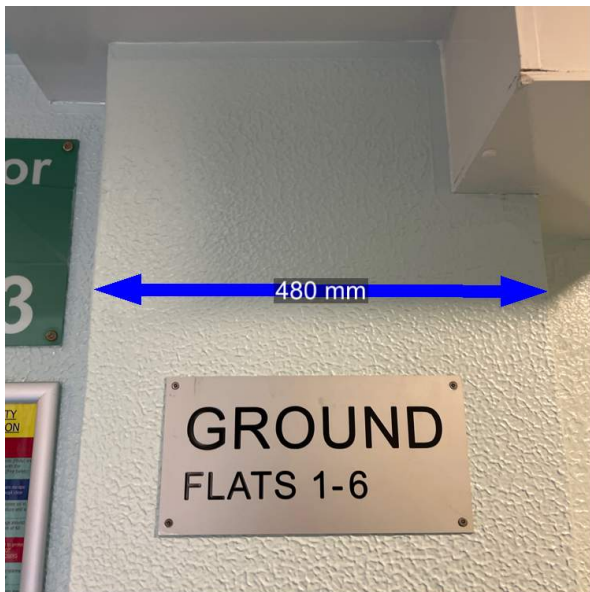
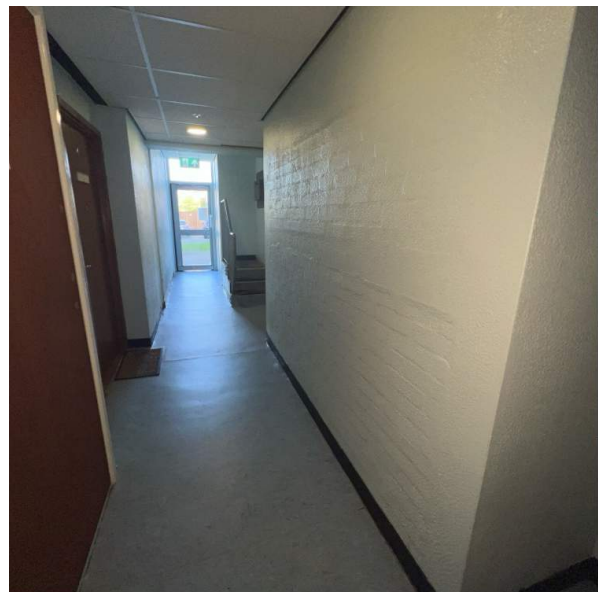
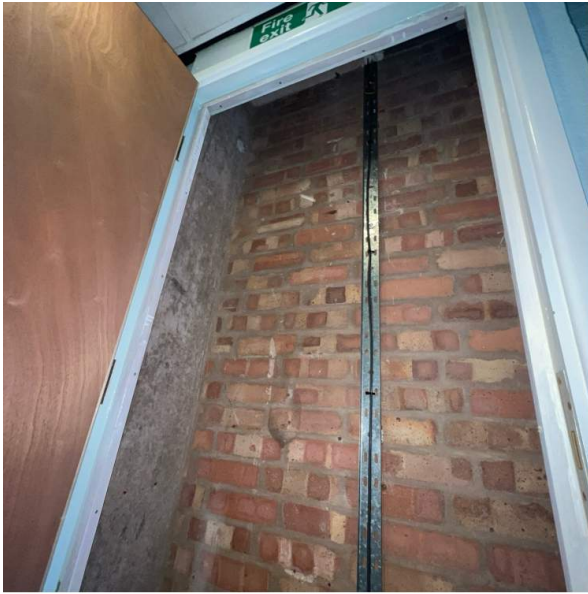
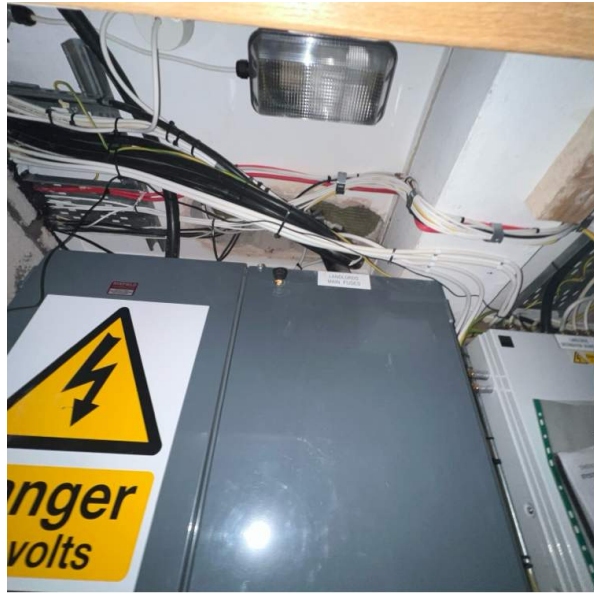
## Ground Floor Hallway

Comments: Hallway walls noted to comprise of a mixture of RC walls/columns and infill (non-load bearing) masonry walls. Concrete walls/columns noted via riser cupboards.

No jams or distortions noted to hallway doors to indicate any serviceability issues.

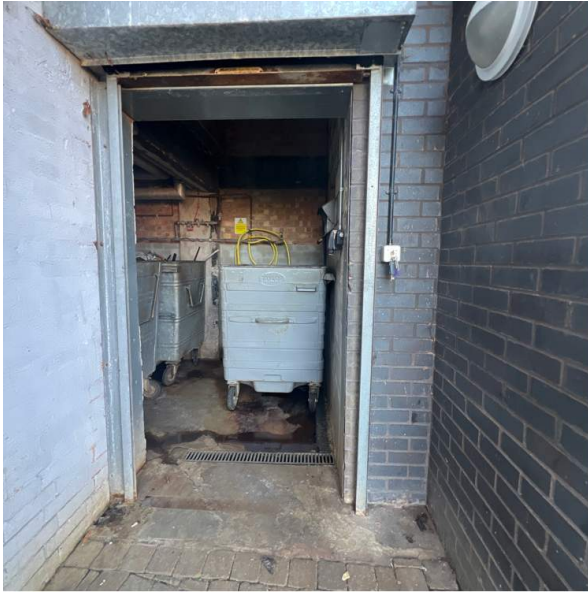
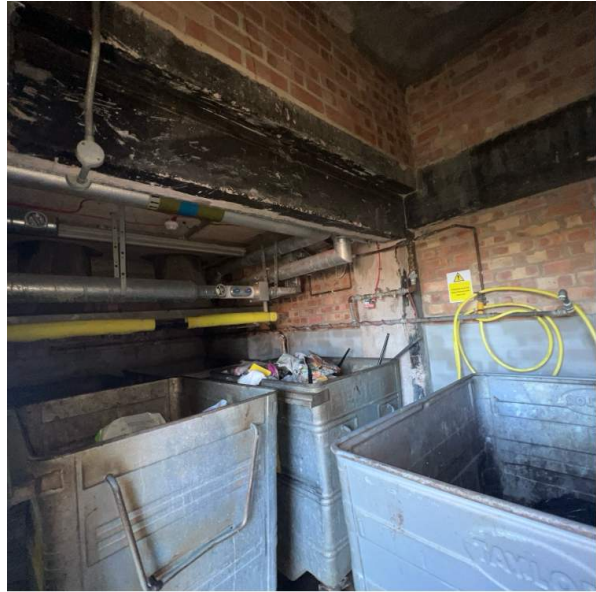
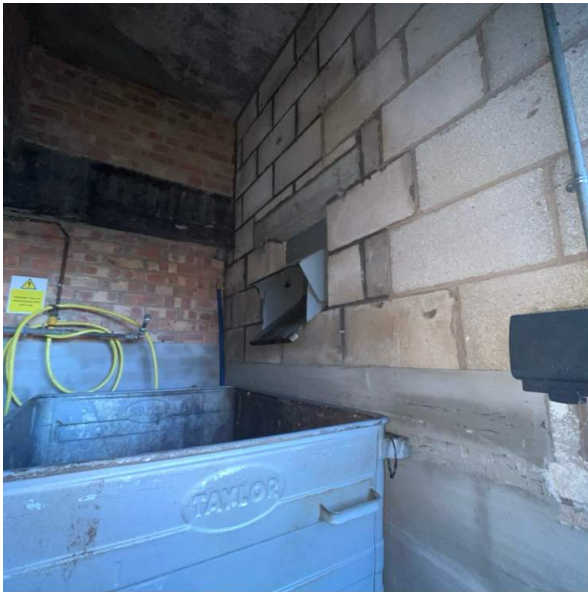
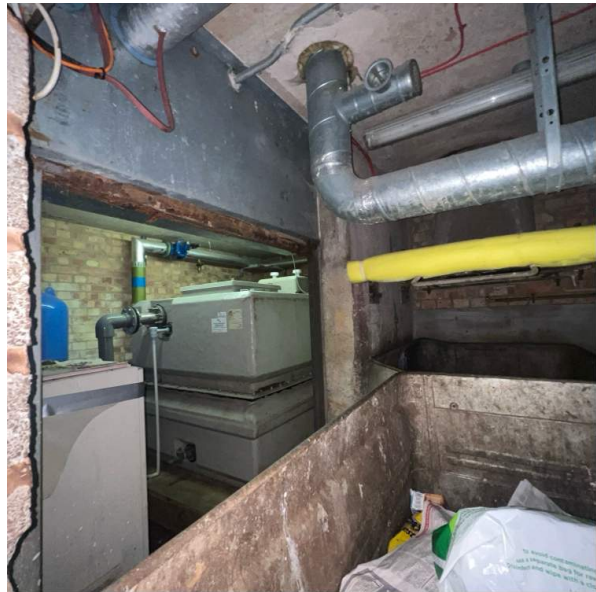
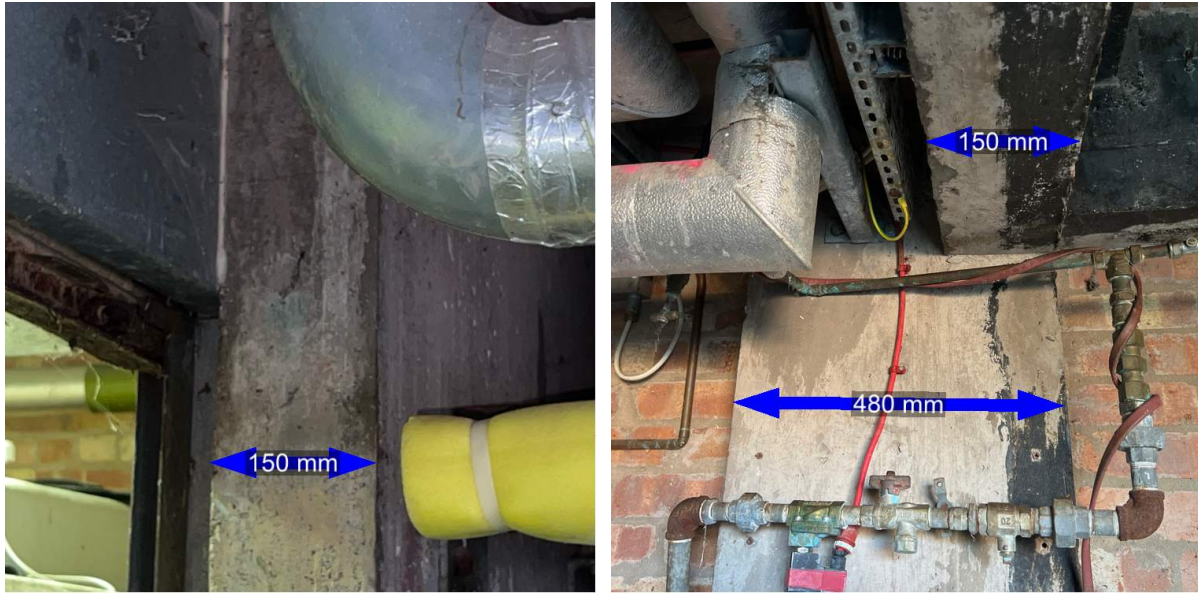
## Binstore

Comments: Mixture of RC shear walls, columns and beams with infill (non-load bearing) masonry noted in binstore.

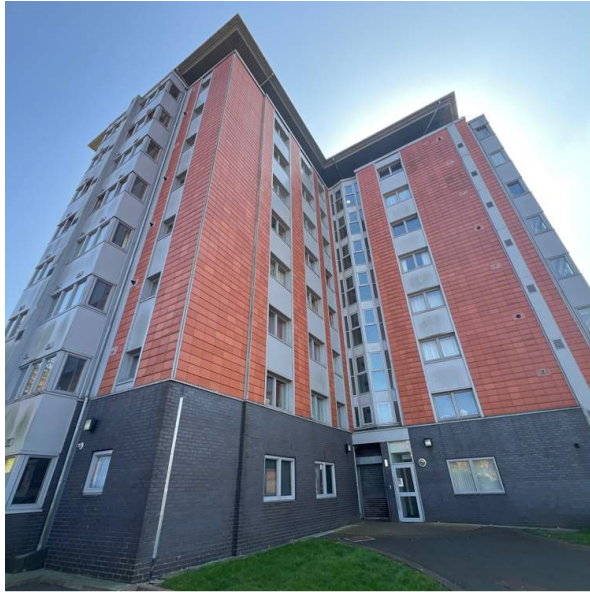
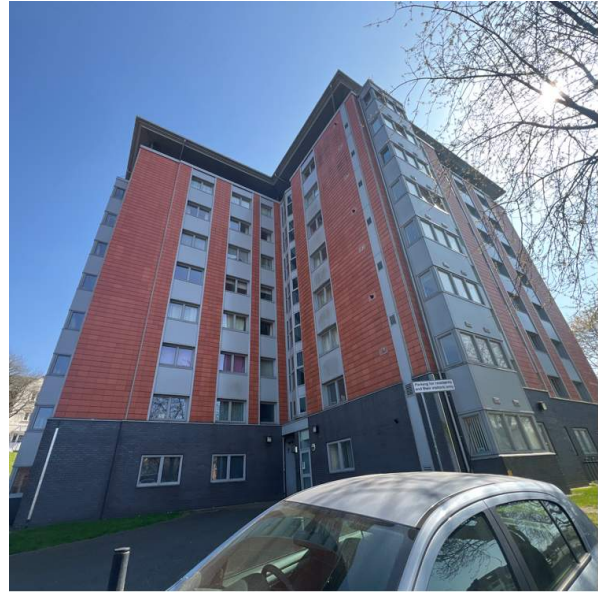
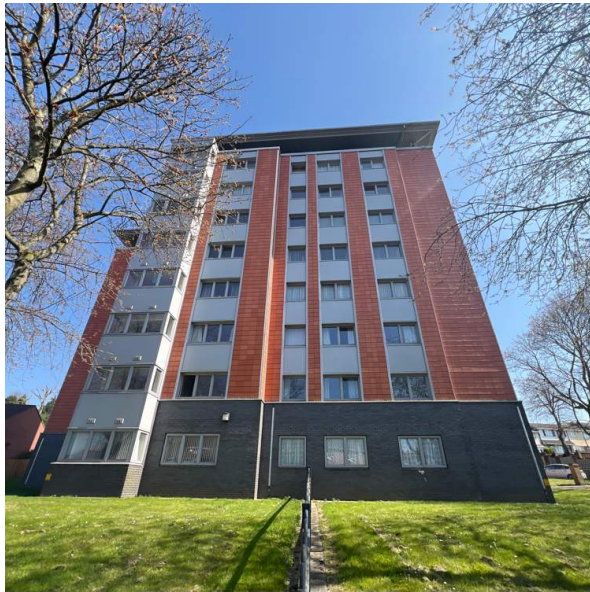
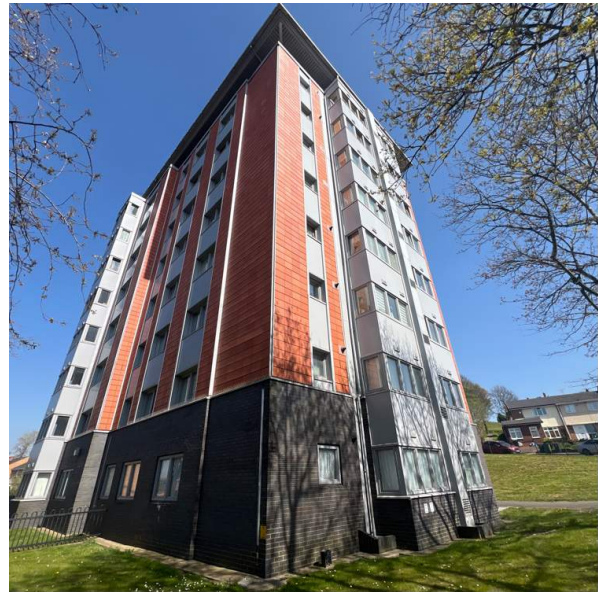
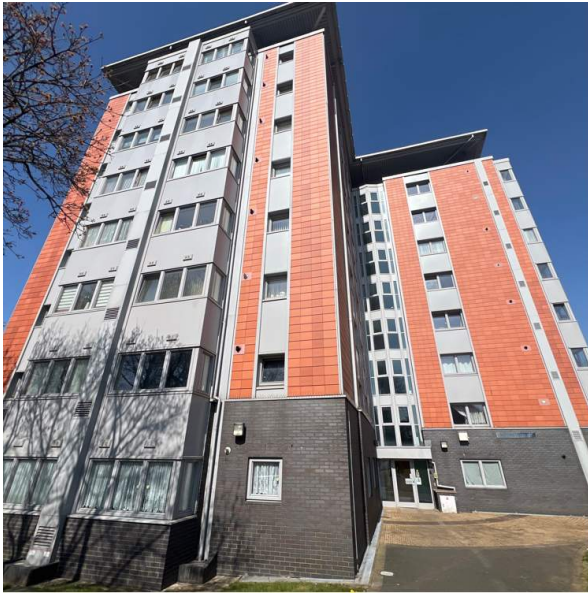
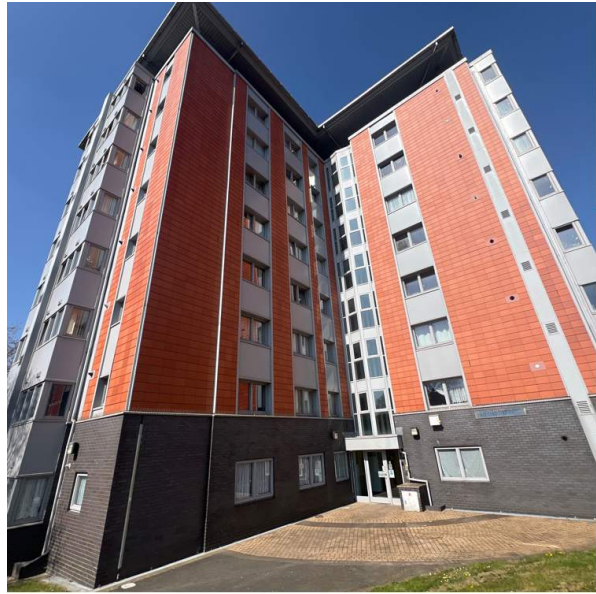
## Elevations

Ground floor level consists of brickwork. Remaining upper floors consist of cladded facade. Balconies have been encased in.
