VISUAL STRUCTURAL APPRAISAL

Beaconview House

Beaconview Road  
West Bromwich  
B71 3PL

31<sup>st</sup> January 2025

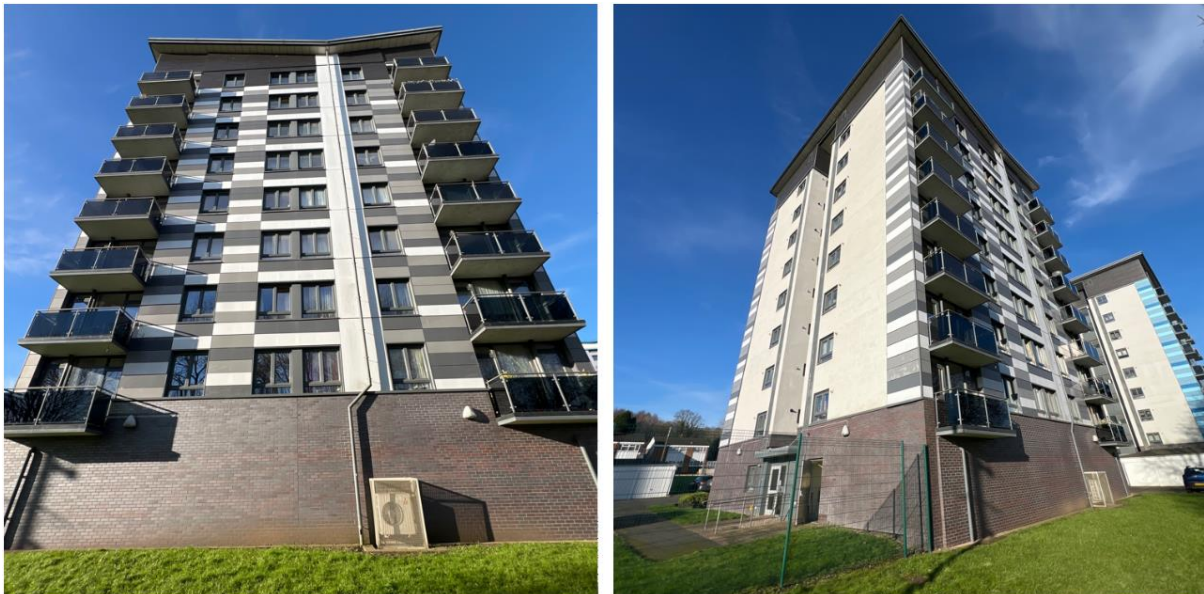
Figure 9 and 10: Building Elevations

The exterior elevations were generally in ok condition and no significant structural defects were noted to the cladding panels. There were no significant cracks or tell-tale signs of any significant structural movement noted at the time of our inspection.

The exterior panels were noted to be plumb with no signs of significant bowing, bulging or leaning noted to the panels indicating failed fixings however their presence and condition cannot be confirmed.

There are balconies at each level which are formed of cantilevered RC slabs tied into the main frame. During the 2015 refurbishment they had steel balustrades with glazed infill installed.

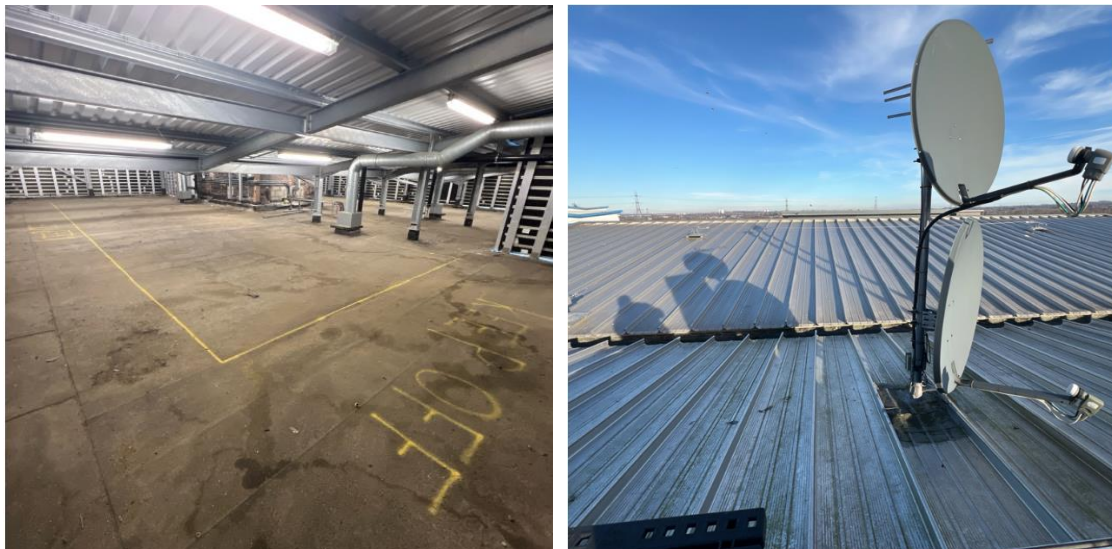
Figure 11 and 12: Roof Level

There were no tell-tale signs of any significant structural movement noted at the time of our inspection. The exterior walls were noted to be plumb with no signs of significant bowing, bulging or leaning noted to the masonry walls.

The roof has subsequently been covered with a new waterproofing covering formed of a steel frame installed to the existing roof which supports pitched corrugated sheets. This roof is not insulated and therefore acts purely as a weather barrier. The fire protection of the steel is unclear as the beams do not appear to be unprotected. Details of this frame should be requested from the contractor who completed the works in 2015. No signs of water ingress of that the roof is not performing as intended.

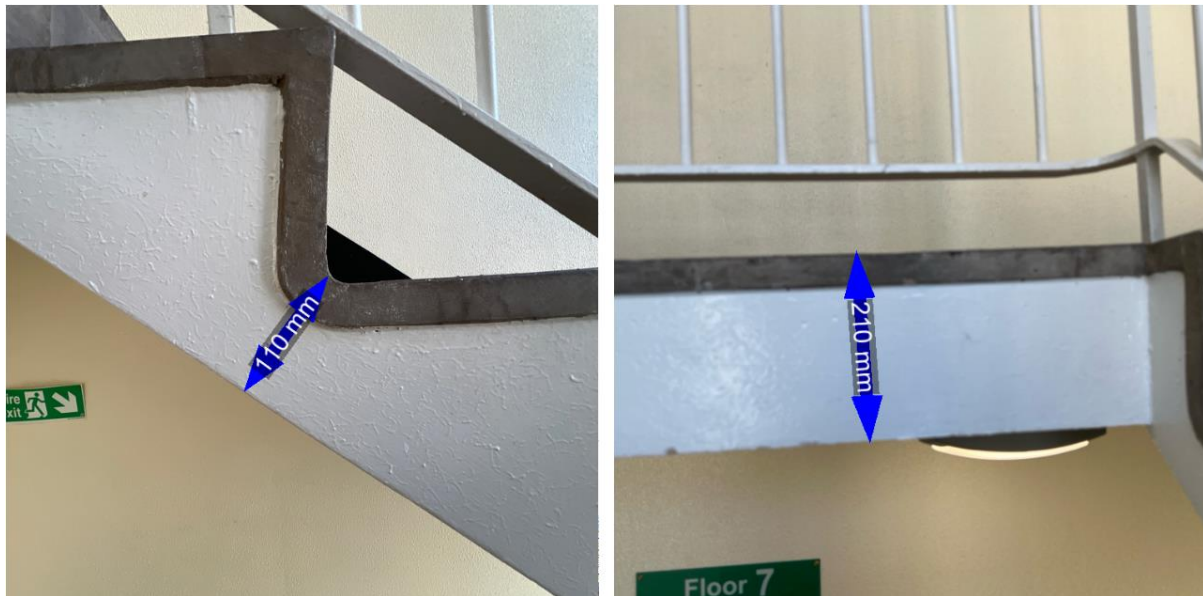
Figure 13 and 14: Stair stringer and concrete slab

concrete appeared in fair condition with few BRE category 1 cracks but no structurally significant defects were noted.

The stair stringer was noted to be 110mm thick which seems slim, certainly short of modern standards. A cover test is required to check the resistance of the concrete section in the event of a fire.

Due to the age of the building it is wise to perform periodical health checks to the concrete elements. This should include tests for concrete strength, cover depth, carbonation, chlorides and HAC. It would appear that these tests have never been performed to this building and therefore we recommend engaging a specialist contractor within the next 24 months who will be able to perform the tests and provide a interpretive report. The fire resistance of the structure is not confirmed until the cover meter tests are completed.

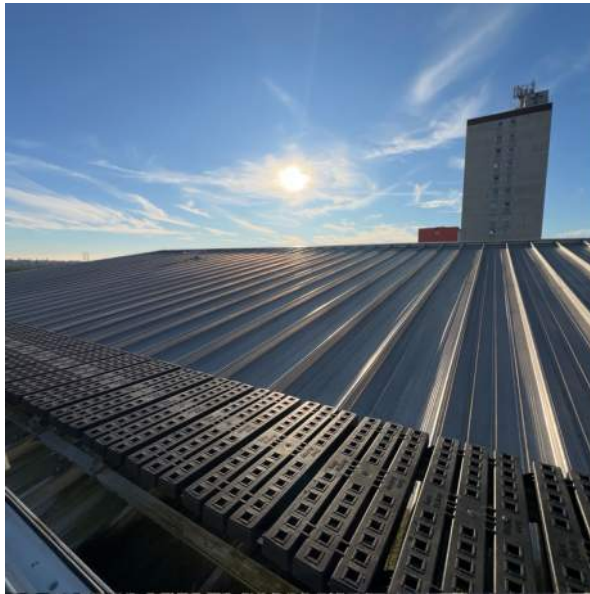
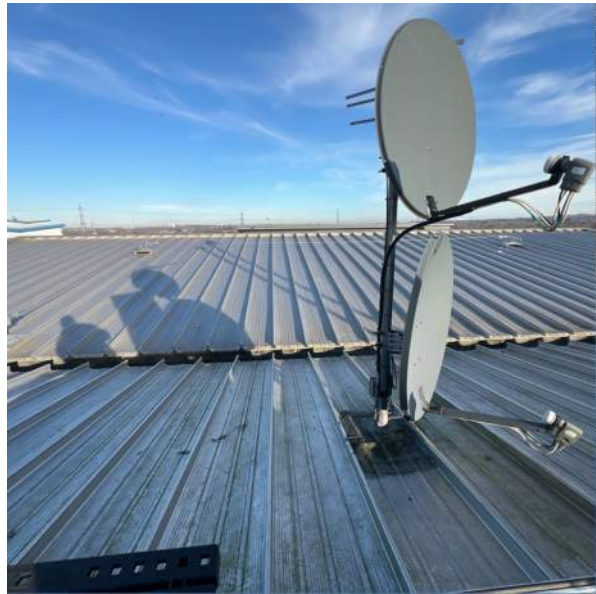
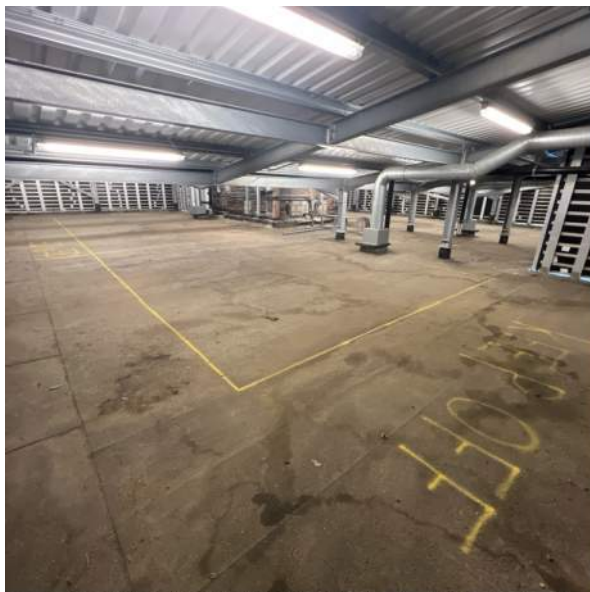
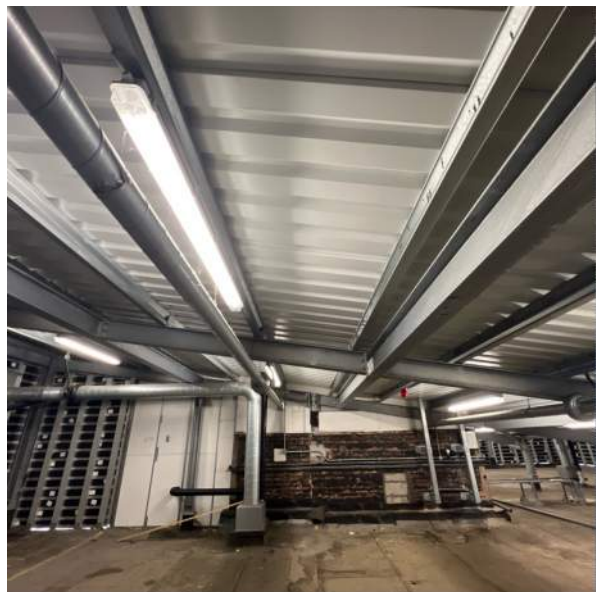
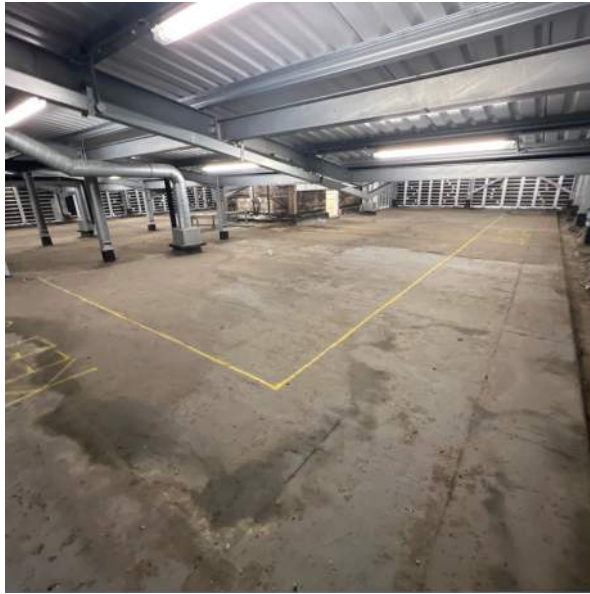
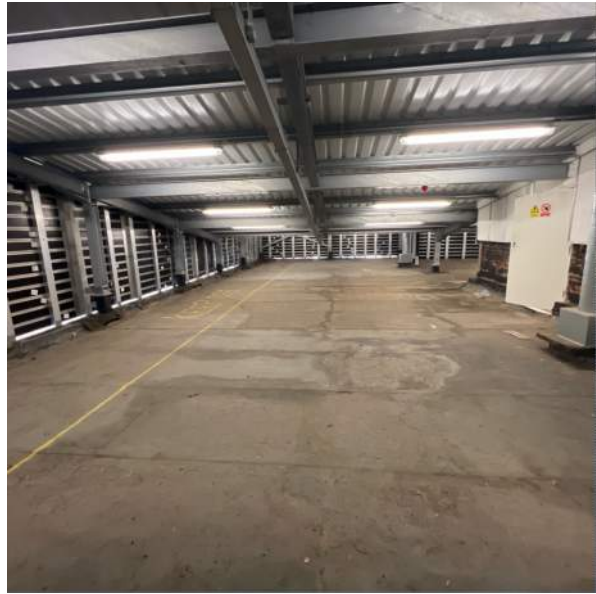
## Main Roof

Comments: A pitched roof constructed above existing original flat roof slab. Steel frame supporting purlins with aluminium standing / mineral wool core profiled panels.  
160mm thick RC core walls noted in motor room.

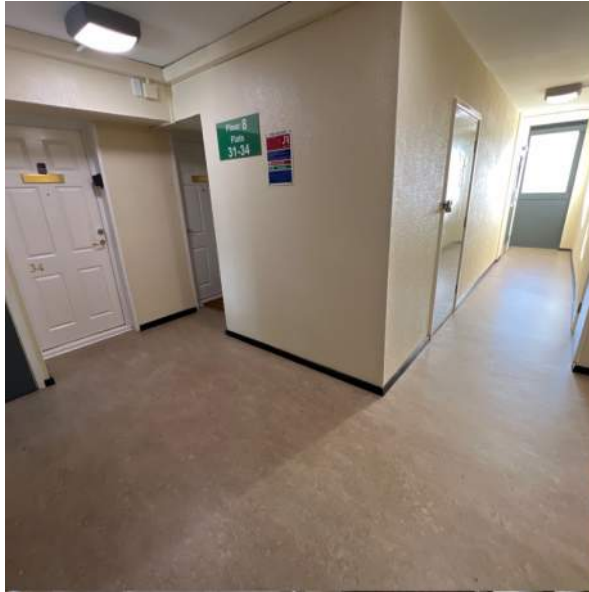
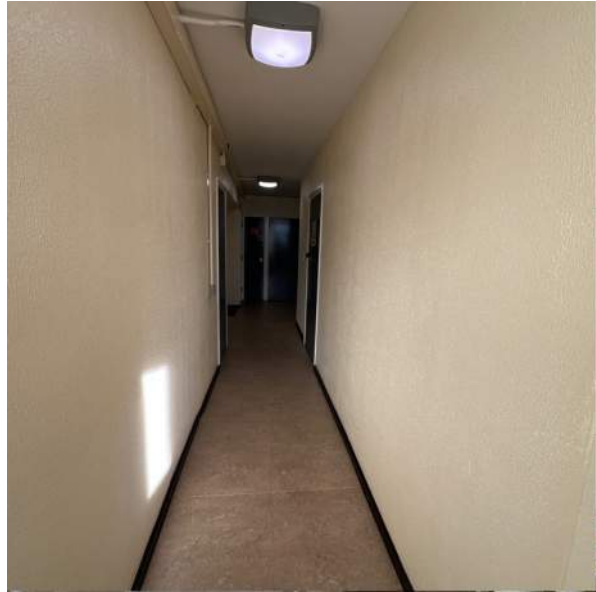
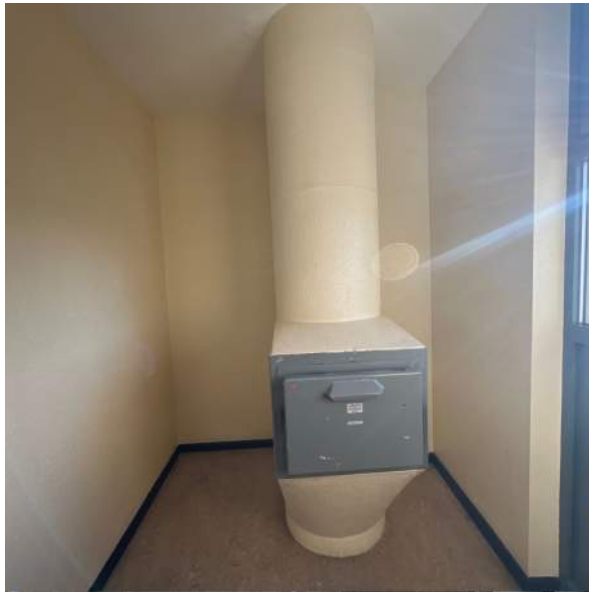
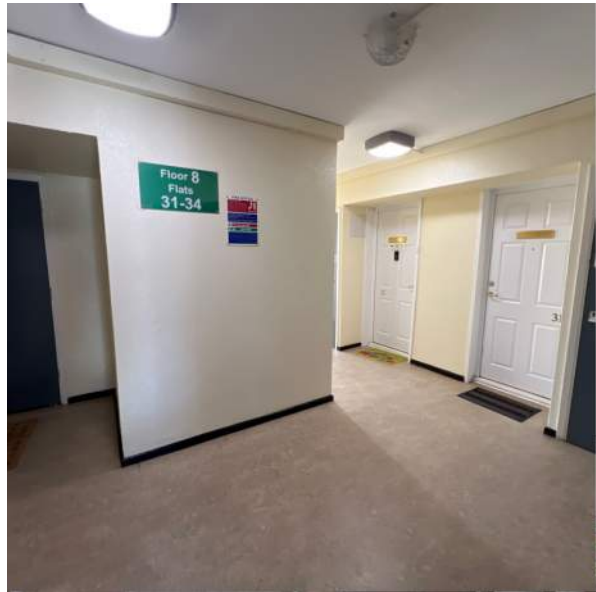
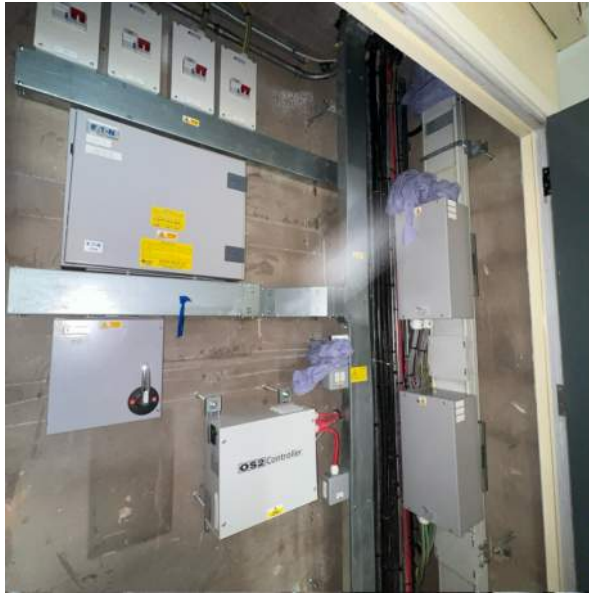
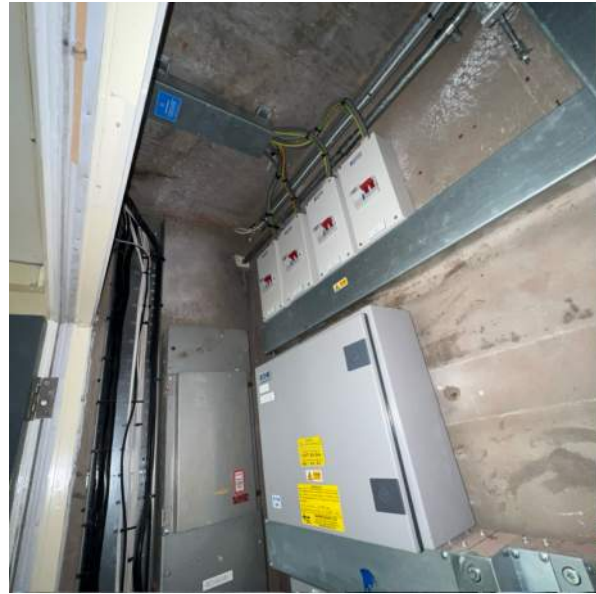
## 8th Floor Hallway

Comments: No jams or distortions noted to hallway doors to indicate any serviceability issues. Generally walls covered with finishes in hallway, likely to consist a mixture of concrete shear walls, embedded columns and masonry infill walls. Limited structure exposed. Concrete walls noted via riser cupboards.

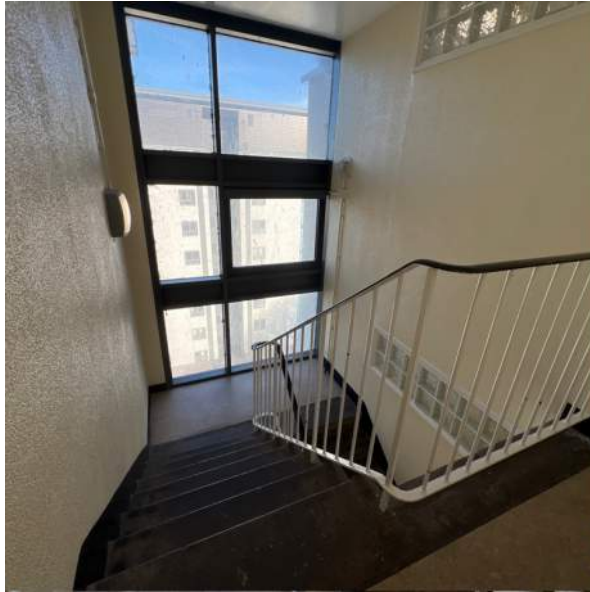
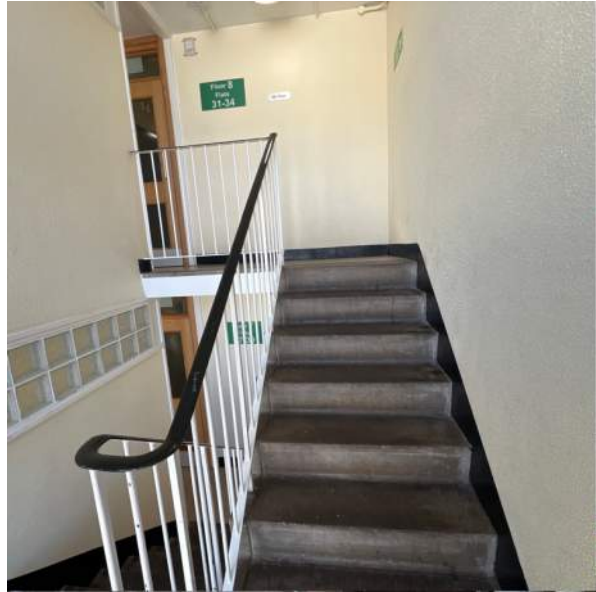
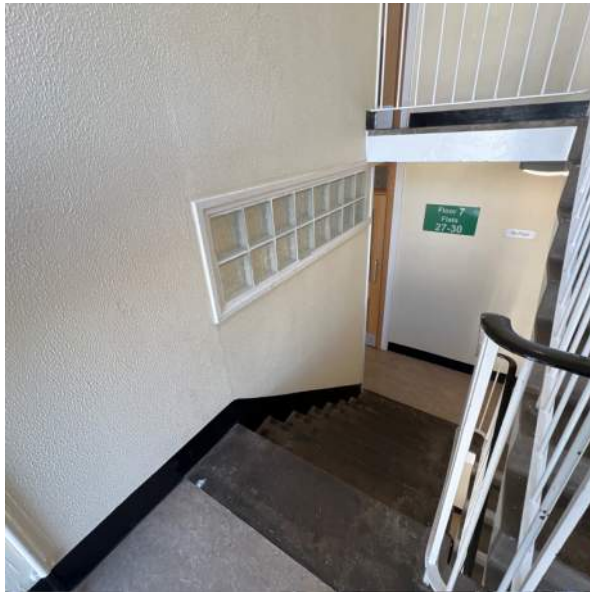
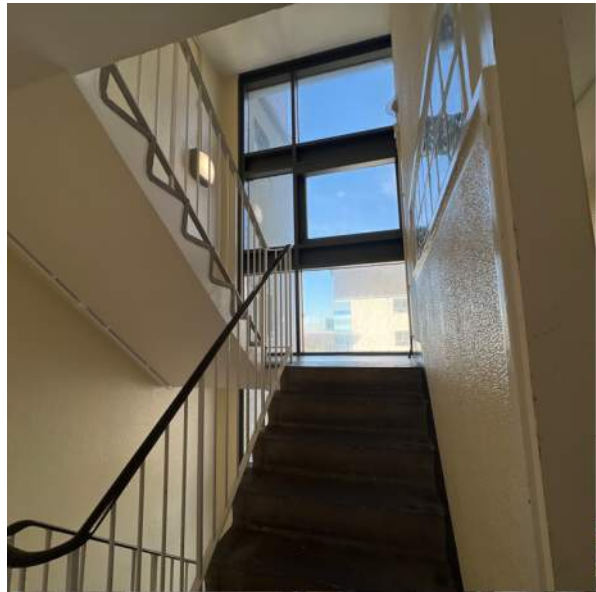
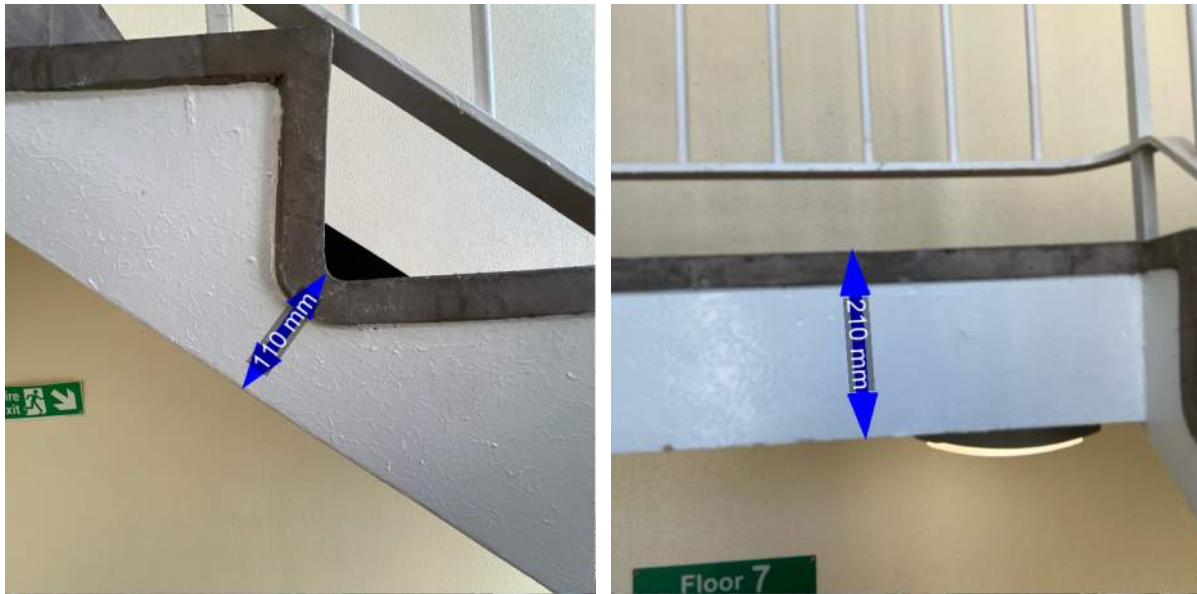
## 8th Floor Staircases

Comments: Insitu concrete stairs with steel hand railing fixed to stairs. Walls and floors appear to be fairly level.  
Stair walls covered with finishes however these would likely form the main concrete shear core walls. Partly infill/non-load bearing wall noted for one side of stair case wall.

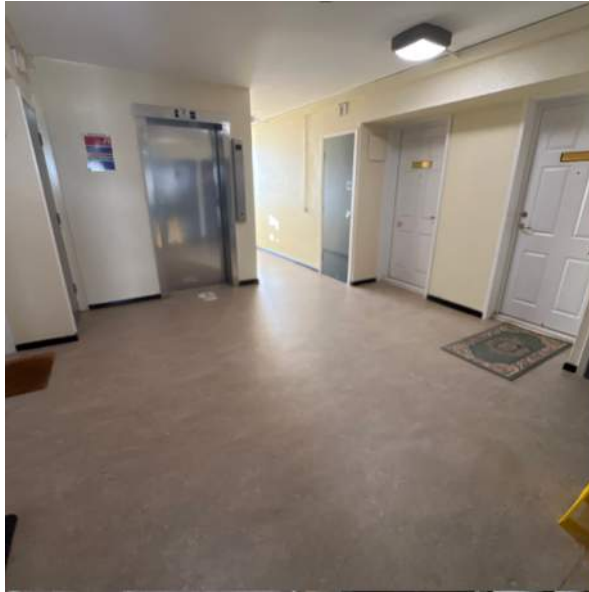
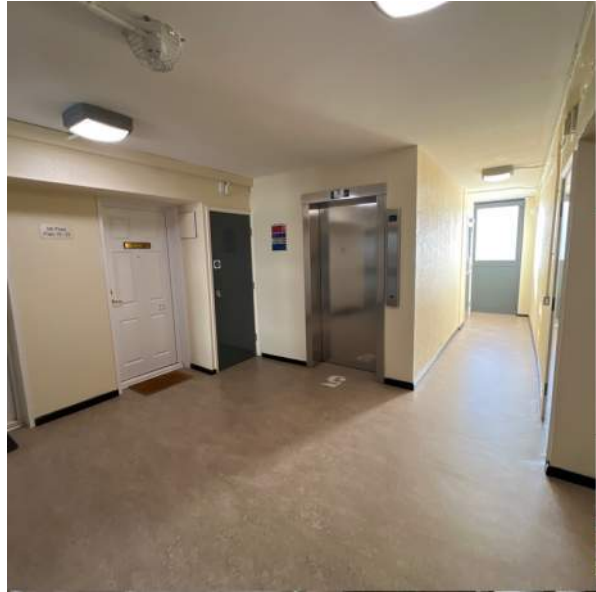
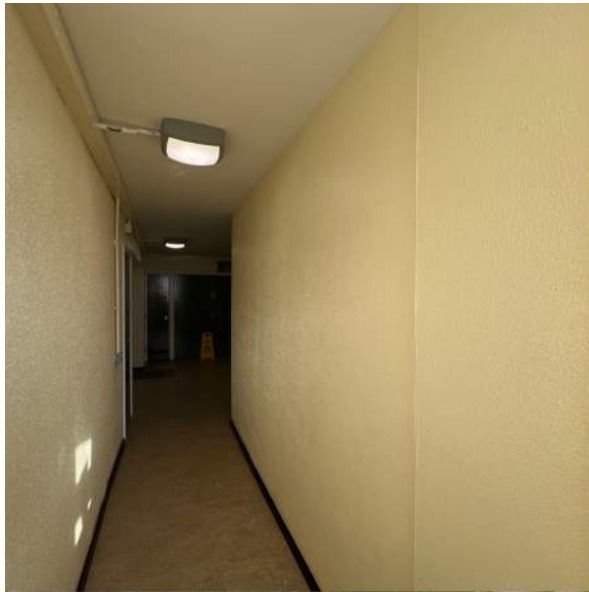
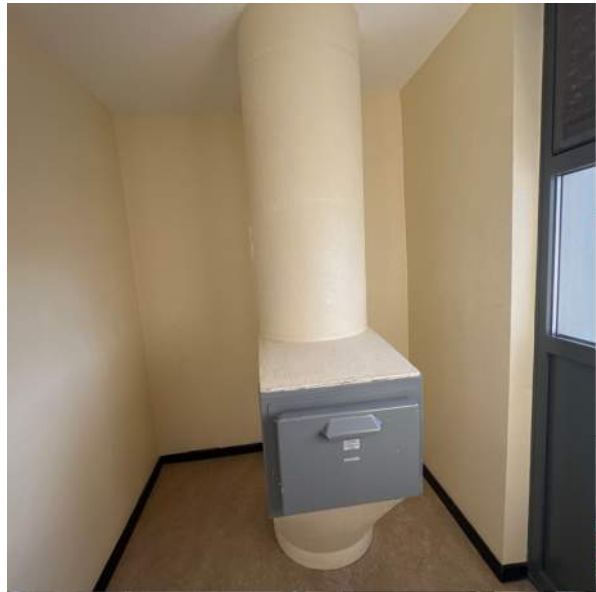
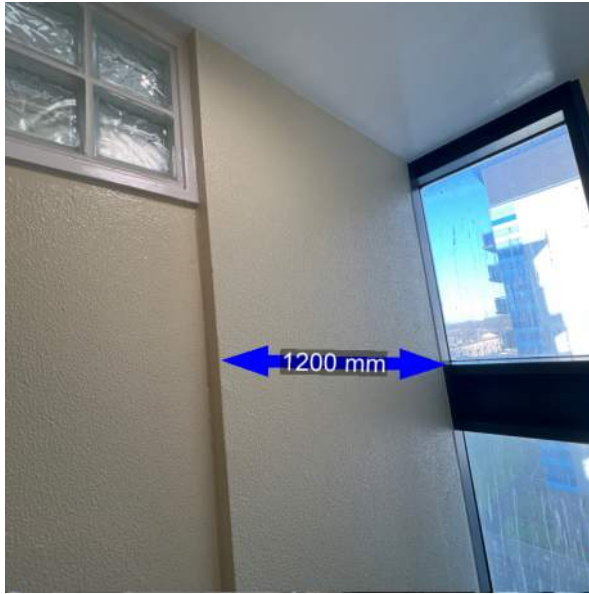
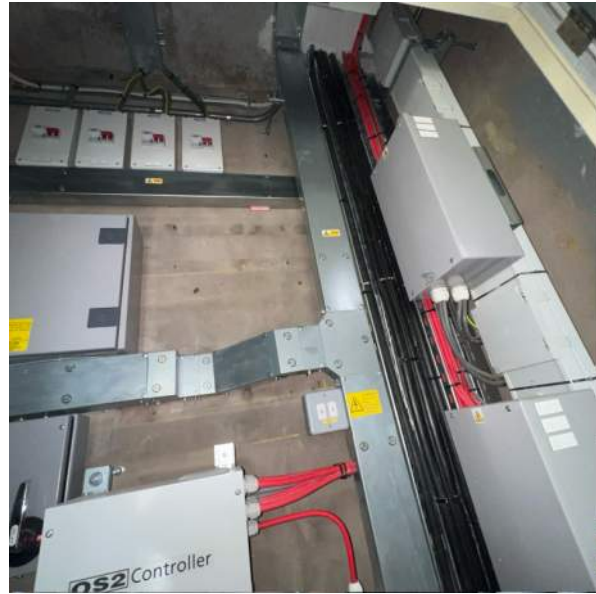
## 5th Floor Hallway

Comments: No jams or distortions noted to hallway doors to indicate any serviceability issues. Generally walls covered with finishes in hallway, likely to consist a mixture of concrete shear walls, embedded columns and masonry infill walls. Limited structure exposed. Concrete walls noted via riser cupboards.

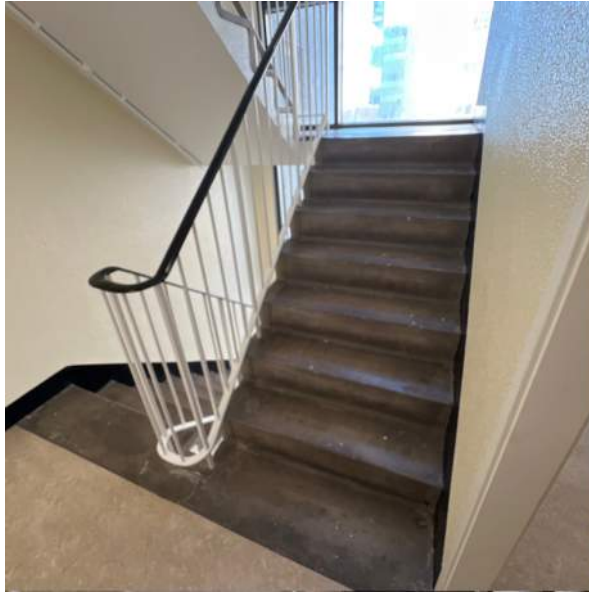
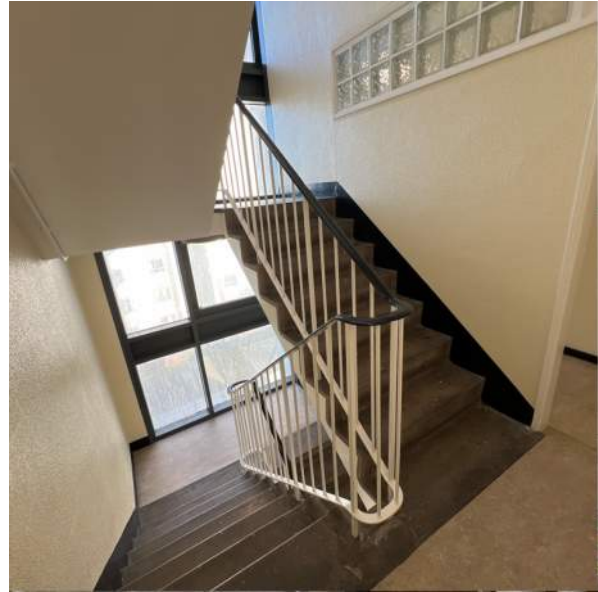
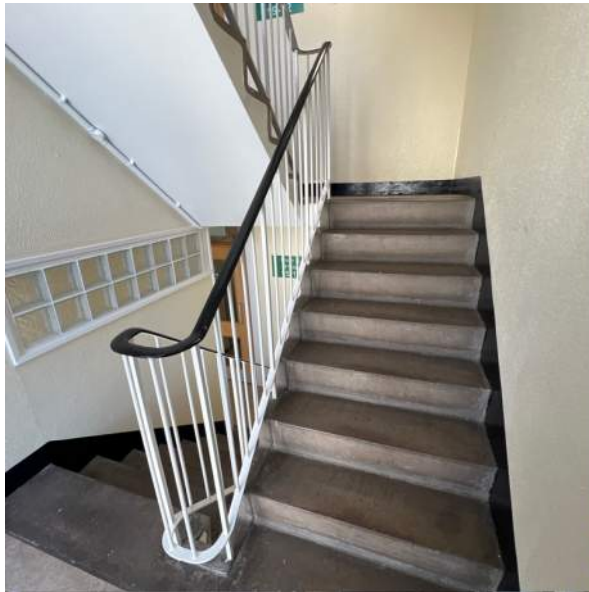
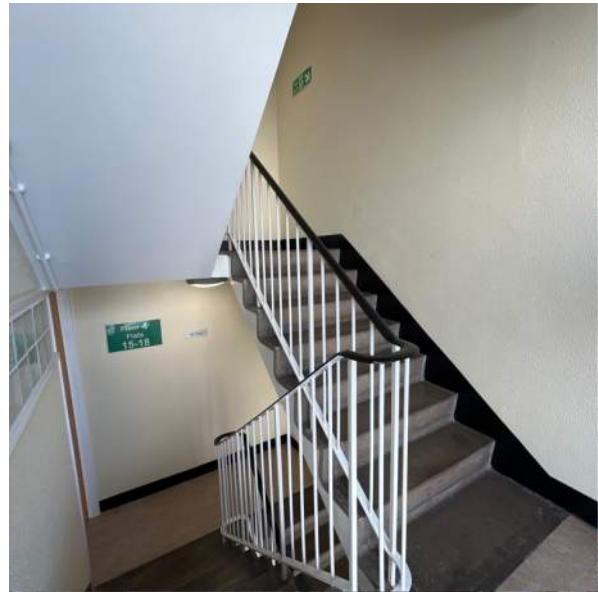
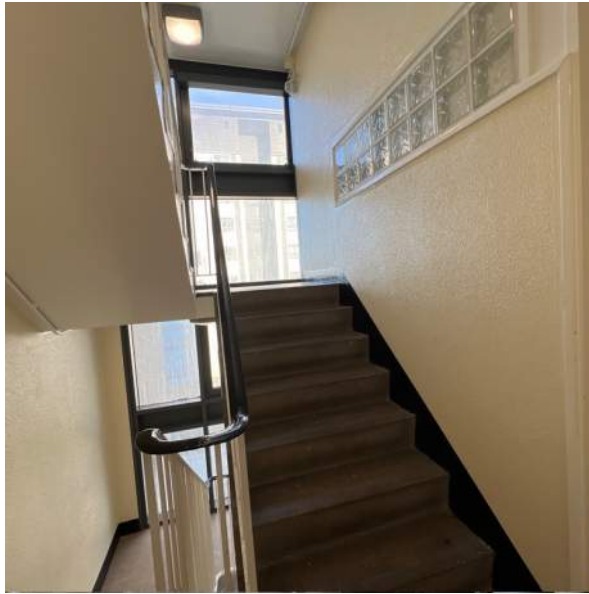
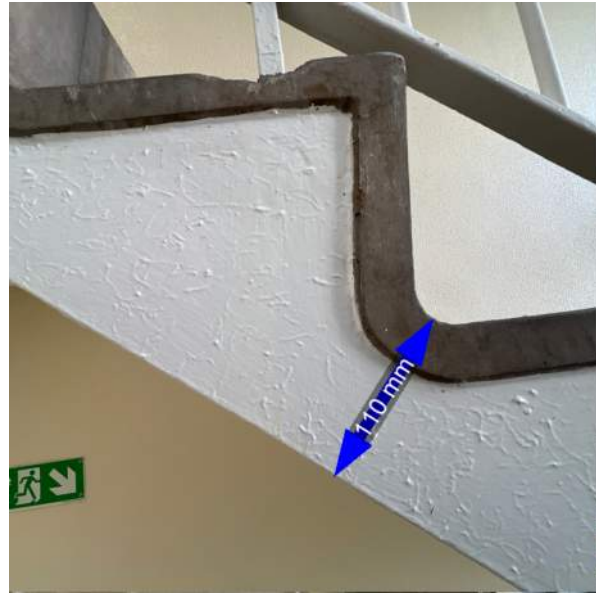
## 5th Floor Staircases

Comments: Insitu concrete stairs with steel hand railing fixed to stairs. Walls and floors appear to be fairly level.  
Stair walls covered with finishes however these would likely form the main concrete shear core walls. Partly infill/non-load bearing wall noted for one side of stair case wall.

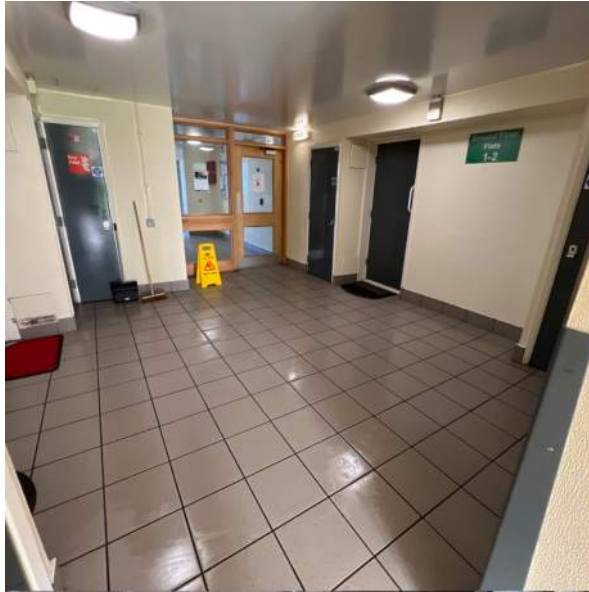
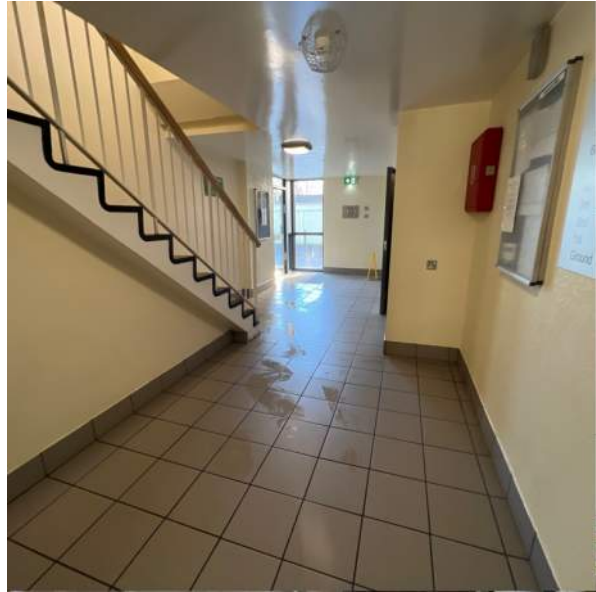
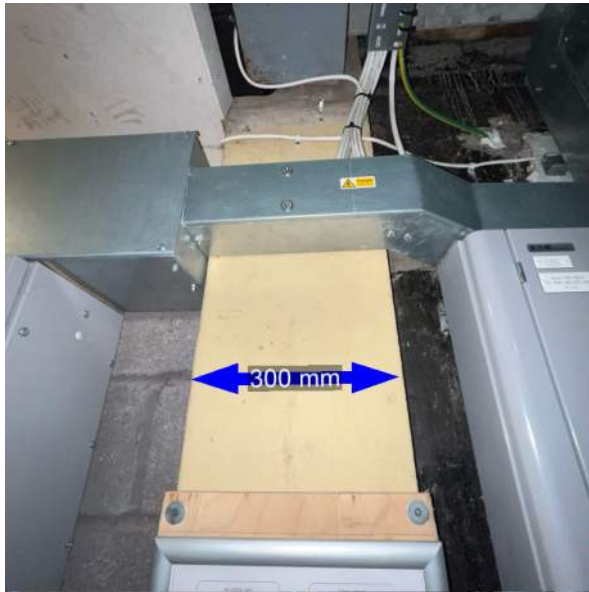
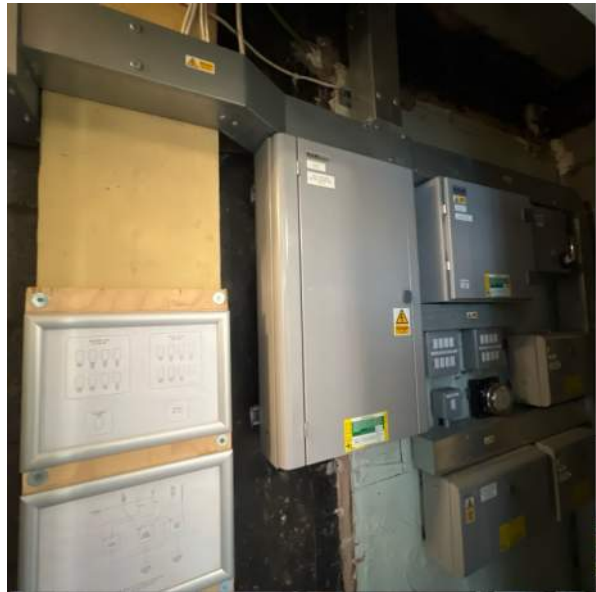
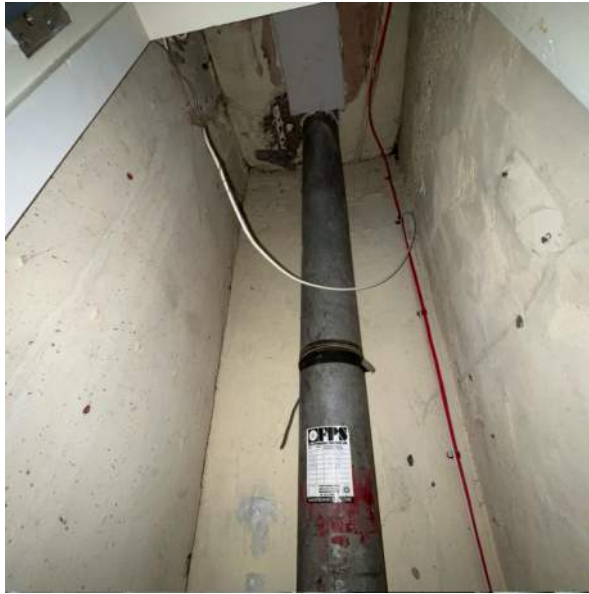
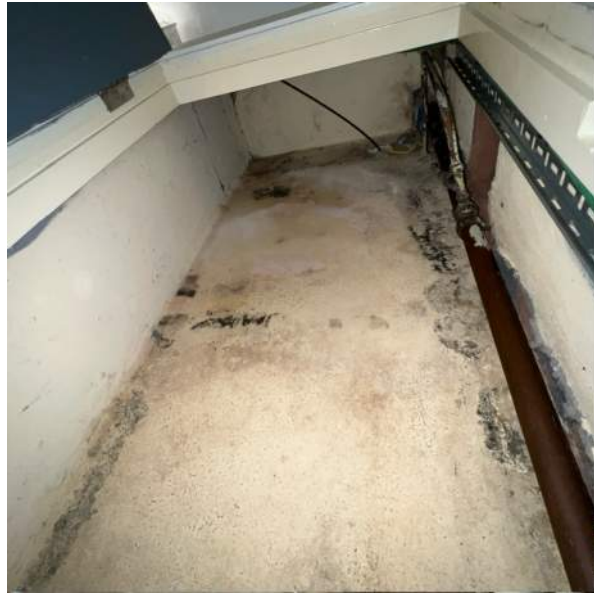
## Ground Floor Hallway

Comments: No jams or distortions noted to hallway doors to indicate any serviceability issues. Generally walls covered with finishes in hallway, likely to consist a mixture of concrete shear walls, embedded columns and block infill walls. Limited structure exposed. Partly visible concrete walls noted via electrical riser cupboards. RC Columns noted in security room.

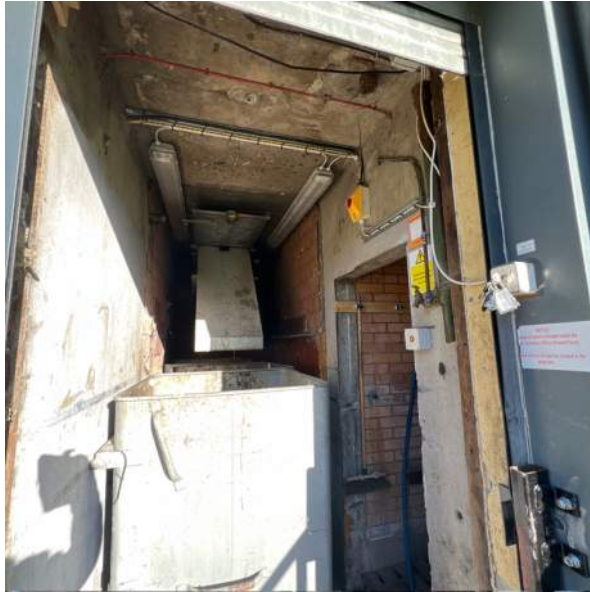
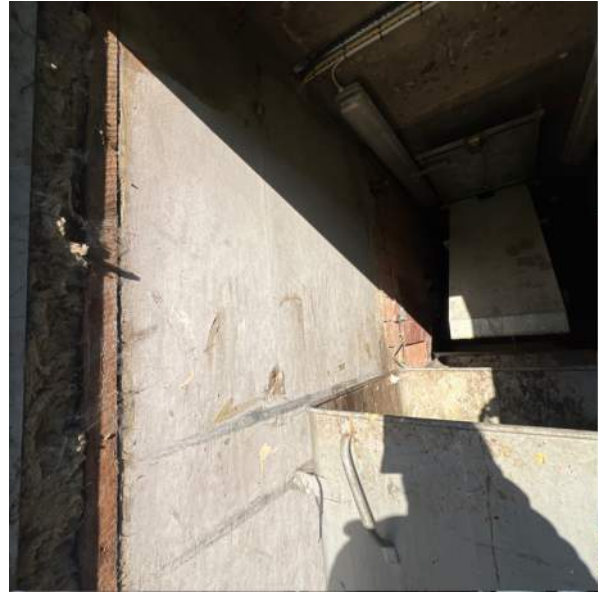
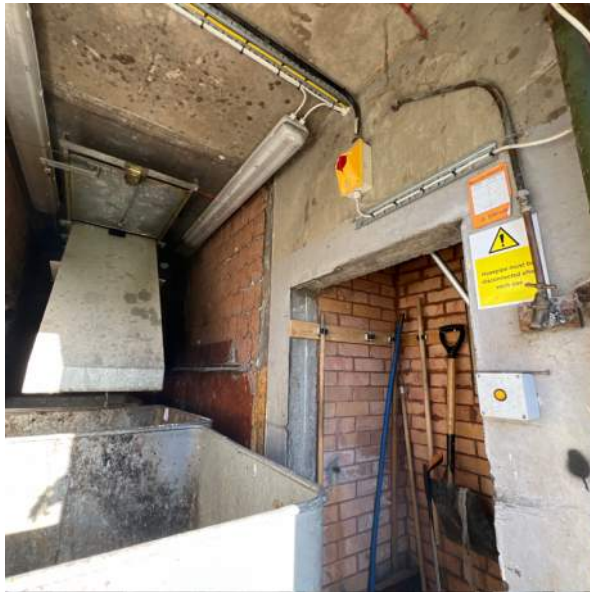
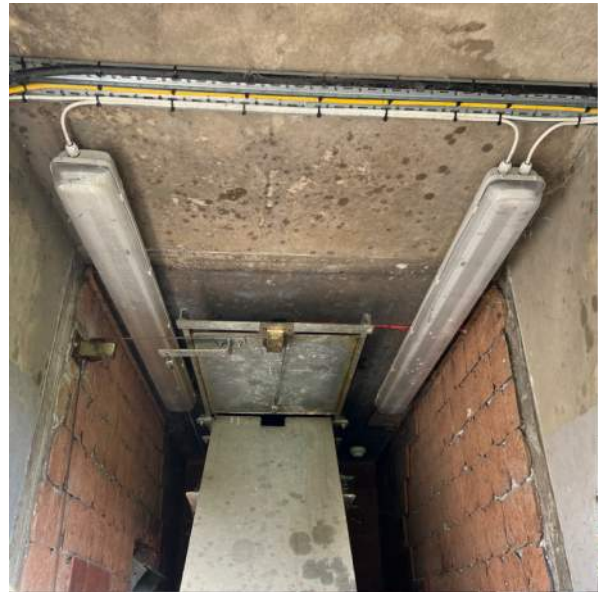
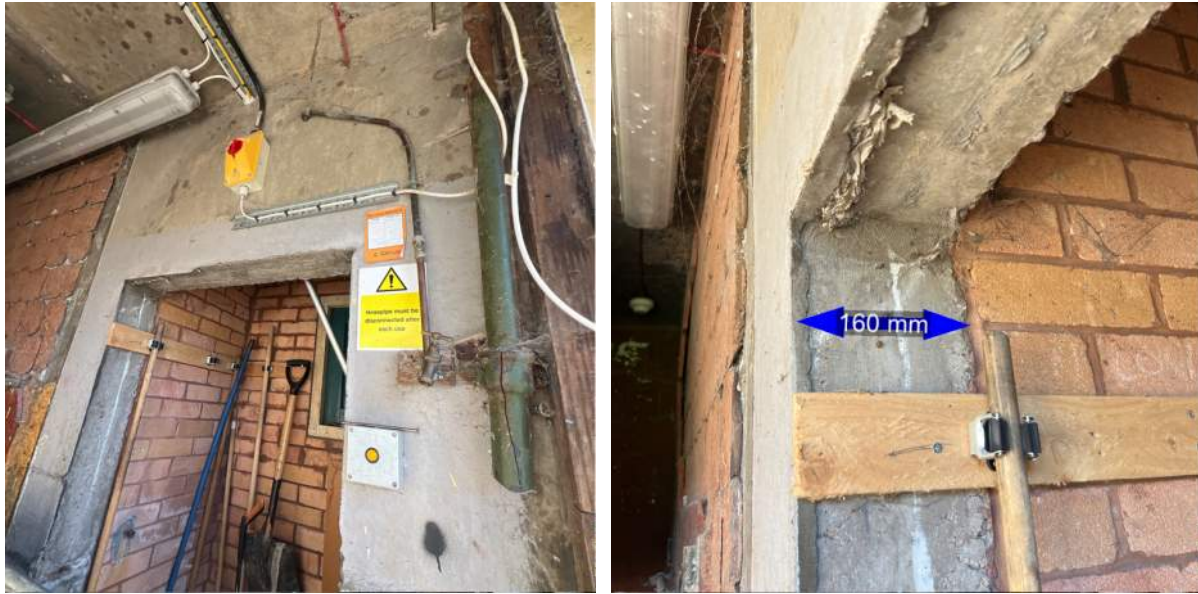
## Binstore

RC shear walls noted in binstore.

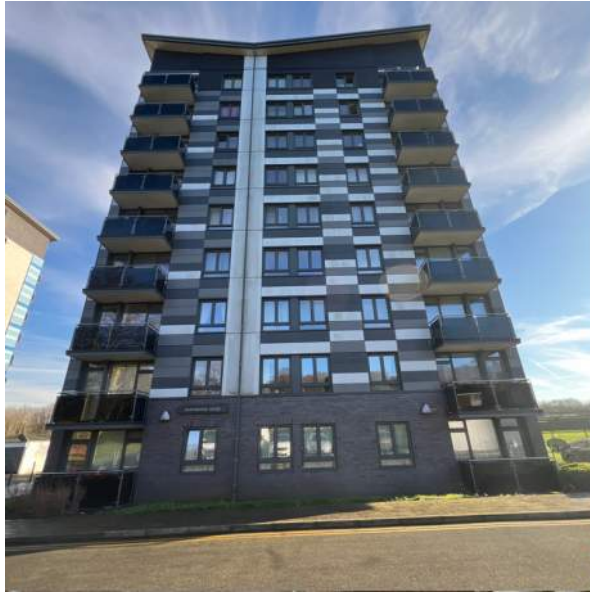
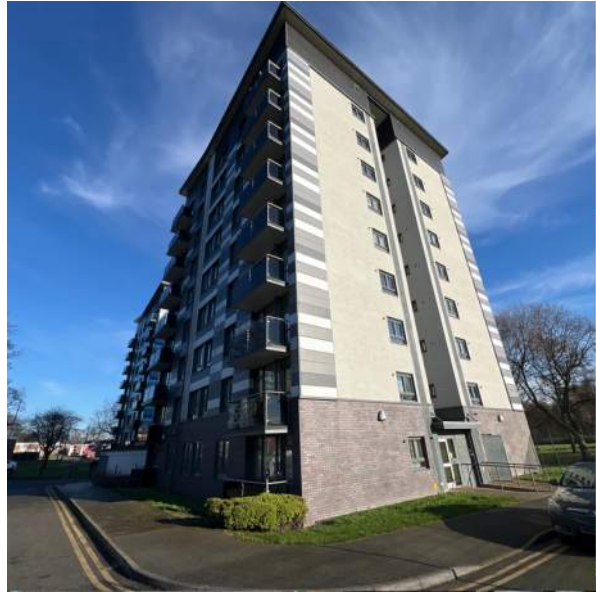
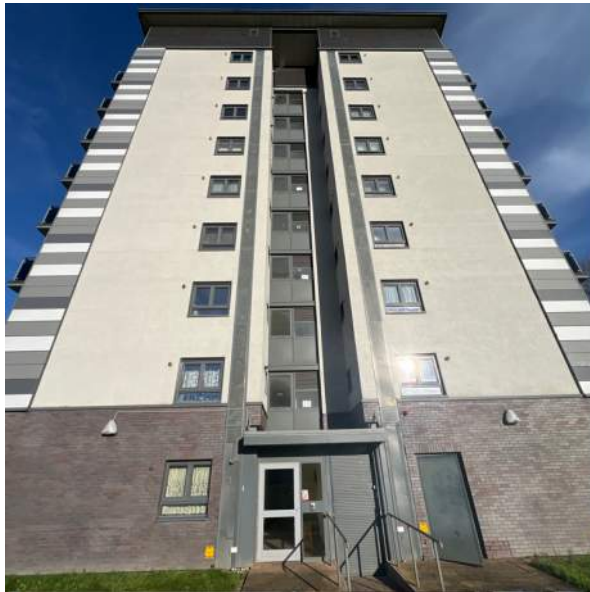
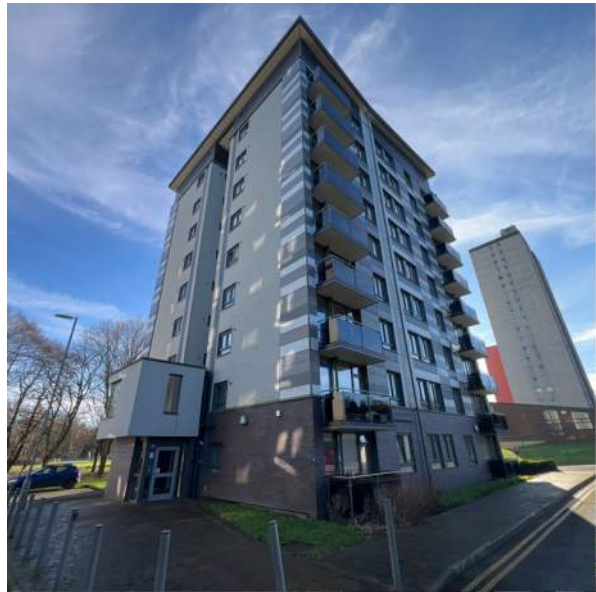
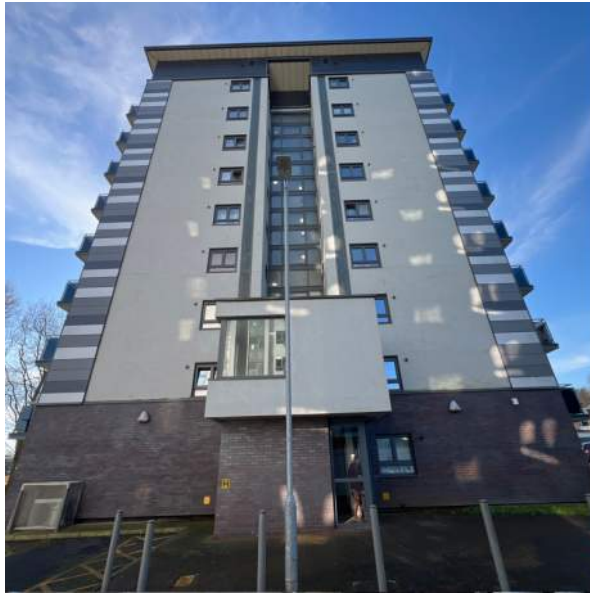
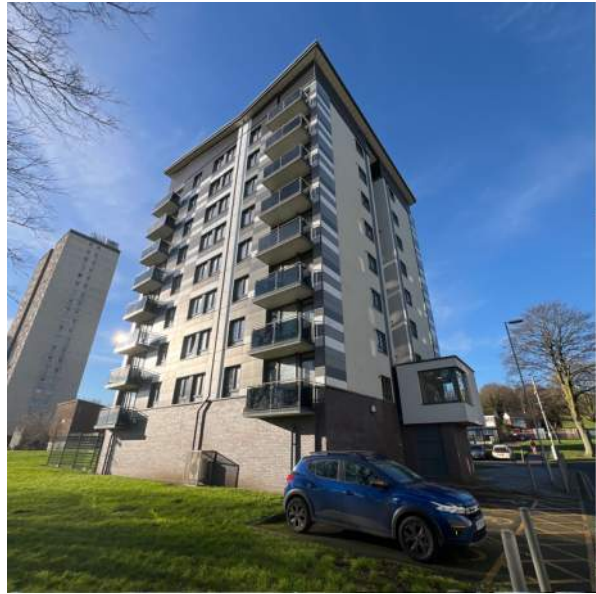
## Elevations

Ground floor level consists of brickwork. Remaining elevations consist of a mixture of rendered and cladded facade.
