**FIRNTEC**  
BUILDING COMPLIANCE

VISUAL STRUCTURAL APPRAISAL

380-450 Beaconview Road

29<sup>th</sup> April 2025

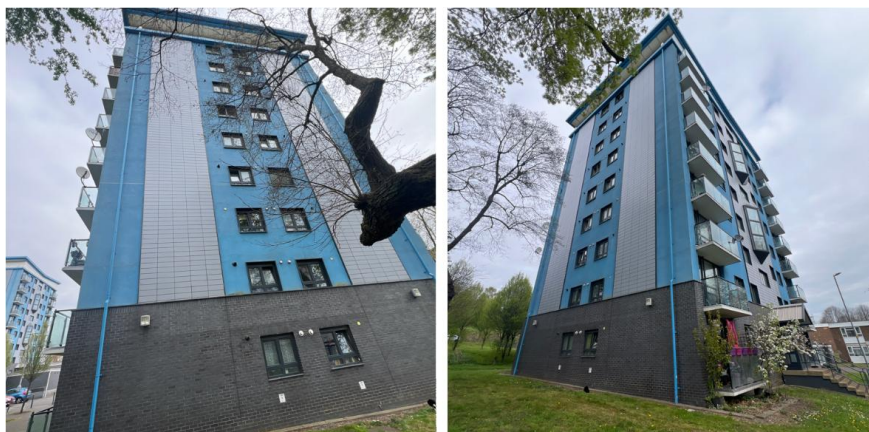
Figure 9 and 10: Building Elevations

The exterior elevations were generally in ok condition and no significant structural defects were noted to the cladding panels. There were no significant cracks or tell-tale signs of any significant structural movement noted at the time of our inspection.

The exterior panels were noted to be plumb with no signs of significant bowing, bulging or leaning noted to the panels indicating failed fixings however their presence and condition cannot be confirmed.

There are balconies at each level which are formed of cantilevered RC slabs tied into the main frame. During the 2011 refurbishment they had steel balustrades with glazed infill installed.

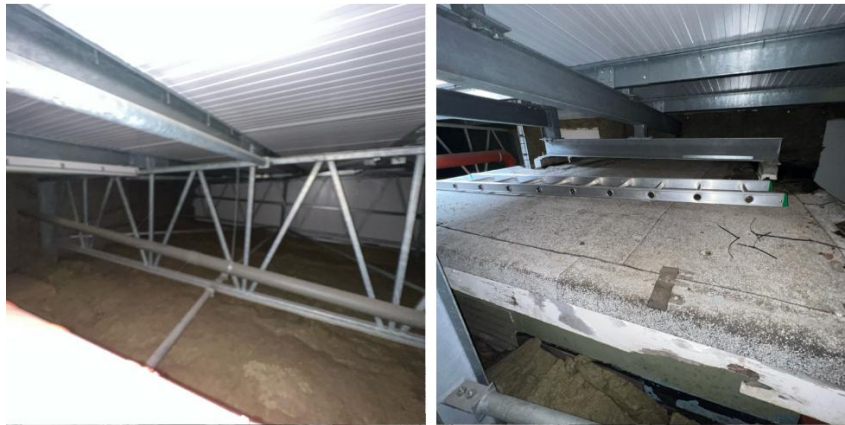
Figure 11 and 12: Roof Level

There were no tell-tale signs of any significant structural movement noted at the time of our inspection. The exterior walls were noted to be plumb with no signs of significant bowing, bulging or leaning noted to the masonry walls.

The roof has subsequently been covered with a new waterproofing covering formed of a steel frame installed to the existing roof which supports pitched corrugated sheets. This roof is not insulated and therefore acts purely as a weather barrier. The fire protection of the steel is unclear as the beams do not appear to be unprotected. Details of this frame should be requested from the contractor who completed the works in 2011. No signs of water ingress of that the roof is not performing as intended.

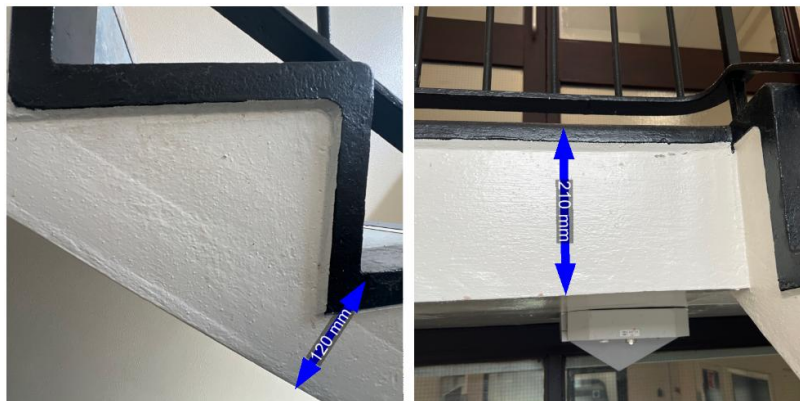
Figure 14 and 15: Stair stringer and concrete slab

The interior of the stair core walls were checked and were plumb and in line with observations made to the exterior – no significant signs of leaning or movement noted. The concrete appeared in fair condition with few BRE category 1 cracks but no structurally significant defects were noted.

The stair stringer was noted to be 120mm thick which seems slim, certainly short of modern standards. A cover test is required to check the resistance of the concrete section in the event of a fire.

Due to the age of the building it is wise to perform periodical health checks to the concrete elements. This should include tests for concrete strength, cover depth, carbonation, chlorides and HAC. It would appear that these tests have never been performed to this building and therefore we recommend engaging a specialist contractor within the next 24 months who will be able to perform the tests and provide a interpretive report.

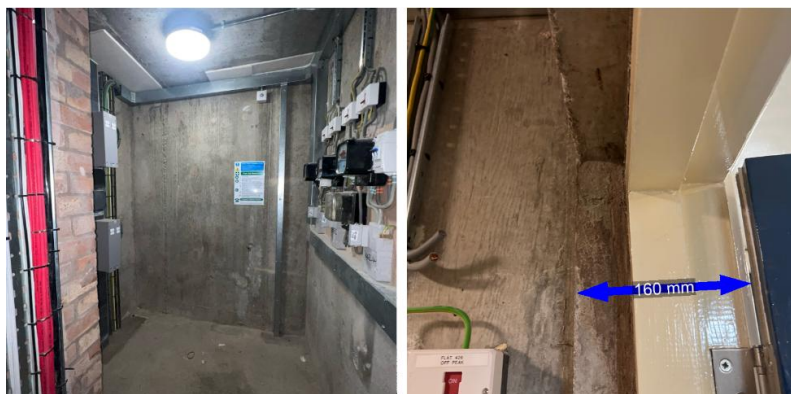
Figure 16 and 17: RC Elements visible at ground floor

There were vertical concrete walls supporting the floor plates at every level. The elements visible matched the floor layout in Figure 6. The walls appear continuous from ground to roof with no transfer structure. The overall condition of the structure observed is good.

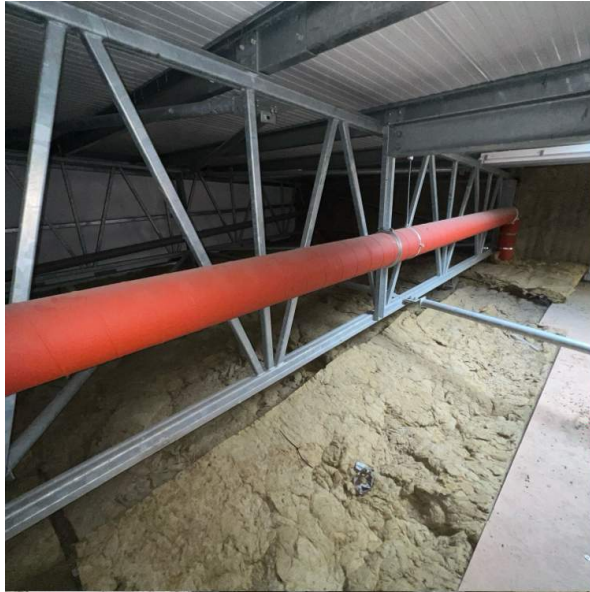
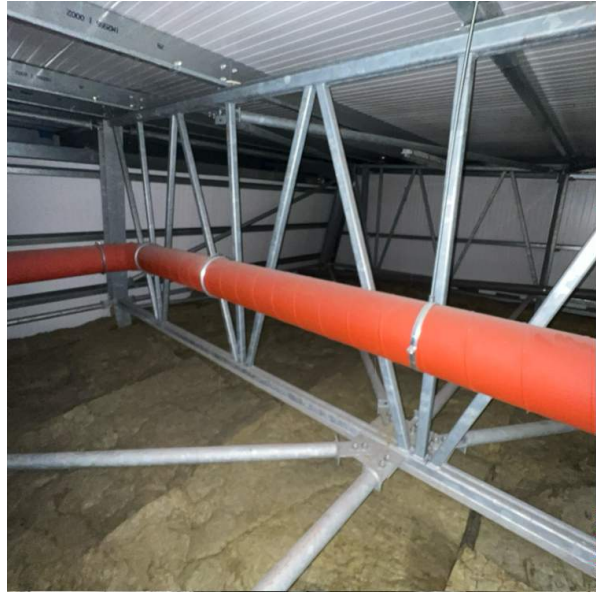
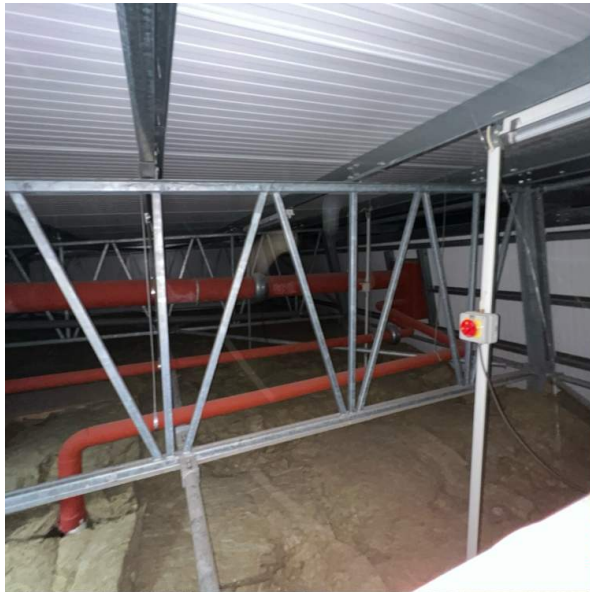
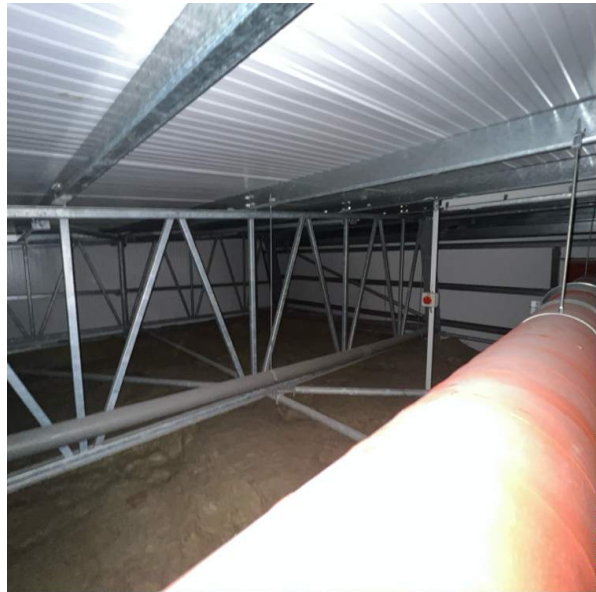
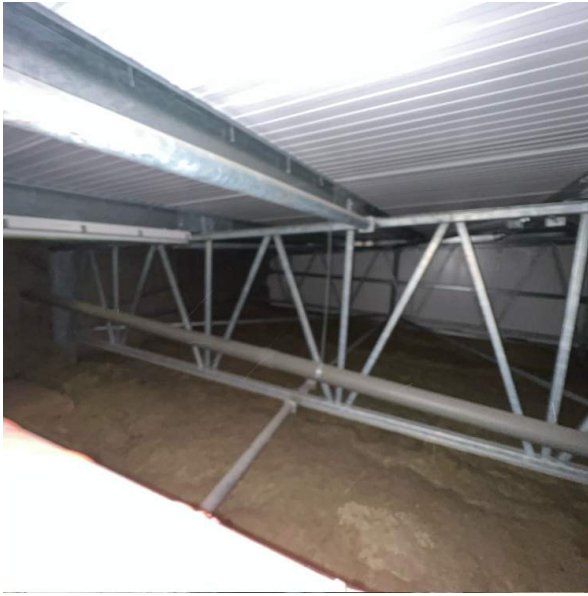
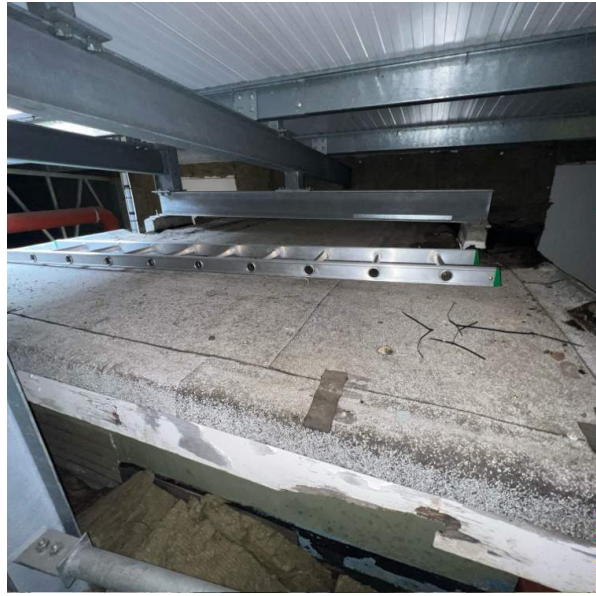
## Main Roof

Comments: A pitched roof constructed above existing original flat roof slab. Steel frame supporting purlins with aluminium standing / mineral wool core profiled panels.

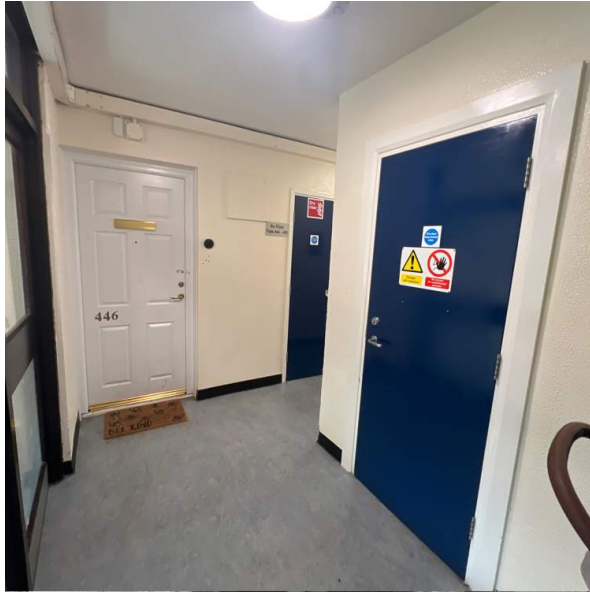
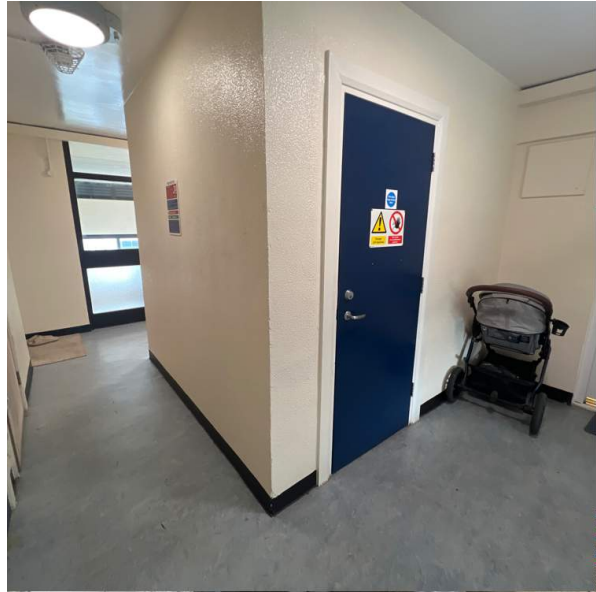
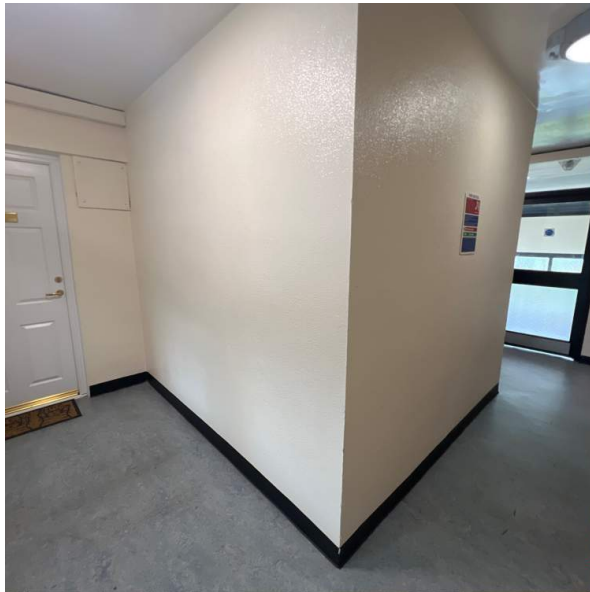
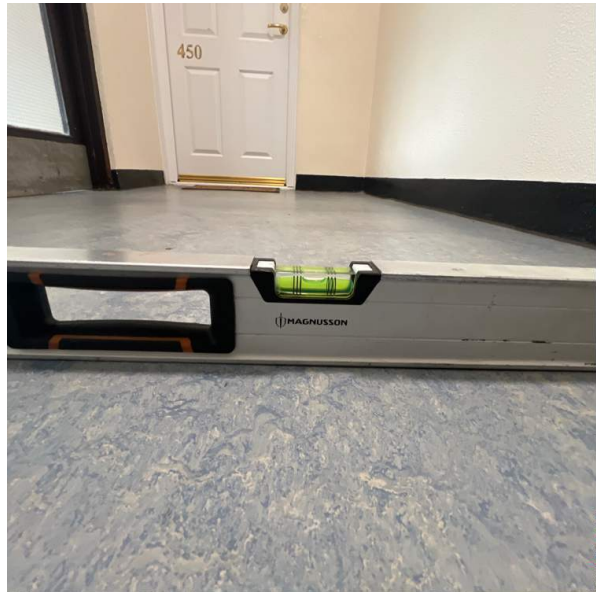
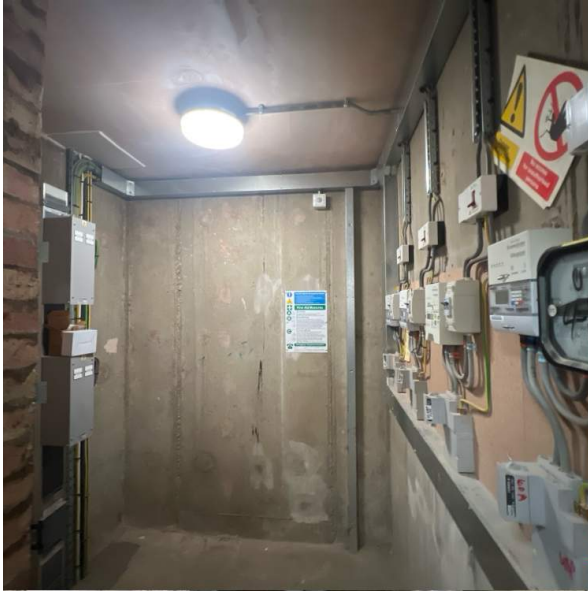
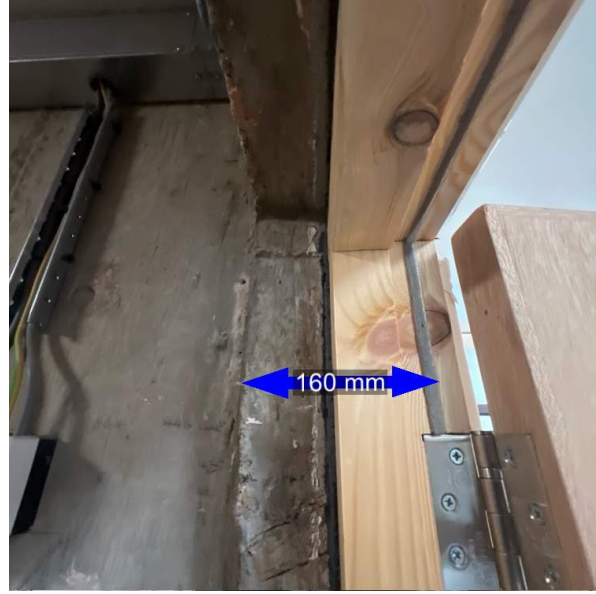
## 8th Floor Hallway

Comments: No jams or distortions noted to hallway doors to indicate any serviceability issues. Generally walls covered with finishes in hallway, likely to consist a mixture of concrete shear walls, embedded columns and masonry infill walls. Limited structure exposed. Concrete walls noted via riser cupboards, approx. 160mm thick.

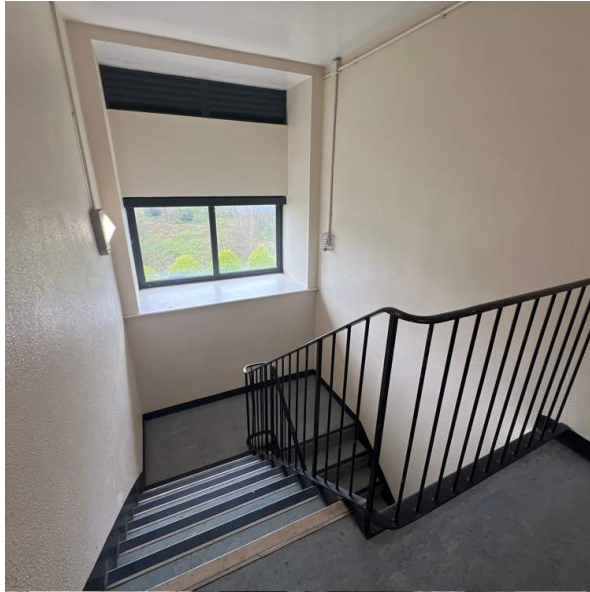
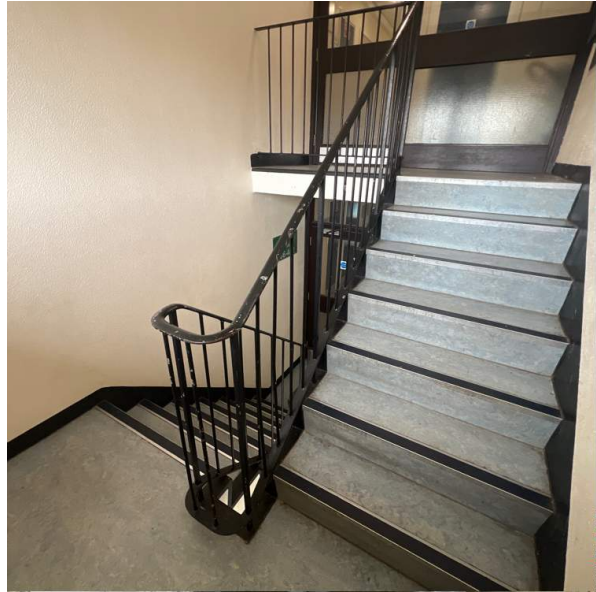
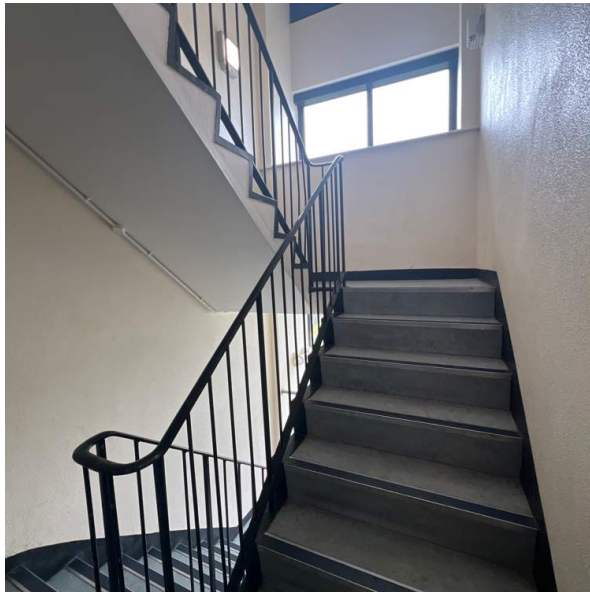
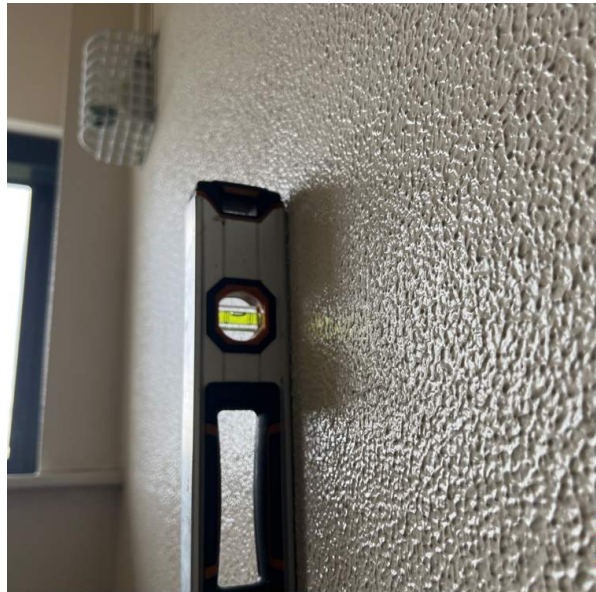
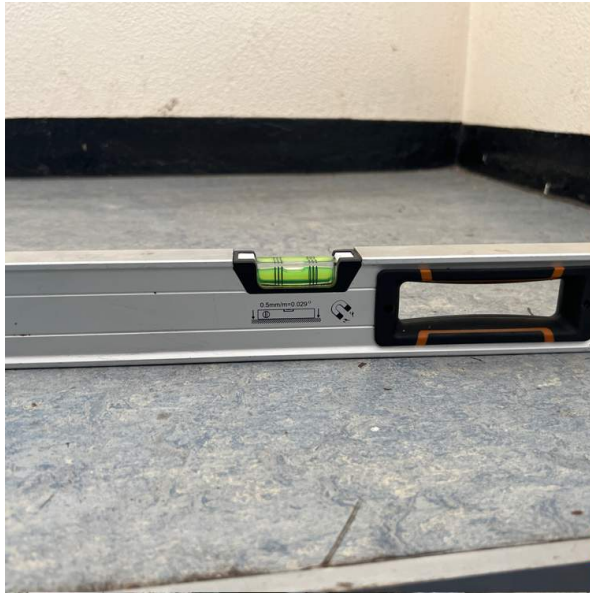
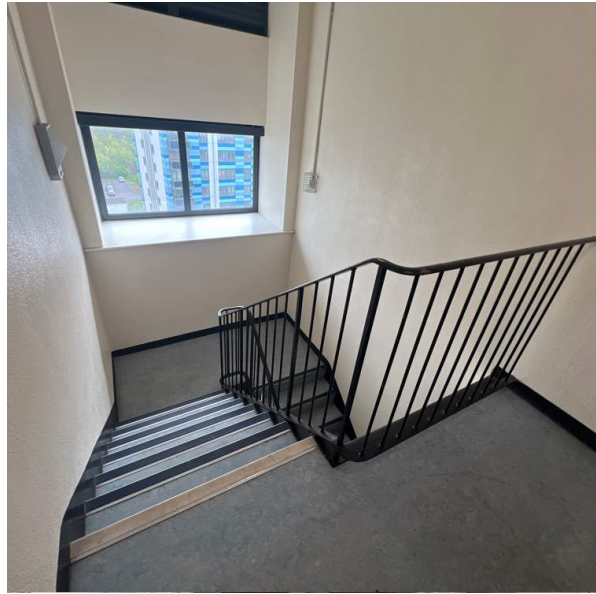
## 8th Floor Staircases

Comments: Insitu concrete stairs with steel hand railing fixed to stairs. Walls and floors appear to be fairly level.  
Stair walls covered with finishes however these would likely form the main concrete shear core walls.

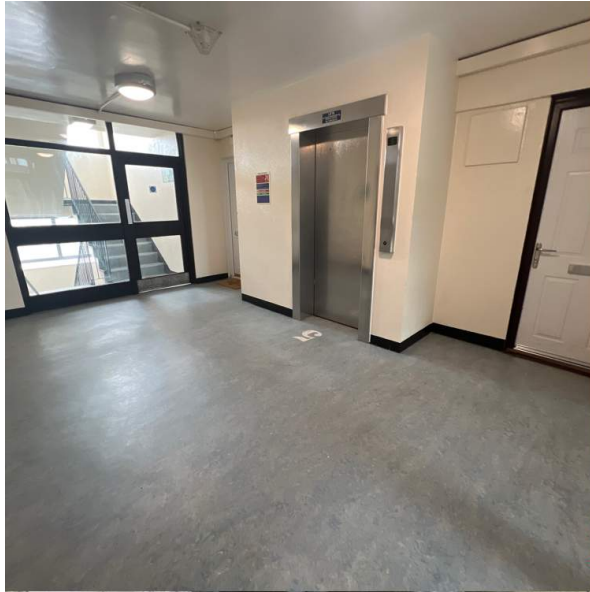
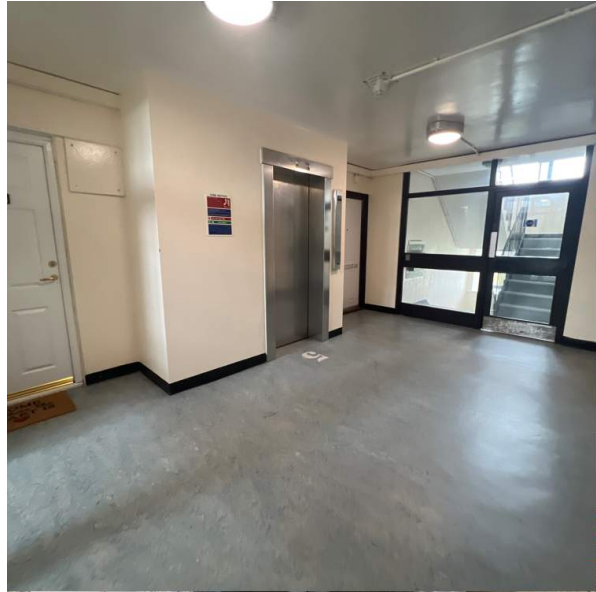
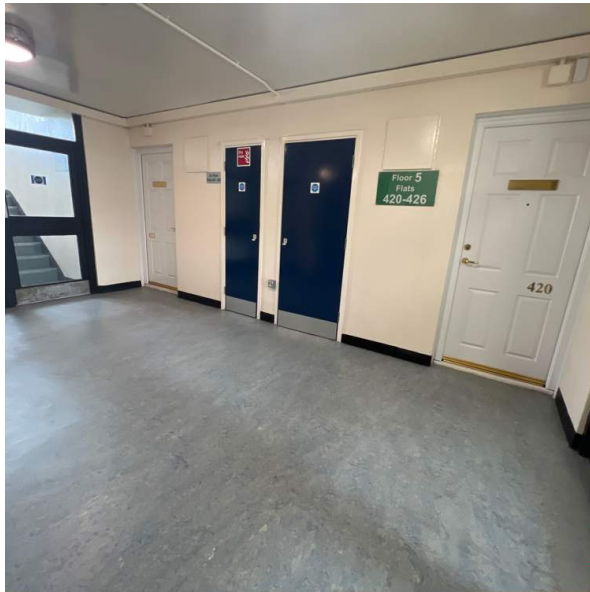
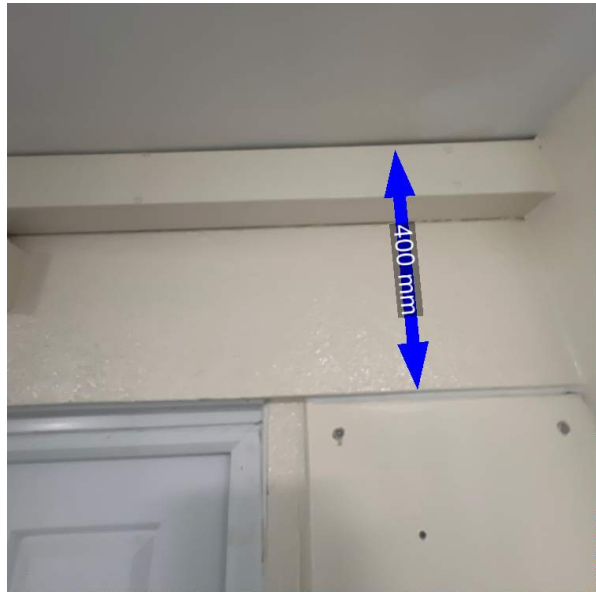
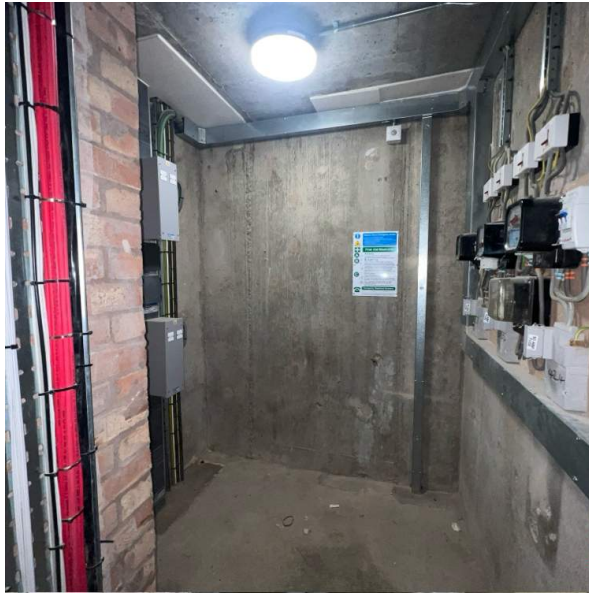
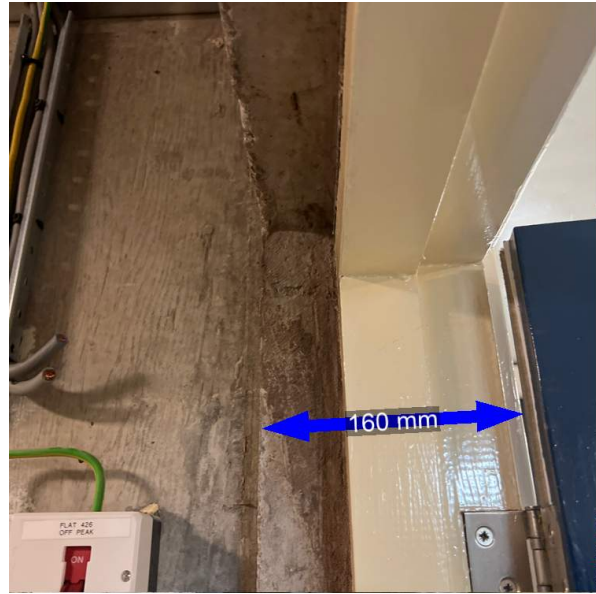
## 5th Floor Hallway

Comments: No jams or distortions noted to hallway doors to indicate any serviceability issues. Generally walls covered with finishes in hallway, likely to consist a mixture of concrete shear walls, embedded columns and masonry infill walls. Limited structure exposed. Concrete walls noted via riser cupboards approx. 160mm thick.

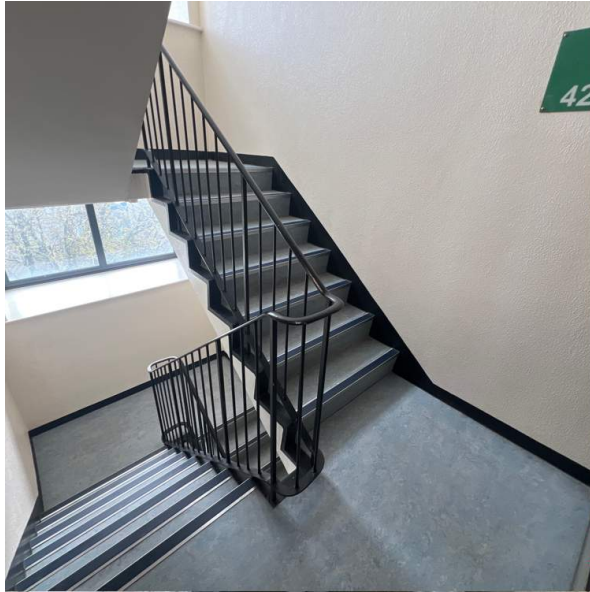
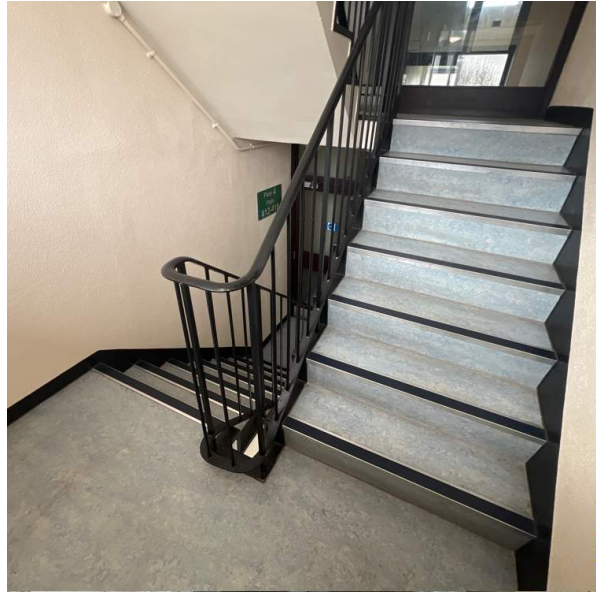
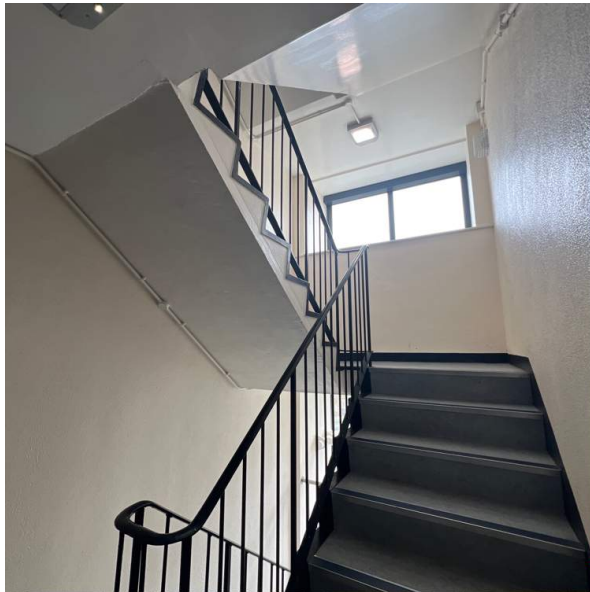
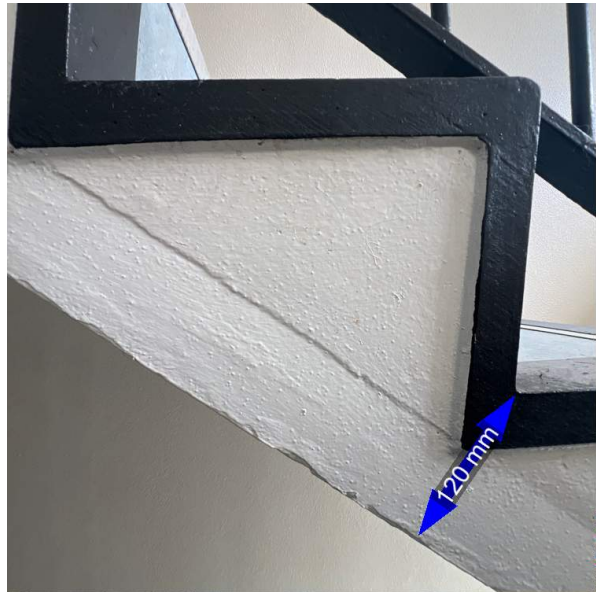
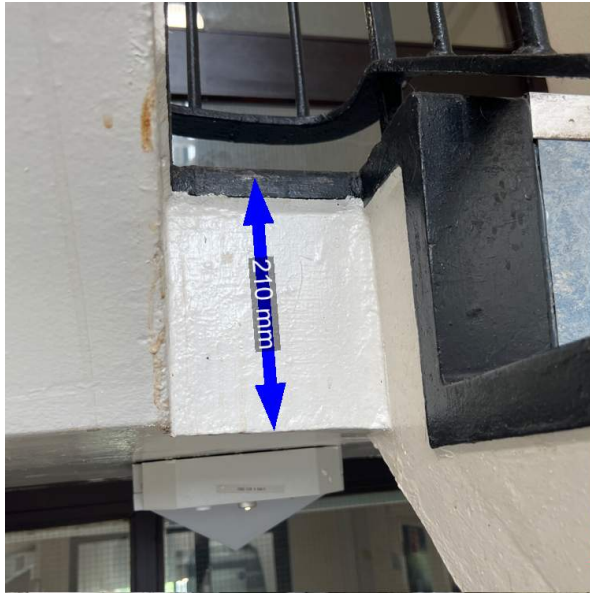
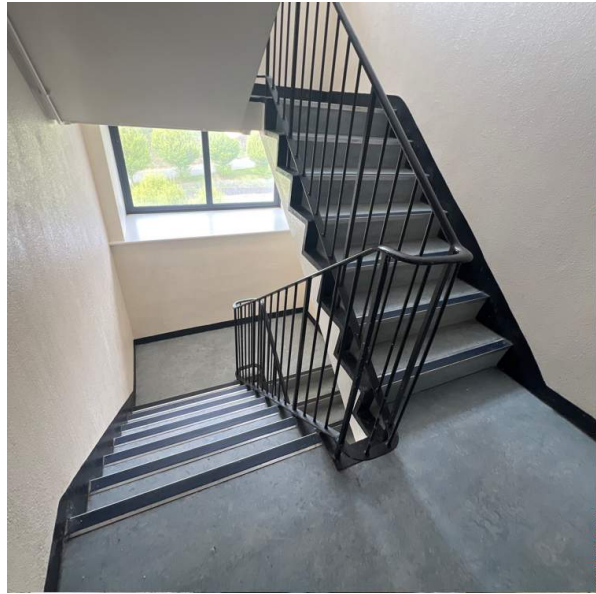
## 5th Floor Staircases

Comments: Insitu concrete stairs with steel hand railing fixed to stairs. Walls and floors appear to be fairly level.  
Stair walls covered with finishes however these would likely form the main concrete shear core walls.

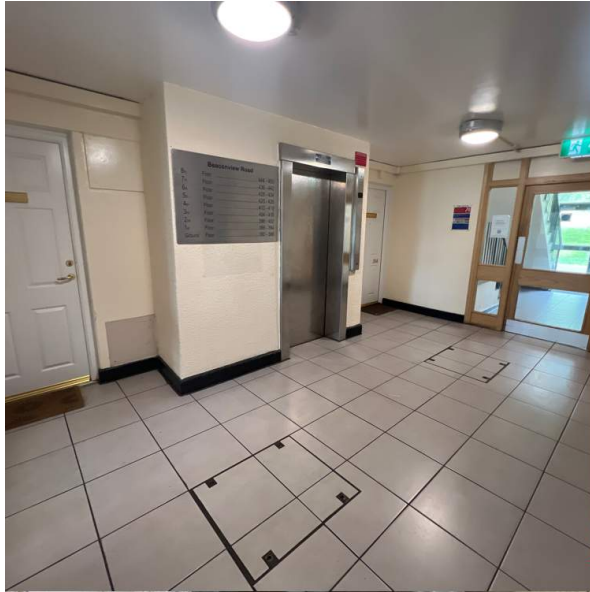
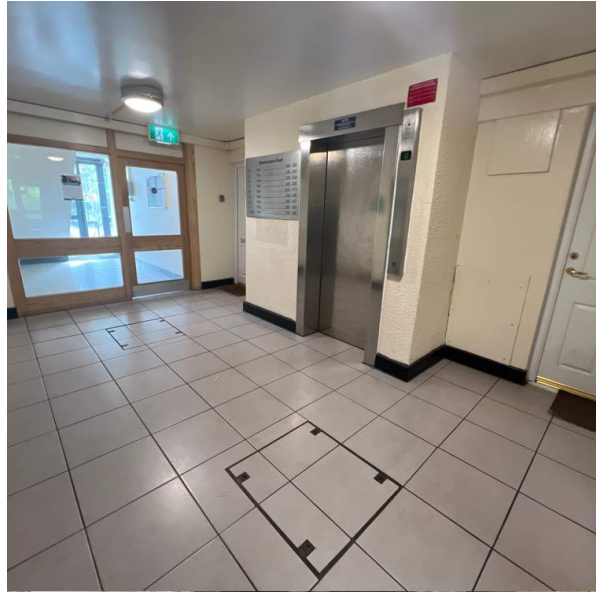
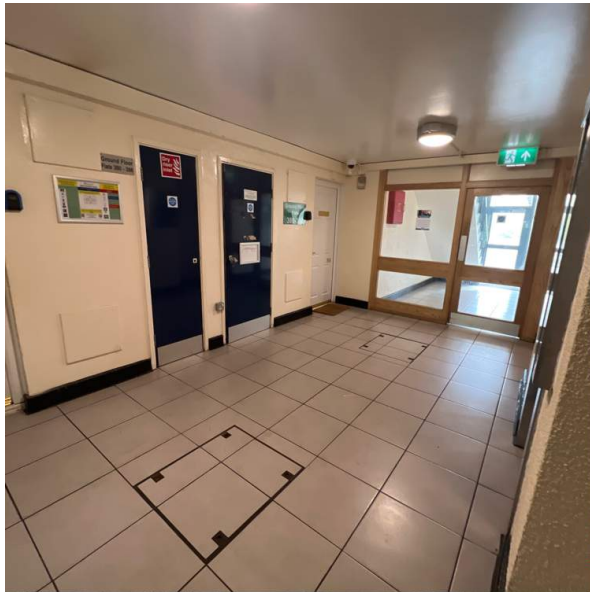
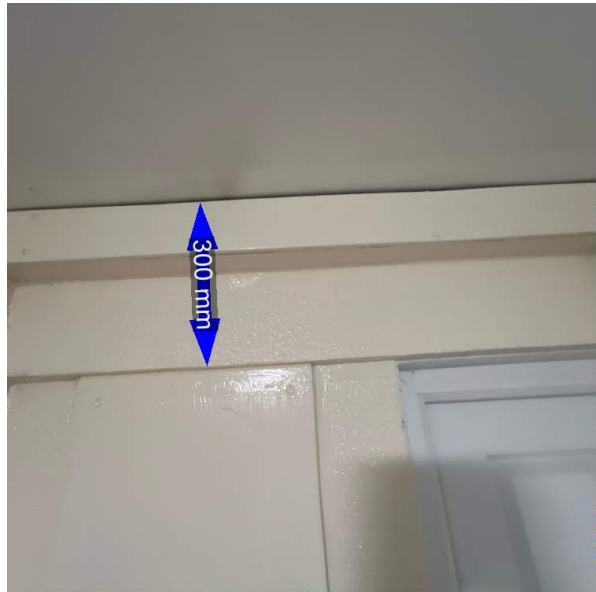
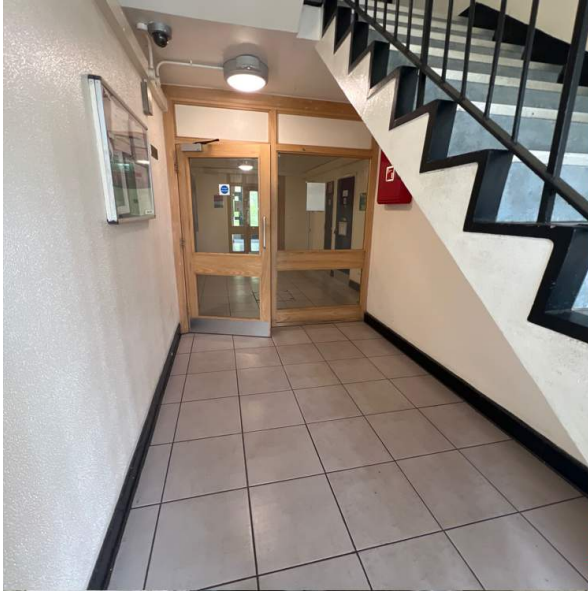
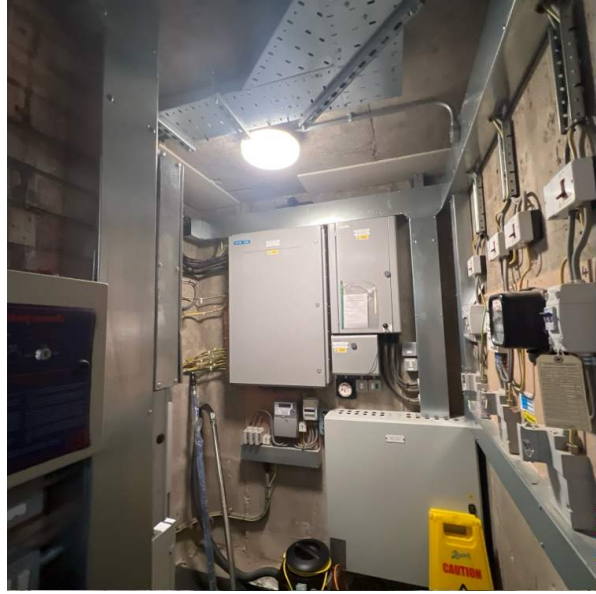
## Ground Floor Hallway

Comments: No jams or distortions noted to hallway doors to indicate any serviceability issues. Generally walls covered with finishes in hallway, likely to consist a mixture of concrete shear walls, embedded columns and block infill walls. Limited structure exposed. Partly visible concrete walls noted via electrical riser cupboards.

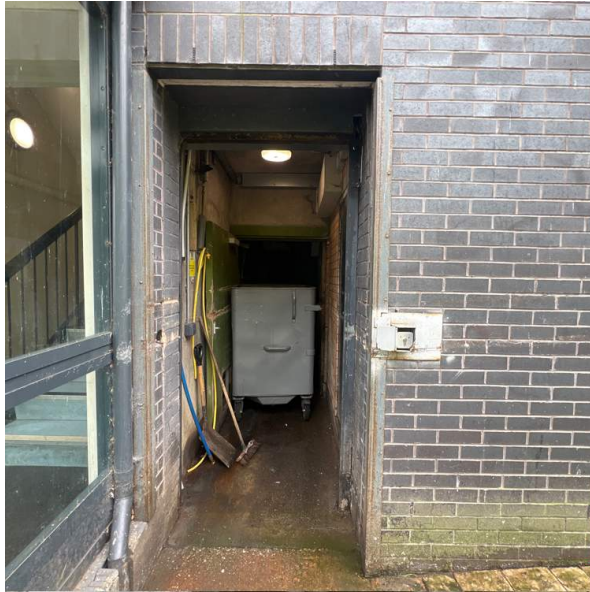
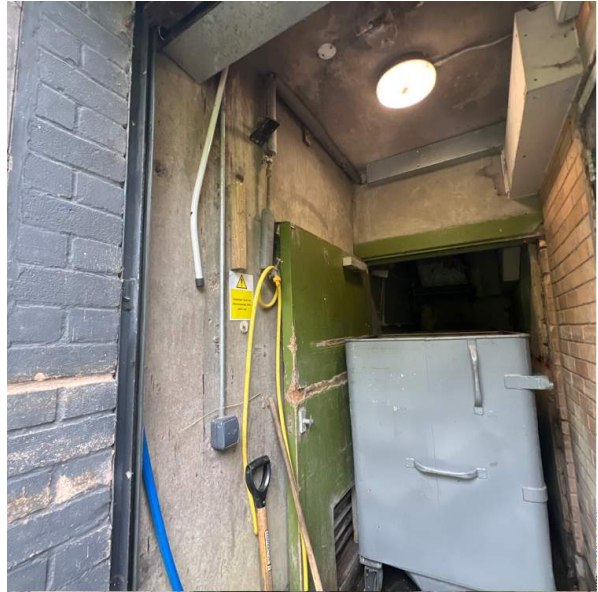
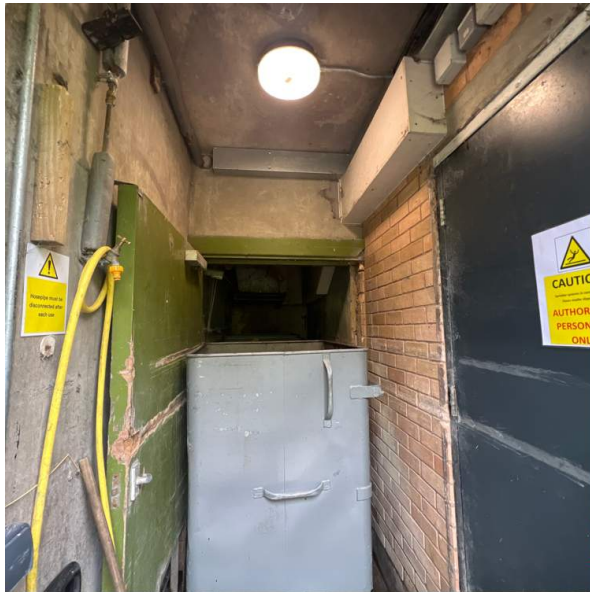
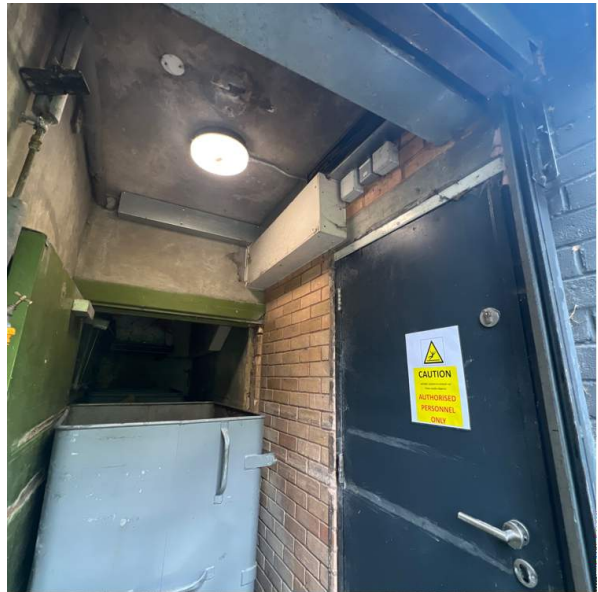
## Binstore

RC shear walls noted in binstore.

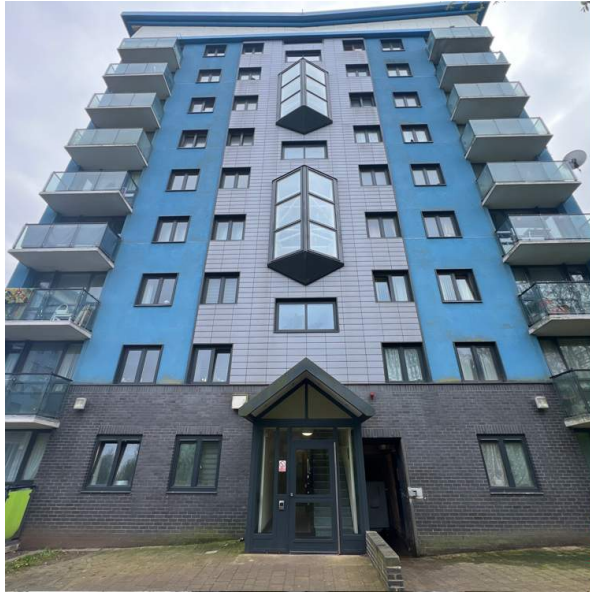
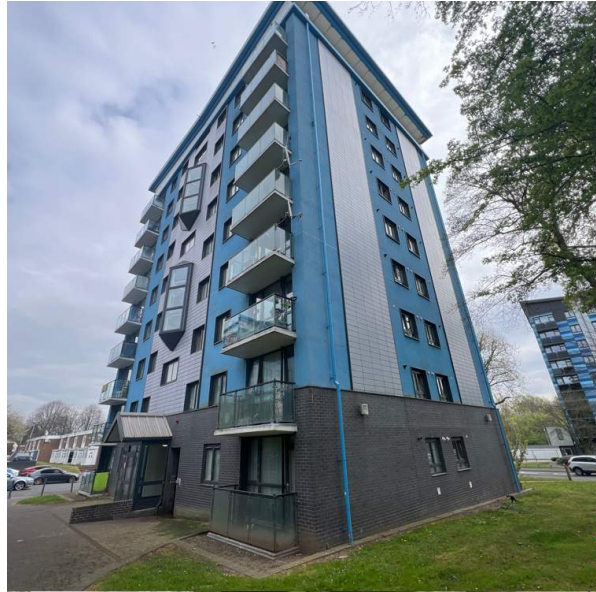
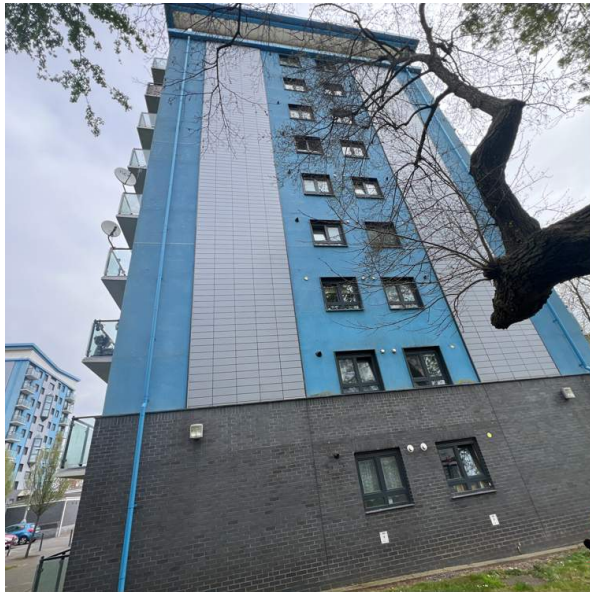
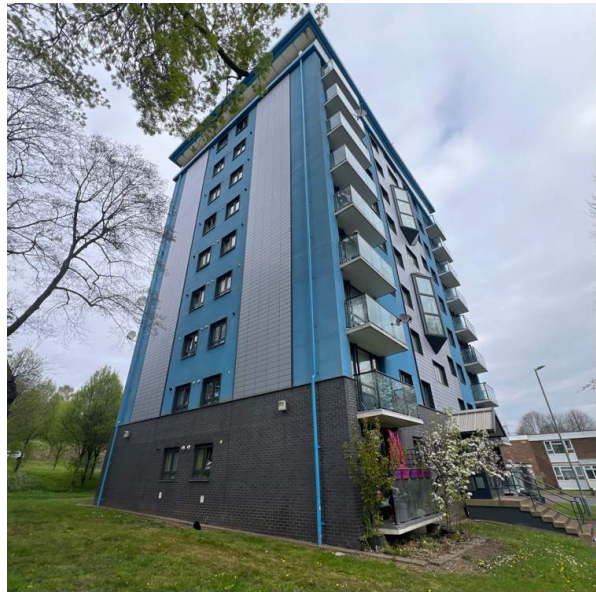
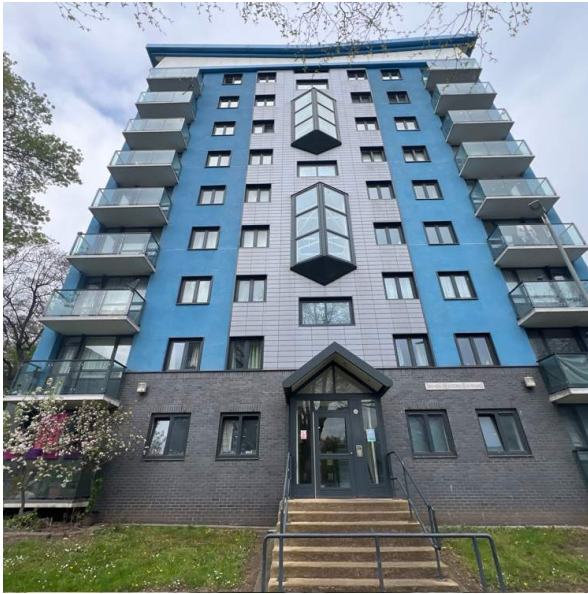
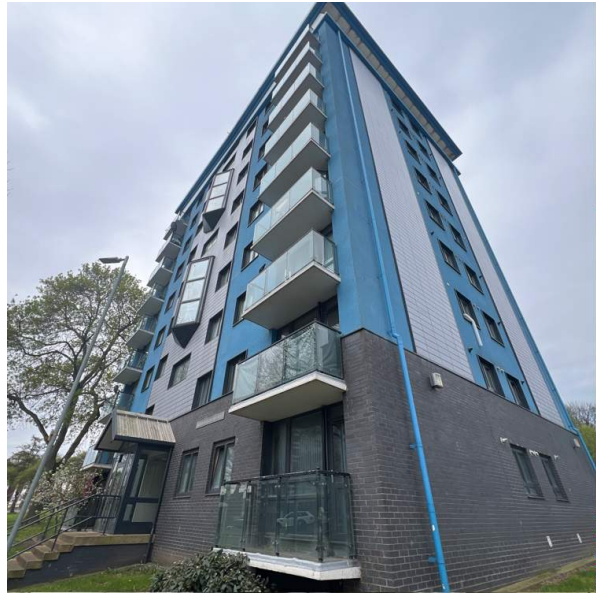
## Elevations

Ground floor level consists of brickwork. Remaining elevations consist of a mixture of rendered and cladded facade.
