**FIRNTEC**  
BUILDING COMPLIANCE

VISUAL STRUCTURAL APPRAISAL

1-90 Birchcroft

11<sup>th</sup> November 2024

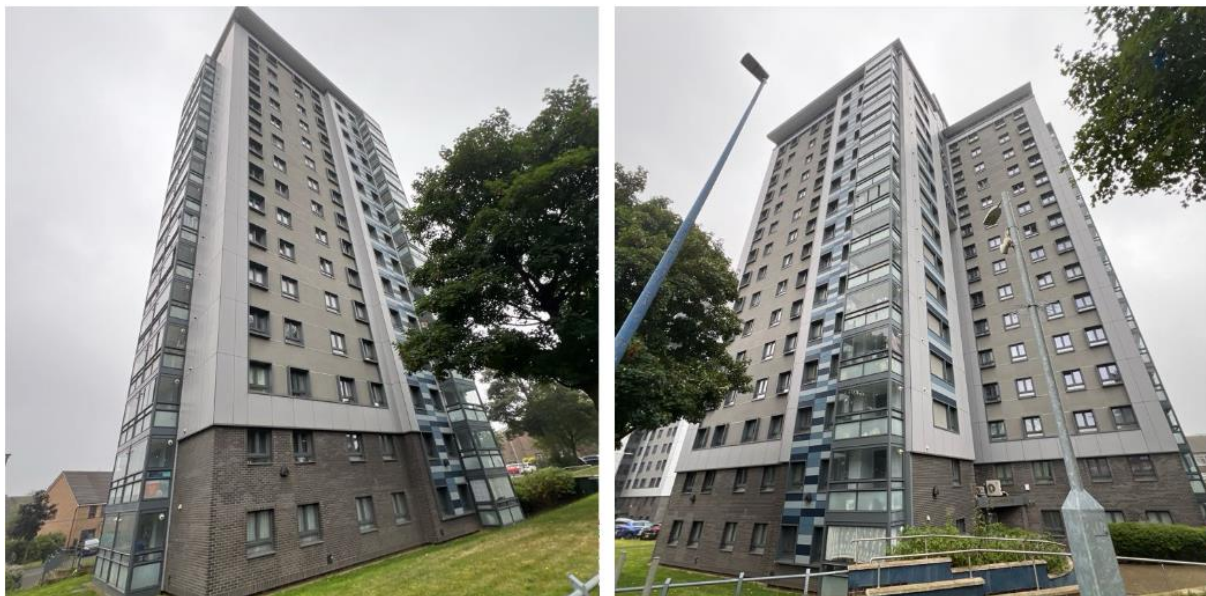
Figure 9 and 10: Building Elevations

The exterior elevations were generally in ok condition and no significant structural defects were noted to the cladding panels. There were no significant cracks or tell-tale signs of any significant structural movement noted at the time of our inspection.

The exterior panels were noted to be plumb with no signs of significant bowing, bulging or leaning noted to the panels indicating failed fixings however their presence and condition cannot be confirmed.

There are balconies at each level which are formed of cantilevered RC slabs tied into the main frame. During the 2016 refurbishment they were transformed into winter gardens by installing glazing around the perimeter of the balcony.

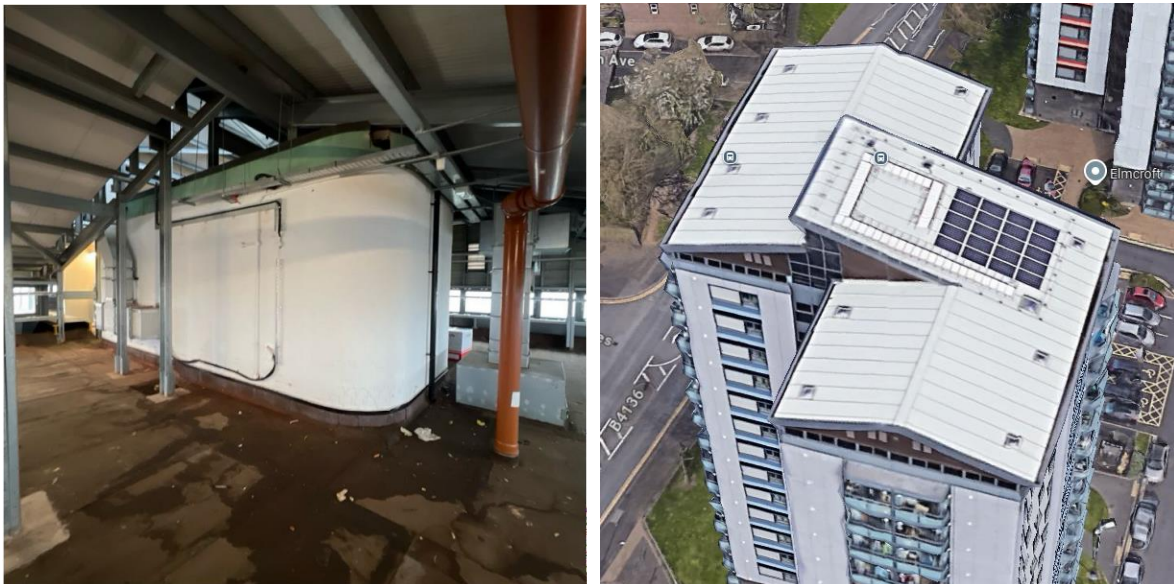
Figure 11 and 12: Roof Level

There were no tell-tale signs of any significant structural movement noted at the time of our inspection. The exterior walls were noted to be plumb with no signs of significant bowing, bulging or leaning noted to the masonry walls.

The roof has subsequently been covered with a new waterproofing covering formed of a steel frame installed to the existing roof which supports pitched corrugated sheets. This roof is not insulated and therefore acts purely as a weather barrier. The fire protection of the steel is unclear as the beams do not appear to be unprotected. Details of this frame should be requested from the contractor who completed the works in 2016.

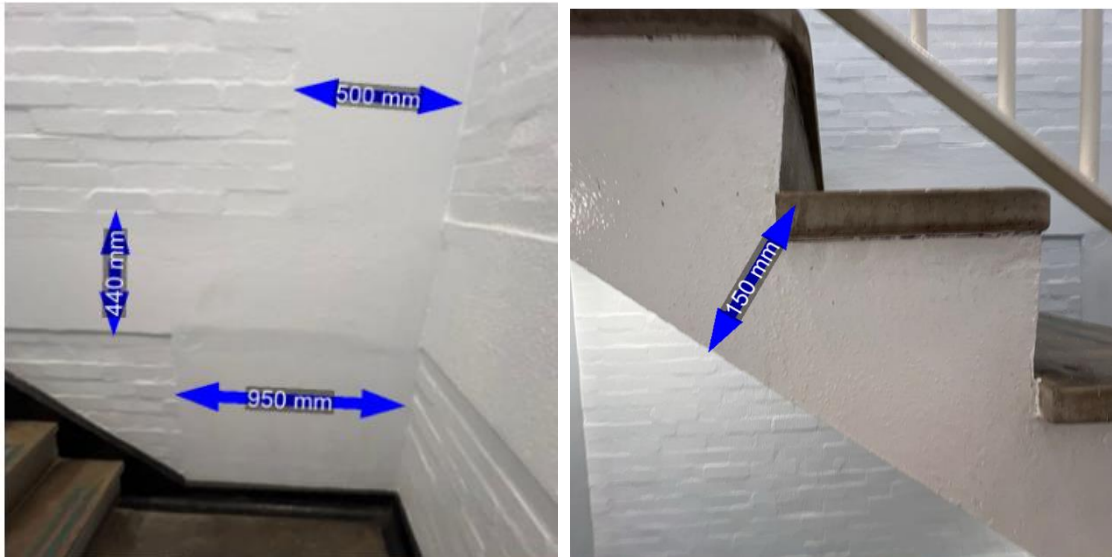
Figure 13 and 14: Stair stringer and concrete frame

The interior of the stair core walls were checked and were plumb and in line with observations made to the exterior – no significant signs of leaning or movement noted. The

concrete appeared in fair condition with few BRE category 1 cracks but no structurally significant defects were noted.

The stair stringer was noted to be 180mm thick which seems reasonable, albeit short of modern standards. A cover test is required to check the resistance of the concrete section in the event of a fire.

Due to the age of the building it is wise to perform periodical health checks to the concrete elements. This should include tests for concrete strength, cover depth, carbonation, chlorides and HAC. It would appear that these tests have never been performed to this building and therefore we recommend engaging a specialist contractor within the next 24 months who will be able to perform the tests and provide a interpretive report.

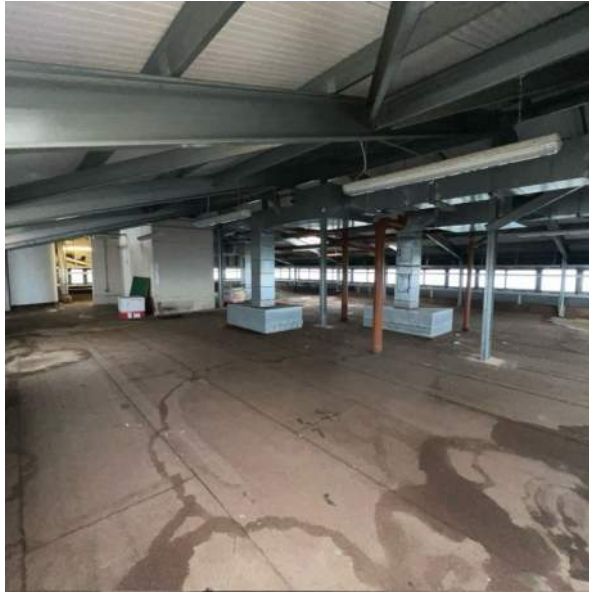
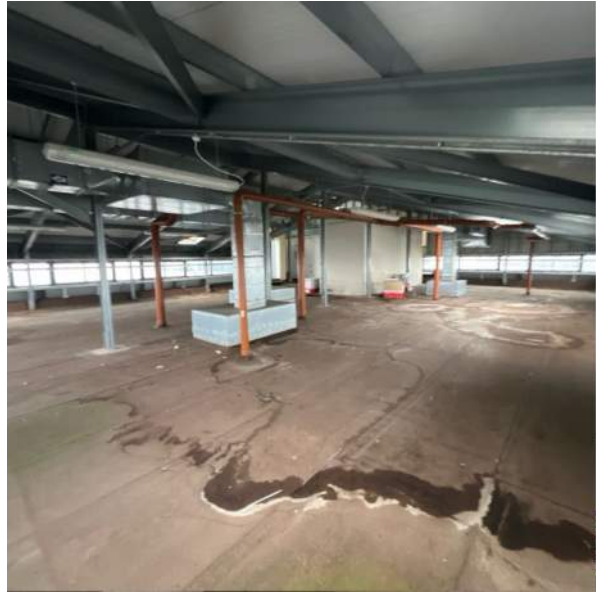
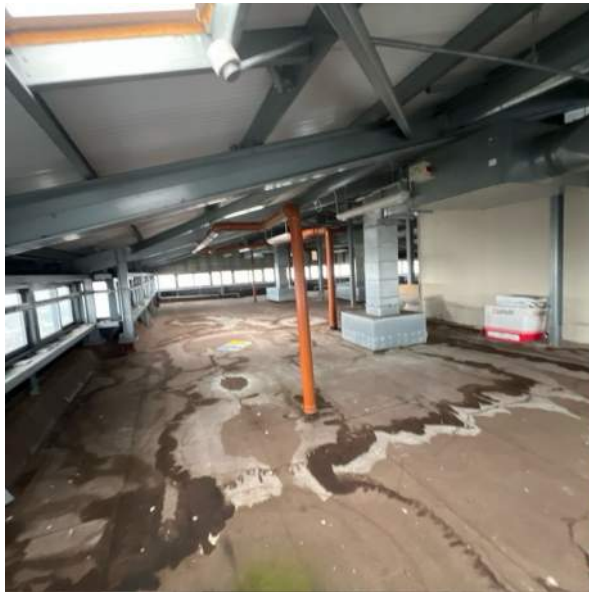
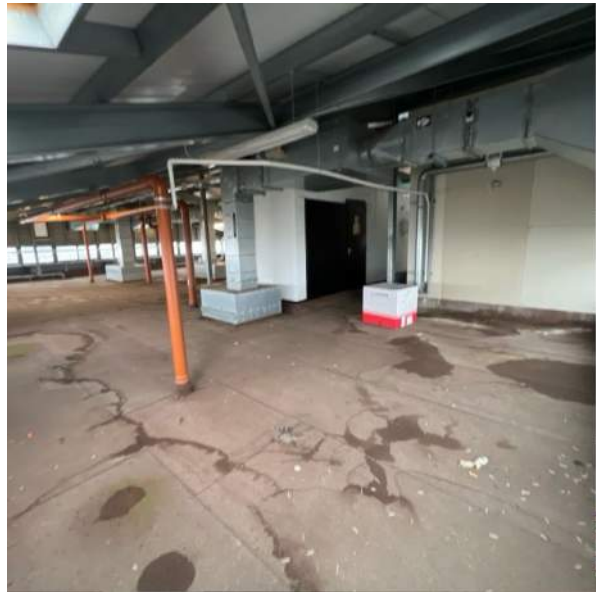
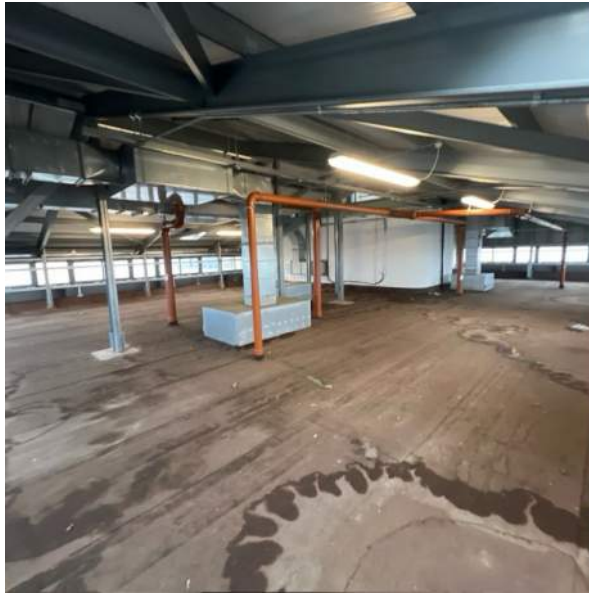
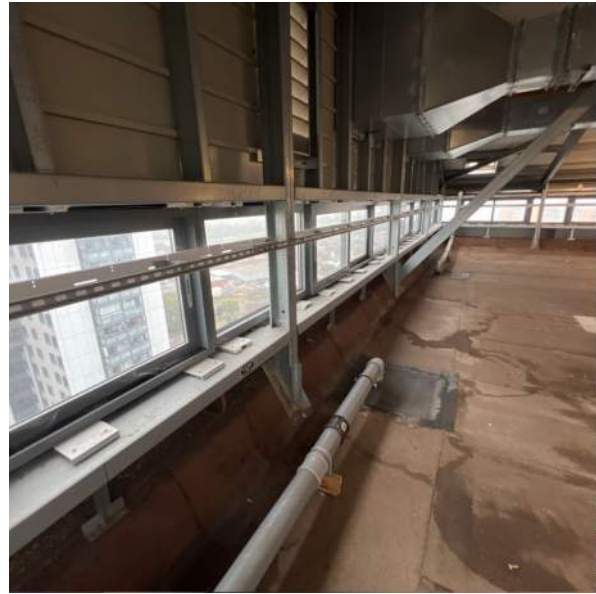
## Main Roof

Comments: Roof structure is formed of a concrete slab with a Lightweight SFS (appear to be cold rolled) frame with a pitched roof fixed on to main roof structure. Frame columns fixed to perimeter of roof.  
Some historical staining to roof coverings noted, potential leaks in pitched roof coverings.

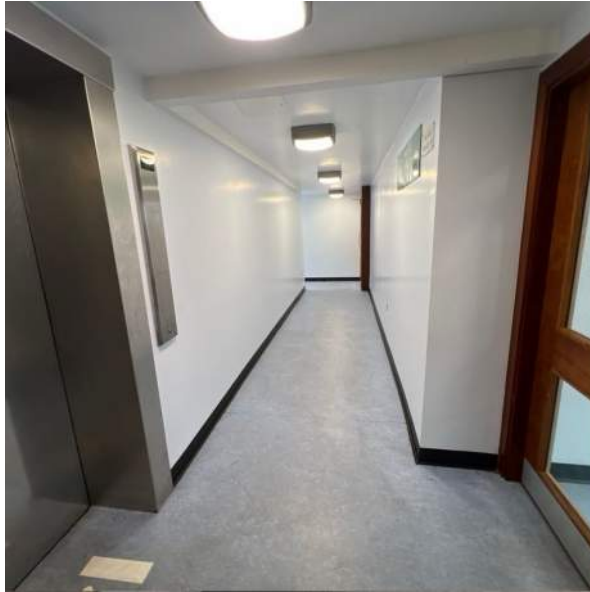
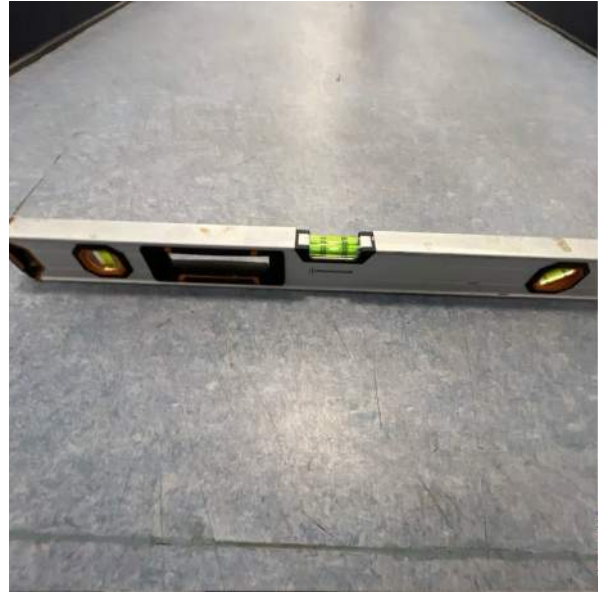
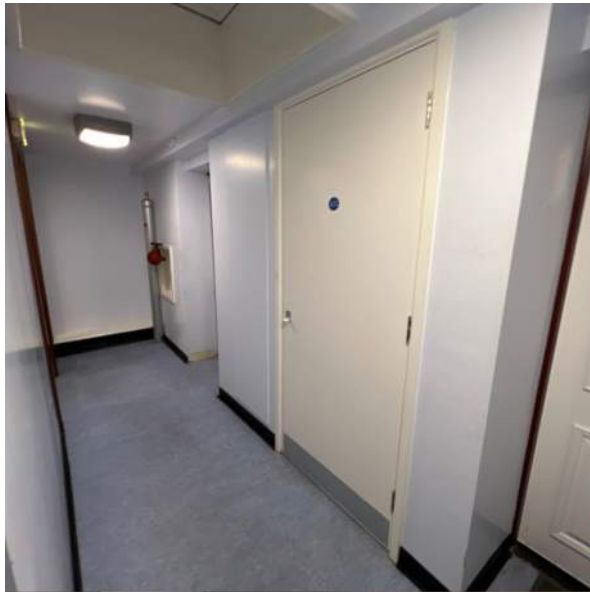
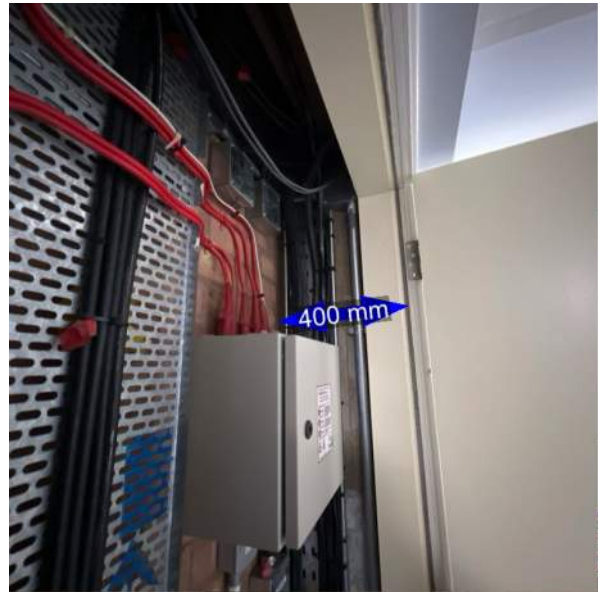
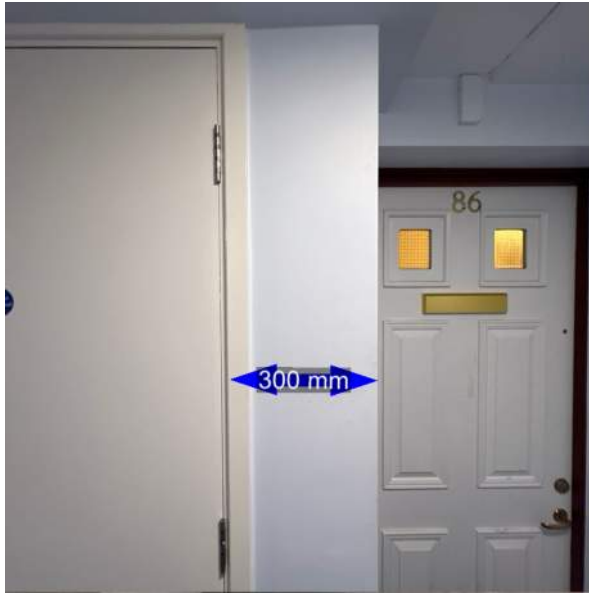
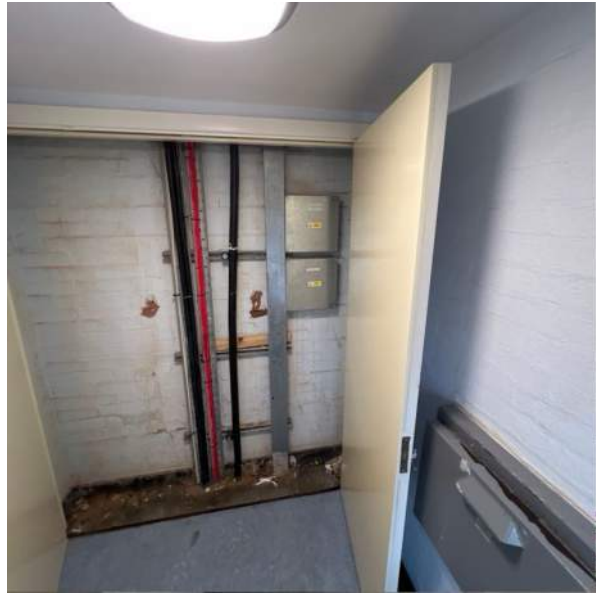
## 14th Floor Hallway

Comments: No jams or distortions noted to hallway doors to indicate any serviceability issues. Generally walls covered with finishes in hallway, likely to consist a mixture of concrete shear walls and embedded columns with internal partition walls. Riser cupboard shows infill masonry walls with partially exposed concrete elements which appears RC Columns.

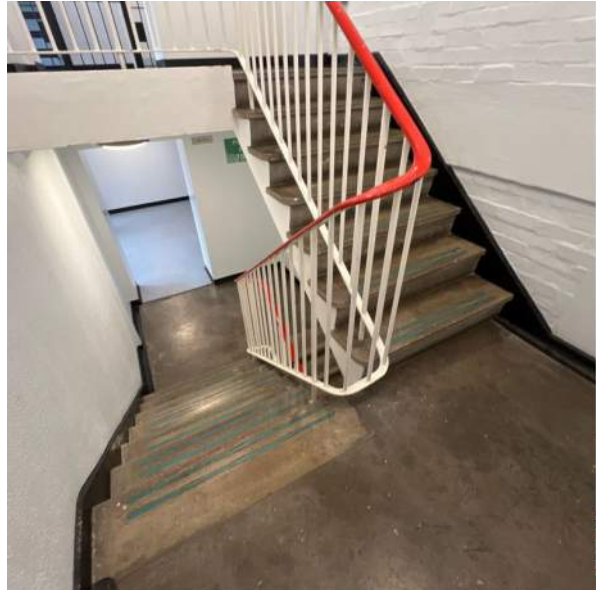
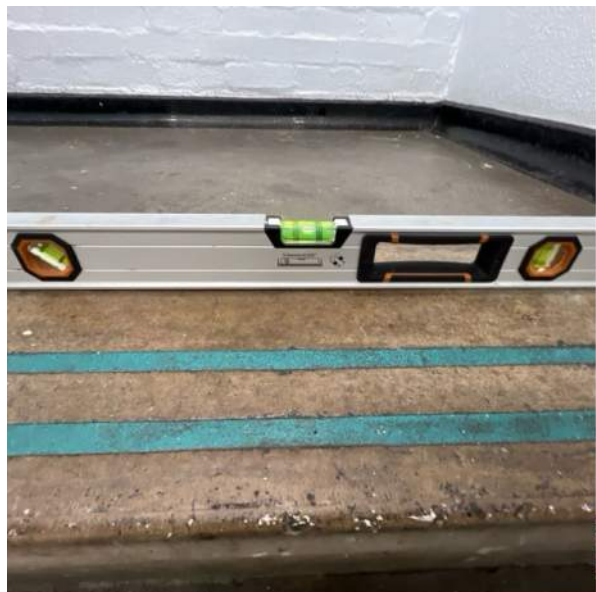
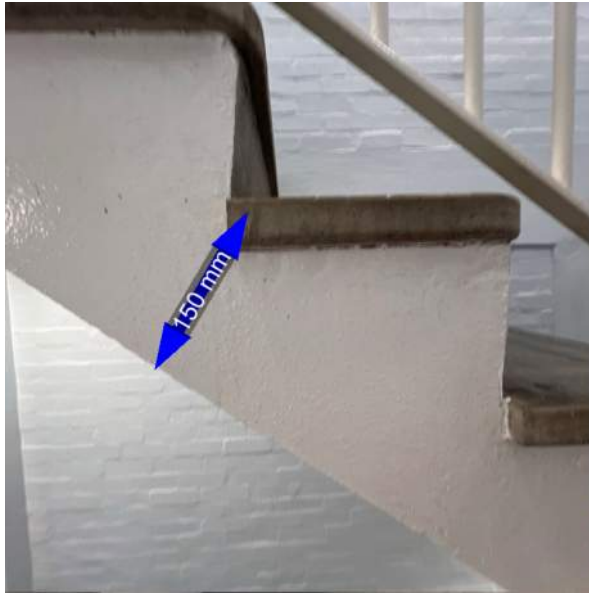
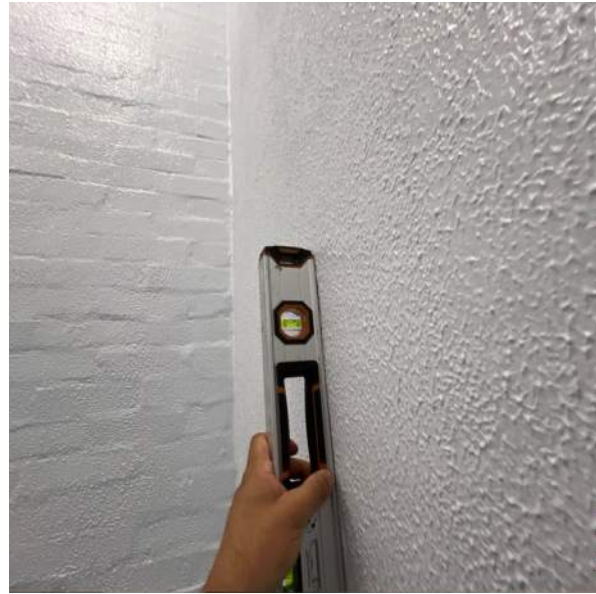
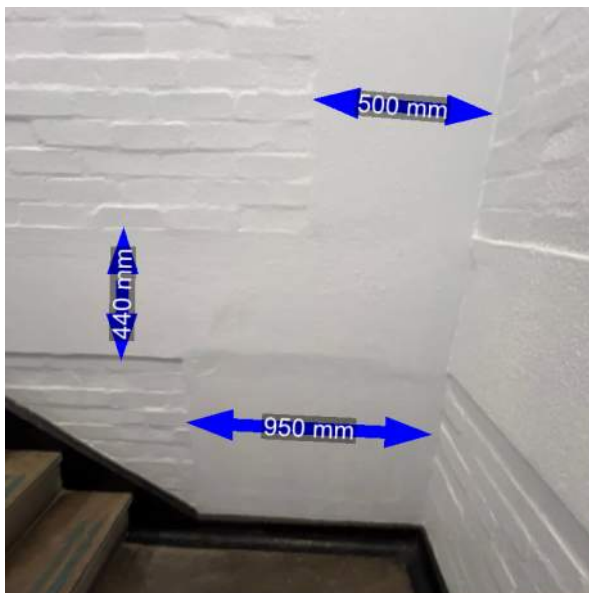
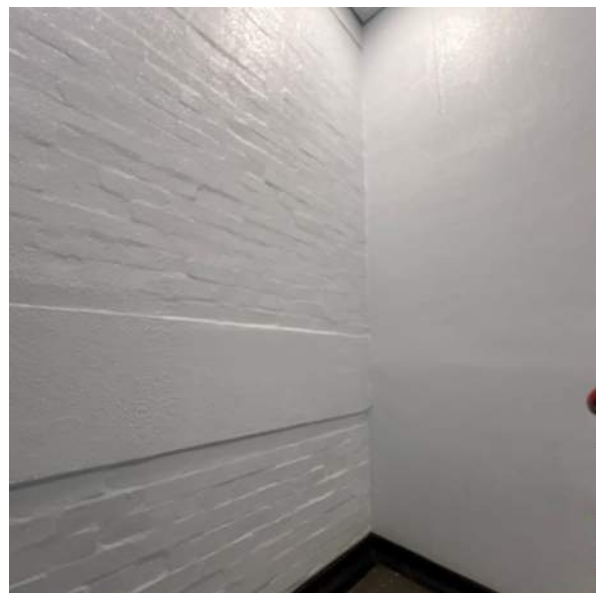
## 14th Floor Staircase

Insitu concrete stairs with steel hand railing fixed to stairs. Walls and floors appear to be fairly level.

Stair walls partly exposed showing infill masonry walls (non-load bearing) and embedded RC Concrete beams and columns noted.

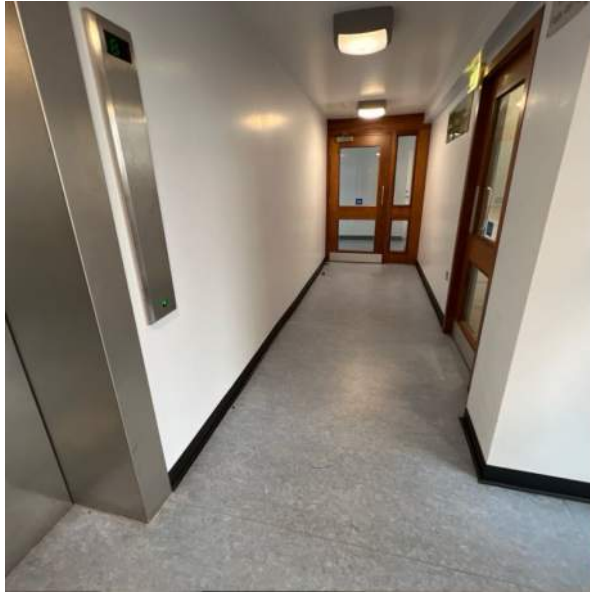
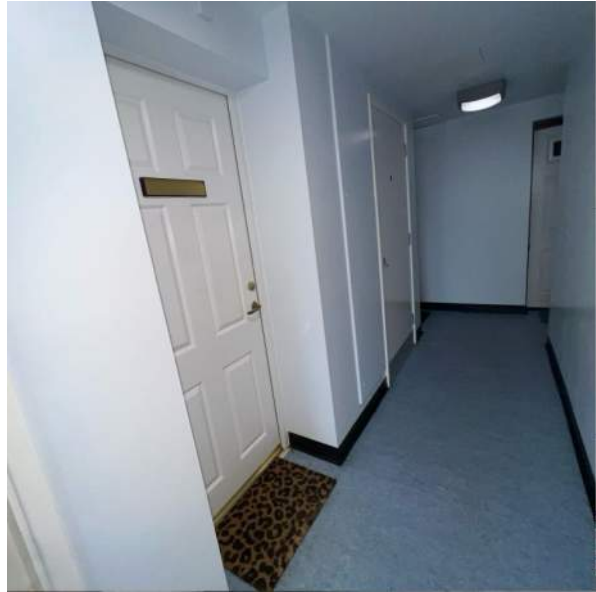
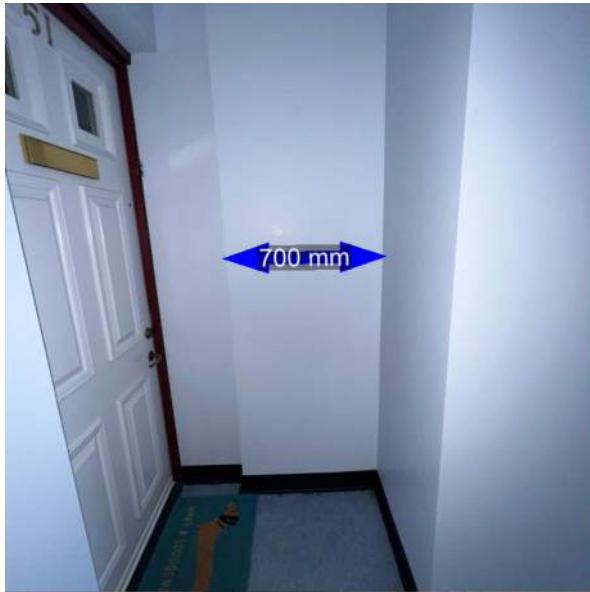
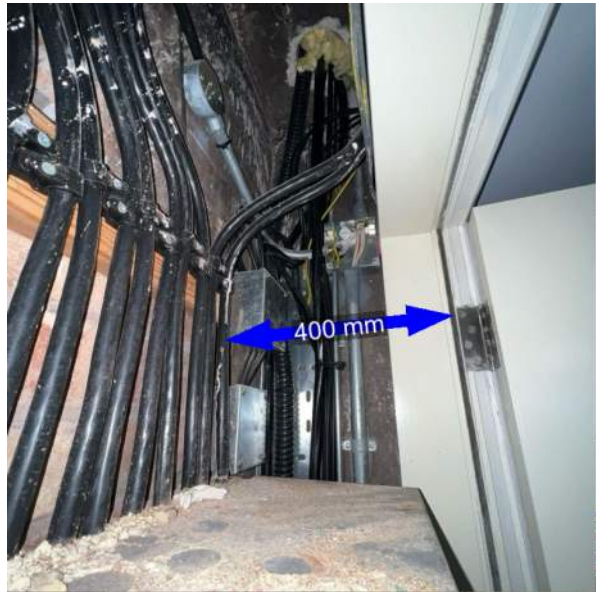
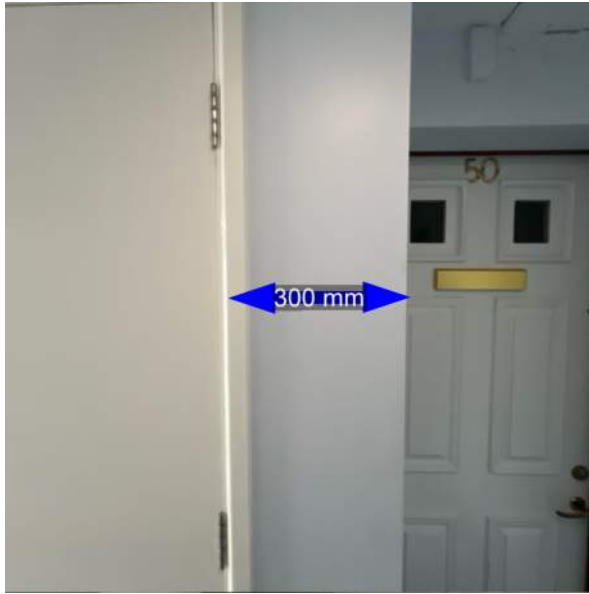
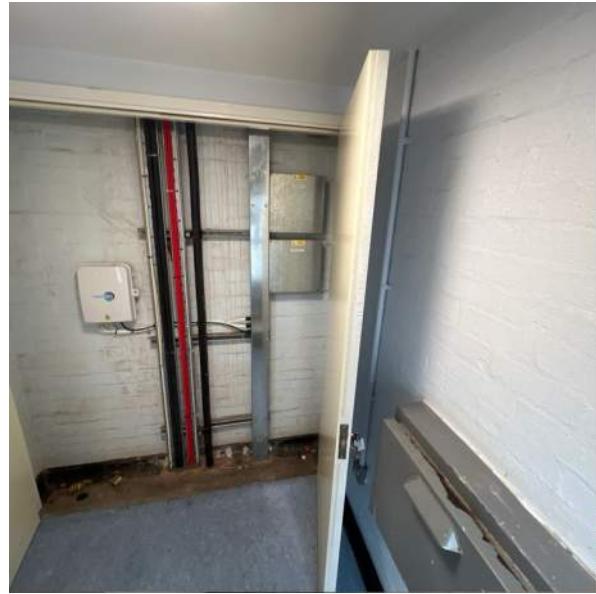
## 8th Floor Hallway

Comments: No jams or distortions noted to hallway doors to indicate any serviceability issues. Generally walls covered with finishes in hallway, likely to consist a mixture of concrete shear walls and embedded columns with internal partition walls. Riser cupboard shows infill masonry walls with partially exposed concrete elements appears to be RC Columns.

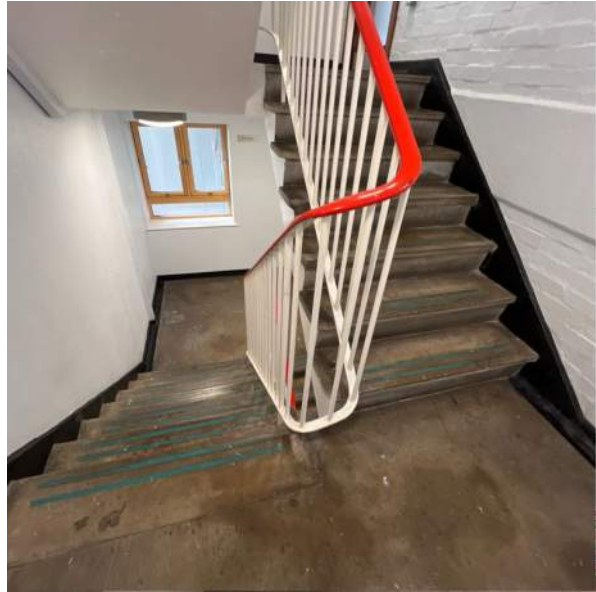
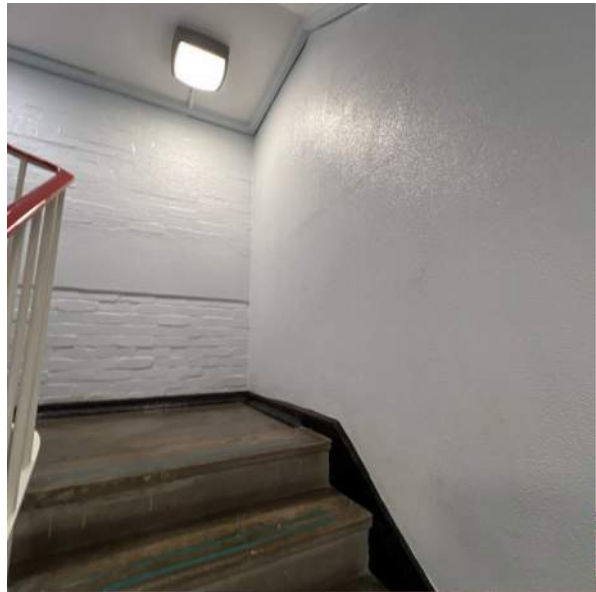
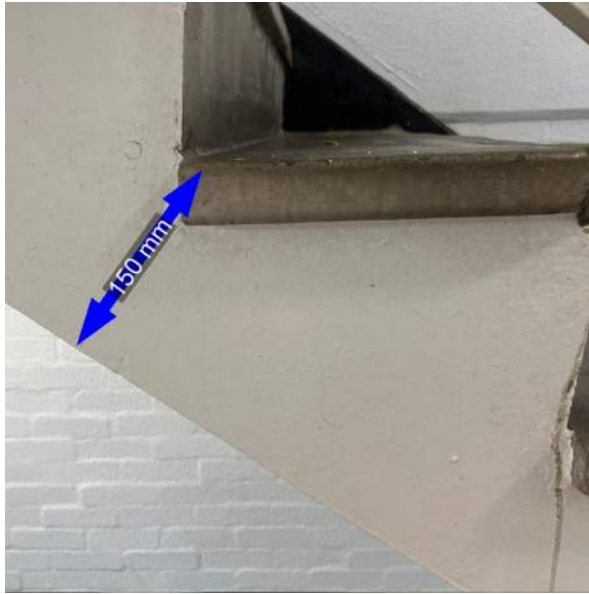
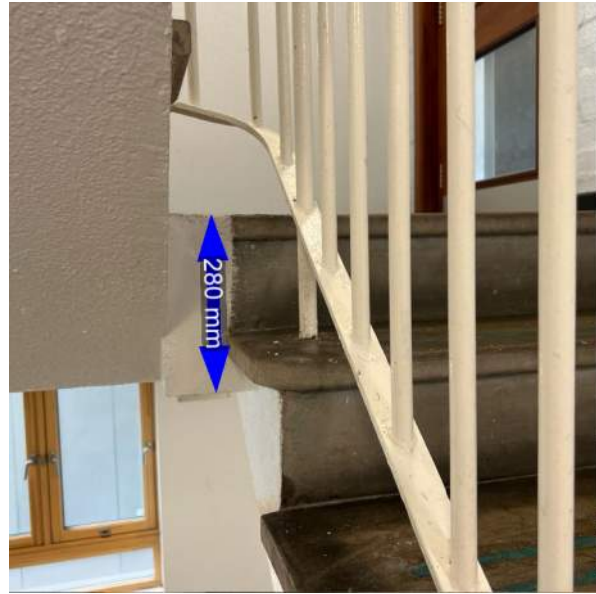
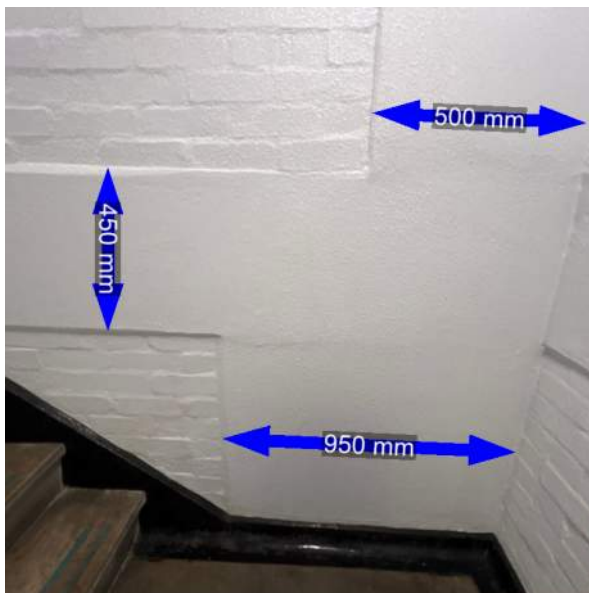
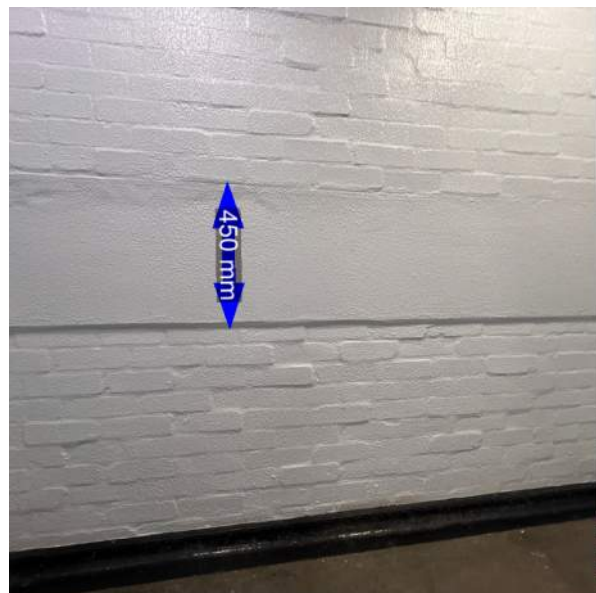
## 8th Floor Staircase

Insitu concrete stairs with steel hand railing fixed to stairs. Walls and floors appear to be fairly level.

Stair walls partly exposed showing infill masonry walls (non-load bearing) and embedded RC Concrete beams and columns noted.

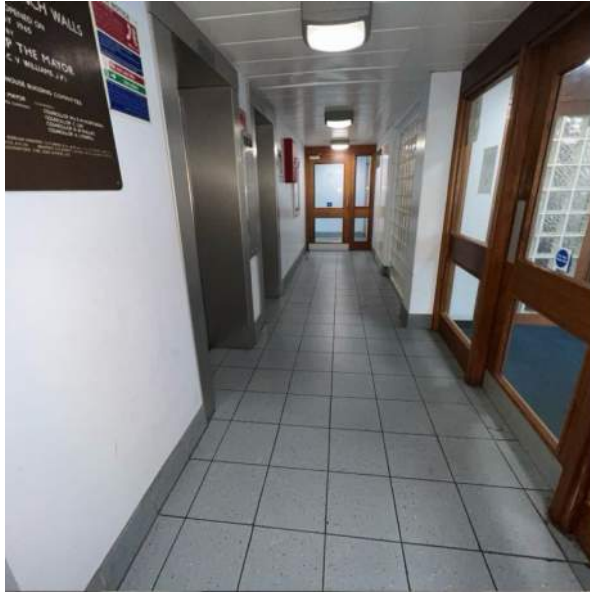
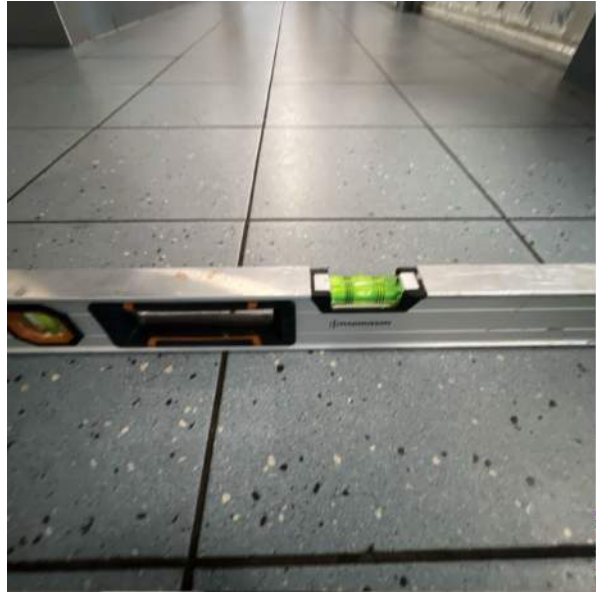
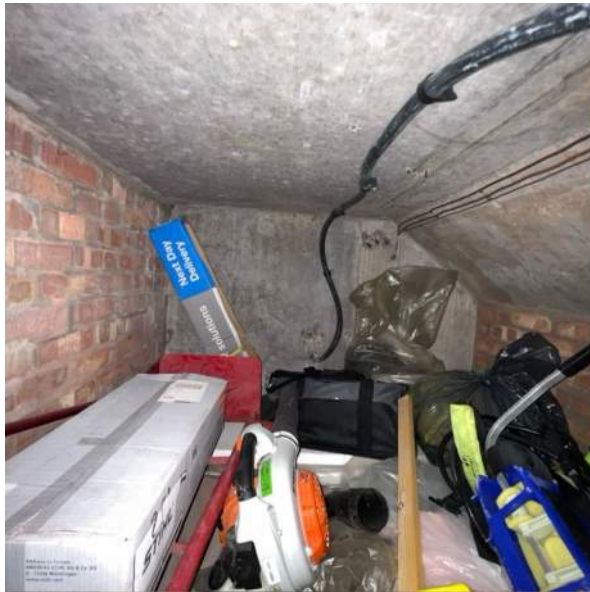
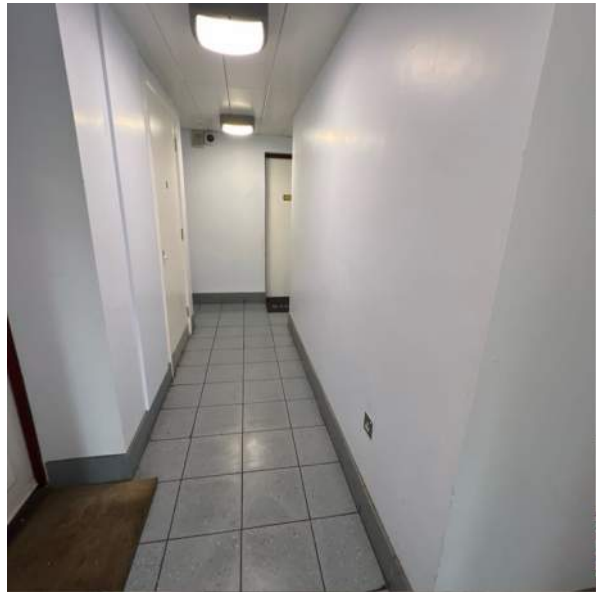
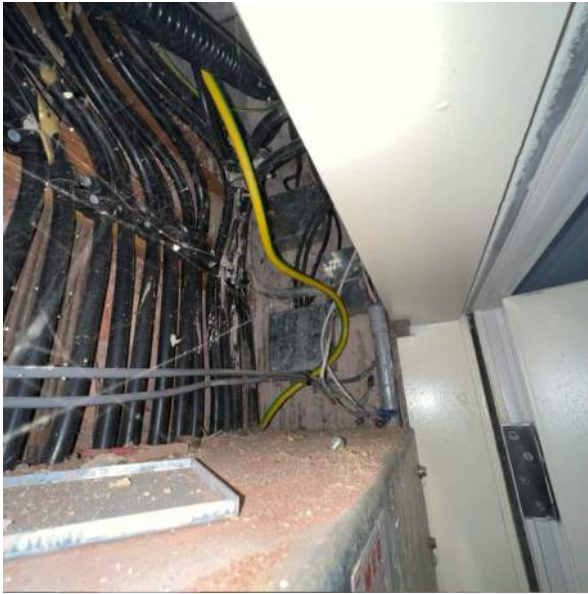
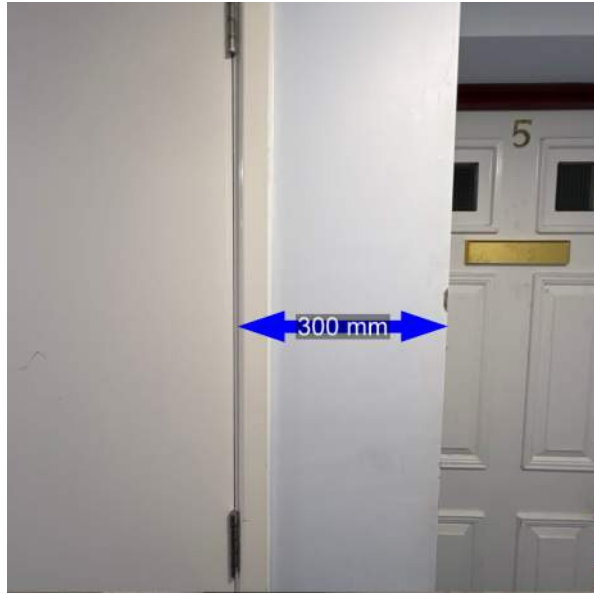
## Ground Floor Hallway

Comments: 24 Jul 2024 at 12:27 PM  
 No jams or distortions noted to hallway doors to indicate any serviceability issues.  
 Generally walls covered with finishes in hallway, likely to consist a mixture of concrete shear walls and embedded columns with internal partition walls.  
 Riser cupboard shows infill masonry walls with a partially exposed concrete element likely an RC Column.  
 Storage room under ground floor staircase shows embedded RC concrete beam and column in infill masonry walls. One side of stair wall noted to be an RC concrete wall likely forming a shear core wall of the structure.

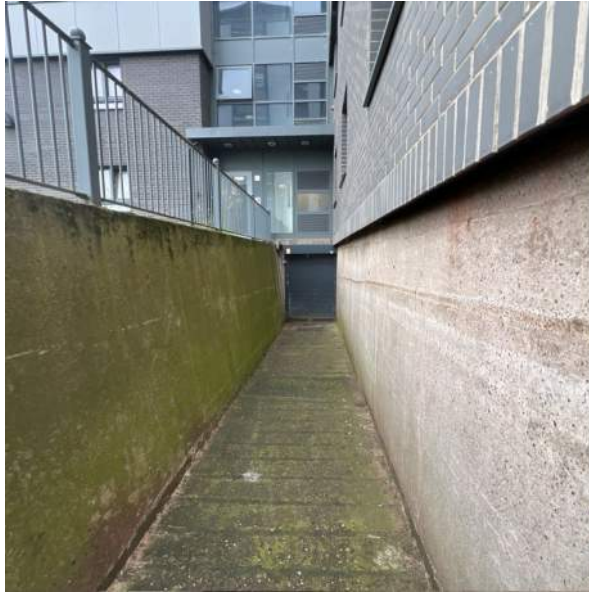
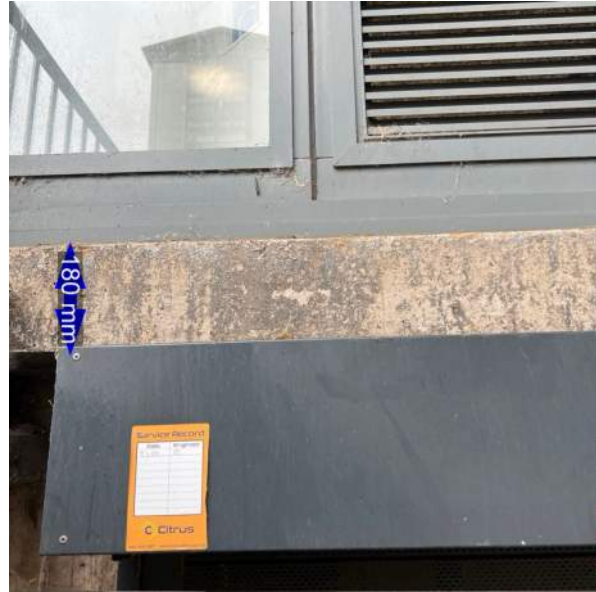
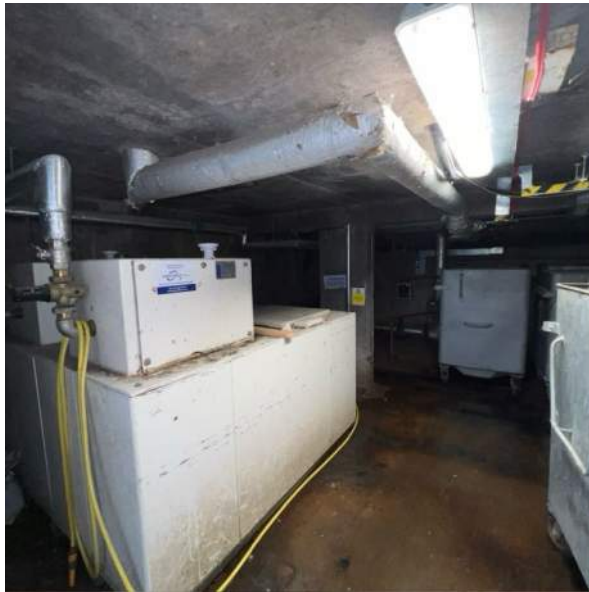
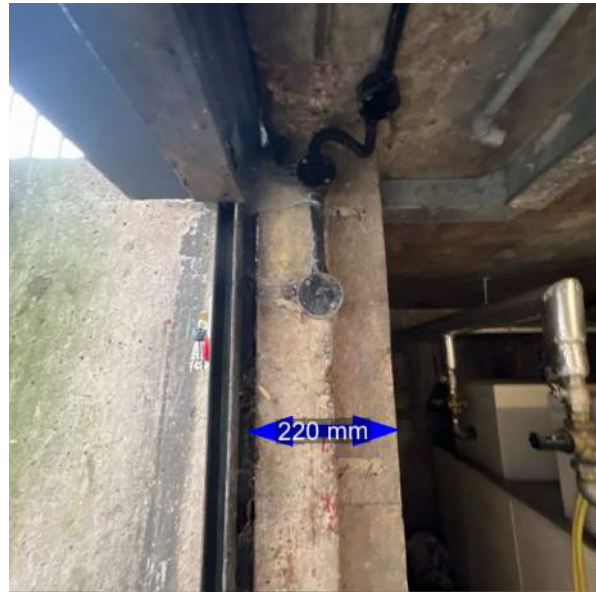
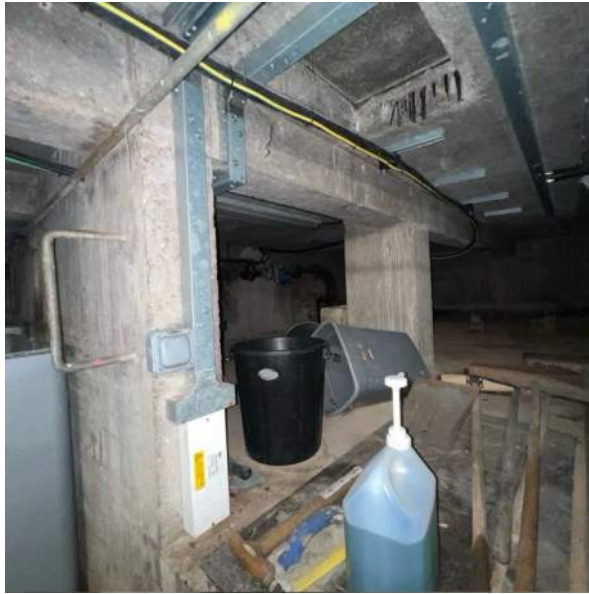
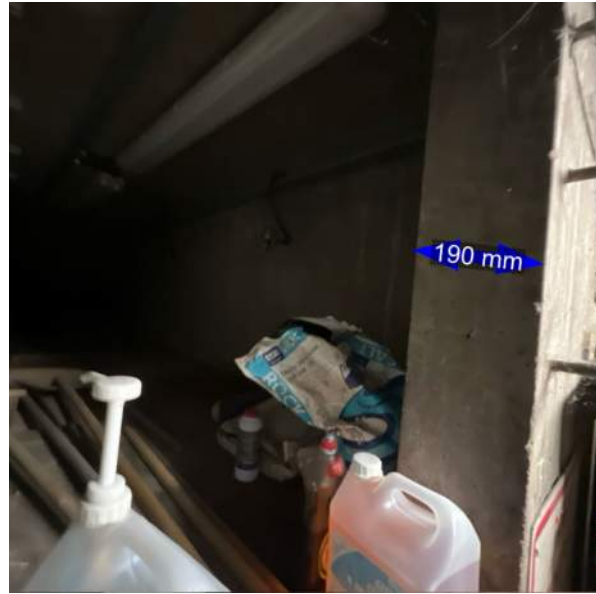
## Bin Store

Bin store located at basement level with a retaining wall leading up to bin store entrance. RC frame structure exposed forming of concrete beams, columns (230x600mm) and shear walls.  
Floor slab measured from bin store entrance noted to be approx. 180mm dp.

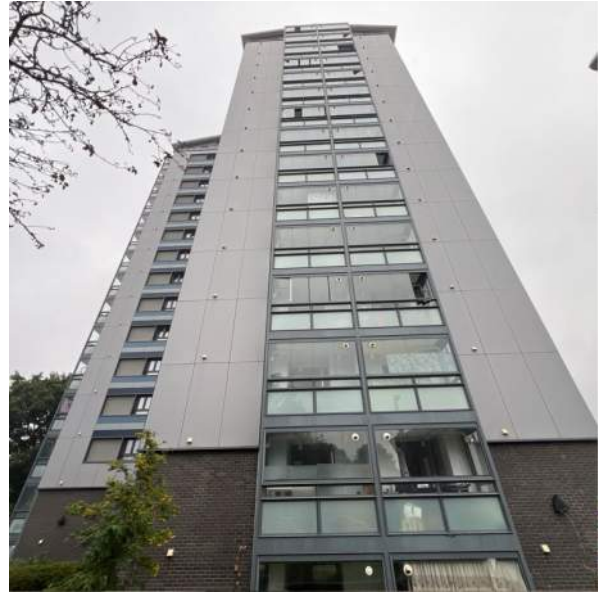
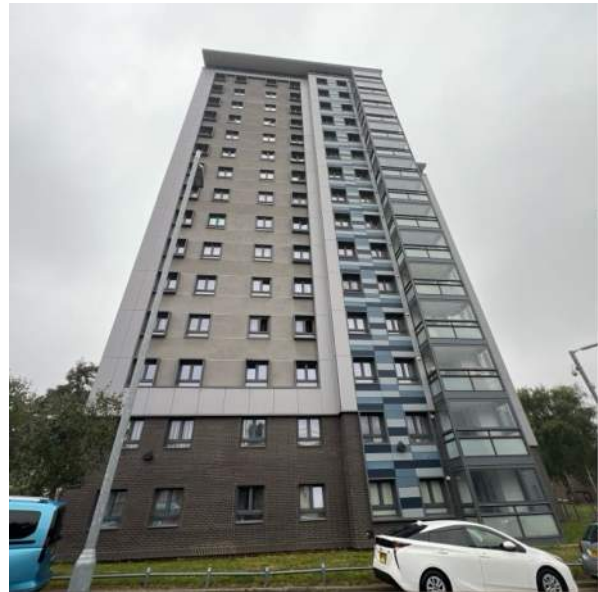
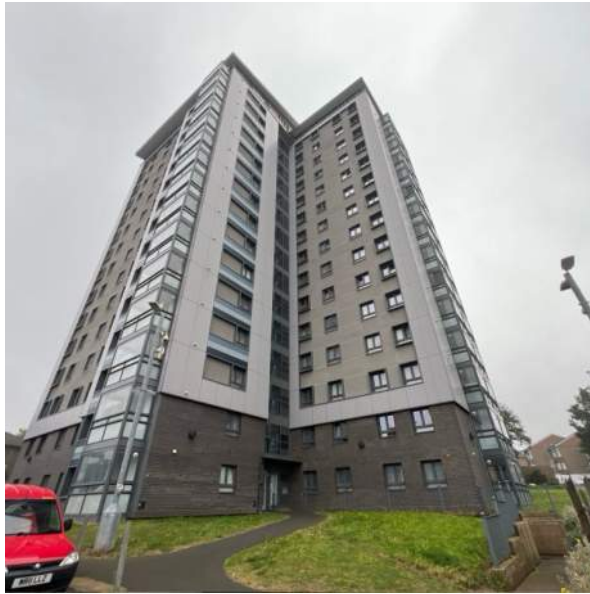
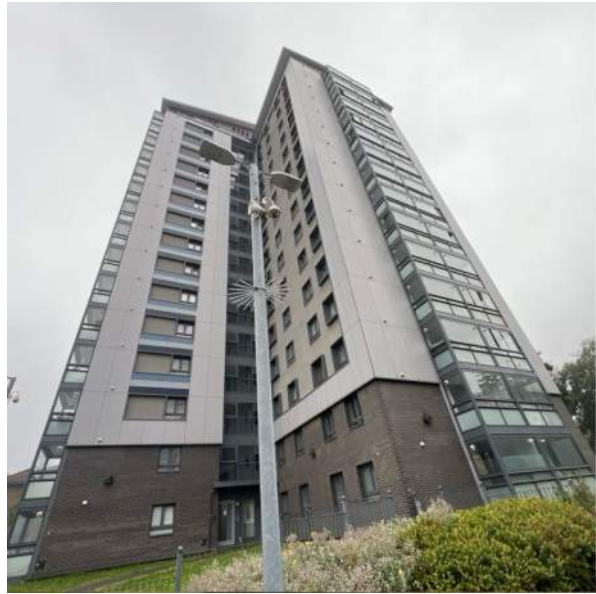
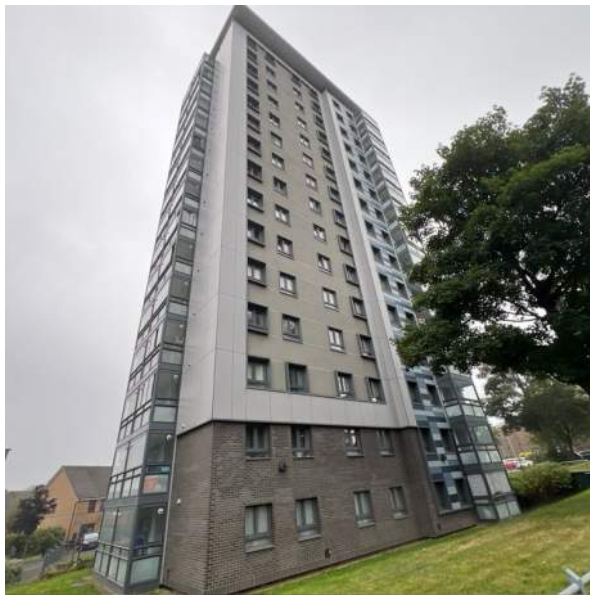
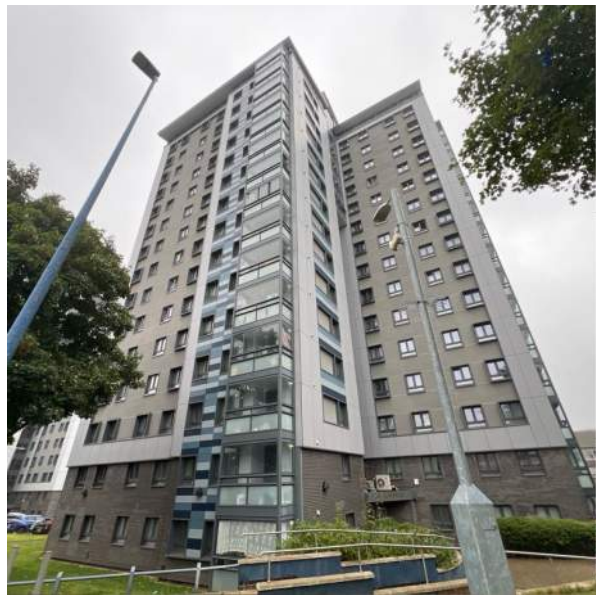
## Elevations

External ground and first level consists of brick work.  
Remaining floors noted to have a cladded facade to exterior.
