**FIRNTEC**  
BUILDING COMPLIANCE

VISUAL STRUCTURAL APPRAISAL

Boulton House  
Spoon Lane  
Tipton  
B70 6BJ

24<sup>th</sup> June 2025

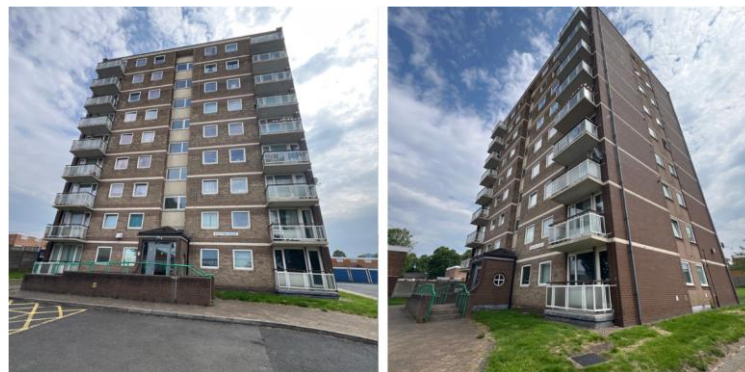
Figure 9 and 10: Building Elevations

The exterior elevations were generally in ok condition and no significant structural defects were noted to the infill panels. There were no significant cracks or tell-tale signs of any significant structural movement noted at the time of our inspection.

The exterior panels were noted to be plumb with no signs of significant bowing, bulging or leaning noted to the panels indicating failed fixings however their presence and condition cannot be confirmed.

There are balconies at each level which are formed of cantilevered RC slabs tied into the main frame. The balconies would benefit from a refurbishment with widespread failed coatings throughout. The cantilevered slabs should be checked for internal corrosion potential at the benchmark inspections.

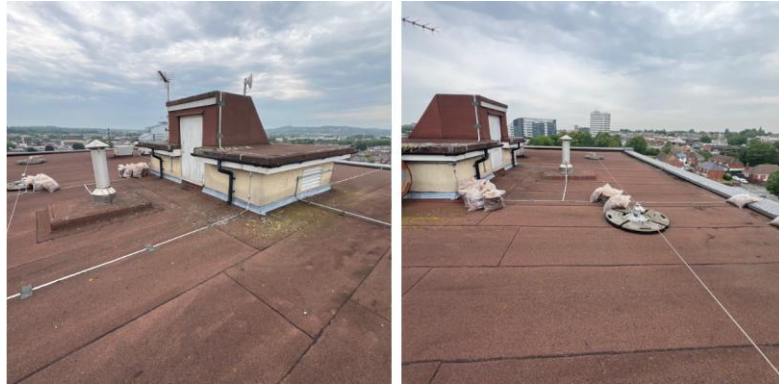
Figure 11 and 12: Roof Level

There were no tell-tale signs of any significant structural movement noted at the time of our inspection.

The roof has a felted waterproofing system. The exact build-up of the roof finishes were not accessible at the time of inspection. It is recommended an intrusive survey of the roof finishes is completed by a specialist surveyor to assess the condition of the roof covering although they were noted in good condition with no known water ingress issues and therefore a low risk element.

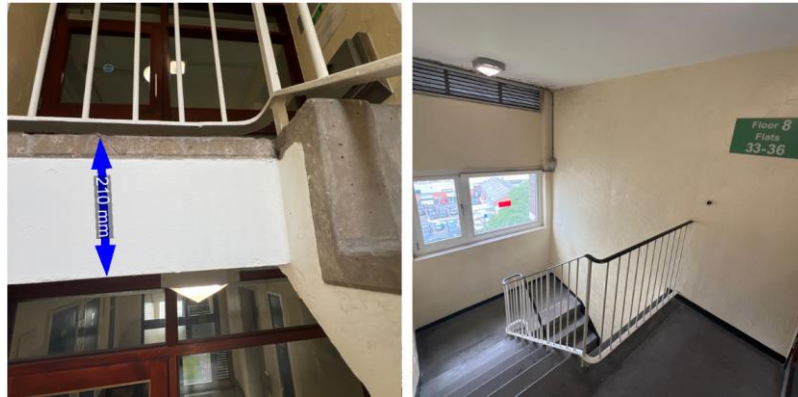
Figure 14 and 15: Slab edge and stair stringer

The interior of the stair core walls were checked and were plumb and in line with observations made to the exterior – no significant signs of leaning or movement noted. The concrete appeared in fair condition with few BRE category 1 cracks but no structurally significant defects were noted.

The stair stringer was noted to be 120mm thick which seems short of modern standards. A cover test is required to check the resistance of the concrete section in the event of a fire.

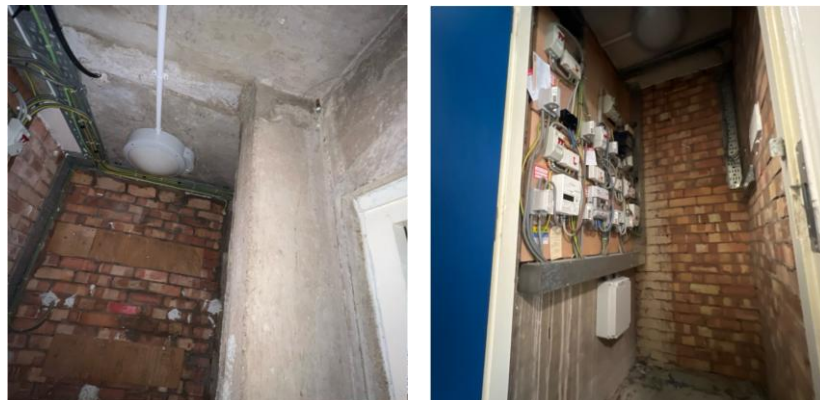
Figure 16 and 17: RC internal elements

There were vertical concrete walls supporting the floor plates at every level. The elements visible matched the floor layout in Figure 6. The walls appear continuous from ground to roof with no transfer structure. The overall condition of the structure observed is good.

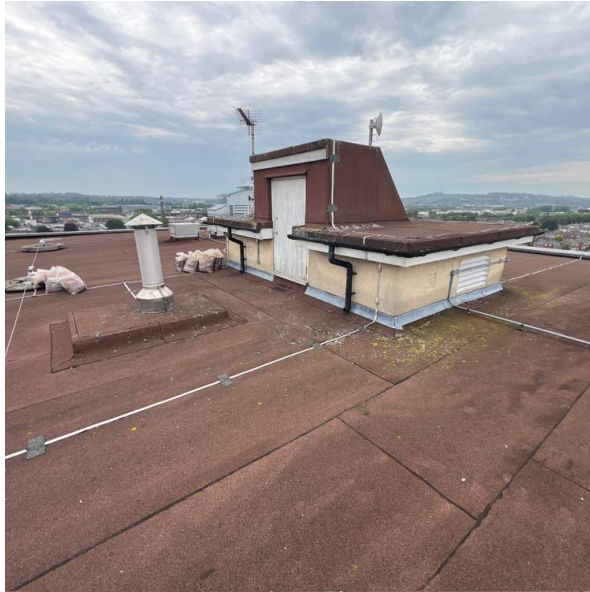
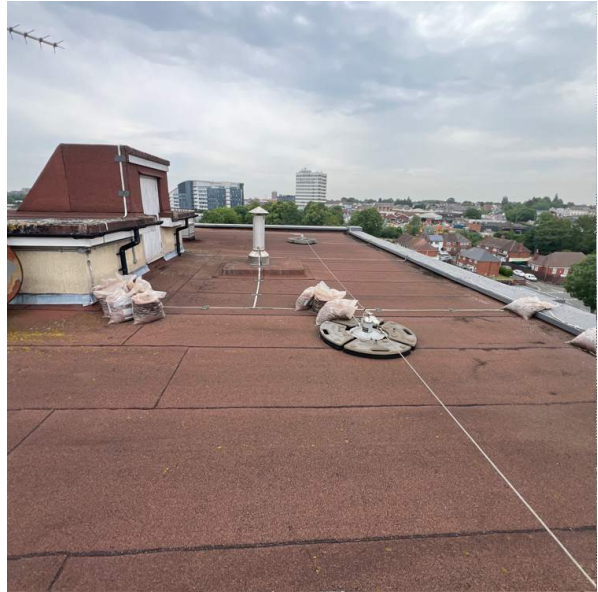
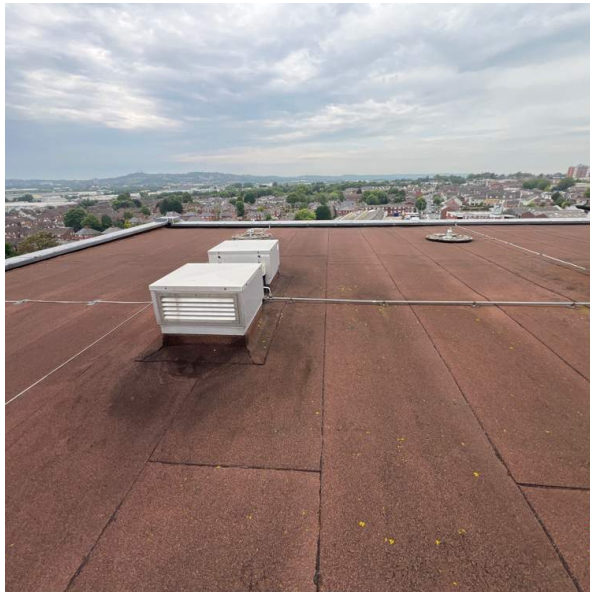
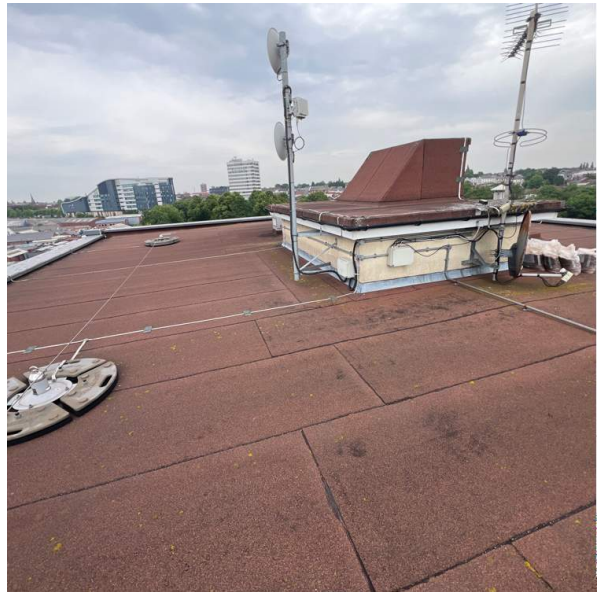
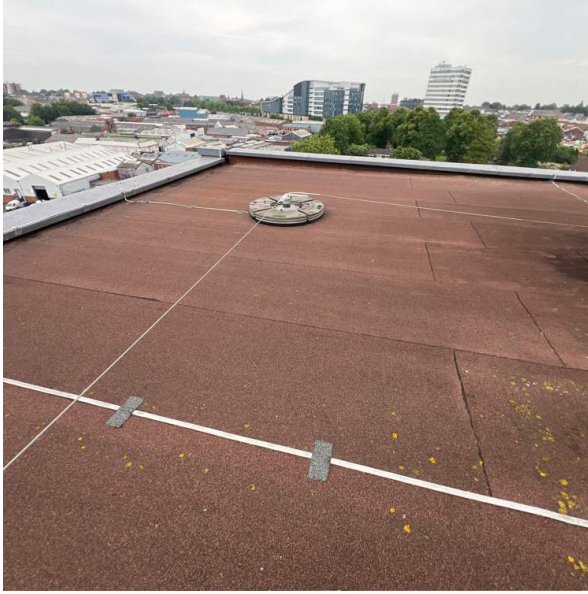
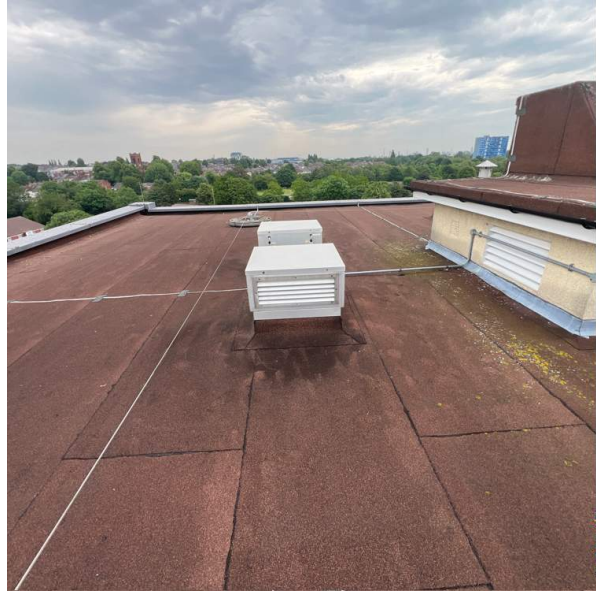
## Main Roof

Comments: Flat roof, RC concrete slab with insulated PIR board and felt coverings.

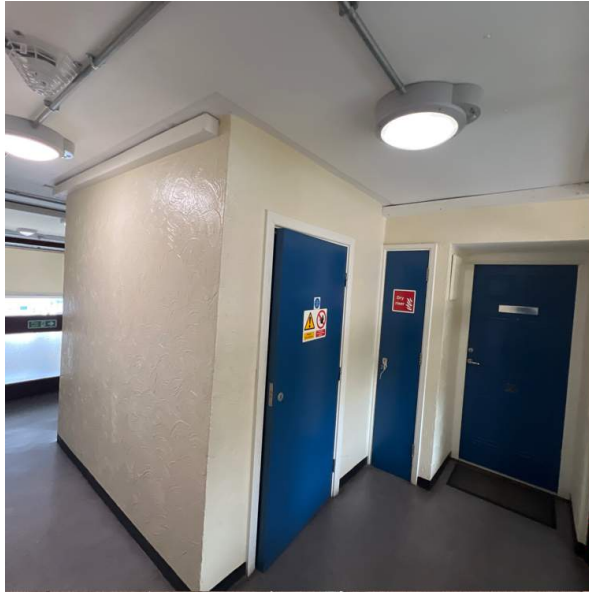
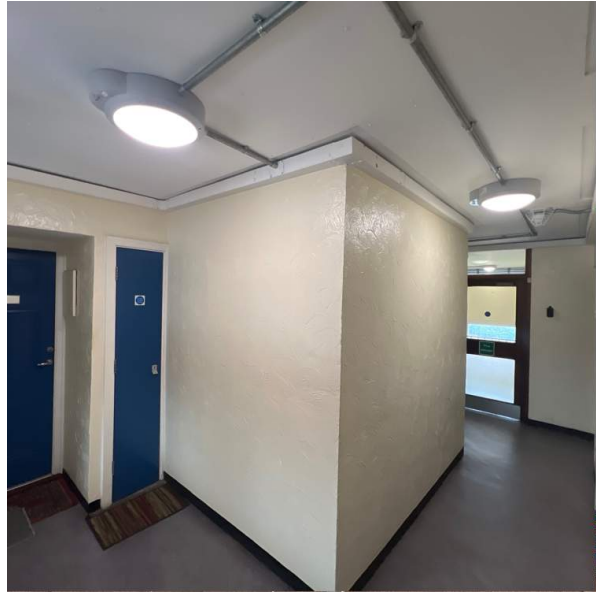
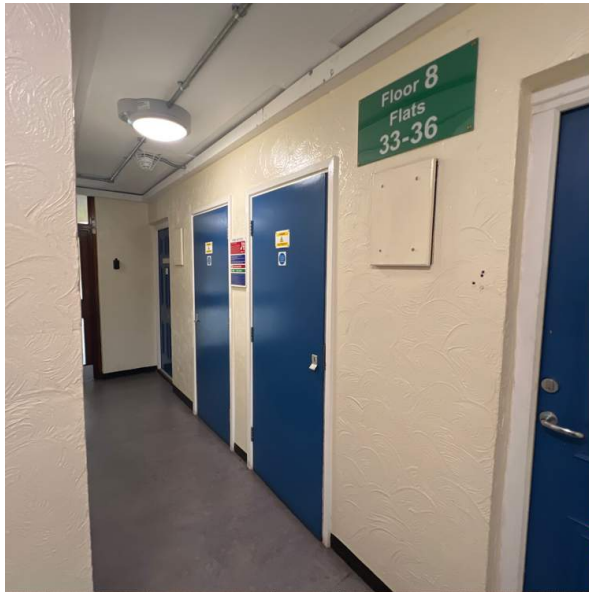
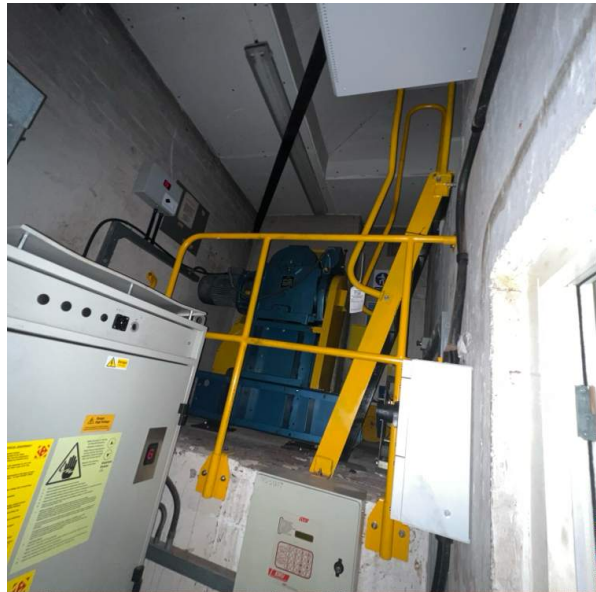
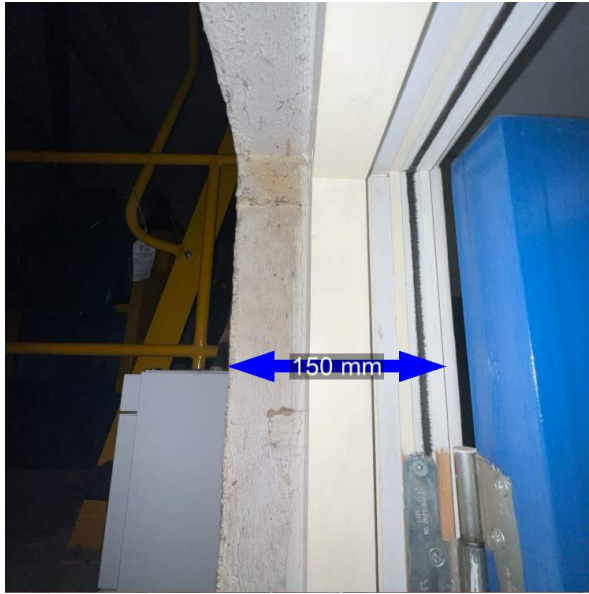
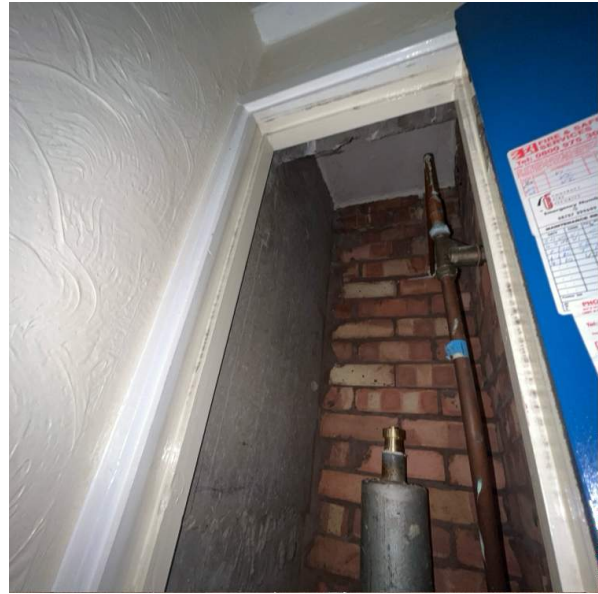
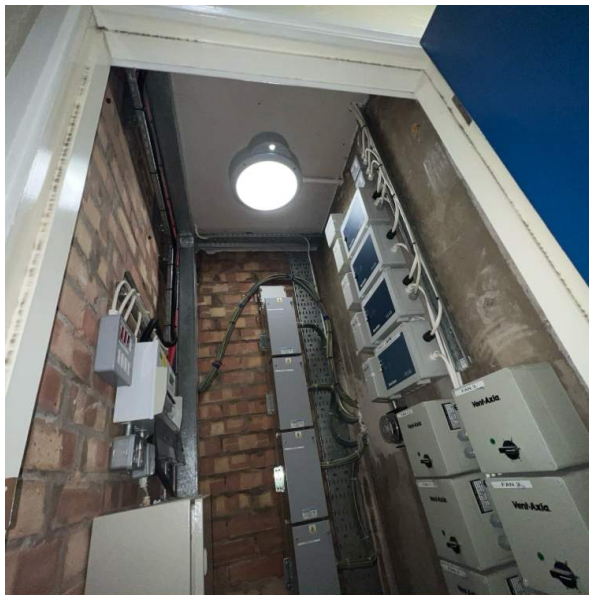
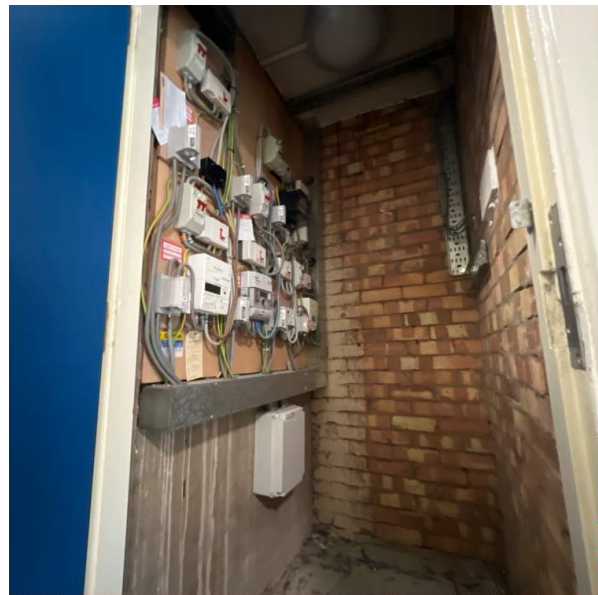
## 8th Floor Hallway

Comments: No jams or distortions noted to hallway doors to indicate any serviceability issues. Generally walls covered with finishes in hallway, likely to consist a mixture of concrete shear walls, embedded columns and masonry infill walls. Limited structure exposed. Concrete walls and infill masonry (non-load bearing) walls noted in riser cupboards.

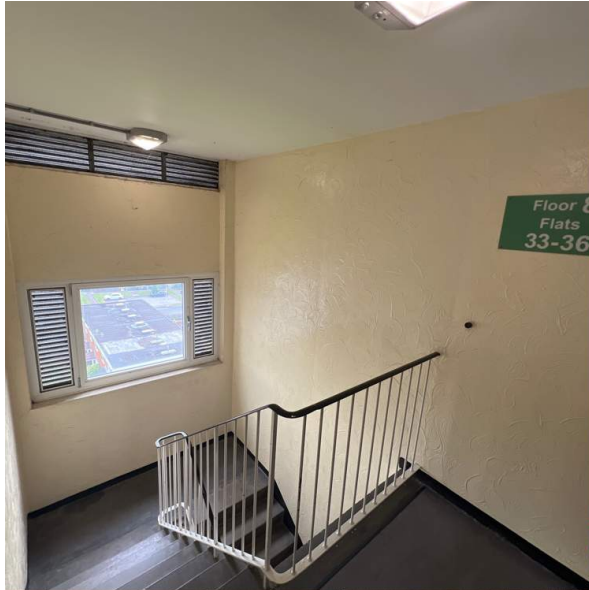
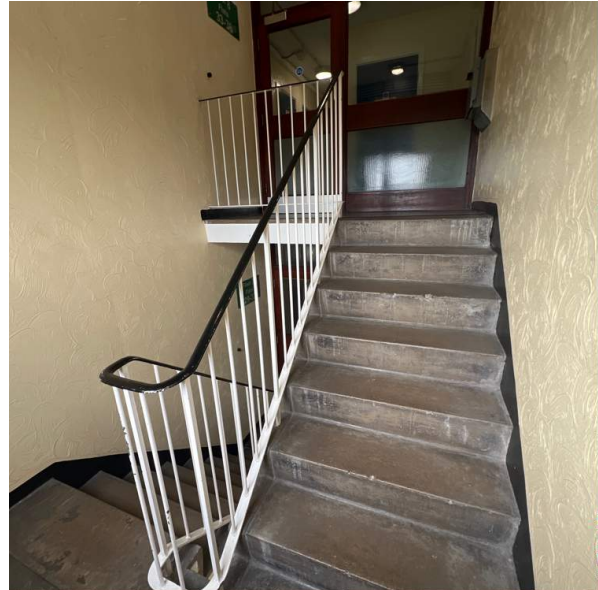
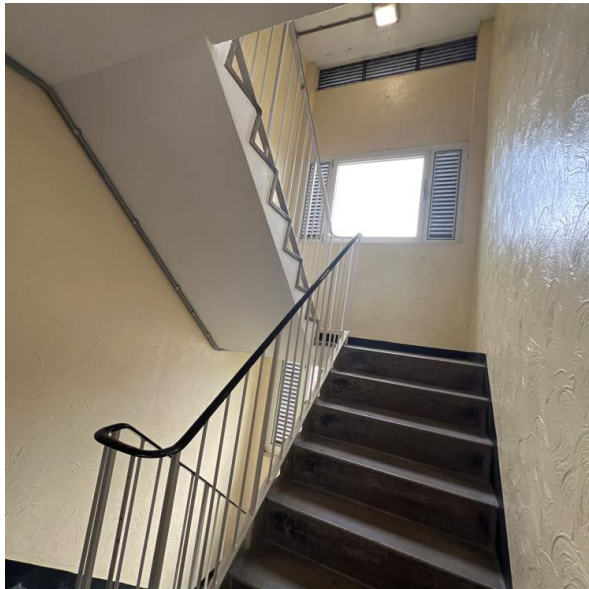
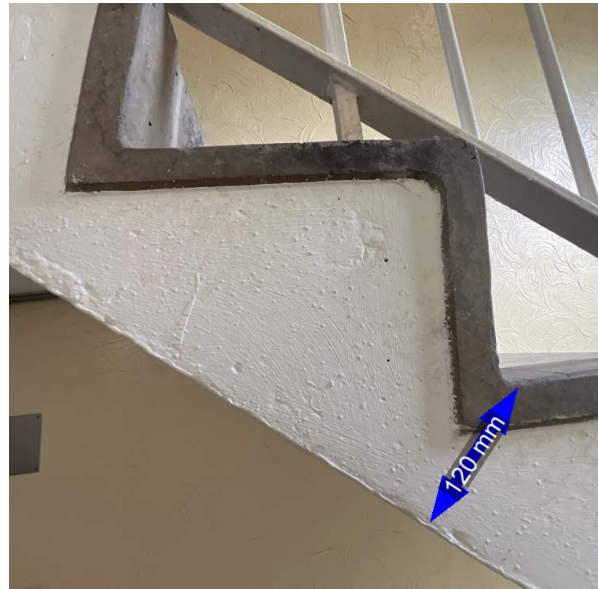
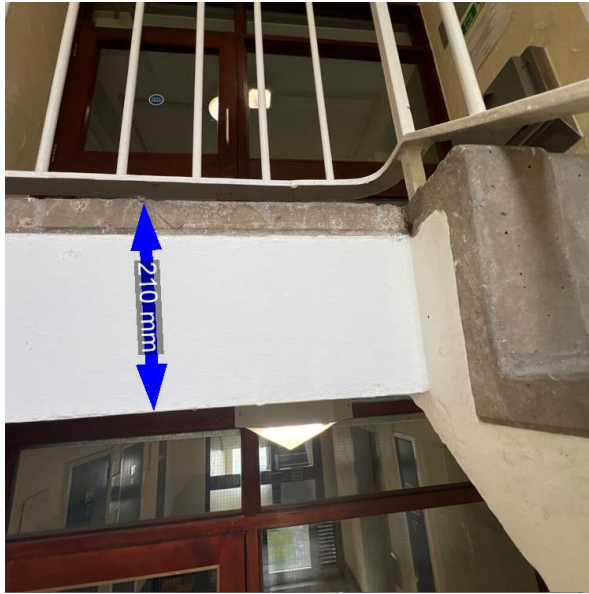
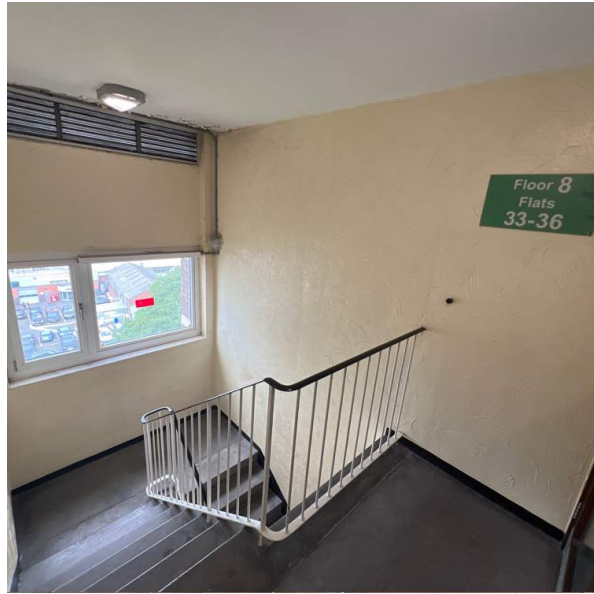
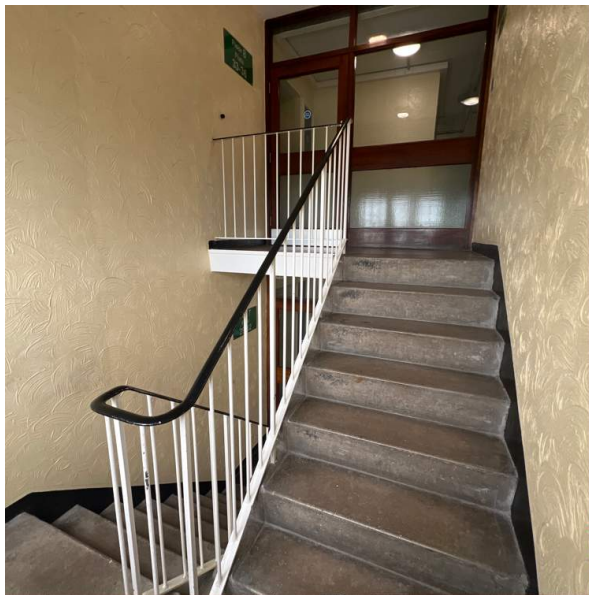
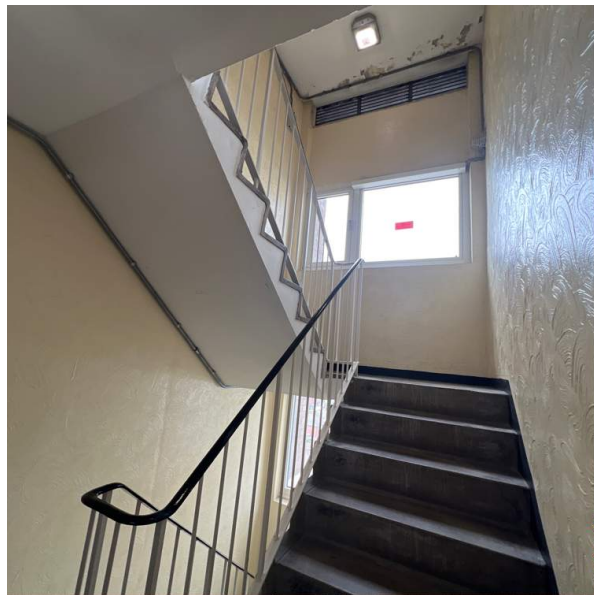
## 8th Floor Staircases

Comments: Insitu concrete stairs with steel hand railing fixed to stairs. Walls and floors appear to be fairly level.  
Stair walls covered with finishes however these would likely form the main concrete shear core walls.

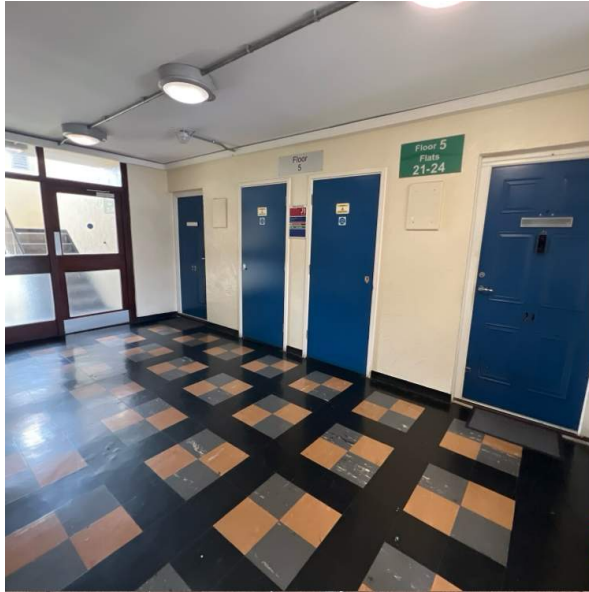
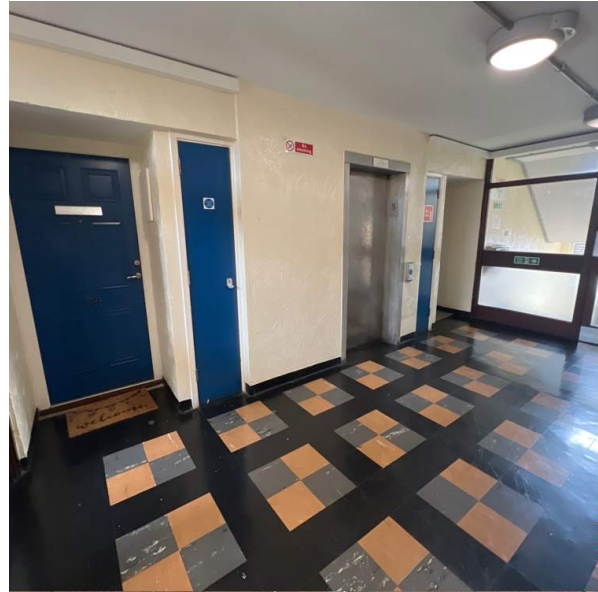
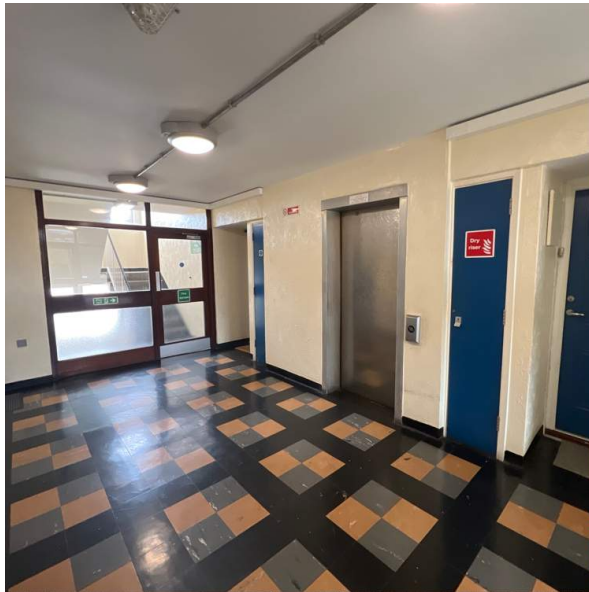
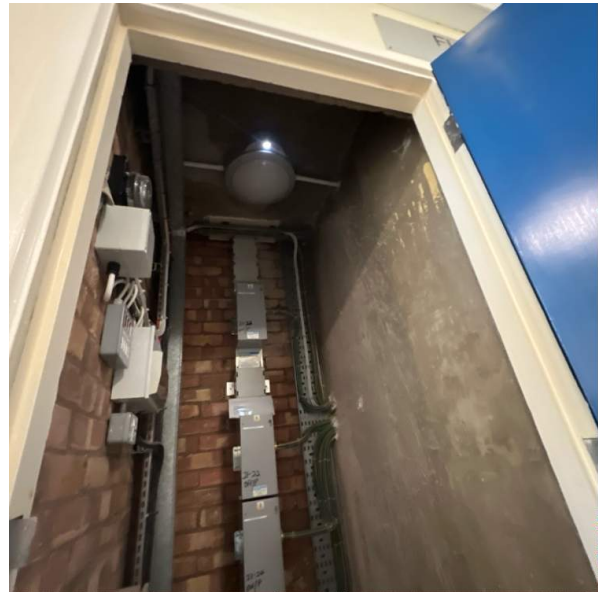
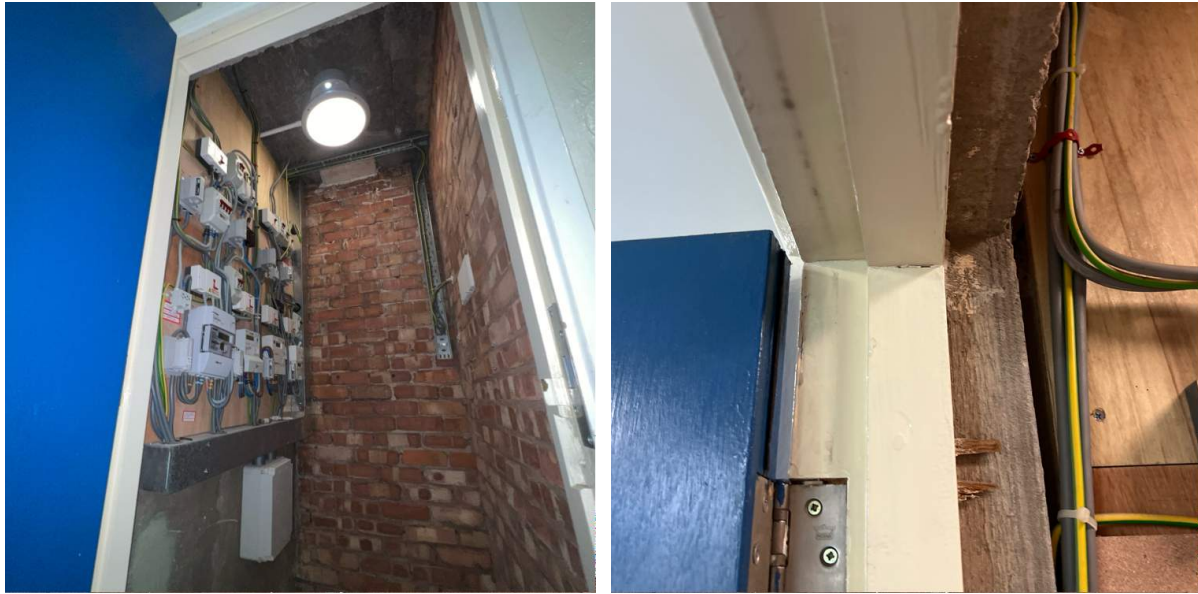
## 5th Floor Hallway

Comments: No jams or distortions noted to hallway doors to indicate any serviceability issues. Generally walls covered with finishes in hallway, likely to consist a mixture of concrete shear walls, embedded columns and masonry infill walls. Limited structure exposed. Concrete walls and infill masonry (non-load bearing) walls noted in riser cupboards.

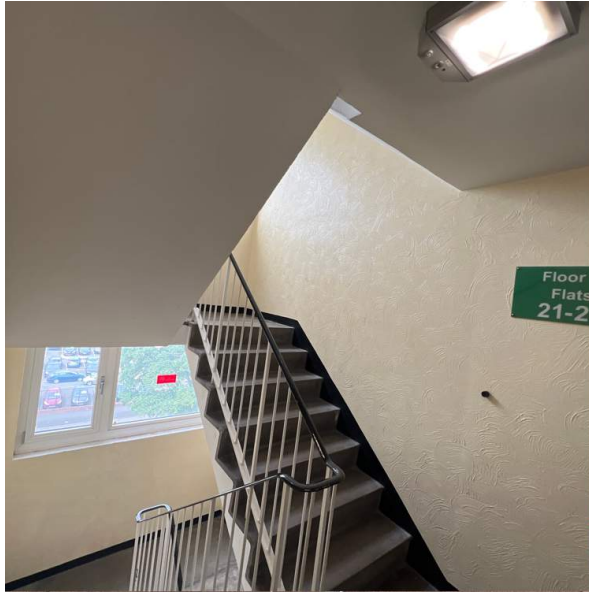
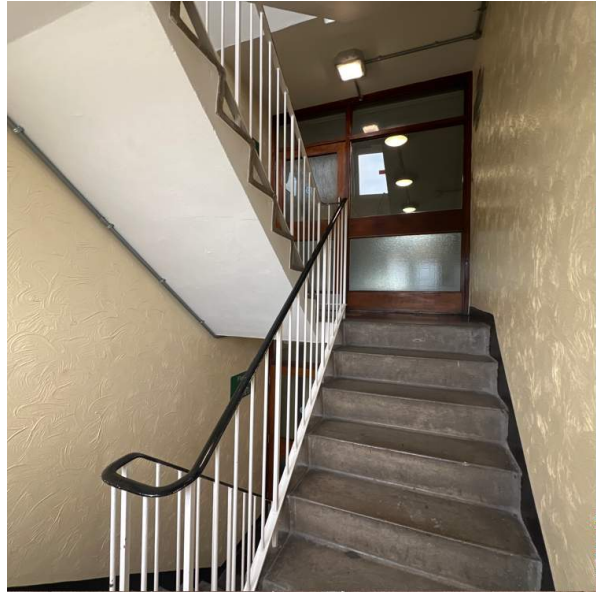
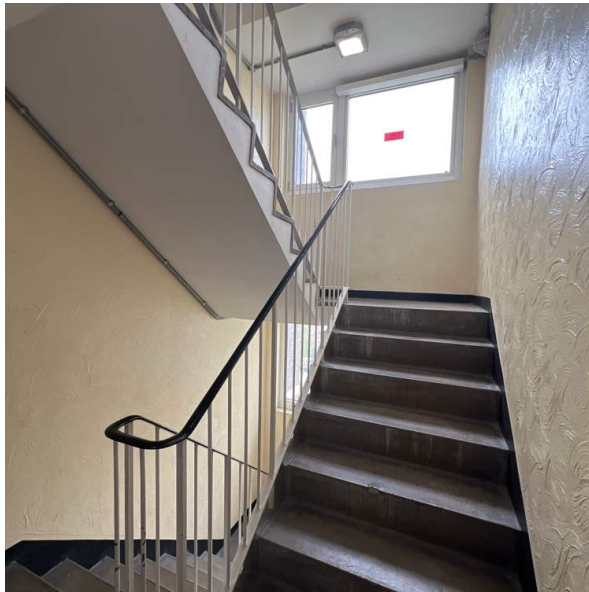
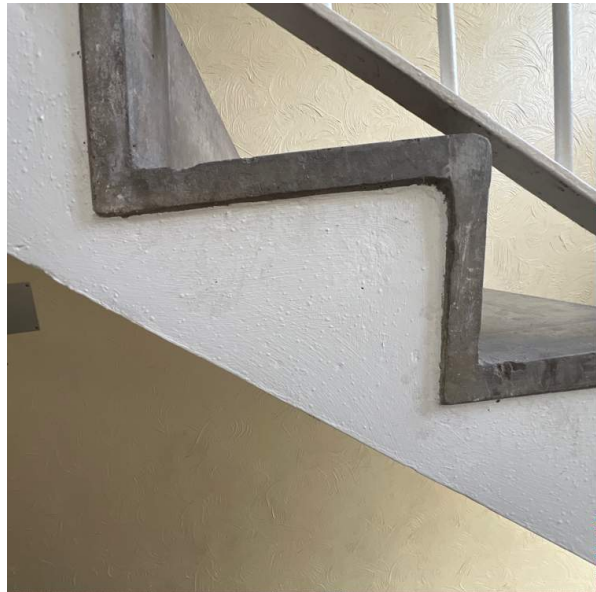
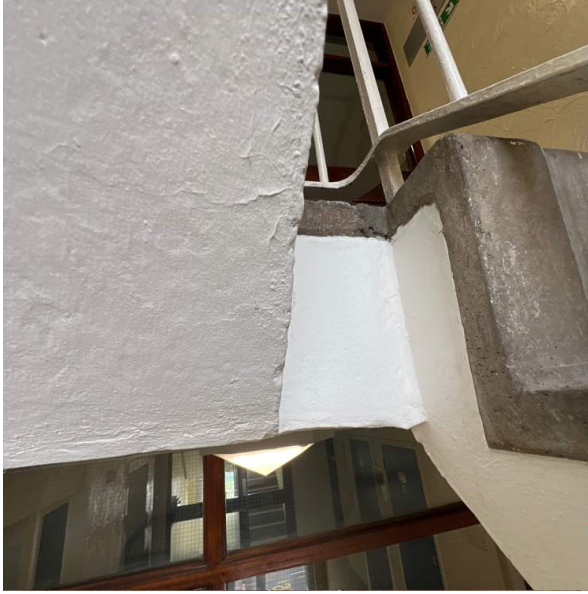
## 5th Floor Staircases

Comments: Insitu concrete stairs with steel hand railing fixed to stairs. Walls and floors appear to be fairly level.  
Stair walls covered with finishes however these would likely form the main concrete shear core walls.

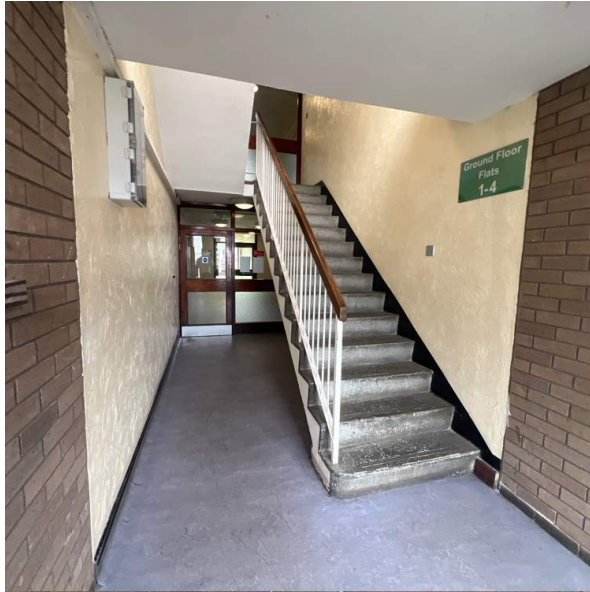
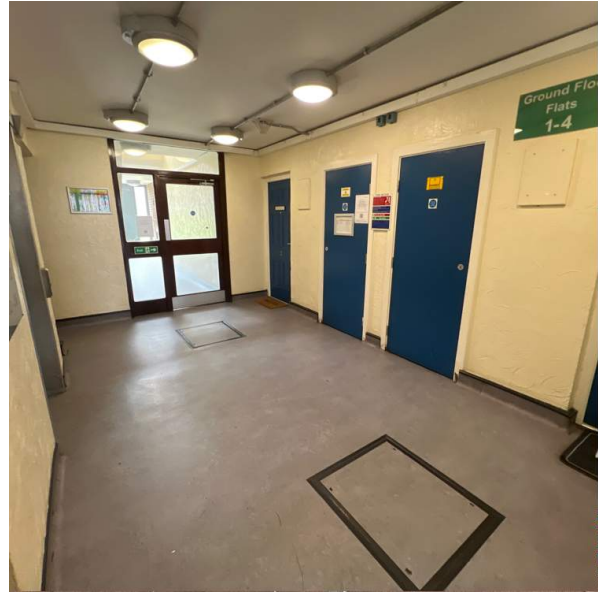
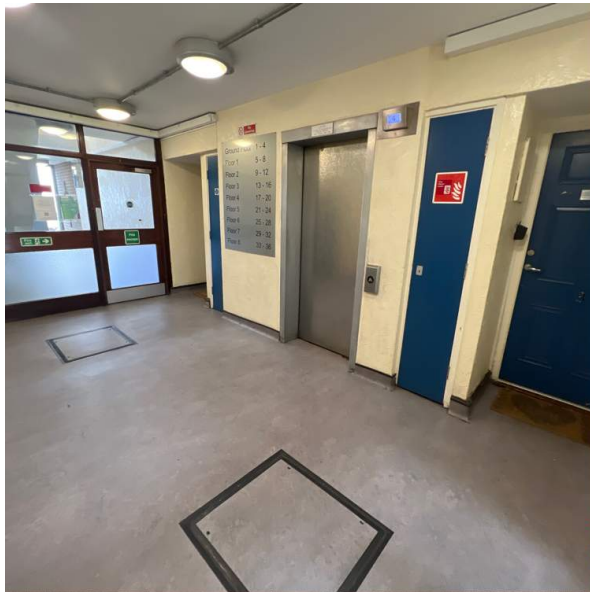
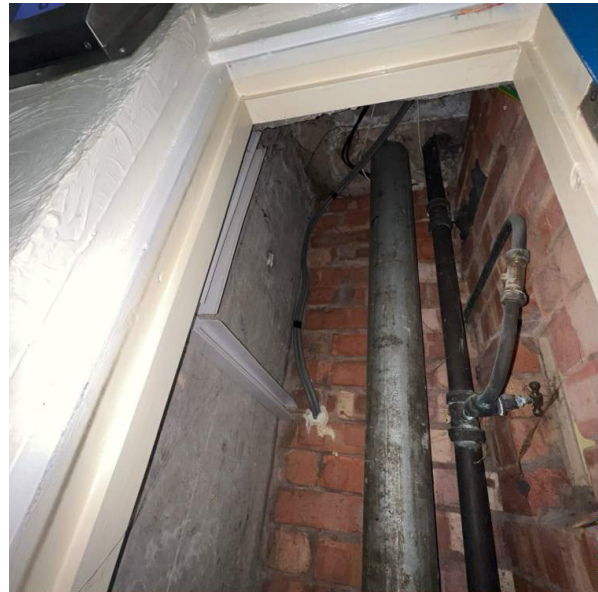
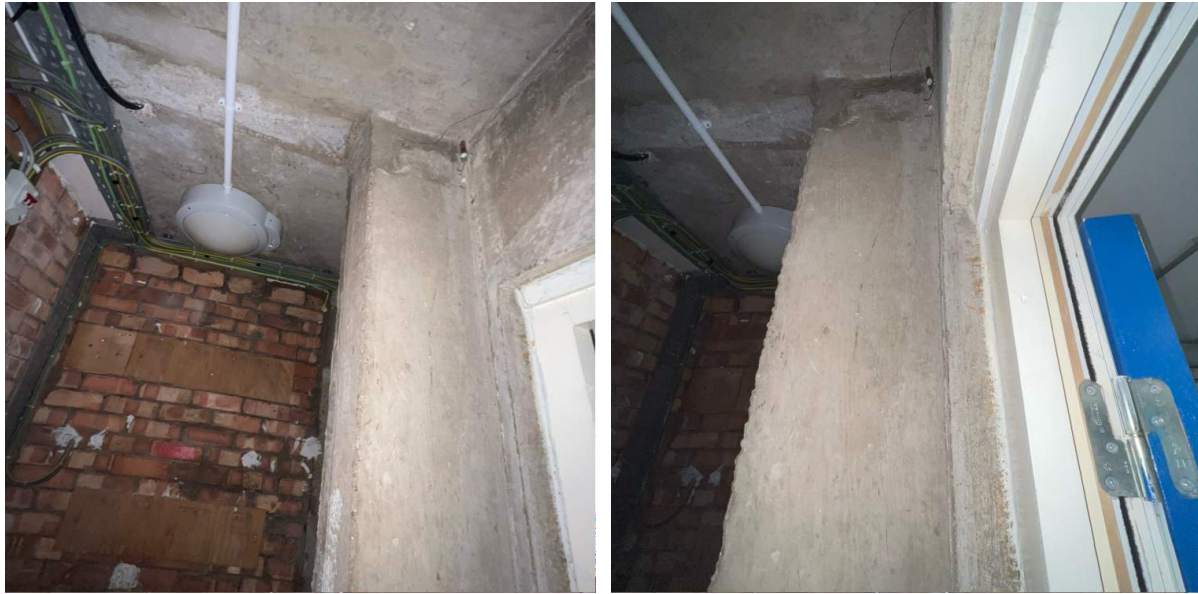
## Ground Floor Hallway

Comments: No jams or distortions noted to hallway doors to indicate any serviceability issues. Generally walls covered with finishes in hallway, likely to consist a mixture of concrete shear walls, embedded columns and masonry infill walls. Limited structure exposed. Concrete walls and infill masonry (non-load bearing) walls noted in riser cupboards.

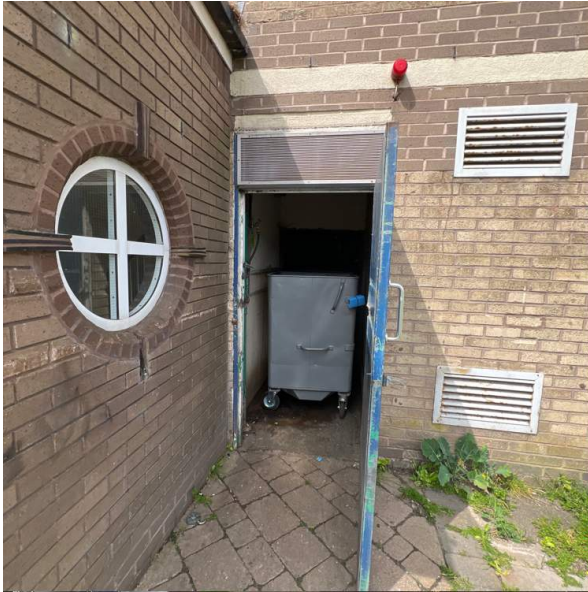
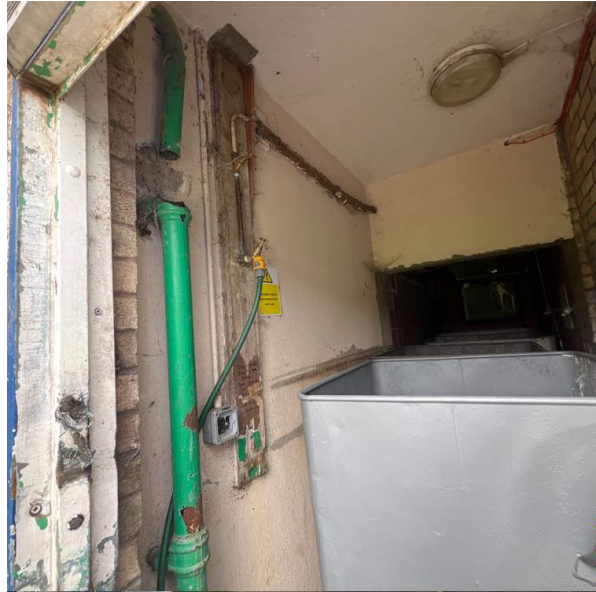
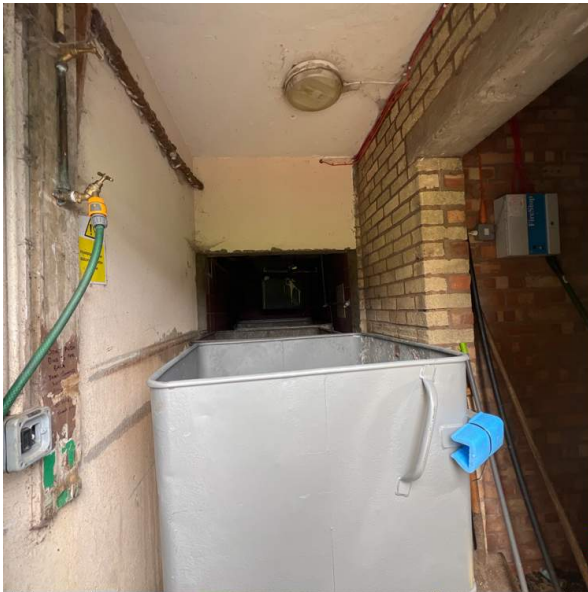
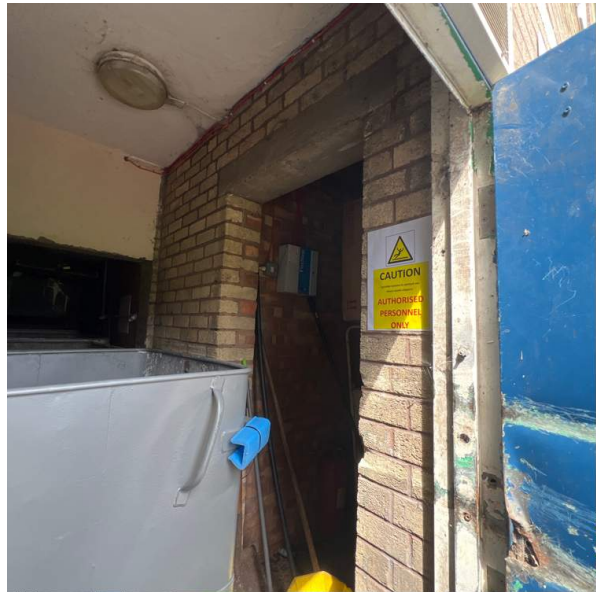
## Bin Store

Comments: RC concrete walls noted in bin store.

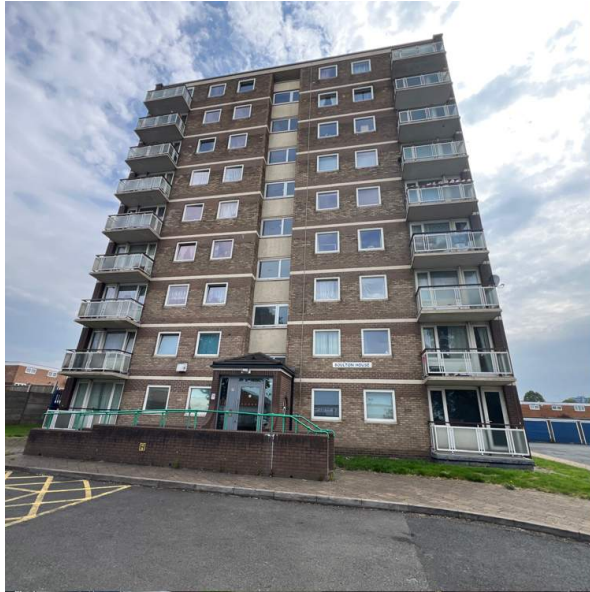
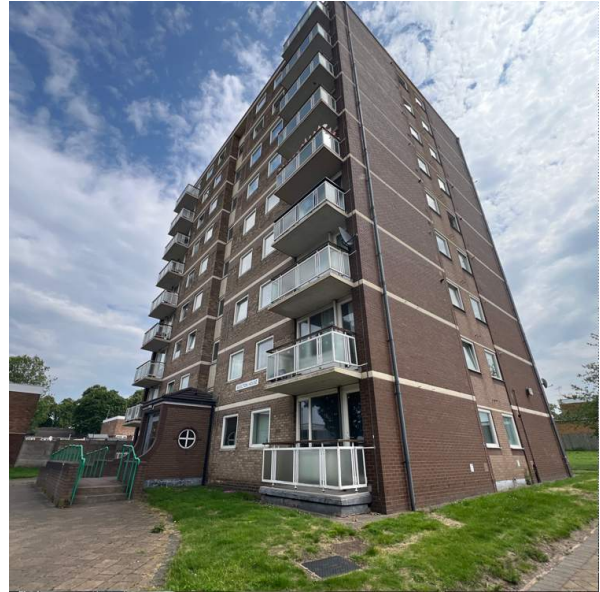
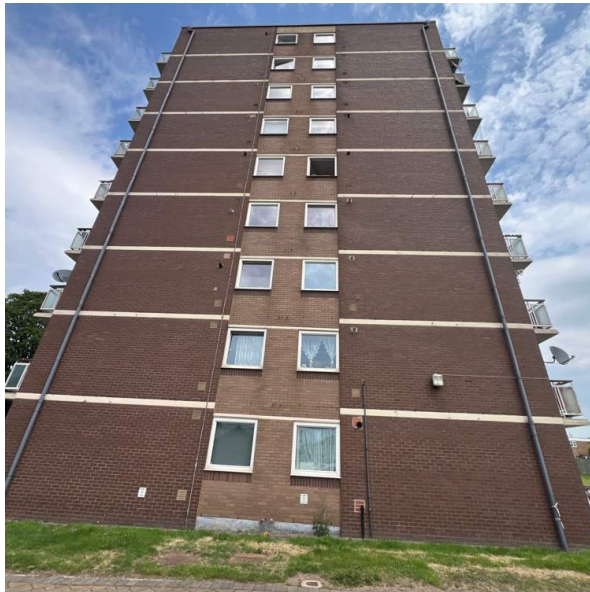
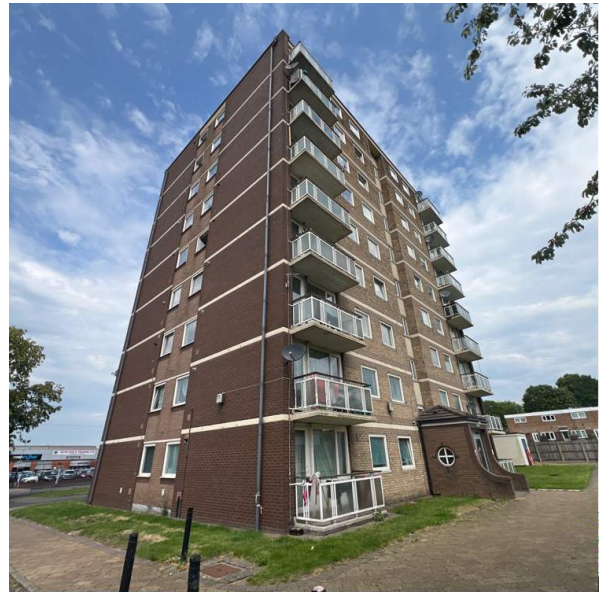
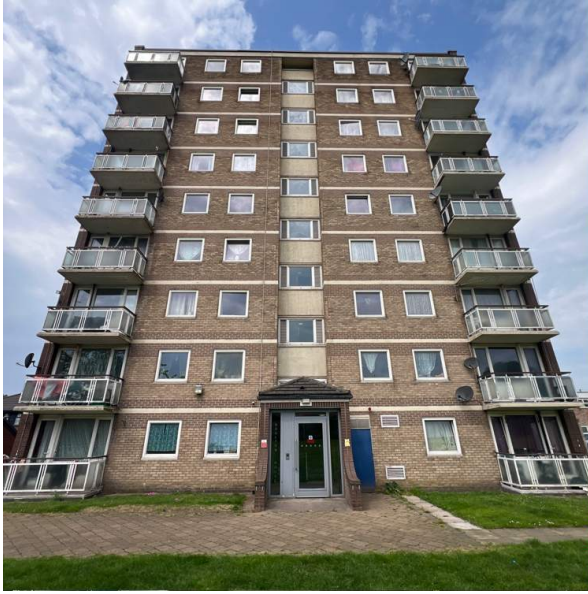
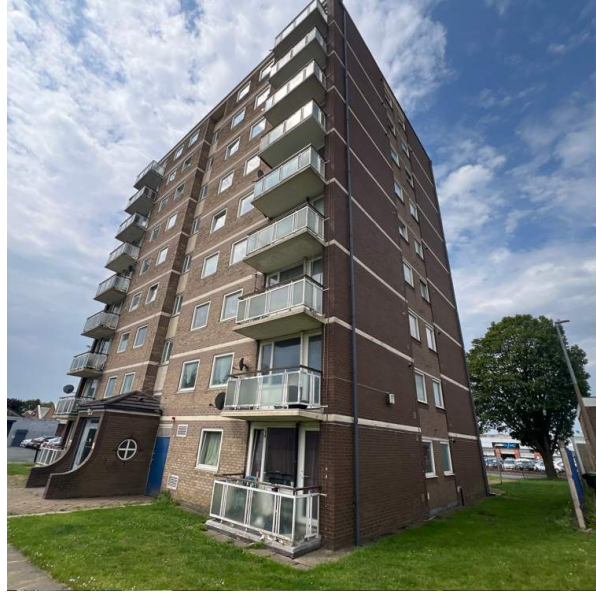
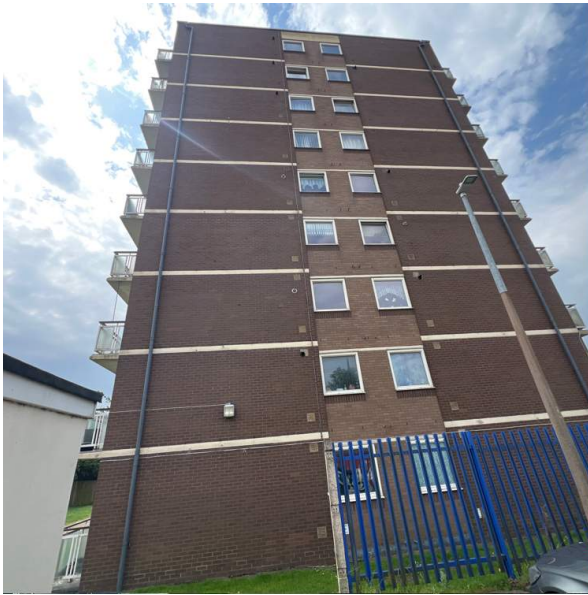
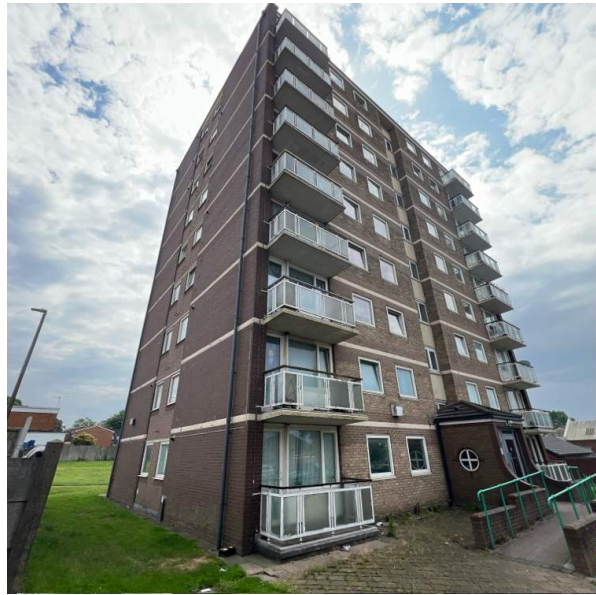
## Elevations

Comments: External facade consists of brick work on all levels for all elevations. Cantilevered balconies noted at each floor.
