VISUAL STRUCTURAL APPRAISAL

Bowater House

Moor Lane  
West Bromwich  
B70 7AW

27<sup>th</sup> November 2024

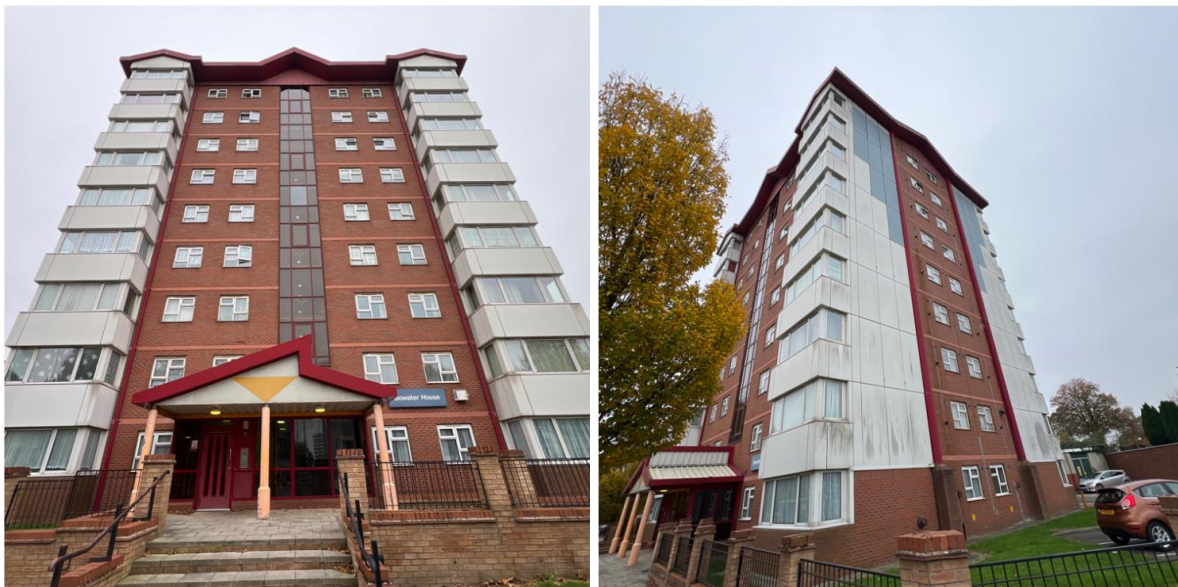
Figure 9 and 10: Building Elevations

The exterior elevations were generally in ok condition and no significant structural defects were noted to the cladding panels. There were no significant cracks or tell-tale signs of any significant structural movement noted at the time of our inspection.

The exterior panels were noted to be plumb with no signs of significant bowing, bulging or leaning noted to the panels indicating failed fixings however their presence and condition cannot be confirmed.

There are balconies at each level which are formed of cantilevered RC slabs tied into the main frame, likely cast monolithically with the primary RC frame. These are finished with glazing and the overclad aluminium panels.

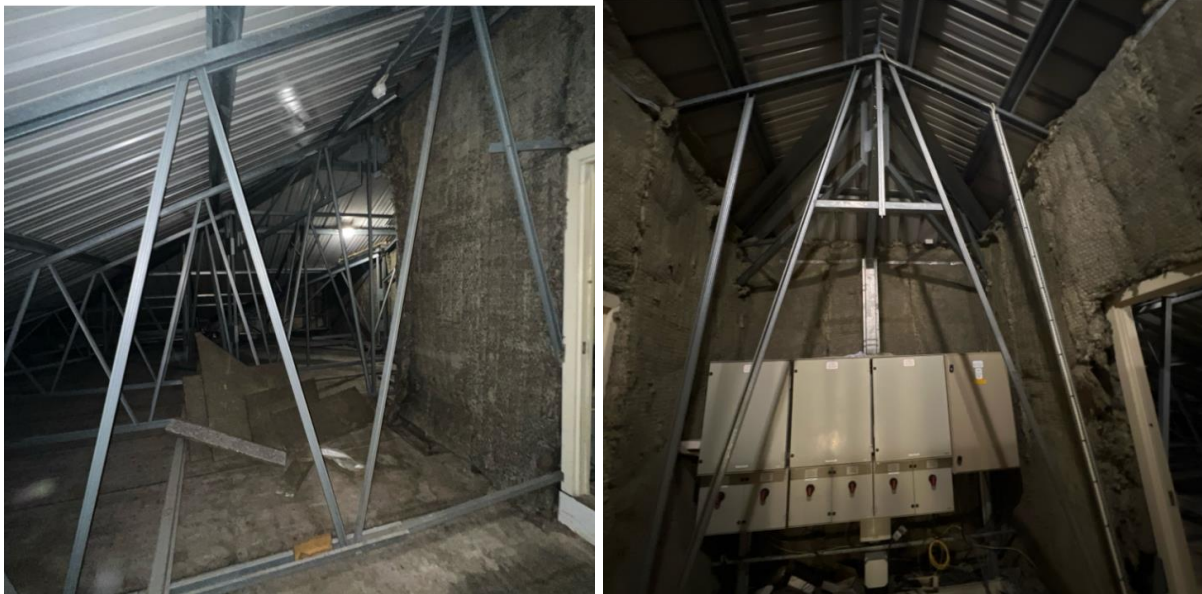
Figure 11 and 12: Roof Level

The original flat roof structure is a reinforced concrete cast slab which has been over roofed during the 1999 refurbishment with a flat to pitch conversion. The pitched roof is supported by lightweight steel trusses which support steel purlins supported off the original RC frame and clad in lightweight standing seam roofing panels.

There were no tell-tale signs of any significant structural movement noted to the steel frames at the time of our inspection. We can't confirm the fire resistance of the frame as it appears unprotected.

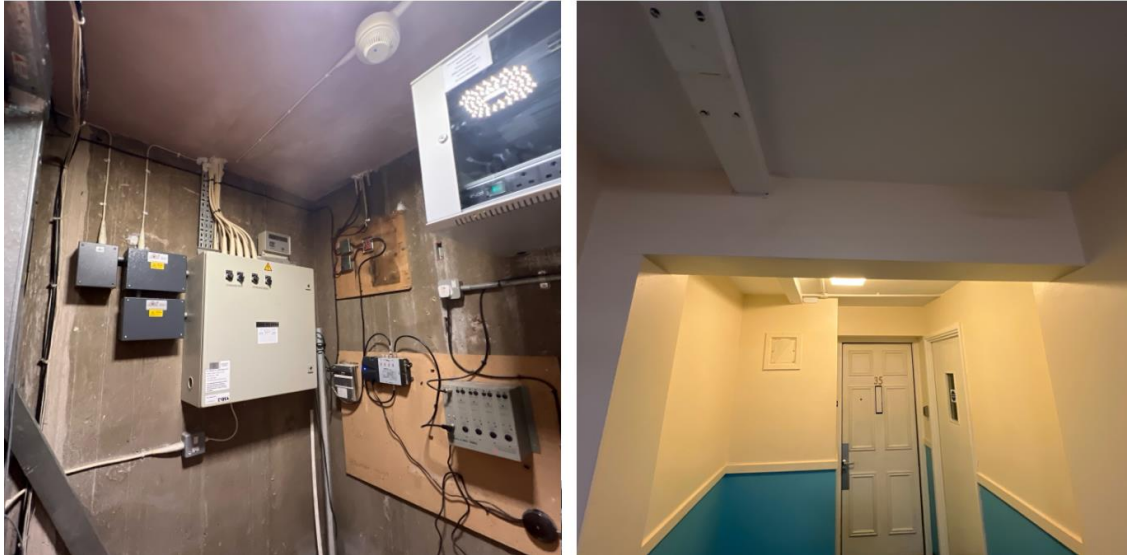
Figure 13 and 14: Structural beams, columns and slab over

The interior of the stair core walls were checked and were plumb and in line with observations made to the exterior – no significant signs of leaning or movement noted. The concrete appeared in fair condition with few BRE category 1 cracks but no structurally significant defects were noted.

The slabs are providing compartmentation to the building and therefore should meet the fire requirements. A cover meter survey is required to estimate the fire resistance of the floor slabs.

Due to the age of the building it is wise to perform periodical health checks to the concrete elements. This should include tests for concrete strength, cover depth, carbonation, chlorides and HAC. It would appear that these tests have never been performed to this building and therefore we recommend engaging a specialist contractor within the next 24 months who will be able to perform the tests and provide a interpretive report. The fire resistance of the structure is not confirmed until the cover meter tests are completed.

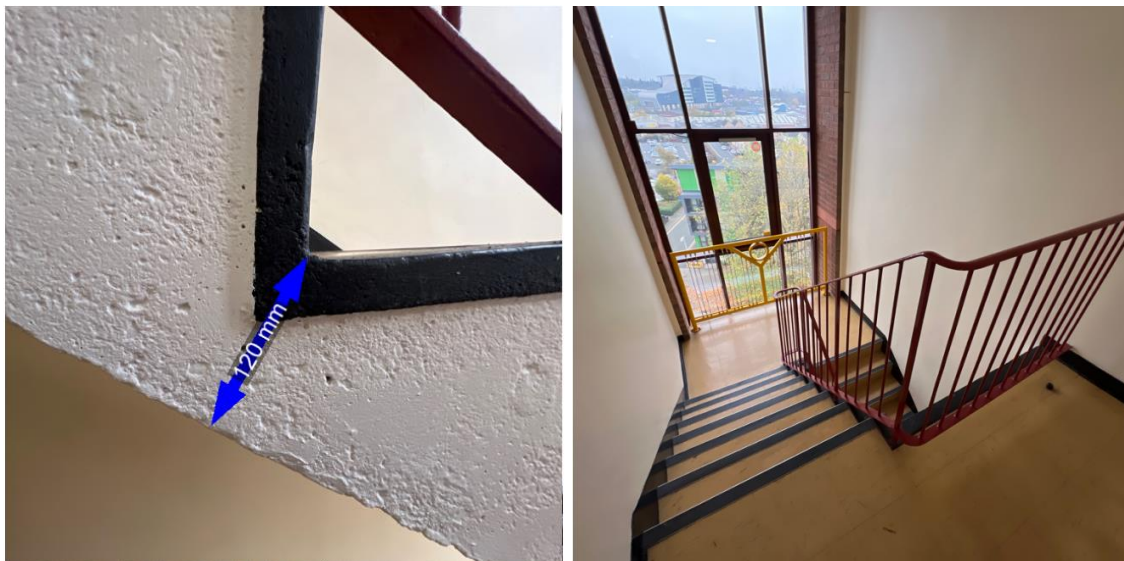
Figure 15 and 16: RC Stringer for staircase

The staircase stringer was measured at 120mm. The fire resistance of this could be inadequate and requires a cover meter test followed by a section analysis to confirm.

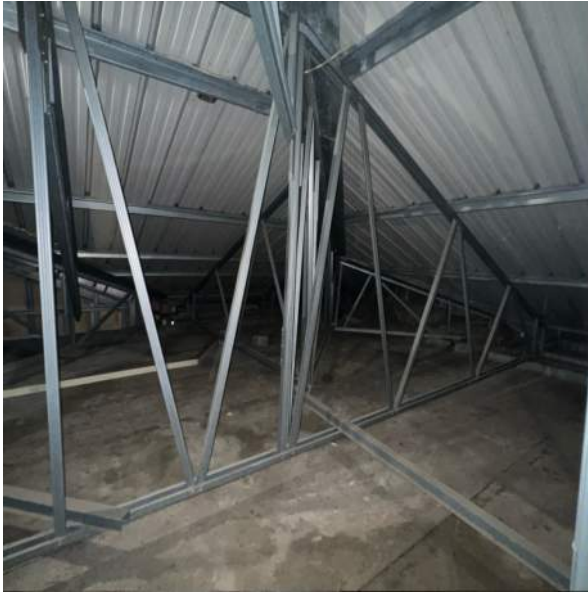
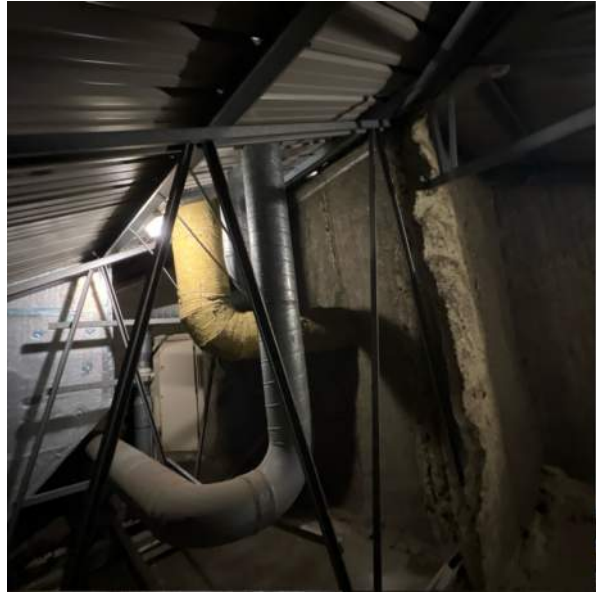
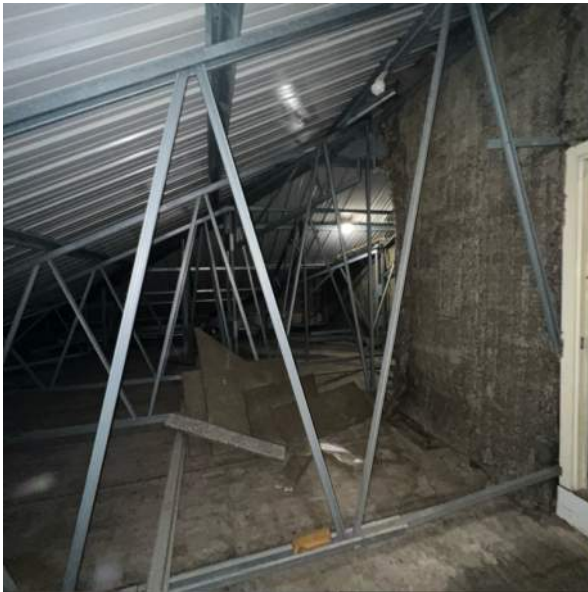
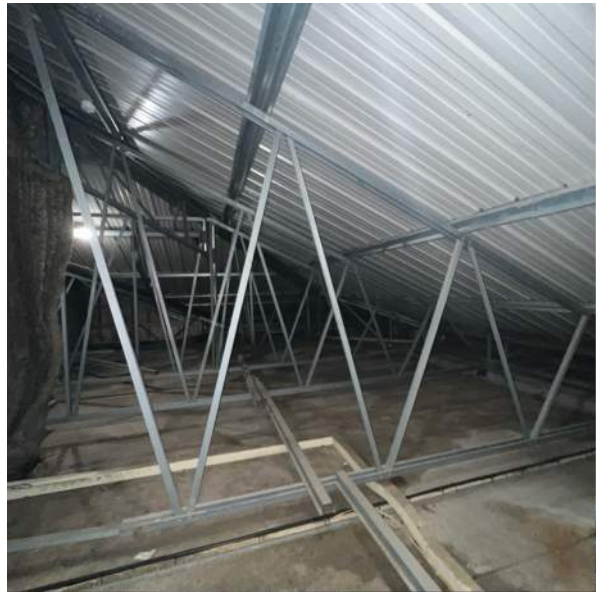
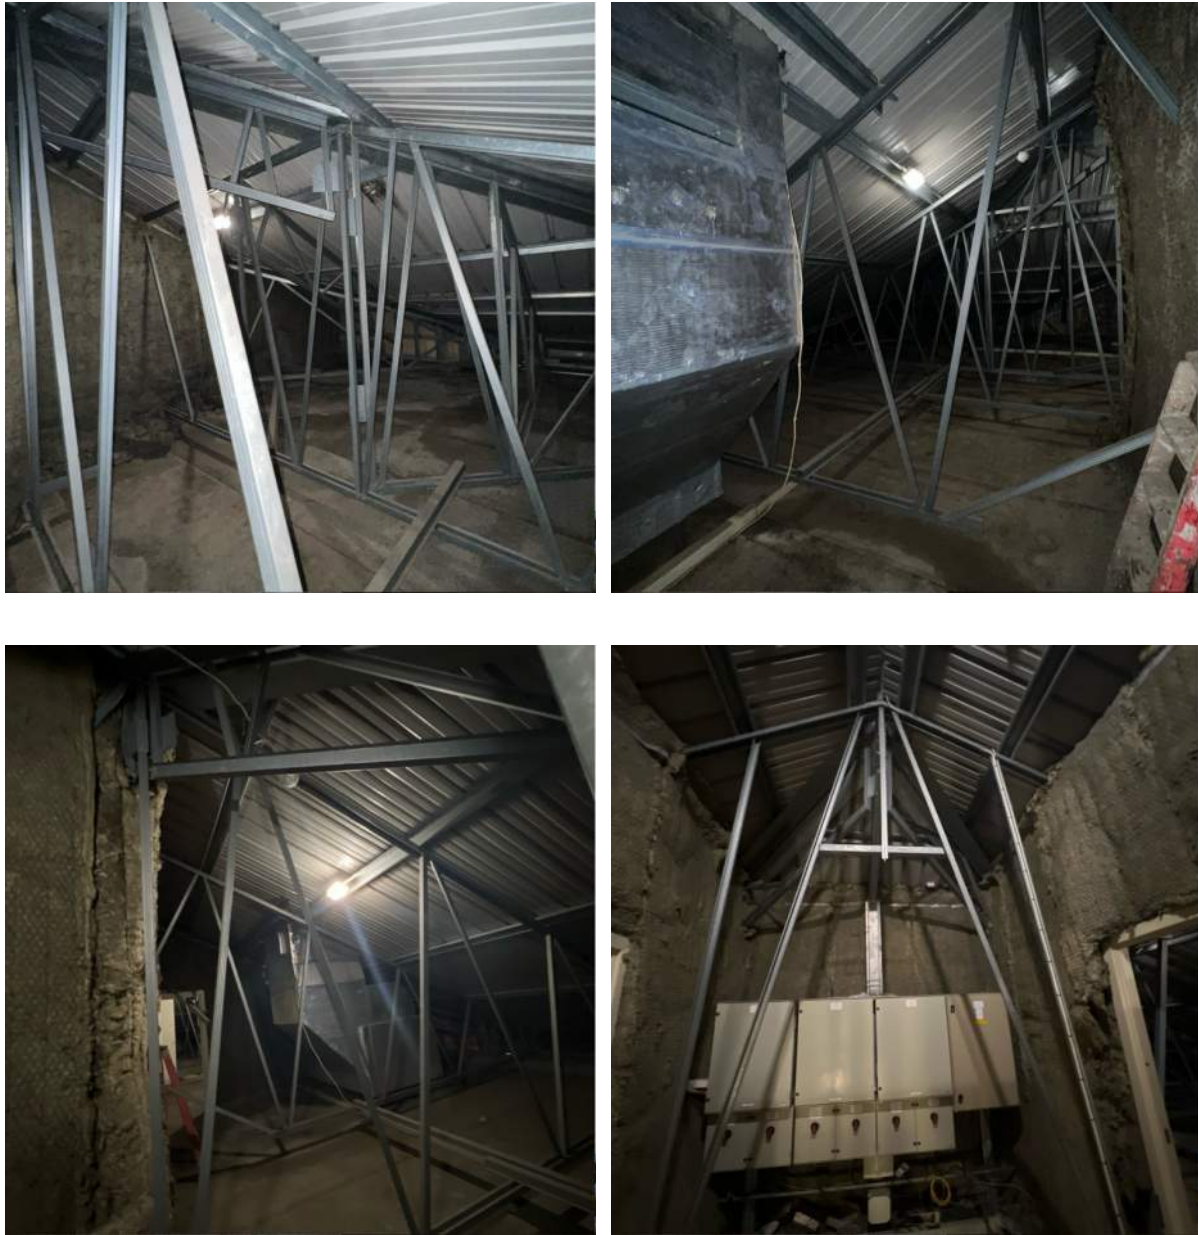
## Main Roof

Comments: A lightweight pitched roof was constructed during the refurbishment utilising beams and purlins with aluminium standing / mineral wool core profiled panels. The solar PV inverters and switch gear are located within the roof space.

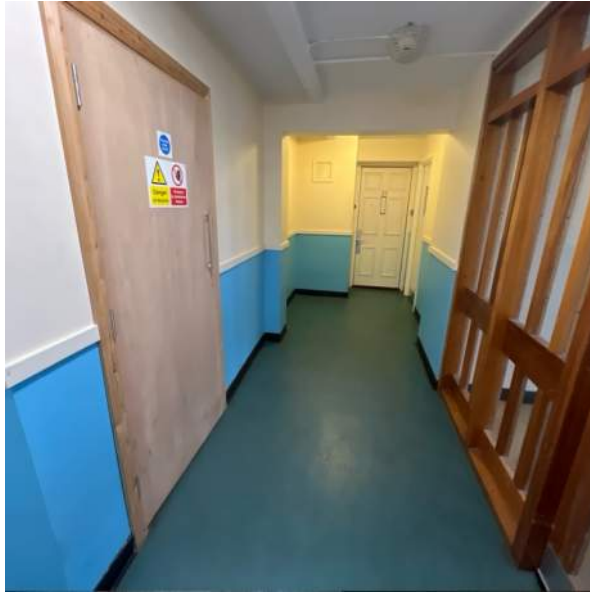
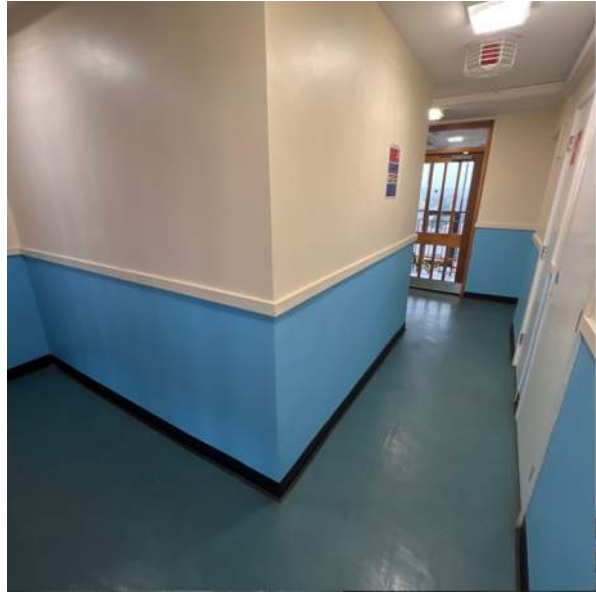
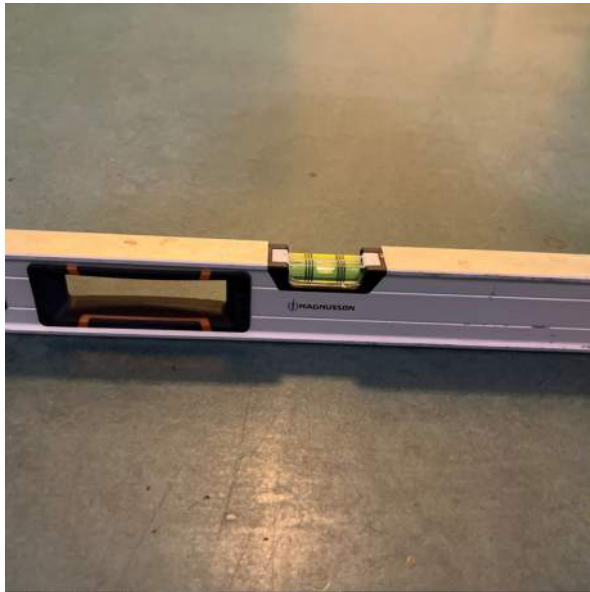
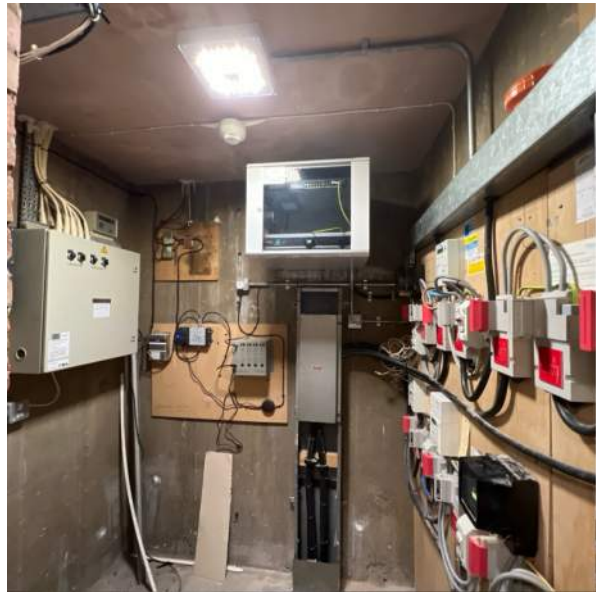
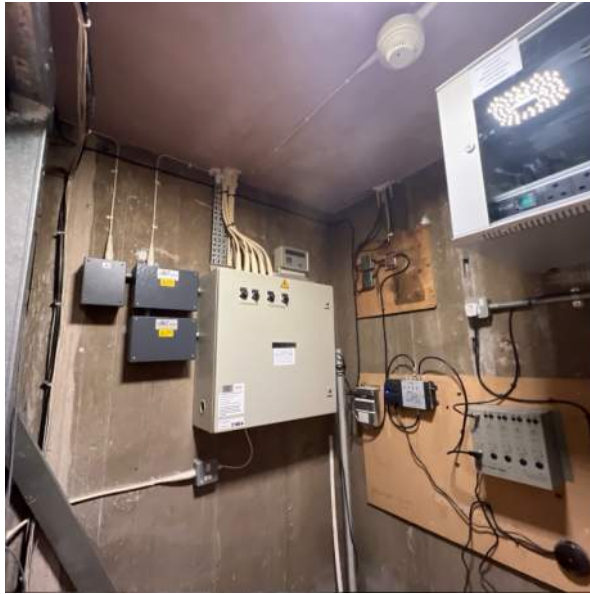
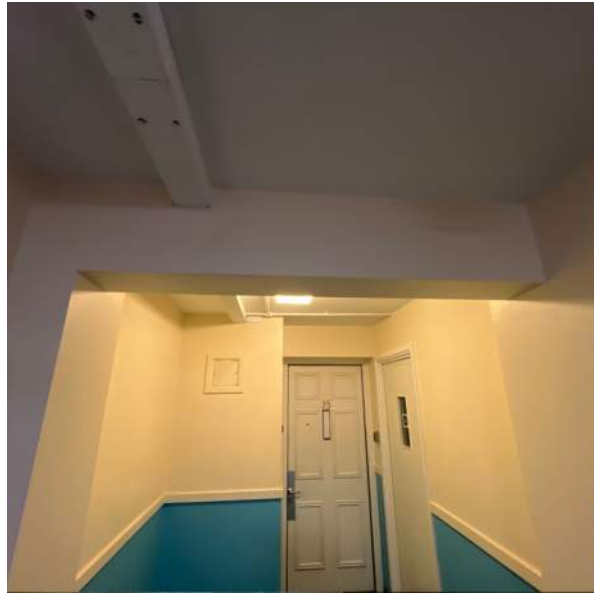
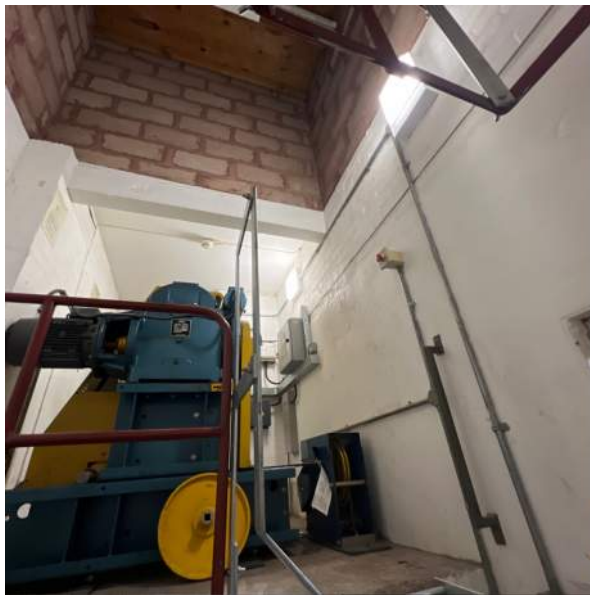
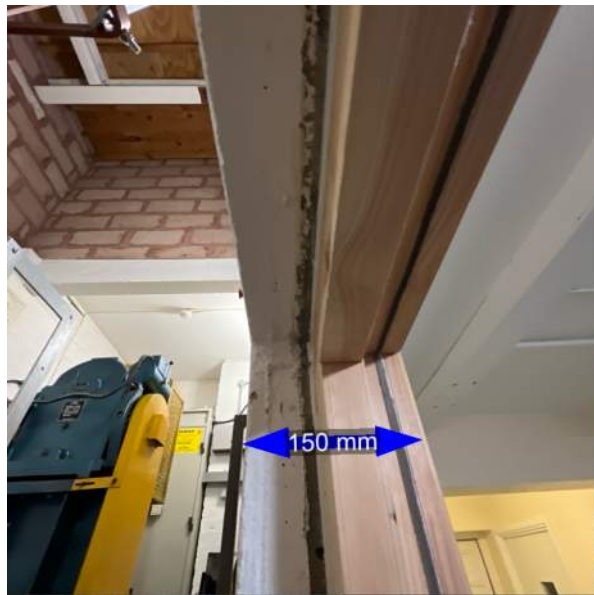
## 8th Floor Hallway

Comments: No jams or distortions noted to hallway doors to indicate any serviceability issues. Generally walls covered with finishes in hallway, likely to consist a mixture of concrete shear walls, embedded columns and masonry infill walls. Limited structure exposed. Concrete walls noted via riser cupboard and lift motor room.

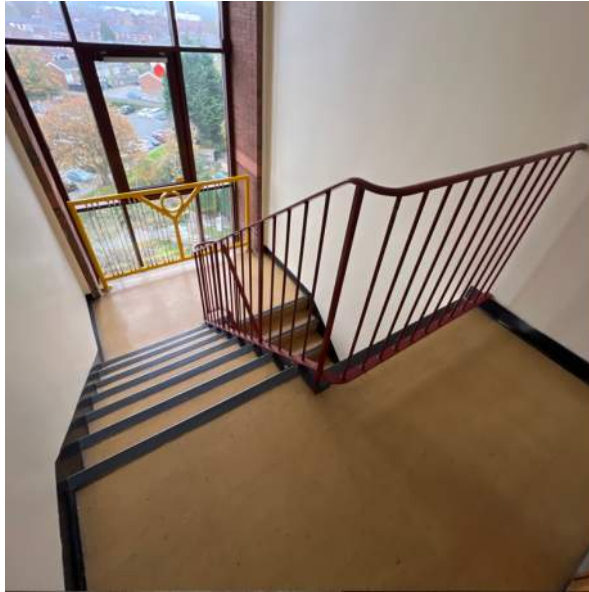
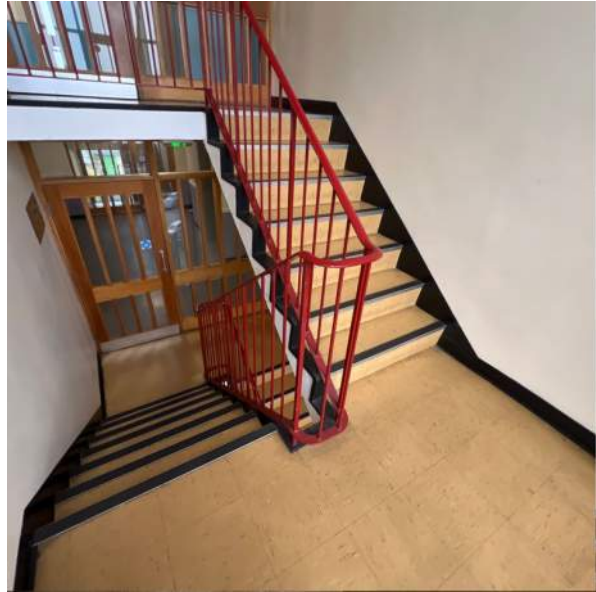
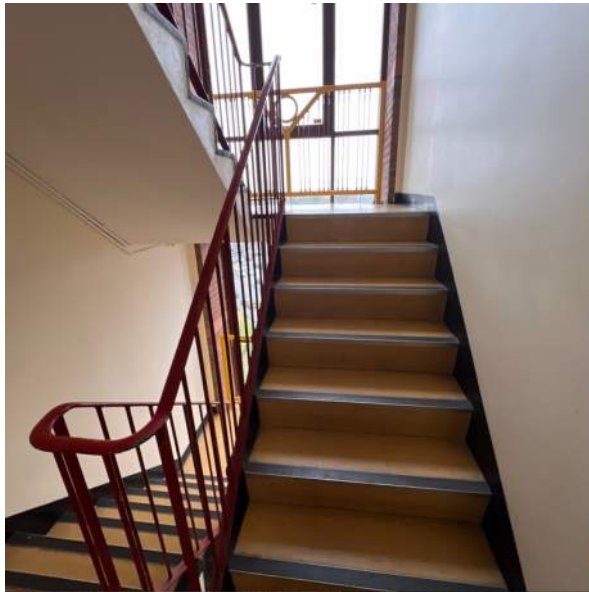
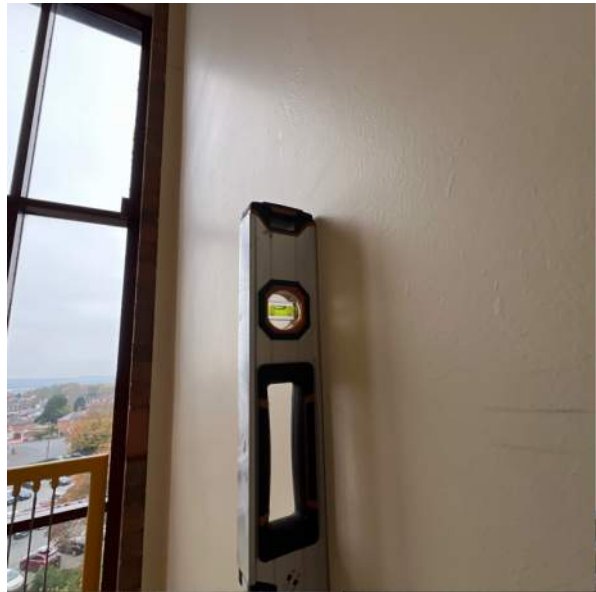
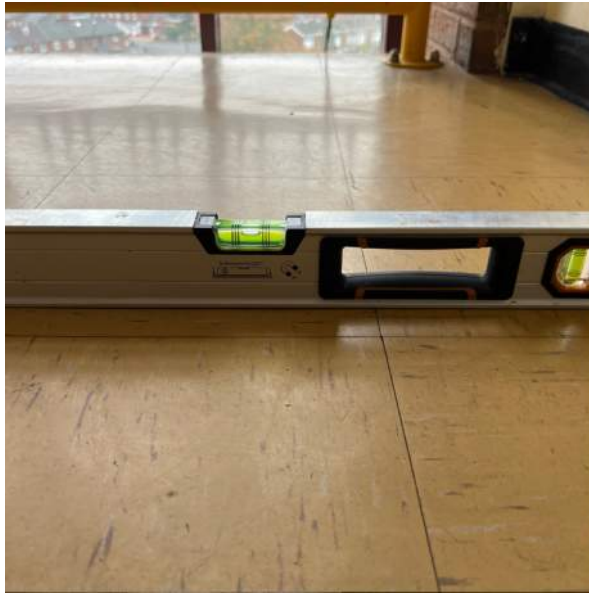
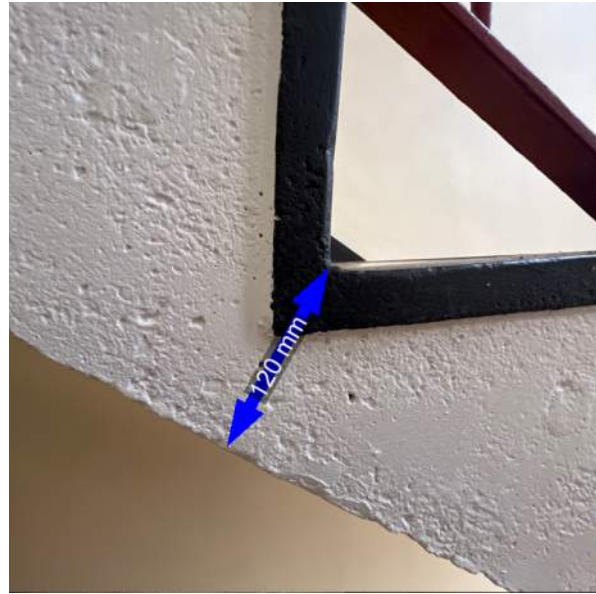
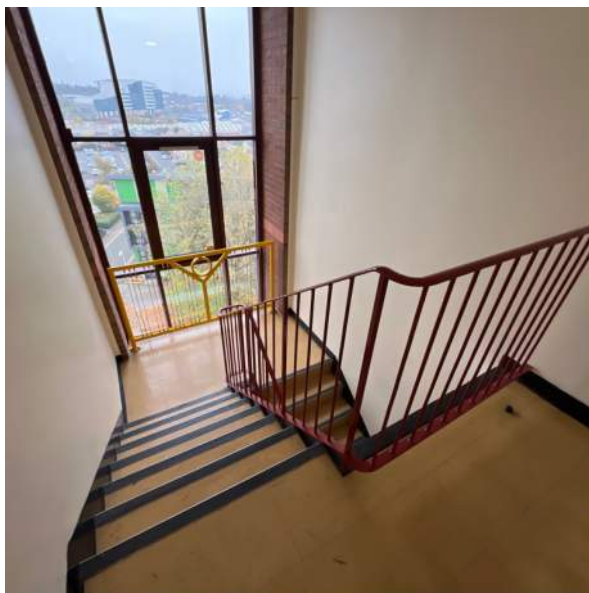
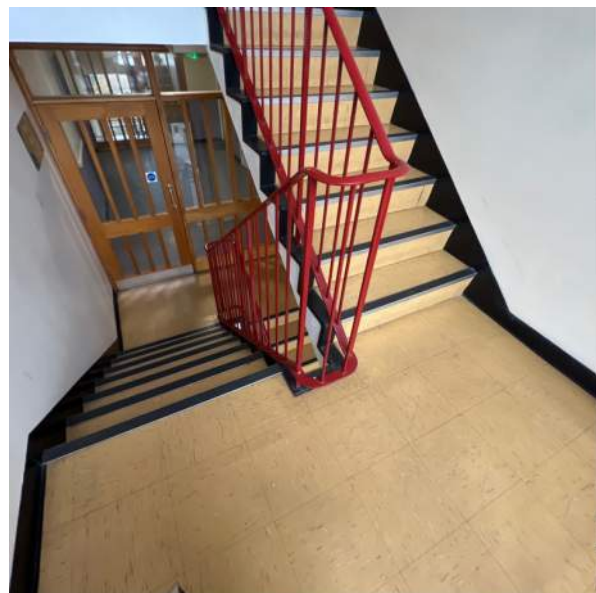
## 8th Floor Staircases

Comments: Insitu concrete stairs with steel hand railing fixed to stairs. Walls and floors appear to be fairly level.  
Stair walls covered with finishes however these would likely form the main concrete shear core walls.  
Stair walls covered with finishes however these would likely form the main concrete shear core walls.

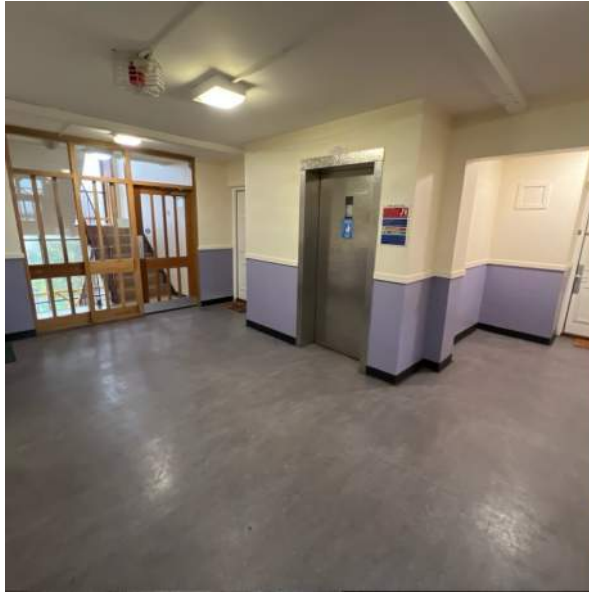
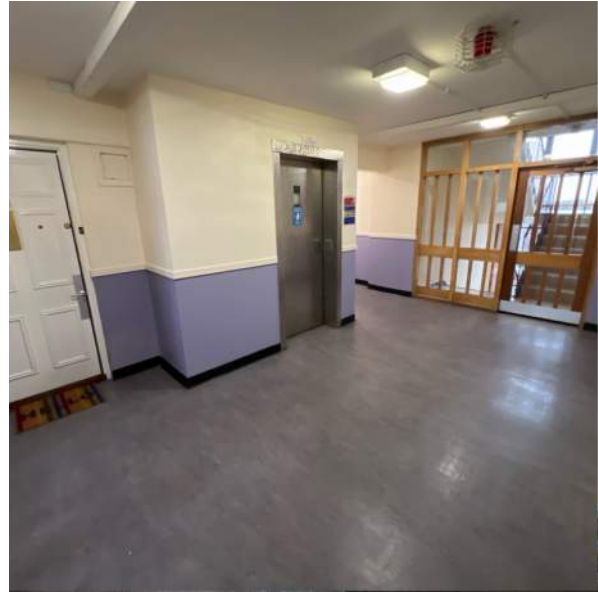
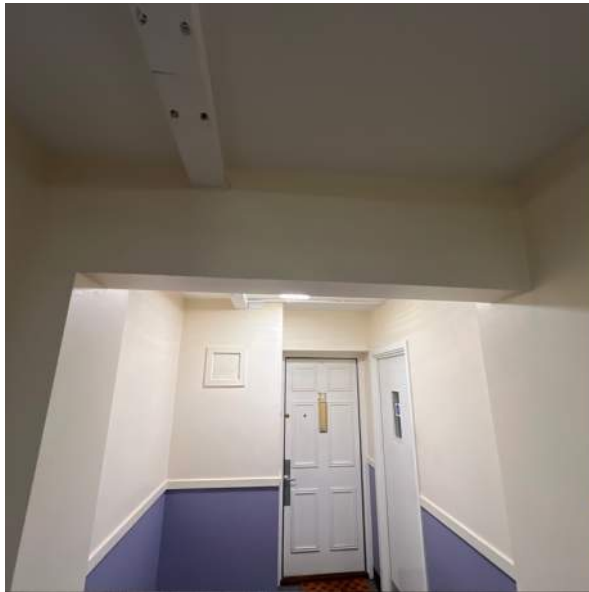
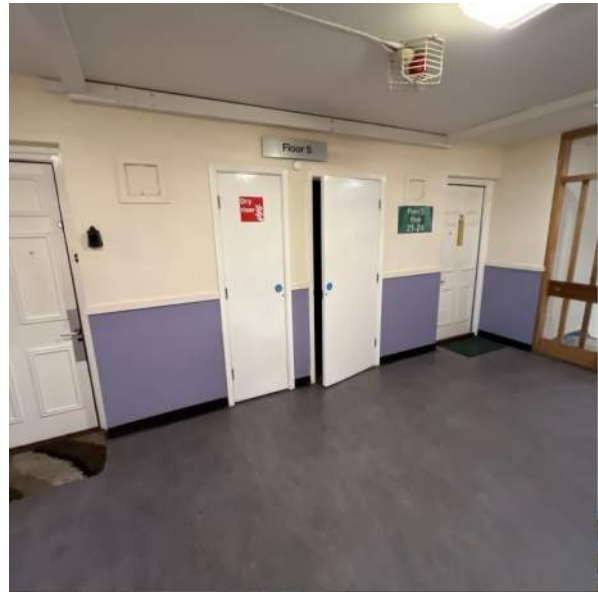
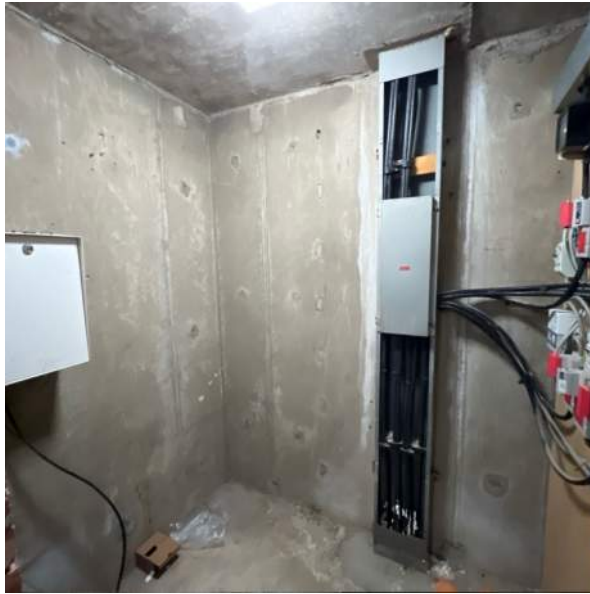
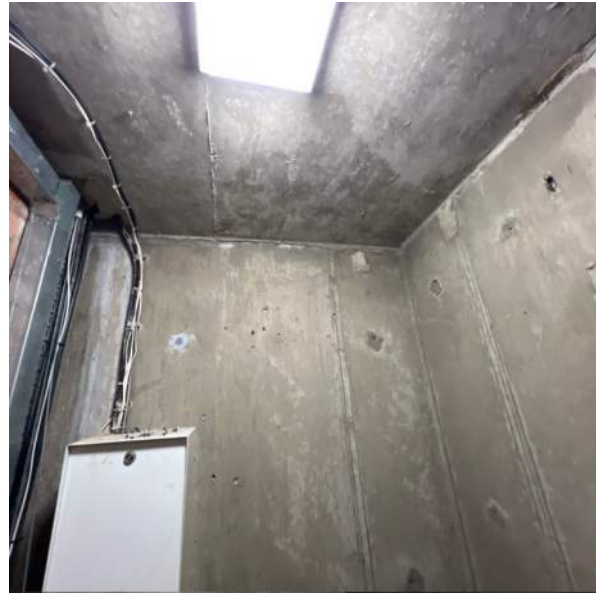
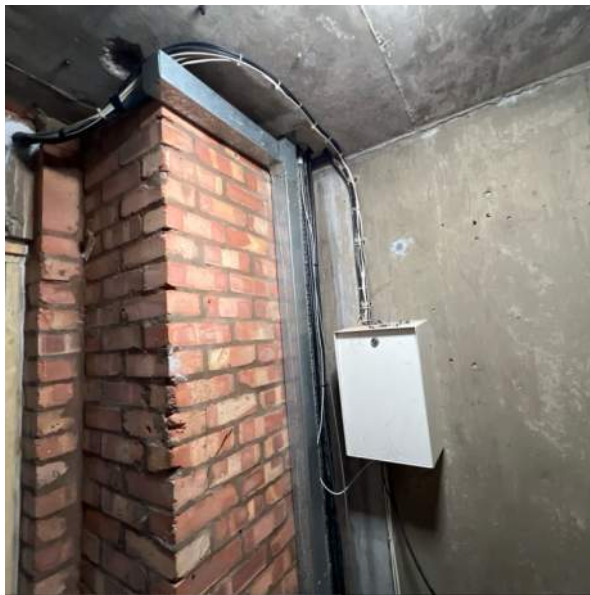
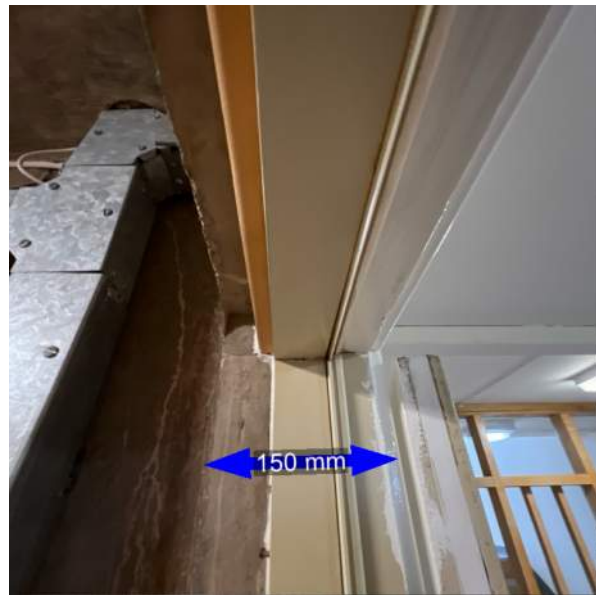
## 8th Floor Hallway

Comments: No jams or distortions noted to hallway doors to indicate any serviceability issues. Generally walls covered with finishes in hallway, likely to consist a mixture of concrete shear walls, embedded columns and masonry infill walls. Limited structure exposed. Concrete walls noted via riser cupboard. Lift walls appear to be solid concrete walls.

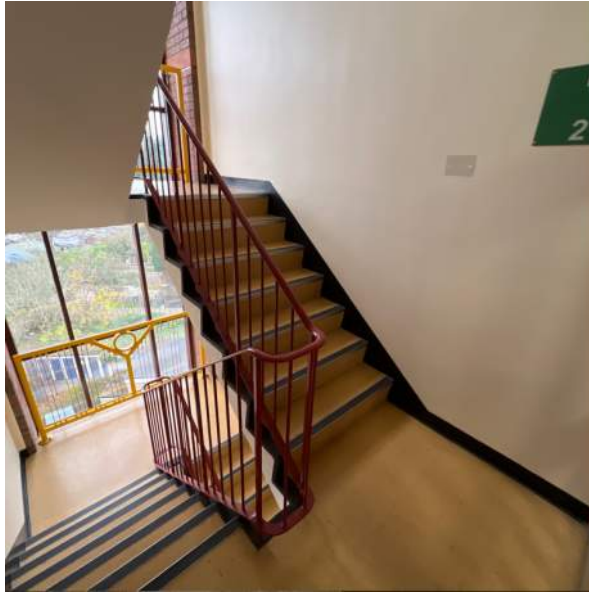
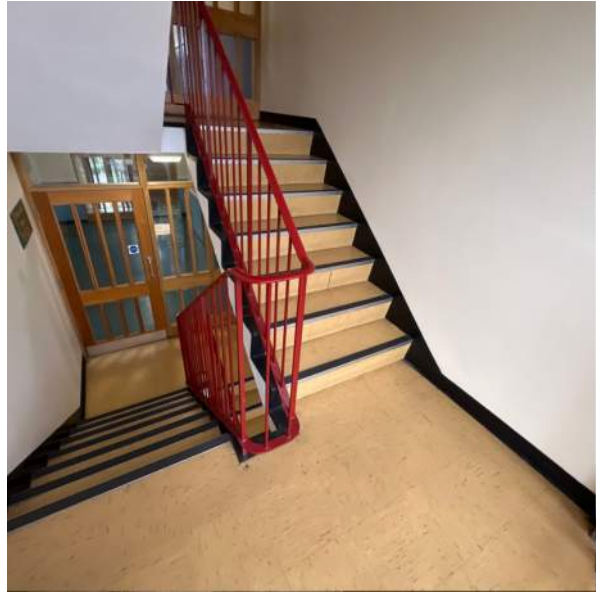
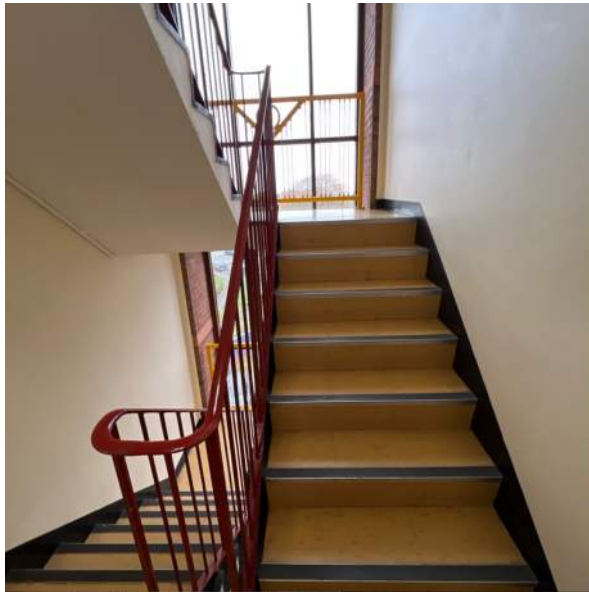
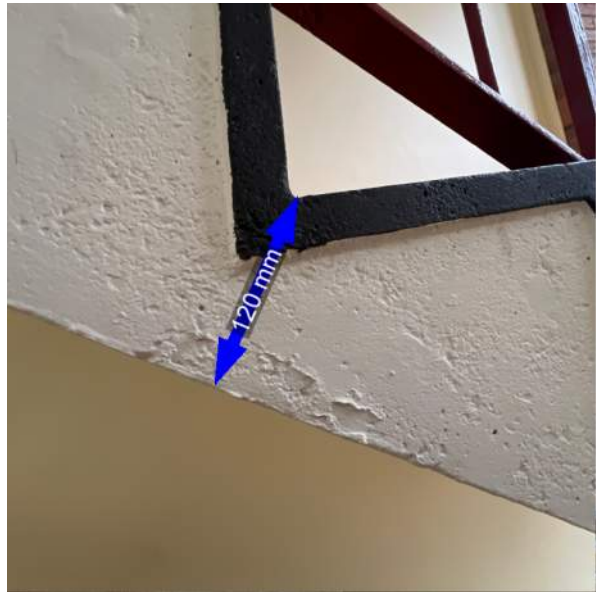
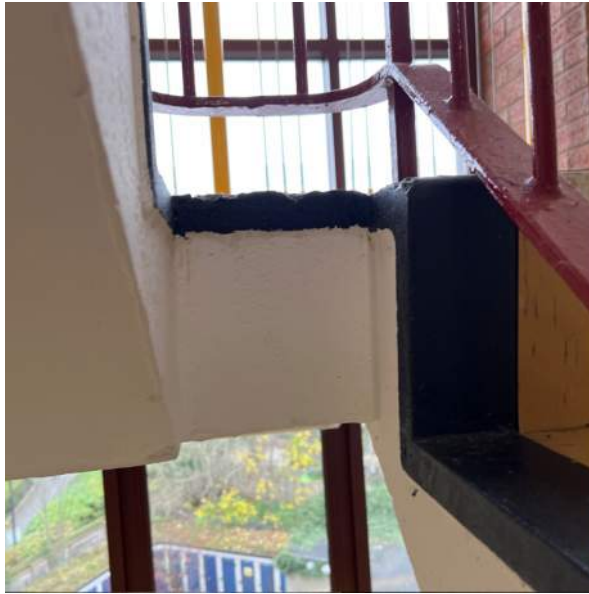
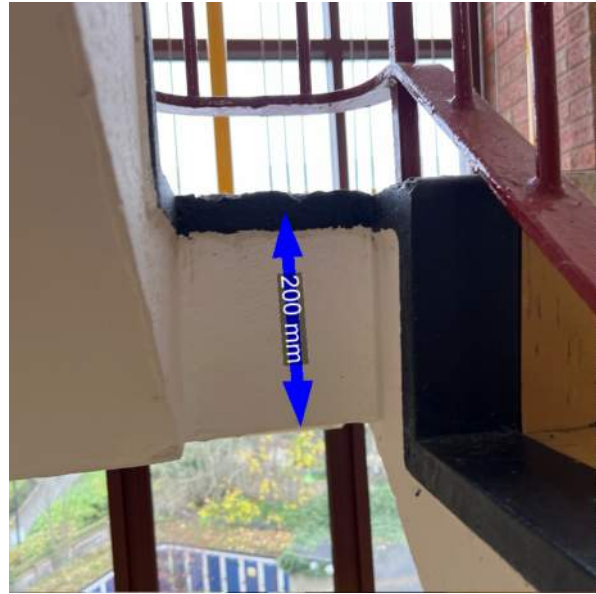
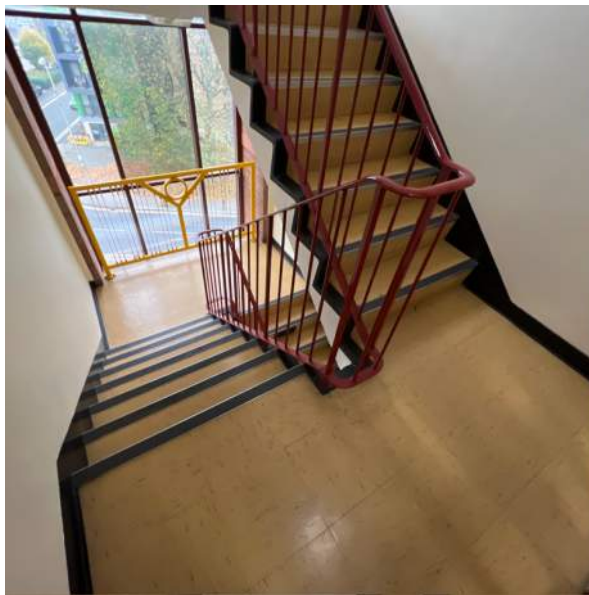
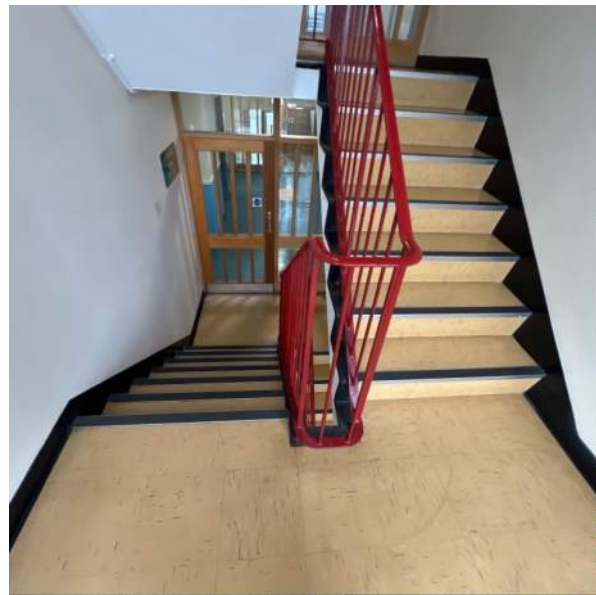
## 5th Floor Staircases

In situ concrete stairs with steel hand railing fixed to stairs. Walls and floors appear to be fairly level.

Stair walls covered with finishes however these would likely form the main concrete shear core walls.

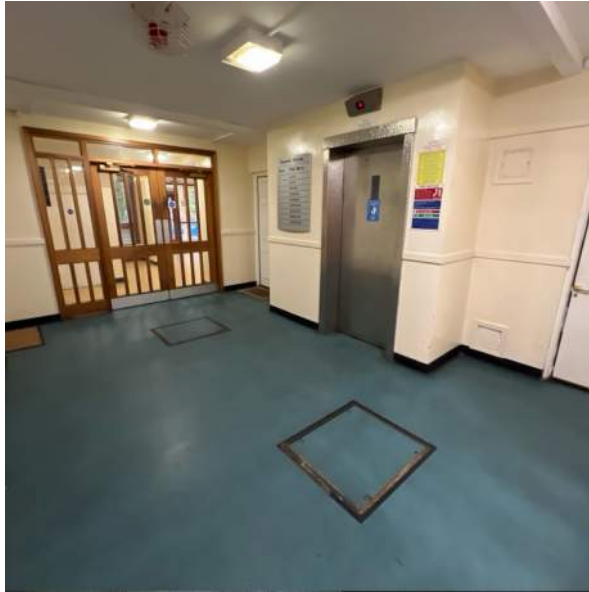
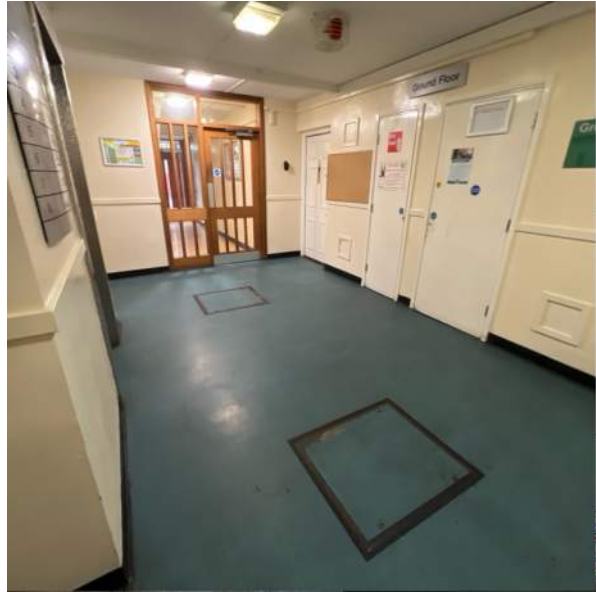
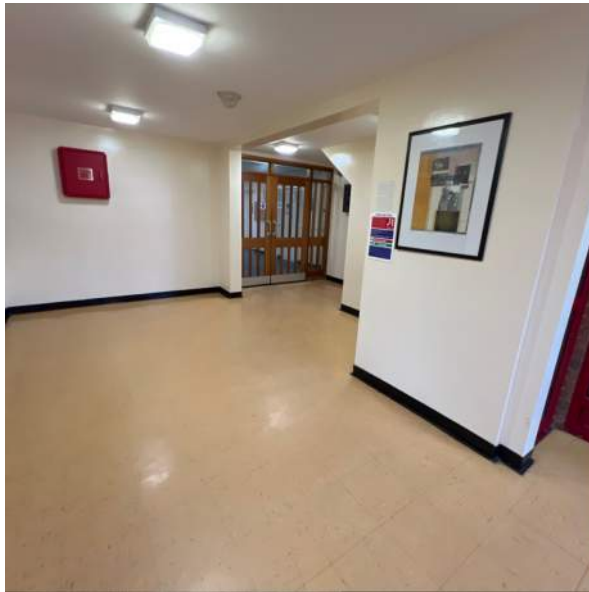
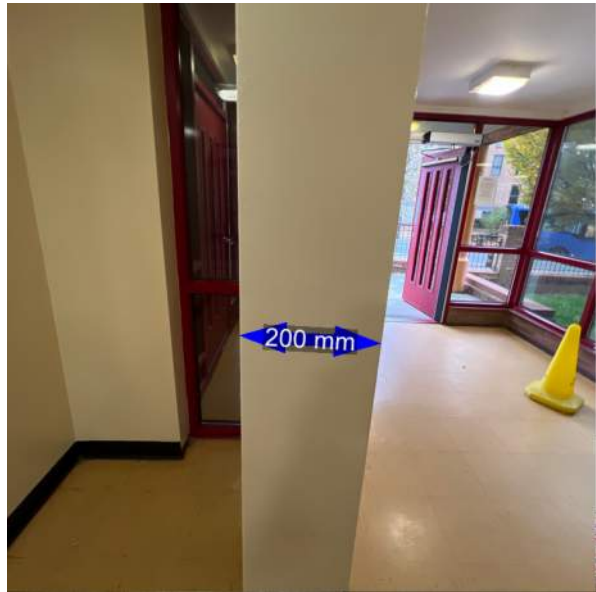
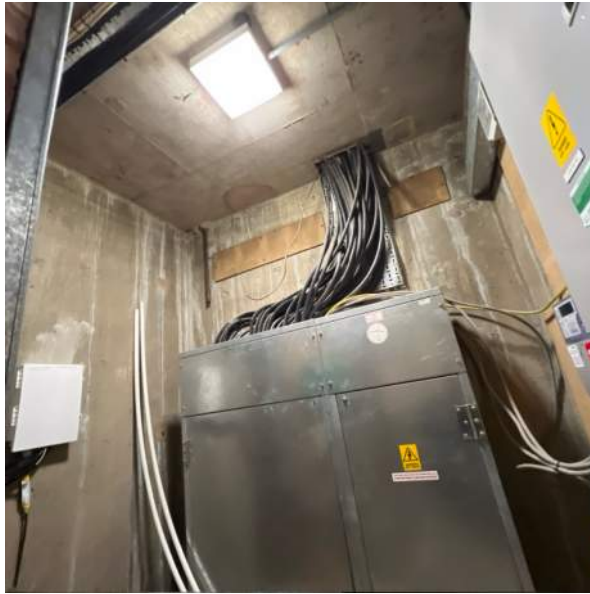
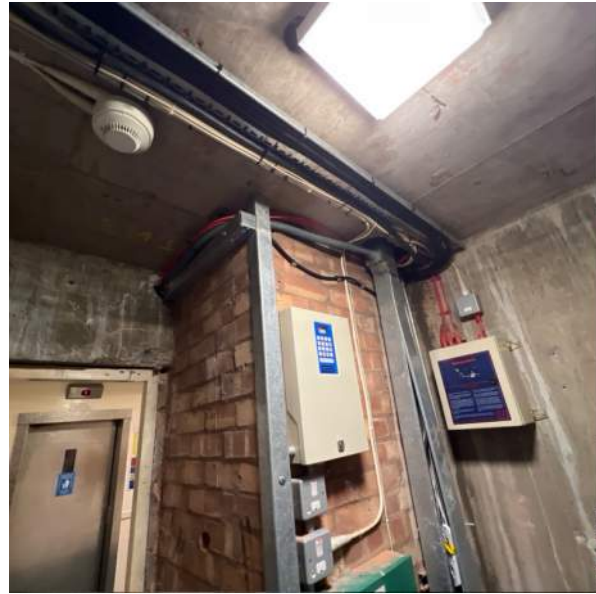
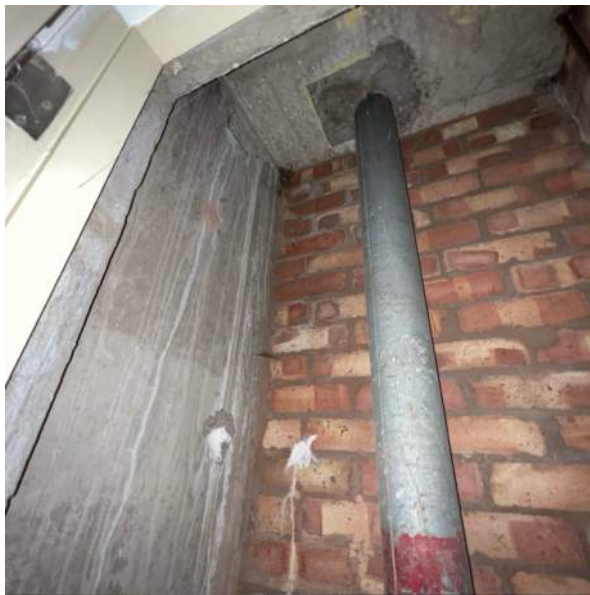
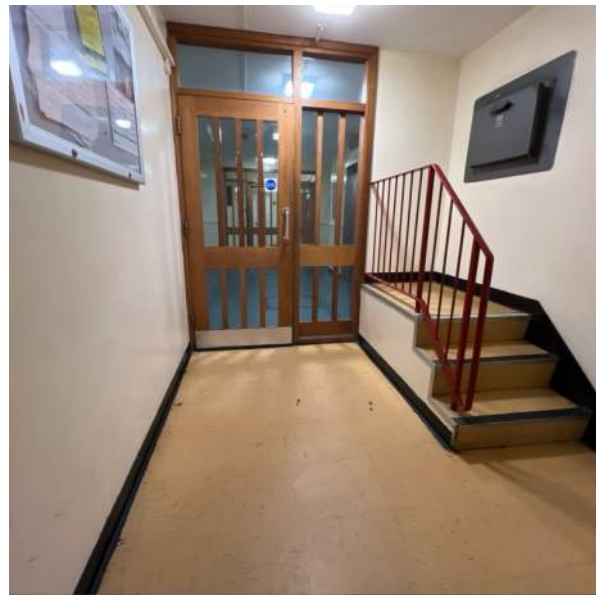
## Ground Floor Hallway

Comments: No jams or distortions noted to hallway doors to indicate any serviceability issues. Generally walls covered with finishes in hallway, likely to consist a mixture of concrete shear walls, embedded columns and block infill walls. Limited structure exposed. Partly visible concrete walls noted via electrical riser cupboards.

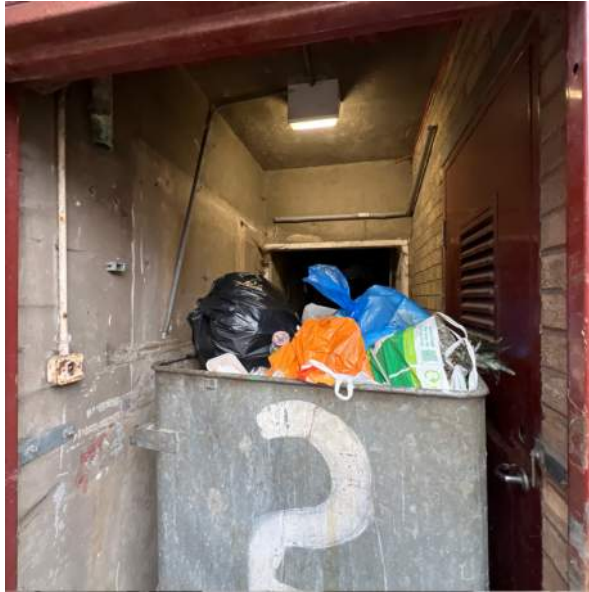
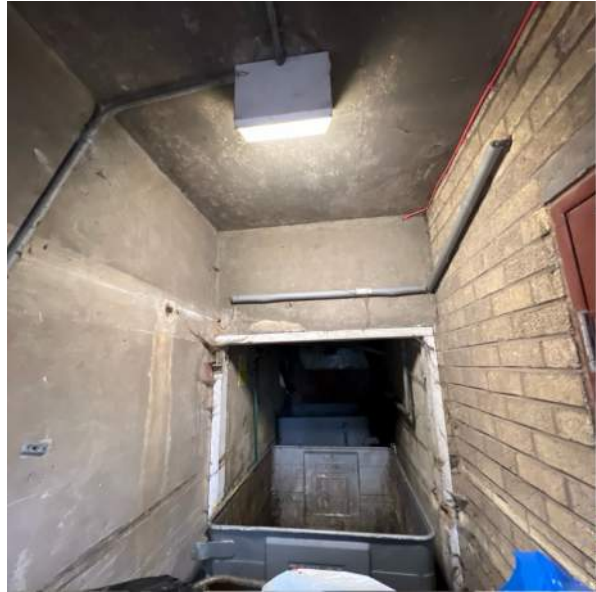
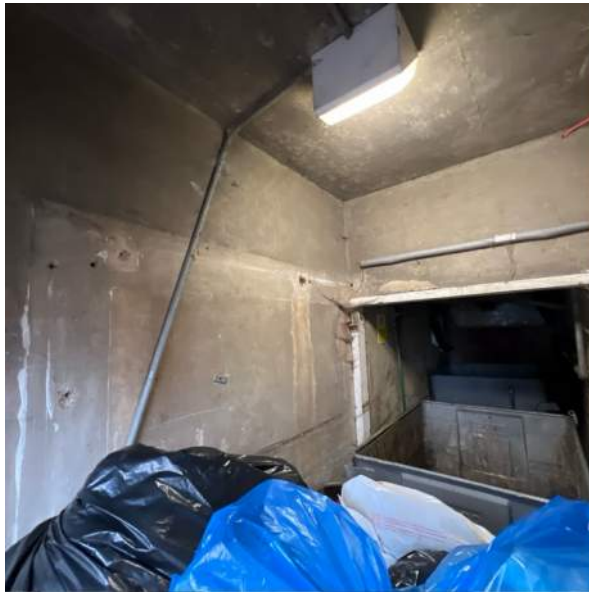
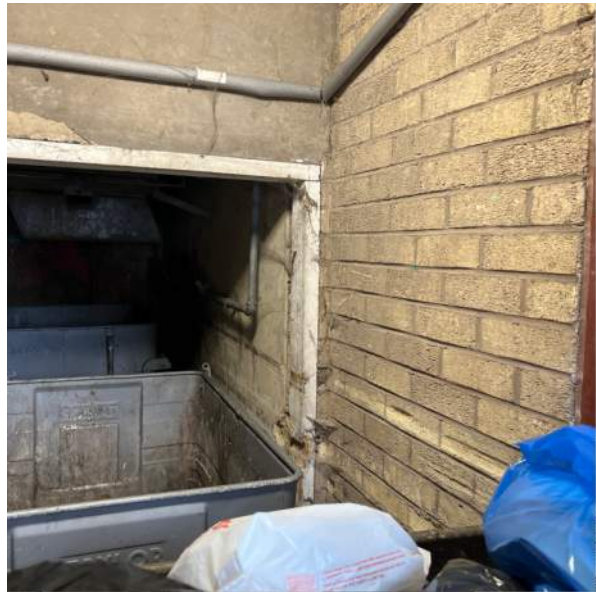
## Binstore

RC shear walls noted in binstore.
