VISUAL STRUCTURAL APPRAISAL

Bowater House

Moor Lane  
West Bromwich  
B70 7AW

27<sup>th</sup> November 2024

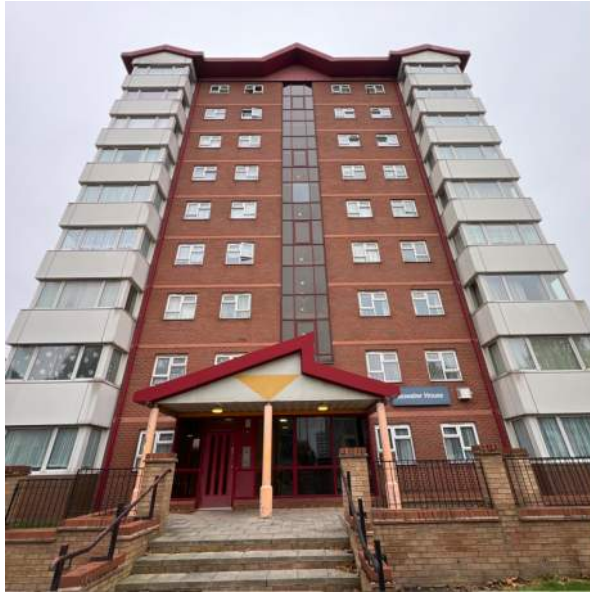
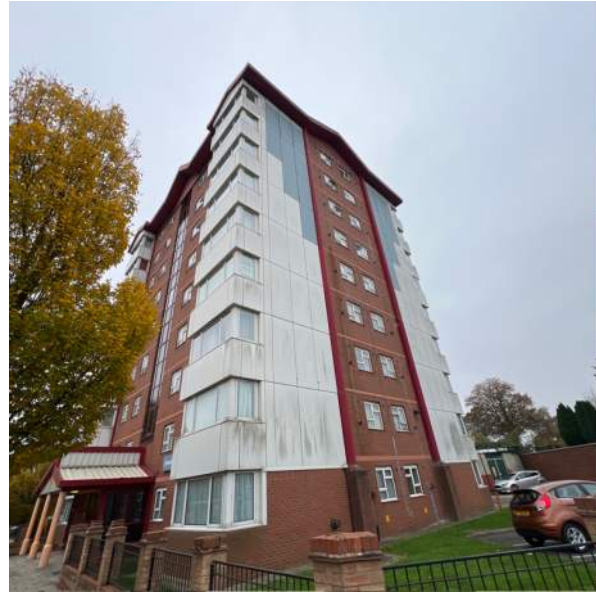
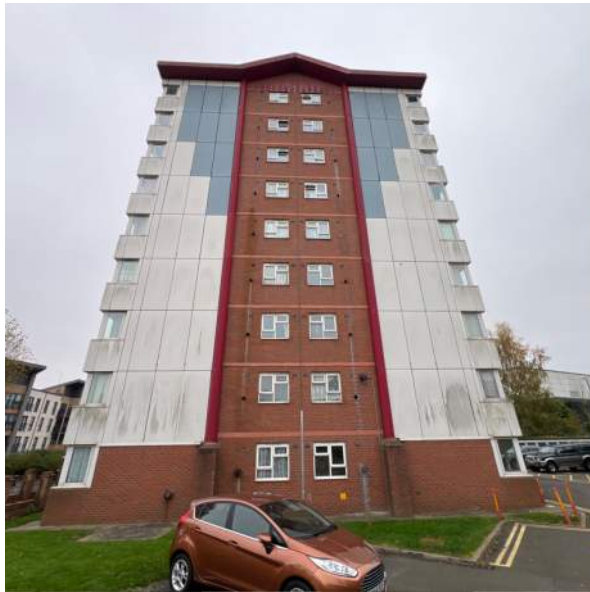
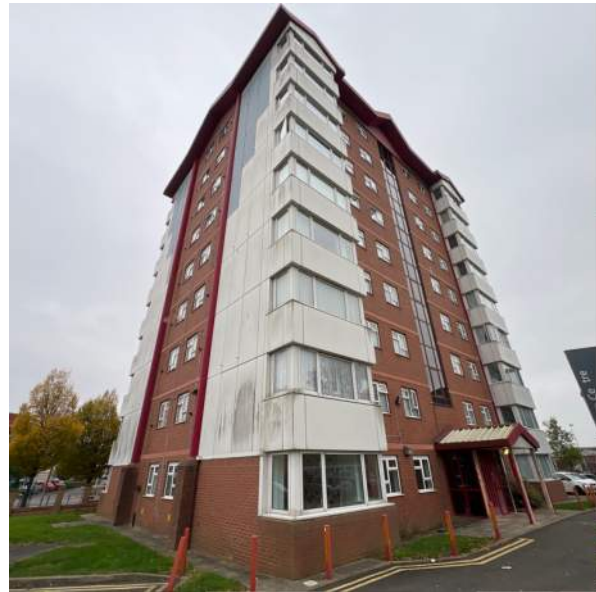
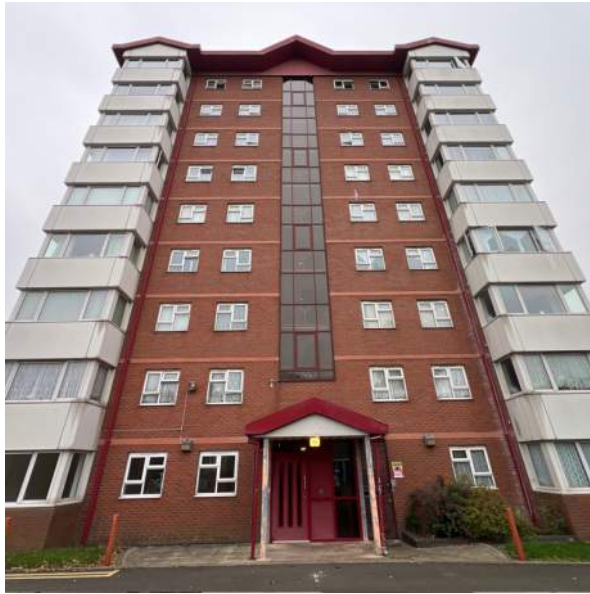
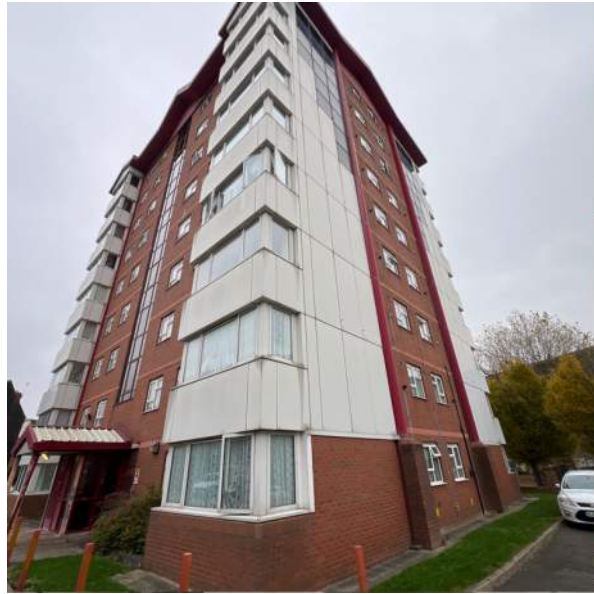
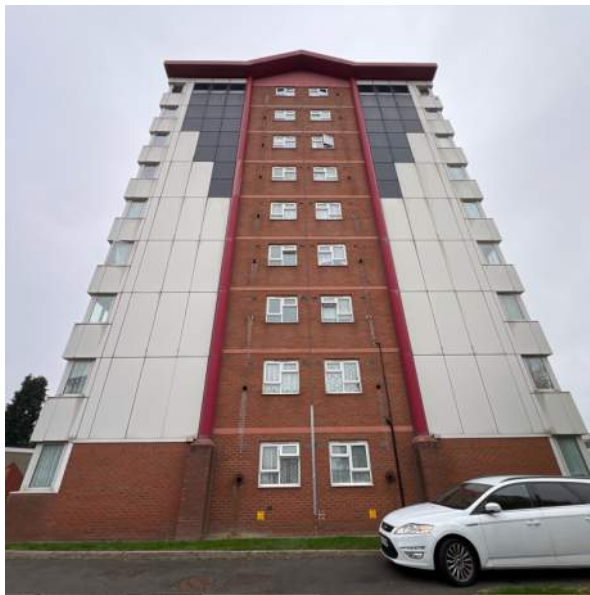
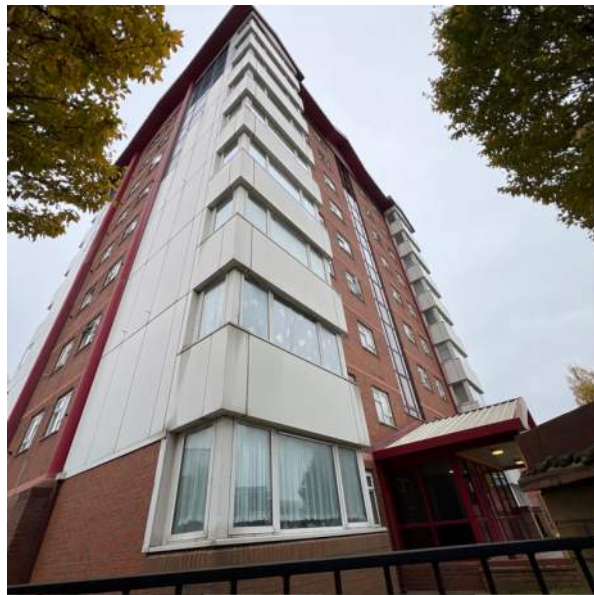
## Elevations

External facade consists of mainly brickwork. Partial elevations and all balconies cladded with aluminium facade.
