VISUAL STRUCTURAL APPRAISAL

Braybrooke House

Moor Lane  
West Bromwich  
B70 7AW

19<sup>th</sup> December 2024

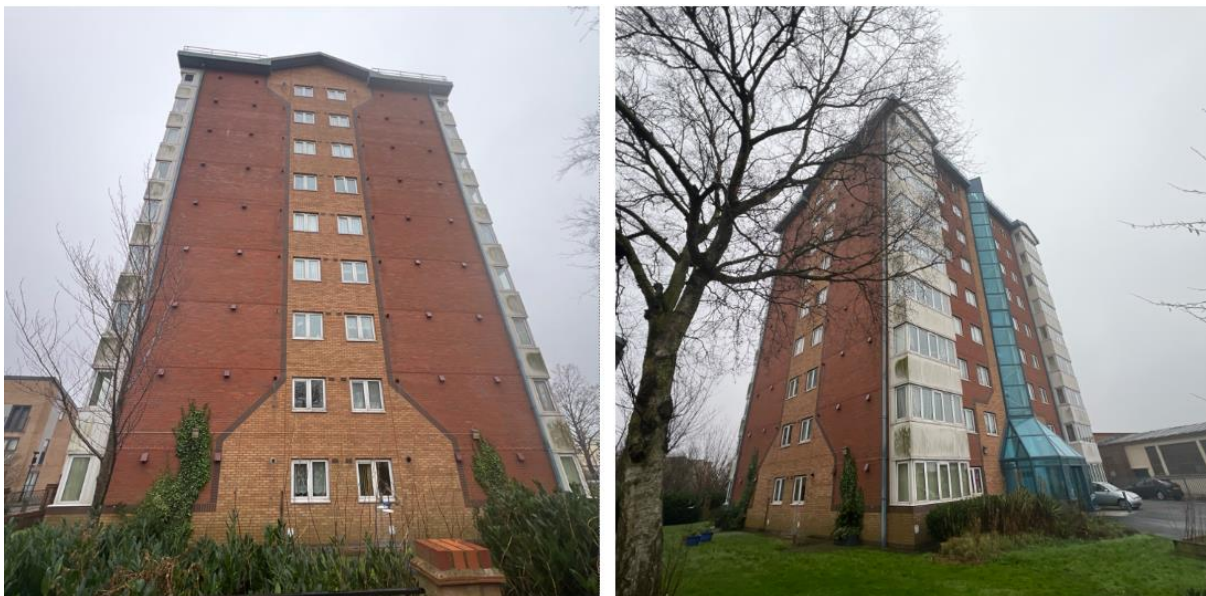
Figure 9 and 10: Building Elevations

The exterior elevations were generally in ok condition and no significant structural defects were noted to the cladding panels. There were no significant cracks or tell-tale signs of any significant structural movement noted at the time of our inspection.

The exterior panels were noted to be plumb with no signs of significant bowing, bulging or leaning noted to the panels indicating failed fixings however their presence and condition cannot be confirmed.

There are balconies at each level which are formed of cantilevered RC slabs tied into the main frame, likely cast monolithically with the primary RC frame. These are finished with glazing and the overclad aluminium panels.

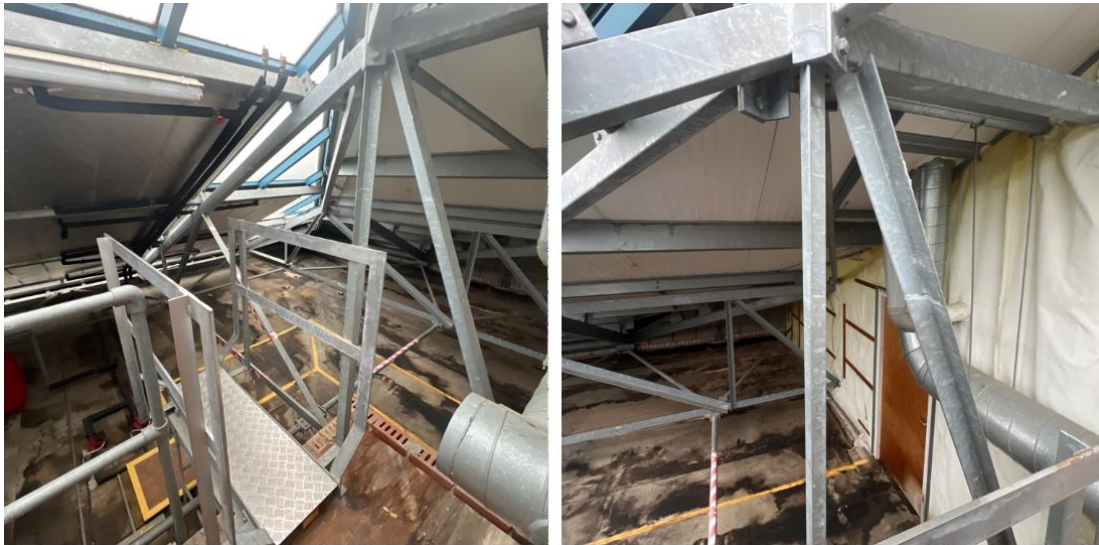
Figure 11 and 12: Roof Level

The original flat roof structure is a reinforced concrete cast slab which has been over roofed during the 1999 refurbishment with a flat to pitch conversion. The pitched roof is supported by lightweight steel trusses which support steel purlins supported off the original RC frame and clad in lightweight standing seam roofing panels.

There were no tell-tale signs of any significant structural movement noted to the steel frames at the time of our inspection. We can't confirm the fire resistance of the frame as it appears unprotected.

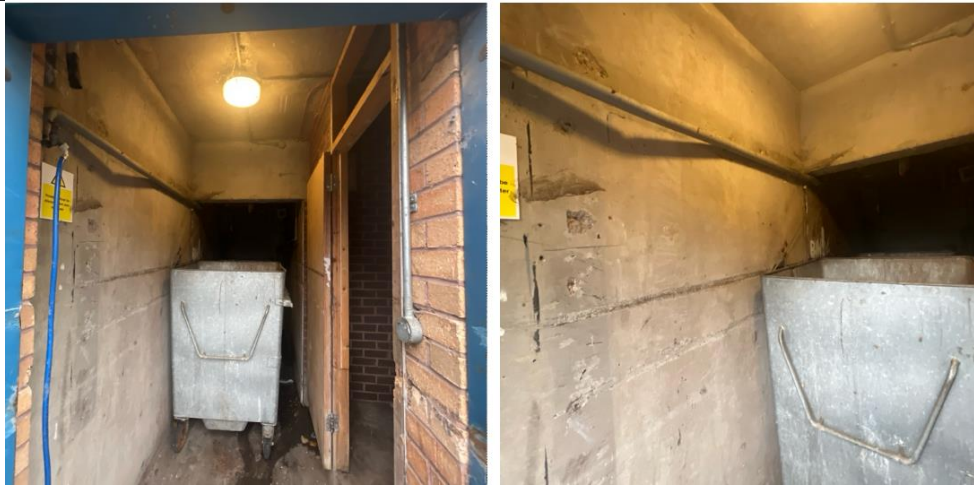
Figure 13 and 14: Structural beams, columns and slab over

The interior of the stair core walls were checked and were plumb and in line with observations made to the exterior – no significant signs of leaning or movement noted. The concrete appeared in fair condition with few BRE category 1 cracks but no structurally significant defects were noted.

The slabs are providing compartmentation to the building and therefore should meet the fire requirements. A cover meter survey is required to estimate the fire resistance of the floor slabs.

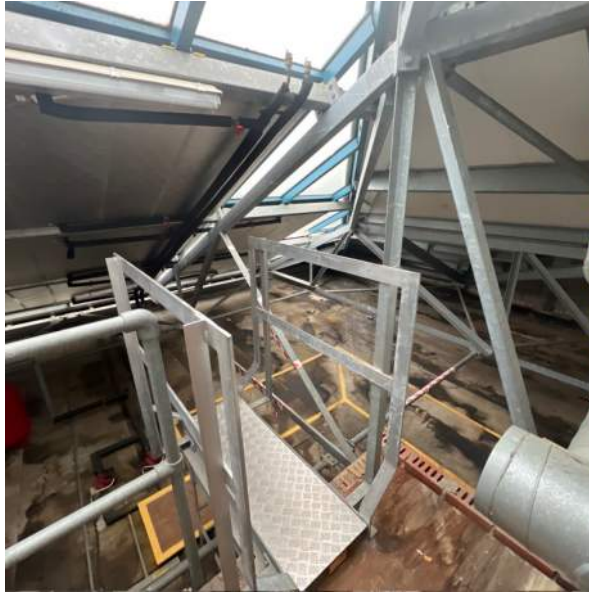
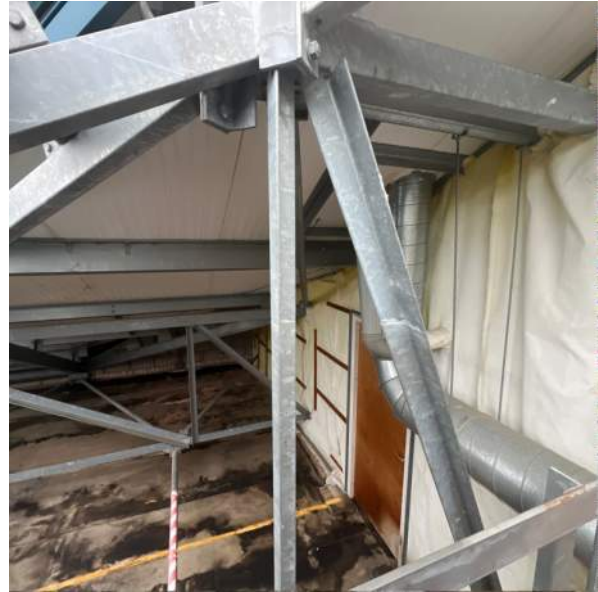
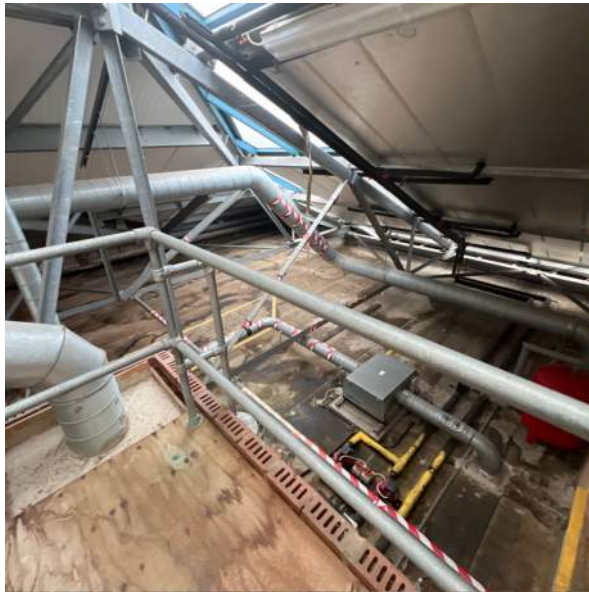
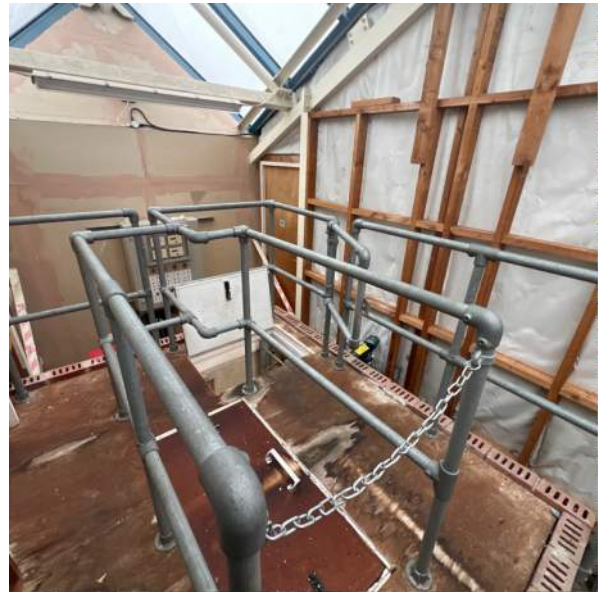
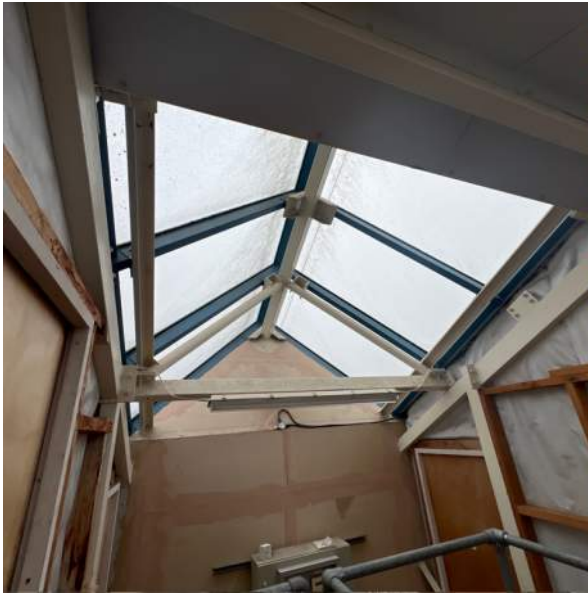
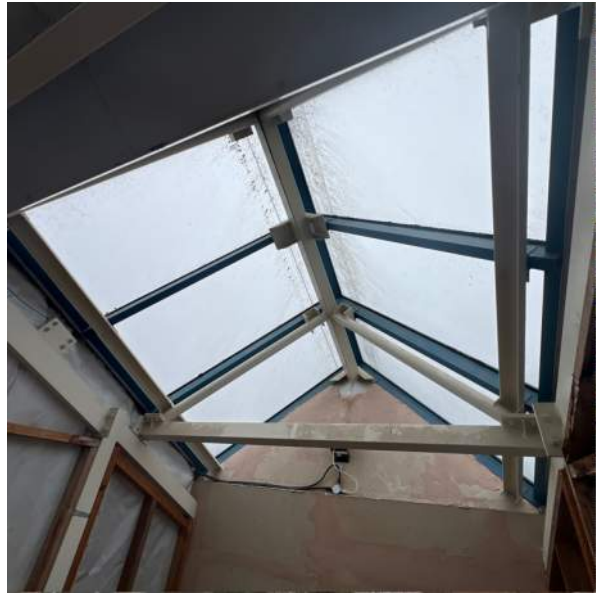
## Main Roof

Comments: A lightweight pitched roof was constructed during the refurbishment utilising beams and purlins with aluminium standing / mineral wool core profiled panels.

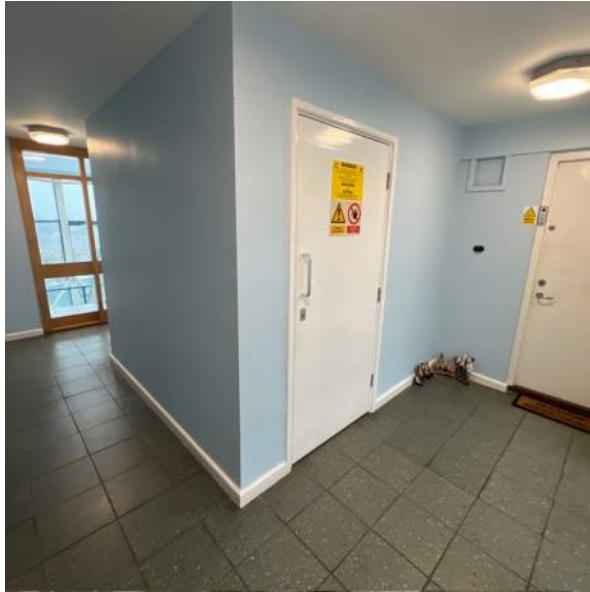
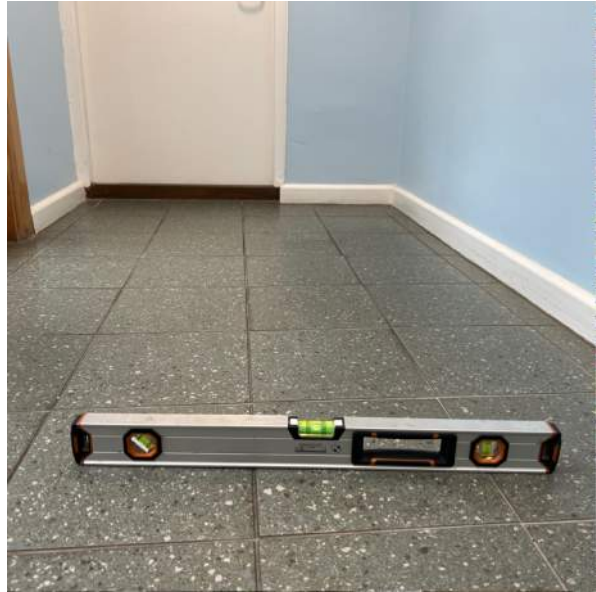
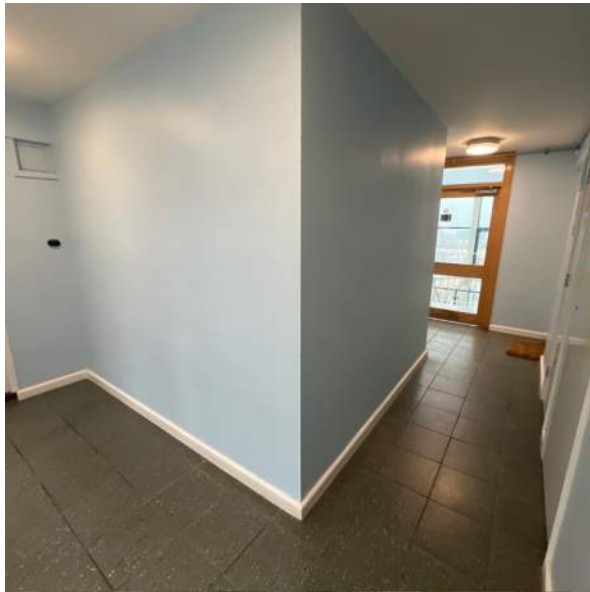
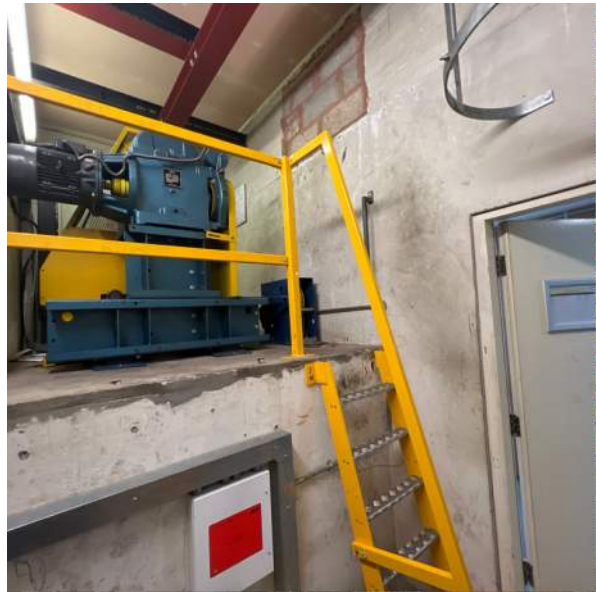
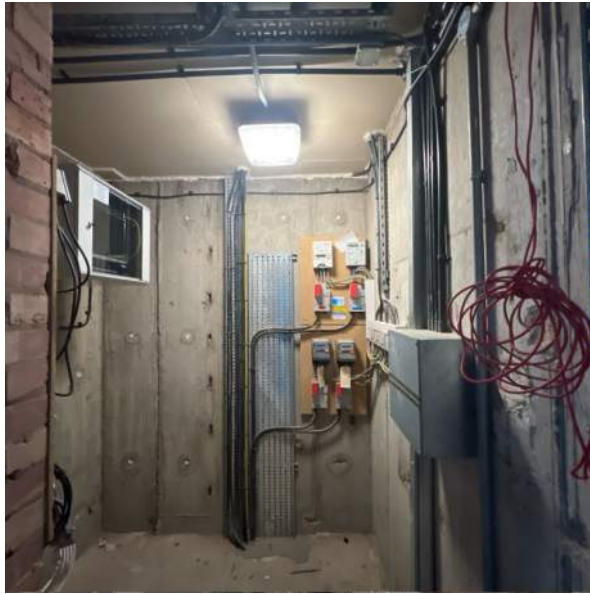
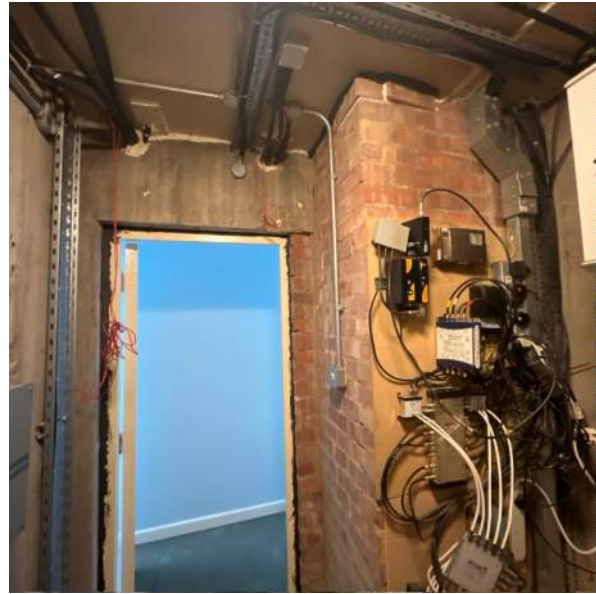
## 8th Floor Hallway

Comments: No jams or distortions noted to hallway doors to indicate any serviceability issues. Generally walls covered with finishes in hallway, likely to consist a mixture of concrete shear walls, embedded columns and masonry infill walls. Limited structure exposed. Concrete walls noted via riser cupboard and lift motor room.

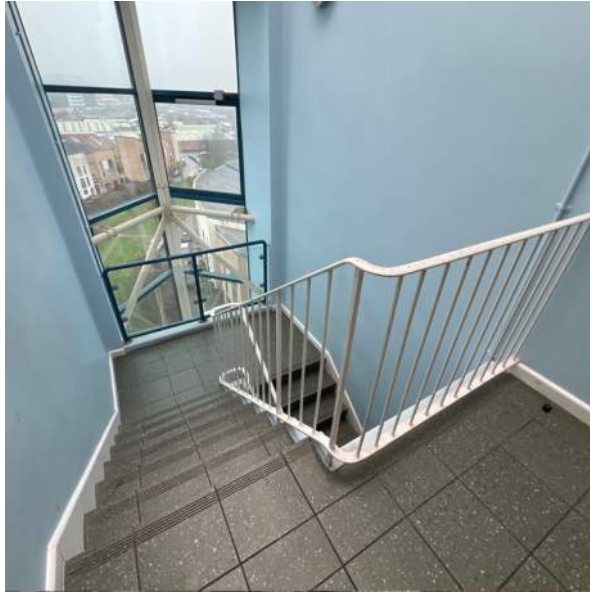
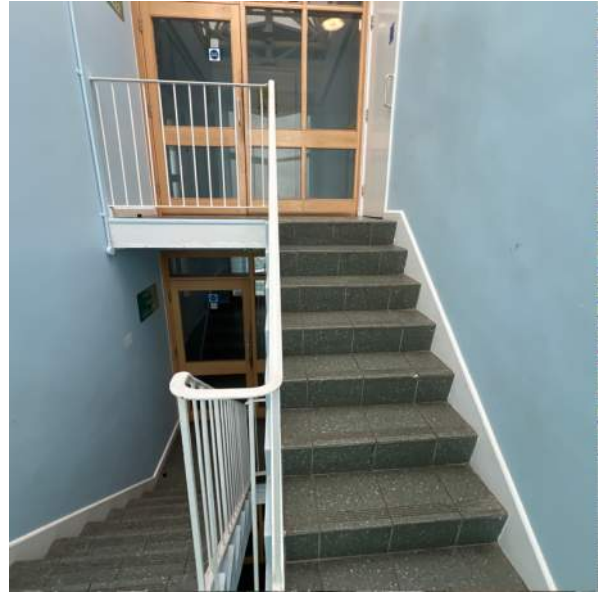
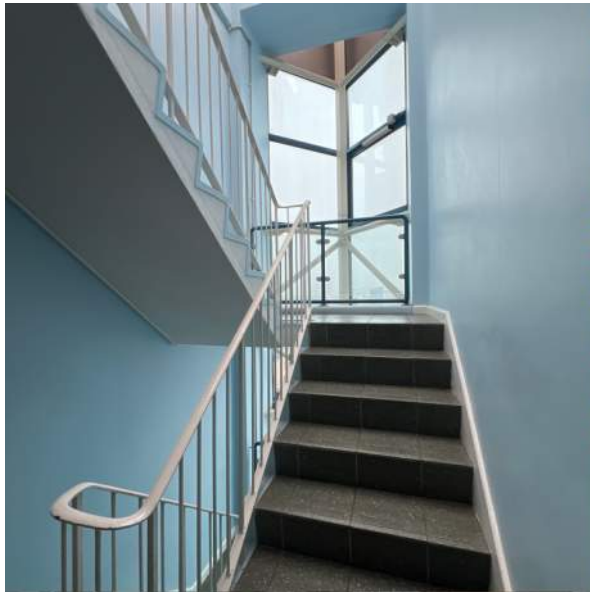
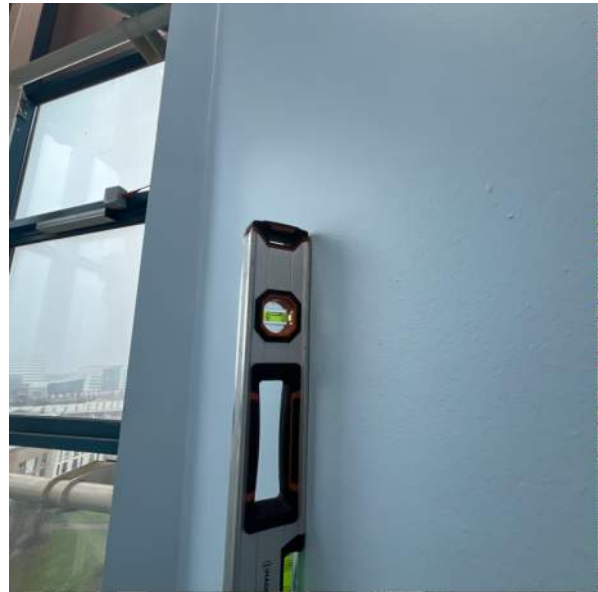
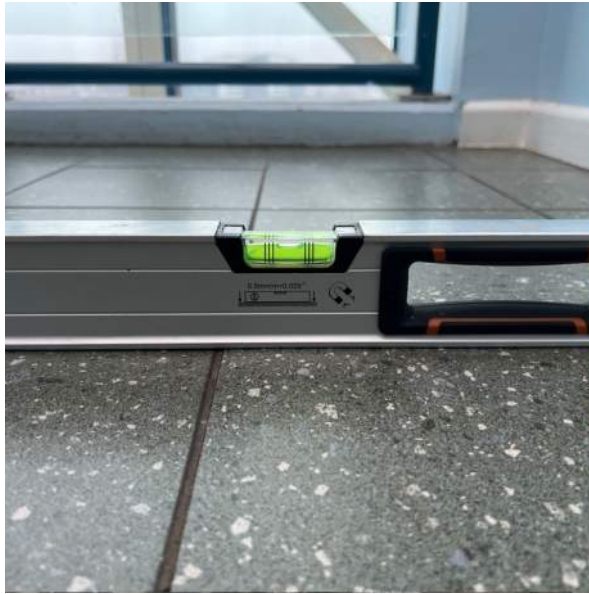
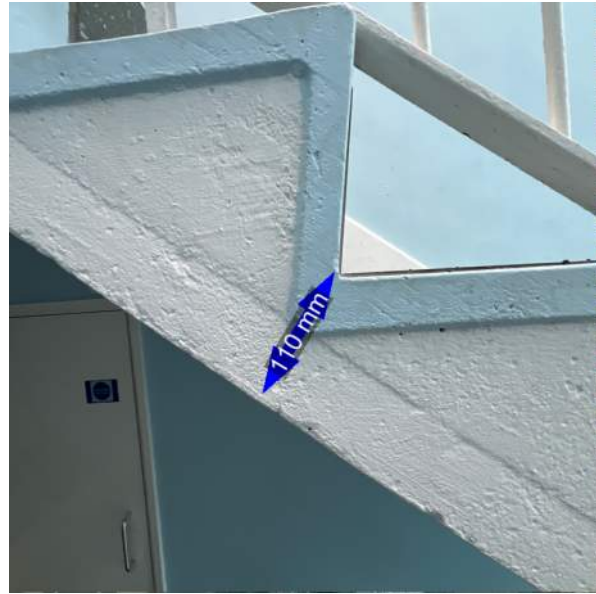
## 8th Floor Staircases

Comments: Insitu concrete stairs with steel hand railing fixed to stairs. Walls and floors appear to be fairly level.  
Stair walls covered with finishes however these would likely form the main concrete shear core walls.

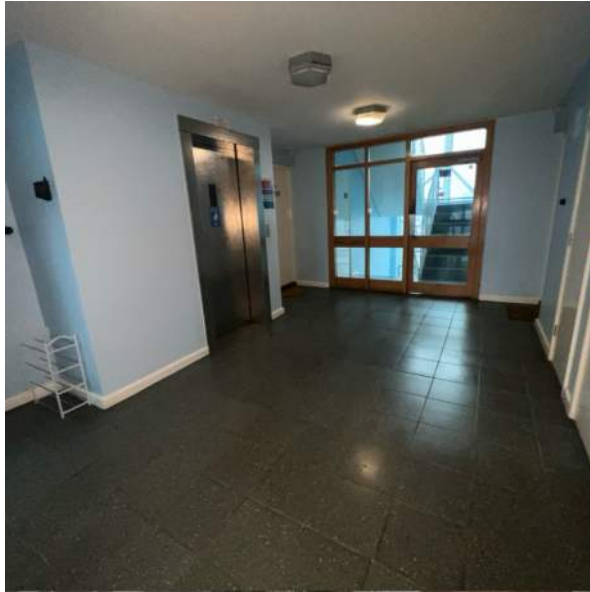
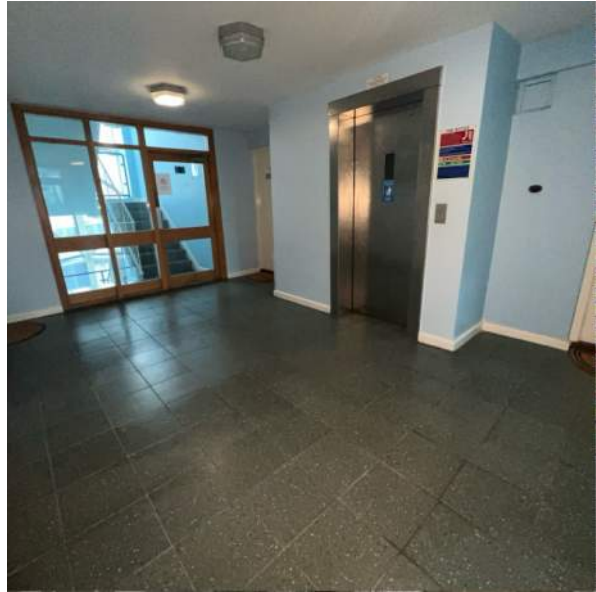
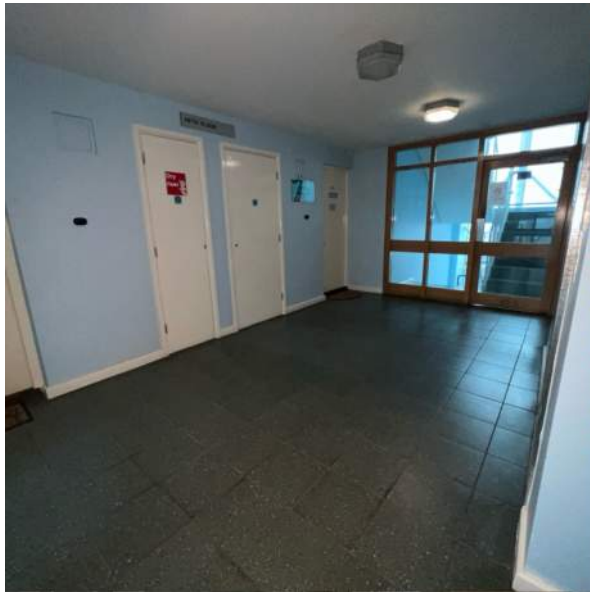
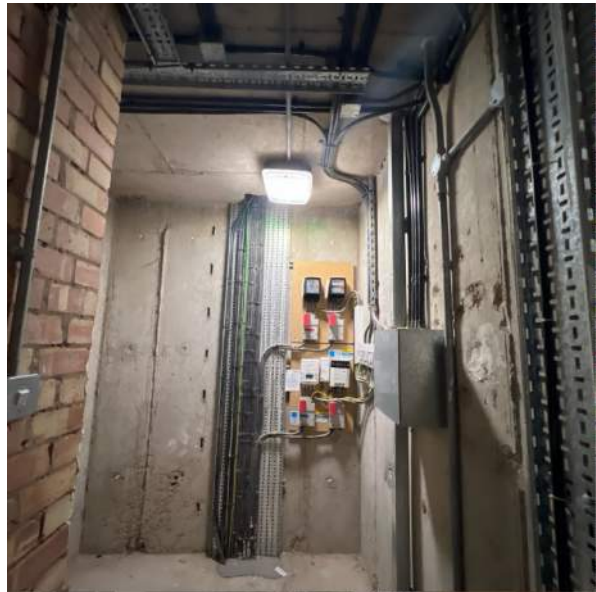
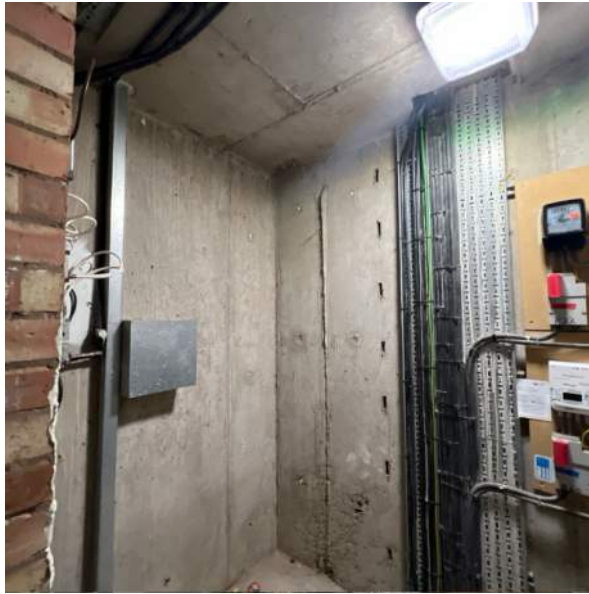
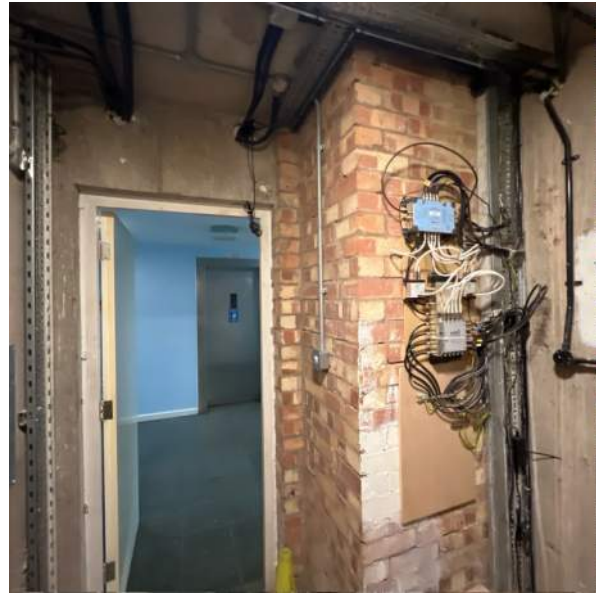
## 5th Floor Hallway

Comments: No jams or distortions noted to hallway doors to indicate any serviceability issues. Generally walls covered with finishes in hallway, likely to consist a mixture of concrete shear walls, embedded columns and masonry infill walls. Limited structure exposed. Concrete walls noted via riser cupboard. Lift walls appear to be solid concrete walls.

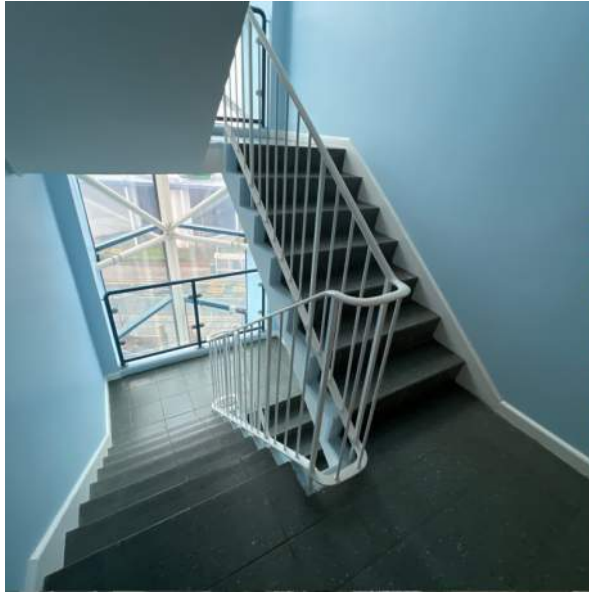
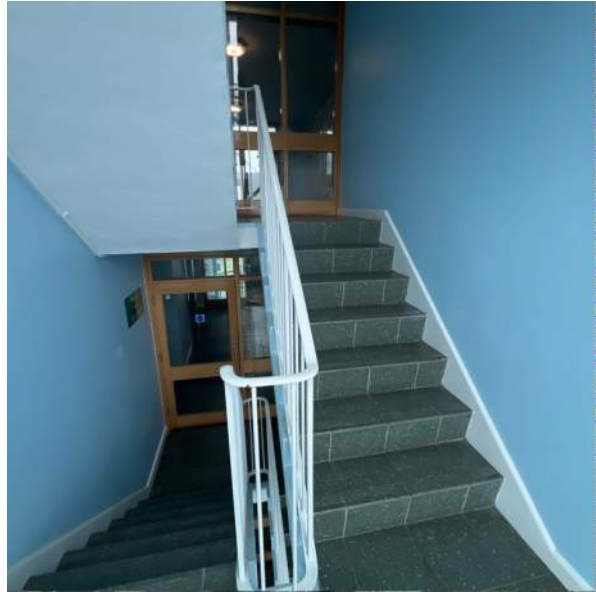
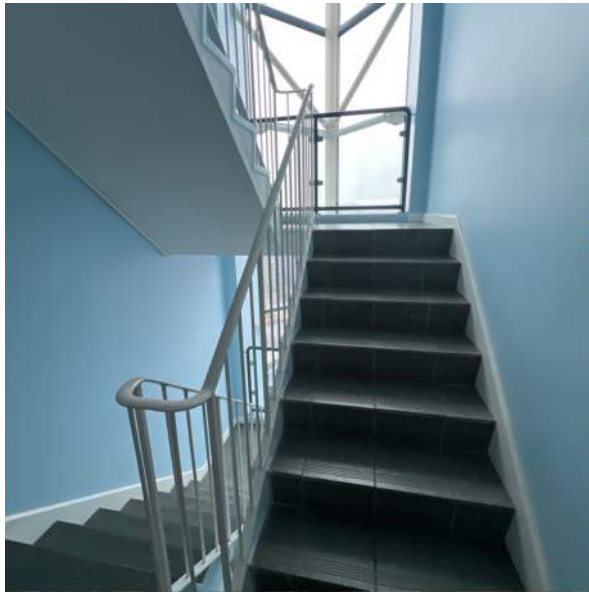
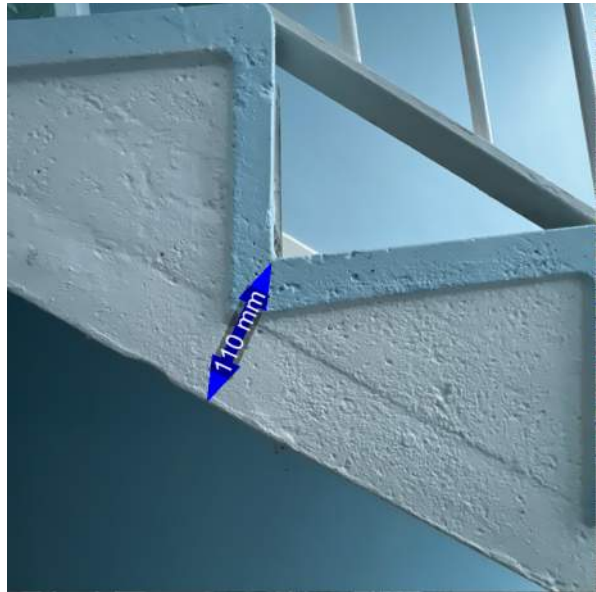
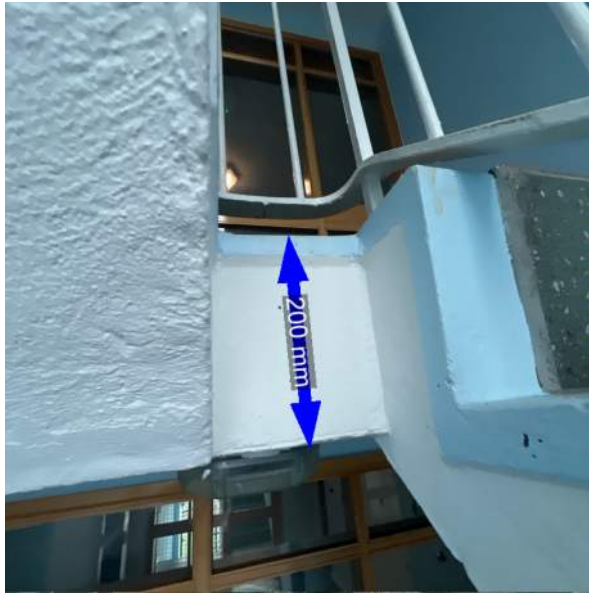
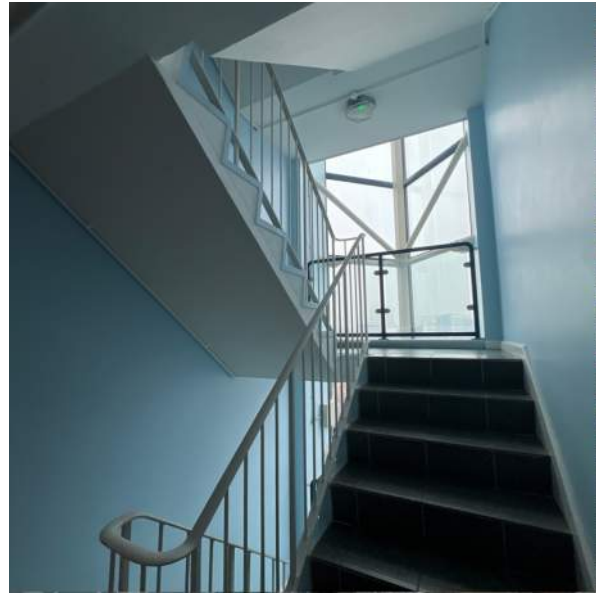
## 5th Floor Staircases

Insitu concrete stairs with steel hand railing fixed to stairs. Walls and floors appear to be fairly level.  
Stair walls covered with finishes however these would likely form the main concrete shear core walls.

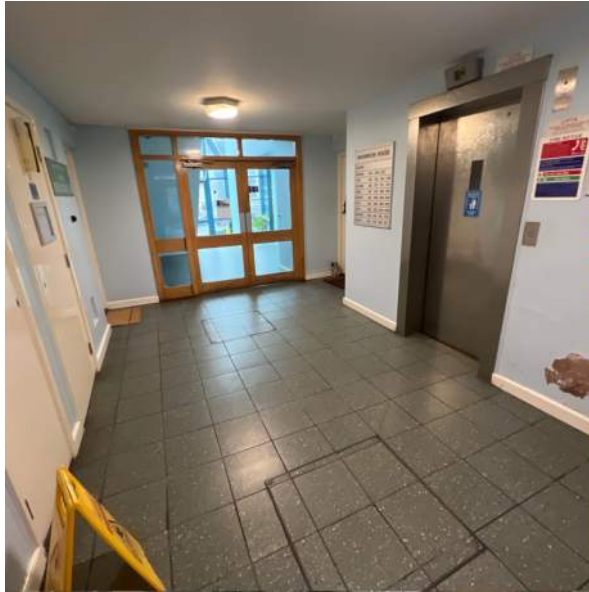
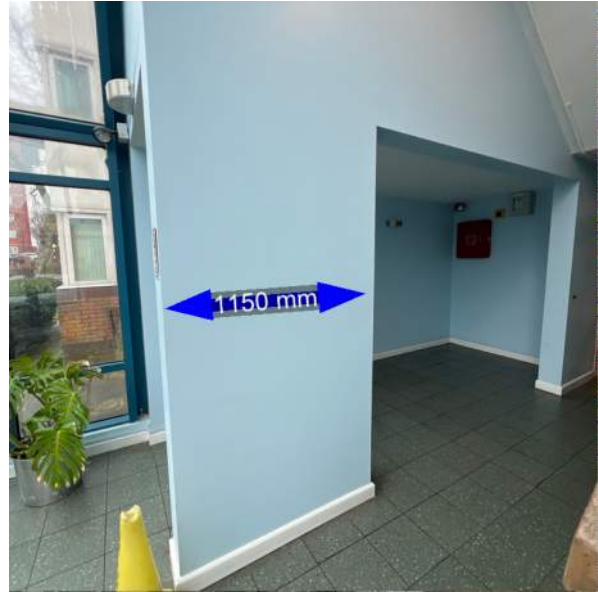
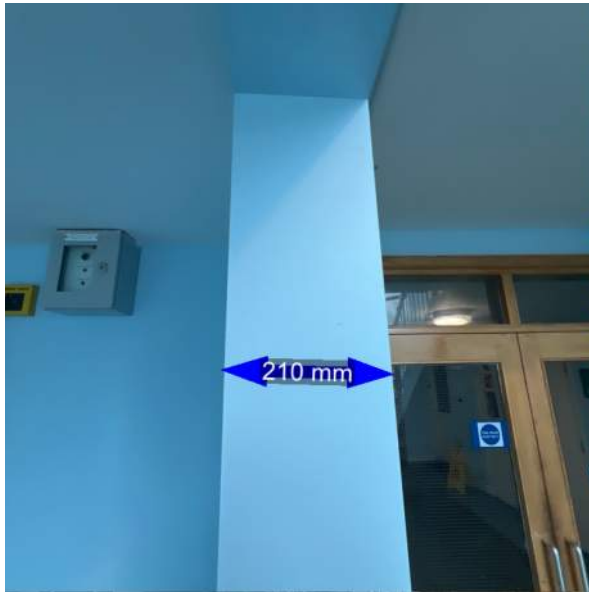
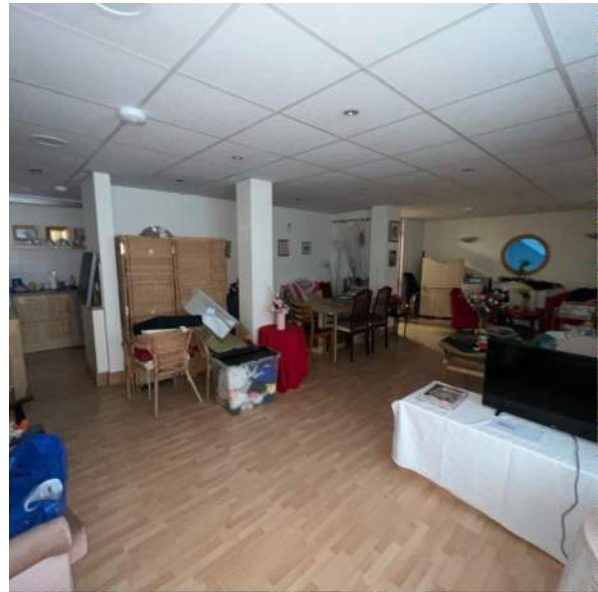
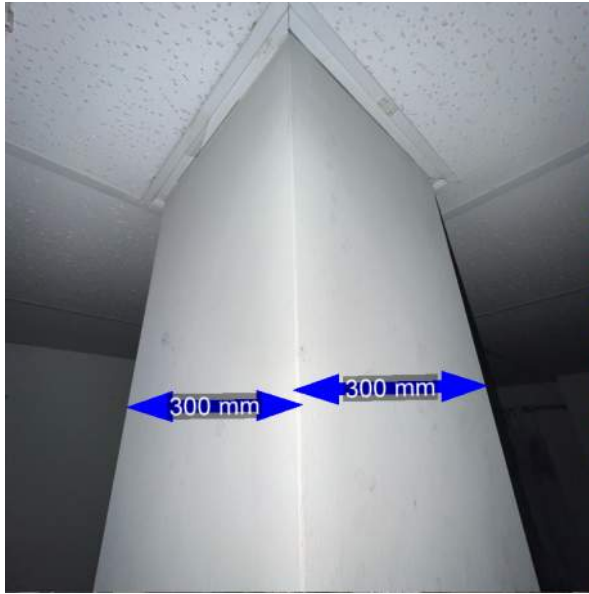
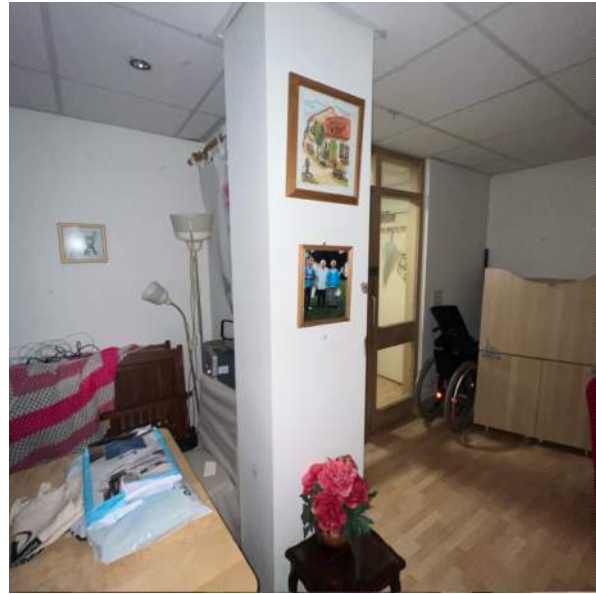
## Ground Floor Hallway

Comments: No jams or distortions noted to hallway doors to indicate any serviceability issues. Generally walls covered with finishes in hallway, likely to consist a mixture of concrete shear walls, embedded columns and block infill walls. Limited structure exposed. Partly visible concrete walls noted via electrical riser cupboard. RC columns noted in communal areas and community room.

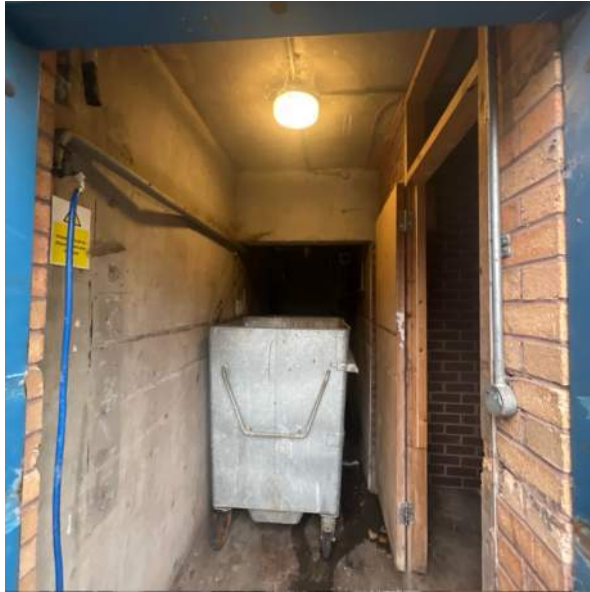
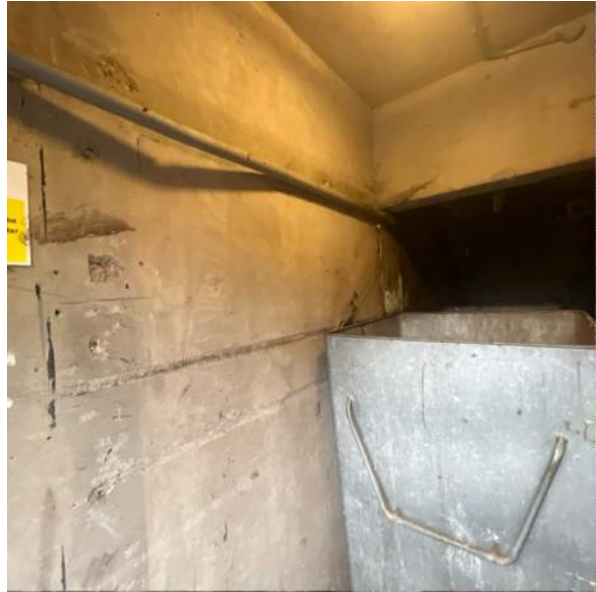
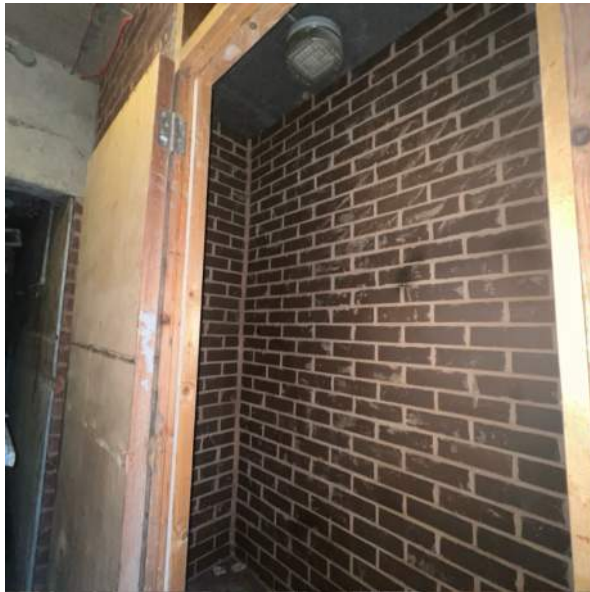
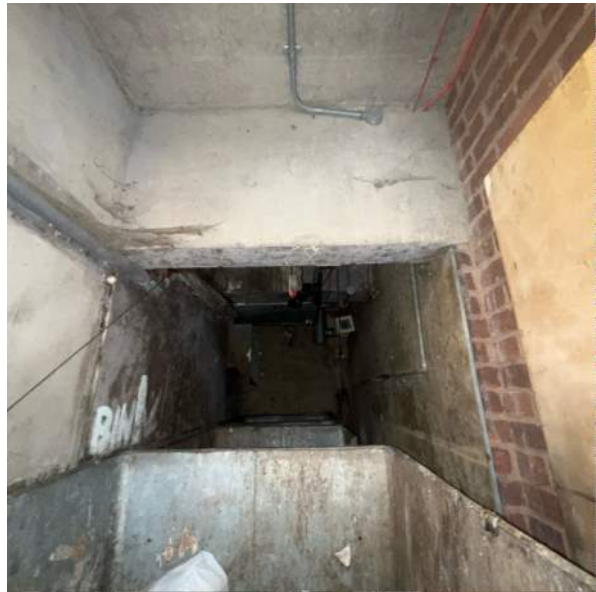
## Binstore

RC shear walls noted in binstore.

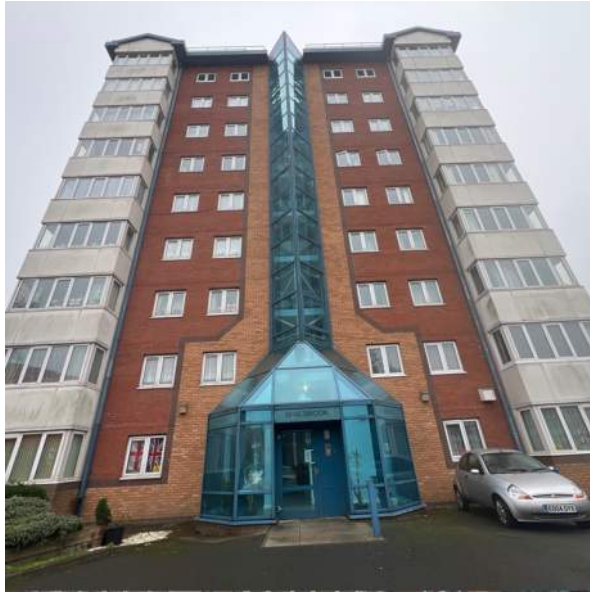
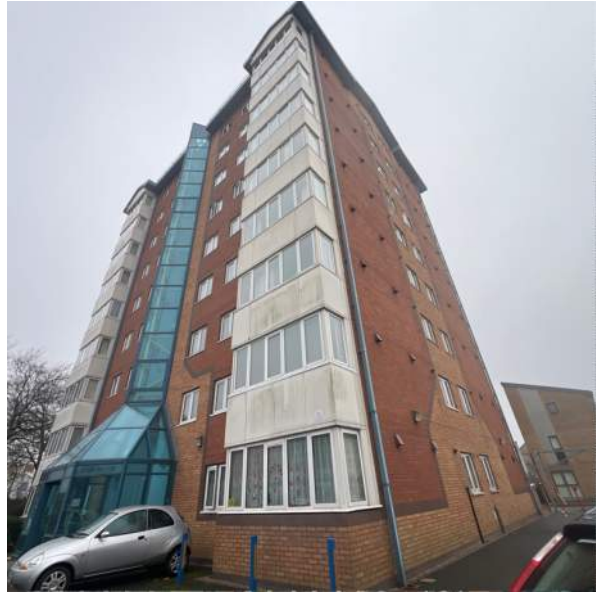
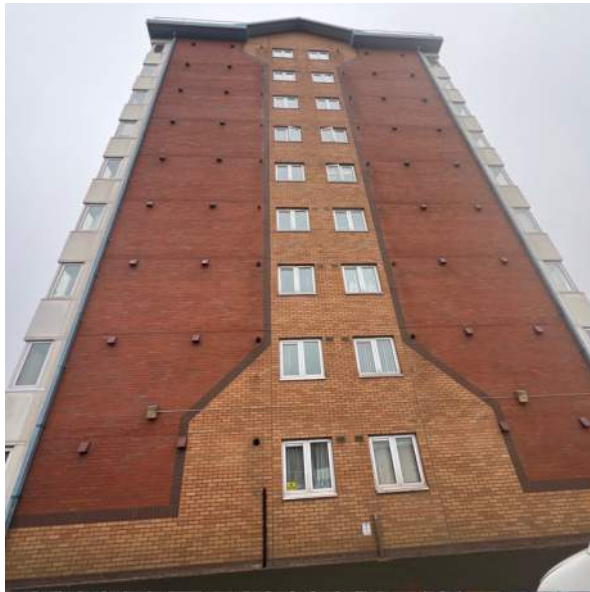
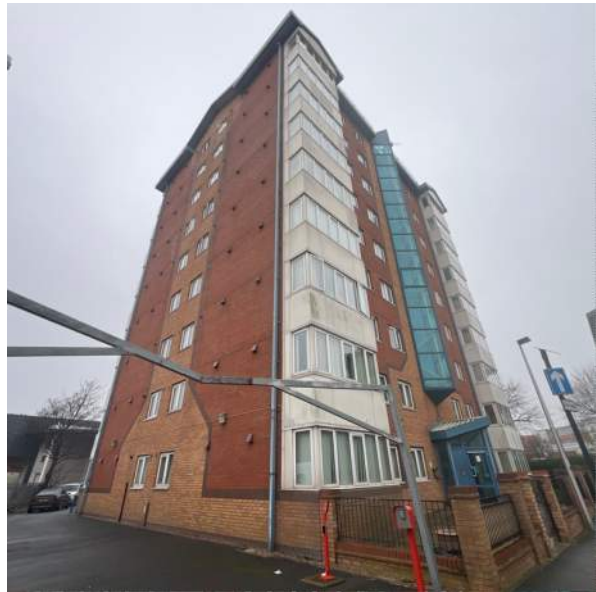
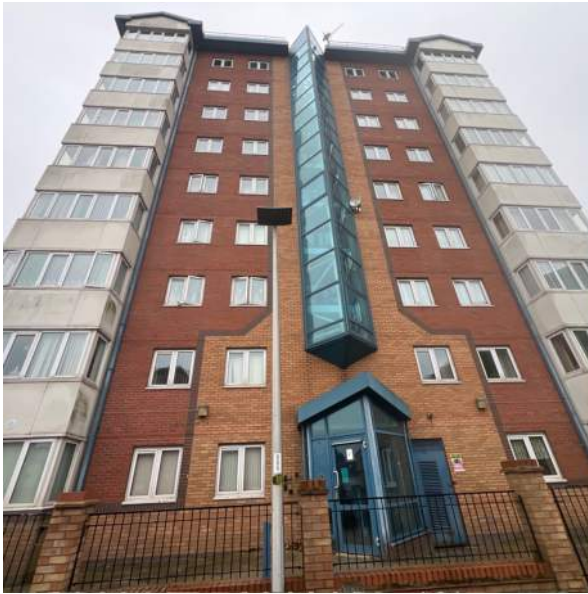
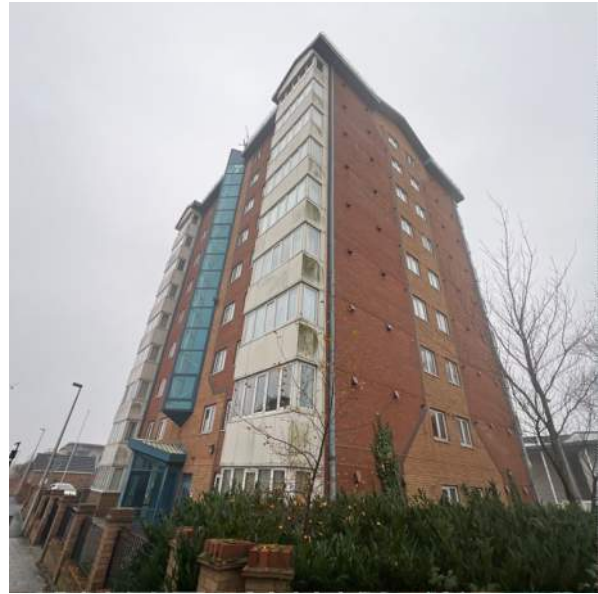
## Elevations

External facade consist of mainly brickwork. Balconies cladded with aluminium facade.
