VISUAL STRUCTURAL APPRAISAL

Broadmead House

Pavillion Avenue  
Smethwick  
B67 6LB

19<sup>th</sup> December 2024

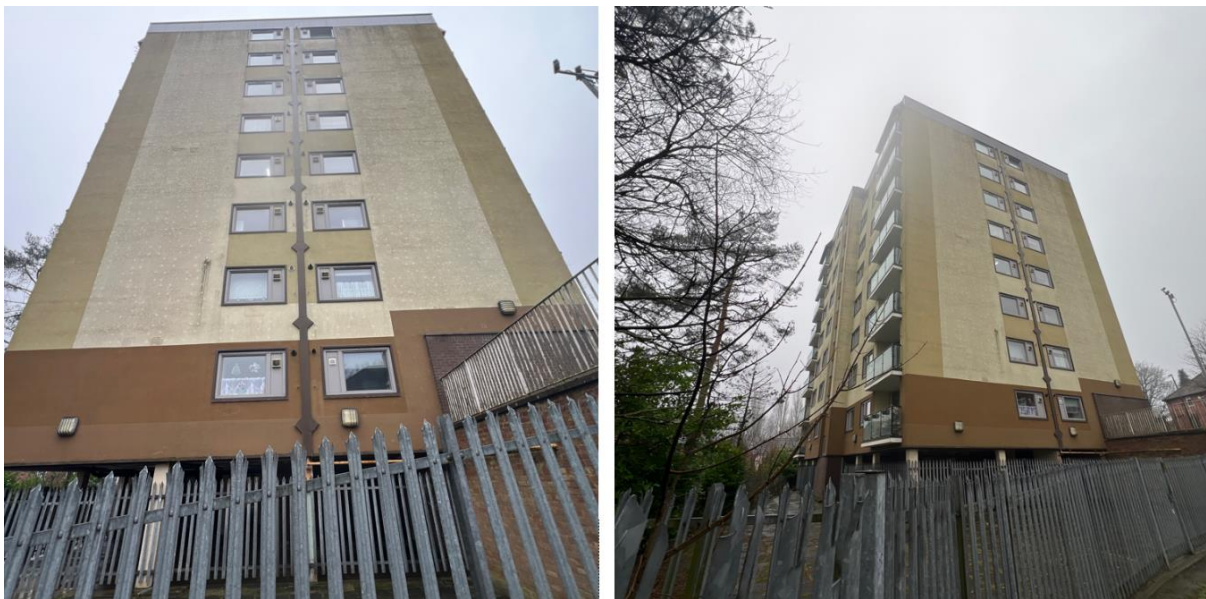
Figure 9 and 10: Front and side Elevations

The exterior elevations were generally in ok condition and no significant structural defects were noted to the cladding panels. There were no significant cracks or tell-tale signs of any significant structural movement noted at the time of our inspection.

The exterior panels were noted to be plumb with no signs of significant bowing, bulging or leaning noted to the panels indicating failed fixings however their presence and condition cannot be confirmed.

There are balconies at each level which have been clad in glazed panels.

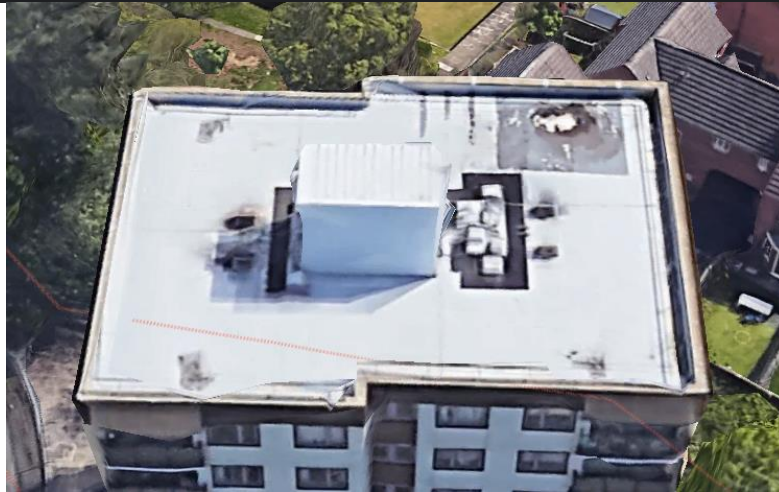
Figure 11: Roof Level

The flat roof structure is a reinforced concrete cast slab with perimeter RC parapet wall. There is an enclosure which partially covers the roof area comprising the lift plant. This structure is formed of solid masonry walls.

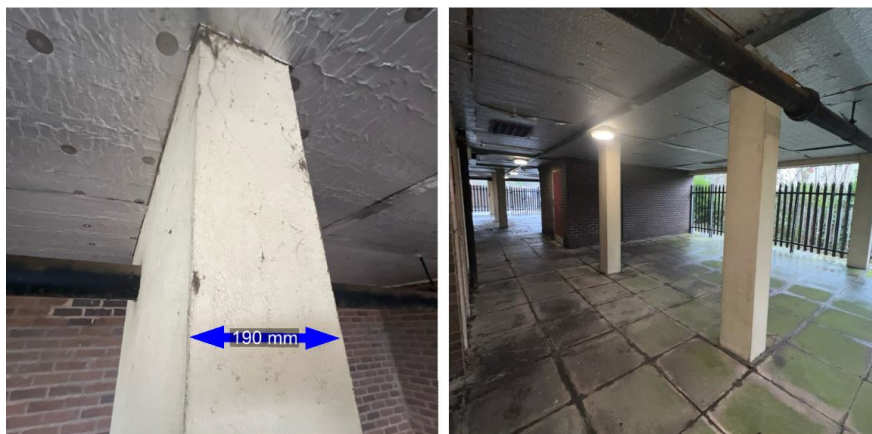
Figure 12 and 13: Vertical RC Structure Visible

The interior of the stair core walls were checked and were plumb and in line with observations made to the exterior – no significant signs of leaning or movement noted. The concrete appeared in fair condition with few BRE category 1 cracks but no structurally significant defects were noted.

The columns are typically 190-270mm thick, a cover test is required to check the resistance of the concrete section in the event of a fire.

Due to the age of the building it is wise to perform periodical health checks to the concrete elements. This should include tests for concrete strength, cover depth, carbonation, chlorides and HAC. It would appear that these tests have never been performed to this building and therefore we recommend engaging a specialist contractor within the next 24 months who will be able to perform the tests and provide a interpretive report. The fire resistance of the structure is not confirmed until the cover meter tests are completed.

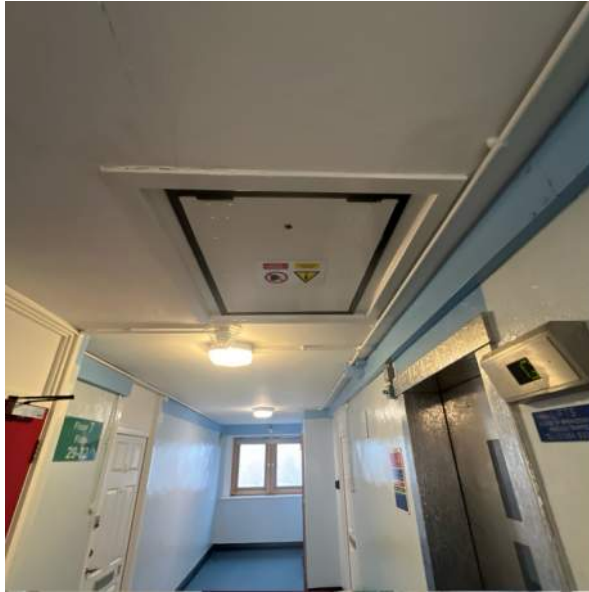
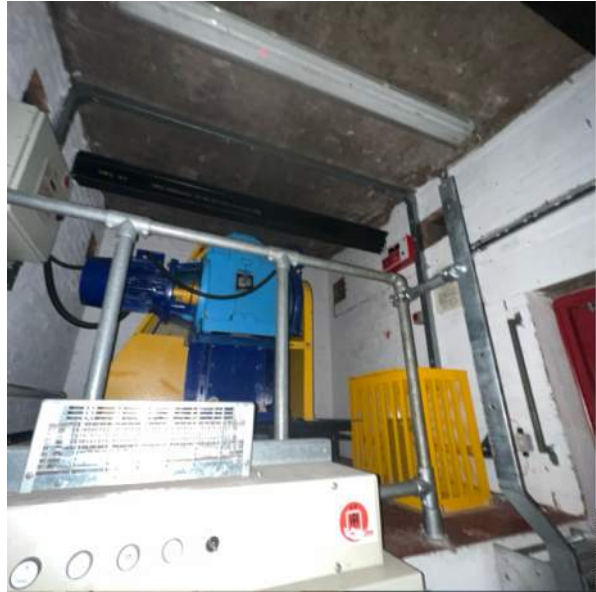
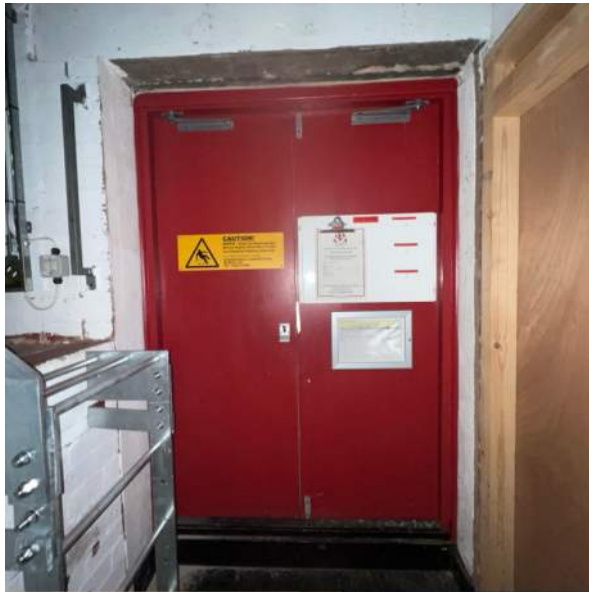
## Main Roof

No access to roof during inspection, key appears to jam whilst attempting to open.

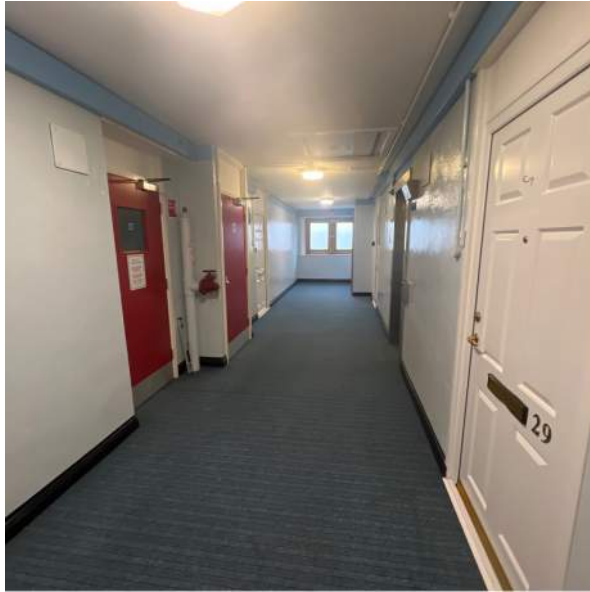
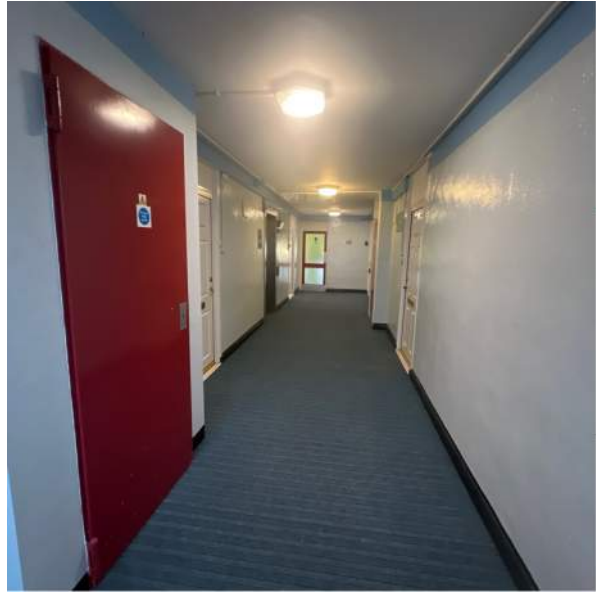
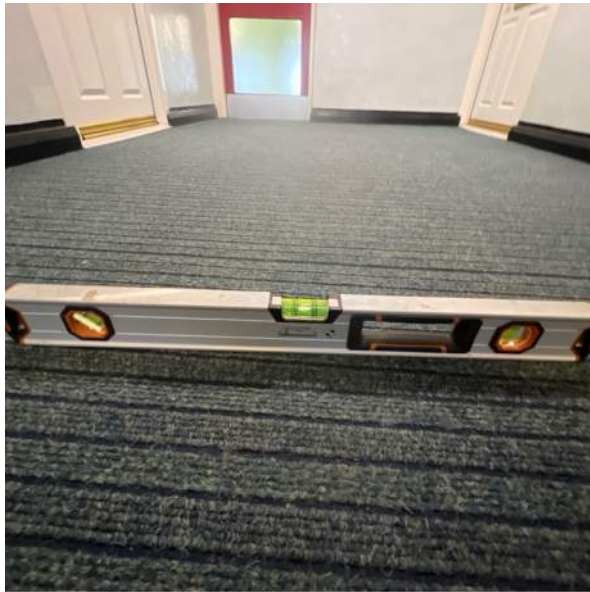
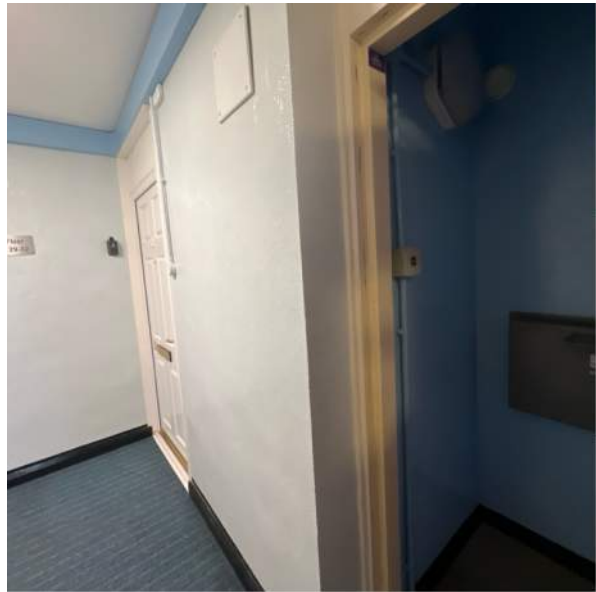
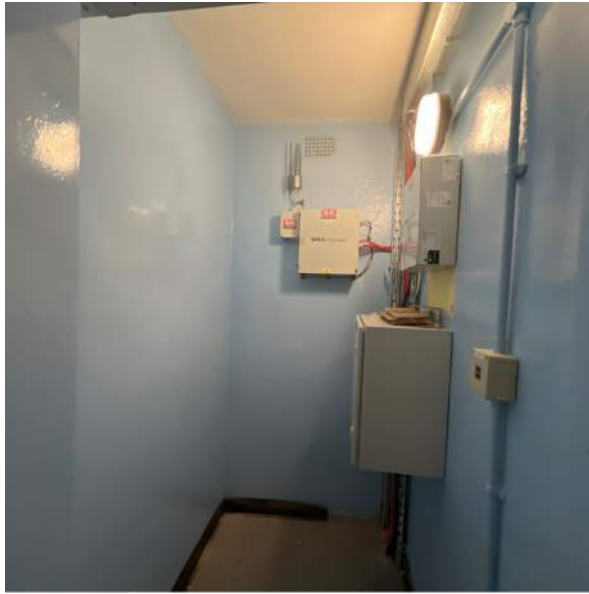
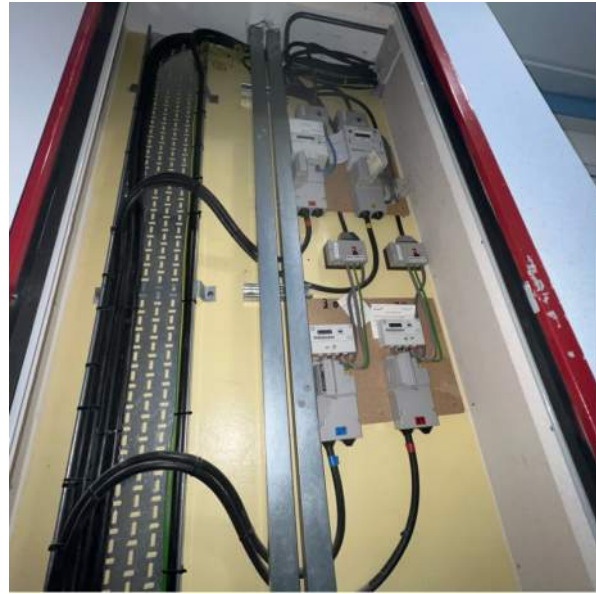
## 7th Floor Hallway

Comments: No jams or distortions noted to hallway doors to indicate any serviceability issues. Generally walls covered with finishes in hallway, appear to consist of concrete shear walls. Concrete walls noted via electrical riser cupboards but covered with finishes. Likely some infill non-load bearing masonry walls present. Concrete wall between hallway and staircase measured to be approx. 220mm thick.

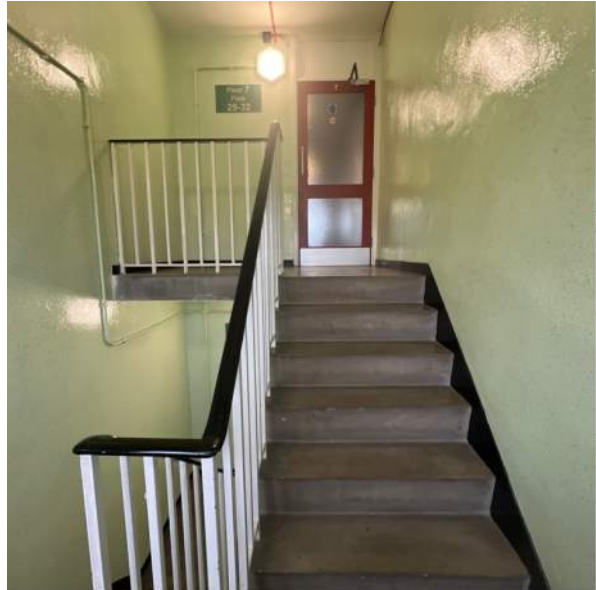
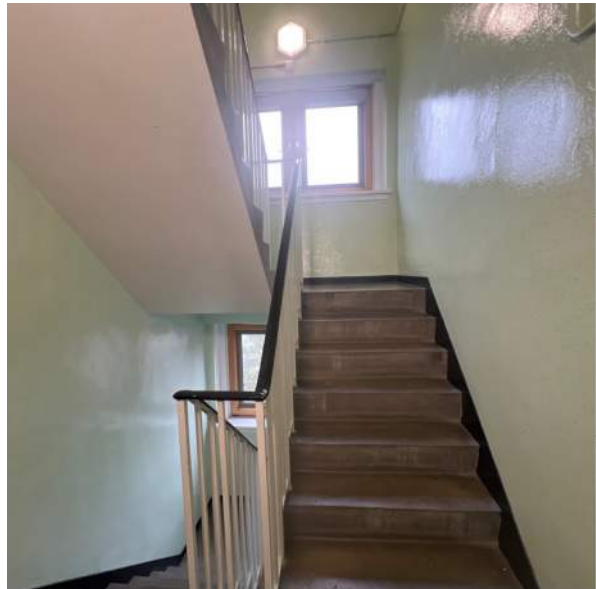
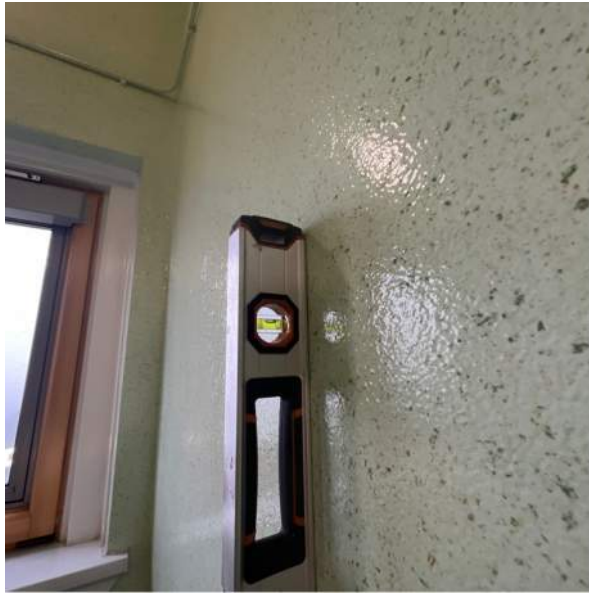
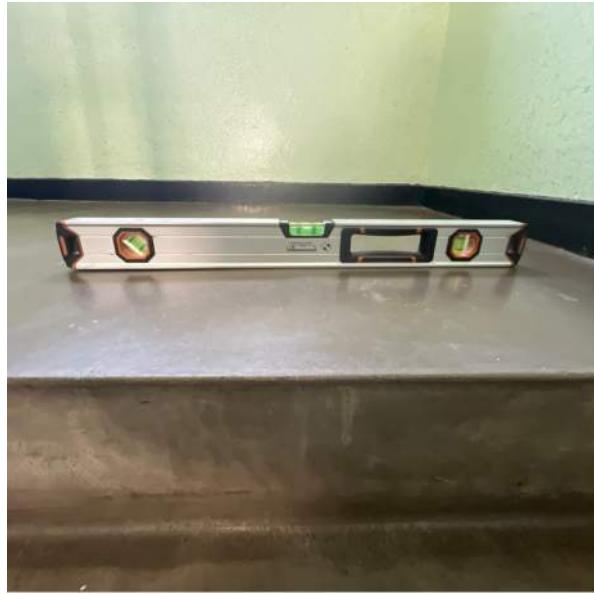
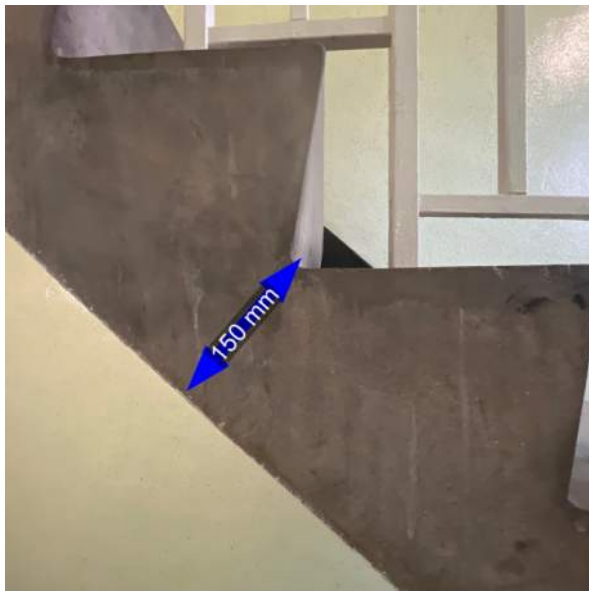
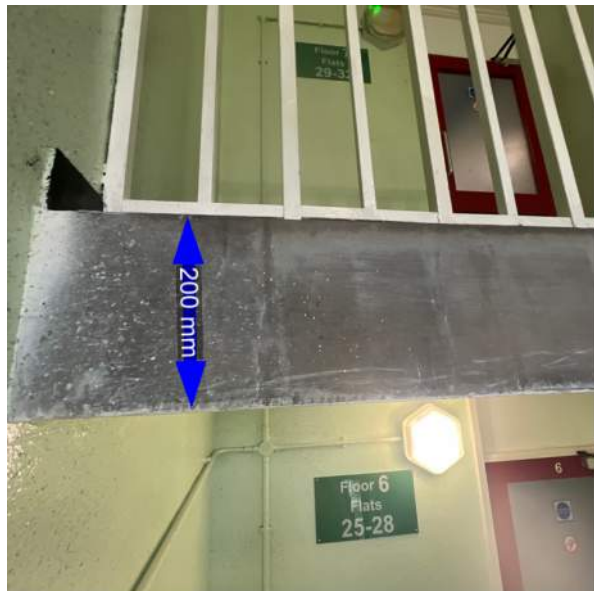
## 7th Floor Staircase

Insitu concrete stairs with steel hand railing fixed to stairs. Walls and floors appear to be fairly level.  
Stair walls covered with finishes however these would likely form the main concrete shear core walls.

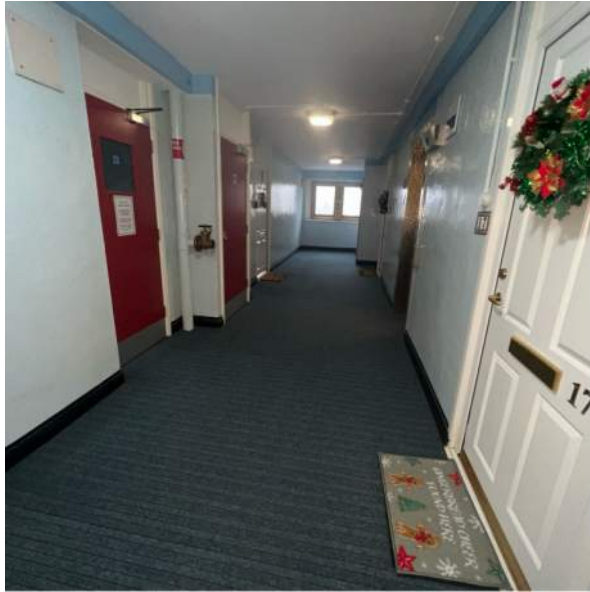
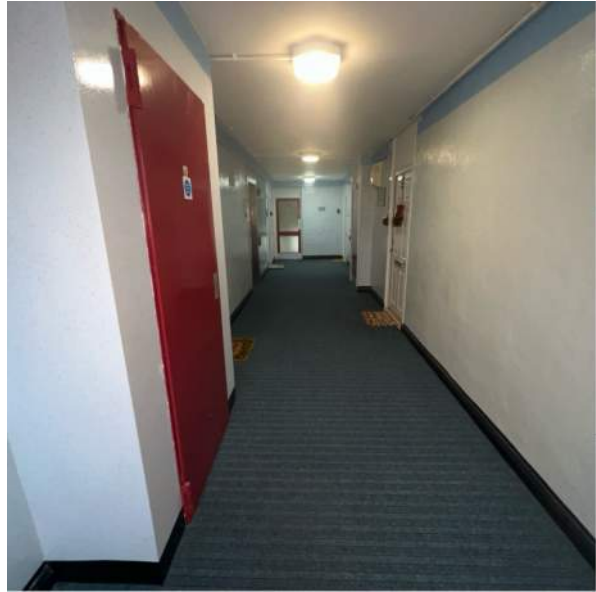
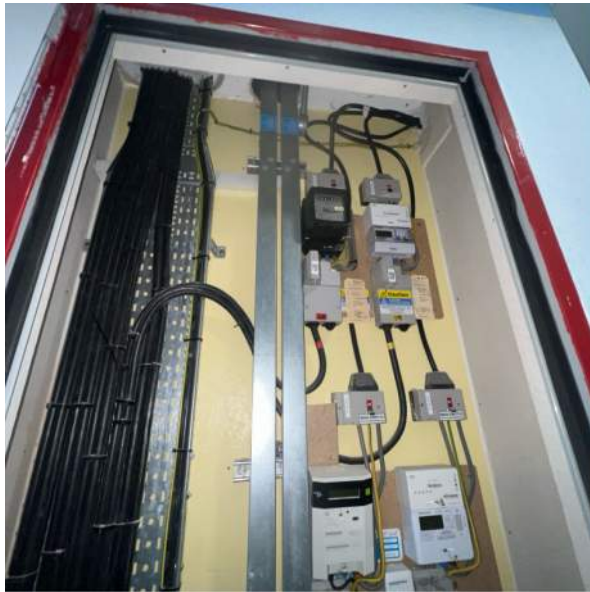
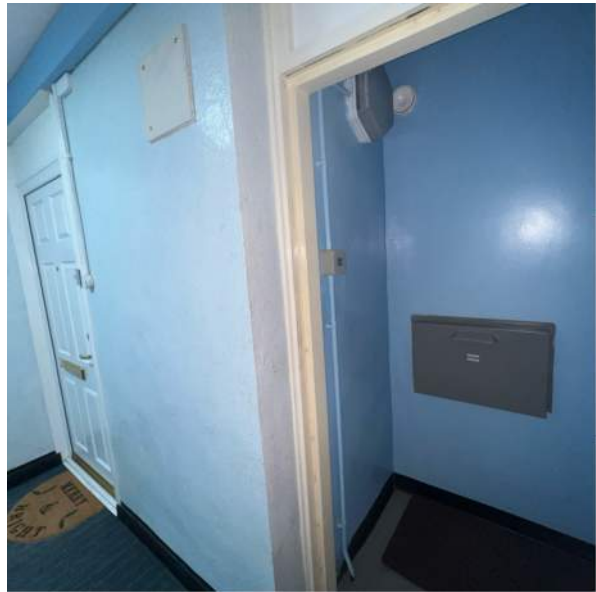
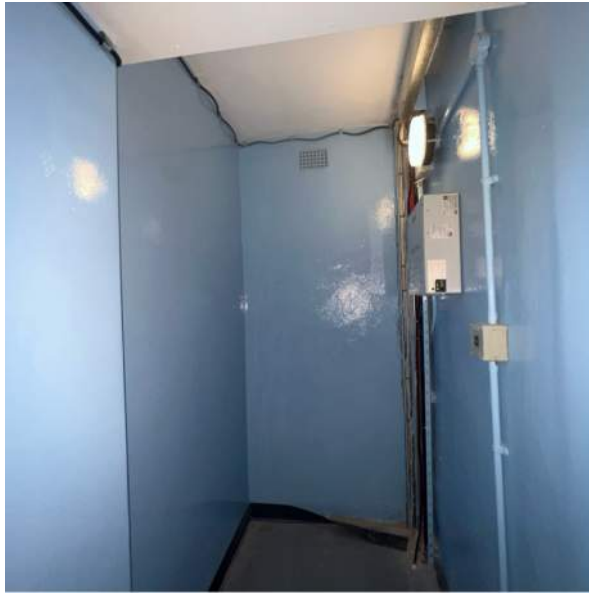
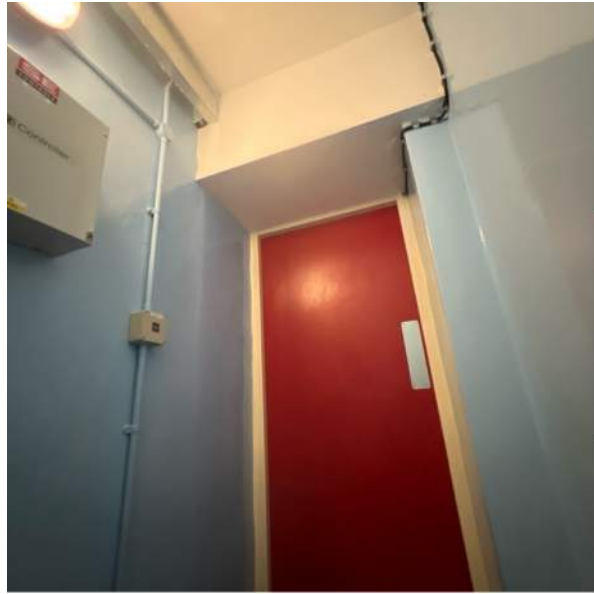
## 4th Floor Hallway

Comments: No jams or distortions noted to hallway doors to indicate any serviceability issues. Generally walls covered with finishes in hallway, appear to consist of concrete shear walls. Concrete walls noted via electrical riser cupboards but covered with finishes. Likely some infill non-load bearing masonry walls present. Concrete wall between hallway and staircase measured to be approx. 220mm thick.

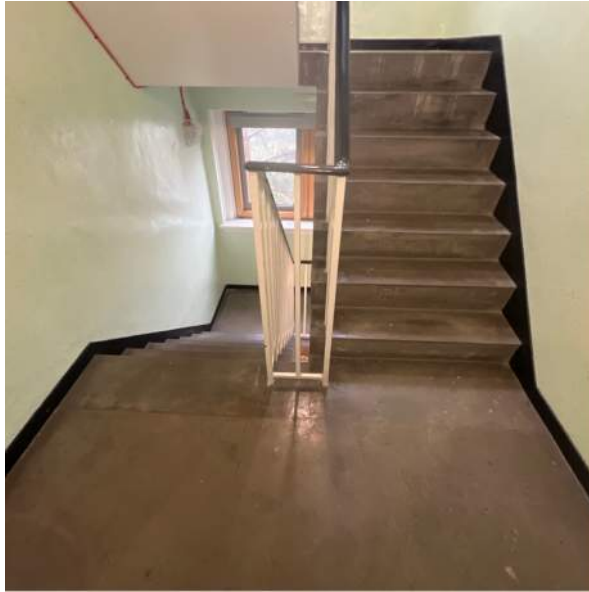
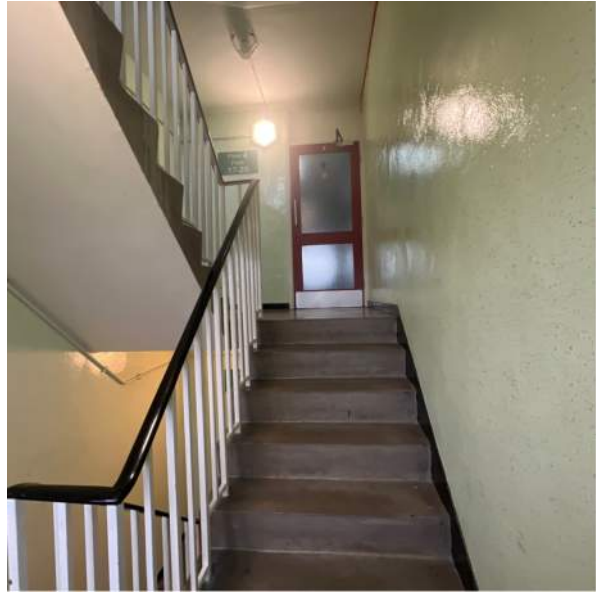
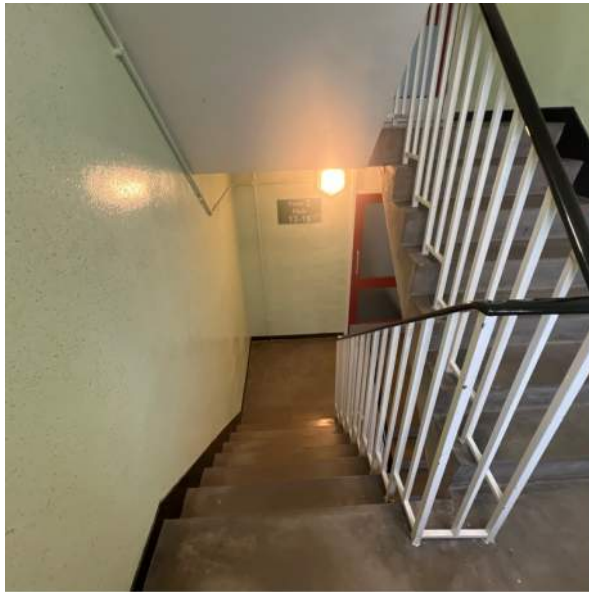
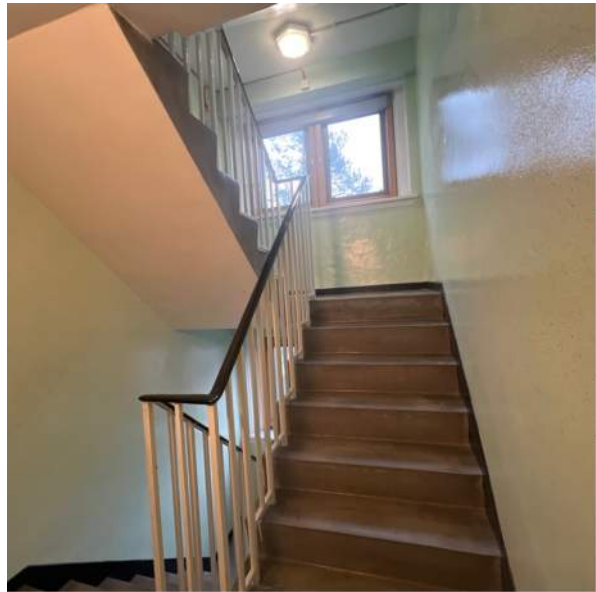
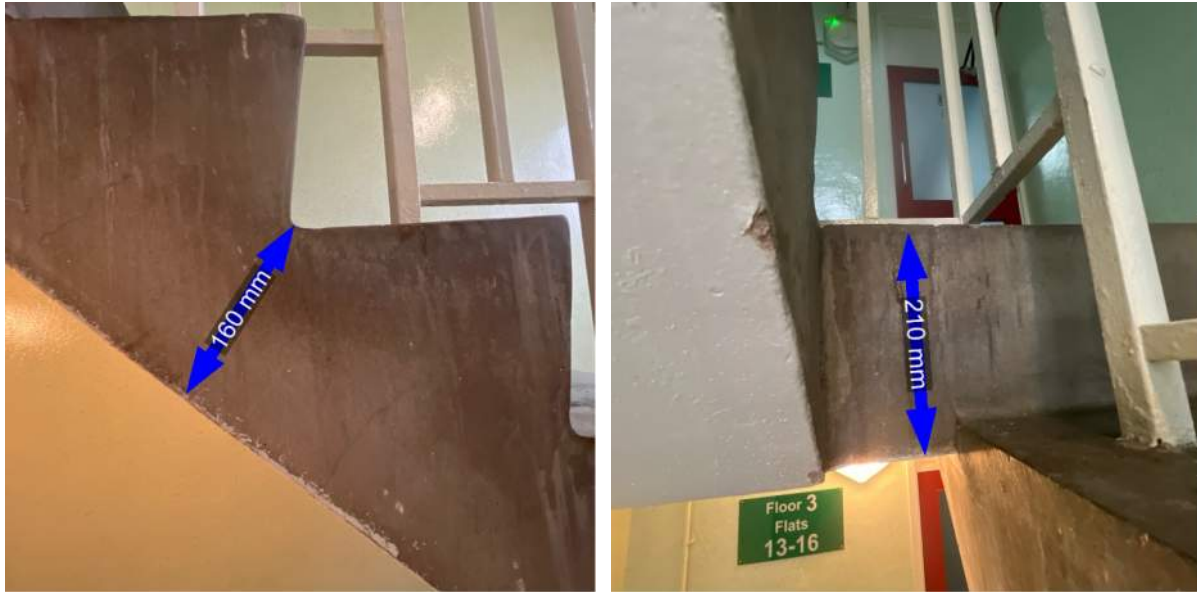
## 4th Floor Staircase

Comments: Insitu concrete stairs with steel hand railing fixed to stairs. Walls and floors appear to be fairly level.  
Stair walls covered with finishes however these would likely form the main concrete shear core walls.

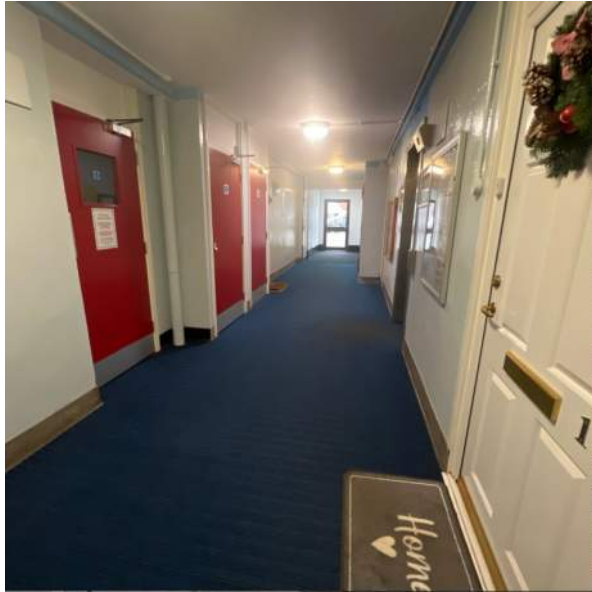
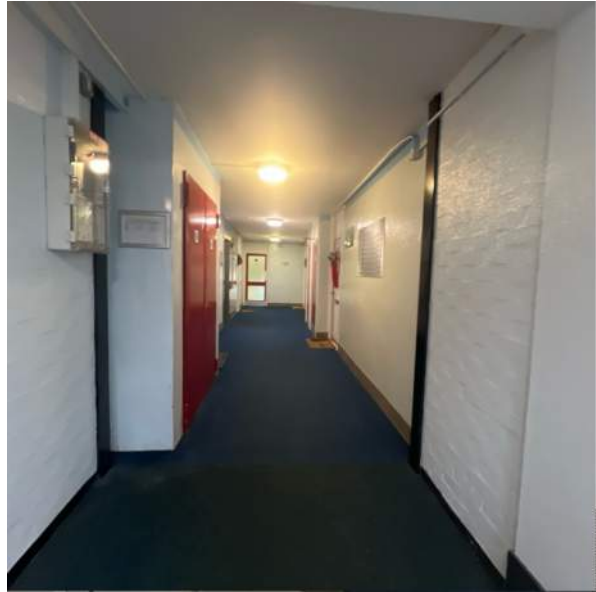
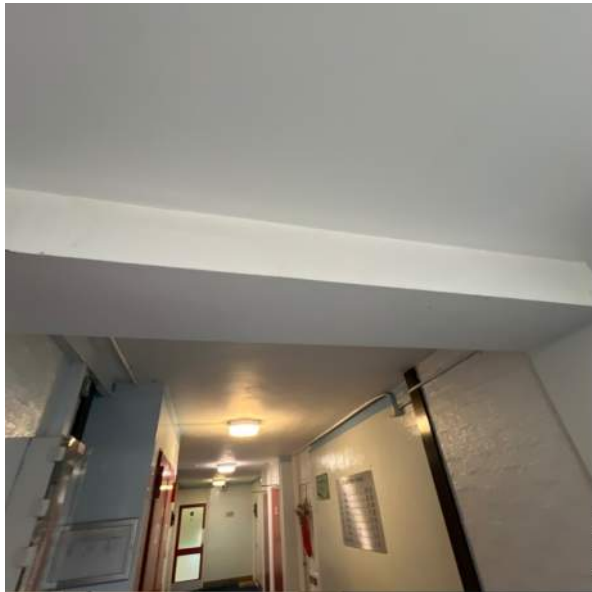
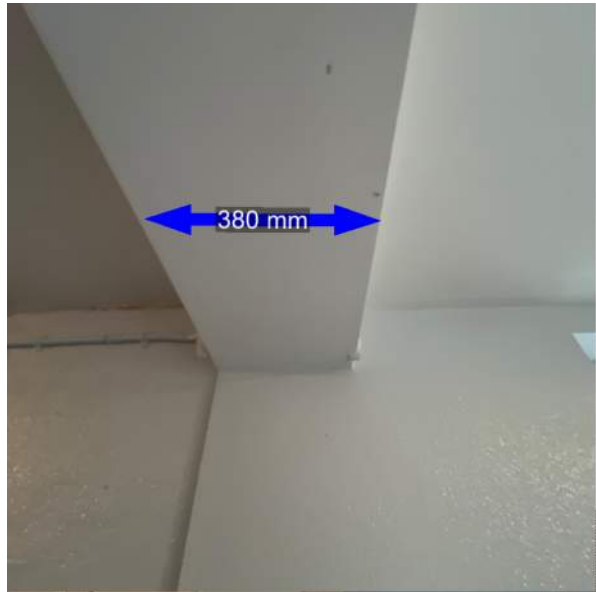
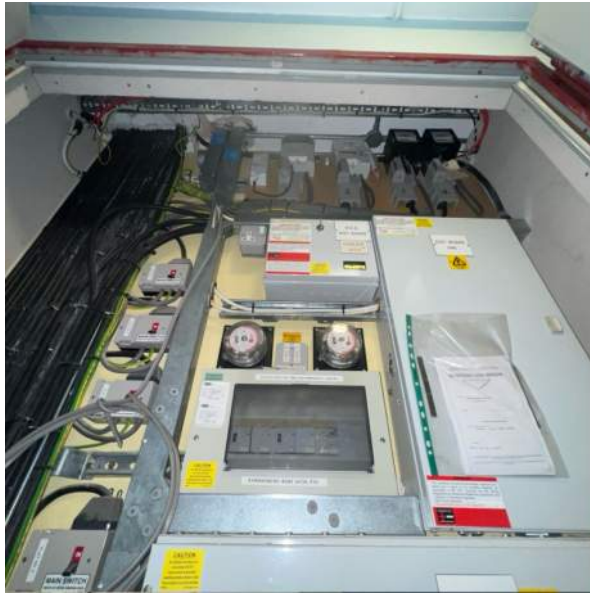
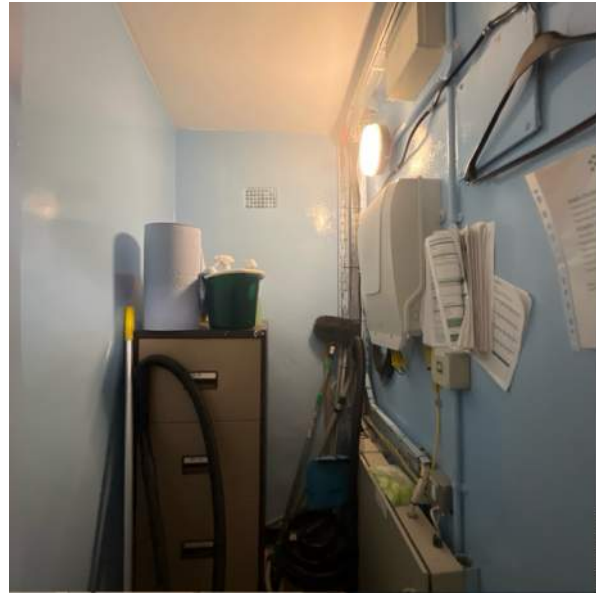
## Ground Floor Hallway

No jams or distortions noted to hallway doors to indicate any serviceability issues. Generally walls covered with finishes in hallway, appear to consist of concrete shear walls. Concrete walls noted via electrical riser cupboards but covered with finishes. Likely some infill non-load bearing masonry walls present. Concrete wall between hallway and staircase measured to be approx. 220mm thick.

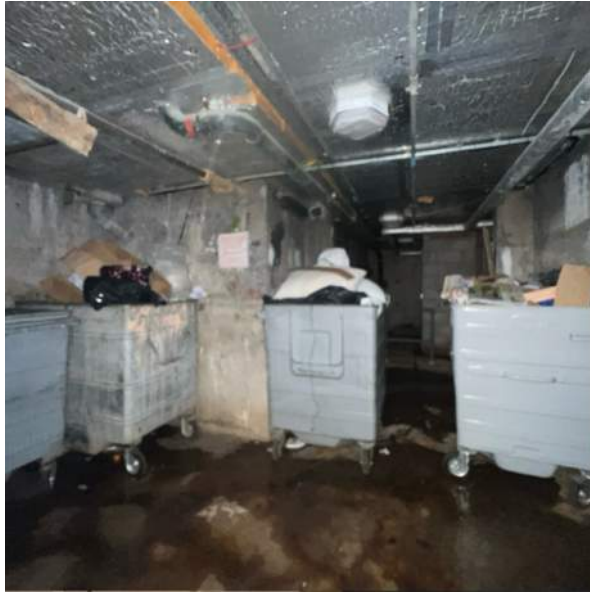
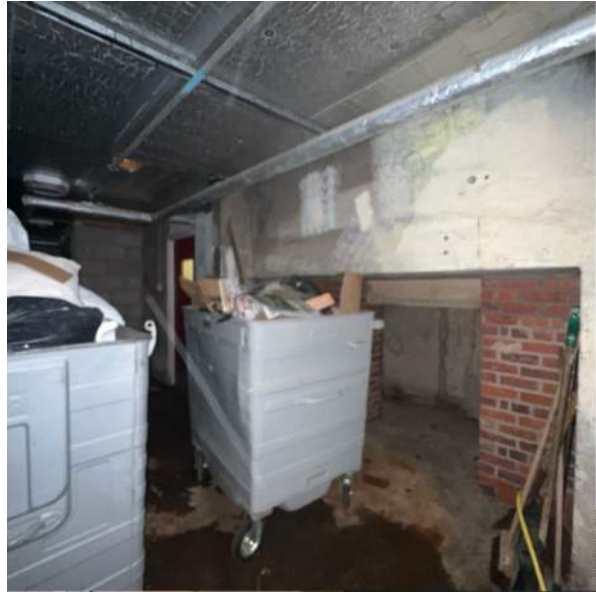
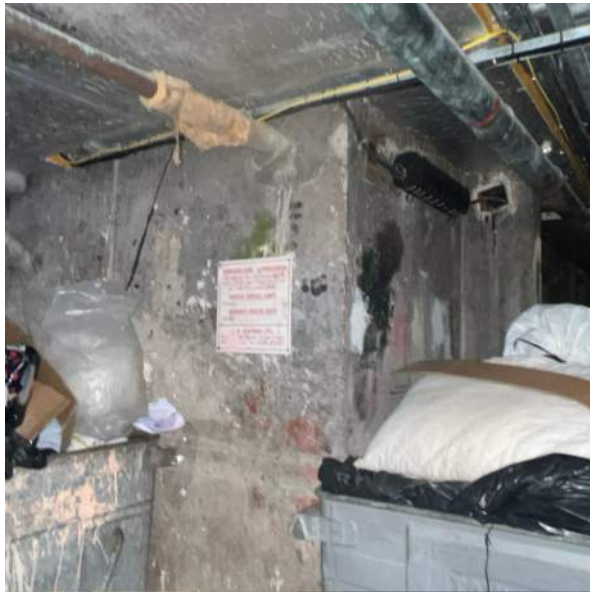
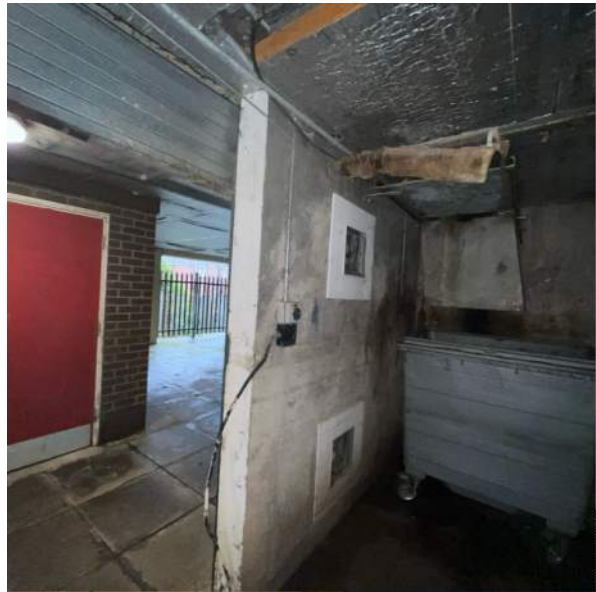
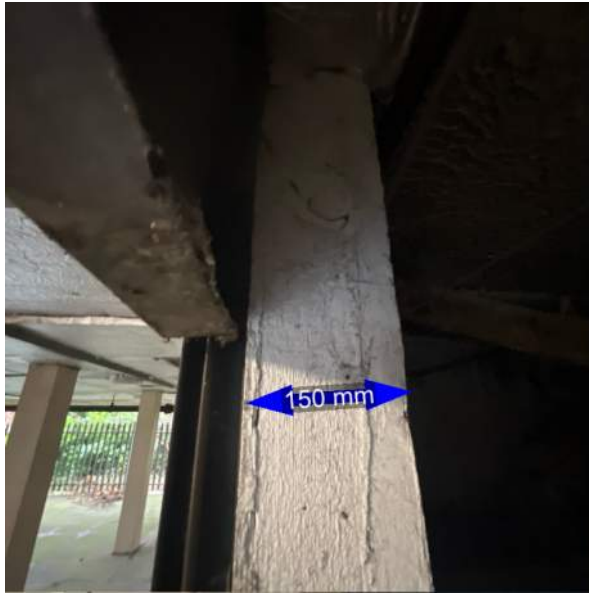
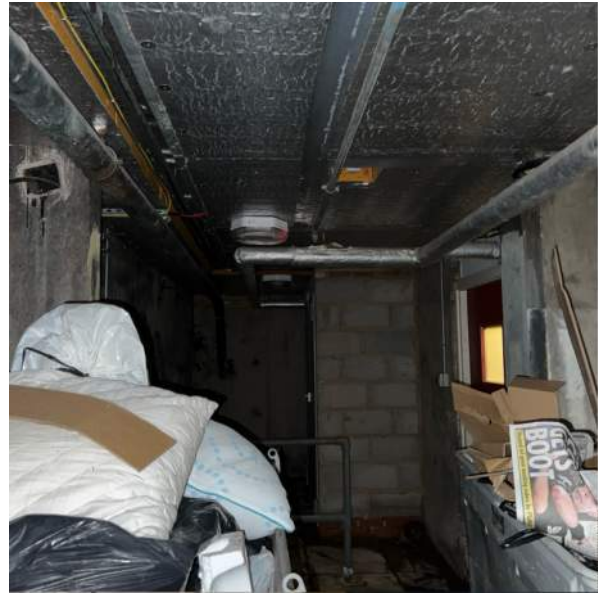
## Binstore

RC shear walls/structure noted in binstore.

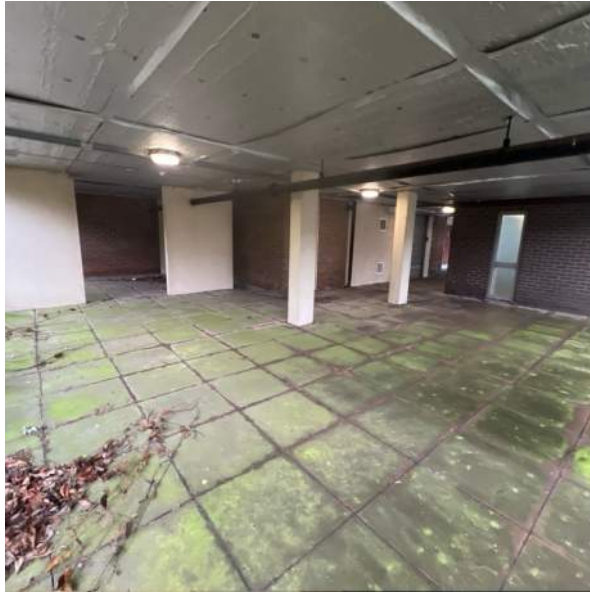
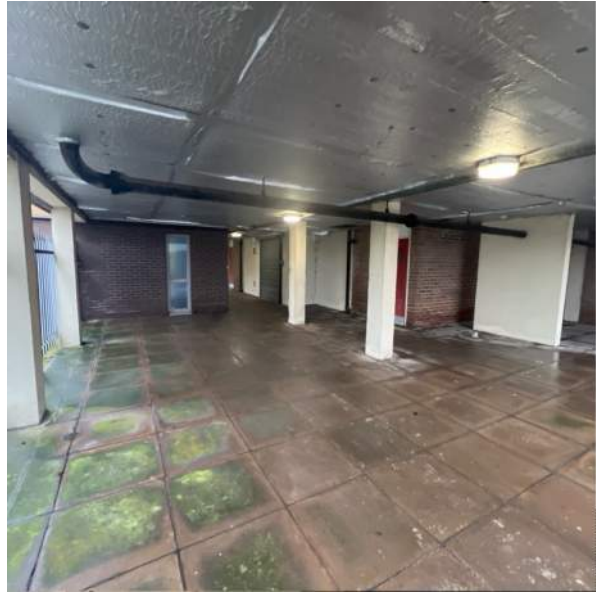
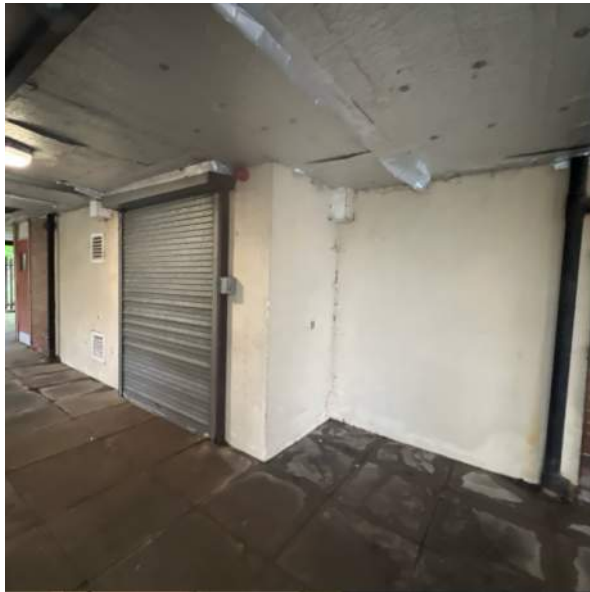
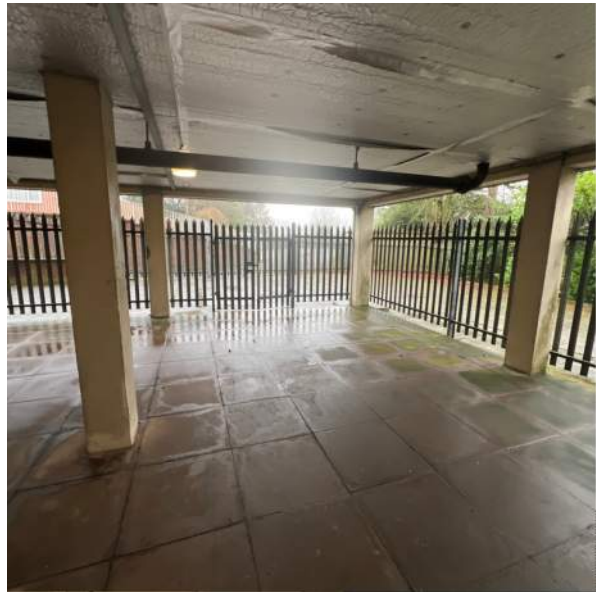
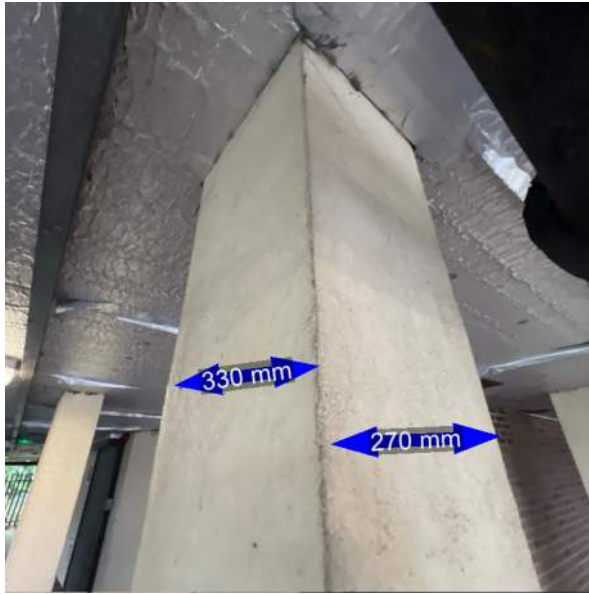
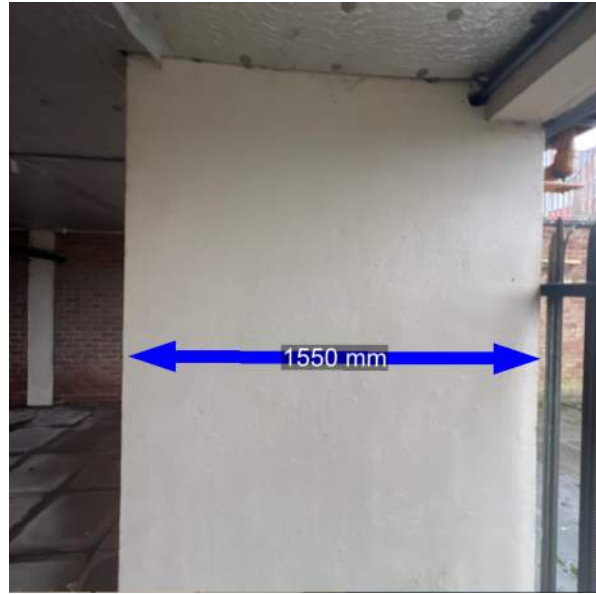
## Lower Ground Floor/Basement

Comments: Mixture of RC Shear Walls, RC Columns and Infill non-load bearing masonry walls noted. Appears to be a transfer structure supporting the floors above.

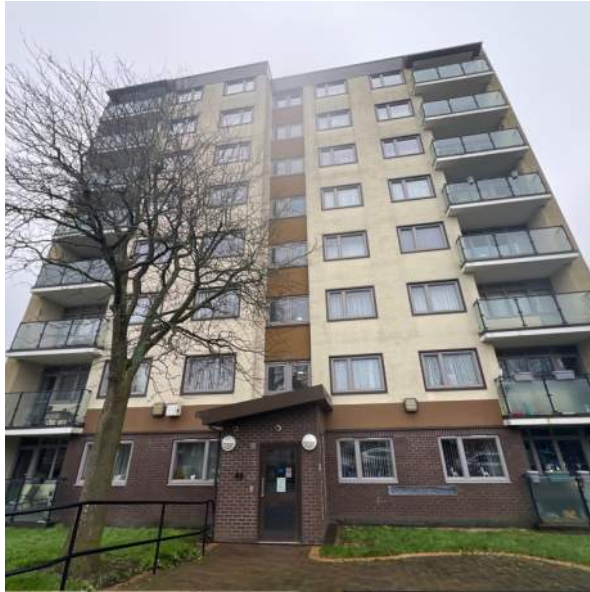
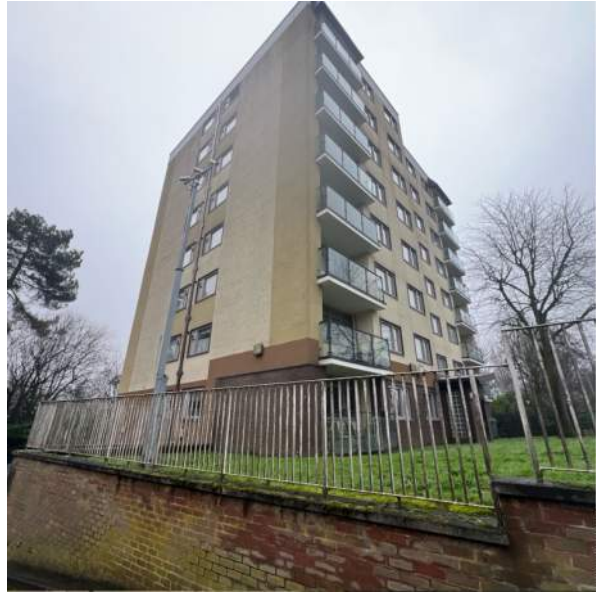
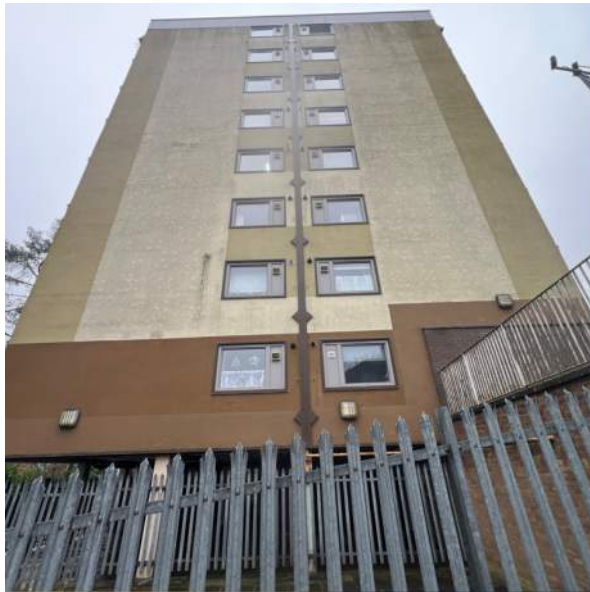
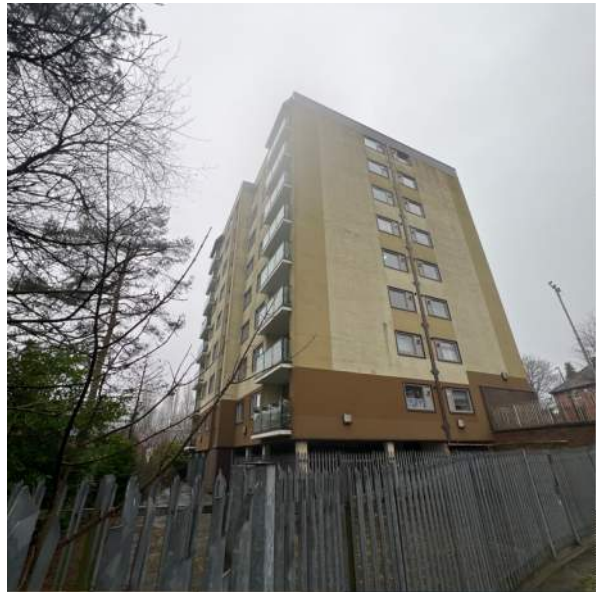
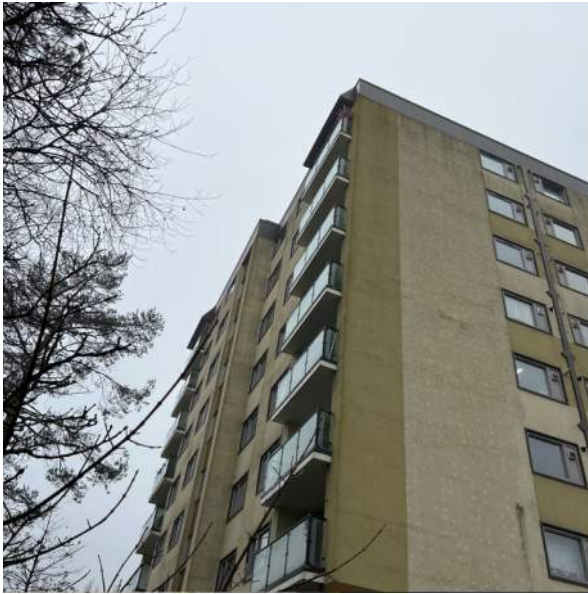
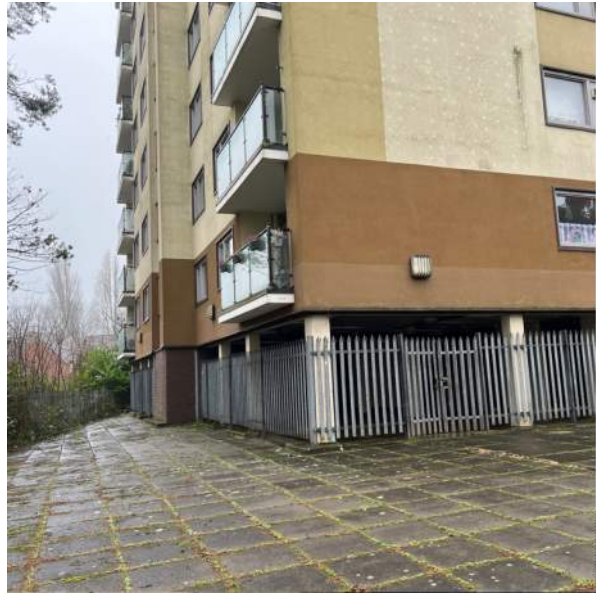
## Elevations

External facade consists of brickwork to ground floor and rendered facade to all upper floors. Cantilevered balconies noted to each level.
