VISUAL STRUCTURAL APPRAISAL

Brookview

Stanhope Road  
Smethwick  
B67 6HG

26<sup>th</sup> November 2024

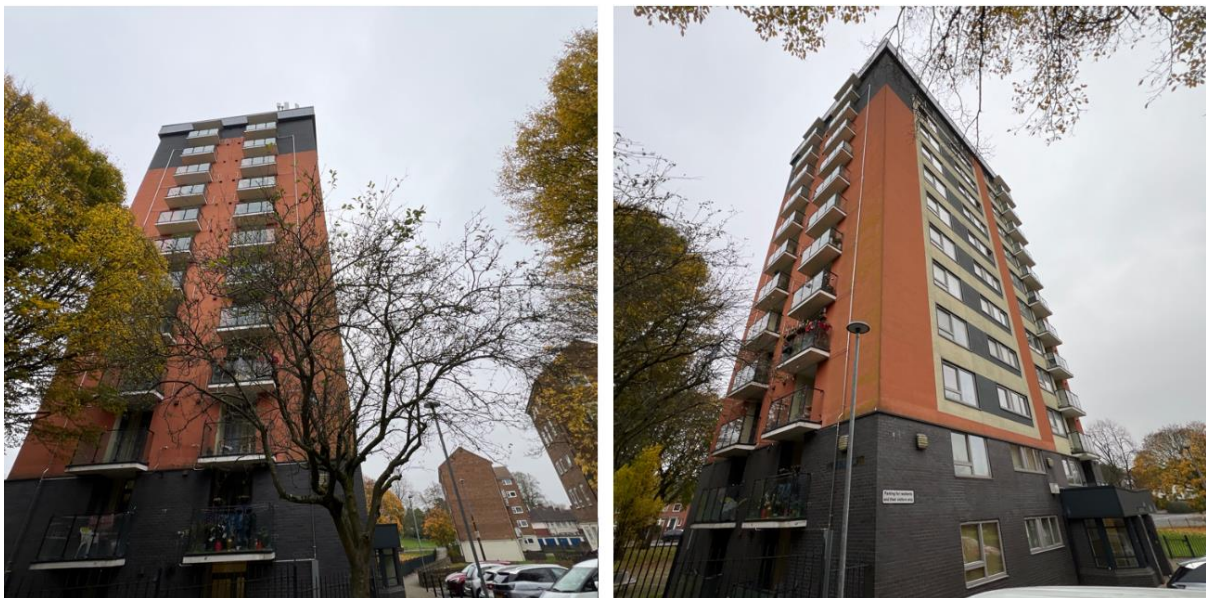
Figure 9 and 10: Building Elevations

The exterior elevations were generally in ok condition and no significant structural defects were noted to the cladding panels. There were no significant cracks or tell-tale signs of any significant structural movement noted at the time of our inspection.

The exterior panels were noted to be plumb with no signs of significant bowing, bulging or leaning noted to the panels indicating failed fixings however their presence and condition cannot be confirmed.

There are balconies at each level which are formed of cantilevered RC slabs tied into the main frame, likely cast monolithically with the primary RC frame. These are finished with glazed steel framed balustrades.

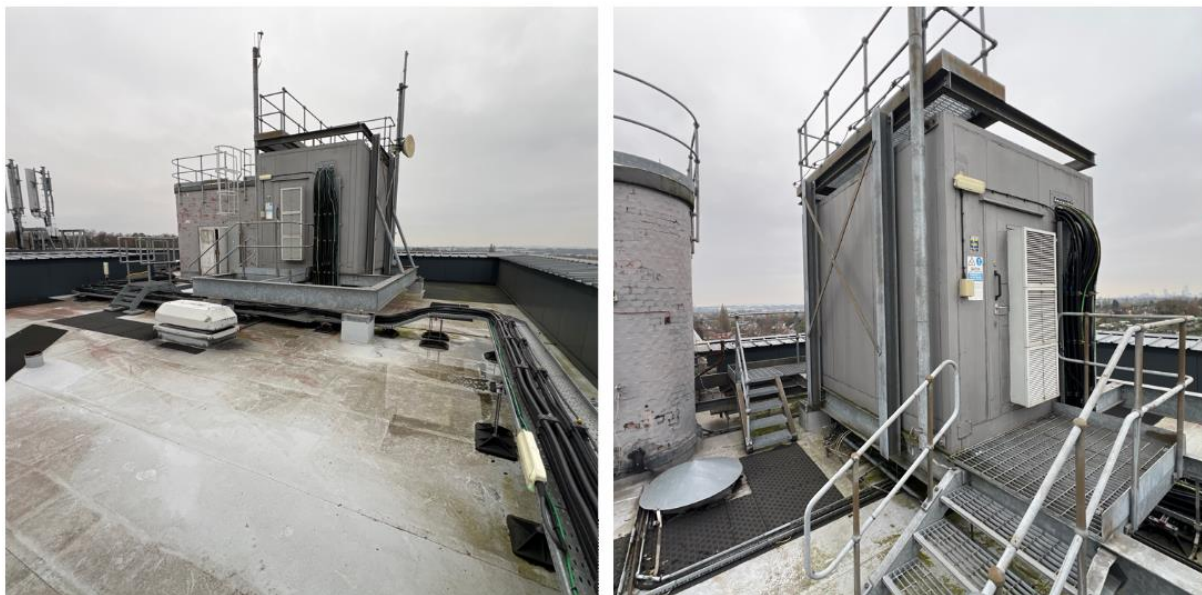
Figure 11 and 12: Roof Level

There were no tell-tale signs of any significant structural movement noted at the time of our inspection. The exterior walls were noted to be plumb with no signs of significant bowing, bulging or leaning noted to the masonry.

The roof has a single ply membrane finish. The exact build-up of the roof finishes were not accessible at the time of inspection. It is recommended an intrusive survey of the roof finishes is completed by a specialist surveyor to assess the condition of the roof covering.

A telecommunications center has been installed to the roof installed off a steel frame which is bolted down to concrete upstand supported off the roof structure. It is unclear if the pads are supported off the slab directly or the beams, however there were no signs of stress surrounding the bearings.

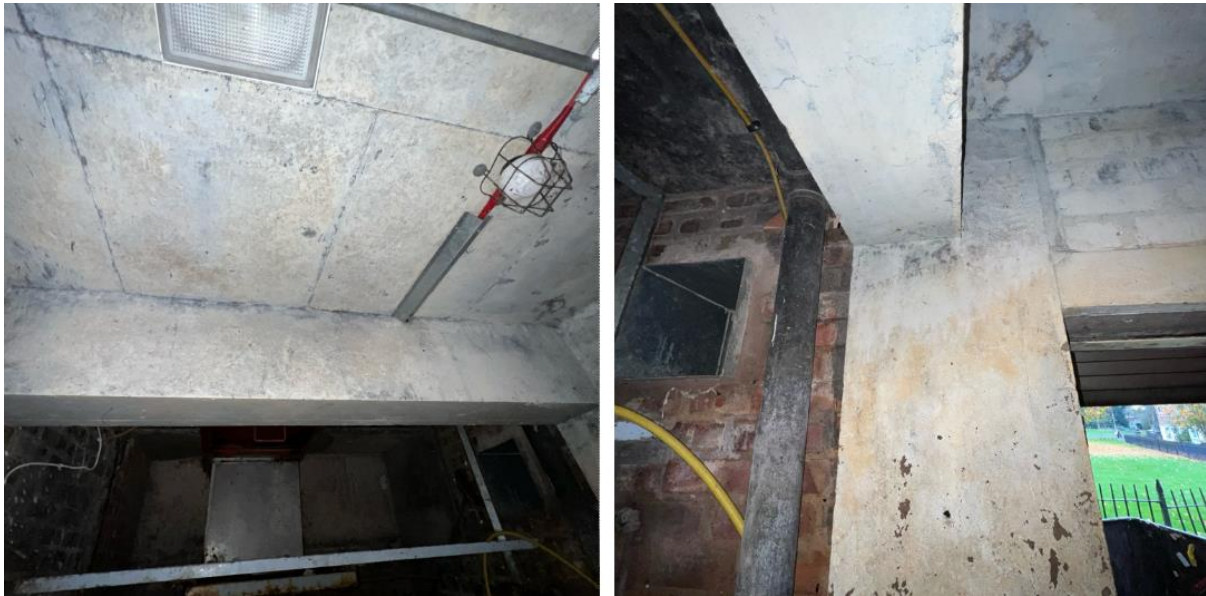
Figure 13 and 14: Structural beams, columns and slab over

The floors in the communal landings were noted to be solid concrete floors. The floors were checked with a spirit level and were considered level and within tolerance. The doors and windows to the communal landings from the stair core all appeared to be level and opened and closed without difficulty. There were no signs of structural movement detected.

The interior of the stair core walls were checked and were plumb and in line with observations made to the exterior – no significant signs of leaning or movement noted. The concrete appeared in fair condition with few BRE category 1 cracks but no structurally significant defects were noted.

The slabs are providing compartmentation to the building and therefore should meet the fire requirements. A cover meter survey is required to estimate the fire resistance of the floor slabs.

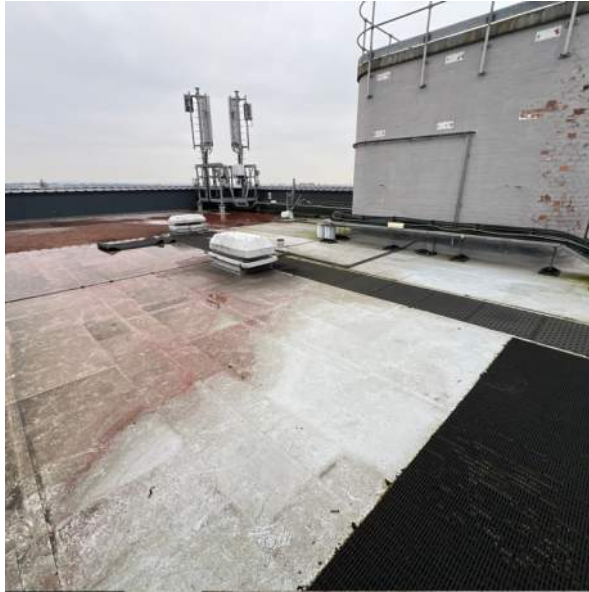
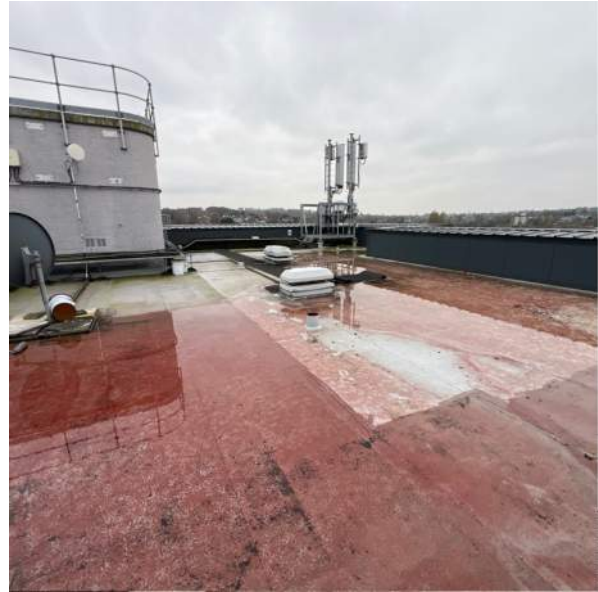
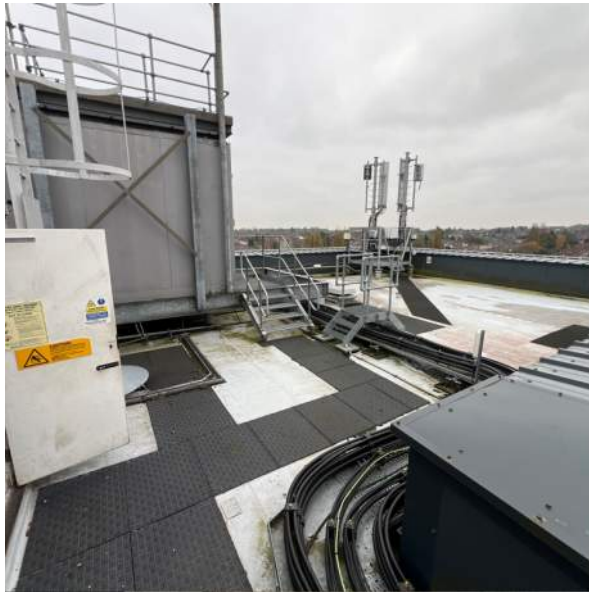
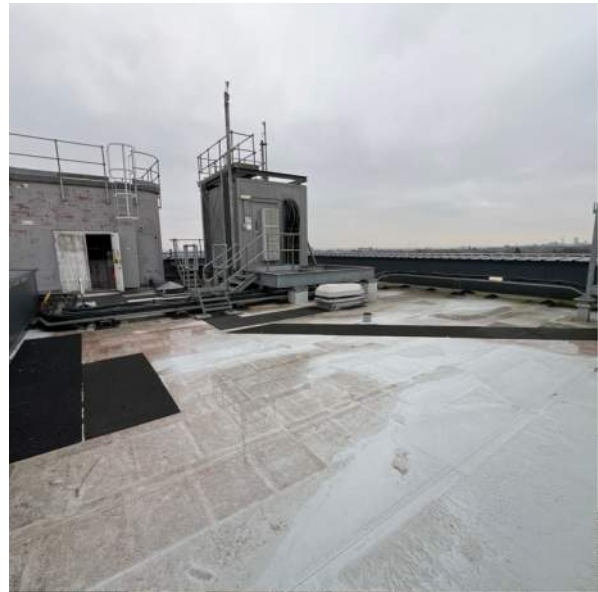
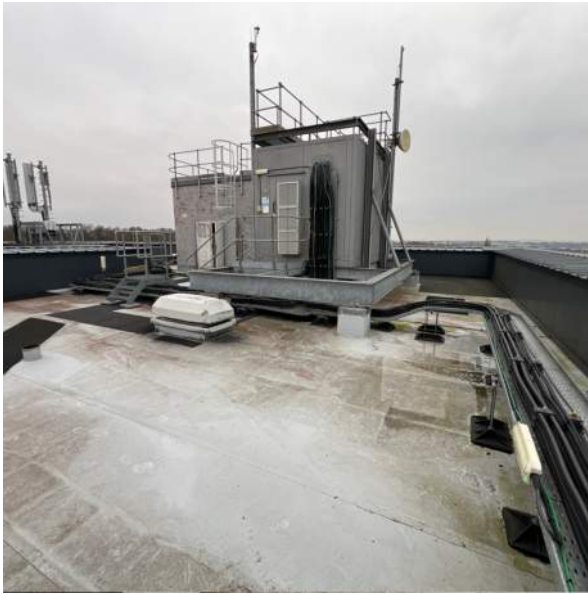
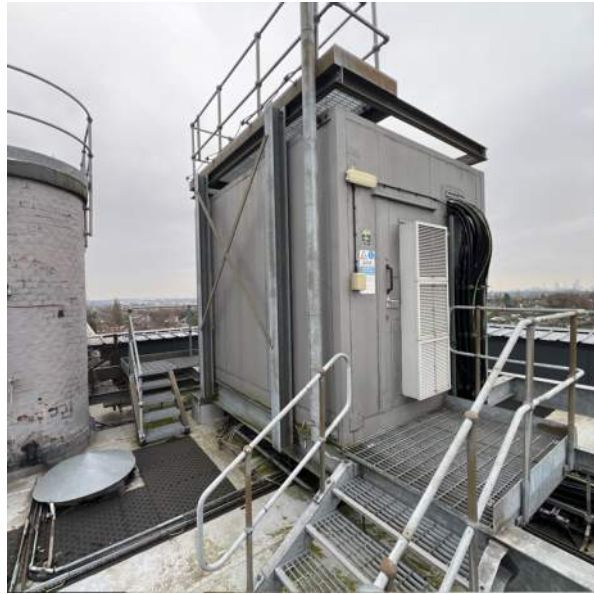
## Main Roof

Comments: Flat roof with parapet walls. RC concrete slab with insulation and roof coverings. Telecommunications equipment installed on the main roof.

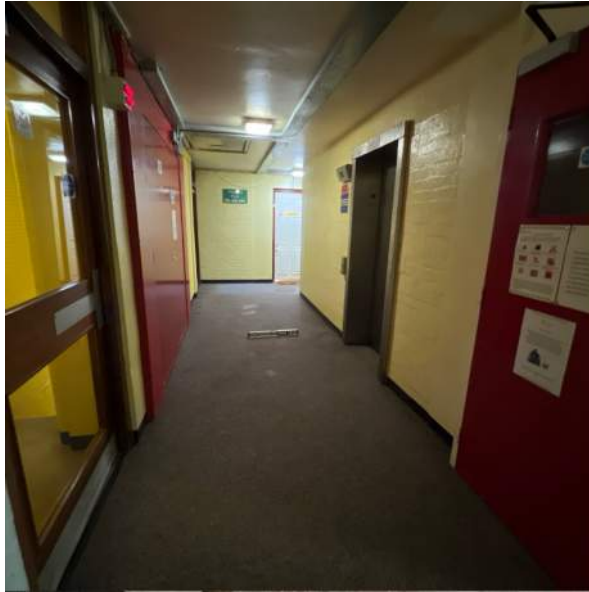
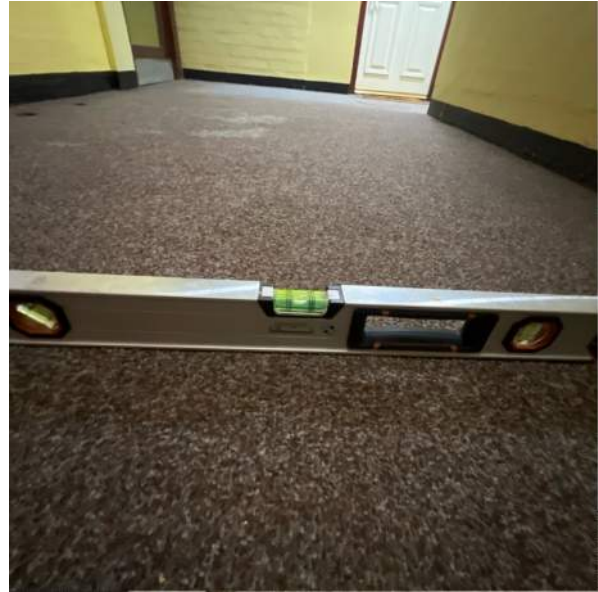
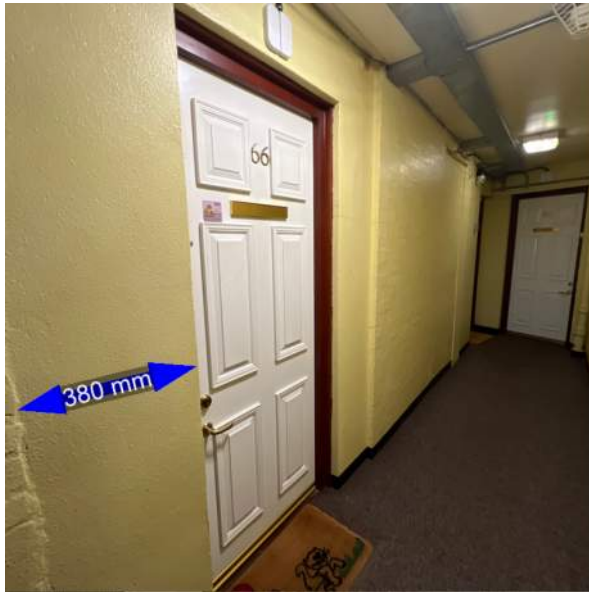
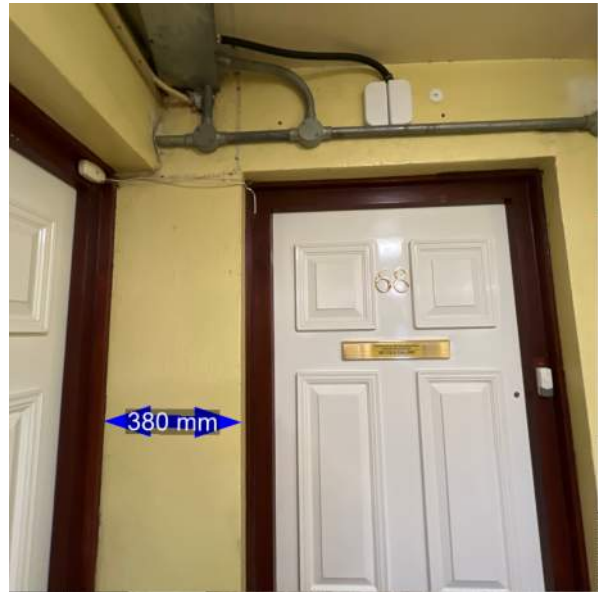
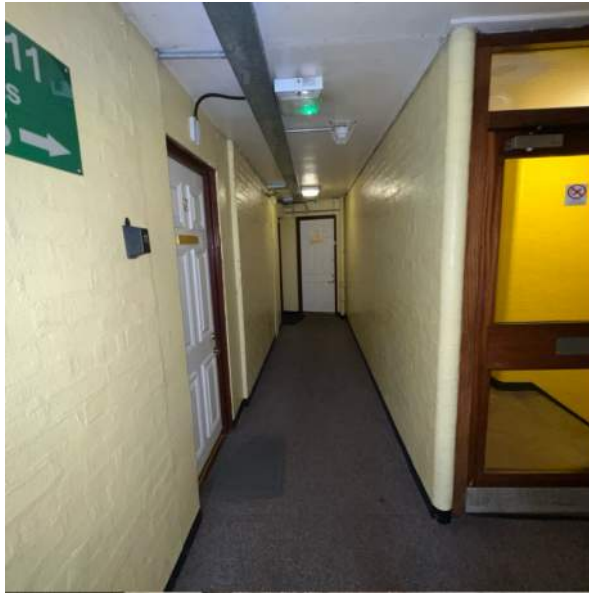
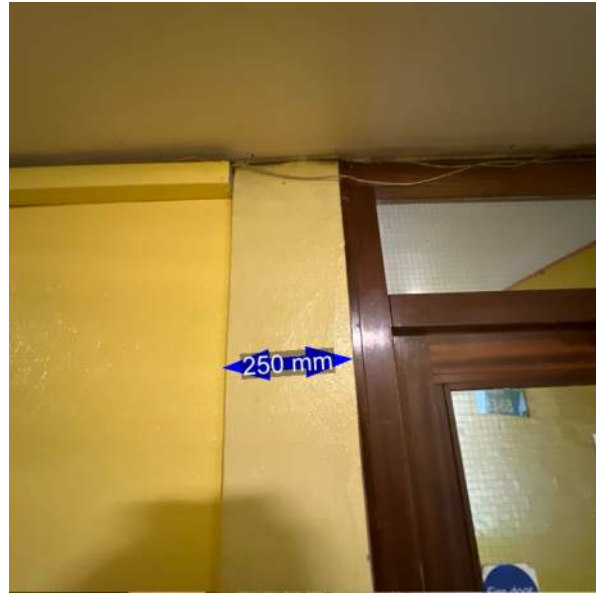
## 11th Floor Hallway

Comments: No jams or distortions noted to hallway doors to indicate any serviceability issues. Generally walls covered with finishes in hallway, likely to consist a mixture of concrete shear walls and embedded columns with internal partition walls. Riser cupboard shows infill masonry walls with a partially exposed concrete element likely an RC Column.

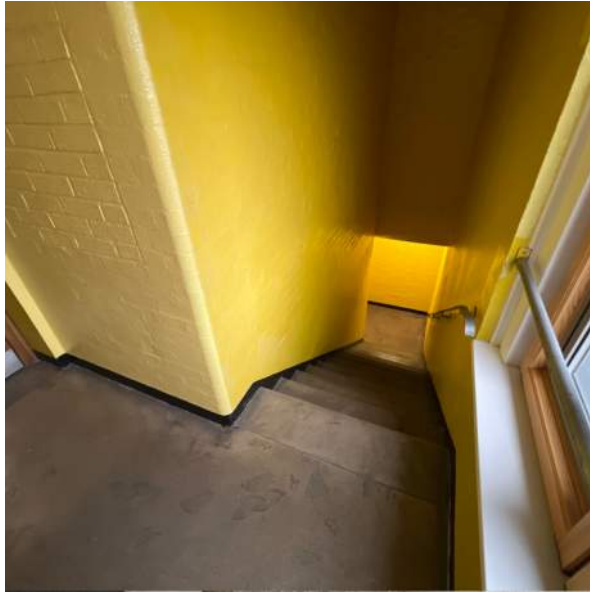
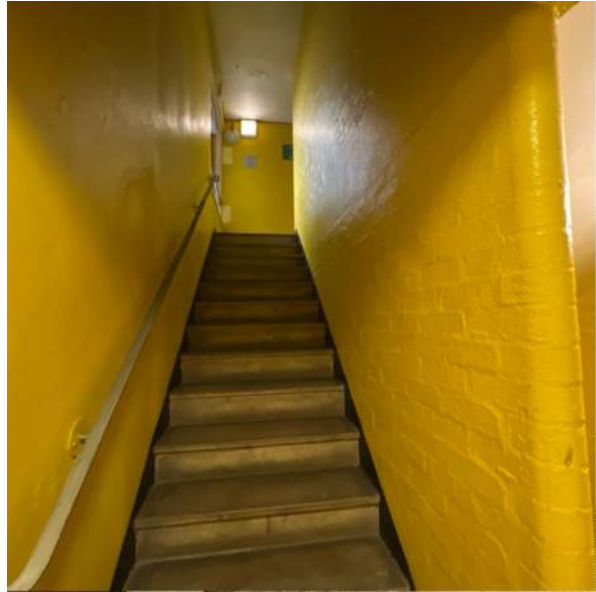
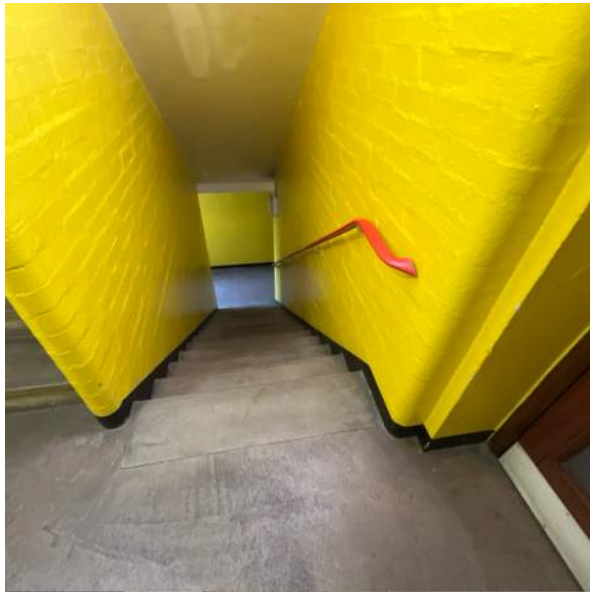
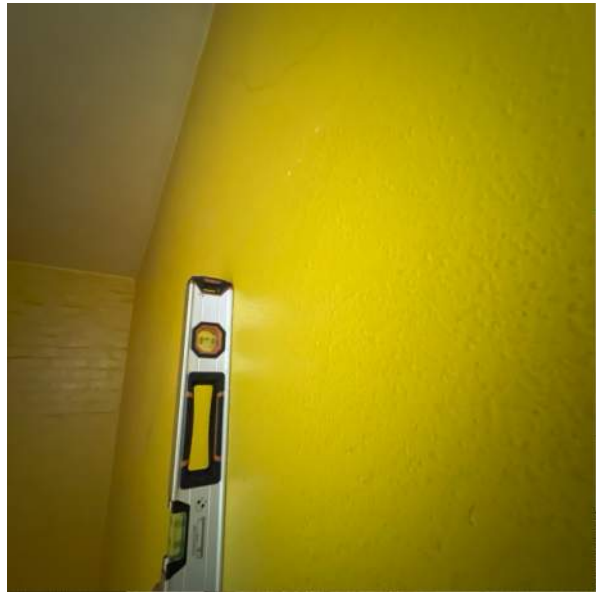
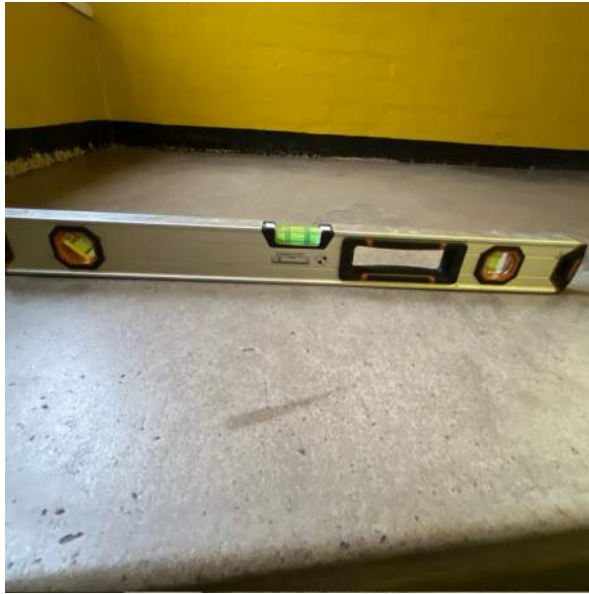
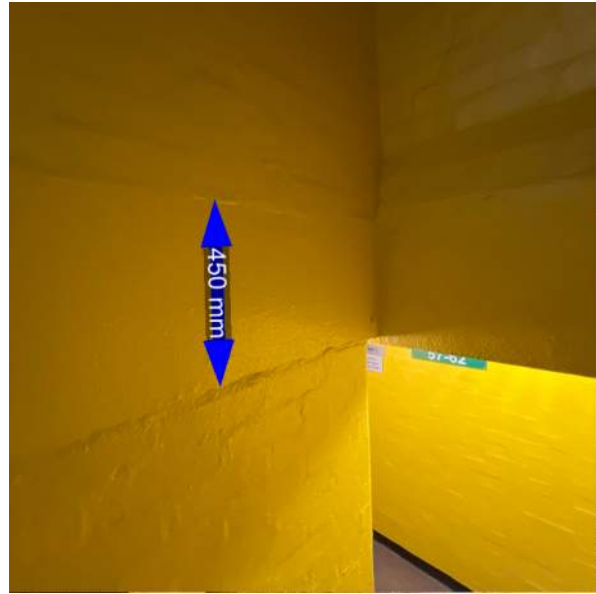
## 11th Floor Staircase

Insitu concrete stairs with steel hand railing fixed to stair walls.  
Walls and floors appear to be fairly level.  
Stair walls mainly consist of infill masonry walls (non-load bearing) and embedded RC  
Concrete beams and columns noted. One side of stair wall noted to be a concrete wall  
likely to form a main shear core wall.

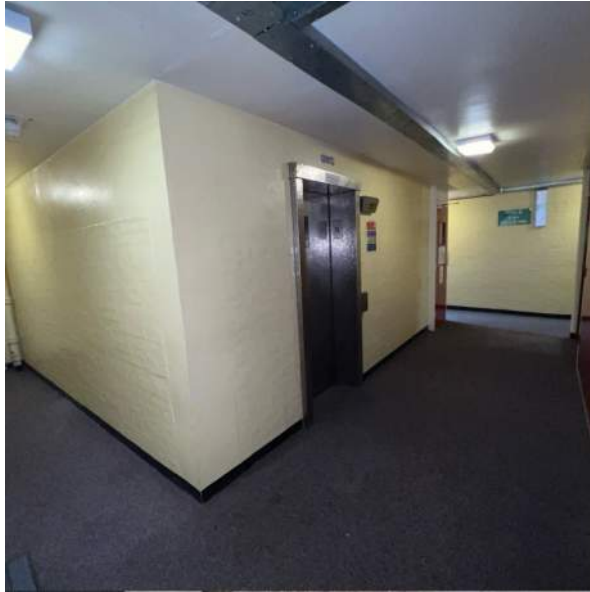
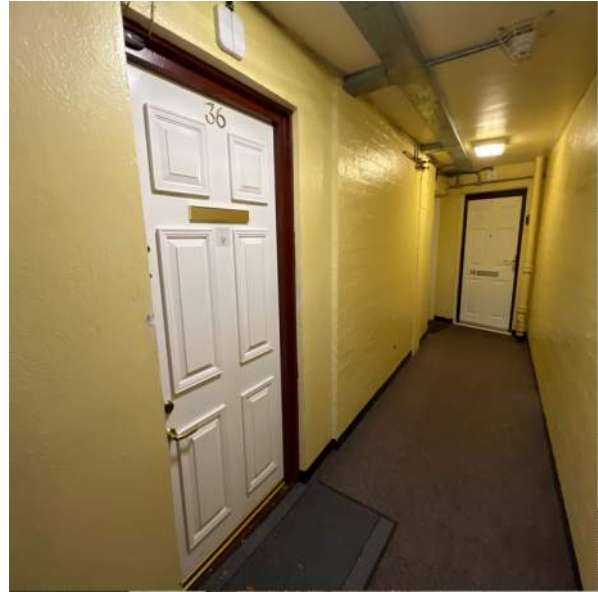
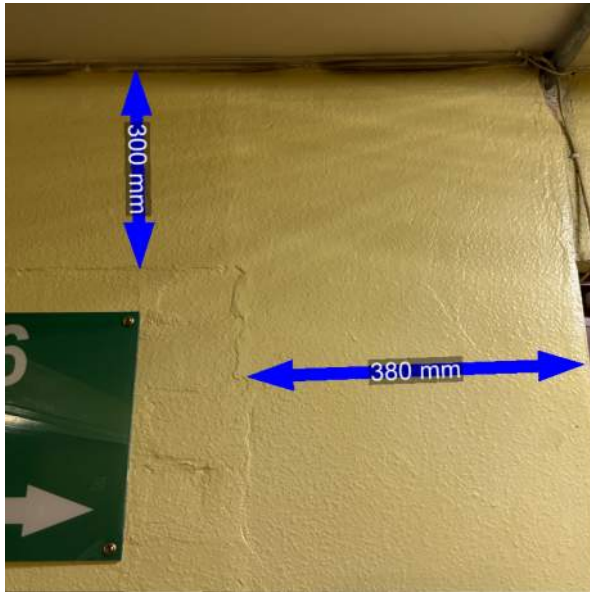
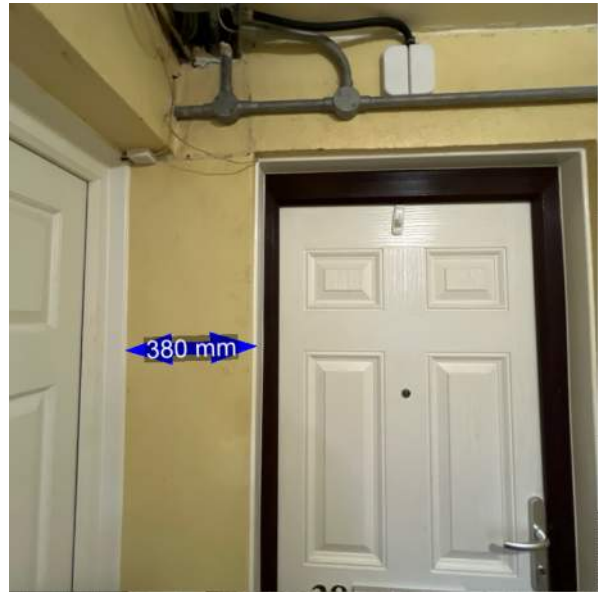
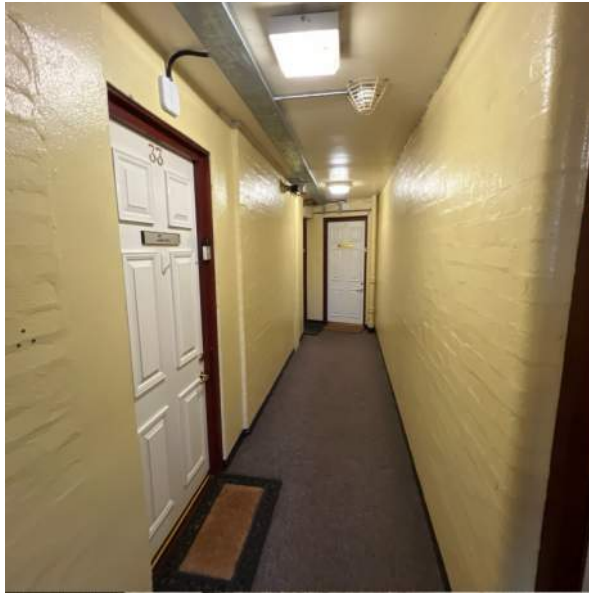
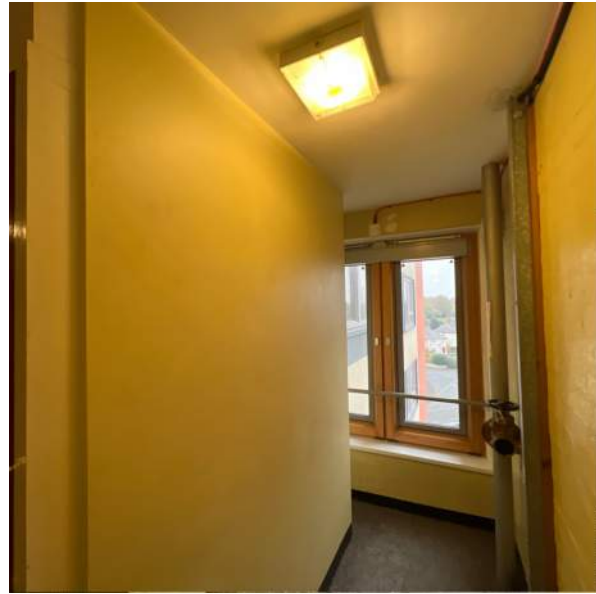
## 6th Floor Hallway

Comments: No jams or distortions noted to hallway doors to indicate any serviceability issues. Generally walls covered with finishes in hallway, likely to consist a mixture of concrete shear walls and embedded columns with internal partition walls. Riser cupboard shows infill masonry walls with a partially exposed concrete element likely an RC Column.

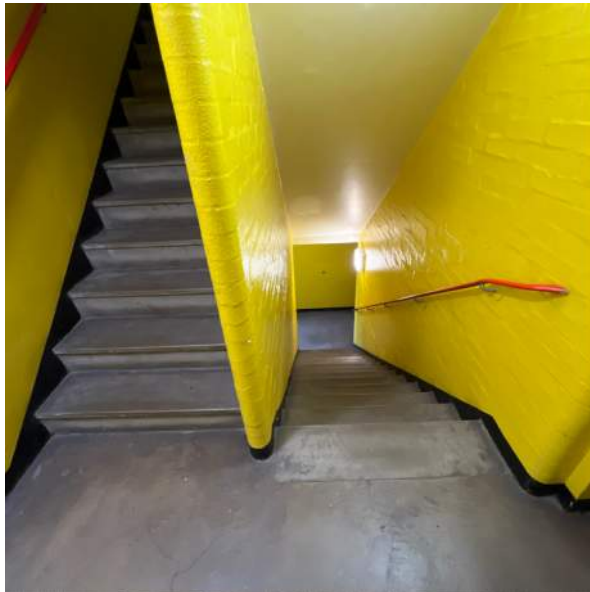
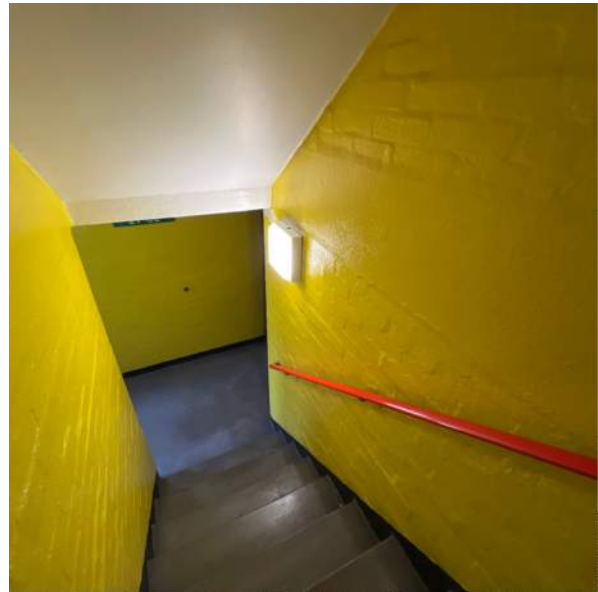
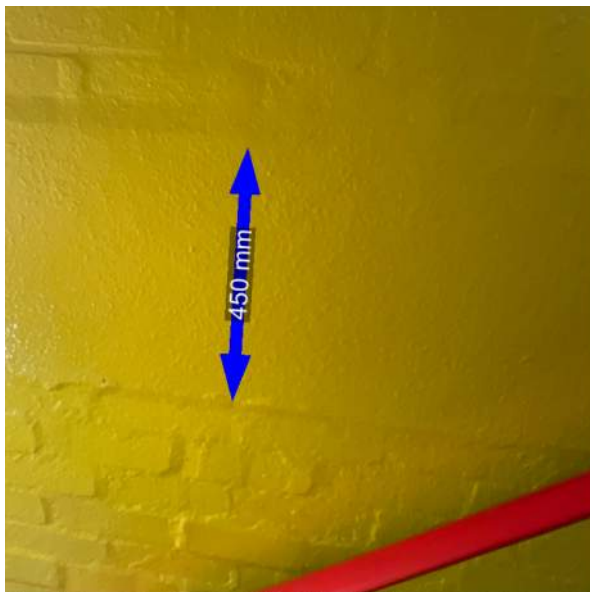
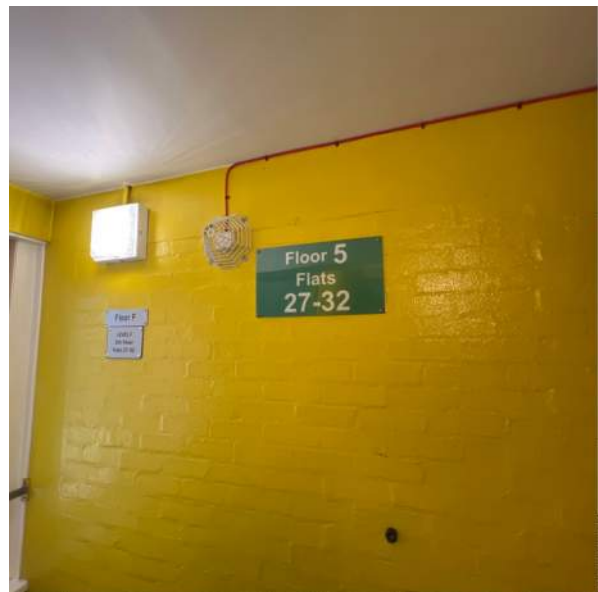
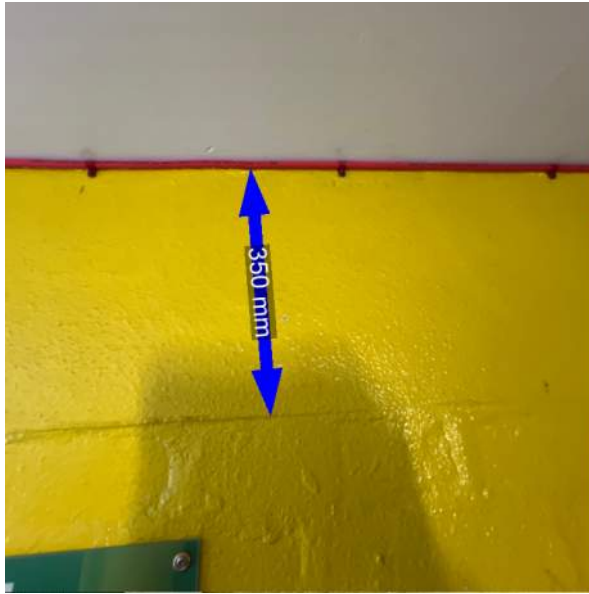
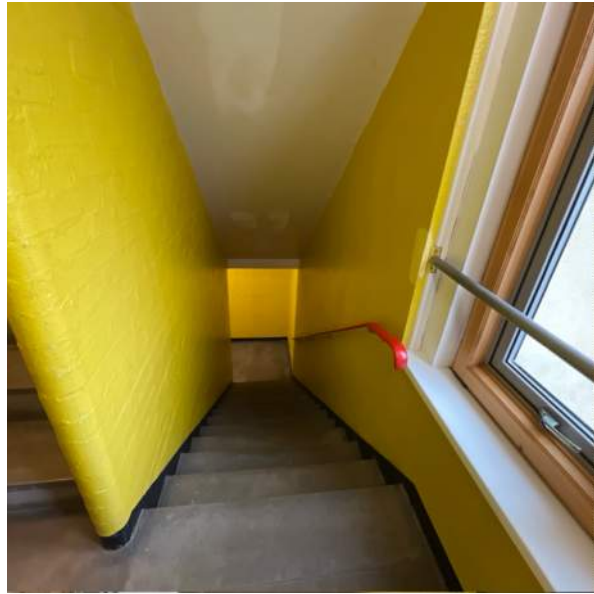
## 6th Floor Staircase

In situ concrete stairs with steel hand railing fixed to stairs. Walls and floors appear to be fairly level.

Stair walls mainly exposed showing infill masonry walls (non-load bearing) and embedded RC Concrete beams and columns noted.

One side of staircase wall noted to be concrete wall likely forming a main shear core wall.

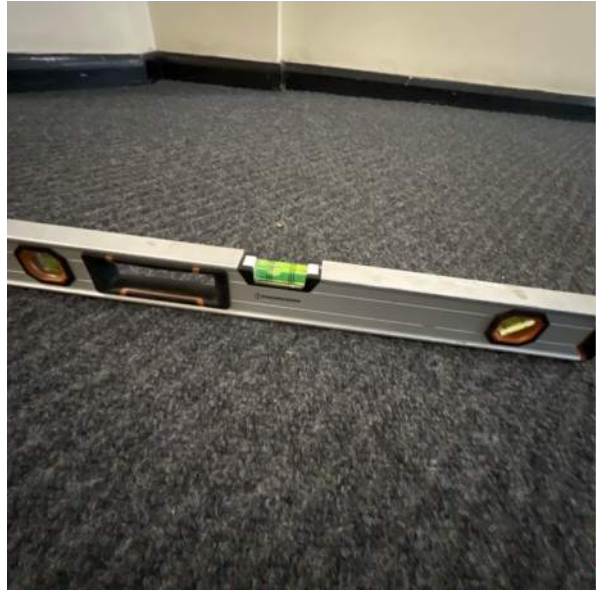
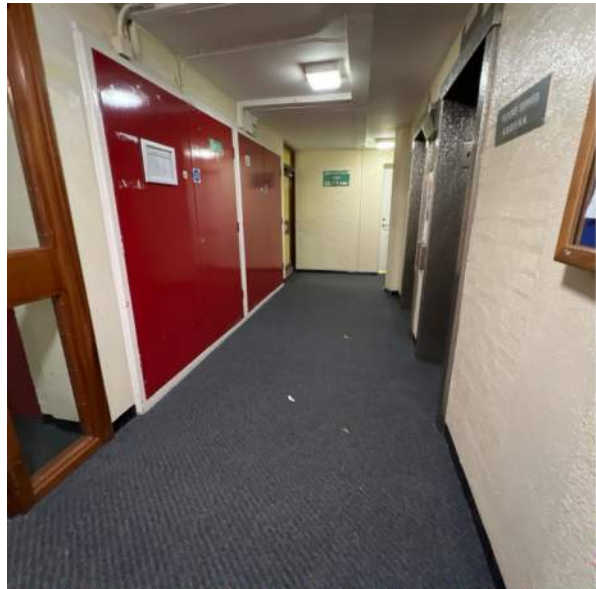
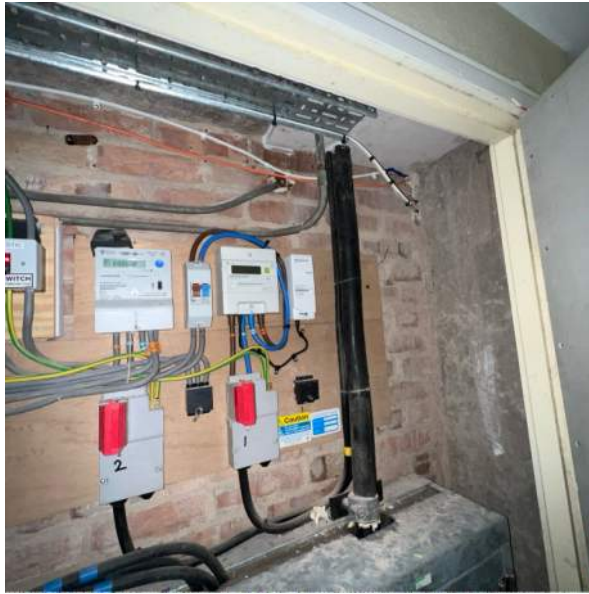
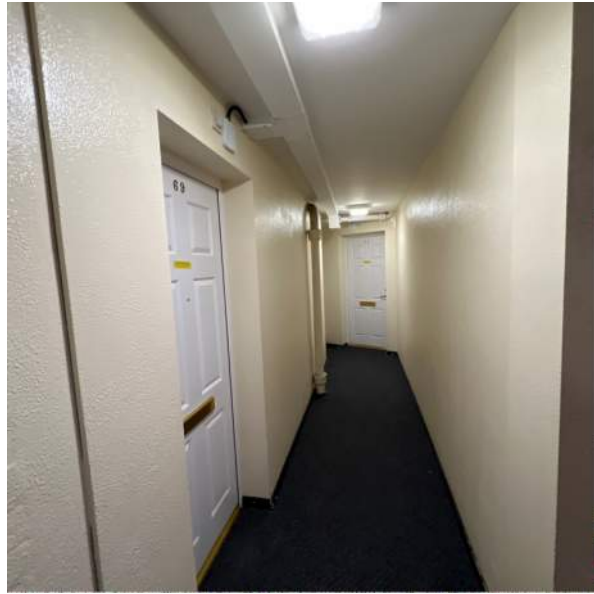
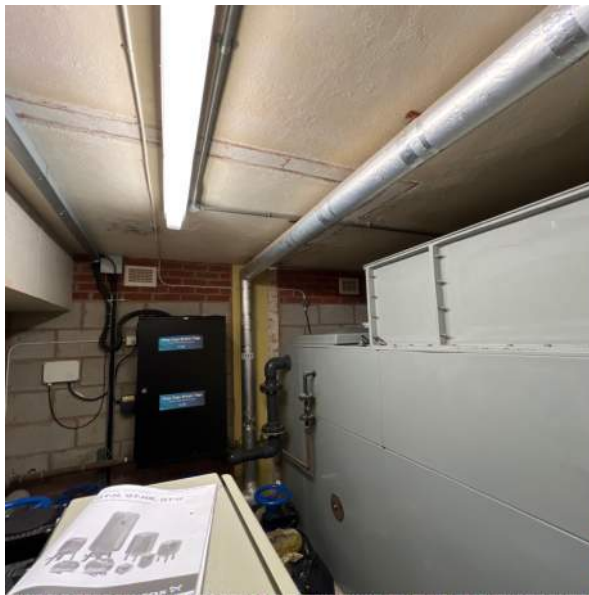
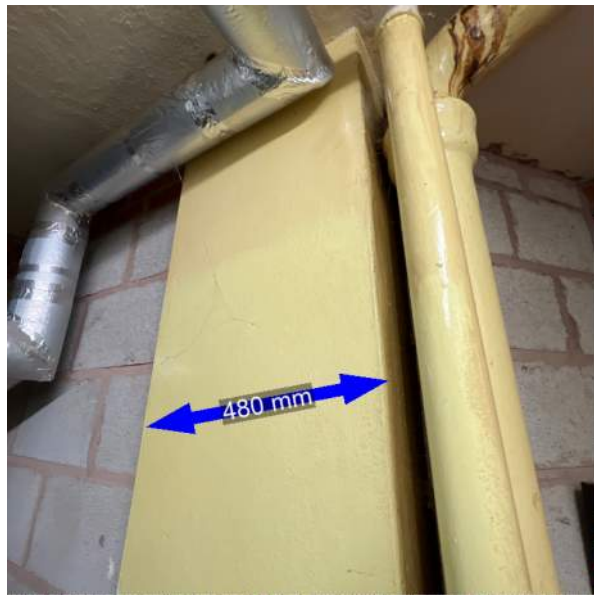
## Ground Floor Hallway

No jams or distortions noted to hallway doors to indicate any serviceability issues.  
Generally walls covered with finishes in hallway, likely to consist a mixture of concrete shear walls and embedded columns with internal partition walls.  
Riser cupboard shows infill masonry walls with a partially exposed concrete element likely an RC Column.  
Storage room shows embedded RC concrete beam and column in infill masonry walls.  
Floor in lobby area appears to be locally sloping - does not appear to be a structural concern.

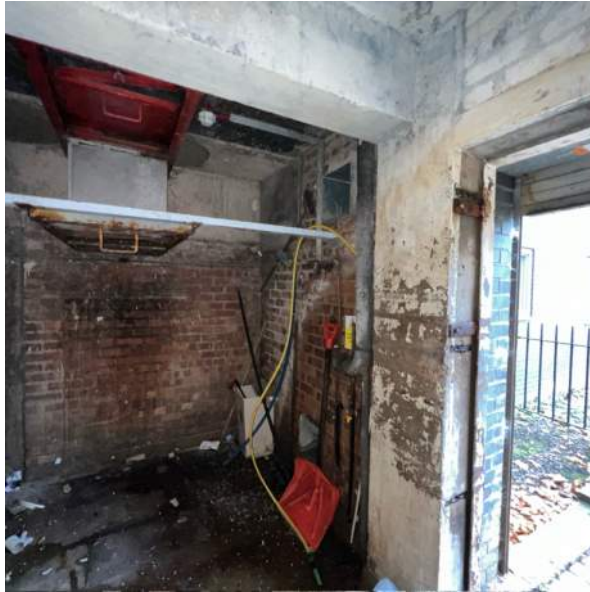
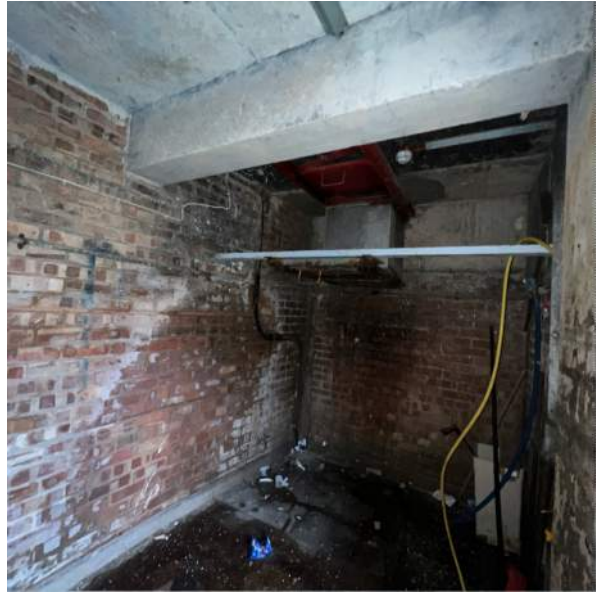
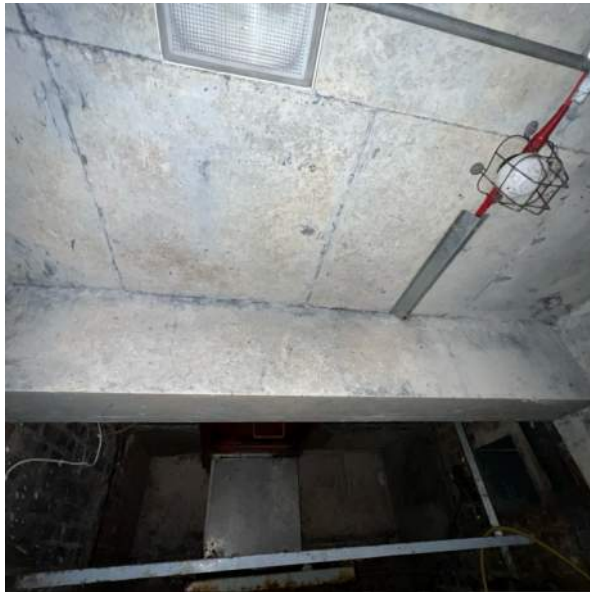
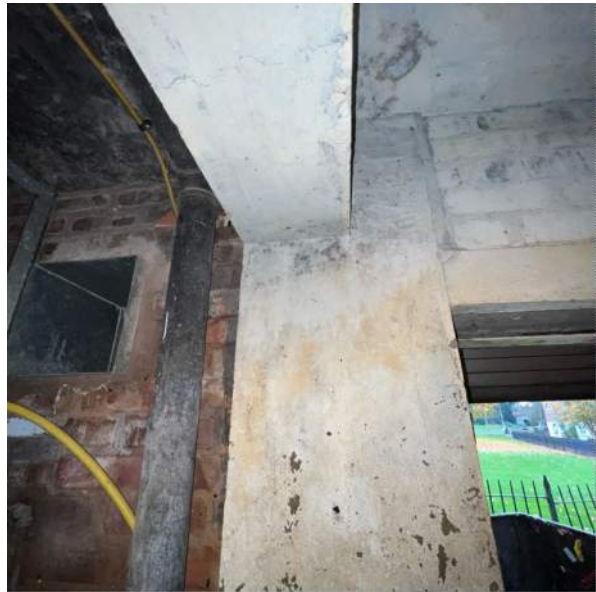
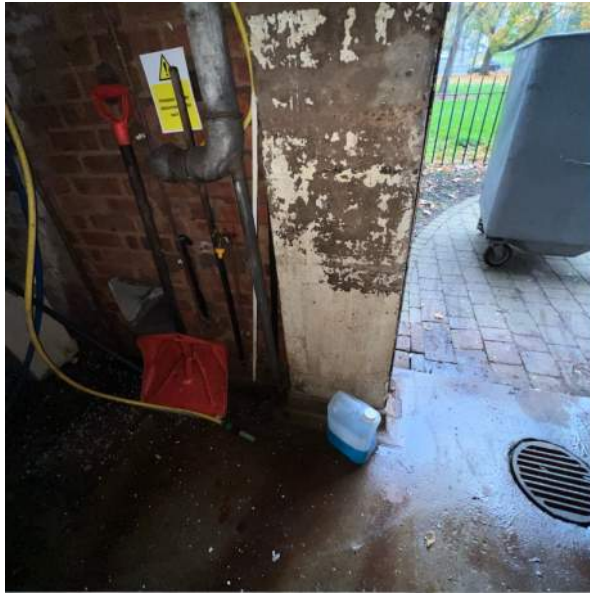
## Bin Store

Bin store noted to have infill (non-load bearing) masonry walls with RC Beam and embedded RC Column noted.

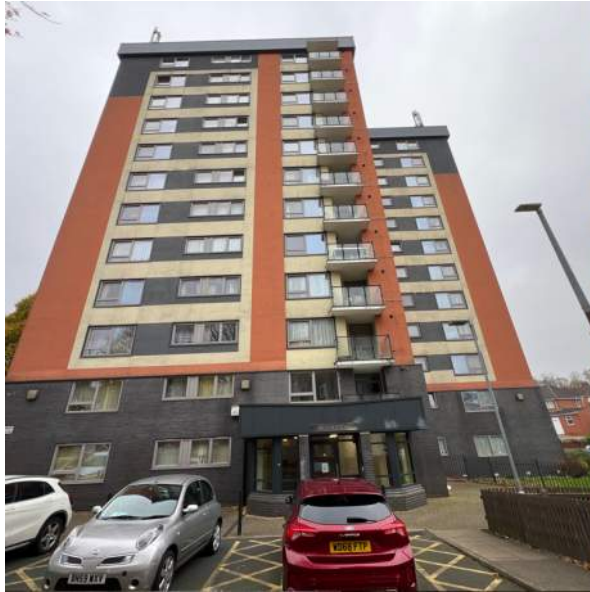
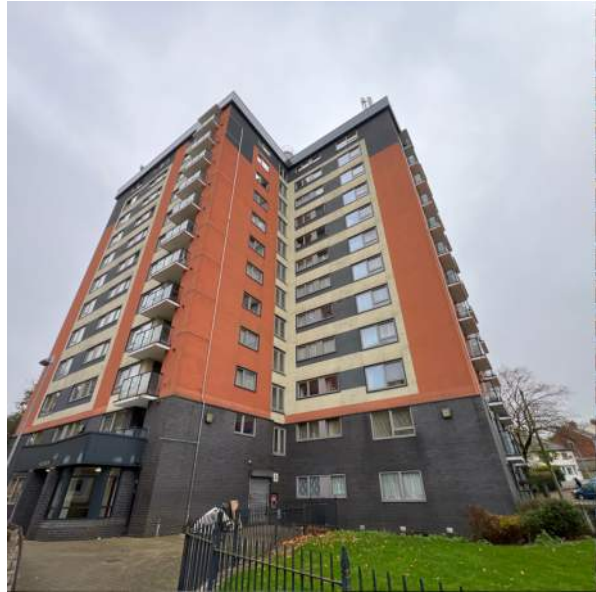
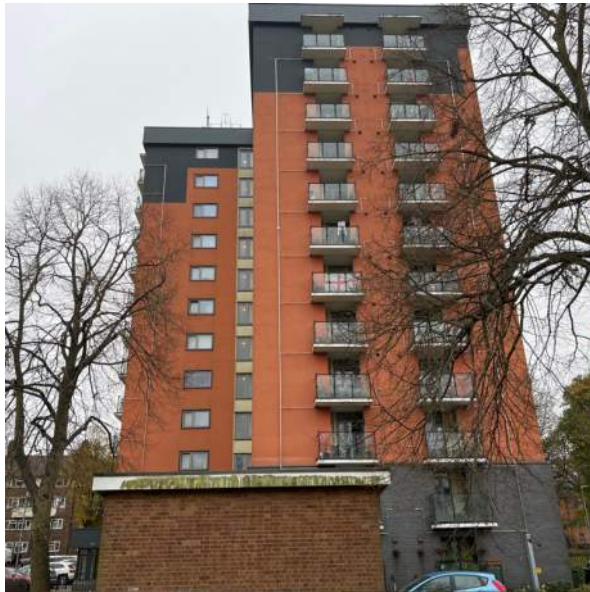
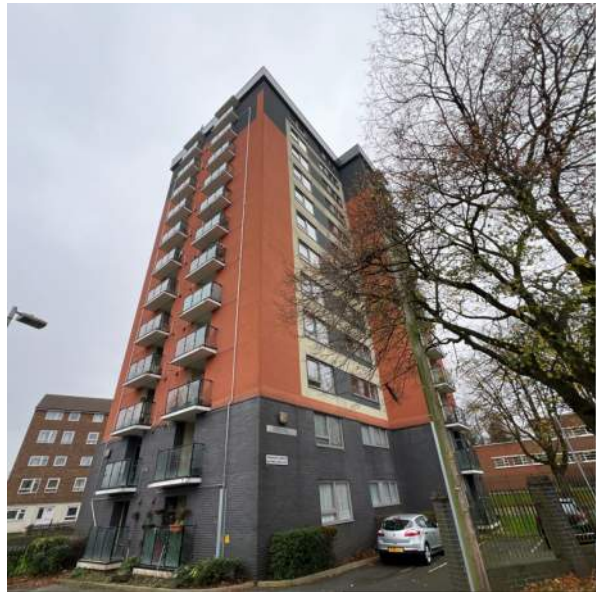
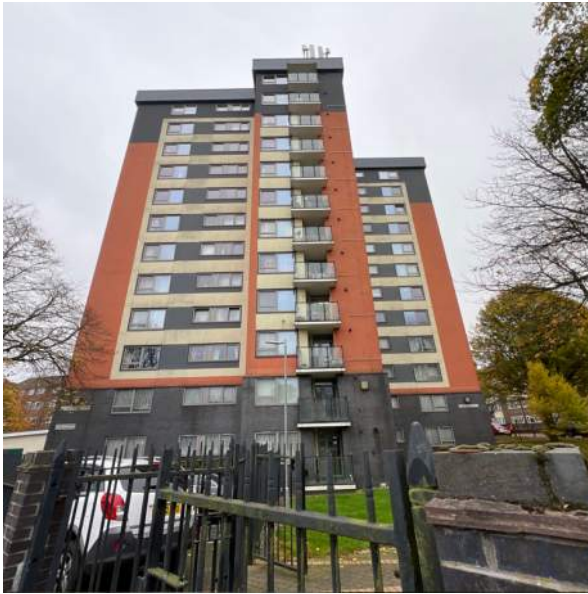
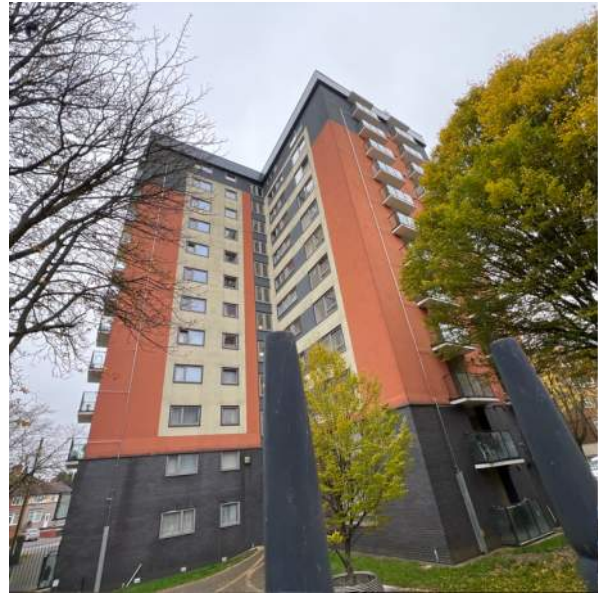
## Elevations

External ground and first level consists of brick work.  
Remaining floors noted to have a cladded facade to exterior.
