VISUAL STRUCTURAL APPRAISAL

Broome House

Beaconview Road  
West Bromwich  
B71 3PN

31<sup>st</sup> January 2025

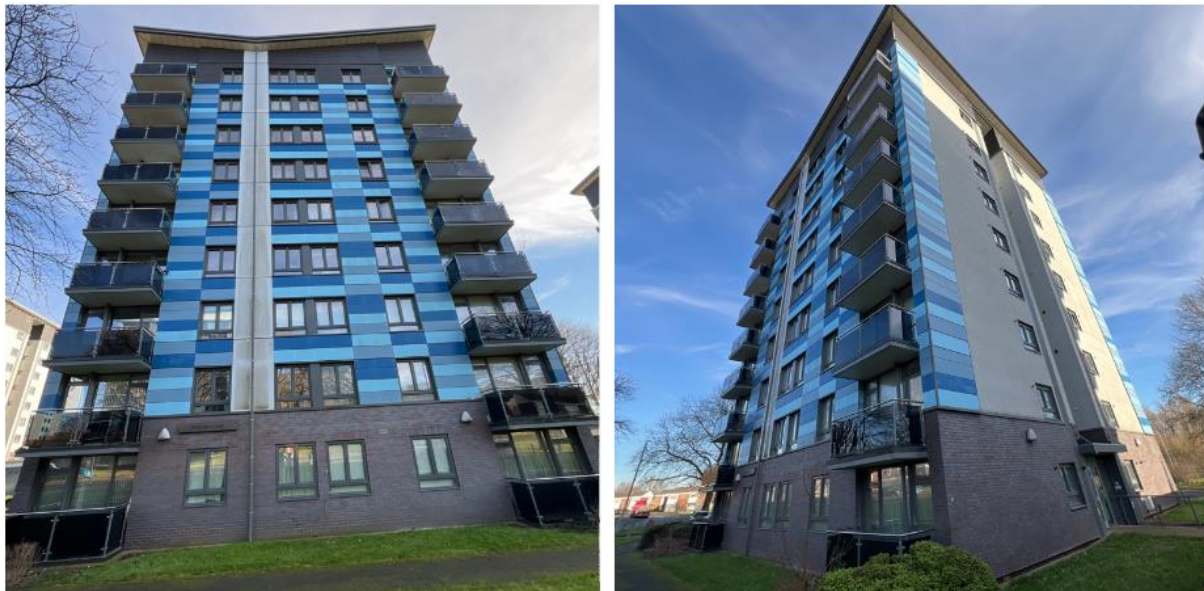
Figure 9 and 10: Building Elevations

The exterior elevations were generally in ok condition and no significant structural defects were noted to the cladding panels. There were no significant cracks or tell-tale signs of any significant structural movement noted at the time of our inspection.

The exterior panels were noted to be plumb with no signs of significant bowing, bulging or leaning noted to the panels indicating failed fixings however their presence and condition cannot be confirmed.

There are balconies at each level which are formed of cantilevered RC slabs tied into the main frame. During the 2015 refurbishment they had steel balustrades with glazed infill installed.

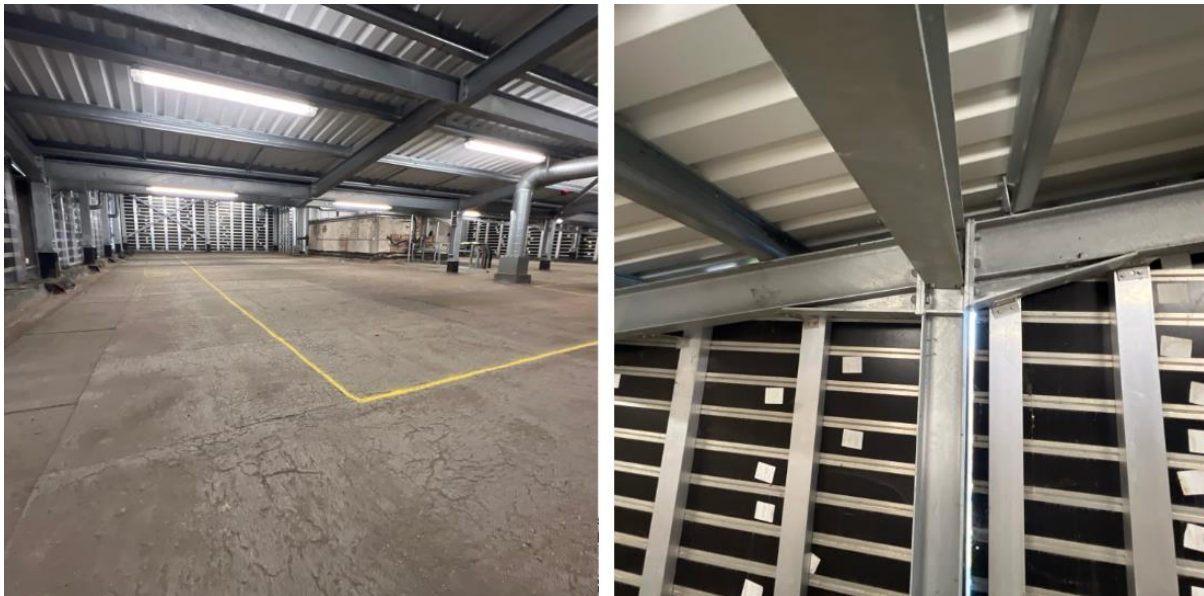
Figure 11 and 12: Roof Level

There were no tell-tale signs of any significant structural movement noted at the time of our inspection. The exterior walls were noted to be plumb with no signs of significant bowing, bulging or leaning noted to the masonry walls.

The roof has subsequently been covered with a new waterproofing covering formed of a steel frame installed to the existing roof which supports pitched corrugated sheets. This roof is not insulated and therefore acts purely as a weather barrier. The fire protection of the steel is unclear as the beams do not appear to be unprotected. Details of this frame should be requested from the contractor who completed the works in 2015. No signs of water ingress of that the roof is not performing as intended.

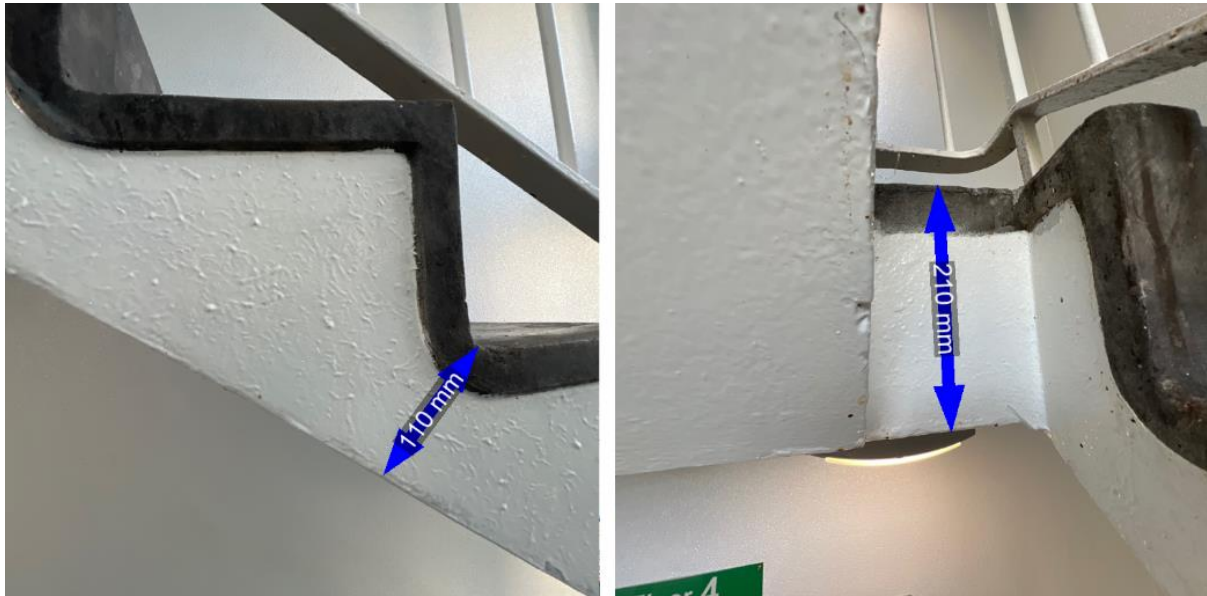
Figure 13 and 14: Stair stringer and concrete slab

The stair stringer was noted to be 110mm thick which seems slim, certainly short of modern standards. A cover test is required to check the resistance of the concrete section in the event of a fire.

Due to the age of the building it is wise to perform periodical health checks to the concrete elements. This should include tests for concrete strength, cover depth, carbonation, chlorides and HAC. It would appear that these tests have never been performed to this building and therefore we recommend engaging a specialist contractor within the next 24 months who will be able to perform the tests and provide a interpretive report. The fire resistance of the structure is not confirmed until the cover meter tests are completed.

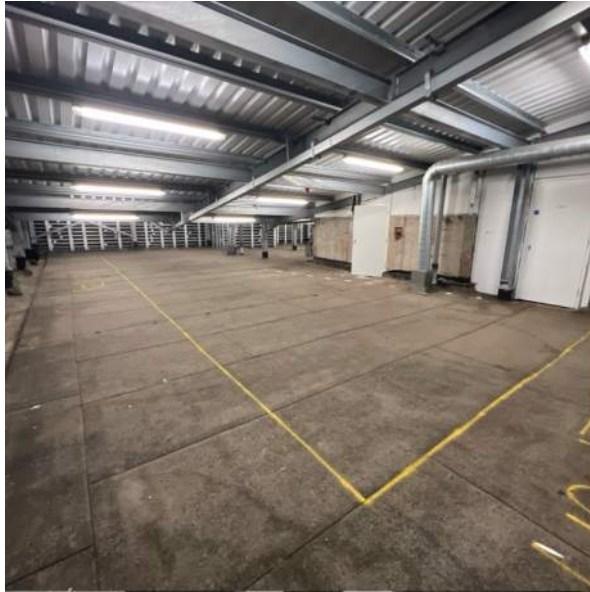
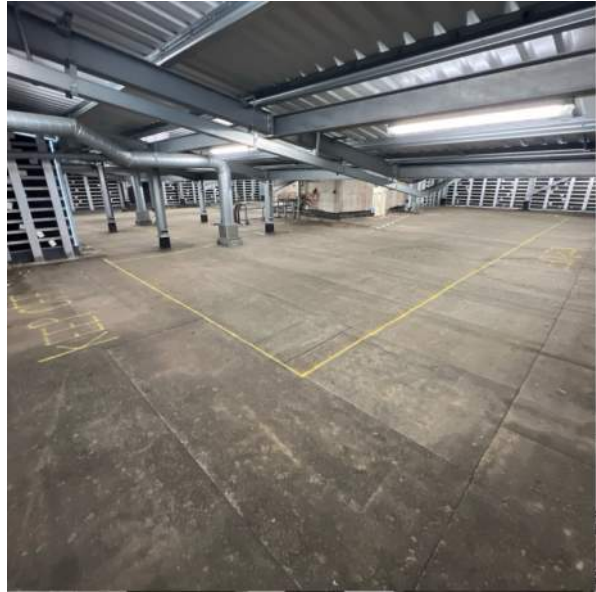
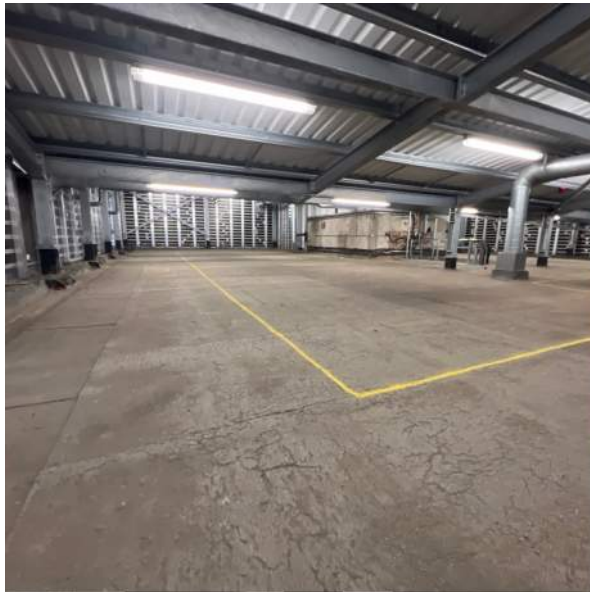
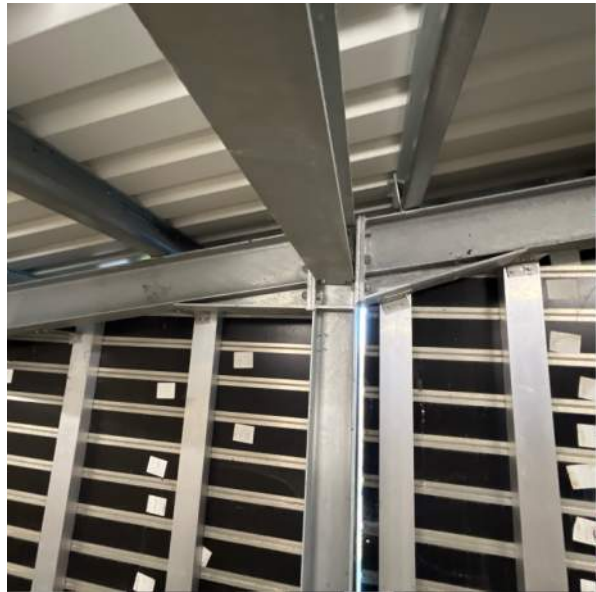
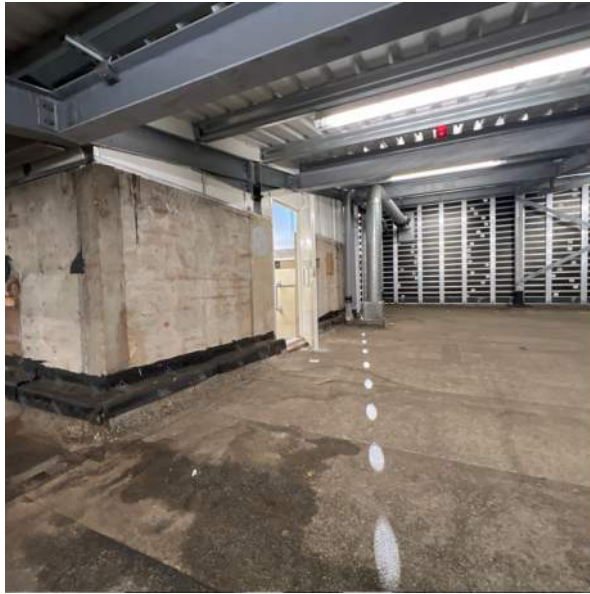
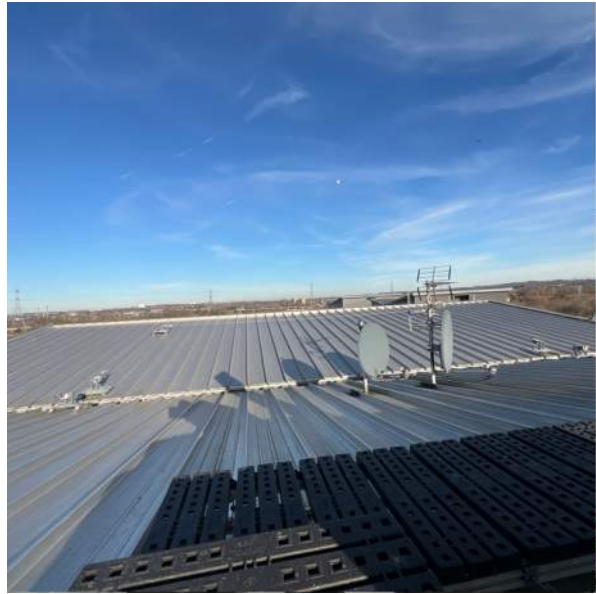
## Main Roof

Comments: A pitched roof constructed above existing original flat roof slab. Steel frame supporting purlins with aluminium standing / mineral wool core profiled panels.  
160mm thick RC core walls noted in motor room.

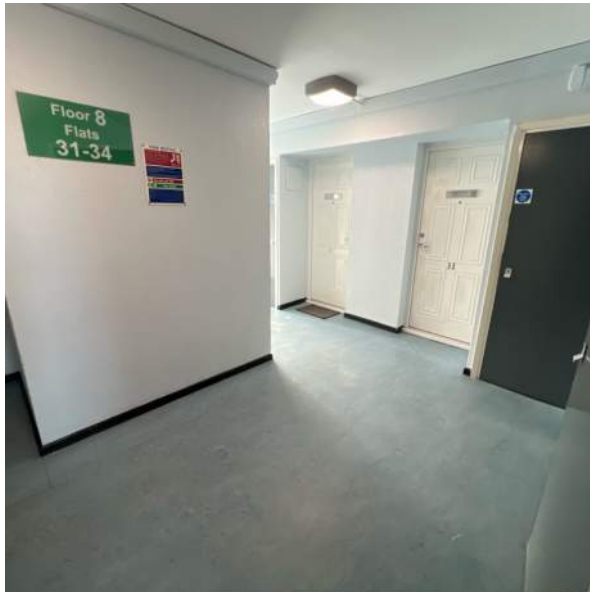
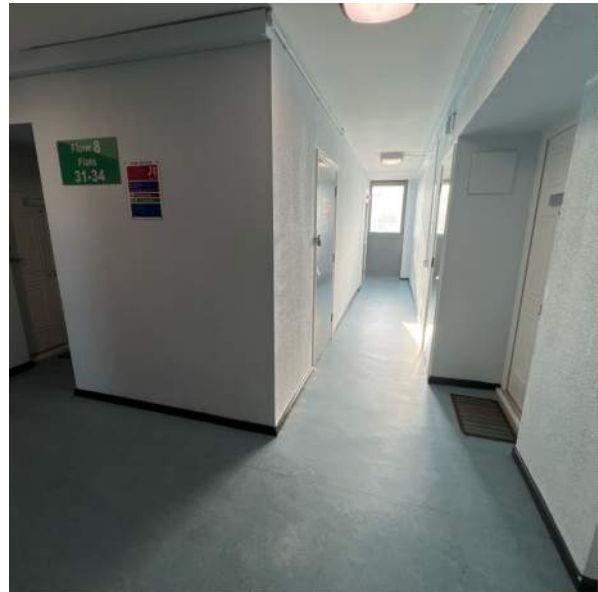
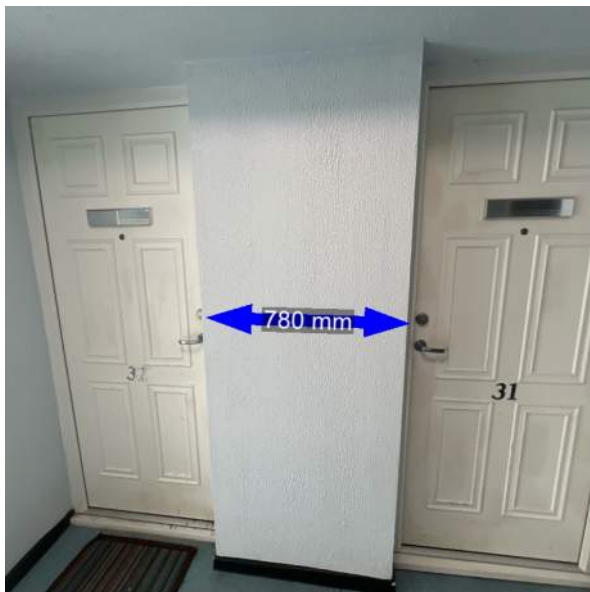
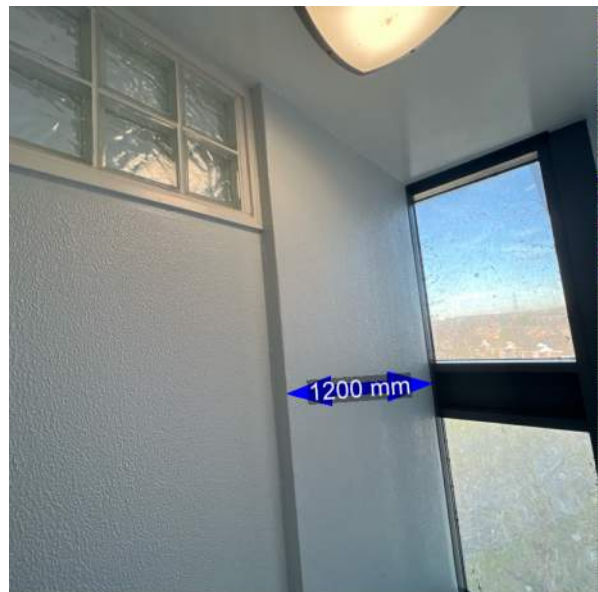
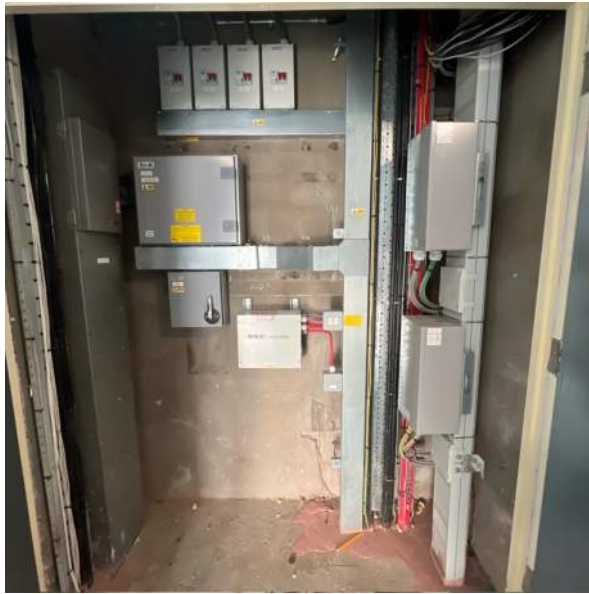
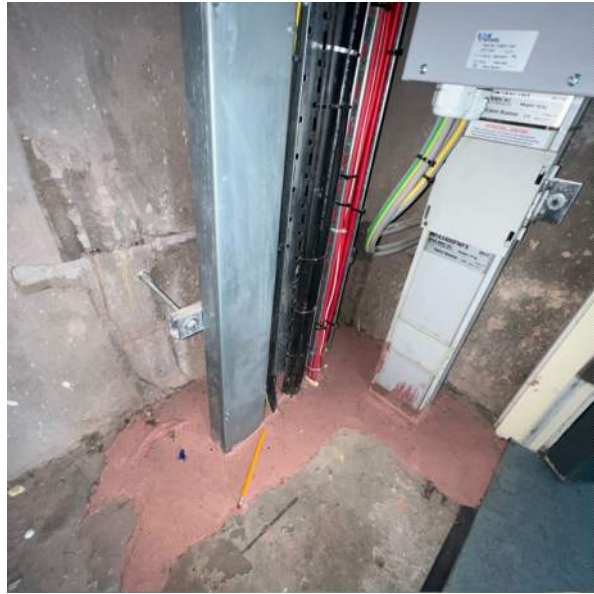
## 8th Floor Hallway

Comments: No jams or distortions noted to hallway doors to indicate any serviceability issues. Generally walls covered with finishes in hallway, likely to consist a mixture of concrete shear walls, embedded columns and masonry infill walls. Limited structure exposed. Concrete walls noted via riser cupboards.

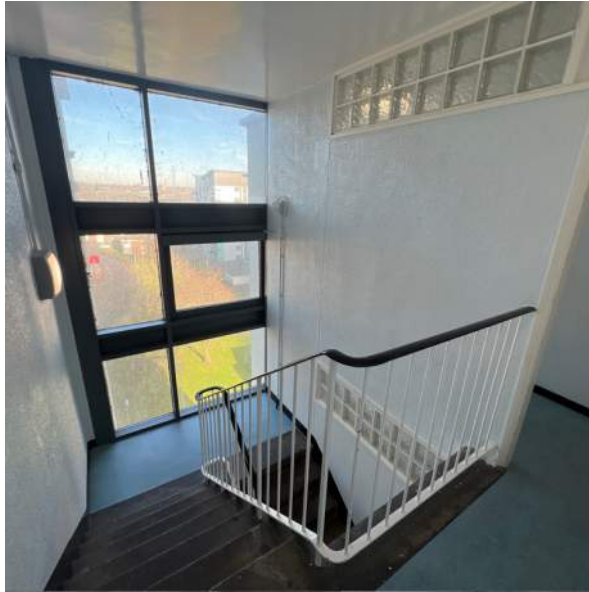
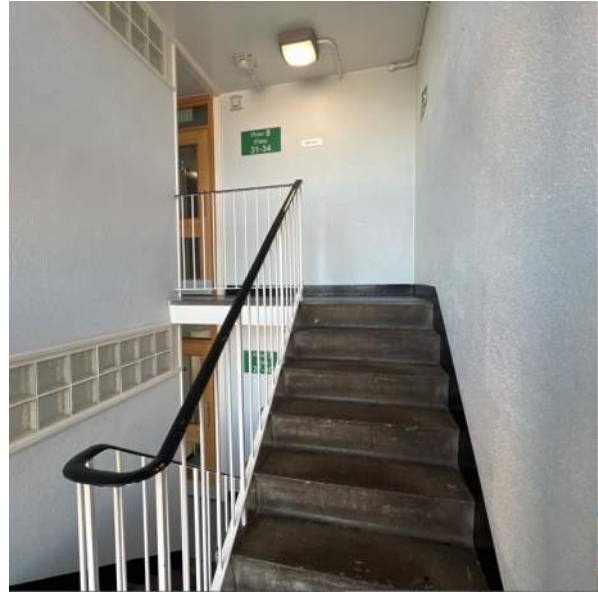
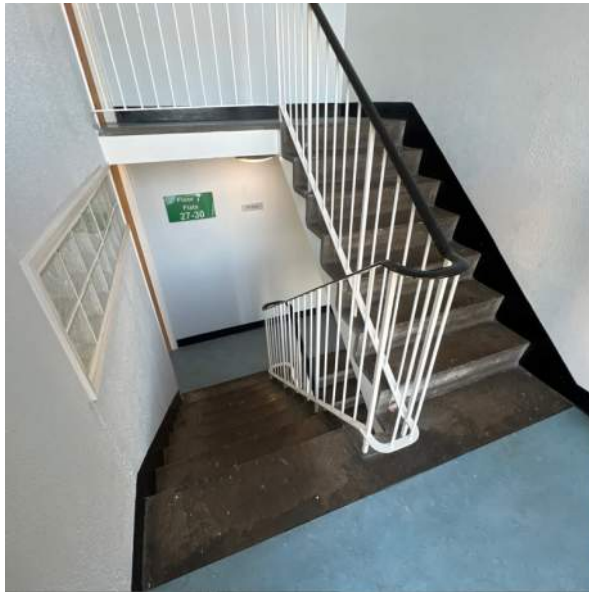
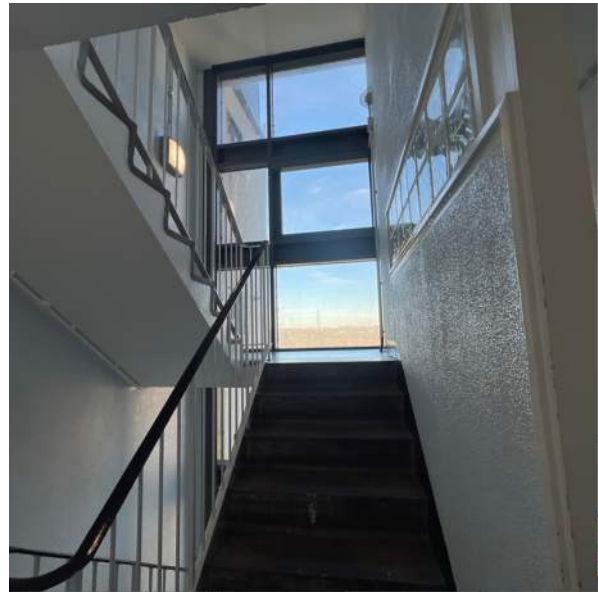
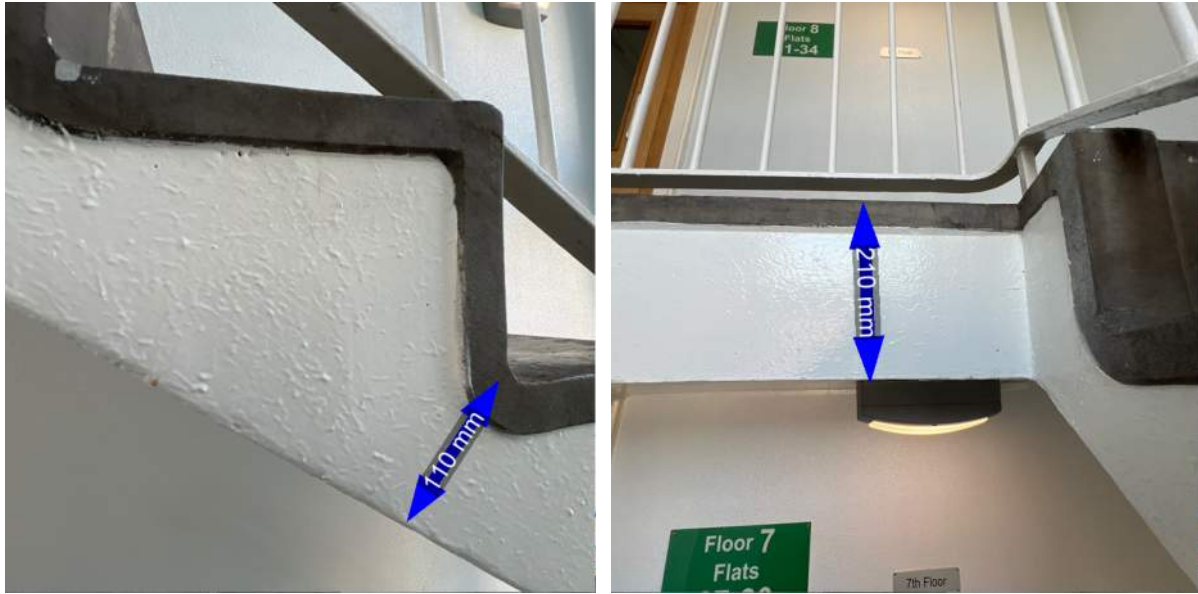
## 8th Floor Staircases

Comments: Insitu concrete stairs with steel hand railing fixed to stairs. Walls and floors appear to be fairly level.  
Stair walls covered with finishes however these would likely form the main concrete shear core walls. Partly infill/non-load bearing wall noted for one side of stair case wall.

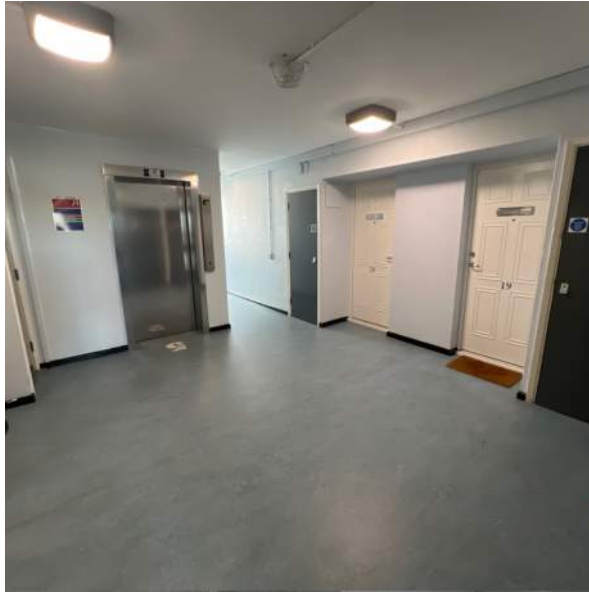
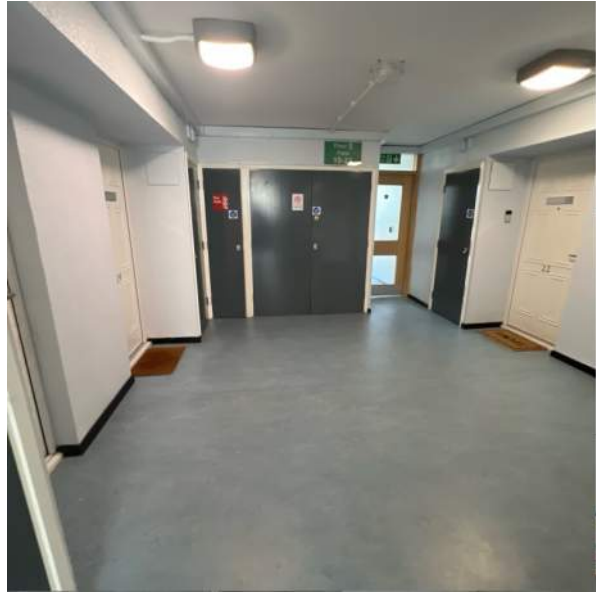
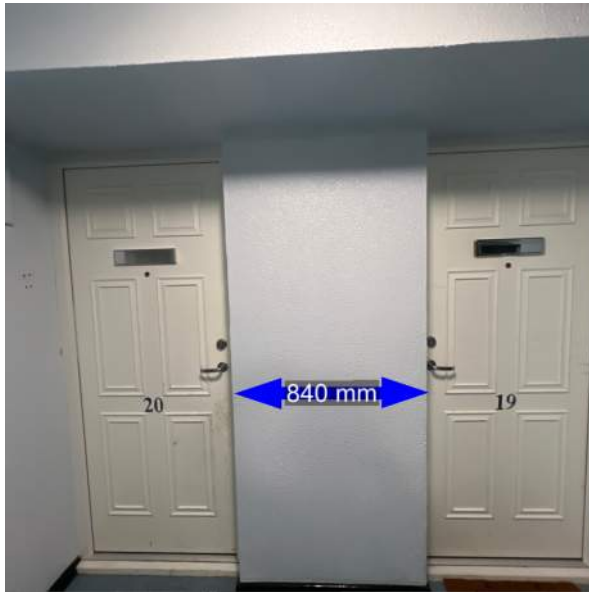
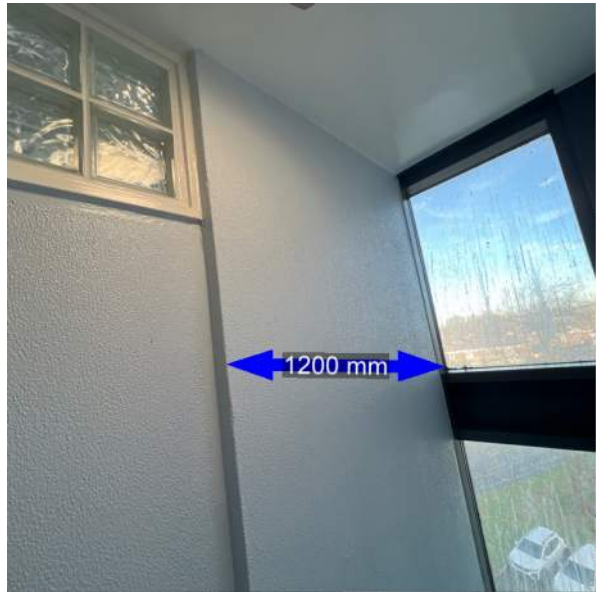
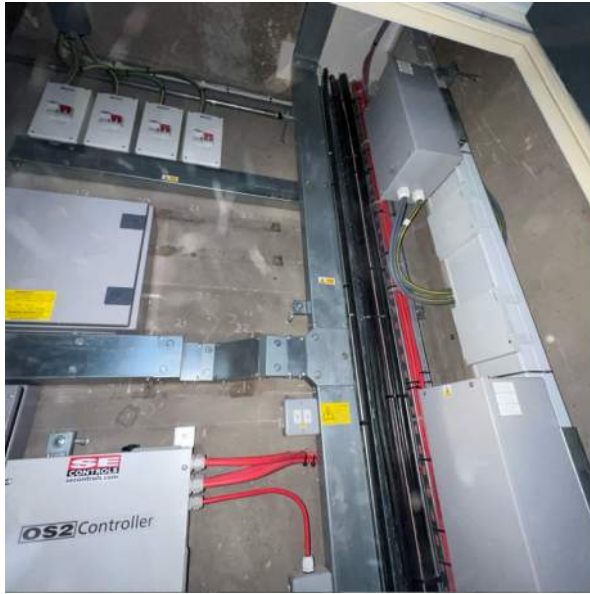
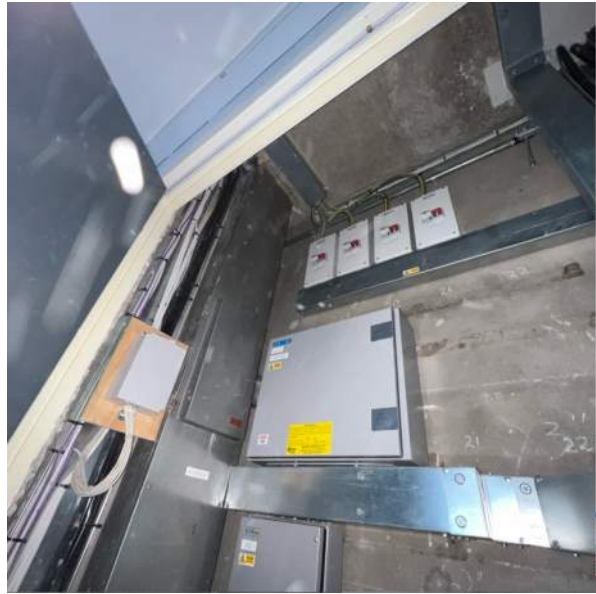
## 5th Floor Hallway

Comments: No jams or distortions noted to hallway doors to indicate any serviceability issues. Generally walls covered with finishes in hallway, likely to consist a mixture of concrete shear walls, embedded columns and masonry infill walls. Limited structure exposed. Concrete walls noted via riser cupboards.

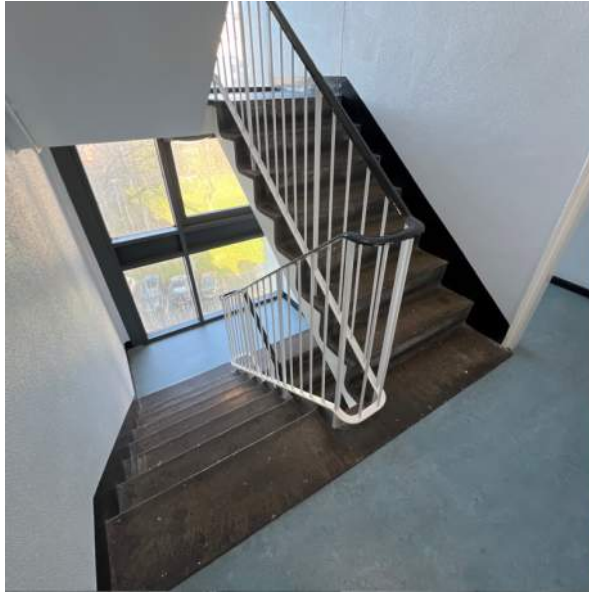
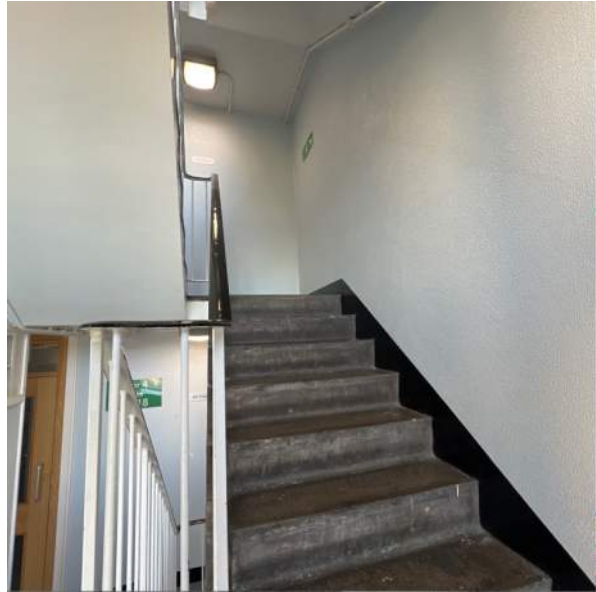
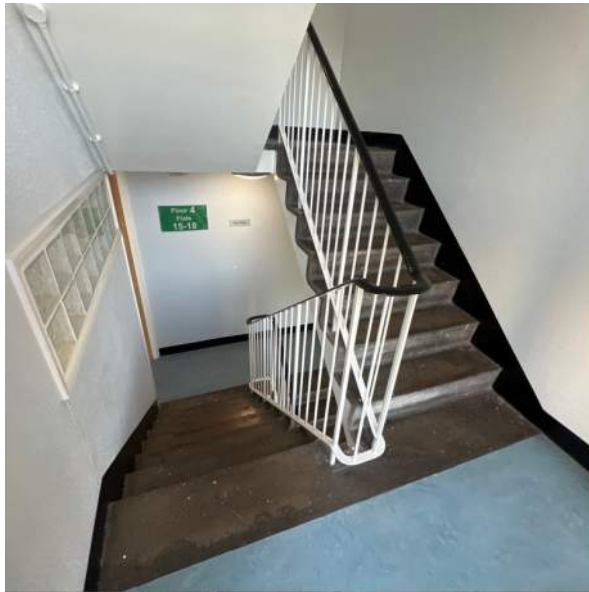
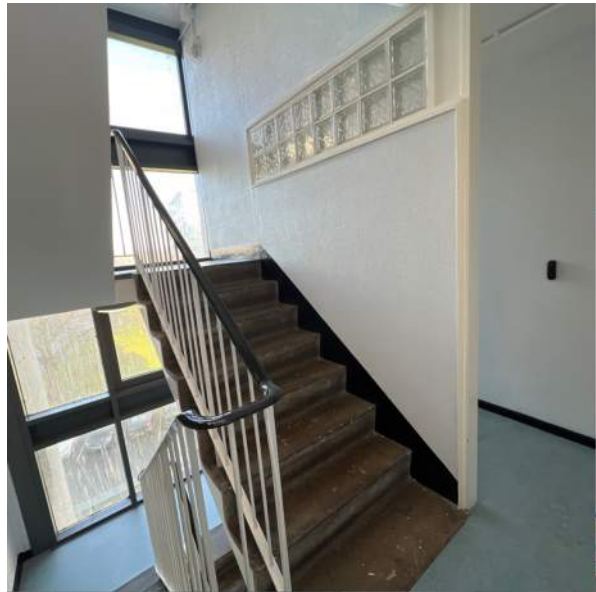
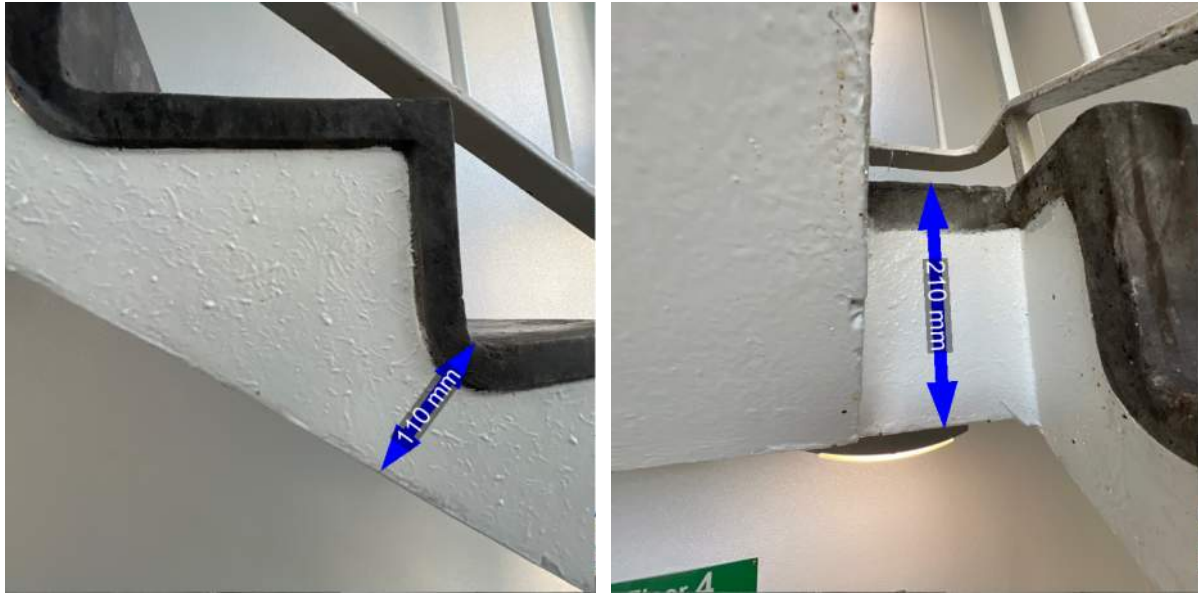
## 5th Floor Staircases

Comments: Insitu concrete stairs with steel hand railing fixed to stairs. Walls and floors appear to be fairly level.  
Stair walls covered with finishes however these would likely form the main concrete shear core walls. Partly infill/non-load bearing wall noted for one side of stair case wall.

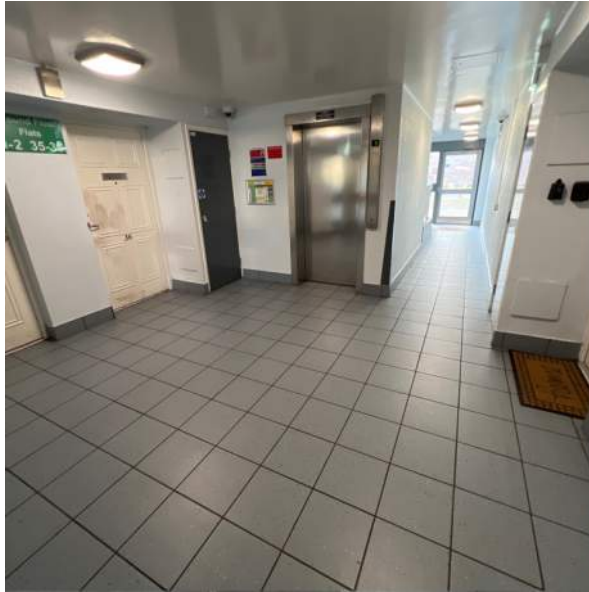
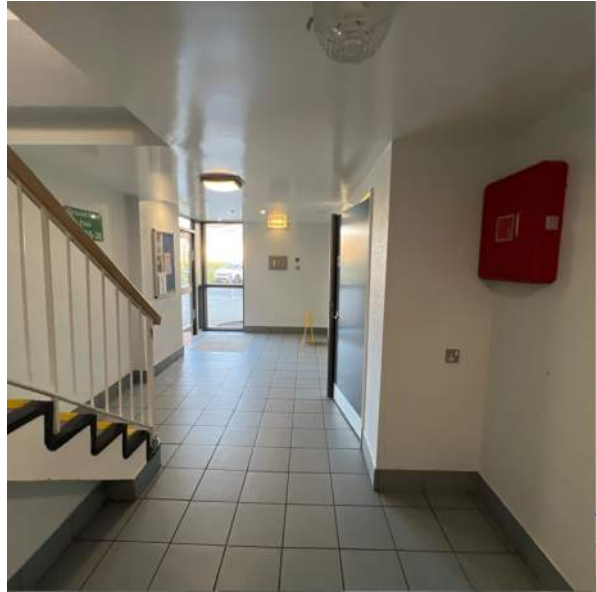
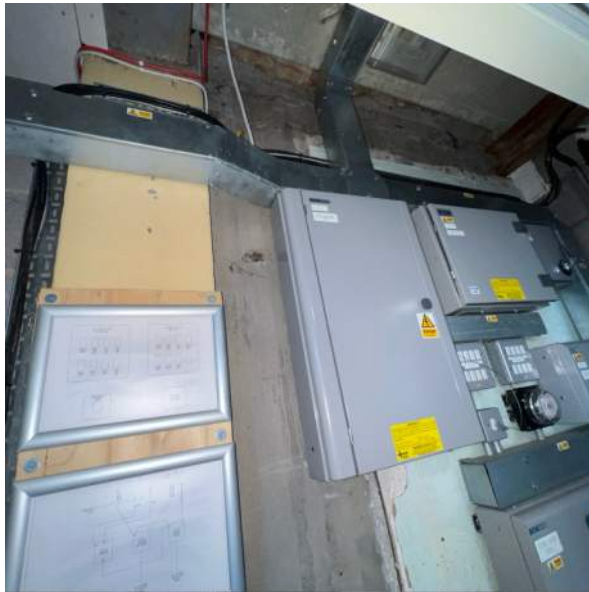
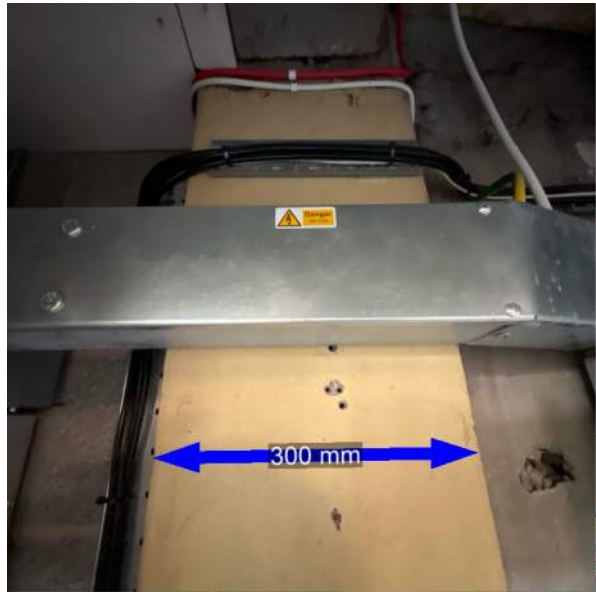
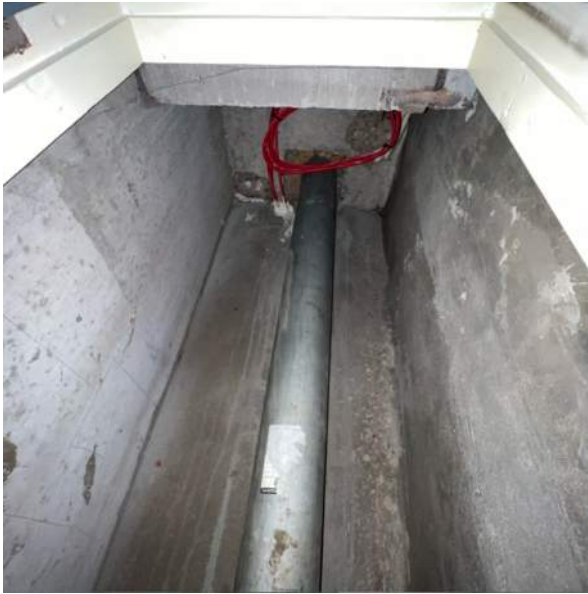
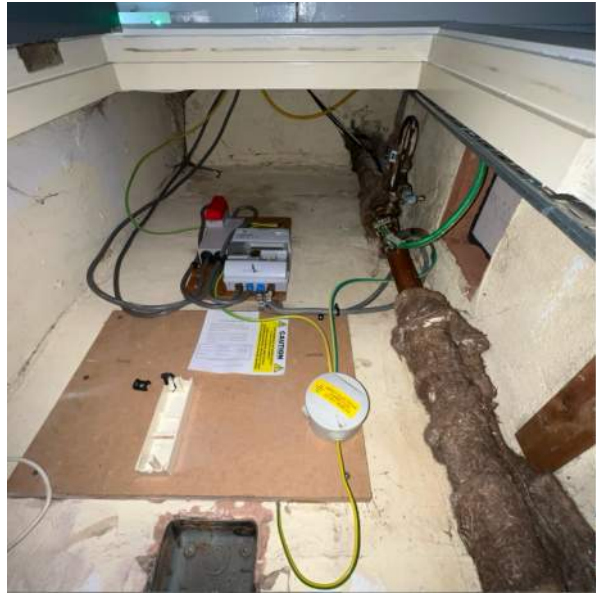
## Ground Floor Hallway

Comments: No jams or distortions noted to hallway doors to indicate any serviceability issues. Generally walls covered with finishes in hallway, likely to consist a mixture of concrete shear walls, embedded columns and block infill walls. Limited structure exposed. Partly visible concrete walls noted via electrical riser cupboards.

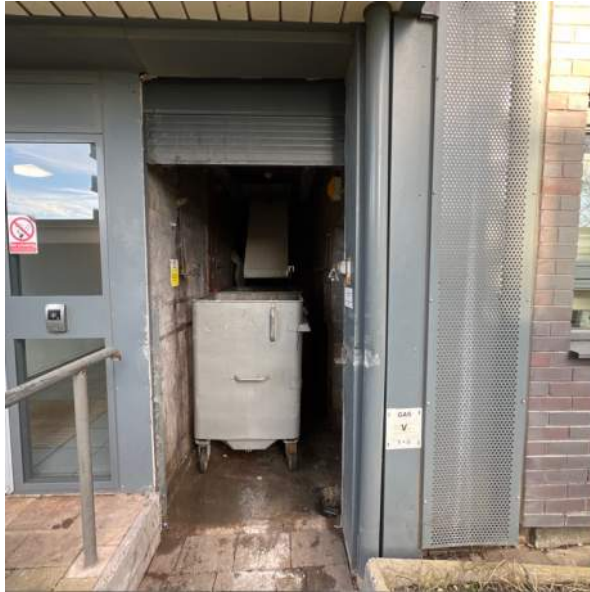
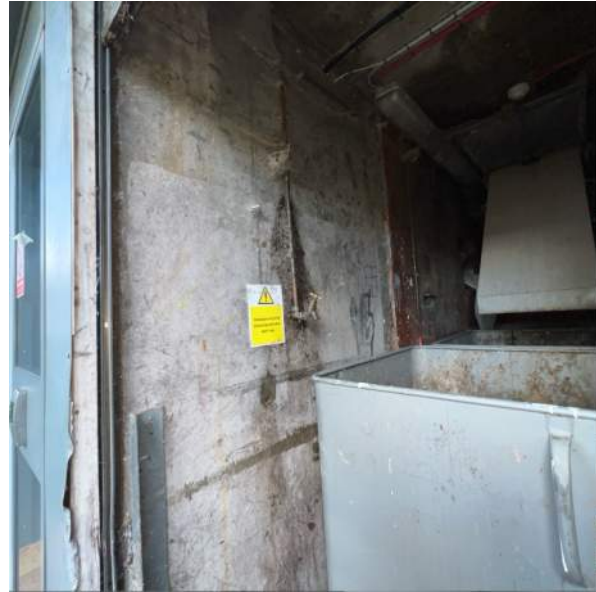
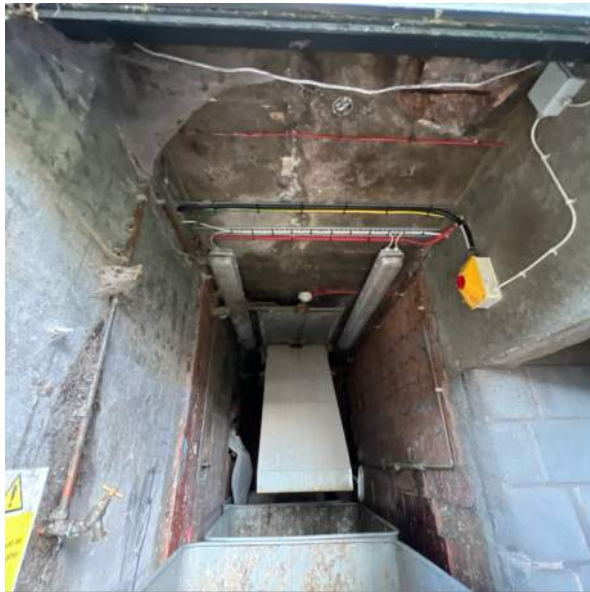
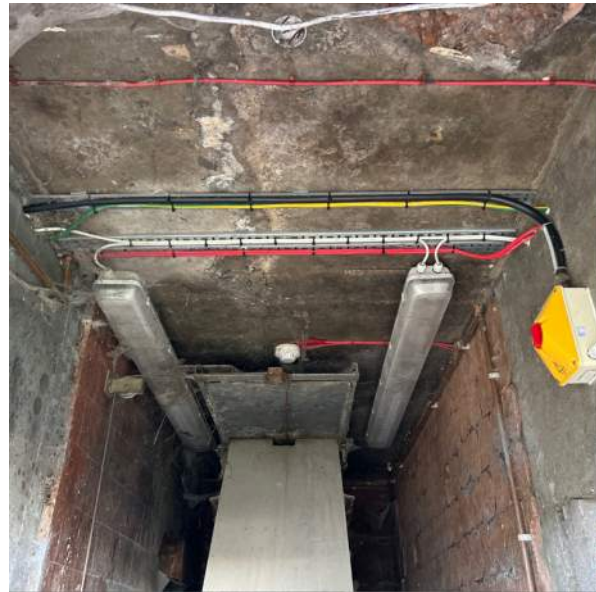
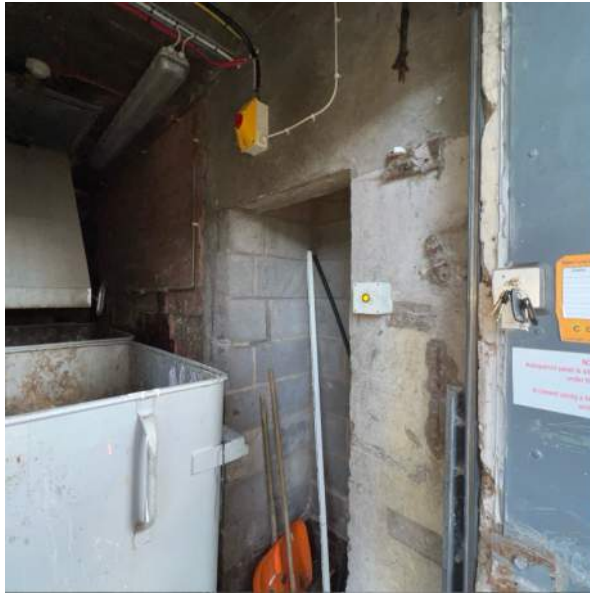
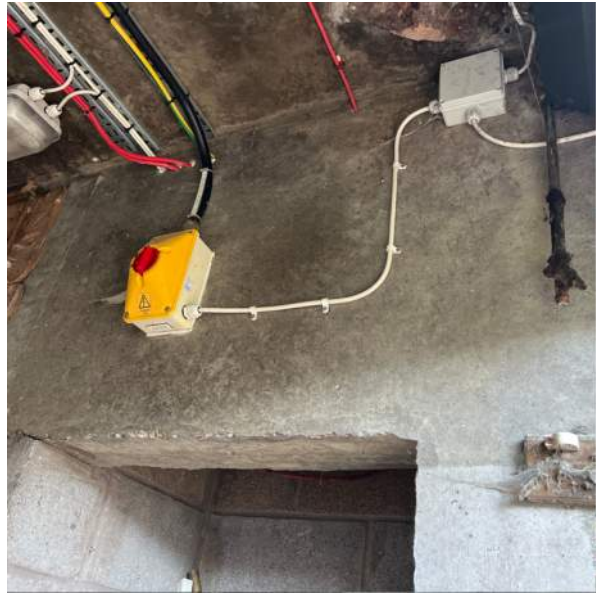
## Binstore

RC shear walls noted in binstore.

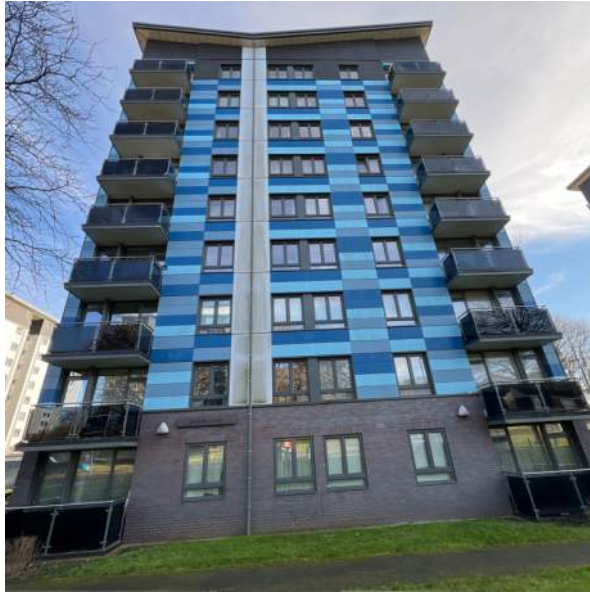
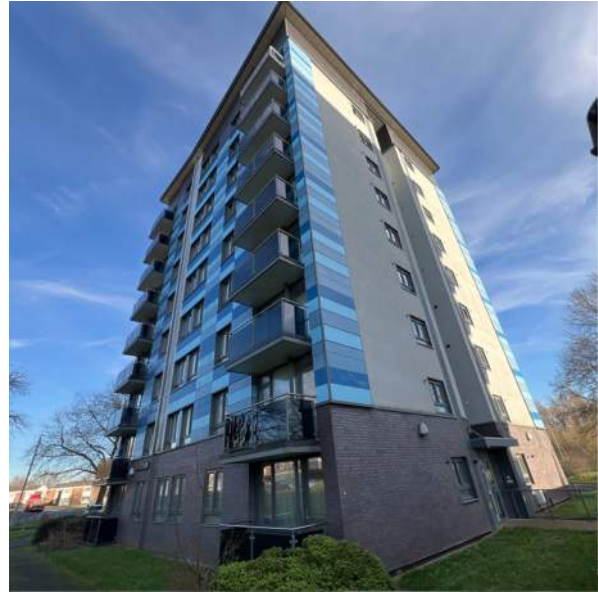
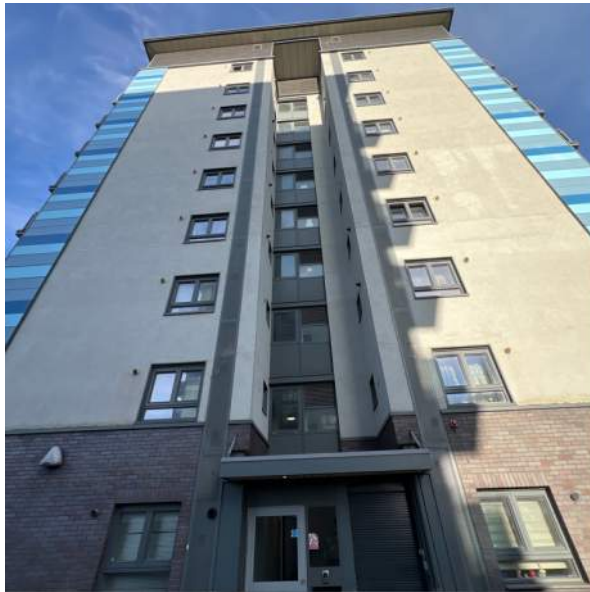
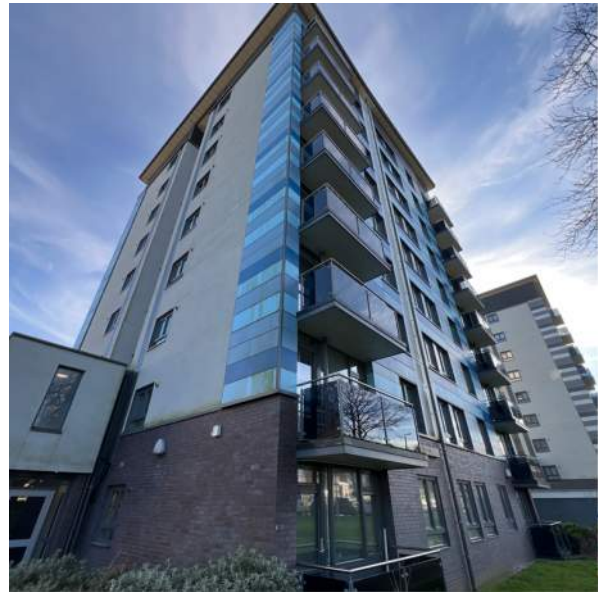
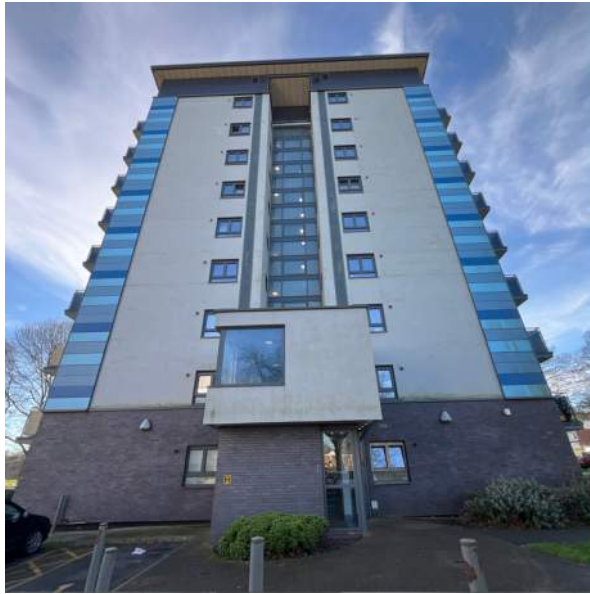
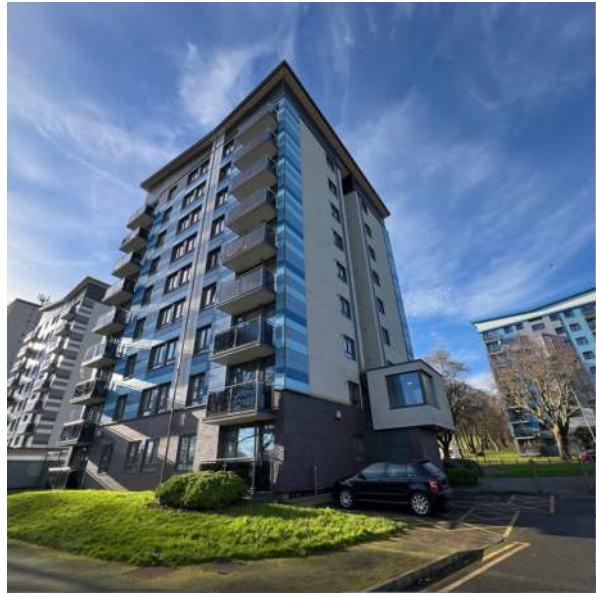
## Elevations

Ground floor level consists of brickwork. Remaining elevations consist of a mixture of rendered and cladded facade.
