**FIRNTEC**  
BUILDING COMPLIANCE

VISUAL STRUCTURAL APPRAISAL

1-90 Elmcroft

Windmill Lane  
Smethwick  
B66 3LN

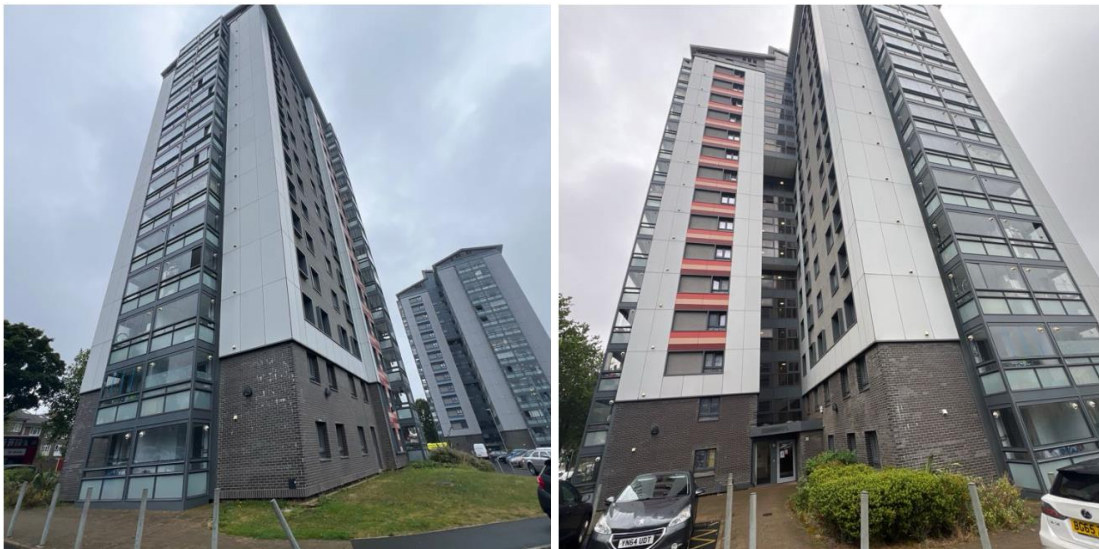
Figure 9 and 10: Building Elevations

The exterior elevations were generally in ok condition and no significant structural defects were noted to the cladding panels. There were no significant cracks or tell-tale signs of any significant structural movement noted at the time of our inspection.

The exterior panels were noted to be plumb with no signs of significant bowing, bulging or leaning noted to the panels indicating failed fixings however their presence and condition cannot be confirmed.

There are balconies at each level which are formed of cantilevered RC slabs tied into the main frame. During the 2016 refurbishment they were transformed into winter gardens by installing glazing around the perimeter of the balcony.

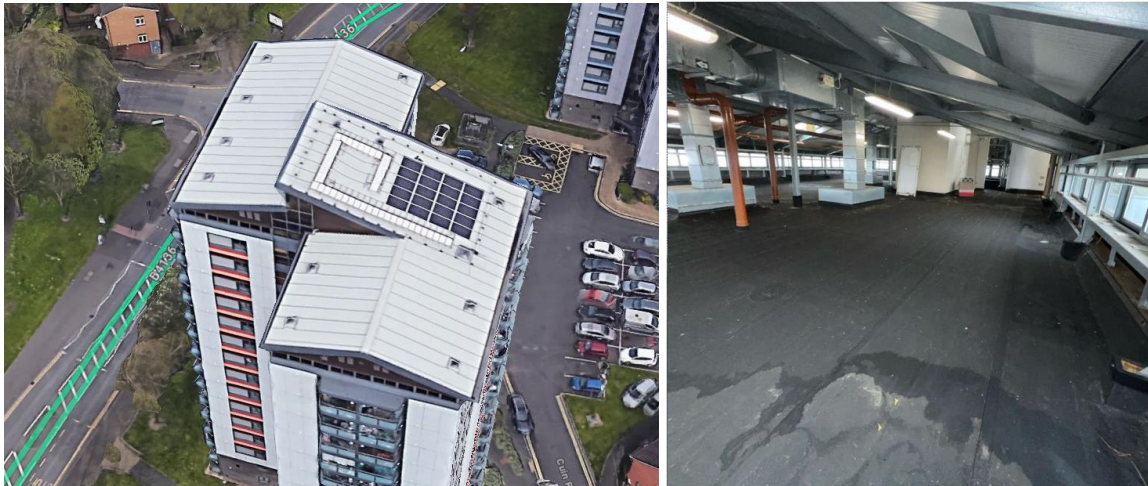
Figure 11 and 12: Roof Level

There were no tell-tale signs of any significant structural movement noted at the time of our inspection. The exterior walls were noted to be plumb with no signs of significant bowing, bulging or leaning noted to the masonry walls.

The roof has subsequently been covered with a new waterproofing covering formed of a steel frame installed to the existing roof which supports pitched corrugated sheets. This roof is not insulated and therefore acts purely as a weather barrier. The fire protection of the steel is unclear as the beams do not appear to be protected. Details of this frame should be requested from the contractor who completed the works in 2016.

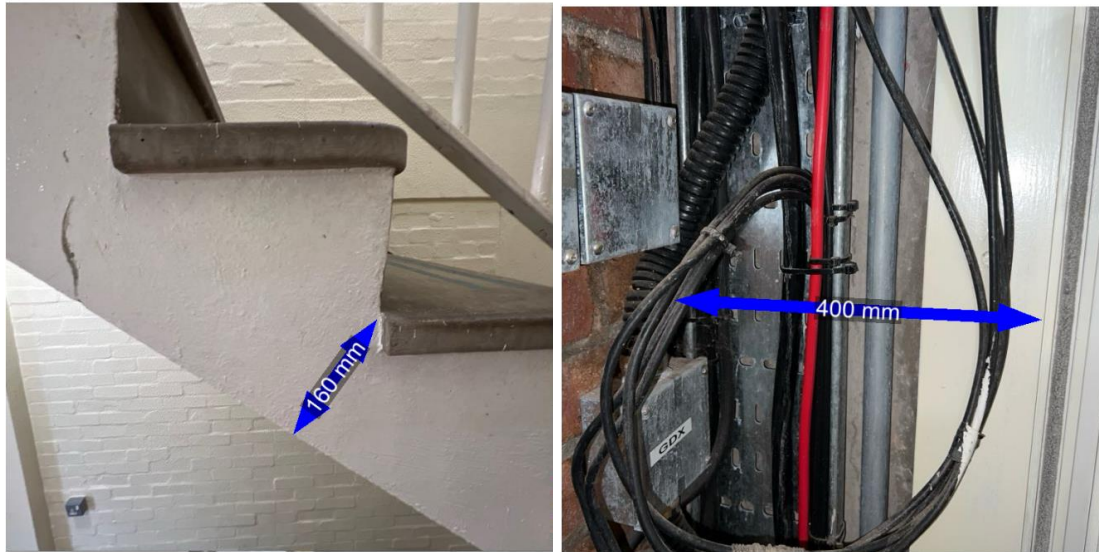
Figure 13 and 14: Stair stringer and size of concrete columns

The stair stringer was noted to be 160mm thick which seems reasonable, albeit short of modern standards. A cover test is required to check the resistance of the concrete section in the event of a fire.

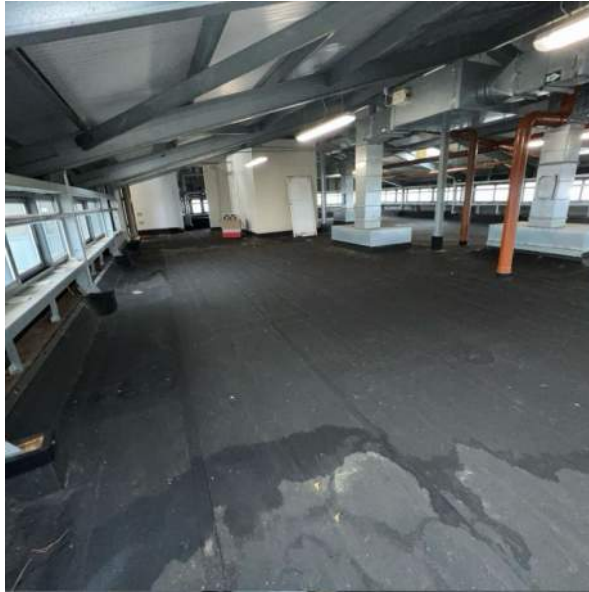
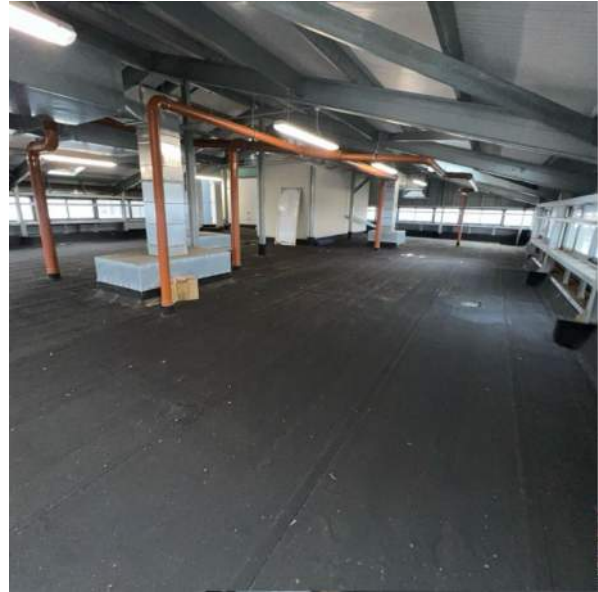
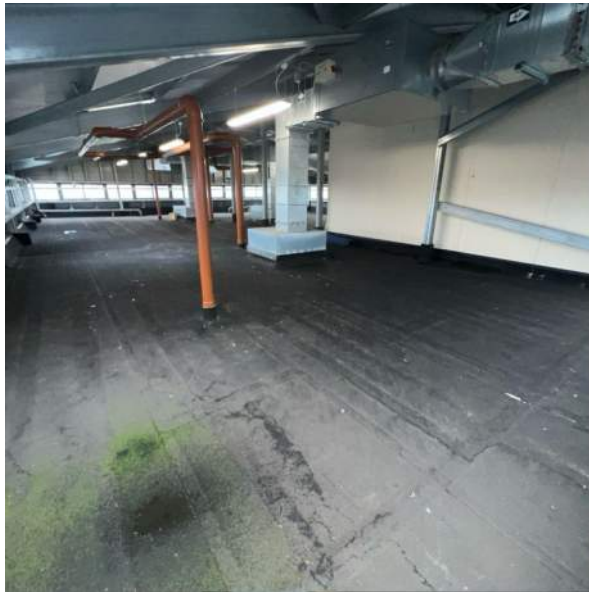
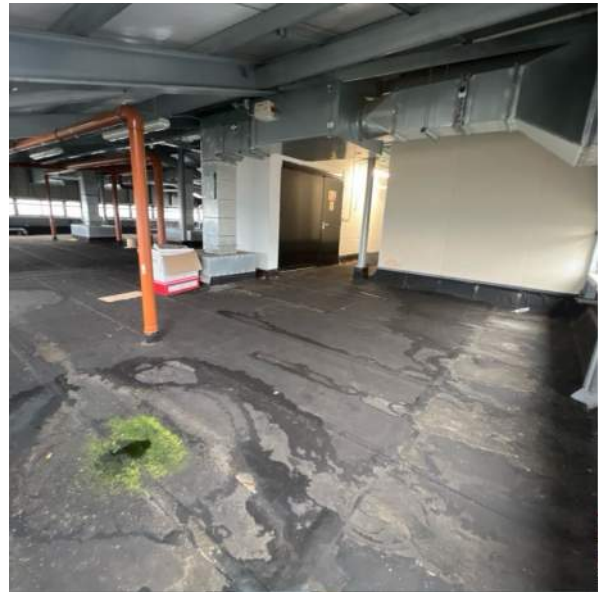
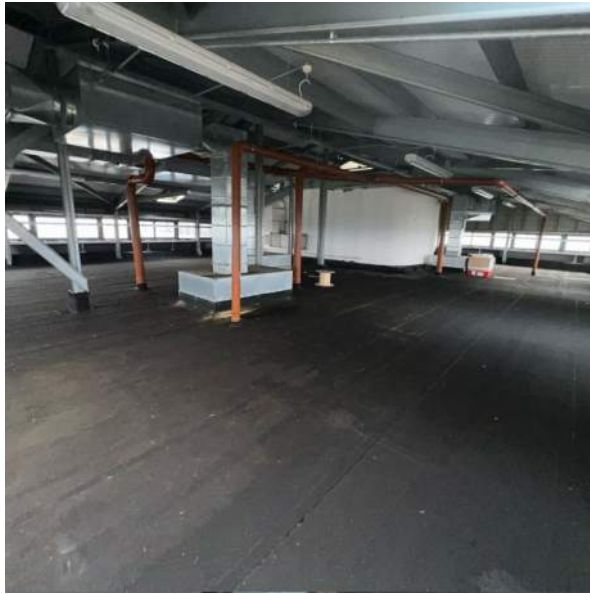
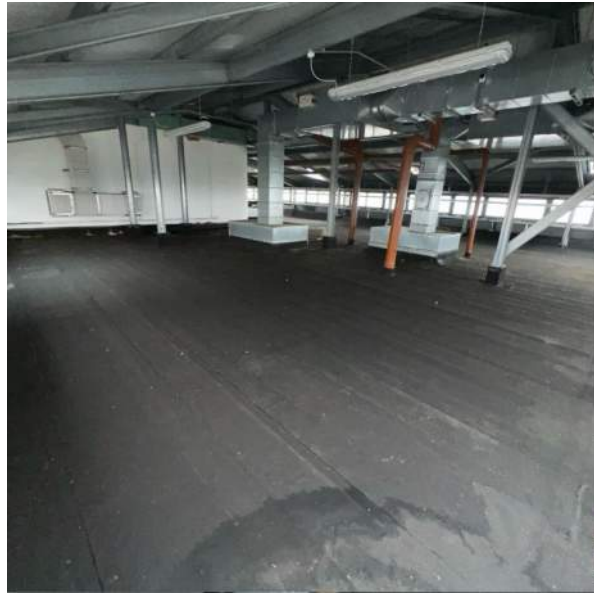
## Main Roof

Comments: Roof structure is formed of a concrete slab with a Lightweight SFS (appear to be cold rolled) frame with a pitched roof fixed on to main roof structure. Frame columns fixed to perimeter of roof.  
Some historical staining to roof coverings noted, potential leaks in pitched roof coverings.

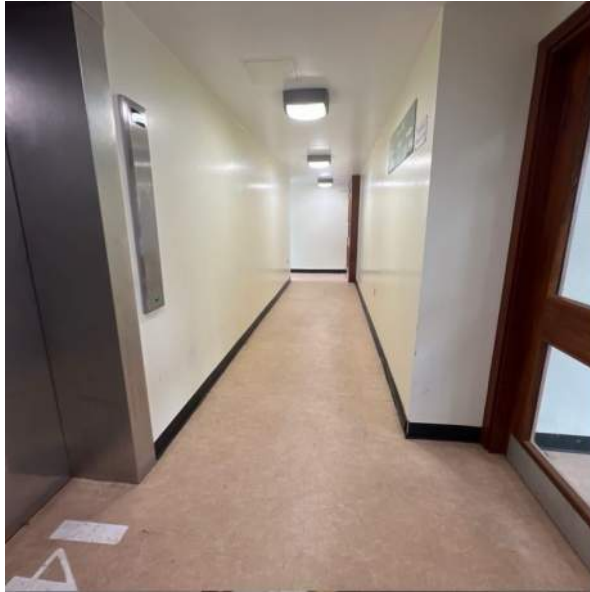
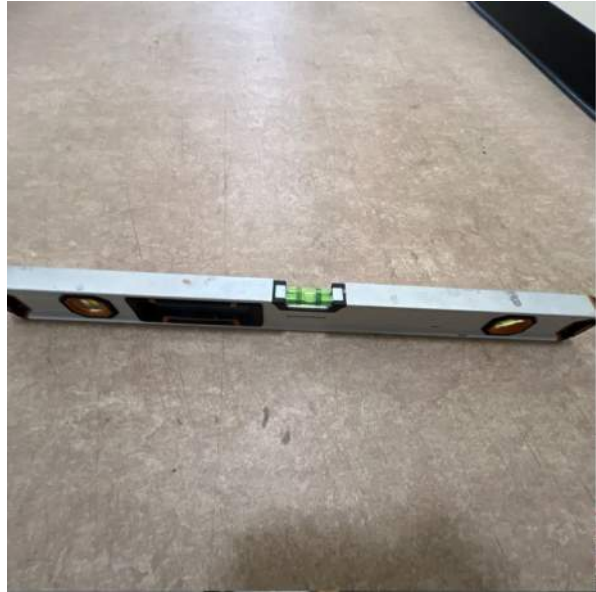
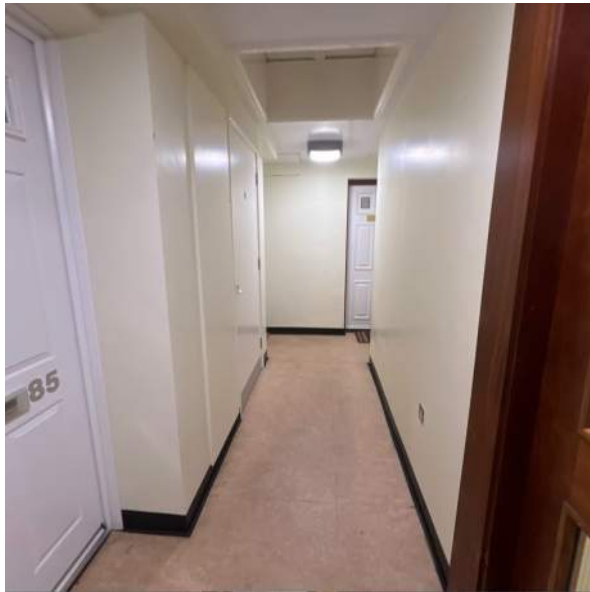
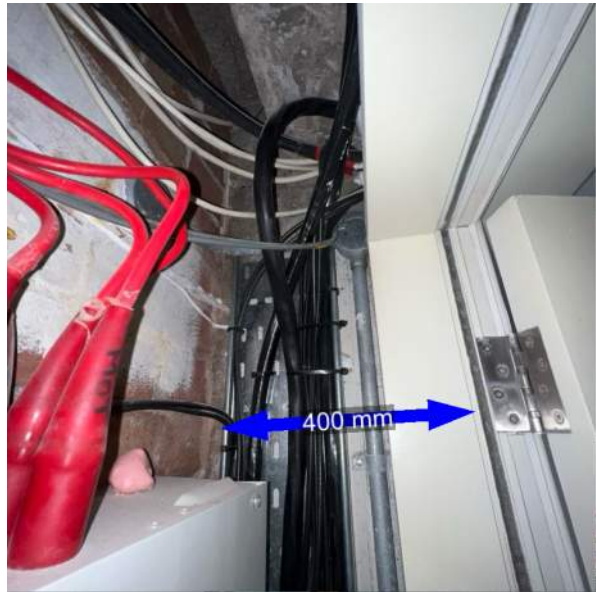
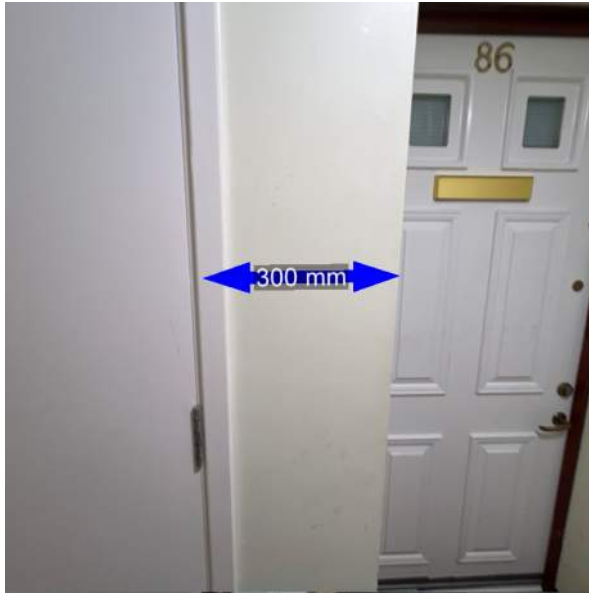
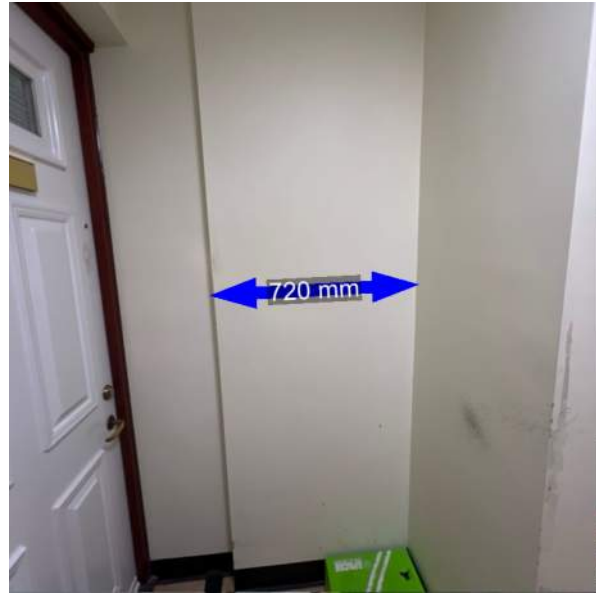
## 14th Floor Hallway

Comments: No jams or distortions noted to hallway doors to indicate any serviceability issues. Generally walls covered with finishes in hallway, likely to consist a mixture of concrete shear walls and embedded columns with internal partition walls. Riser cupboard shows infill masonry walls with partially exposed concrete elements which appears RC Columns.

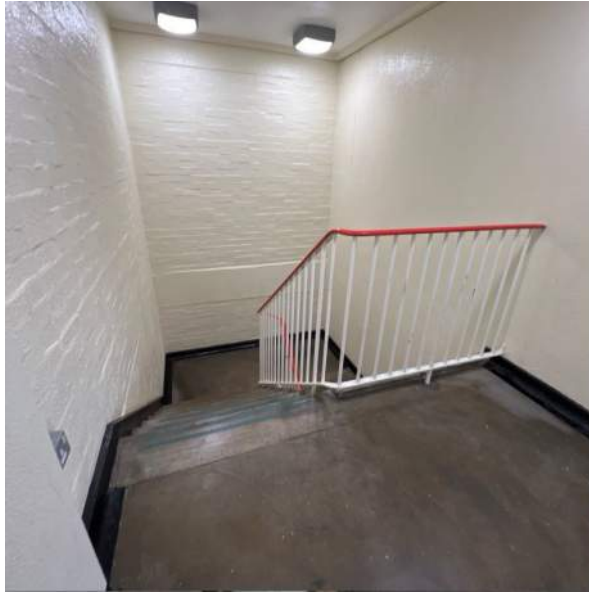
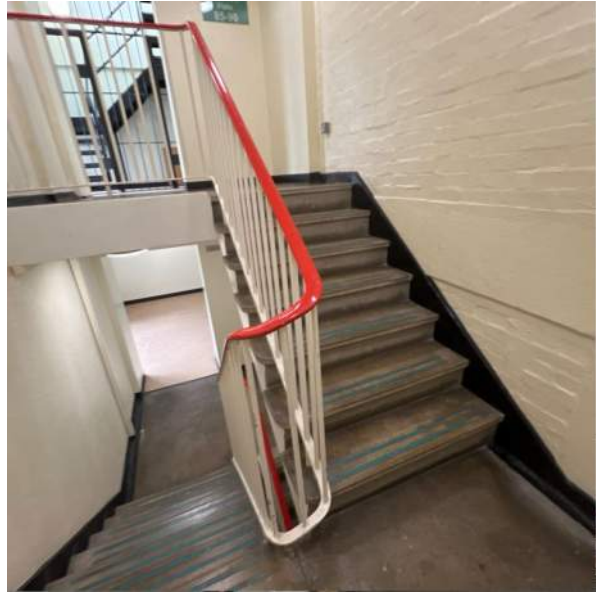
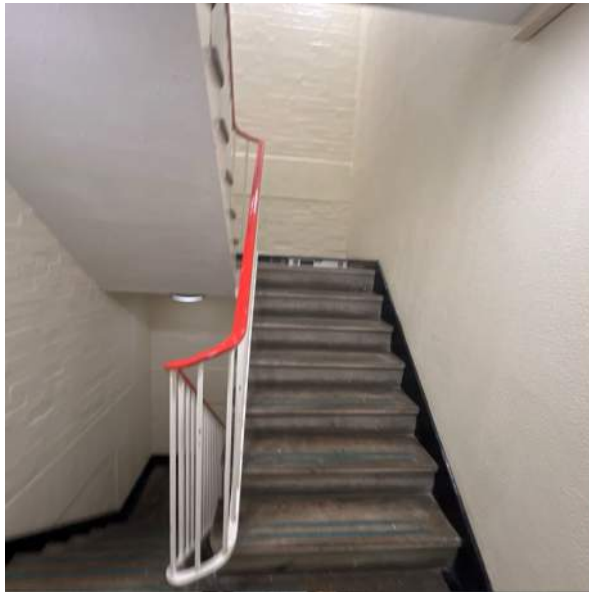
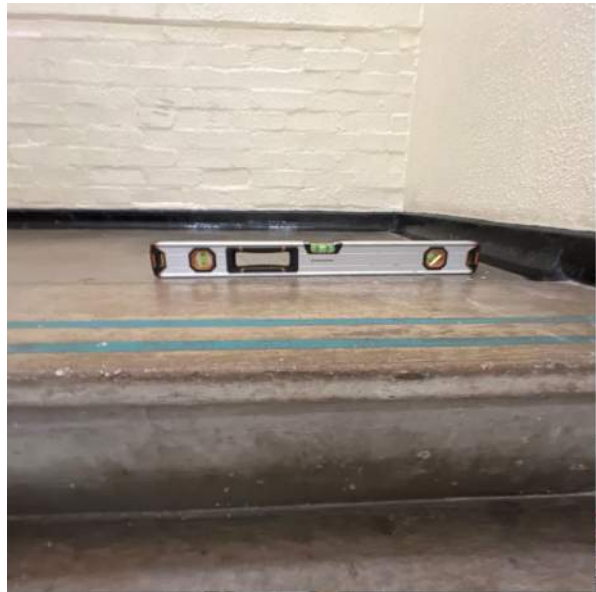
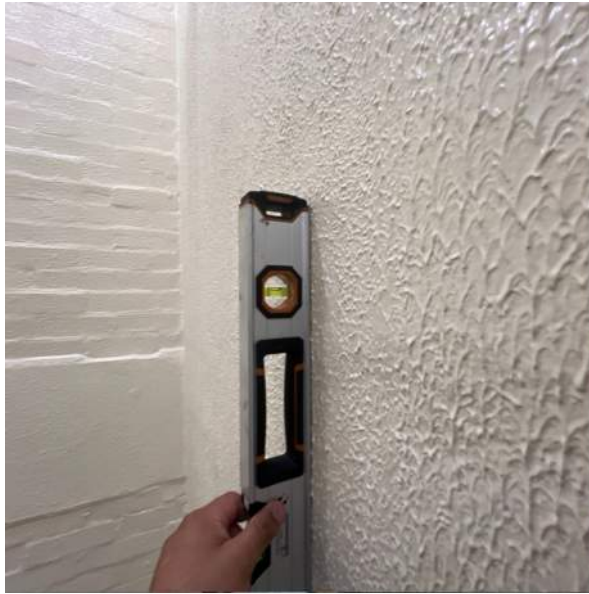
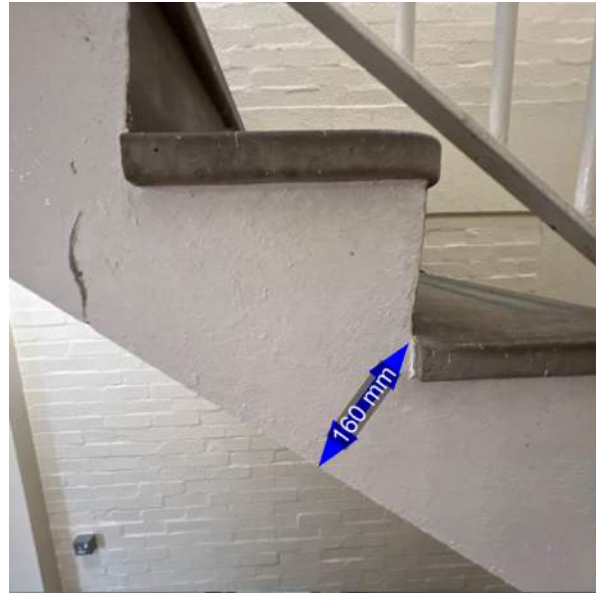
## 14th Floor Staircase

Insitu concrete stairs with steel hand railing fixed to stairs. Walls and floors appear to be fairly level.

Stair walls partly exposed showing infill masonry walls (non-load bearing) and embedded RC Concrete beams and columns noted.

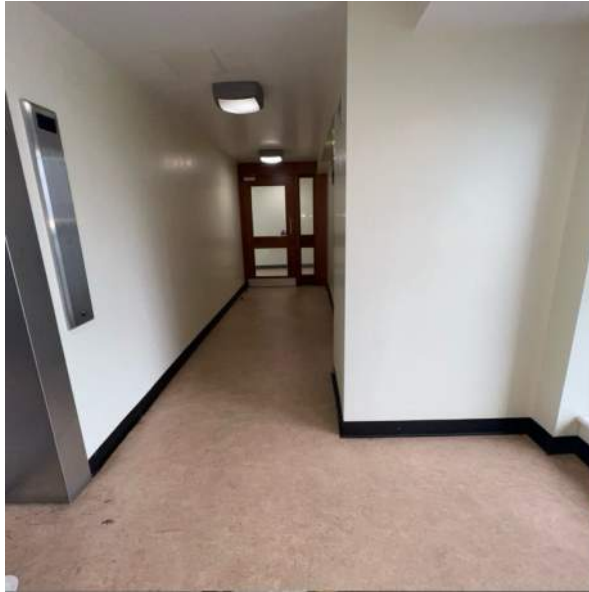
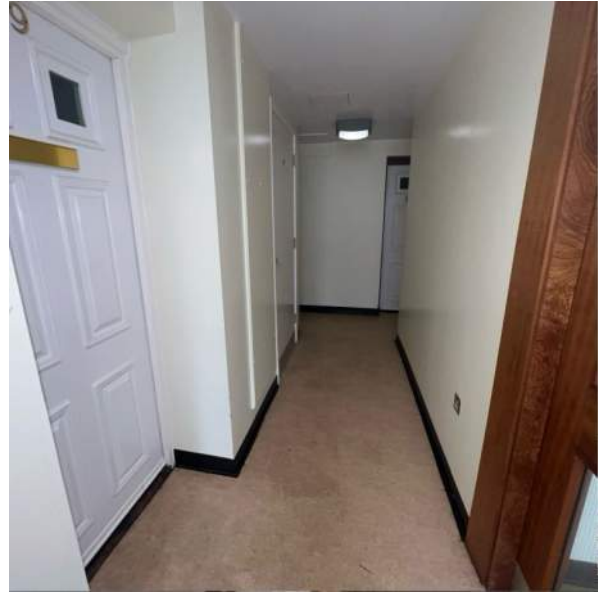
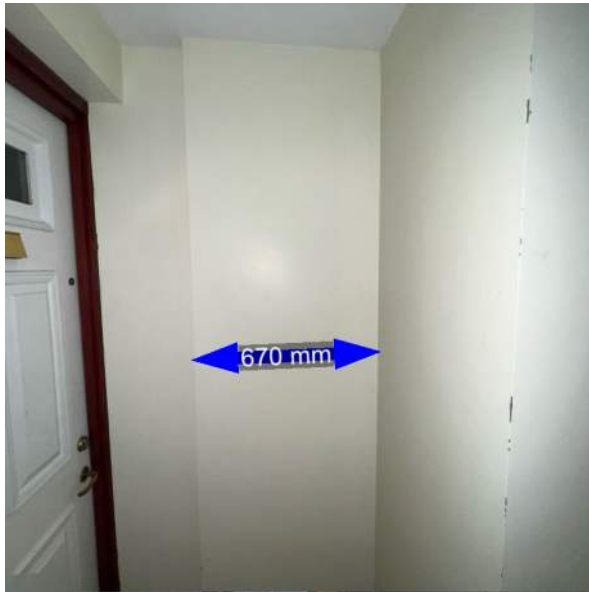
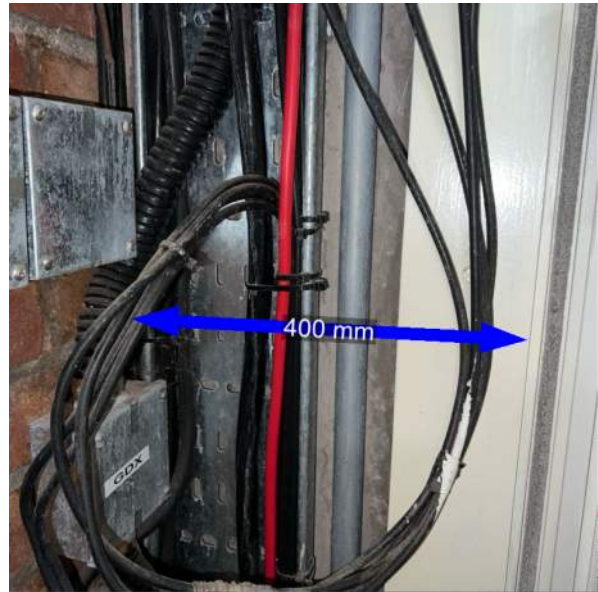
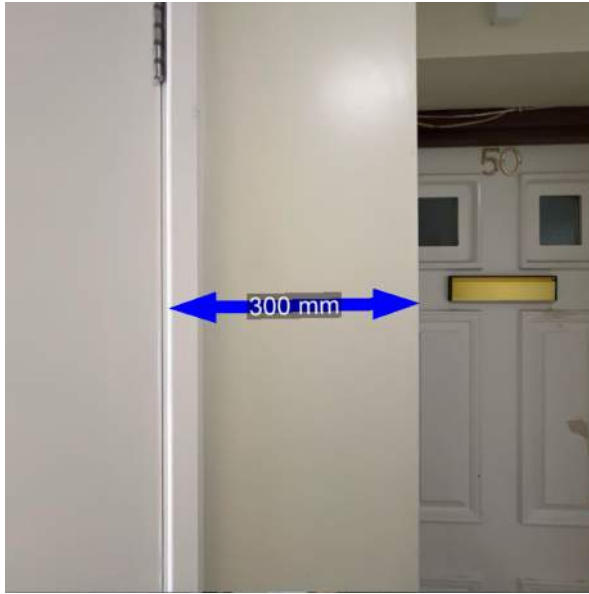
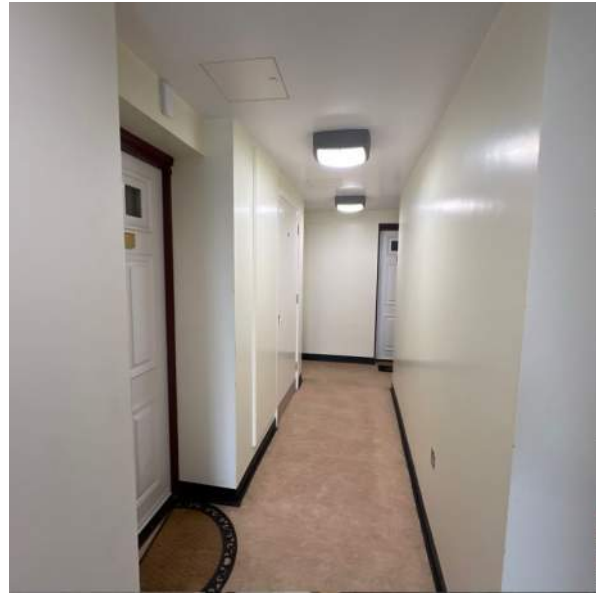
## 8th Floor Hallway

Comments: No jams or distortions noted to hallway doors to indicate any serviceability issues. Generally walls covered with finishes in hallway, likely to consist a mixture of concrete shear walls and embedded columns with internal partition walls. Riser cupboard shows infill masonry walls with partially exposed concrete elements appears to be RC Columns.

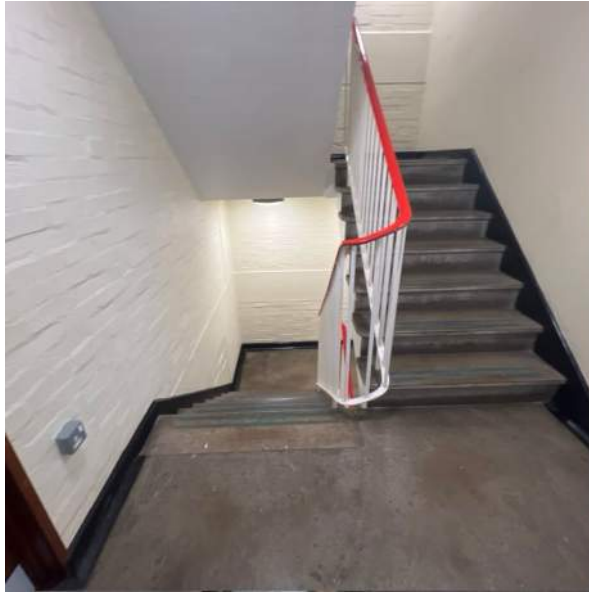
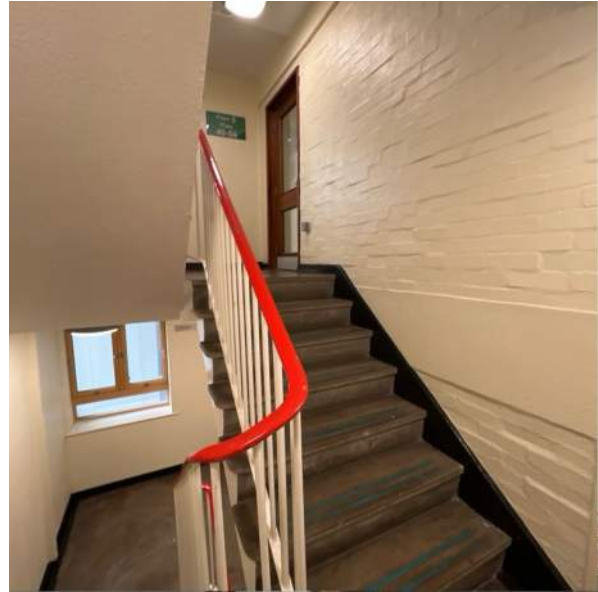
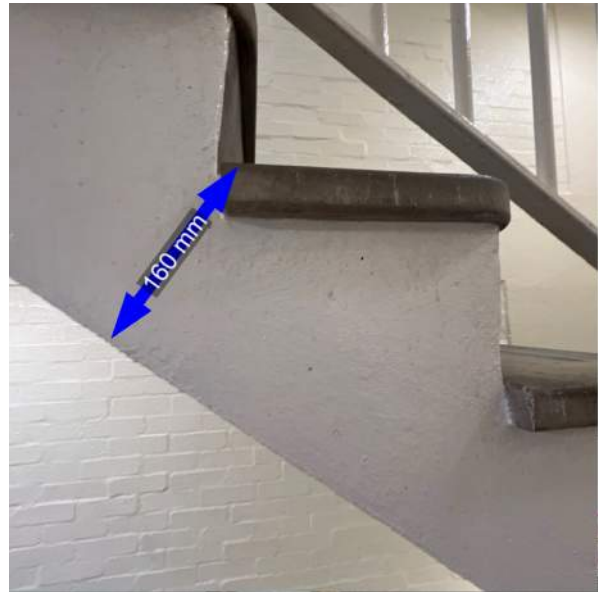
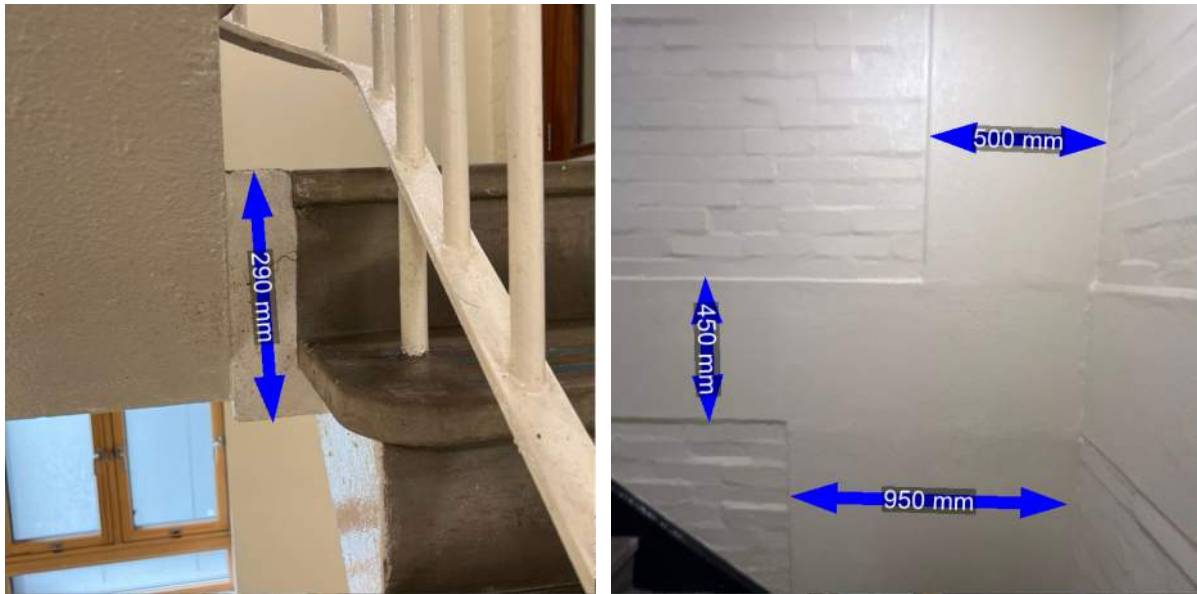
## 8th Floor Staircase

Insitu concrete stairs with steel hand railing fixed to stairs. Walls and floors appear to be fairly level.

Stair walls partly exposed showing infill masonry walls (non-load bearing) and embedded RC Concrete beams and columns noted.

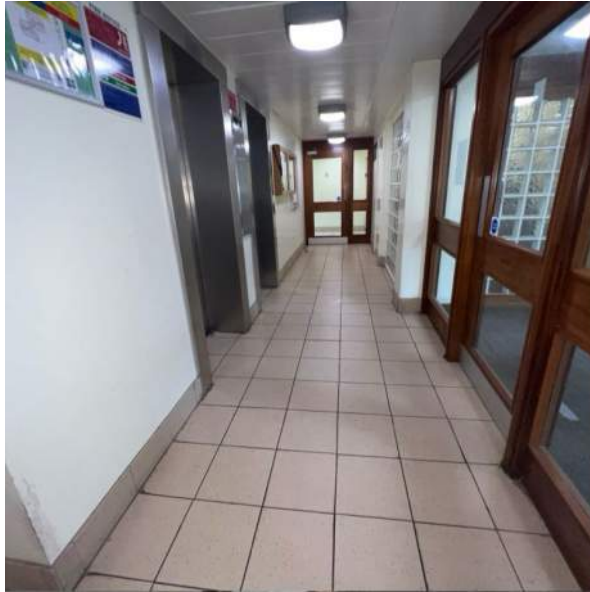
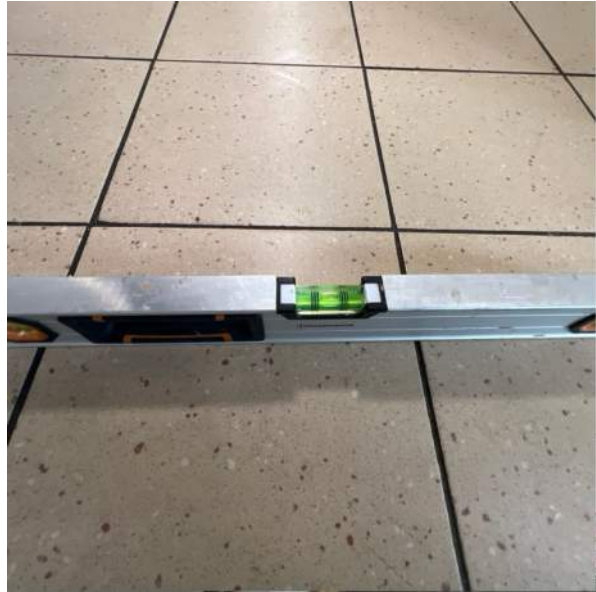
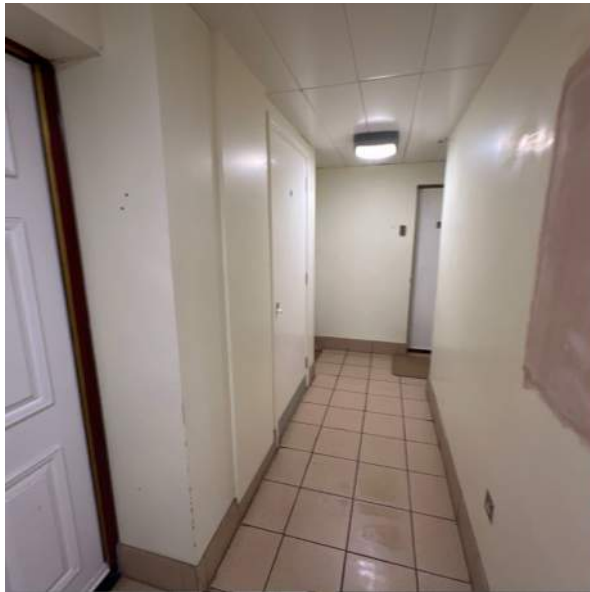
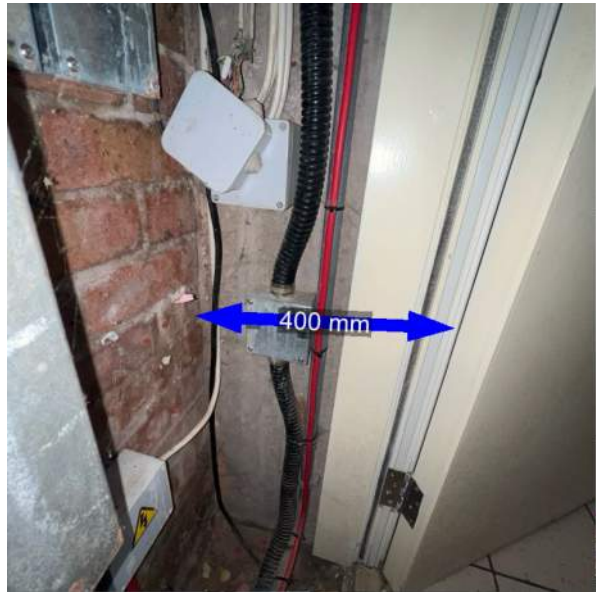
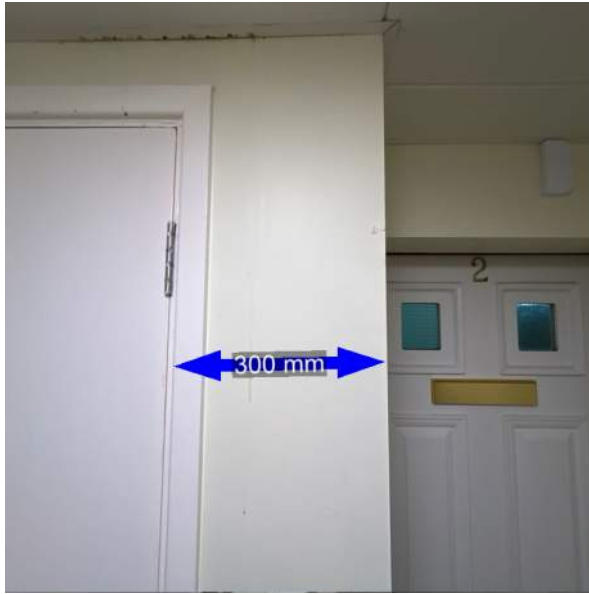
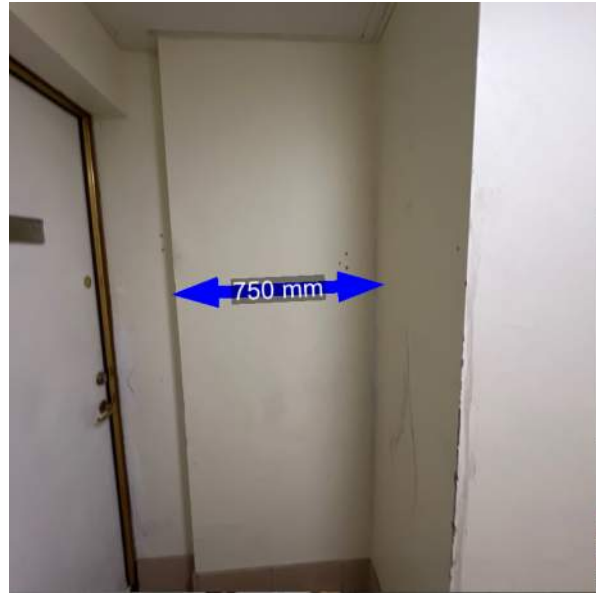
## Ground Floor Hallway

Comments: 24 Jul 2024 at 12:27 PM  
 No jams or distortions noted to hallway doors to indicate any serviceability issues.  
 Generally walls covered with finishes in hallway, likely to consist a mixture of concrete shear walls and embedded columns with internal partition walls.  
 Riser cupboard shows infill masonry walls with a partially exposed concrete element likely an RC Column.  
 Storage room under ground floor staircase shows embedded RC concrete beam and column in infill masonry walls. One side of stair wall noted to be an RC concrete wall likely forming a shear core wall of the structure.

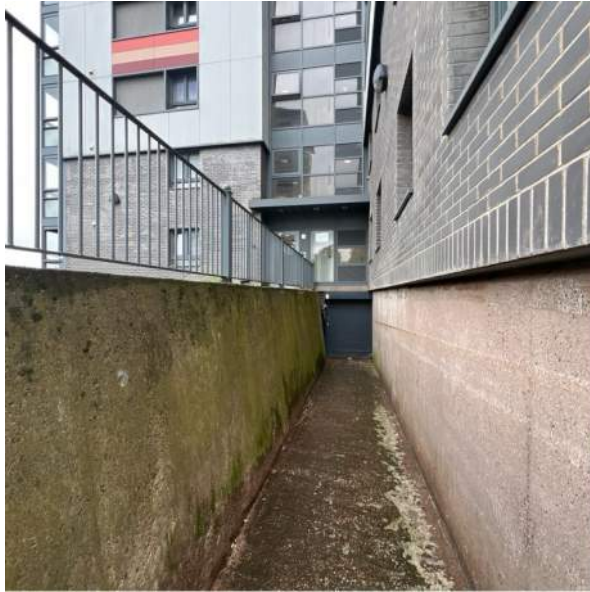
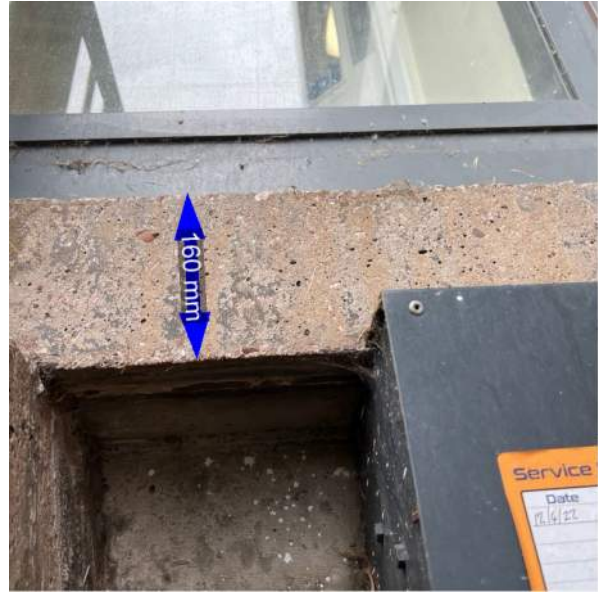
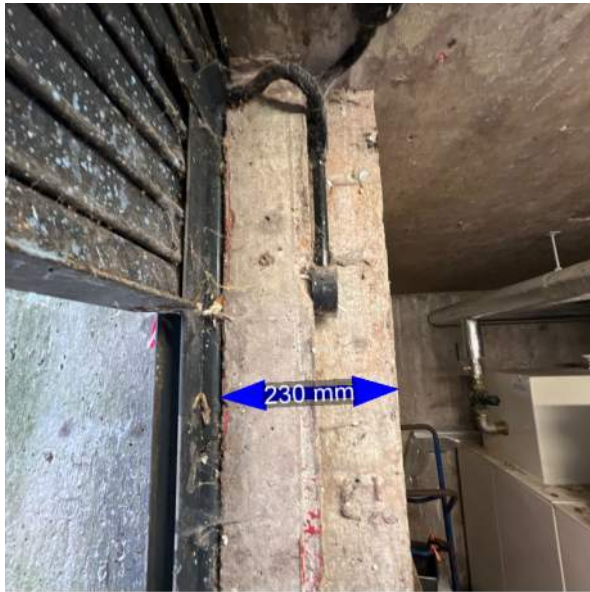
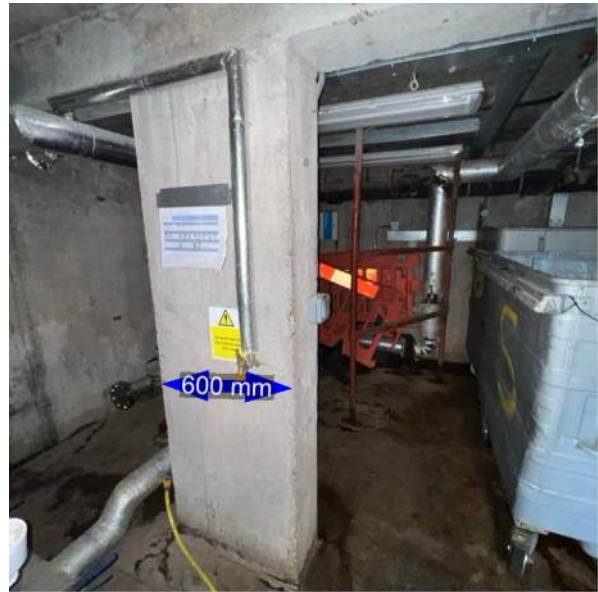
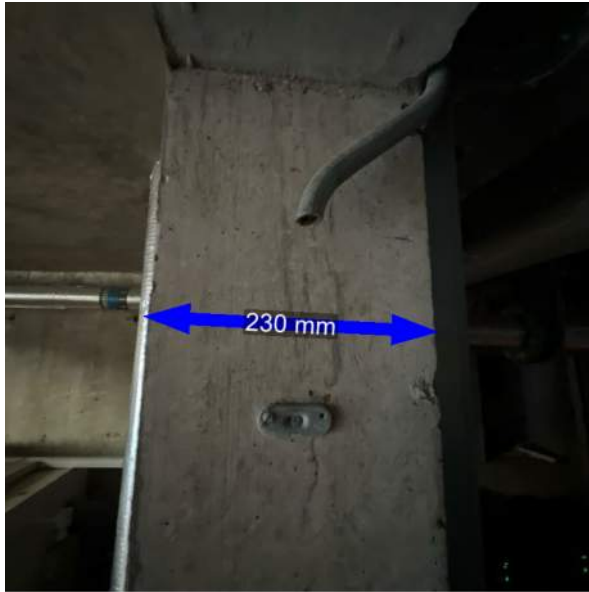
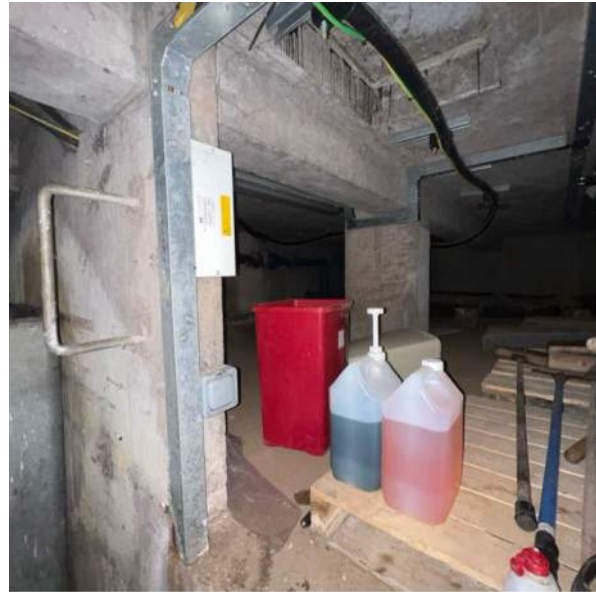
## Bin Store

Bin store located at basement level with a retaining wall leading up to bin store entrance. RC frame structure exposed forming of concrete beams, columns (230x600mm) and shear walls.  
Floor slab measured from bin store entrance noted to be approx. 160mm dp.

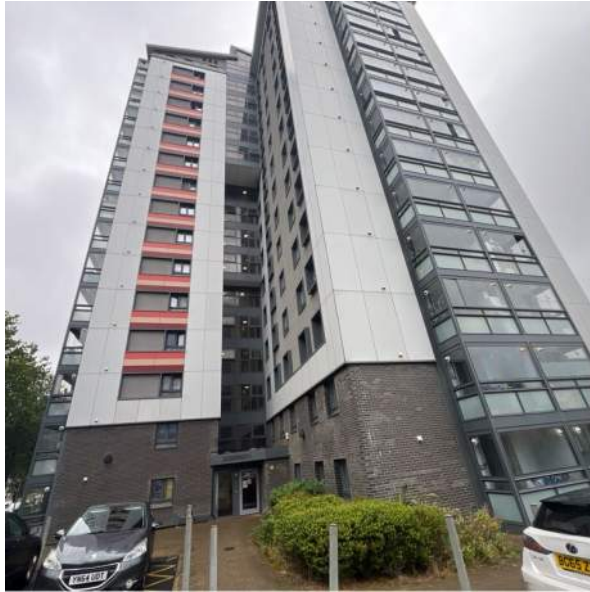
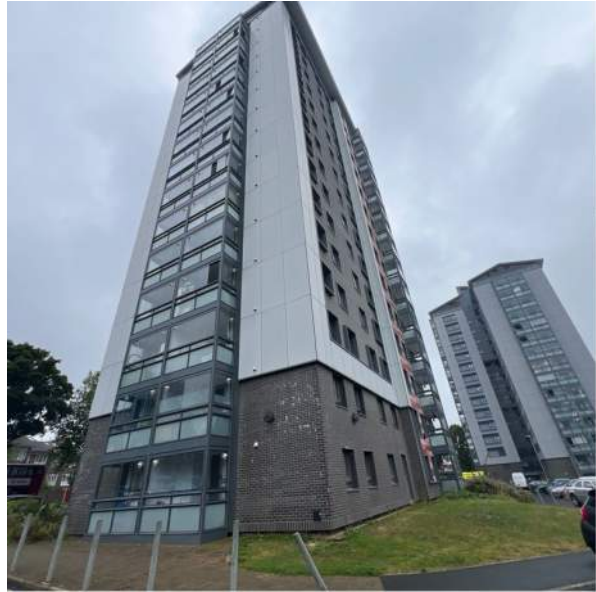
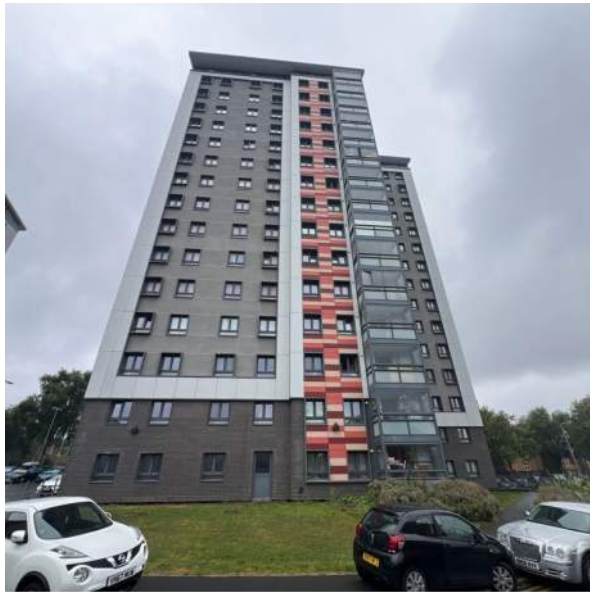
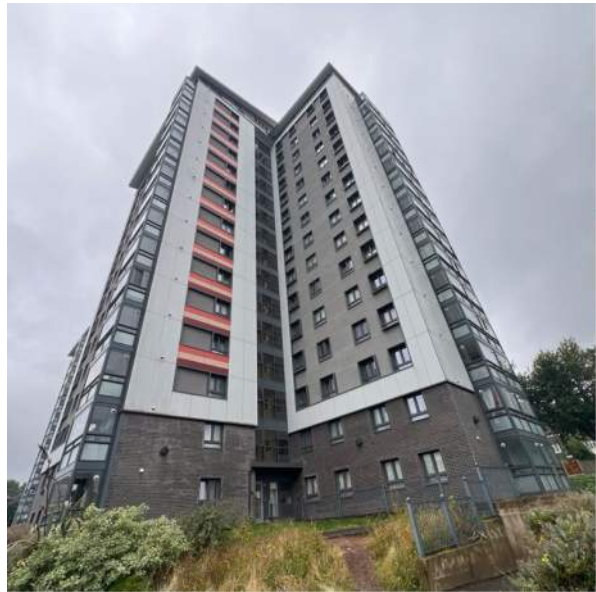
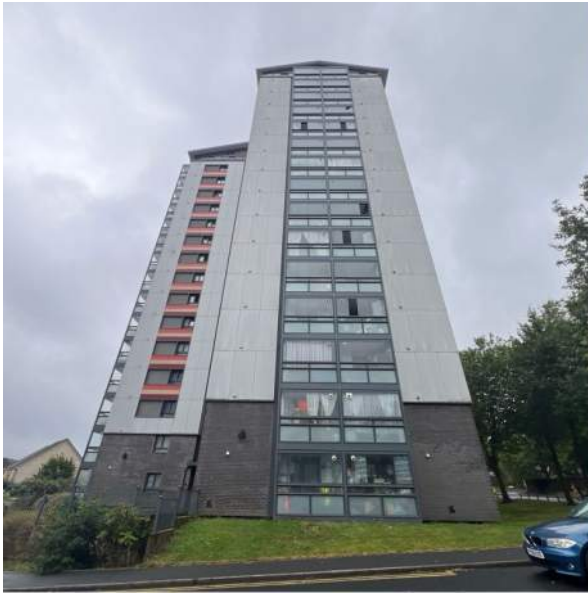
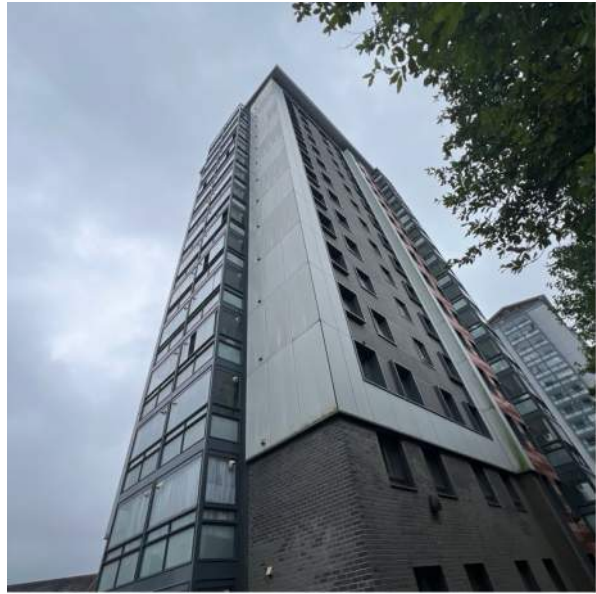
## Elevations

External ground and first level consists of brick work.  
Remaining floors noted to have a cladded facade to exterior.
