VISUAL STRUCTURAL APPRAISAL

Farley St

Farley St  
West Bromwich  
DY4 7LA

30<sup>th</sup> April 2025

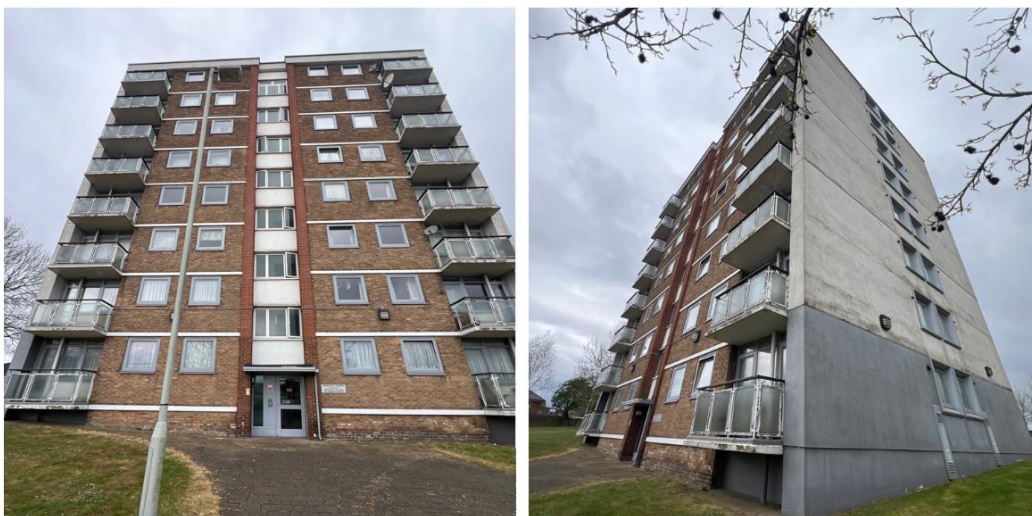
Figure 9 and 10: Building Elevations

The exterior elevations were generally in ok condition and no significant structural defects were noted to the cladding panels. There were no significant cracks or tell-tale signs of any significant structural movement noted at the time of our inspection.

The exterior panels were noted to be plumb with no signs of significant bowing, bulging or leaning noted to the panels indicating failed fixings however their presence and condition cannot be confirmed.

There are balconies at each level which are formed of cantilevered RC slabs tied into the main frame. The balconies have the coatings which are peeling away and the balustrades would benefit from a refurbishment. The cantilevered slabs should be checked for internal corrosion potential at the benchmark inspections.

The balconies have the coatings which are peeling away and the balustrades would benefit from a refurbishment. The cantilevered slabs should be checked for internal corrosion potential as part of the benchmark inspections above.

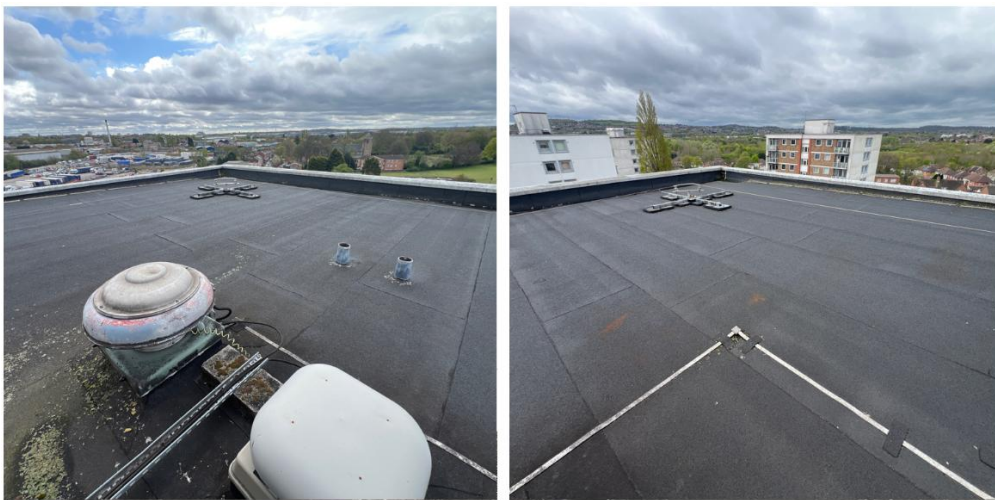
Figure 11 and 12: Roof Level

There were no tell-tale signs of any significant structural movement noted at the time of our inspection.

The roof has an asphalt finish. The exact build-up of the roof finishes were not accessible at the time of inspection. It is recommended an intrusive survey of the roof finishes is completed by a specialist surveyor to assess the condition of the roof covering.

There was moss growth and build-ups of debris noted which should be cleared as part of a normal maintenance regimen

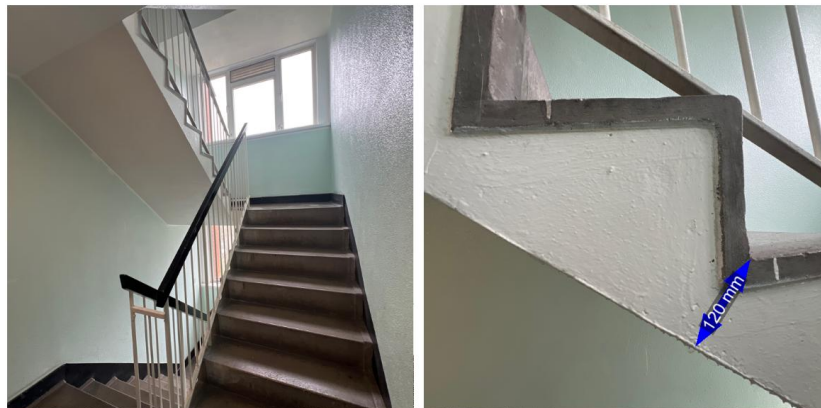
Figure 14 and 15: Stair stringer and Staircase

The interior of the stair core walls were checked and were plumb and in line with observations made to the exterior – no significant signs of leaning or movement noted. The concrete appeared in fair condition with few BRE category 1 cracks but no structurally significant defects were noted.

The stair stringer was noted to be 120mm thick which seems slim, certainly short of modern standards. A cover test is required to check the resistance of the concrete section in the event of a fire.

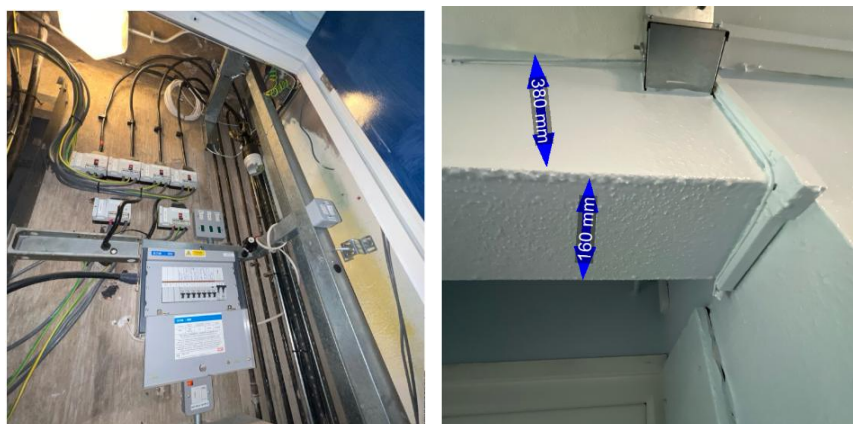
Figure 16 and 17: RC Elements visible

There were vertical concrete walls supporting the floor plates at every level. The elements visible matched the floor layout in Figure 6. The walls appear continuous from ground to roof with no transfer structure. The overall condition of the structure observed is good.

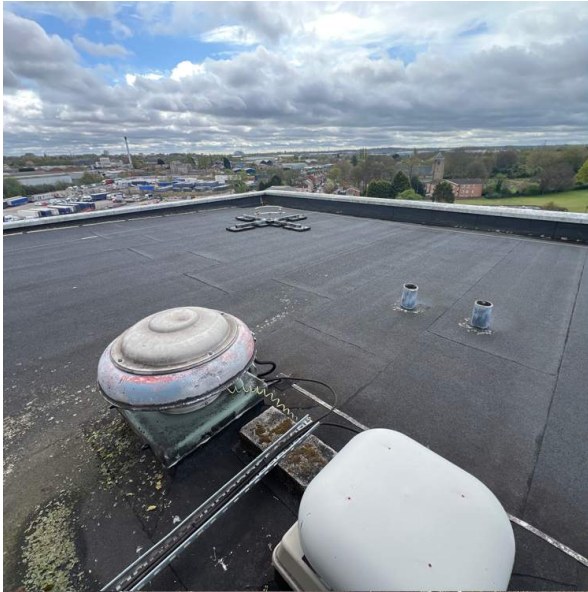
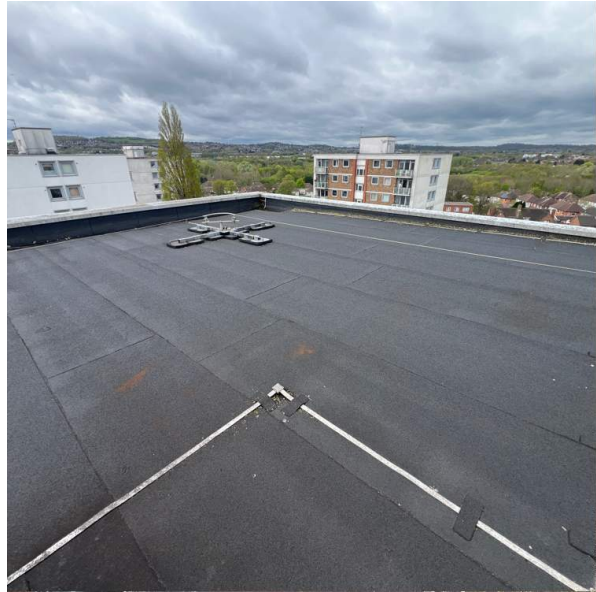
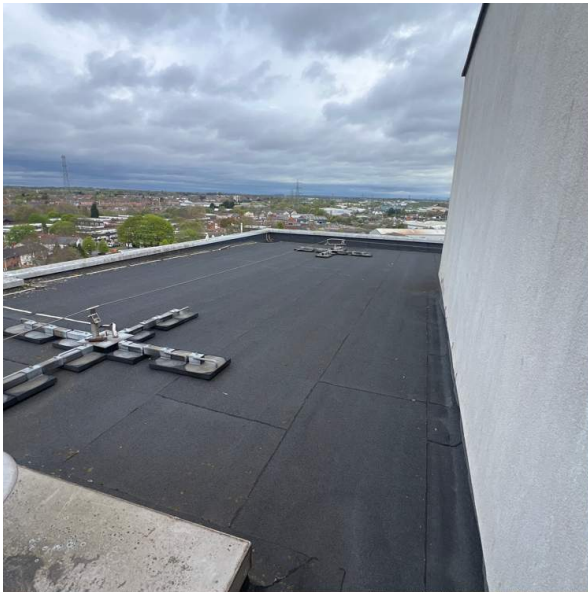
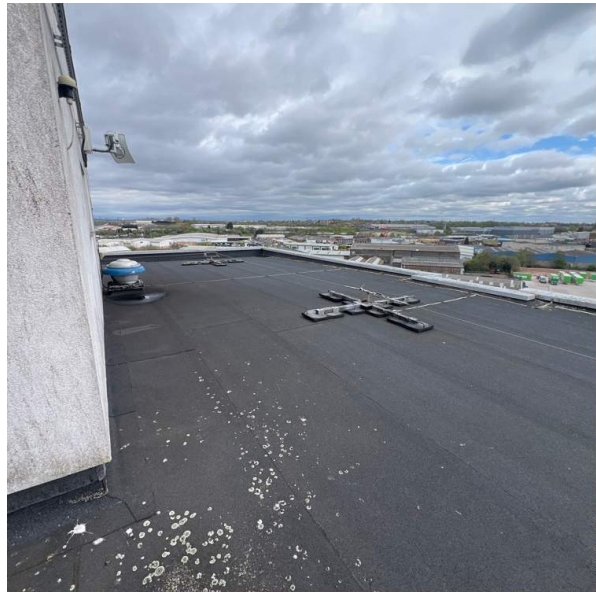
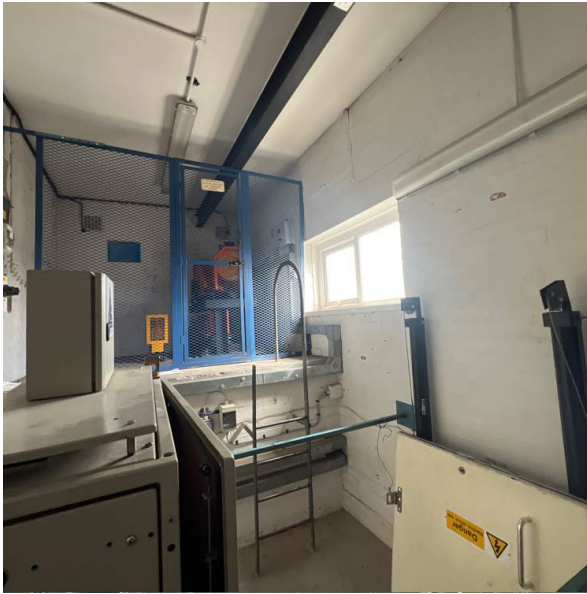
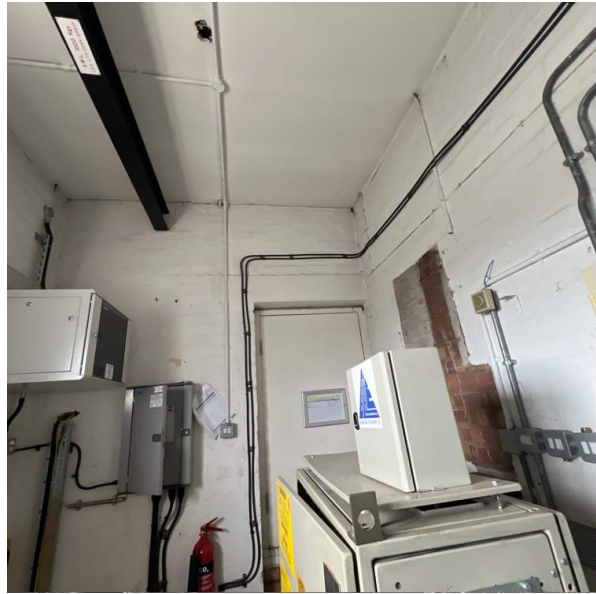
## Main Roof

Comments: Flat roof, RC concrete slab with insulated PIR board and felt coverings.

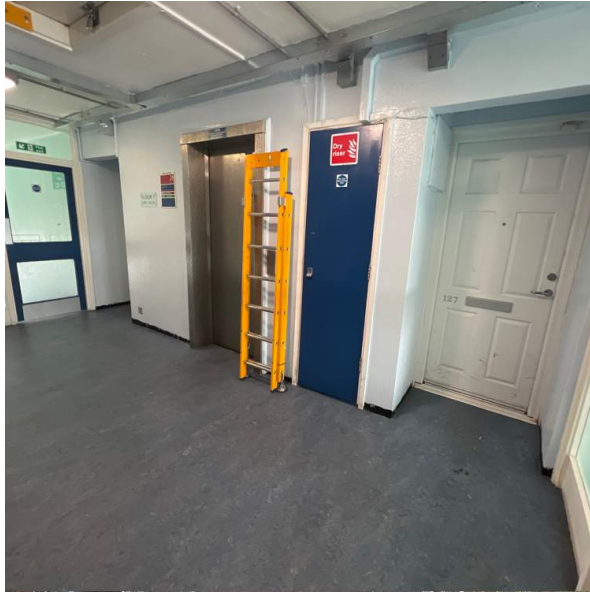
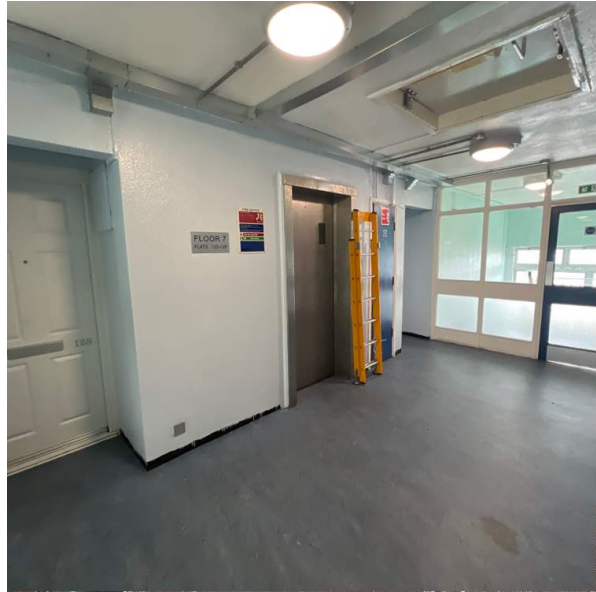
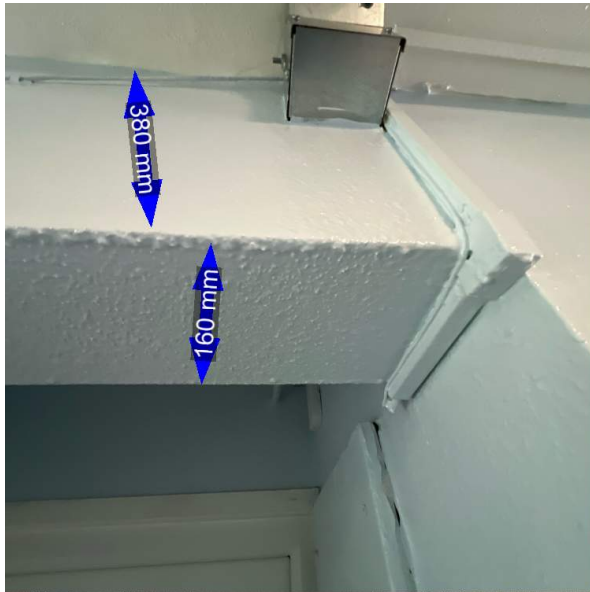
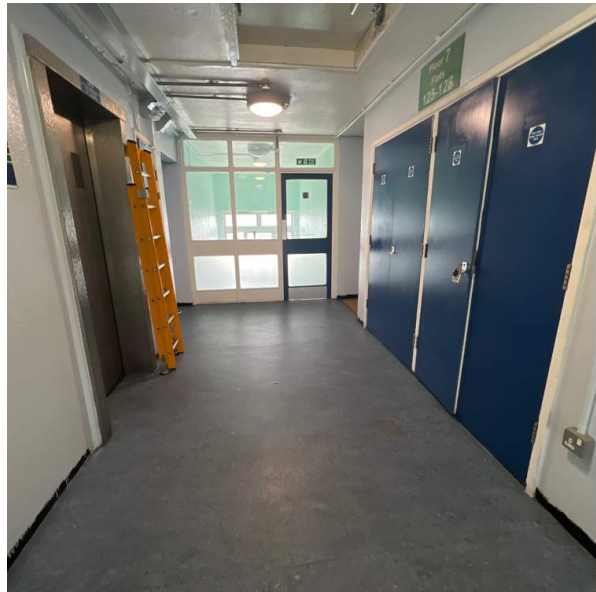
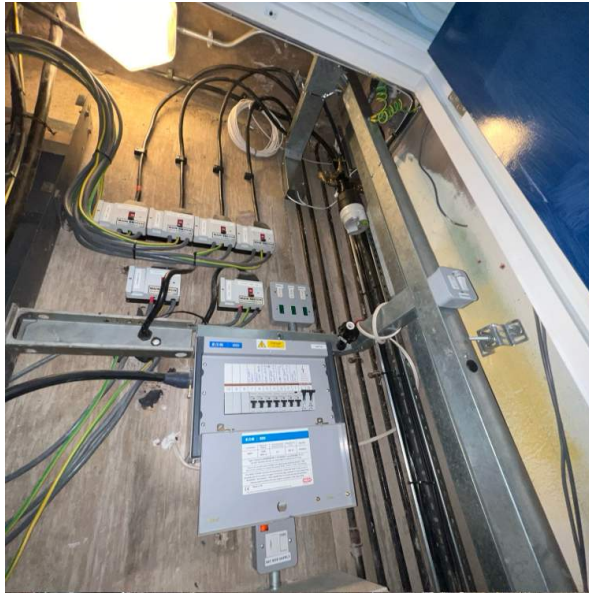
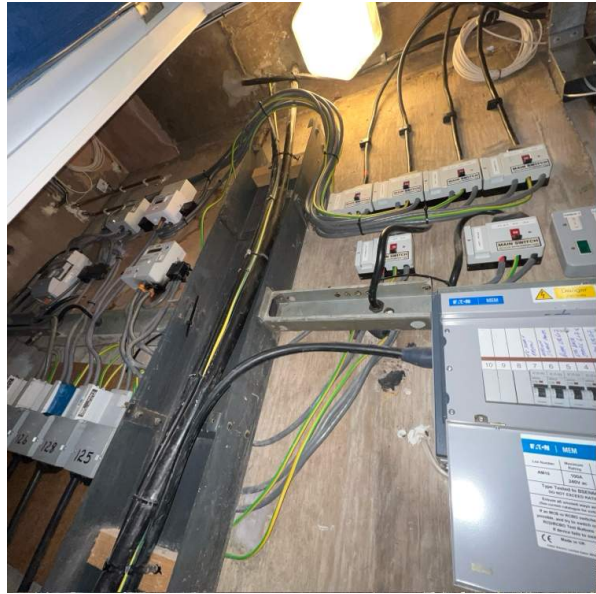
## 7th Floor Hallway

Comments: No jams or distortions noted to hallway doors to indicate any serviceability issues. Generally walls covered with finishes in hallway, likely to consist a mixture of concrete shear walls, embedded columns and masonry infill walls. Limited structure exposed. Concrete walls and infill masonry (non-load bearing) walls noted in riser cupboards.

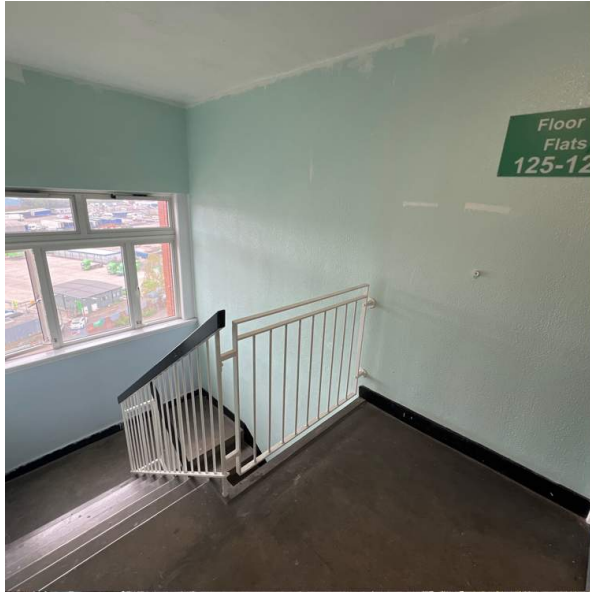
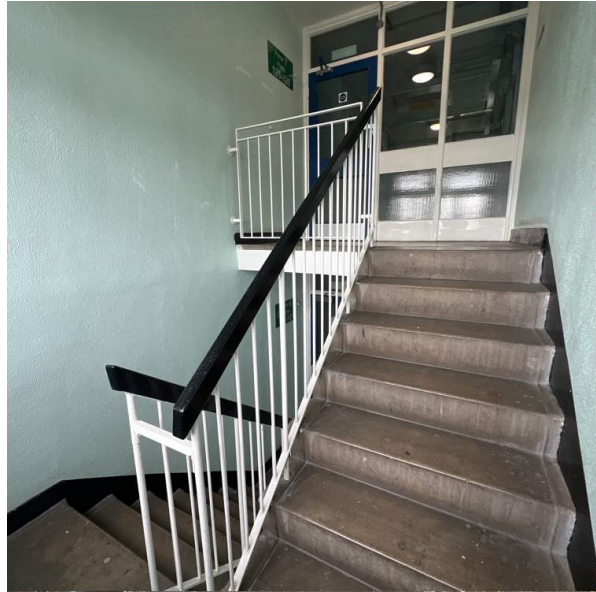
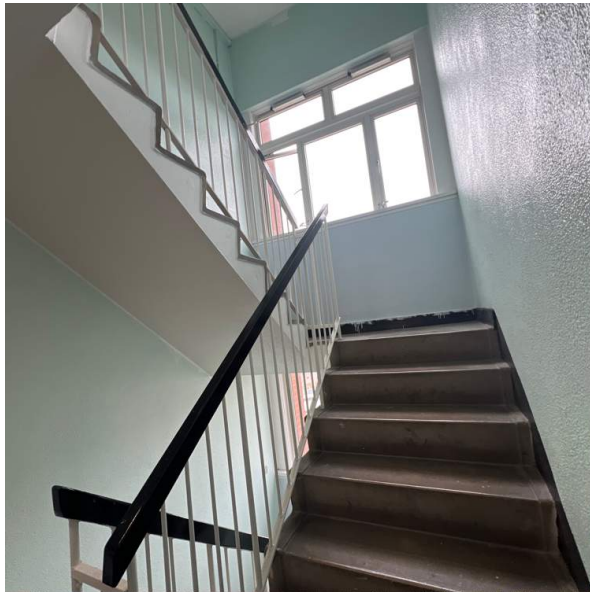
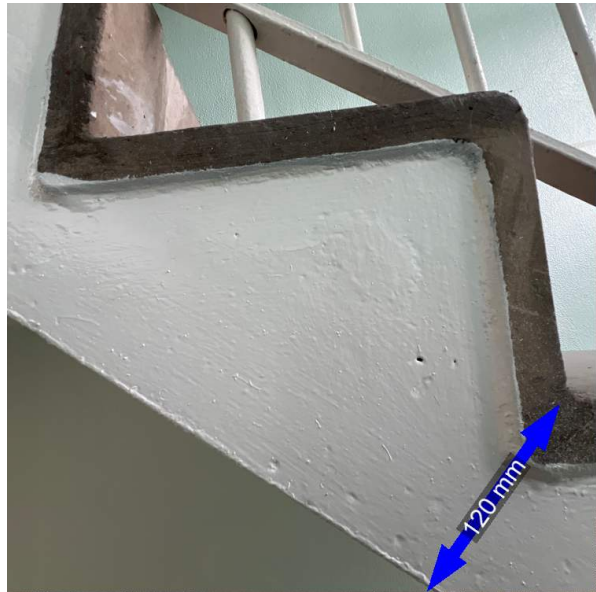
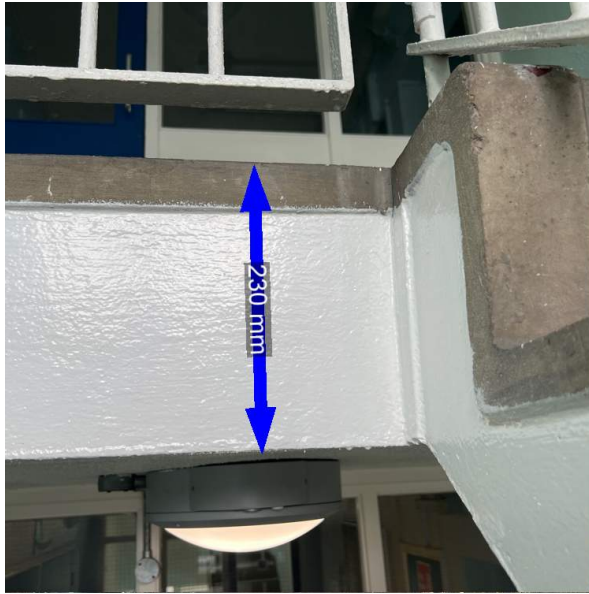
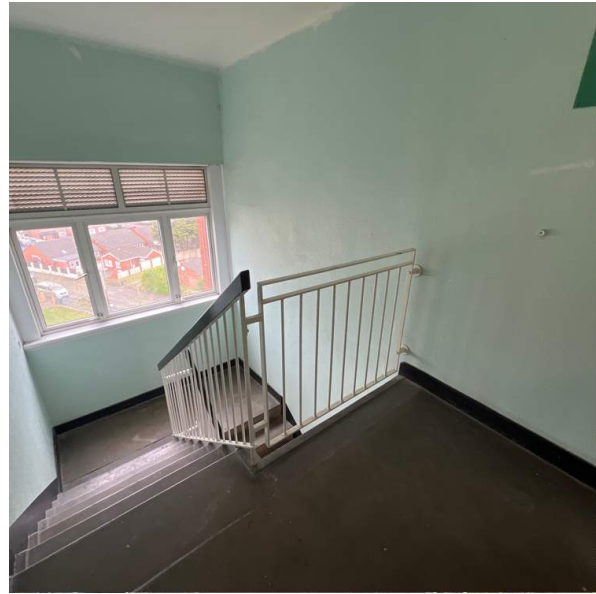
## 7th Floor Staircases

Comments: Insitu concrete stairs with steel hand railing fixed to stairs. Walls and floors appear to be fairly level.  
Stair walls covered with finishes however these would likely form the main concrete shear core walls.

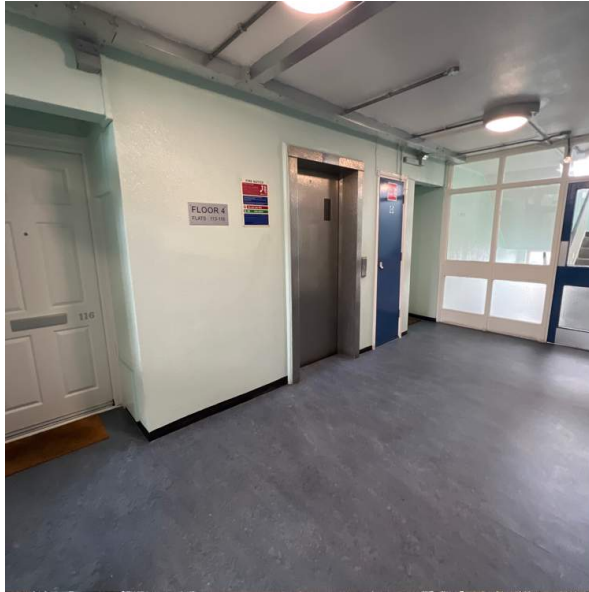
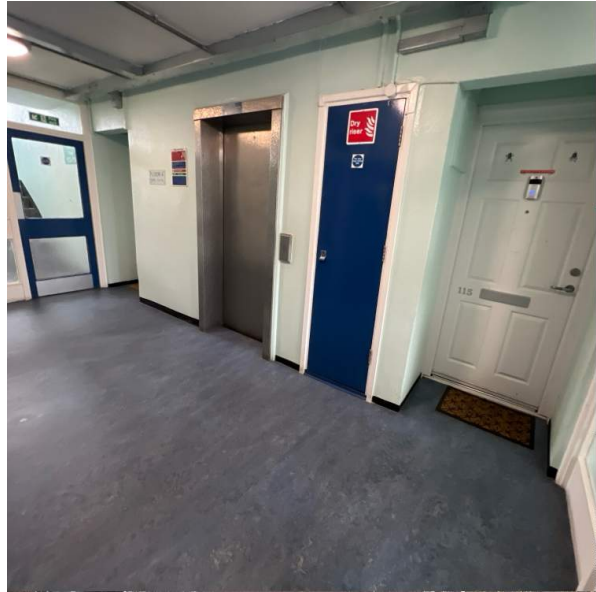
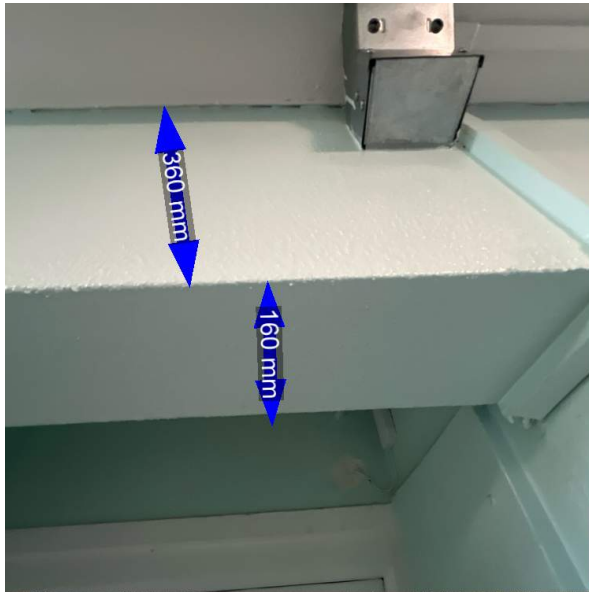
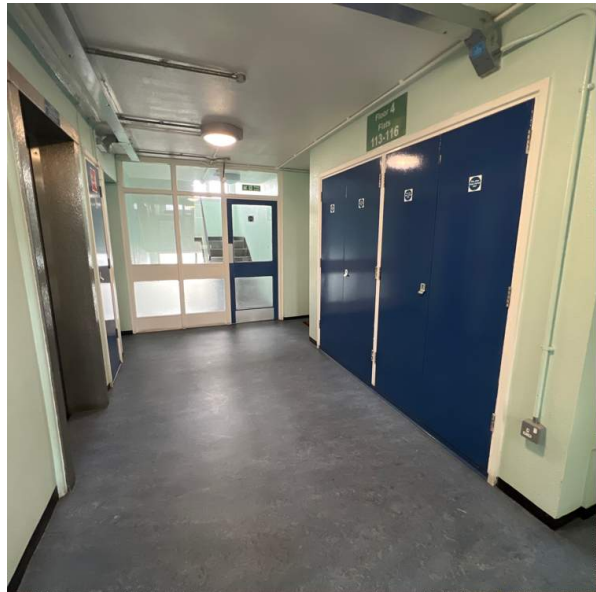
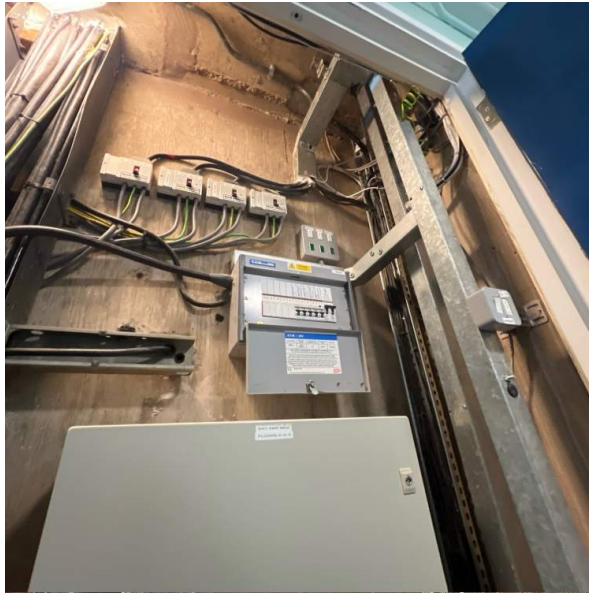
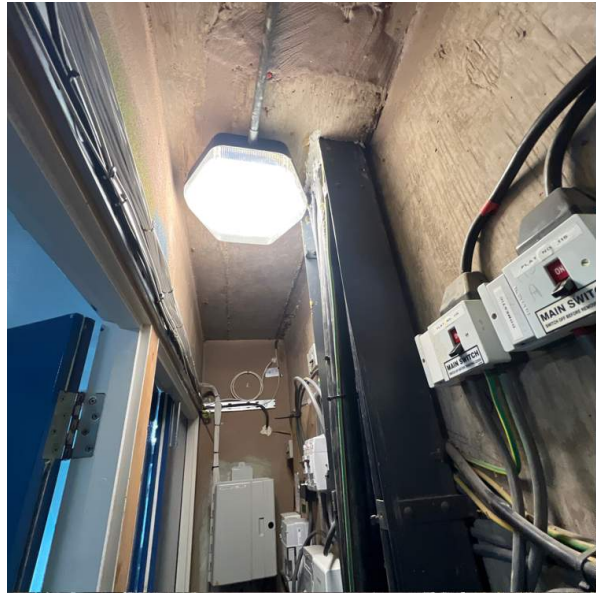
## 4th Floor Hallway

Comments: No jams or distortions noted to hallway doors to indicate any serviceability issues. Generally walls covered with finishes in hallway, likely to consist a mixture of concrete shear walls, embedded columns and masonry infill walls. Limited structure exposed. Concrete walls and infill masonry (non-load bearing) walls noted in riser cupboards.

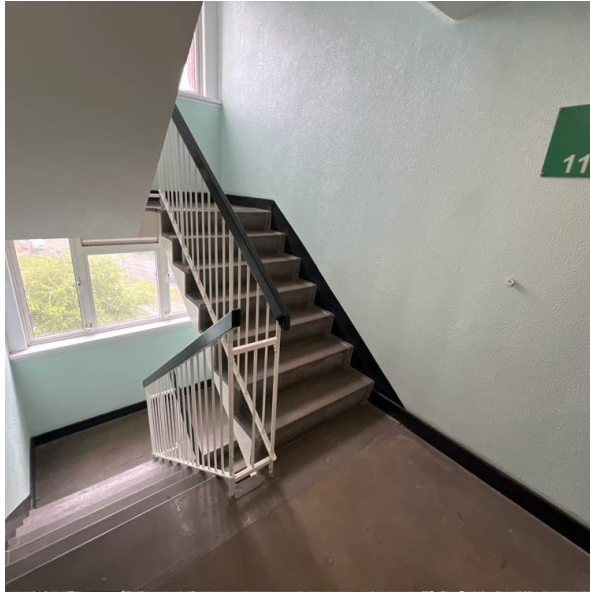
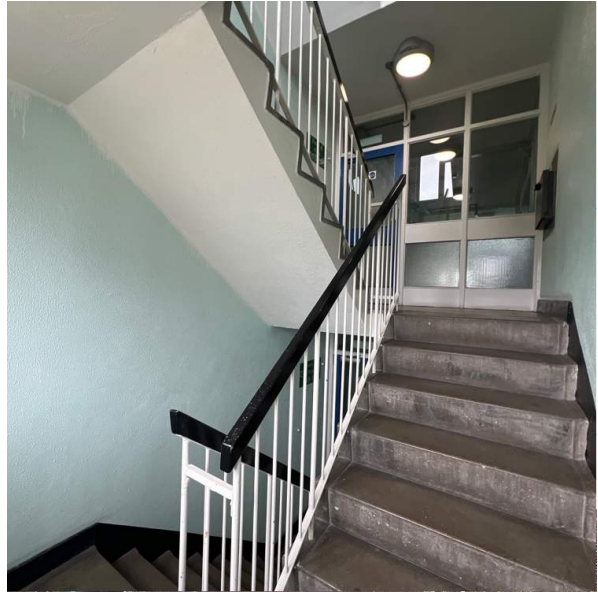
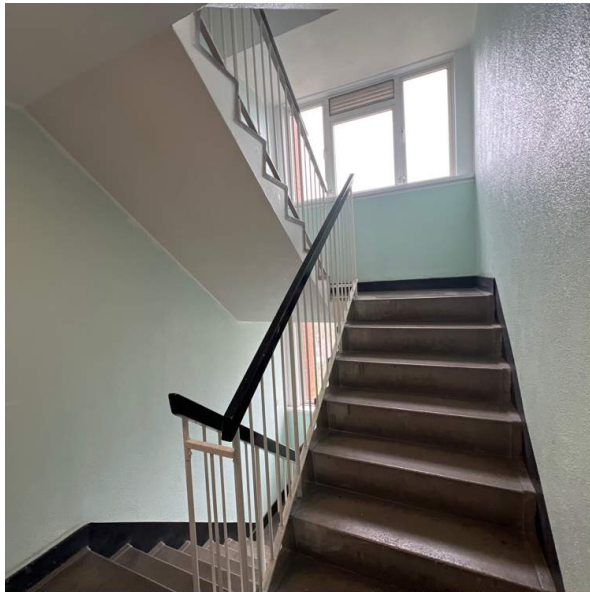
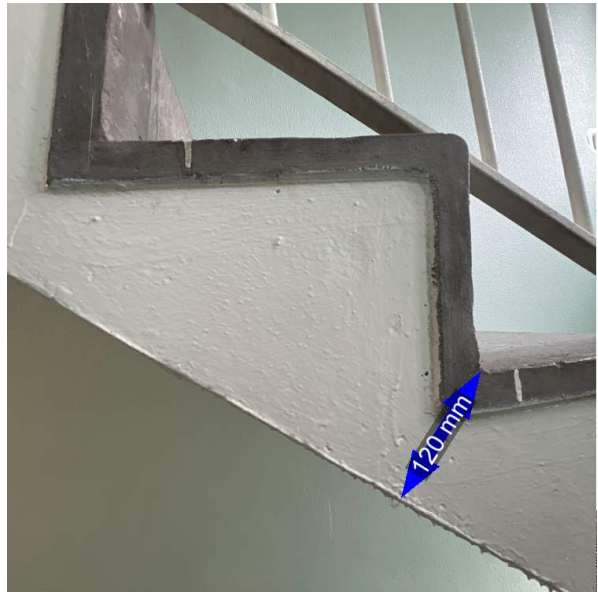
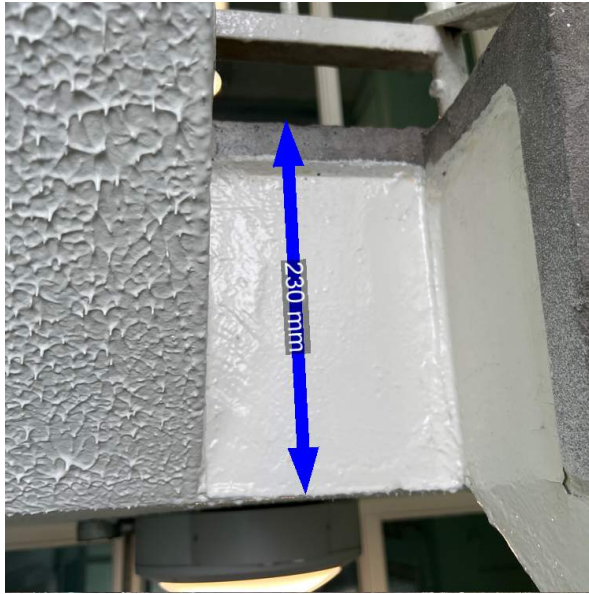
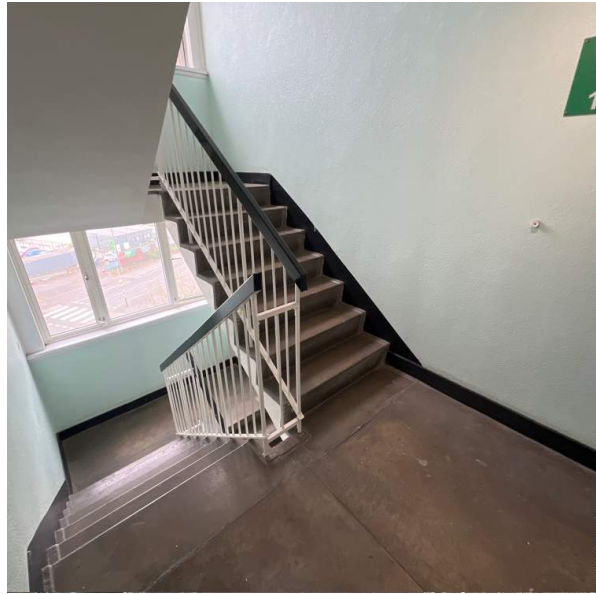
## 4th Floor Staircases

Comments: Insitu concrete stairs with steel hand railing fixed to stairs. Walls and floors appear to be fairly level.  
Stair walls covered with finishes however these would likely form the main concrete shear core walls.

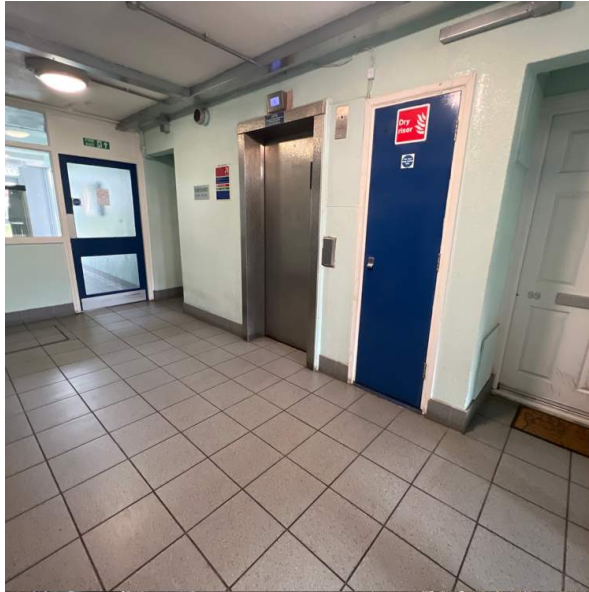
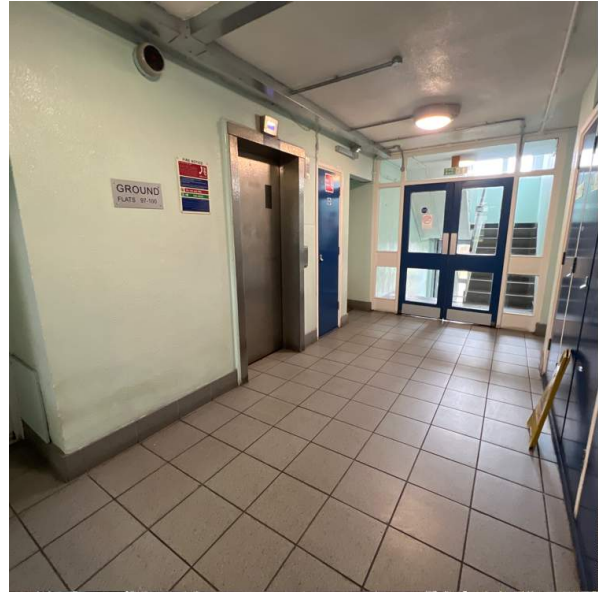
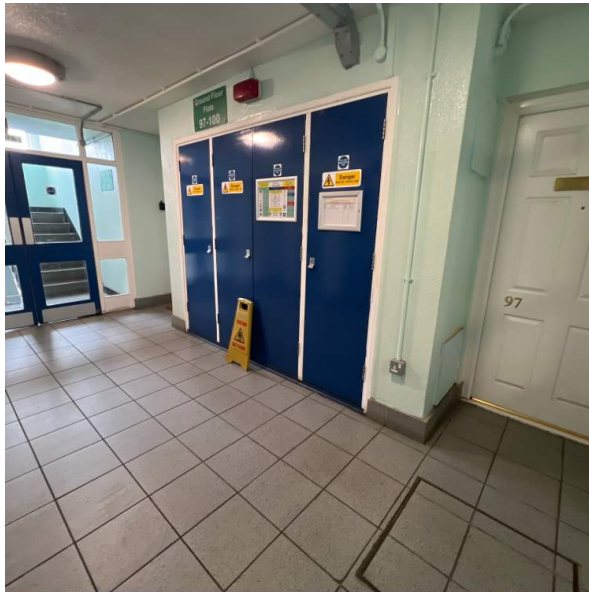
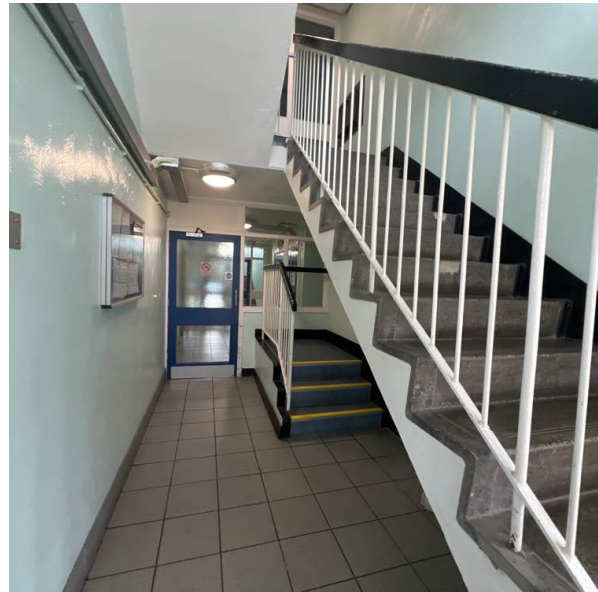
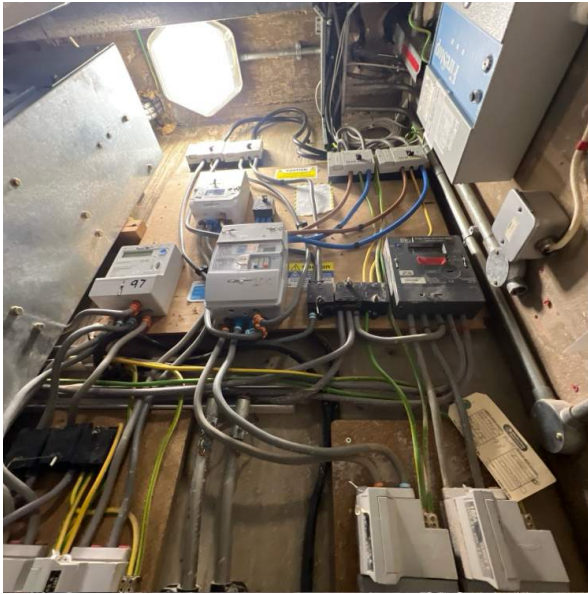
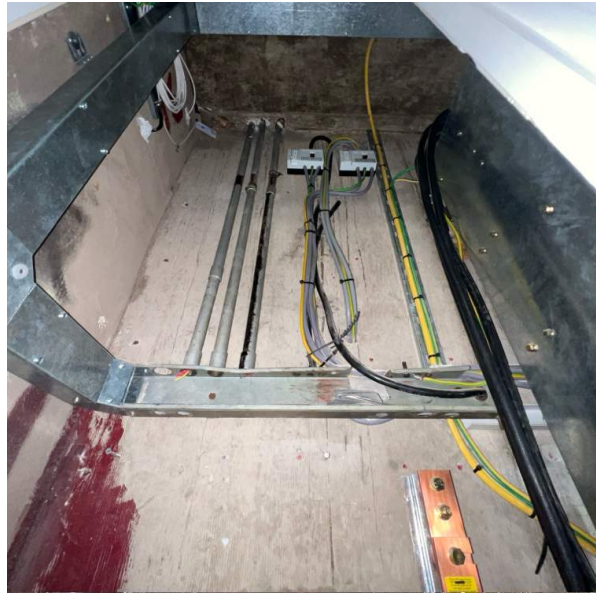
## Ground Floor Hallway

Comments: No jams or distortions noted to hallway doors to indicate any serviceability issues. Generally walls covered with finishes in hallway, likely to consist a mixture of concrete shear walls, embedded columns and masonry infill walls. Limited structure exposed. Concrete walls and infill masonry (non-load bearing) walls noted in riser cupboards.

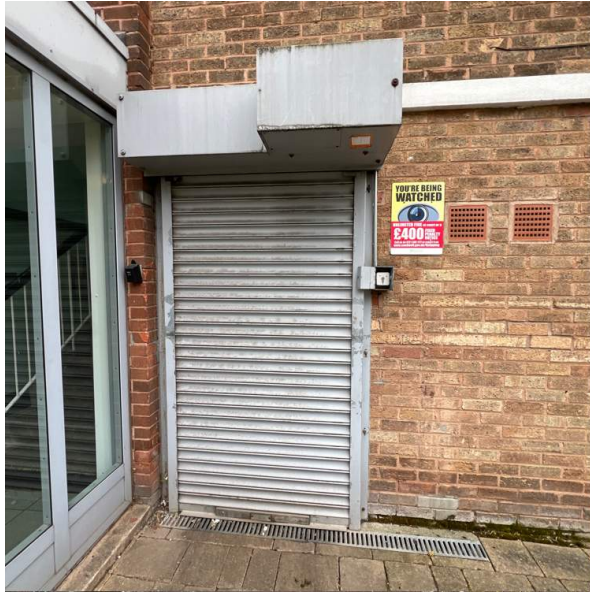
## Binstore

Comments: No key access to bin store during inspection.

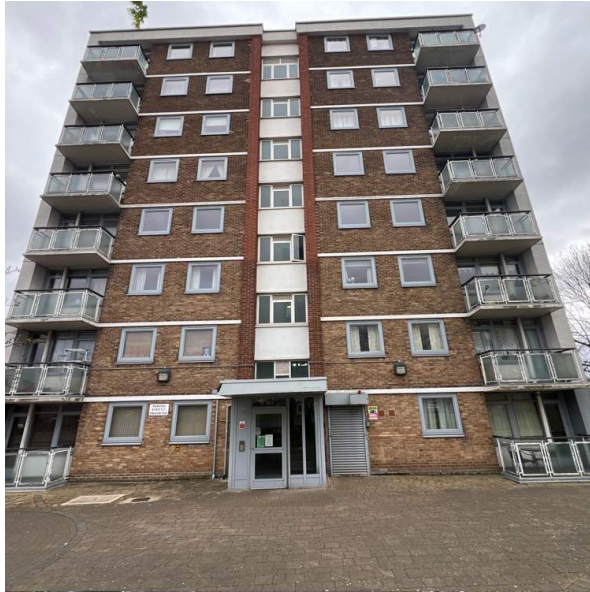
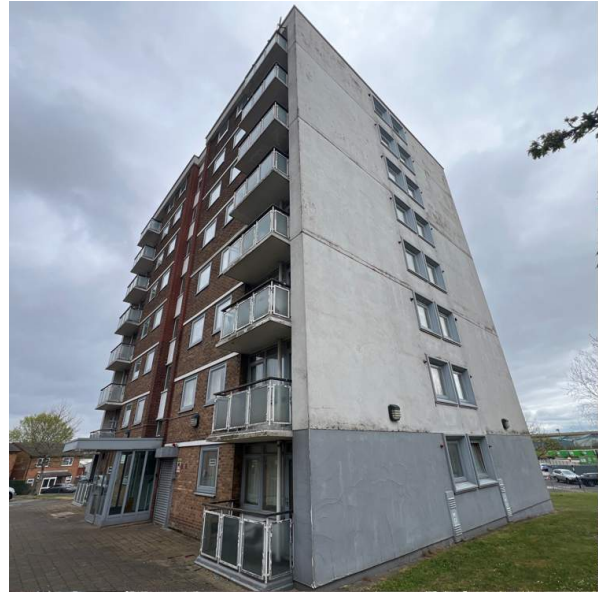
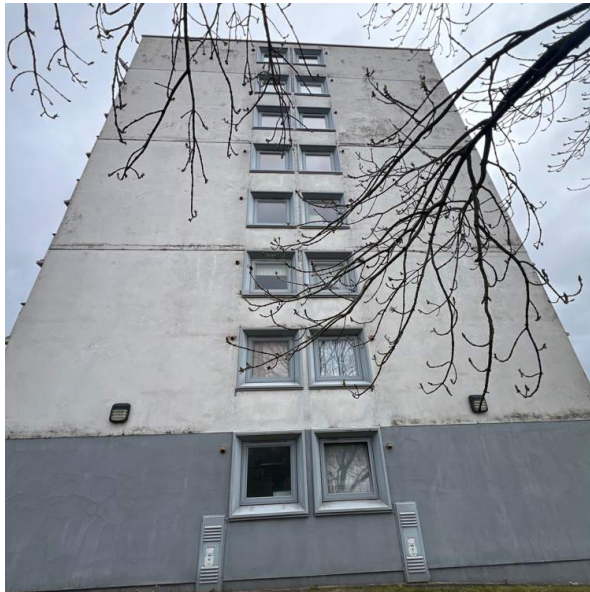
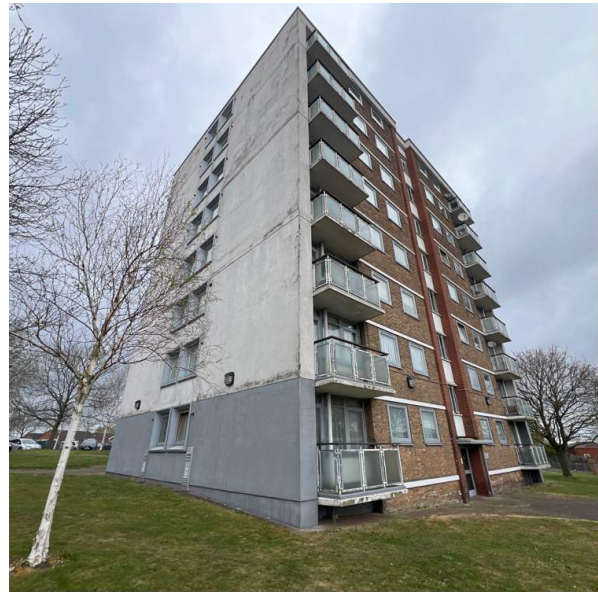
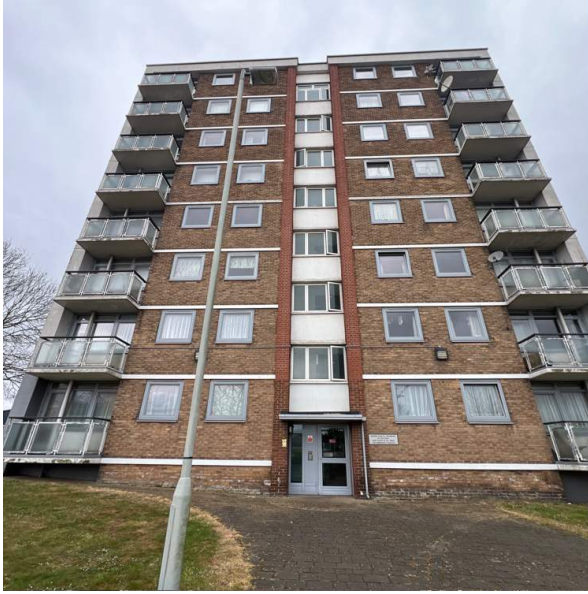
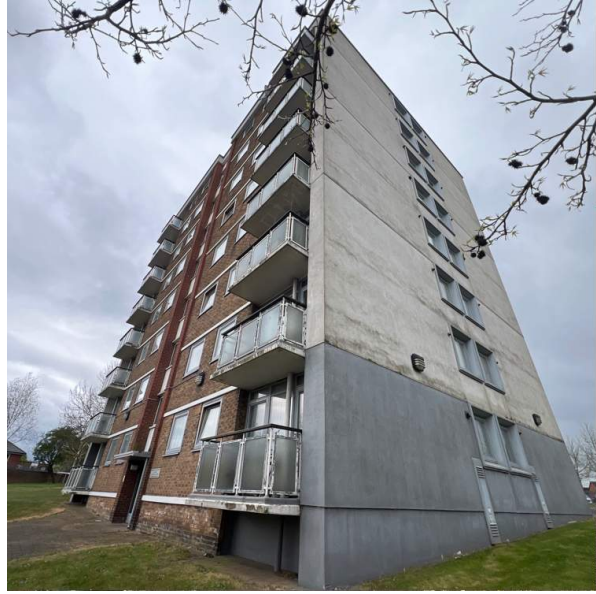
## Elevations

Comments: External facade consists of brick work on all levels to front and rear elevations with cantilevered balconies situated on corners. Side elevations consist of render to full height of walls.
