VISUAL STRUCTURAL APPRAISAL

Greenford House

Maria Street  
West Bromwich  
B70 6DX

29<sup>th</sup> November 2024

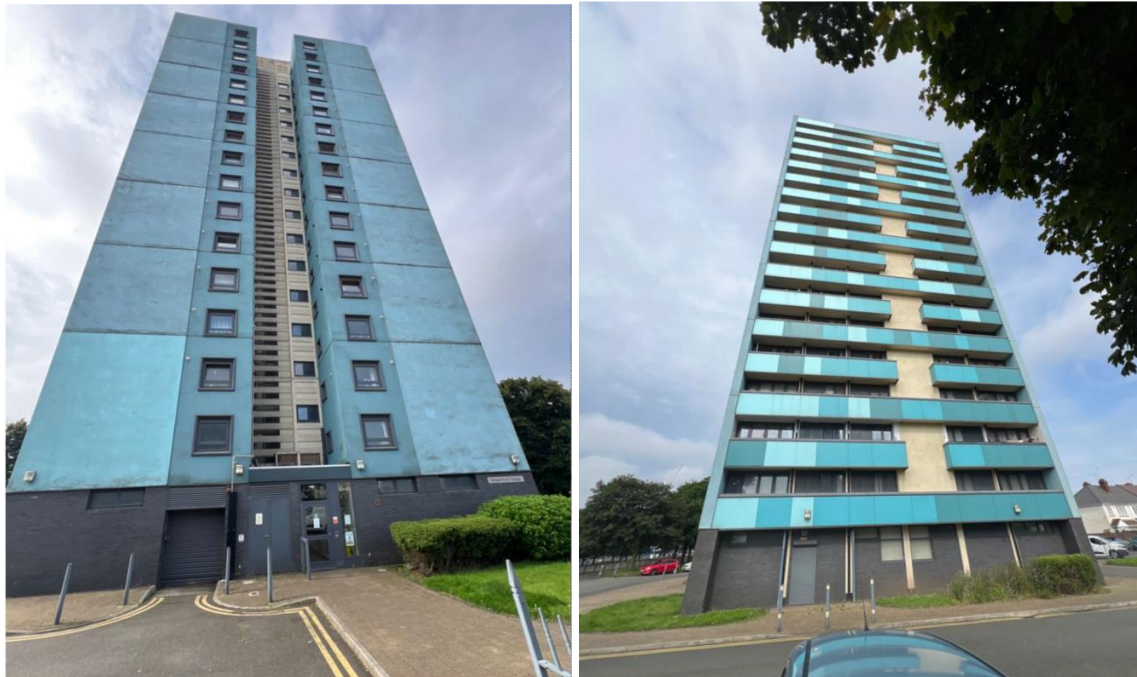
Figure 9 and 10: Front and side Elevations

The exterior elevations were generally in ok condition and no significant structural defects were noted to the cladding panels. There were no significant cracks or tell-tale signs of any significant structural movement noted at the time of our inspection.

The exterior panels were noted to be plumb with no signs of significant bowing, bulging or leaning noted to the panels indicating failed fixings however their presence and condition cannot be confirmed.

There are balconies at each level which have been clad in High Pressure Laminate panels.

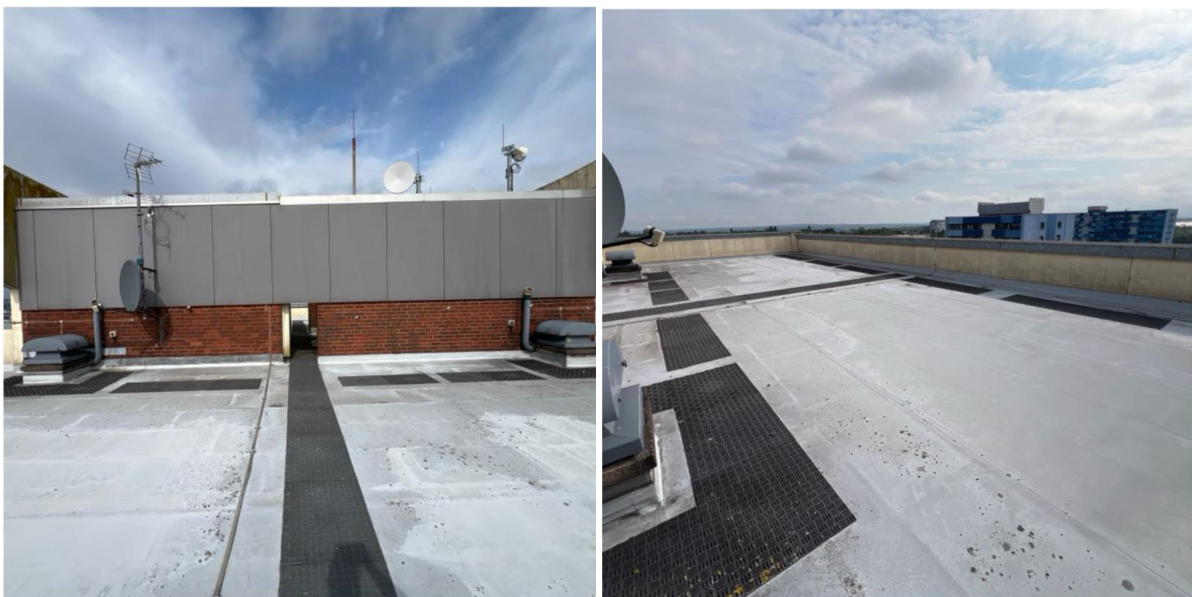
Figure 11 and 12: Roof Level

There were no tell-tale signs of any significant structural movement noted at the time of our inspection. The exterior walls were noted to be plumb with no signs of significant bowing, bulging or leaning noted to the masonry walls.

The roof has a single ply membrane finish. The exact build-up of the roof finishes were not accessible at the time of inspection. It is recommended an intrusive survey of the roof finishes is completed by a specialist surveyor to assess the condition of the roof covering.

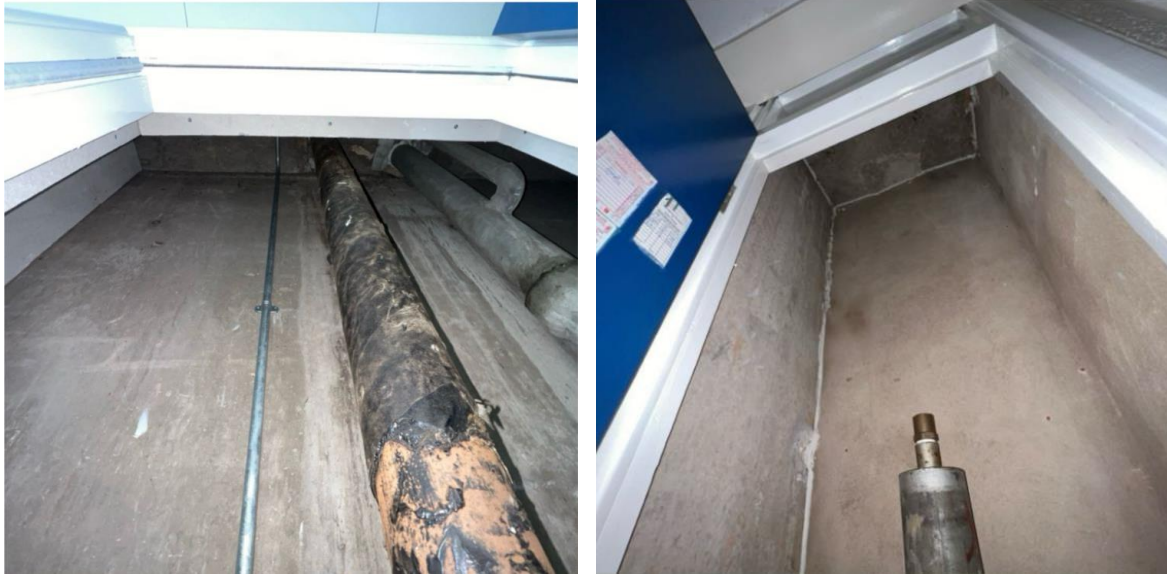
Figure 13 and 14: Vertical RC Structure Visible

The interior of the stair core walls were checked and were plumb and in line with observations made to the exterior – no significant signs of leaning or movement noted. The concrete appeared in fair condition with few BRE category 1 cracks but no structurally significant defects were noted.

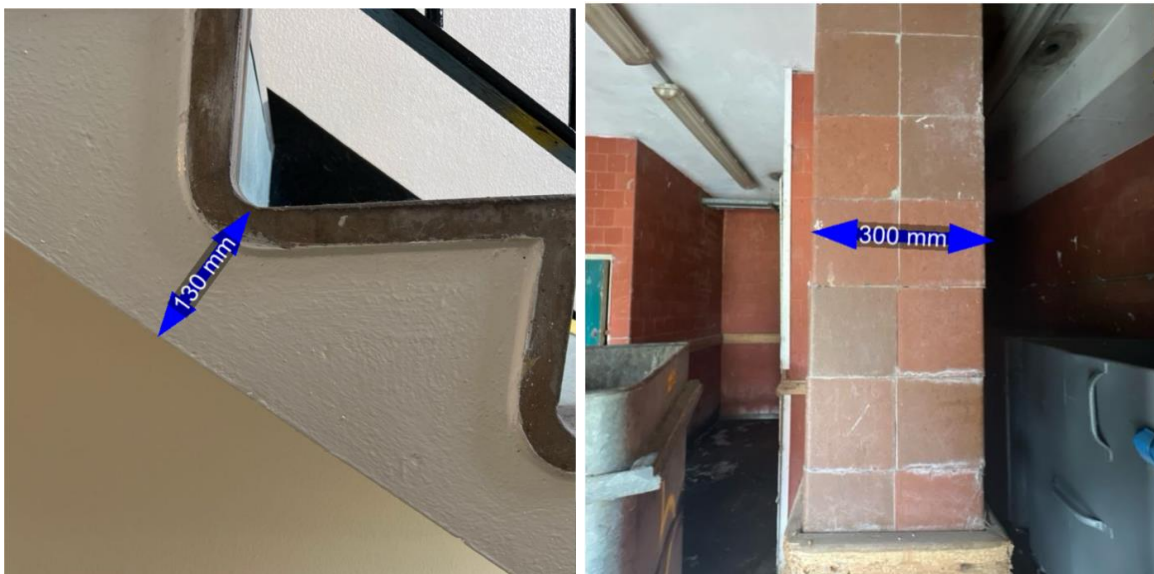
Figure 15 and 16: Staircase Stringer and clad column at ground floor

The stair stringer was noted to be 130mm thick which is less than we would expect to modern standards, a cover test is required to check the resistance of the concrete section in the event of a fire.

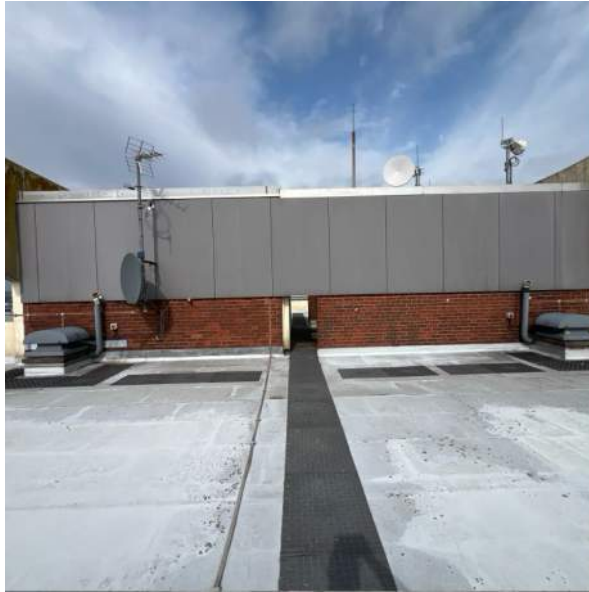
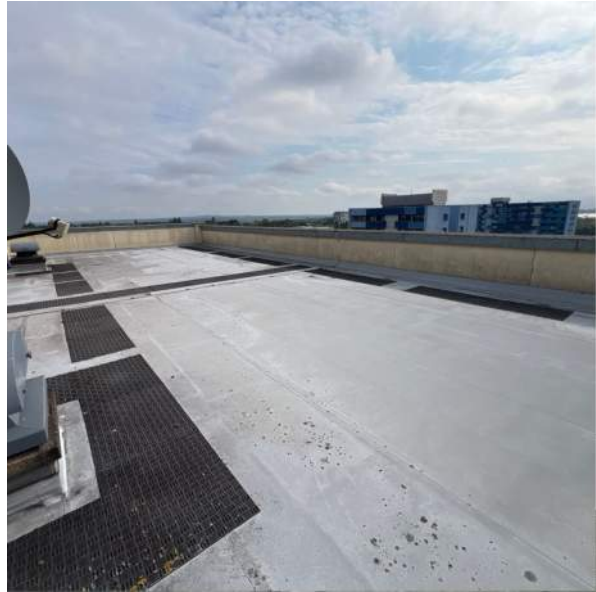
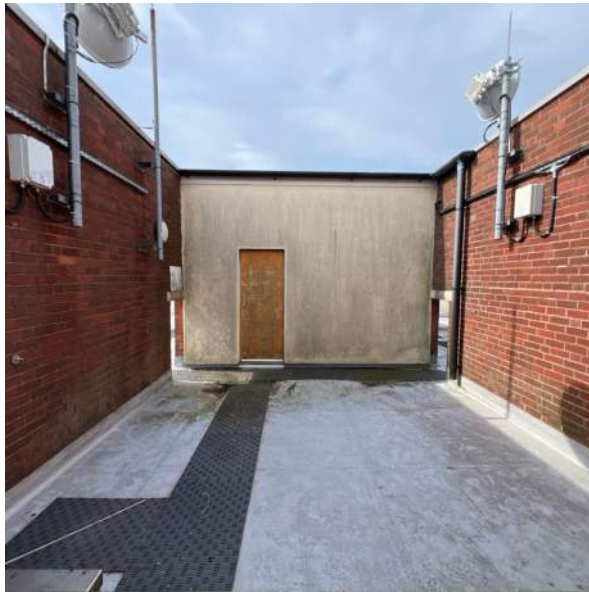
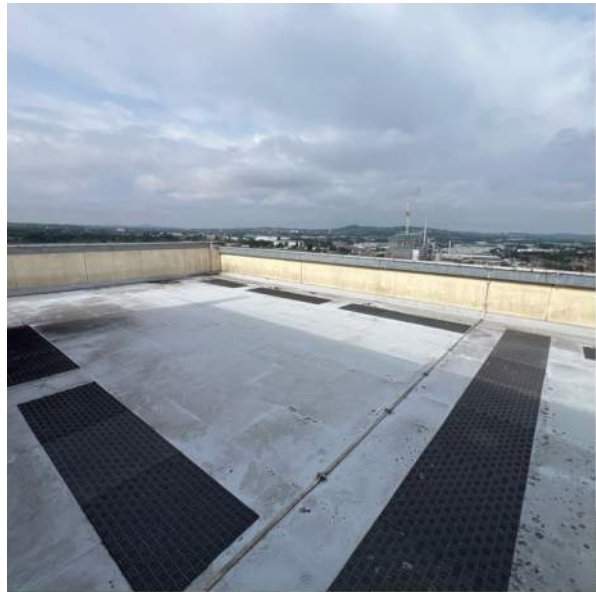
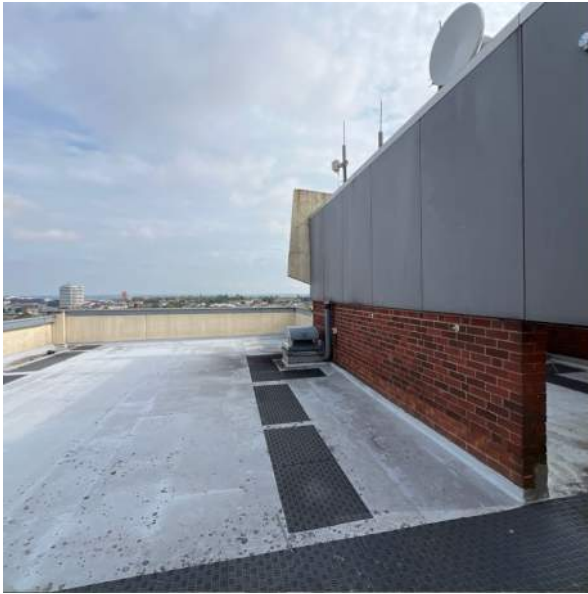
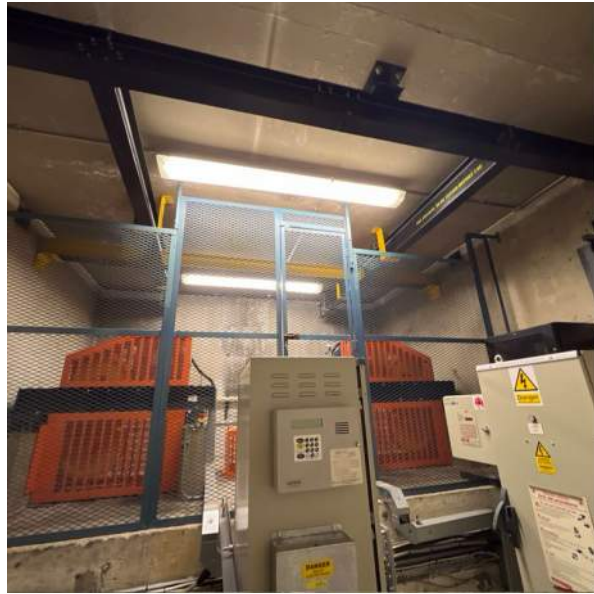
## Main Roof

Lift motor room located on roof formed of masonry walls.  
Parapet walls noted to perimeter of roof.  
Insitu concrete roof slab with insulated PIR Boad and roof coverings.

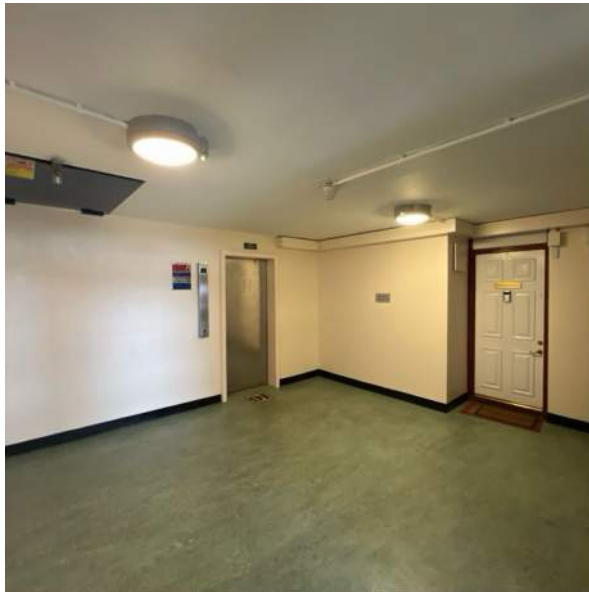
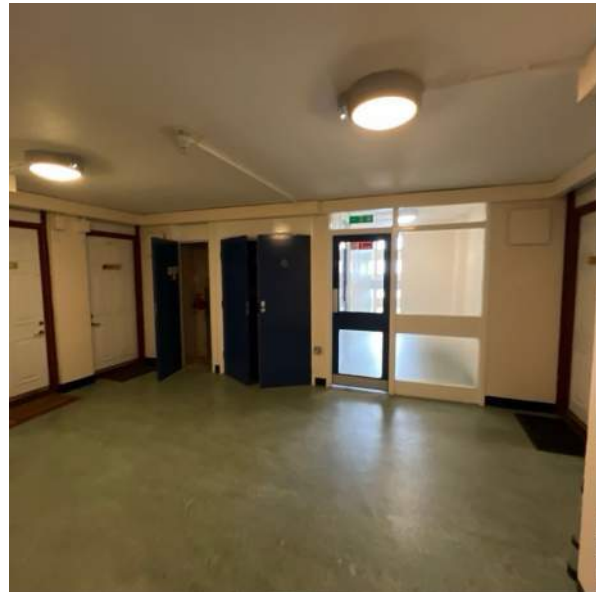
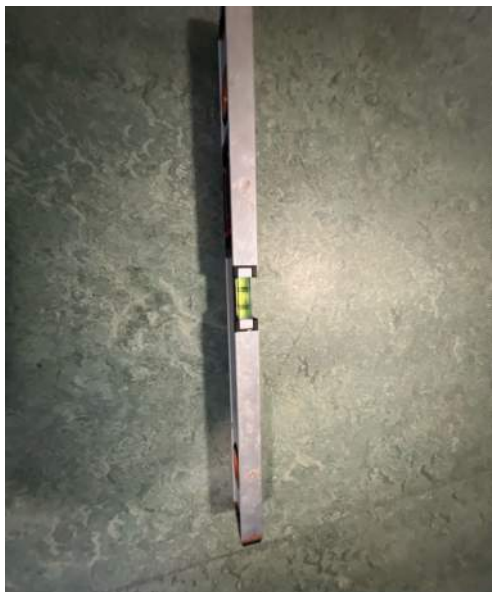
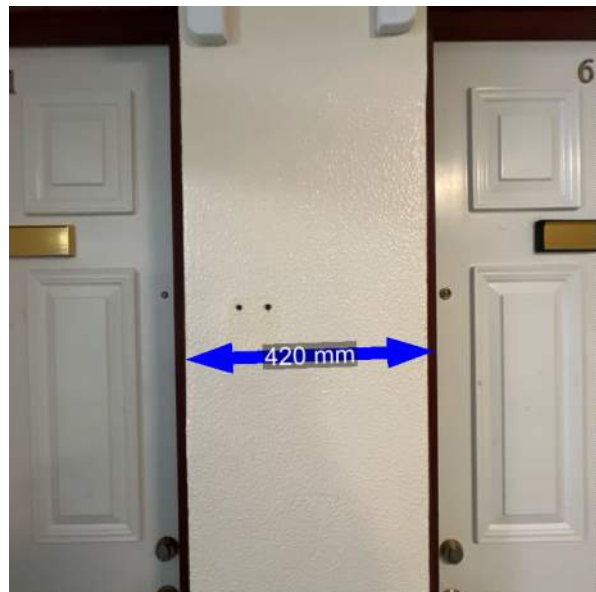
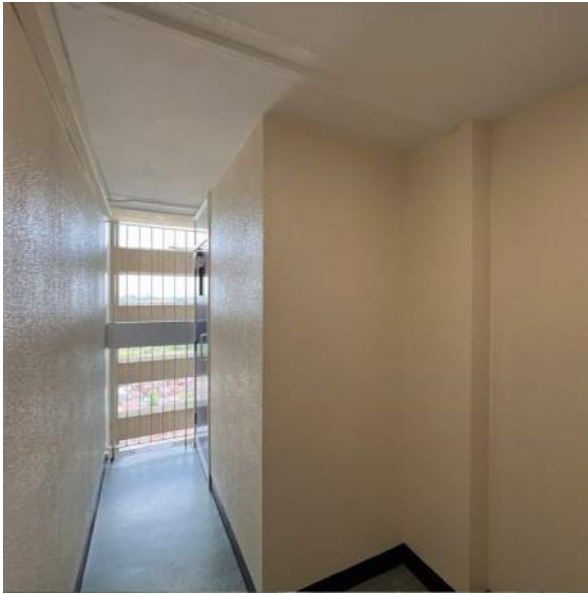
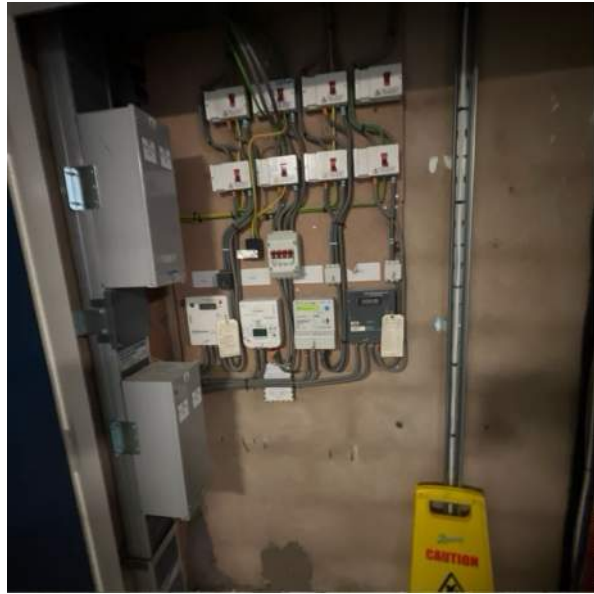
## 16th Floor Hallway

Comments: No jams or distortions noted to hallway doors to indicate any serviceability issues.  
Generally walls covered with finishes in hallway, likely to consist a mixture of concrete shear walls, embedded columns and block infill walls.  
Electrical cabinet shows infill blockwork with render on top.  
Dry riser cupboard shows some exposed concrete (likely embedded concrete column).

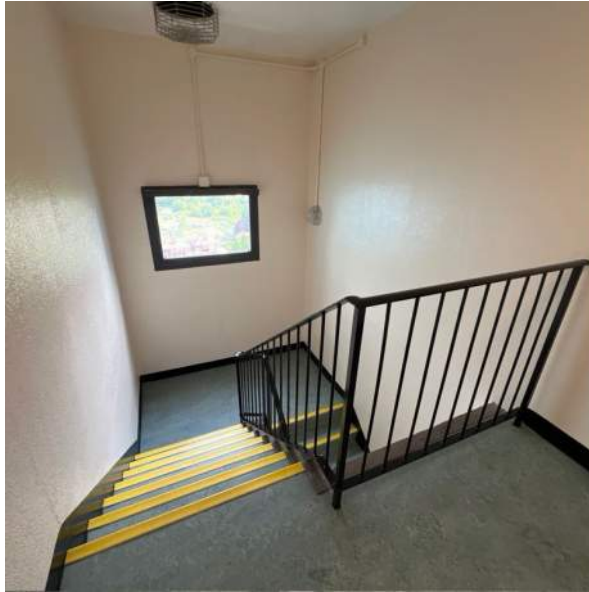
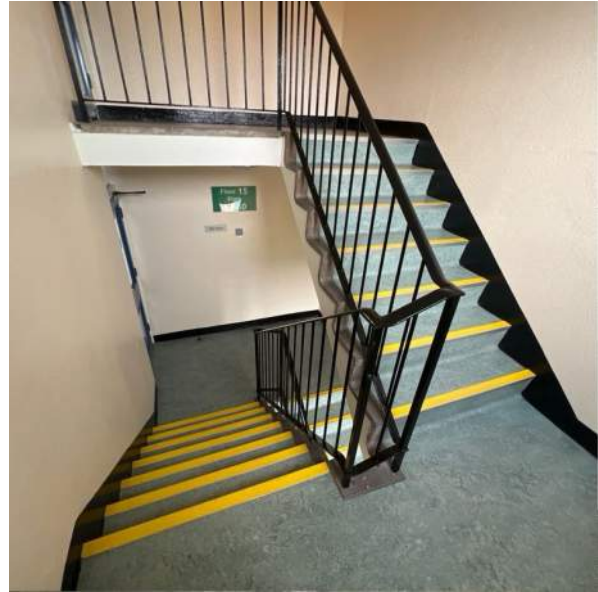
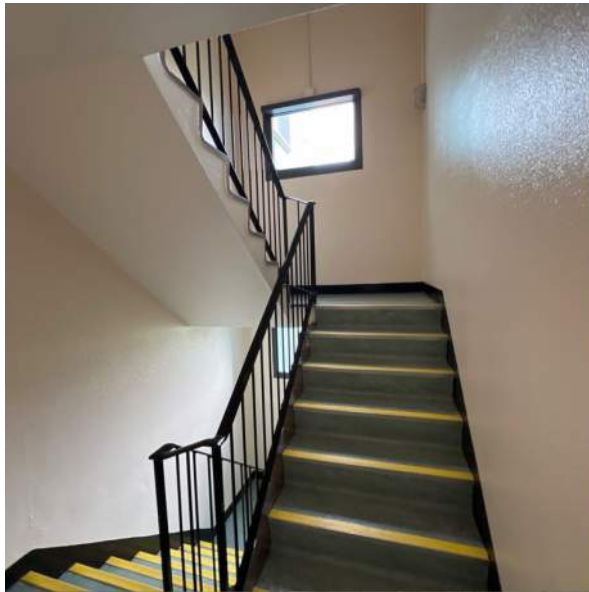
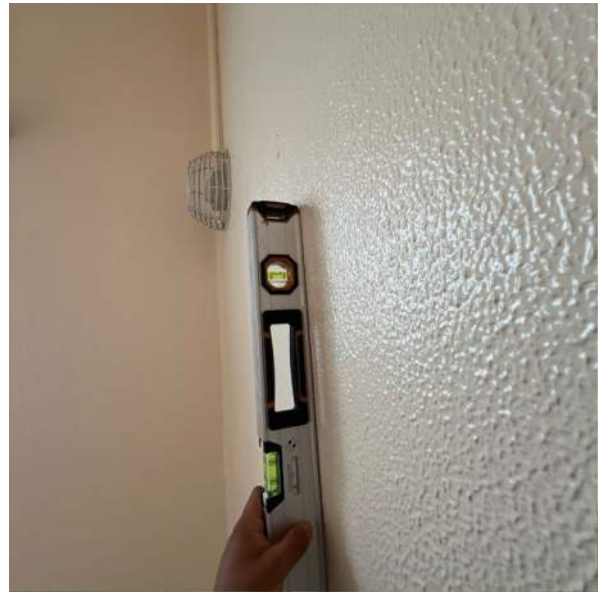
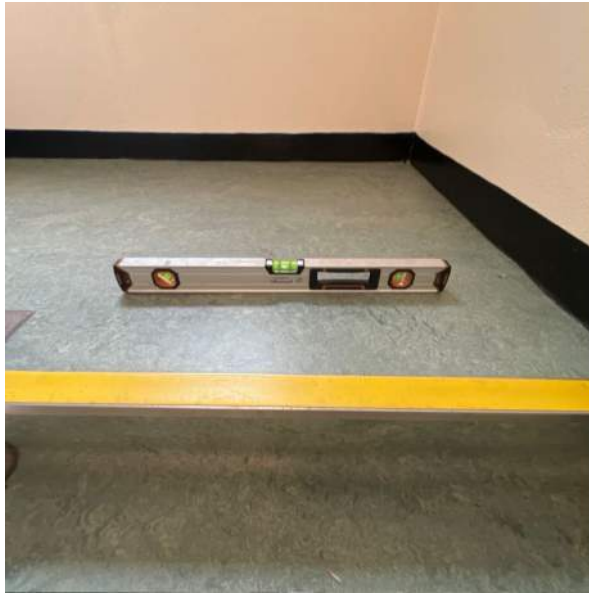
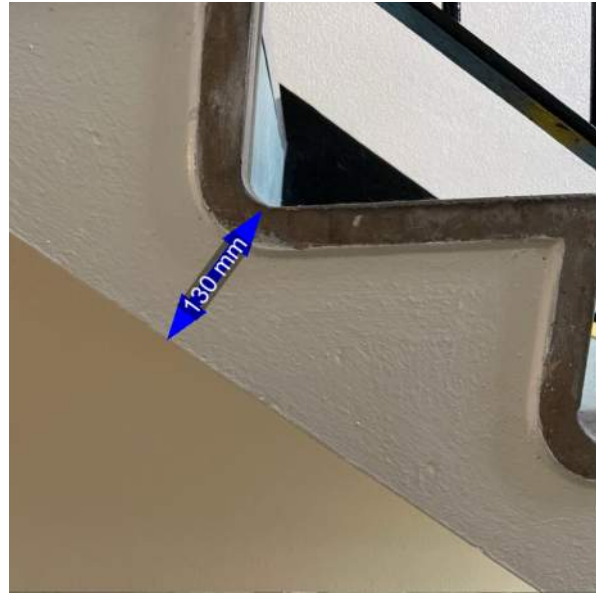
## 16th Floor Staircase

Insitu concrete stairs with steel hand railing fixed to stairs. Walls and floors appear to be fairly level.  
Stair walls covered with finishes however these would likely form the main concrete shear core walls.  
Floor slab measures from stair platform appears to be approx. 220mm thick.

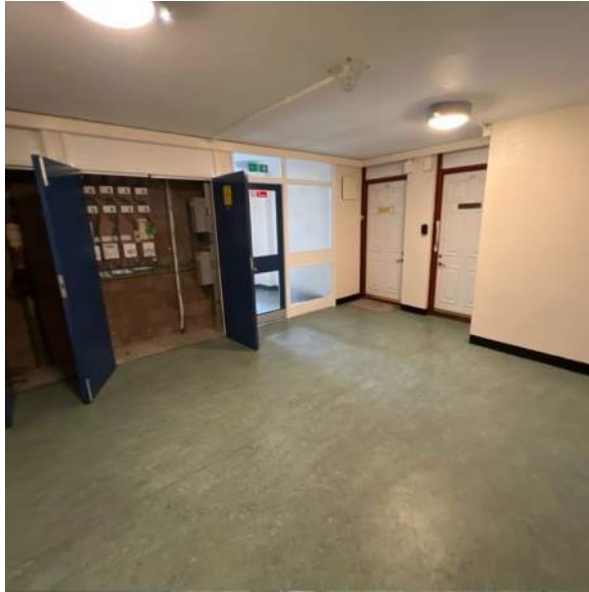
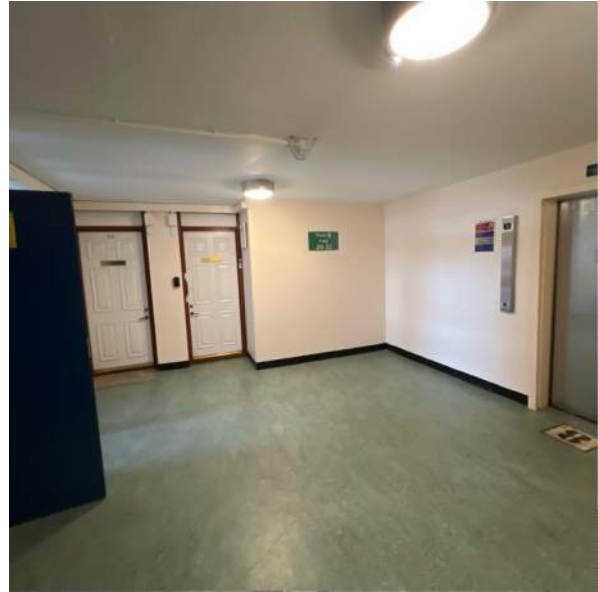
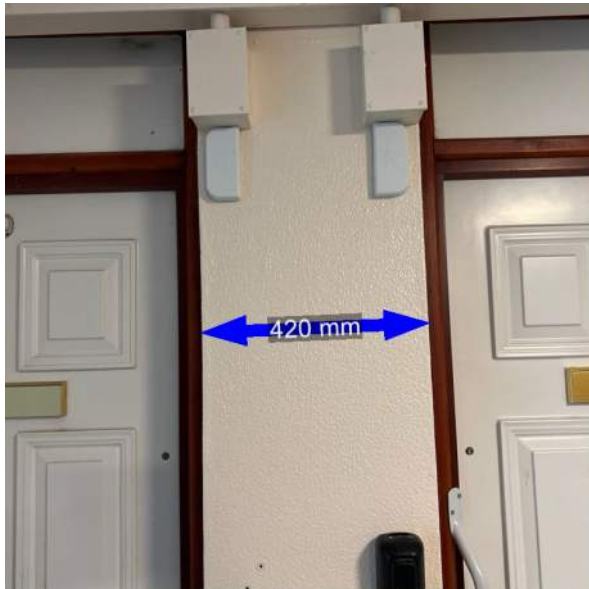
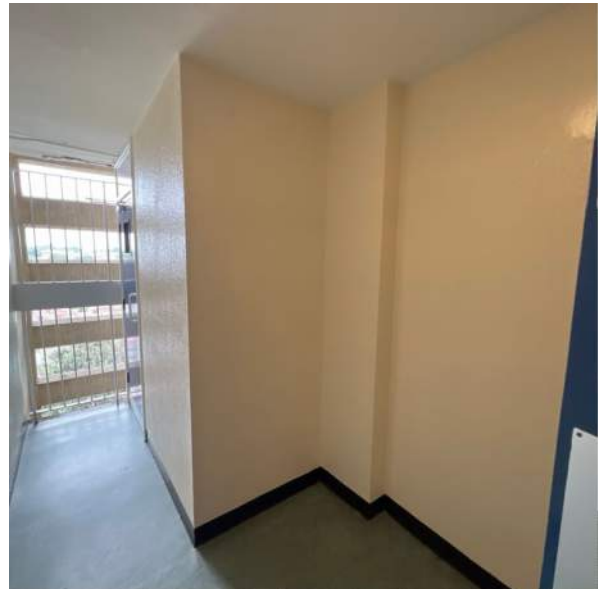
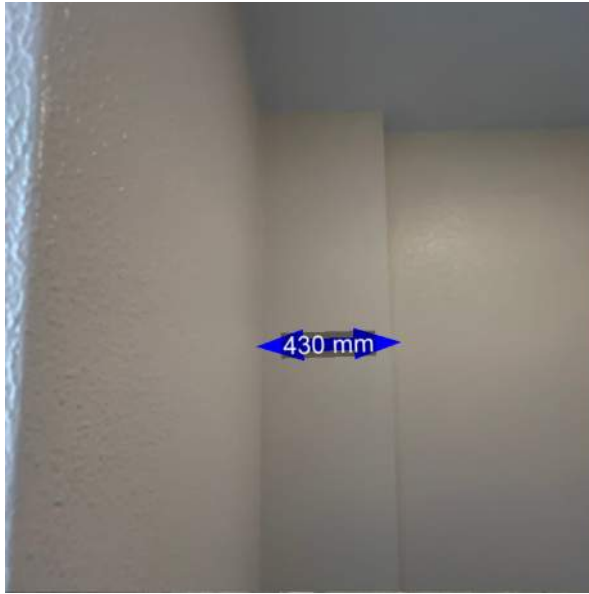
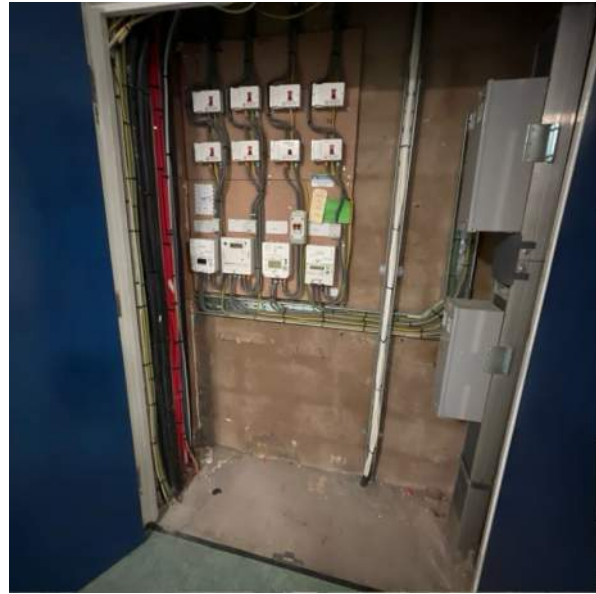
## 8th Floor Hallway

Comments: No jams or distortions noted to hallway doors to indicate any serviceability issues.  
Generally walls covered with finishes in hallway, likely to consist a mixture of concrete shear walls, embedded columns and block infill walls.  
Electrical cabinet shows infill blockwork with render.  
Dry riser cupboard shows exposed concrete likely to form part of stair shear core wall.

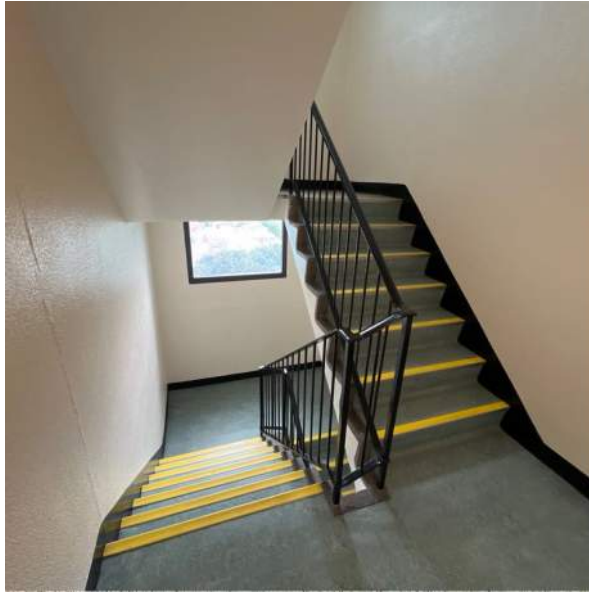
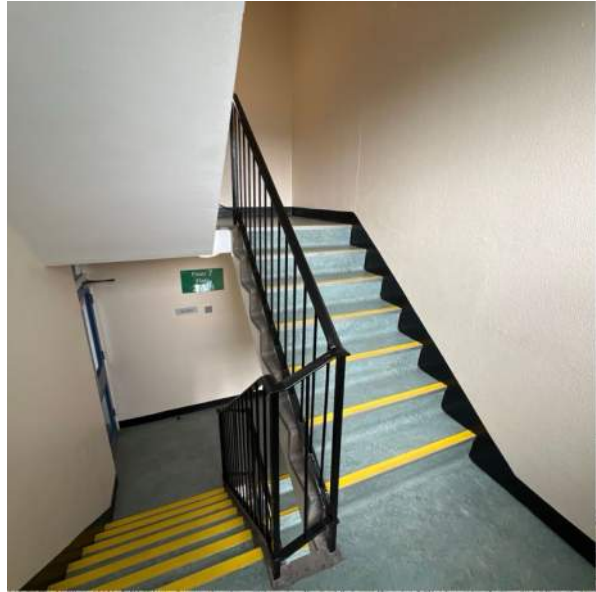
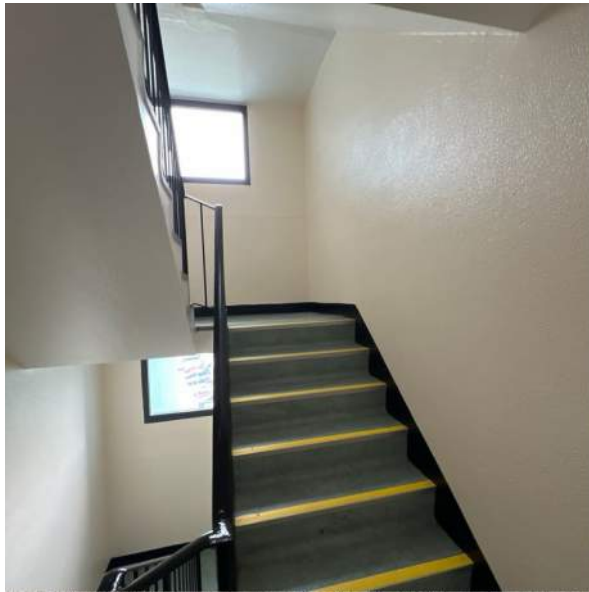
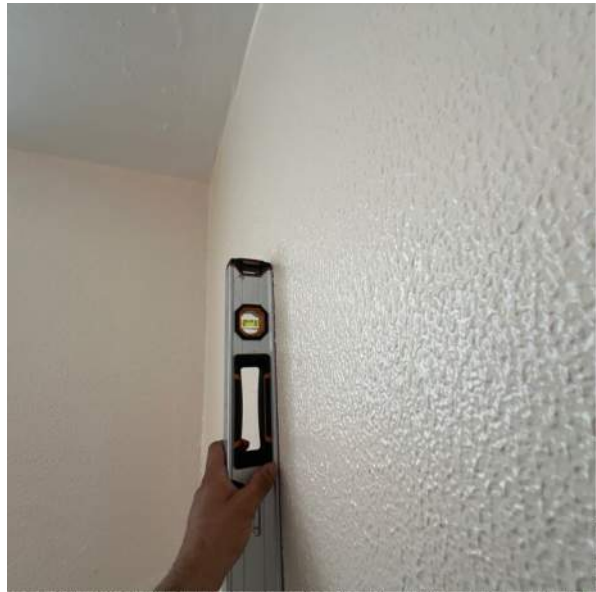
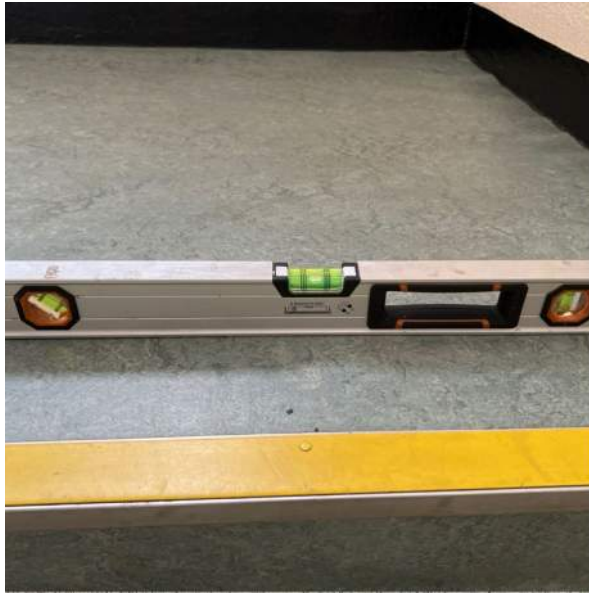
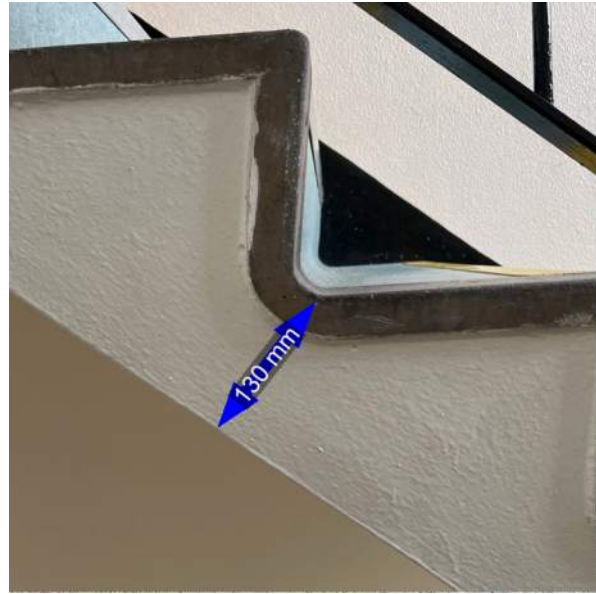
## 8th Floor Staircase

In situ concrete stairs with steel hand railing fixed to stairs. Walls and floors appear to be fairly level.

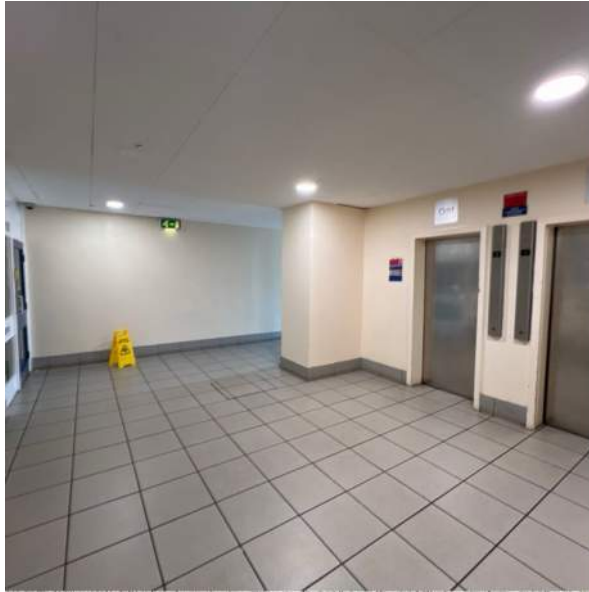
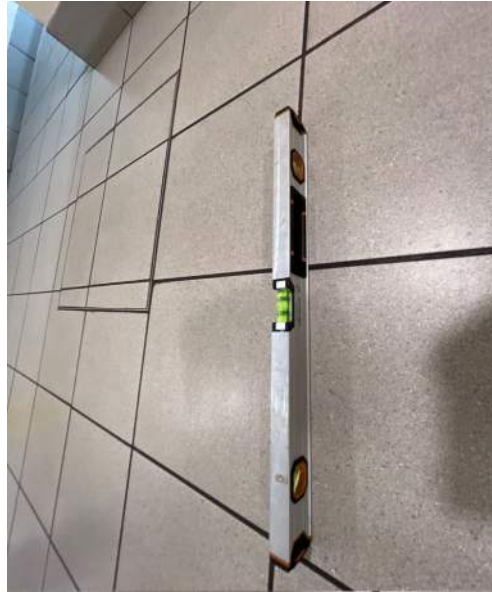
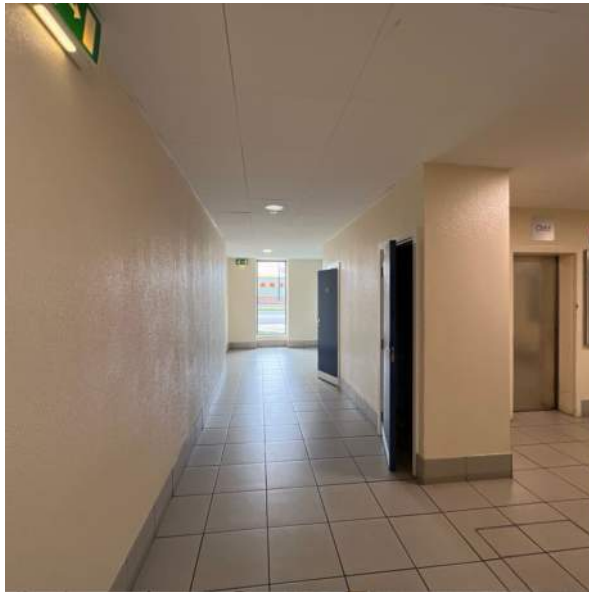
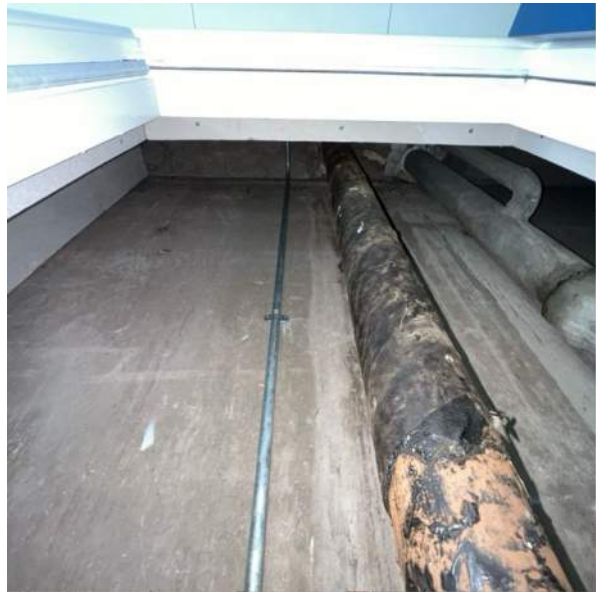
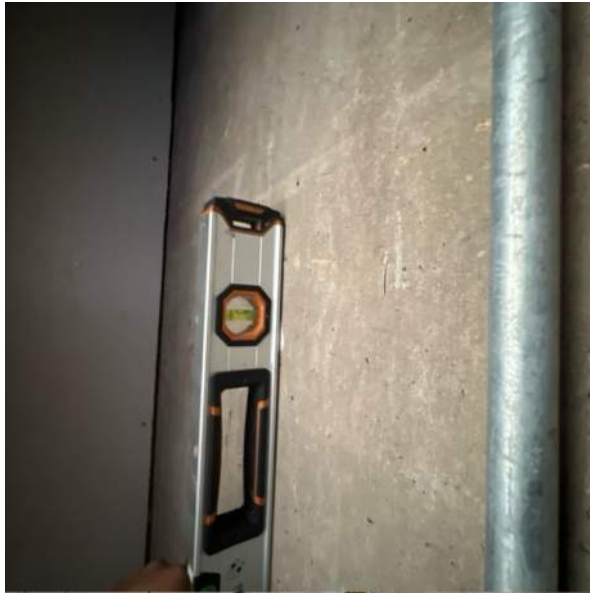
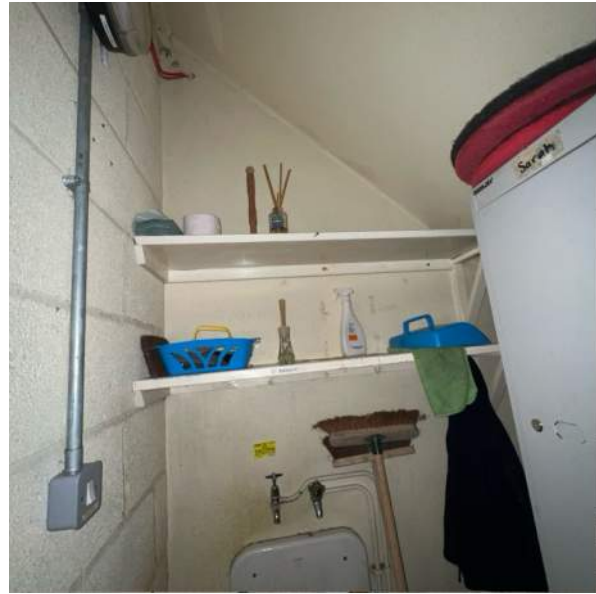
## Ground Floor Hallway

Comments: No jams or distortions noted to hallway doors to indicate any serviceability issues. Generally walls covered with finishes in hallway, likely to consist a mixture of concrete shear walls, embedded columns and block infill walls. RC Concrete Shear Core wall of lift visibly noted from riser cupboard and meterage room. Other internal main walls noted to solid concrete walls, these are likely to be shear core walls forming part of the primary structural elements.

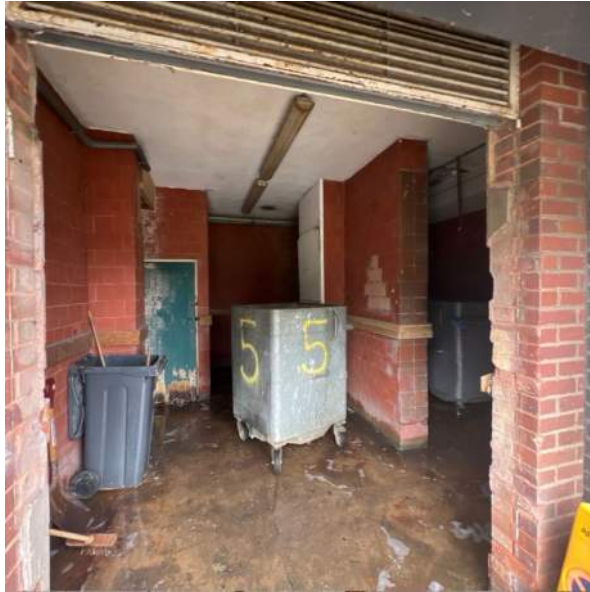
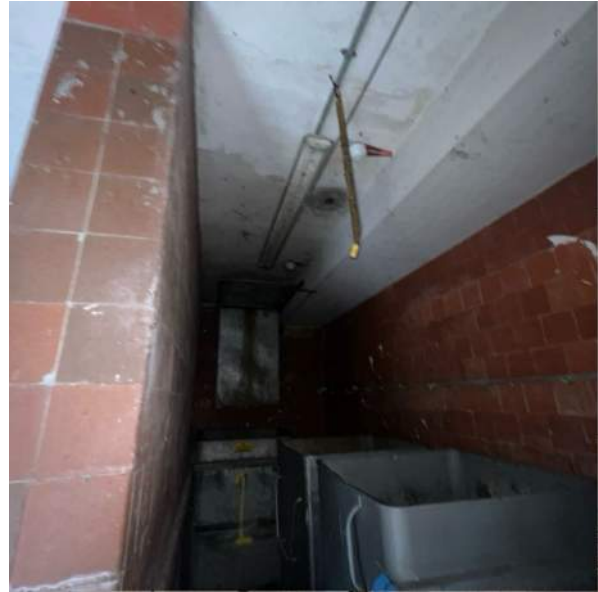
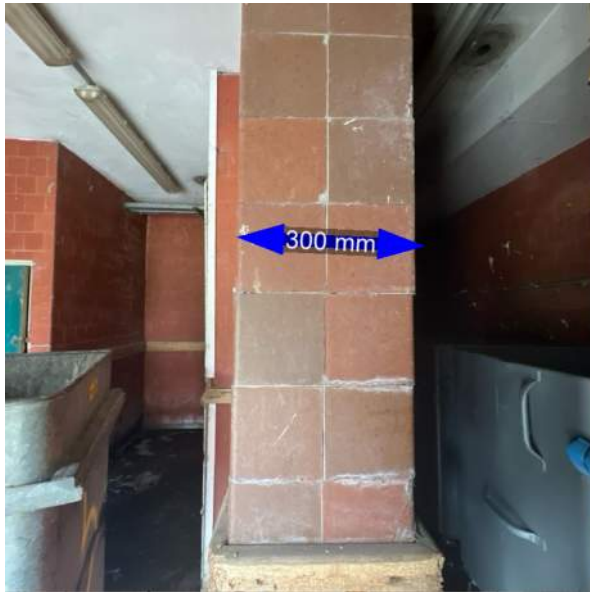
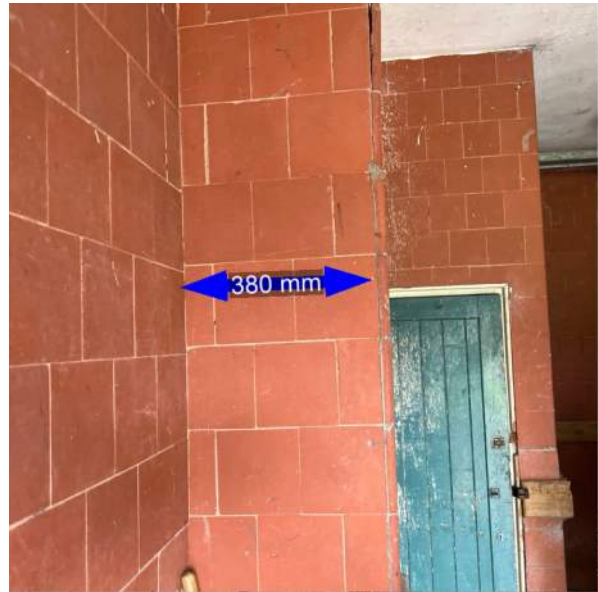
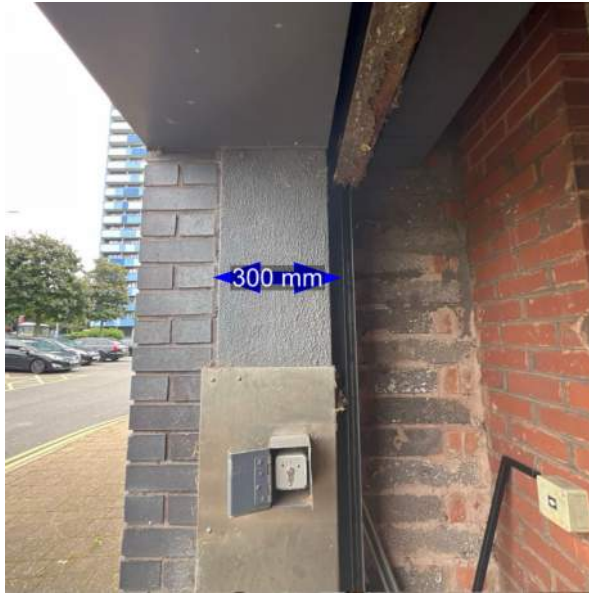
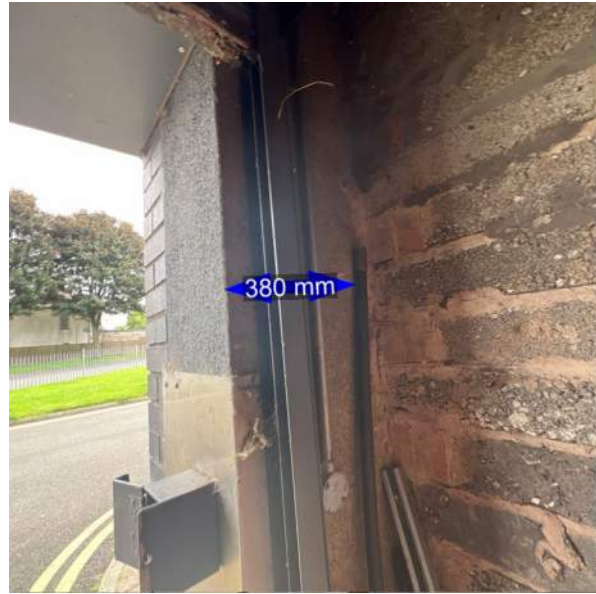
## Bin Store

Shear concrete walls (300mm wide including finishes) and embedded concrete columns (approx. 300mm wide) noted in bin store and storage areas. Concrete infill (non-load bearing walls) noted.

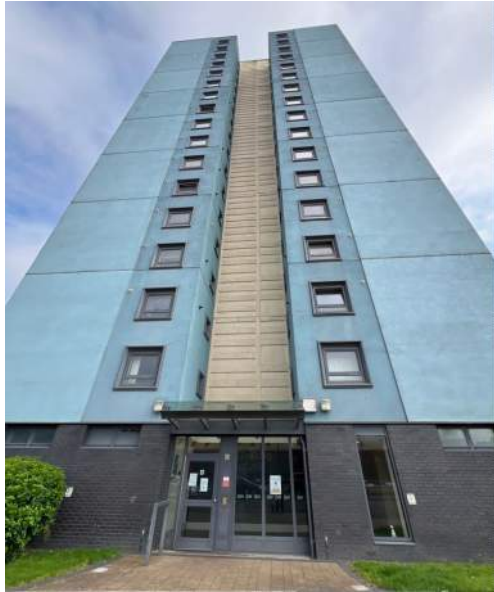
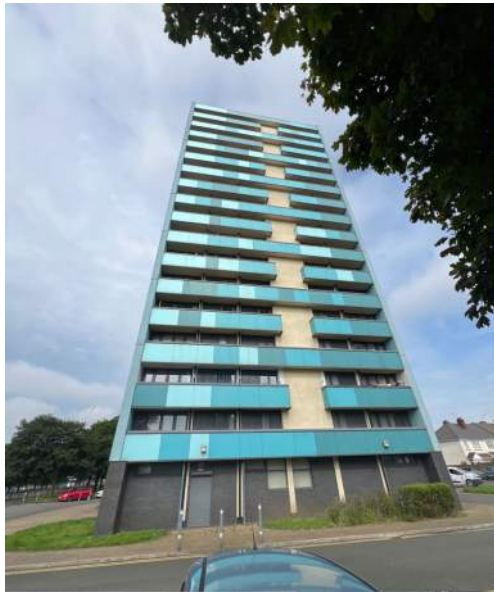
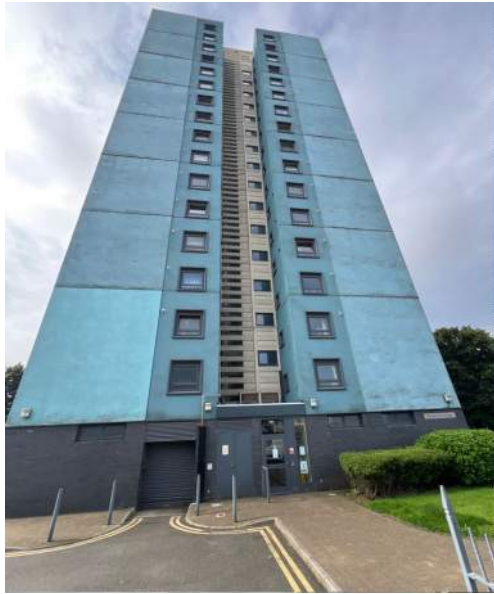
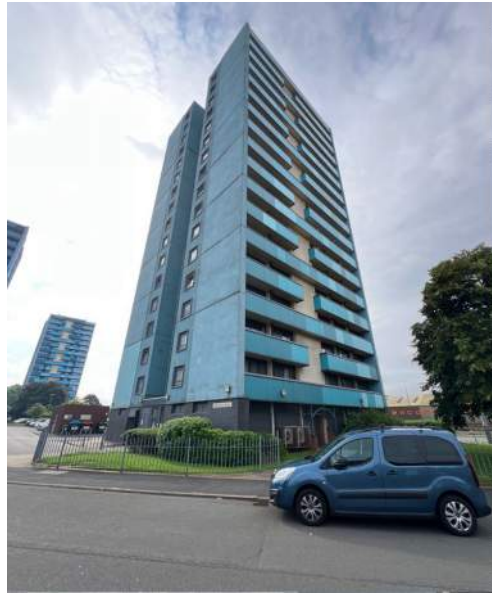
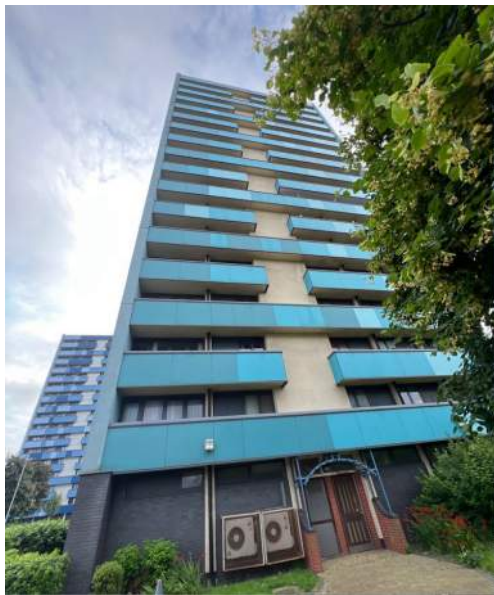
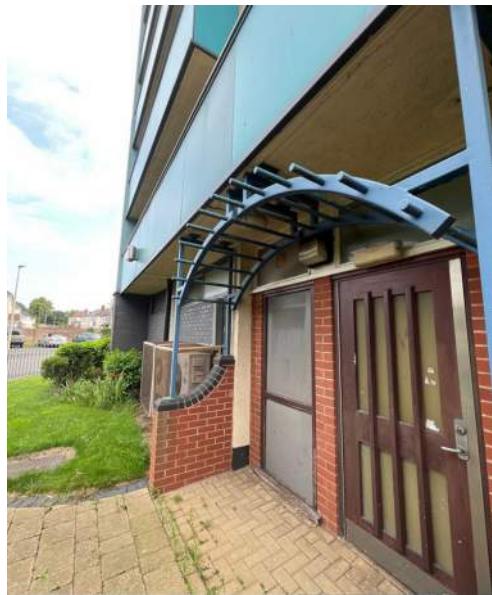
## Elevations

External ground floor level consists of brick work.  
Upper floors noted to have a rendered facade and cladding to balconies.  
Concrete columns (300mm wide) noted to perimeter which form part of the primary structural elements of the building.  
Staircase exterior appears to have a concrete panel facade feature.
