**FIRNTEC**  
BUILDING COMPLIANCE

VISUAL STRUCTURAL APPRAISAL

1-73 Hackwood House

Hartlebury Rd  
Oldbury  
B69 1EG

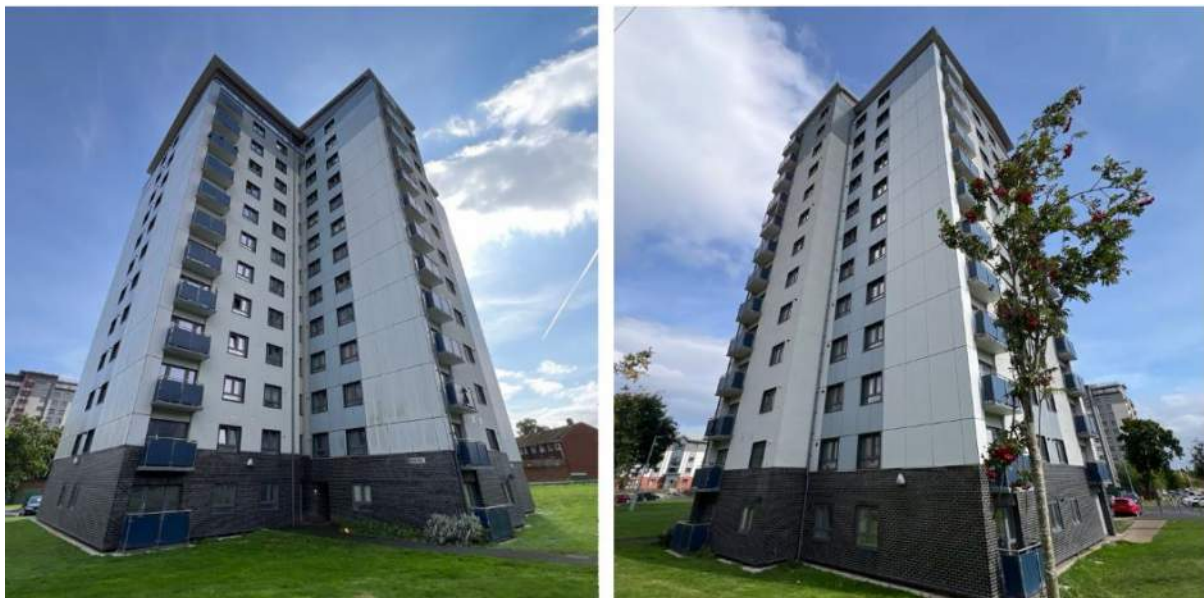
Figure 9 and 10: Building Elevations

The exterior elevations were generally in ok condition and no significant structural defects were noted to the cladding panels. There were no significant cracks or tell-tale signs of any significant structural movement noted at the time of our inspection.

The exterior panels were noted to be plumb with no signs of significant bowing, bulging or leaning noted to the panels indicating failed fixings however their presence and condition cannot be confirmed.

There are balconies at each level which are formed of cantilevered RC slabs tied into the main frame, likely cast monolithically with the primary RC frame.

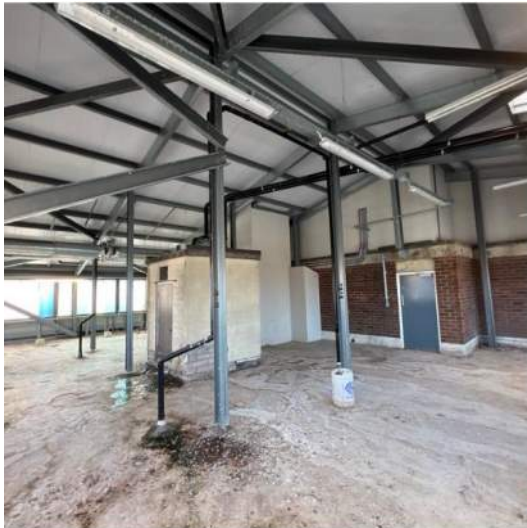
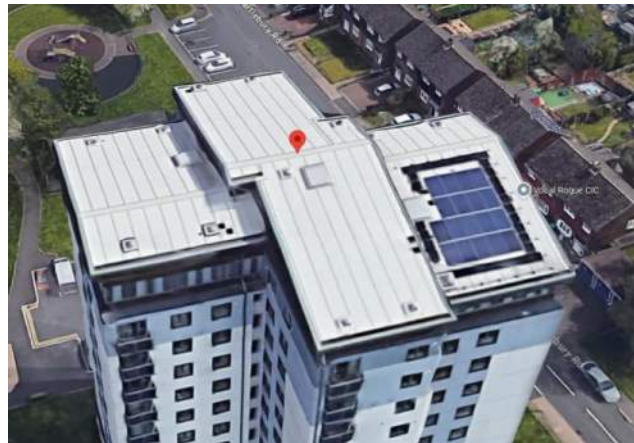
Figure 11 and 12: Roof Level

There were no tell-tale signs of any significant structural movement noted at the time of our inspection. The exterior walls were noted to be plumb with no signs of significant bowing, bulging or leaning noted to the masonry walls.

The roof has subsequently been covered with a new waterproofing covering formed of a steel frame installed to the existing roof which supports pitched corrugated sheets. This roof is not insulated and therefore acts purely as a weather barrier. The fire protection of the steel is unclear as the beams do not appear to be protected. Details of this frame should be requested from the contractor who completed the works in 2018.

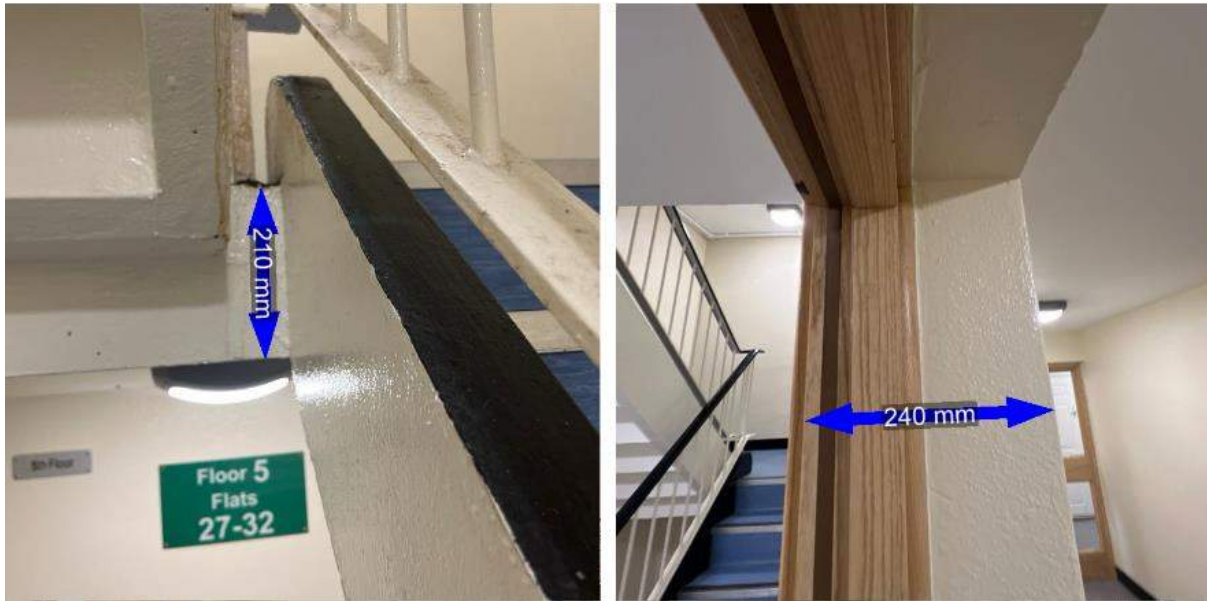
Figure 13 and 14: Stair stringer and concrete frame

The interior of the stair core walls were checked and were plumb and in line with observations made to the exterior – no significant signs of leaning or movement noted. The concrete appeared in fair condition with few BRE category 1 cracks but no structurally significant defects were noted.

The shear walls around stair core appeared to be 240mm including finishes, therefore ~200mm RC wall. A cover test is required to check the resistance of the concrete section in the event of a fire.

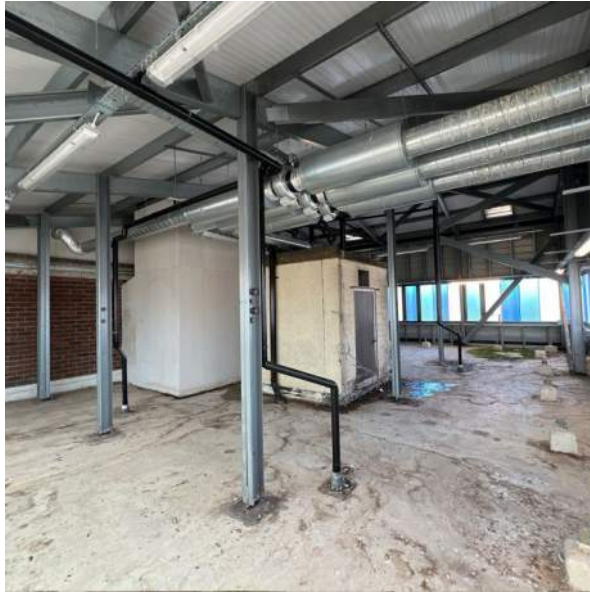
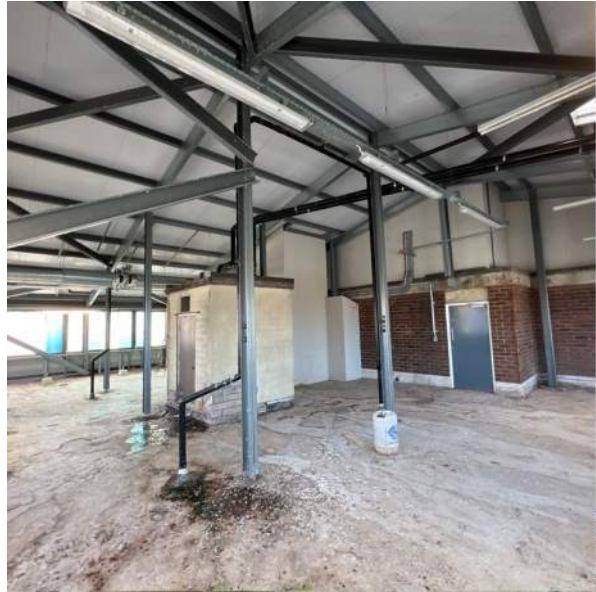
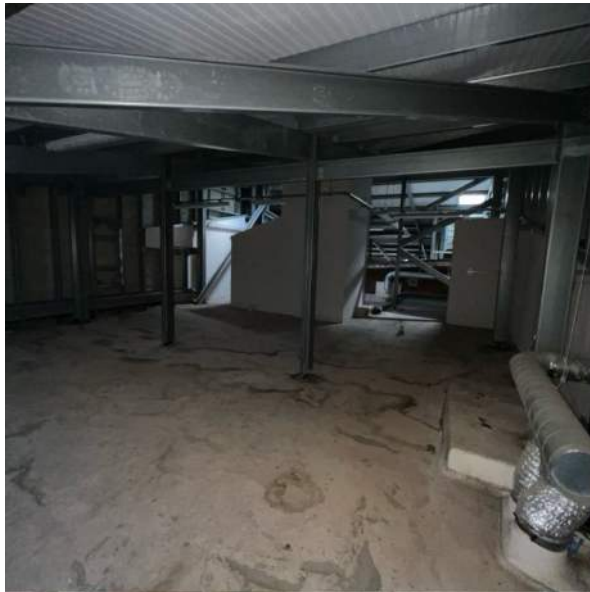
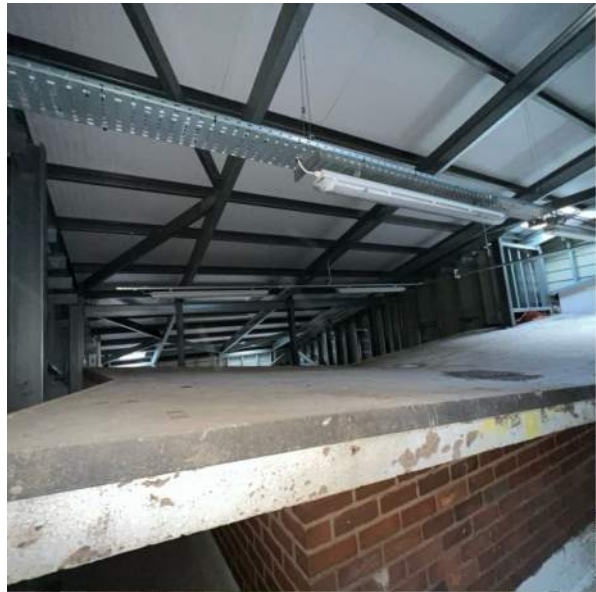
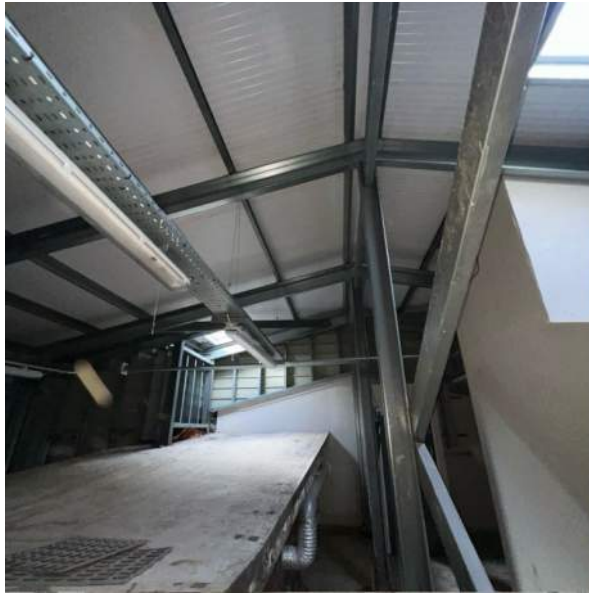
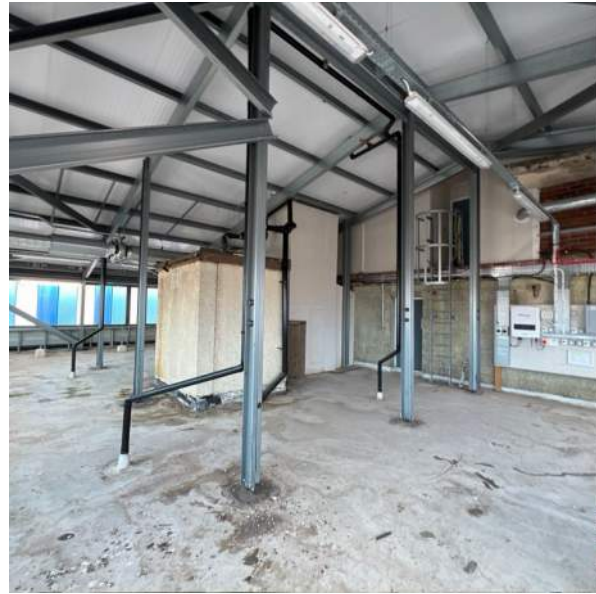
## Main Roof

Comments: Roof structure consists of a lower and higher section and is formed of a concrete slab with a Lightweight SFS (appear to be cold rolled) frame with a pitched roof fixed on to main roof structure. Frame columns fixed to perimeter of roof. Some historical staining to roof slab.

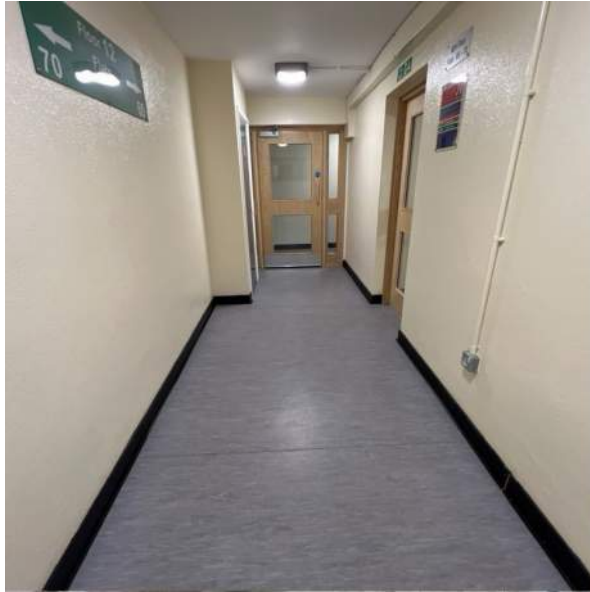
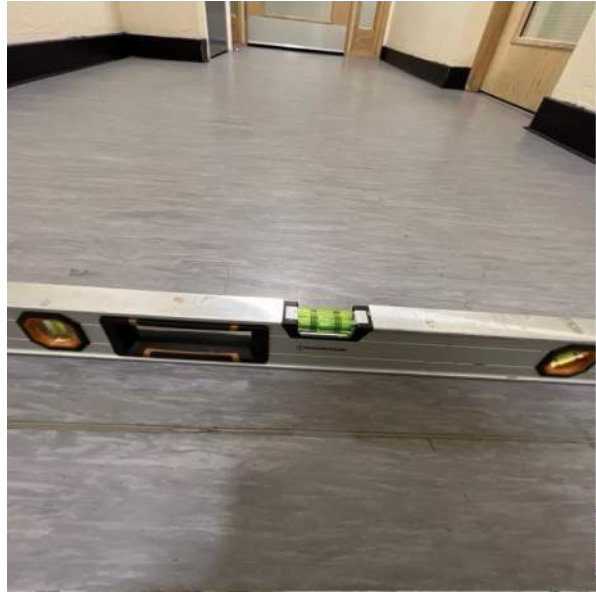
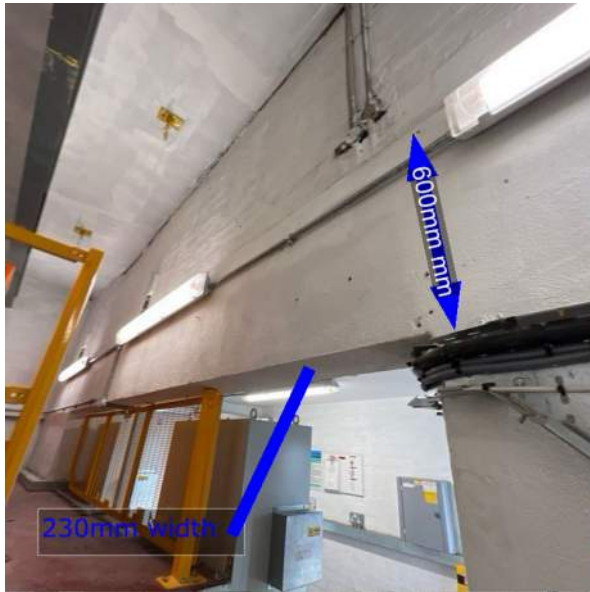
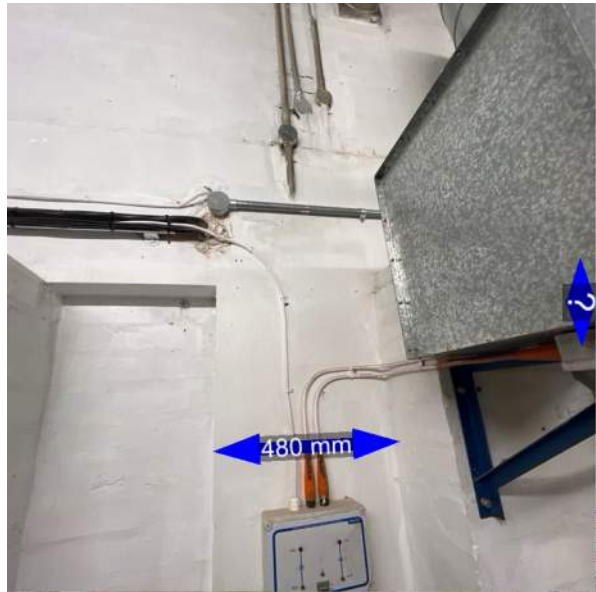
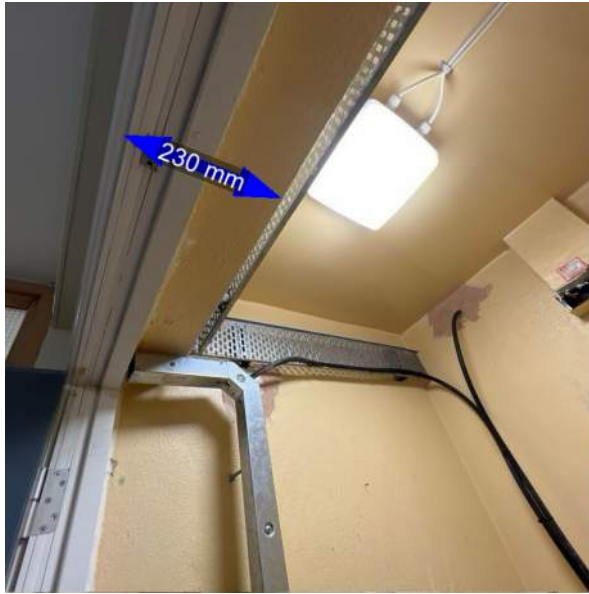
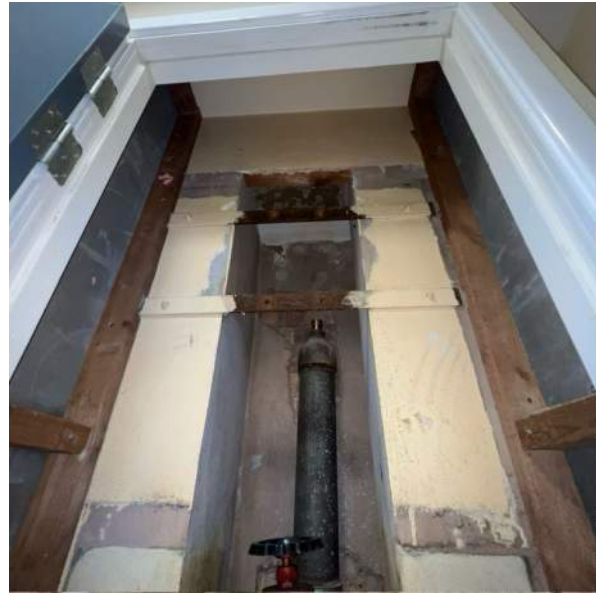
## 12th Floor Hallway

Comments: No jams or distortions noted to hallway doors to indicate any serviceability issues. Generally walls covered with finishes in hallway, likely to consist a mixture of concrete shear walls and embedded columns with internal partition walls. Visible concrete elements (RC Beams and Columns) noted via lift room. Some infill (non-load bearing) masonry noted, some of which are rendered.

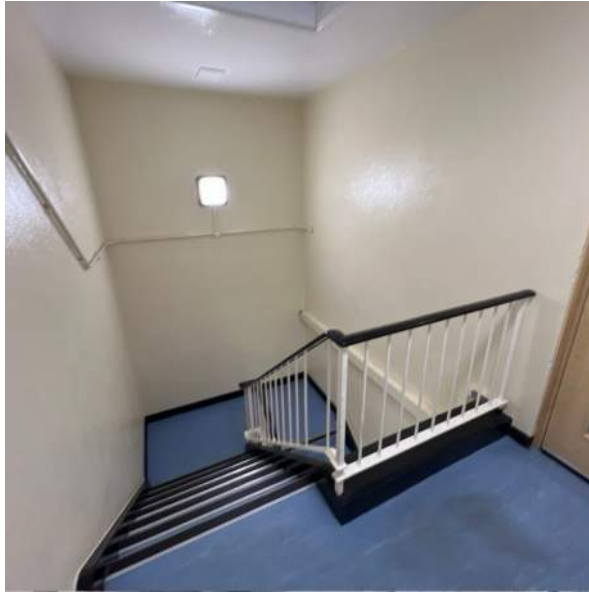
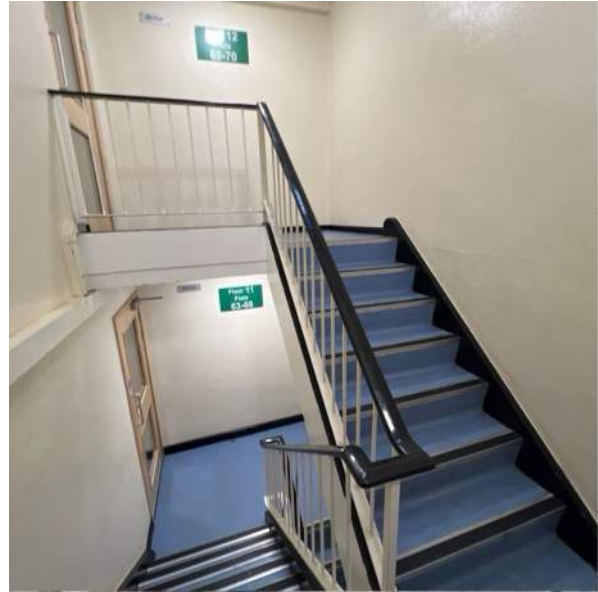
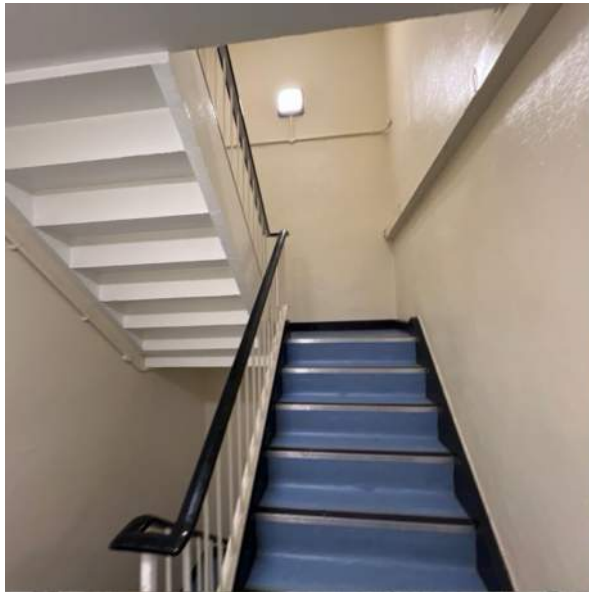
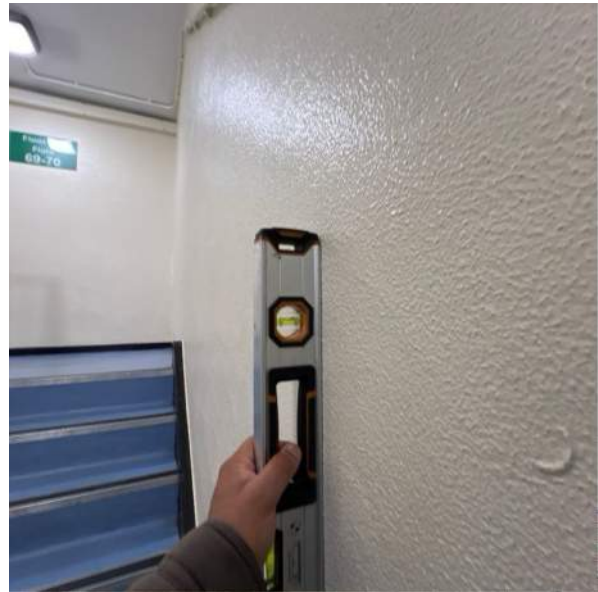
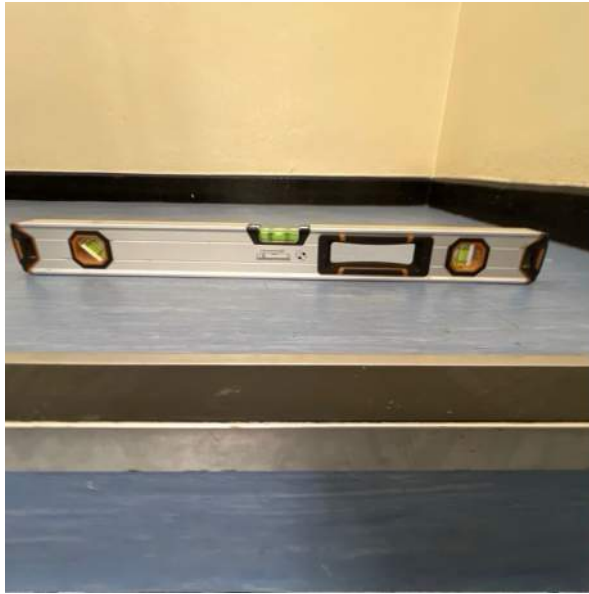
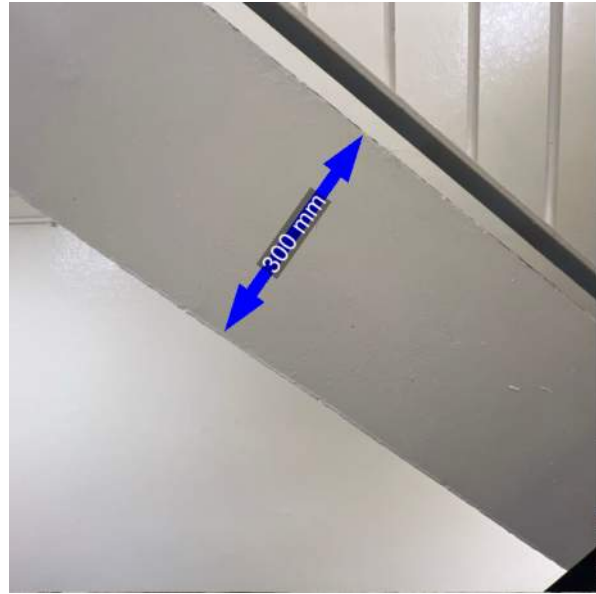
## 12th Floor Staircase

In situ concrete stairs with steel hand railing fixed to stairs. Walls and floors appear to be fairly level.

Staircase/hallway wall measured to be approx. 240mm thick.

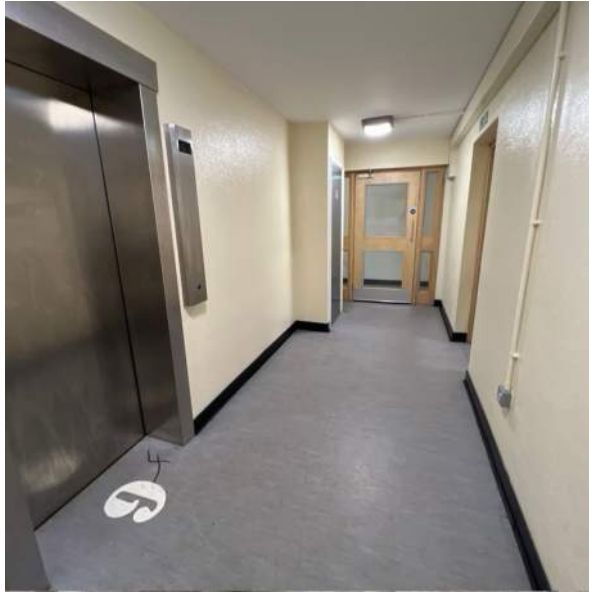
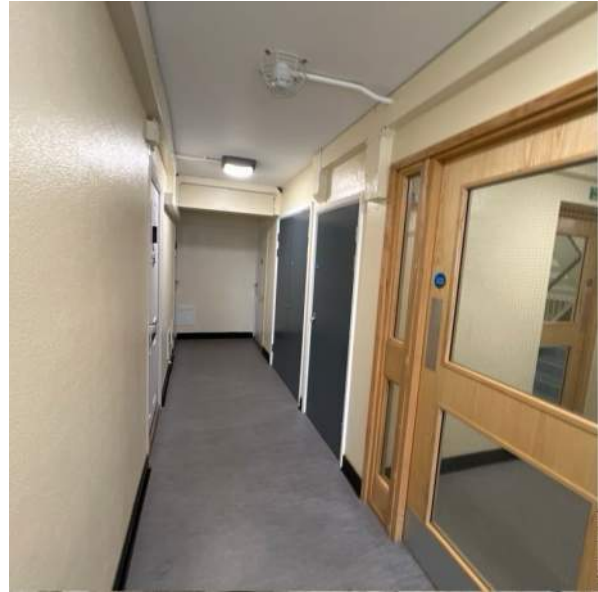
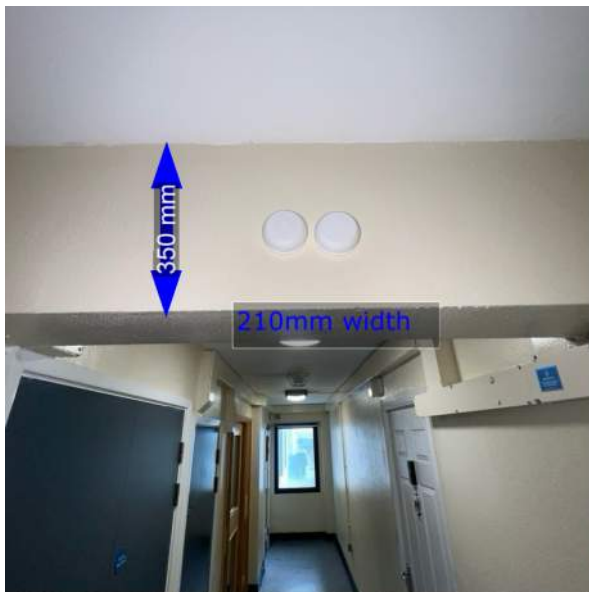
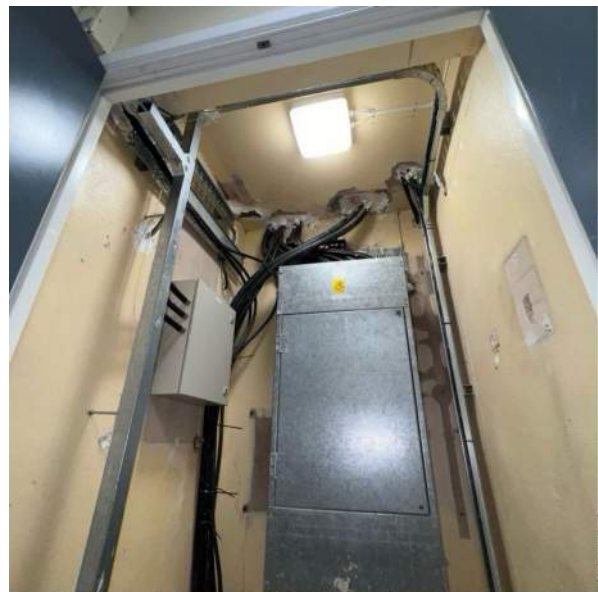
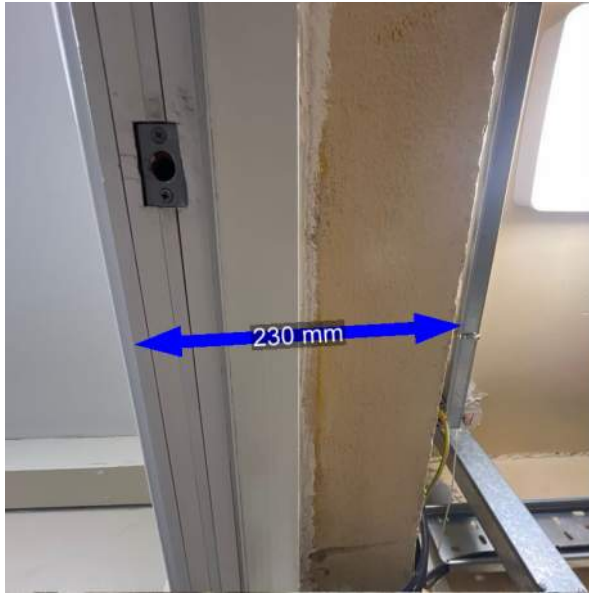
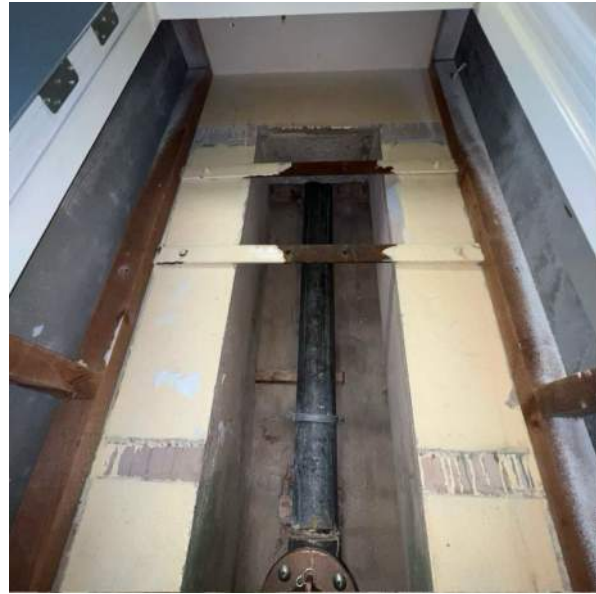
## 6th Floor Hallway

No jams or distortions noted to hallway doors to indicate any serviceability issues. Generally walls covered with finishes in hallway, likely to consist a mixture of concrete shear walls and embedded columns with internal partition walls. Possible concrete walls noted via riser cupboard. Some infill (non-load bearing) masonry noted some of which are rendered.

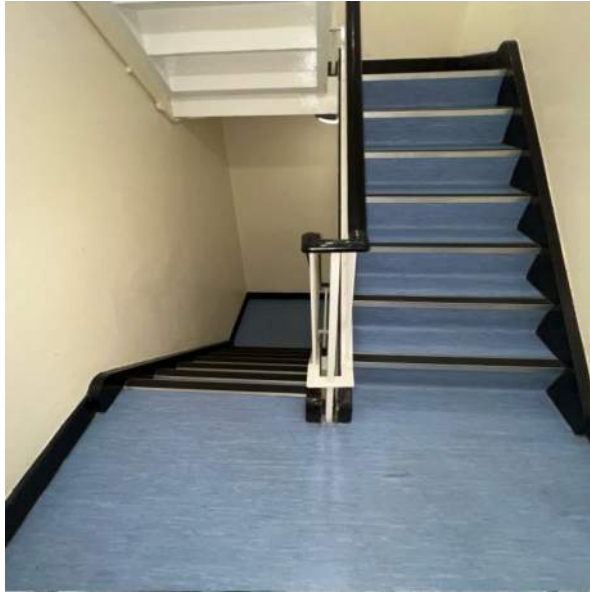
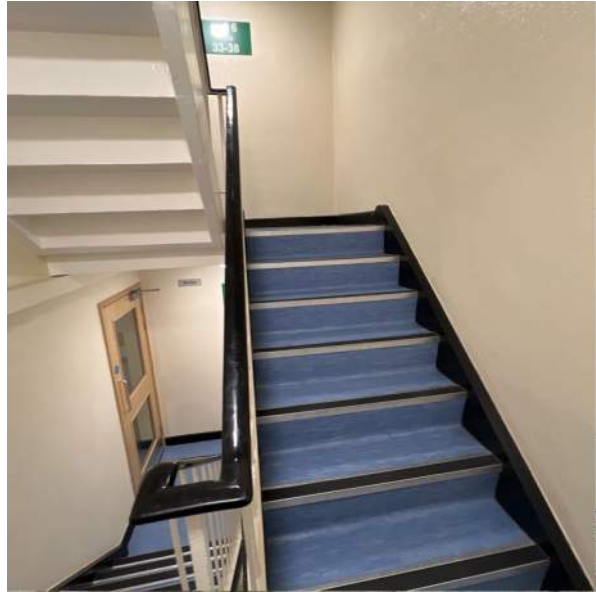
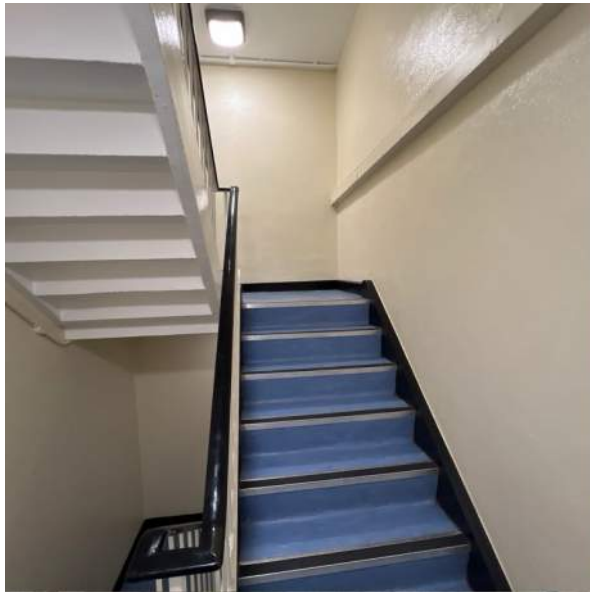
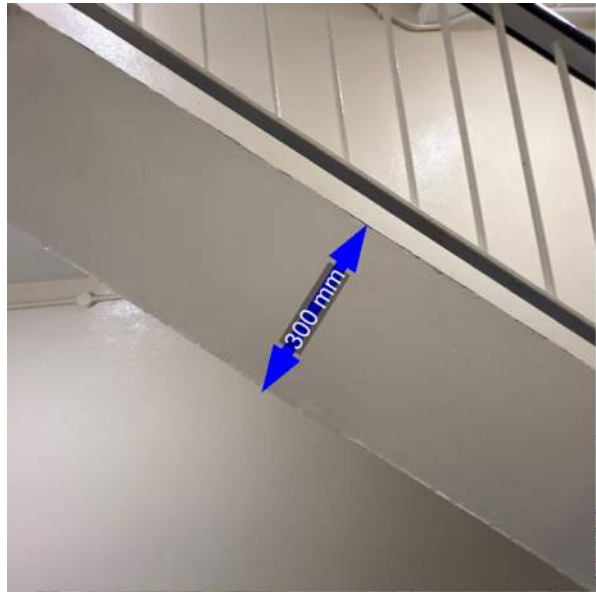
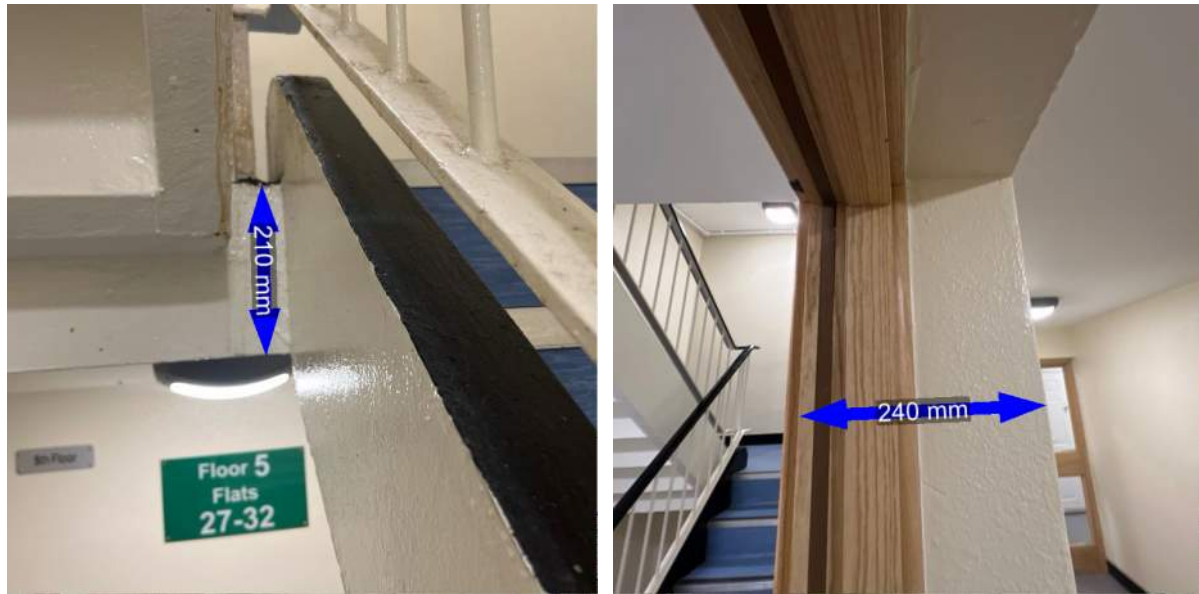
## 6th Floor Staircase

In situ concrete stairs with steel hand railing fixed to stairs. Walls and floors appear to be fairly level.

Staircase/hallway wall measured to be approx. 240mm thick.

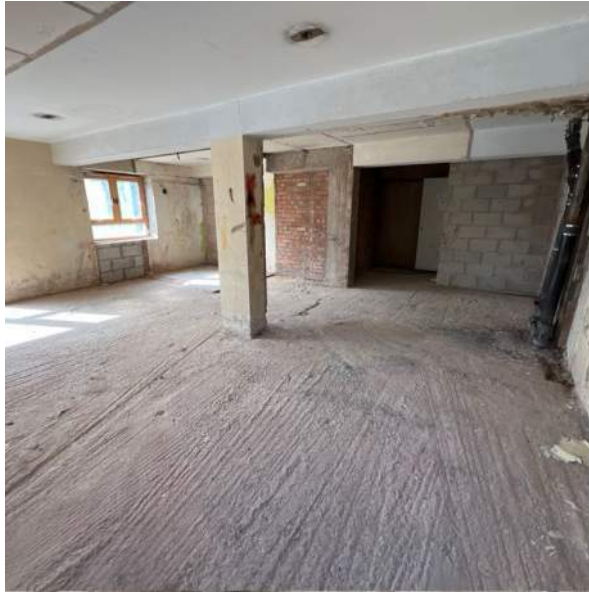
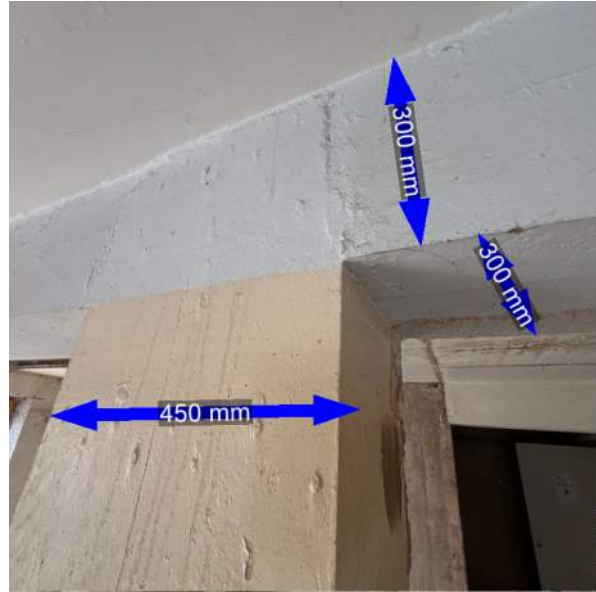
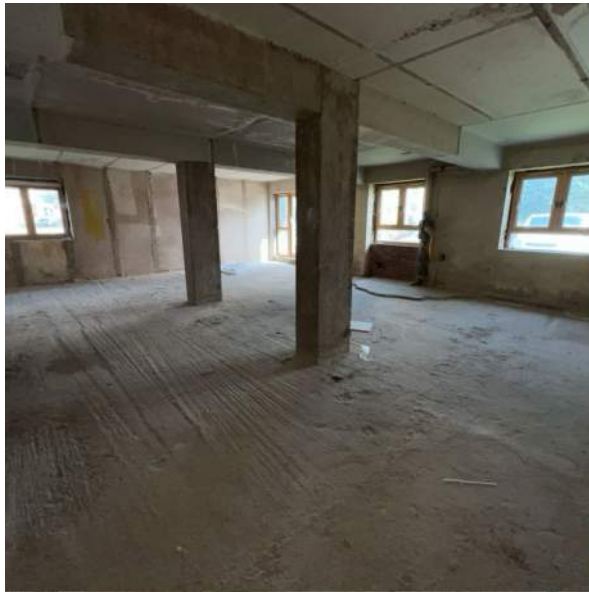
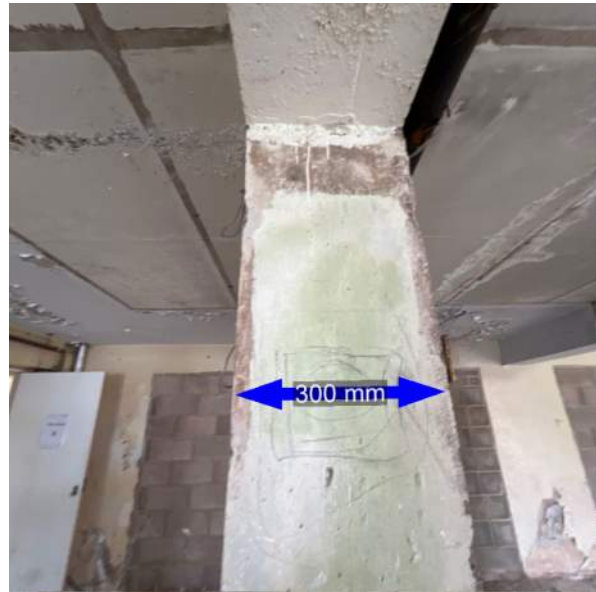
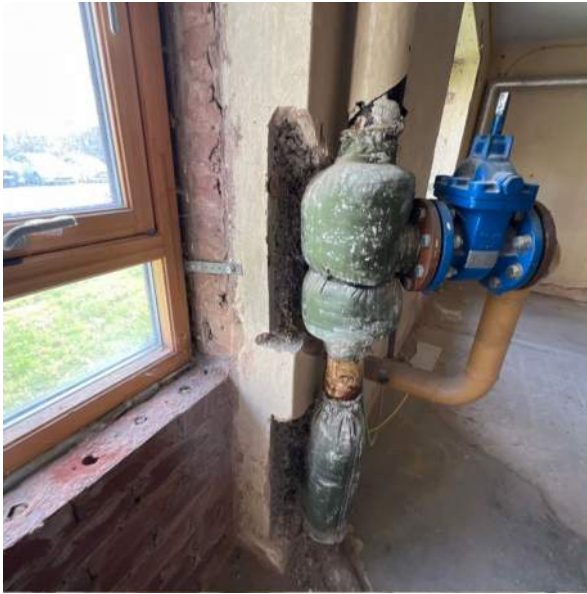
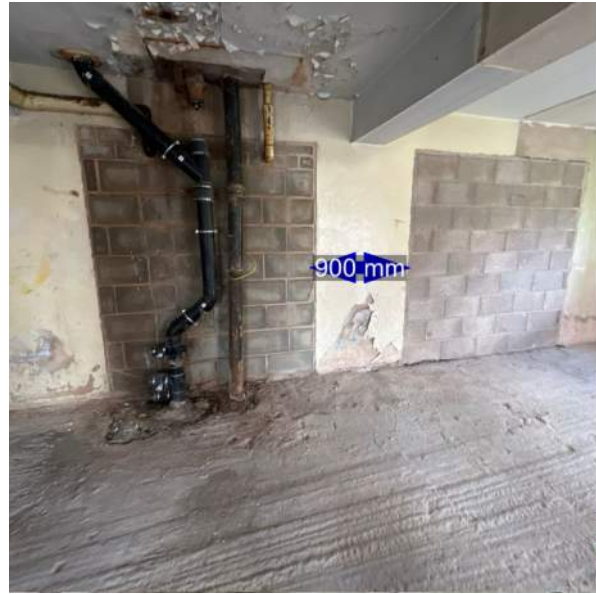
## Ground Floor Hallway

No jams or distortions noted to hallway doors to indicate any serviceability issues. Generally walls covered with finishes in hallway, likely to consist a mixture of concrete shear walls and embedded columns with internal partition walls. Concrete frame consisting of RC columns, Shear Walls and RC Beams noted in visible areas of ground floor rooms. Infill (non-load bearing) walls noted. Perimeter walls noted to have RC columns/walls and No-fines concrete infill walls.

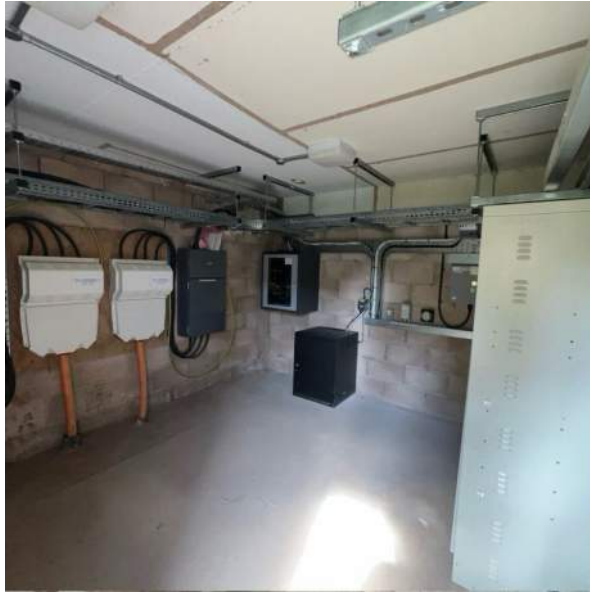
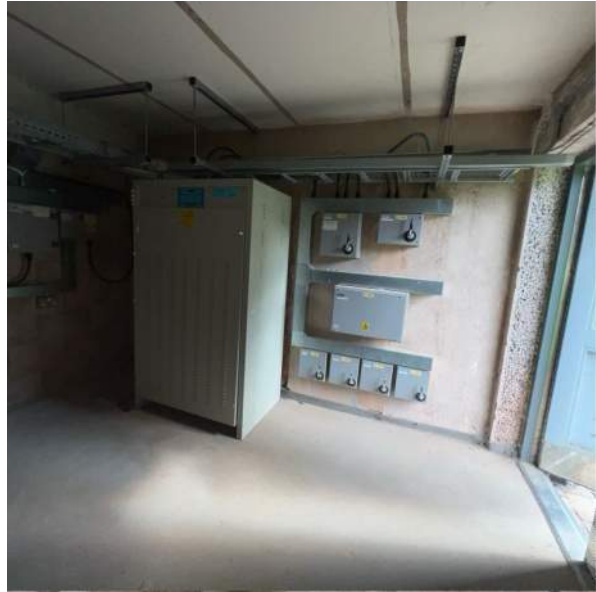
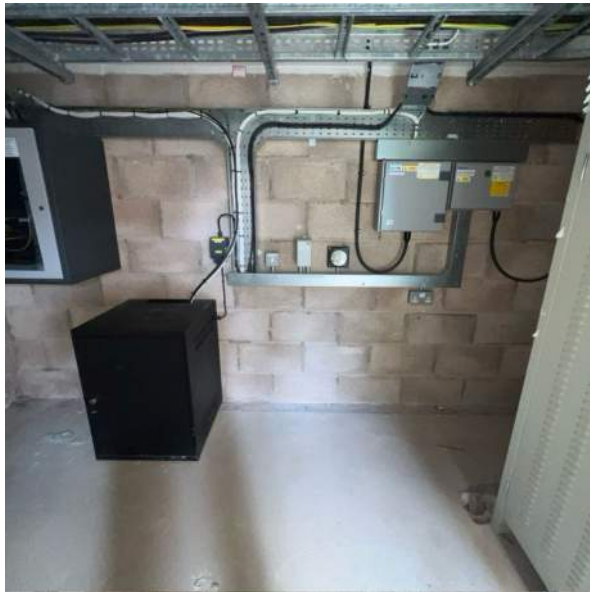
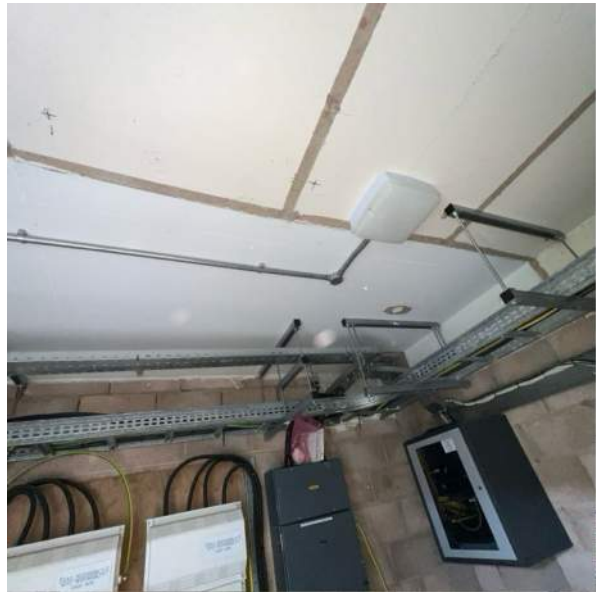
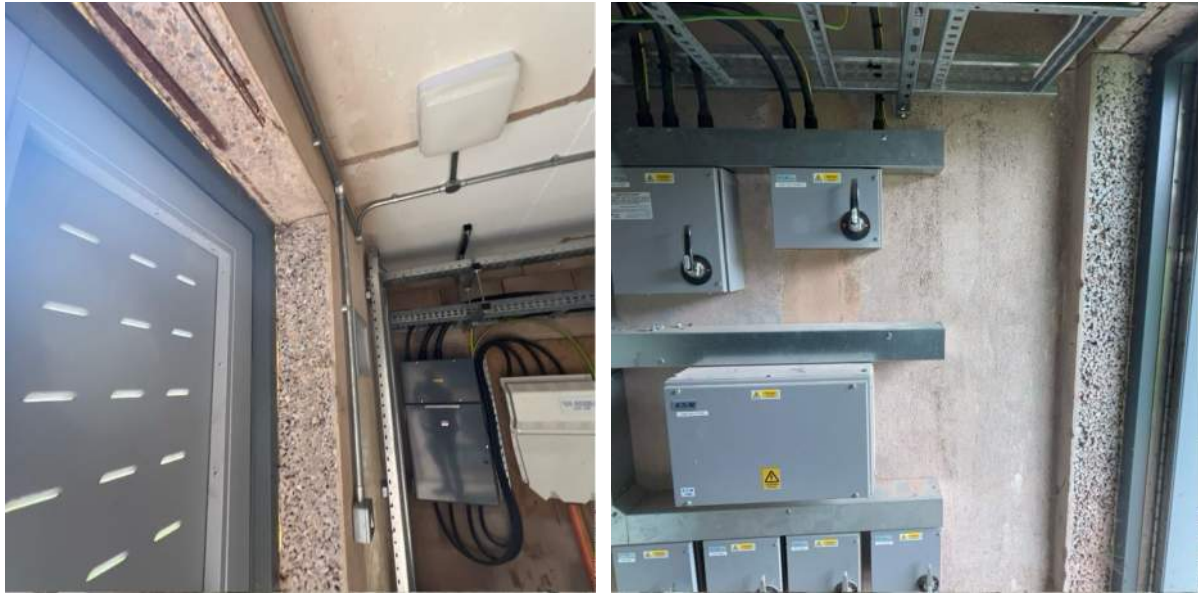
## External Electrical Room

Comments: No-fines concrete noted to perimeter walls. Possible RC wall noted. Infill (non-load bearing) concrete block walls noted.

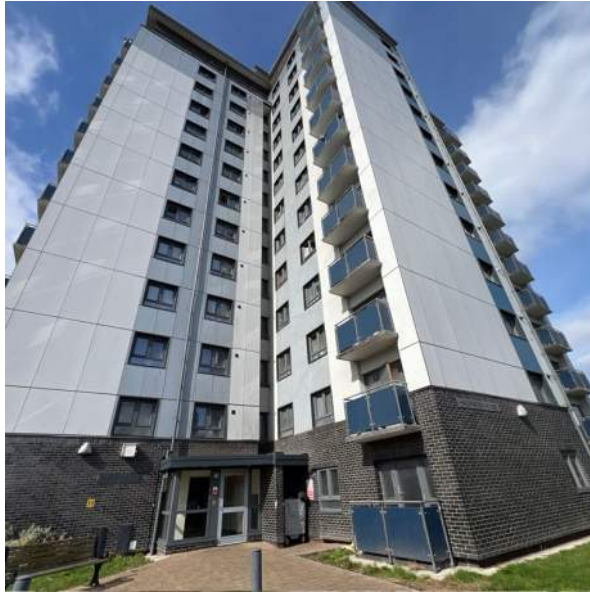
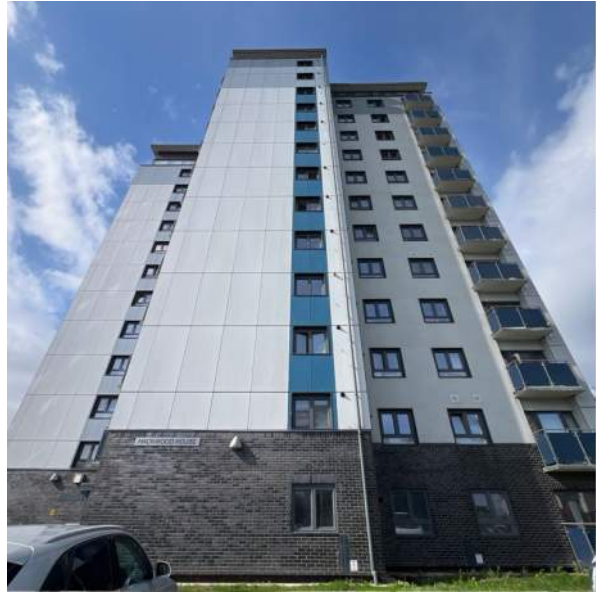
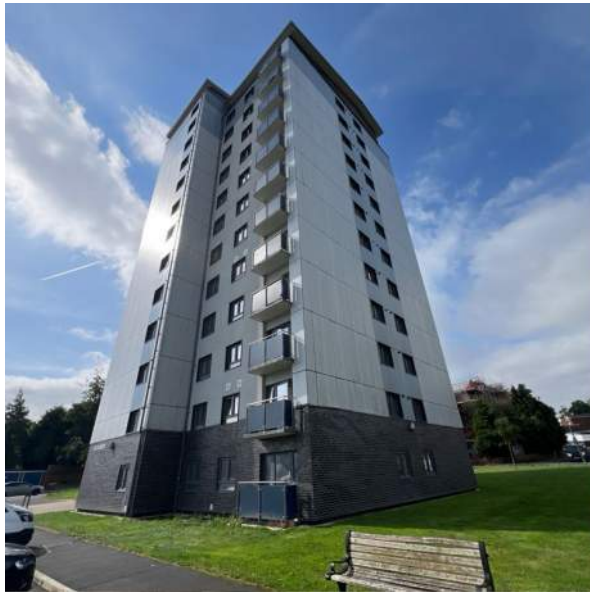
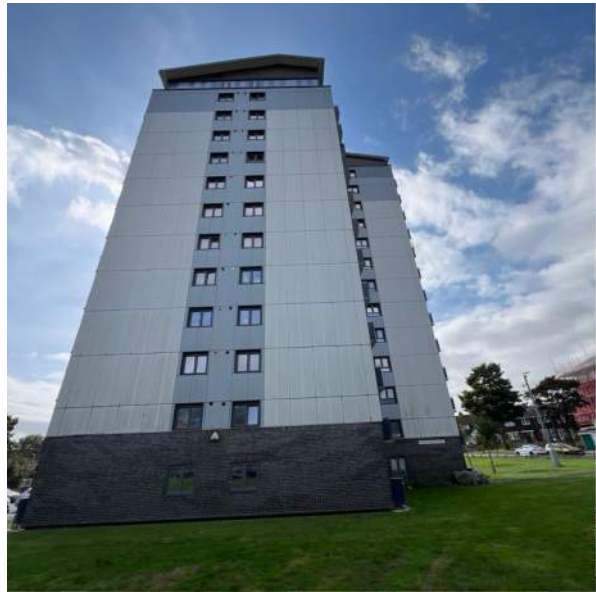
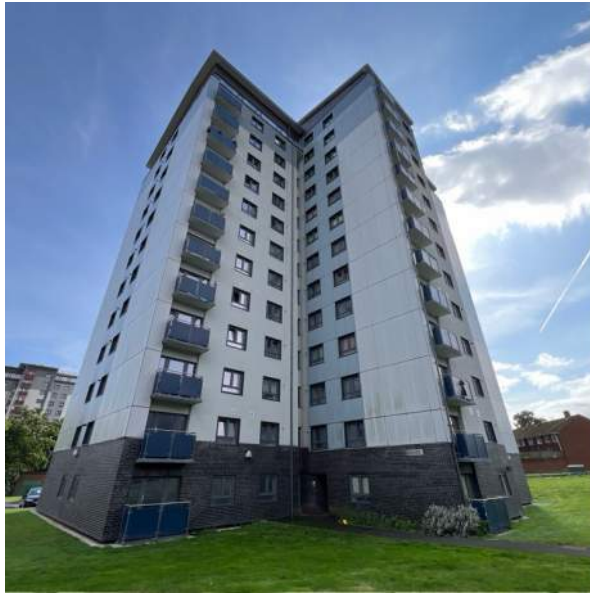
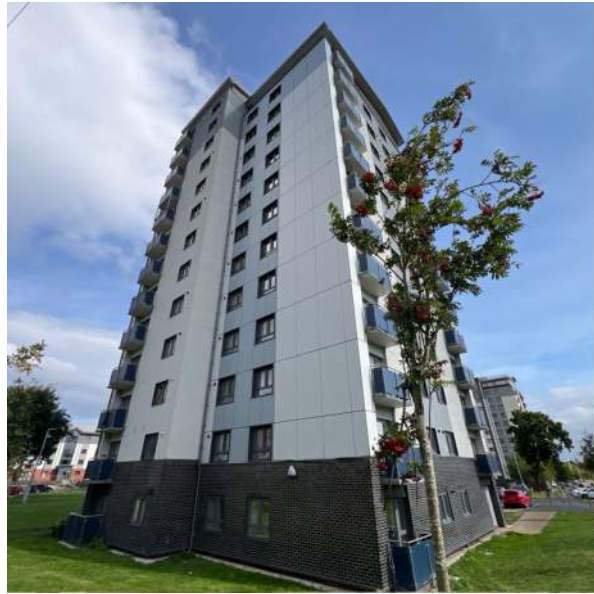
## Elevations

External ground floor level consists of brick work.  
Remaining floors noted to have a cladded facade to exterior. Balconies noted.

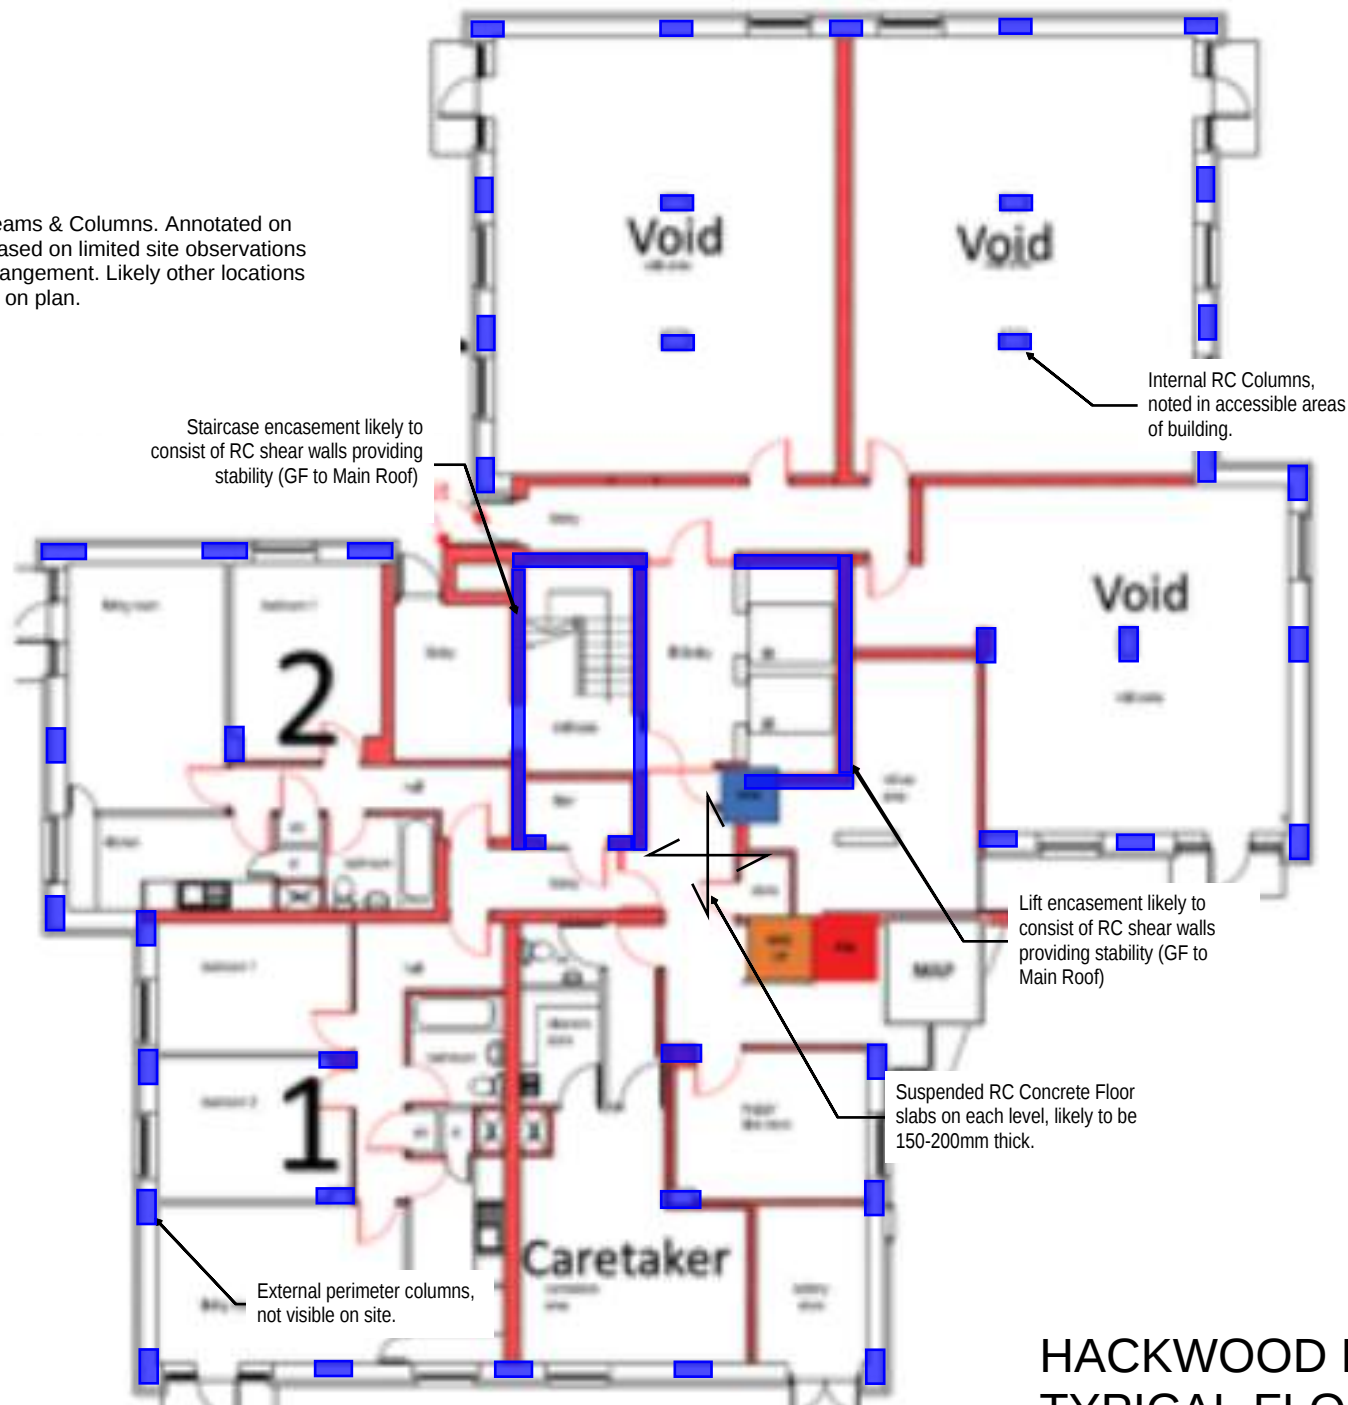
HACKWOOD HOUSE  
TYPICAL FLOOR LAYOUT

RC Shear/Core Walls, Beams & Columns. Annotated on plan shown indicatively based on limited site observations and general floor plan arrangement. Likely other locations present where not shown on plan.
