**FIRNTEC**  
BUILDING COMPLIANCE

VISUAL STRUCTURAL APPRAISAL

Hamstead House

Coniston Crescent  
Hamstead  
B43 5NU

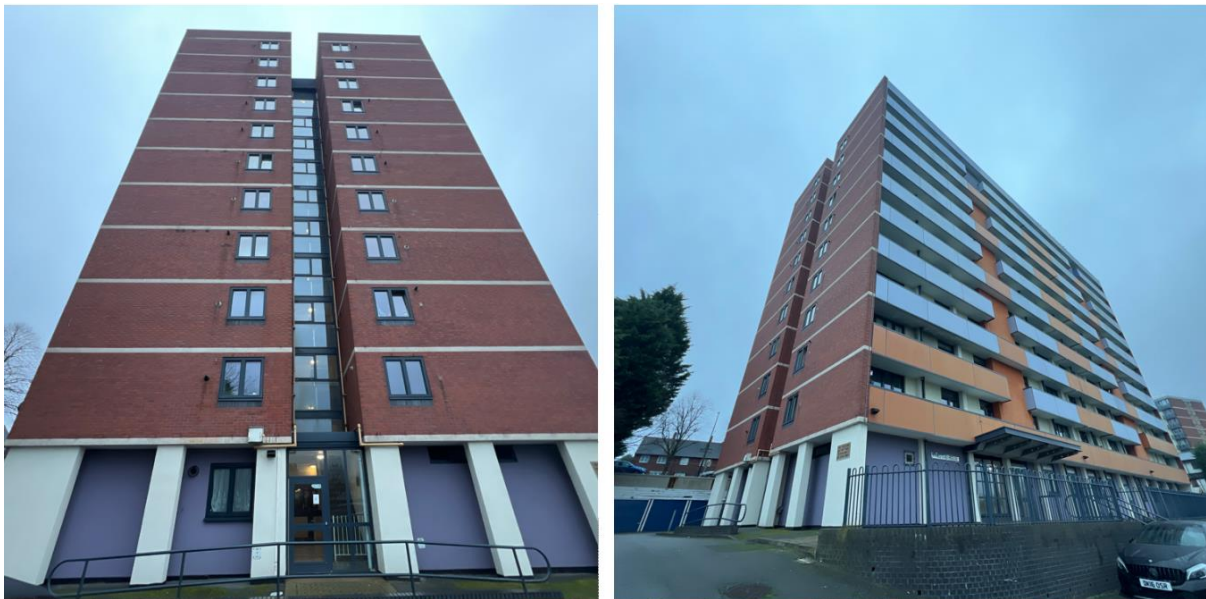
Figure 9 and 10: Front and side Elevations

The exterior elevations were generally in ok condition and no significant structural defects were noted to the cladding panels. There were no significant cracks or tell-tale signs of any significant structural movement noted at the time of our inspection.

The exterior panels were noted to be plumb with no signs of significant bowing, bulging or leaning noted to the panels or cavity wall indicating failed fixings however their presence and condition cannot be confirmed.

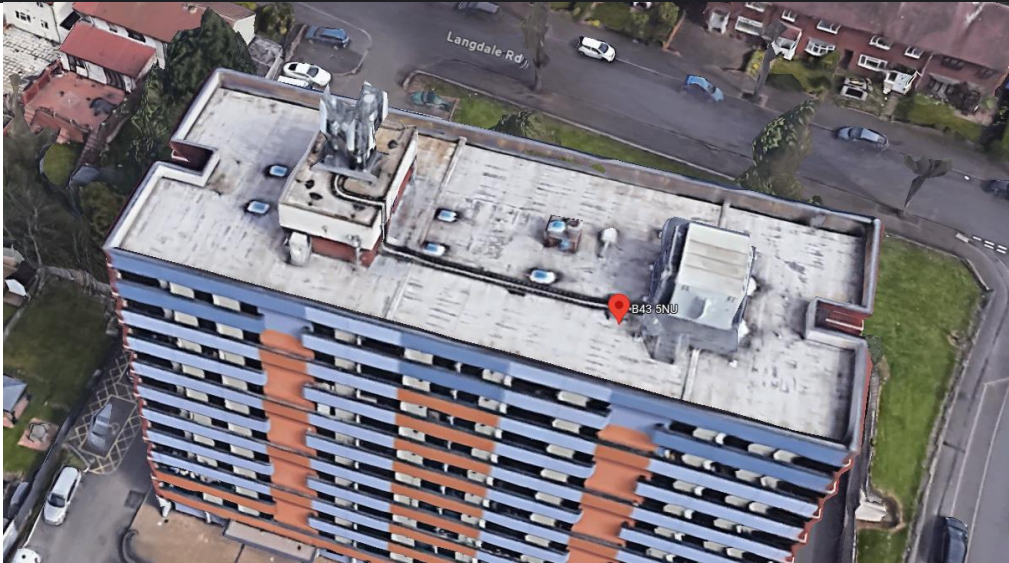
Figure 11: Roof level enclosure

The flat roof structure is a reinforced concrete cast slab with perimeter RC parapet wall. There is an enclosure which partially covers the roof area comprising the lift plant. This structure is formed of solid masonry walls.

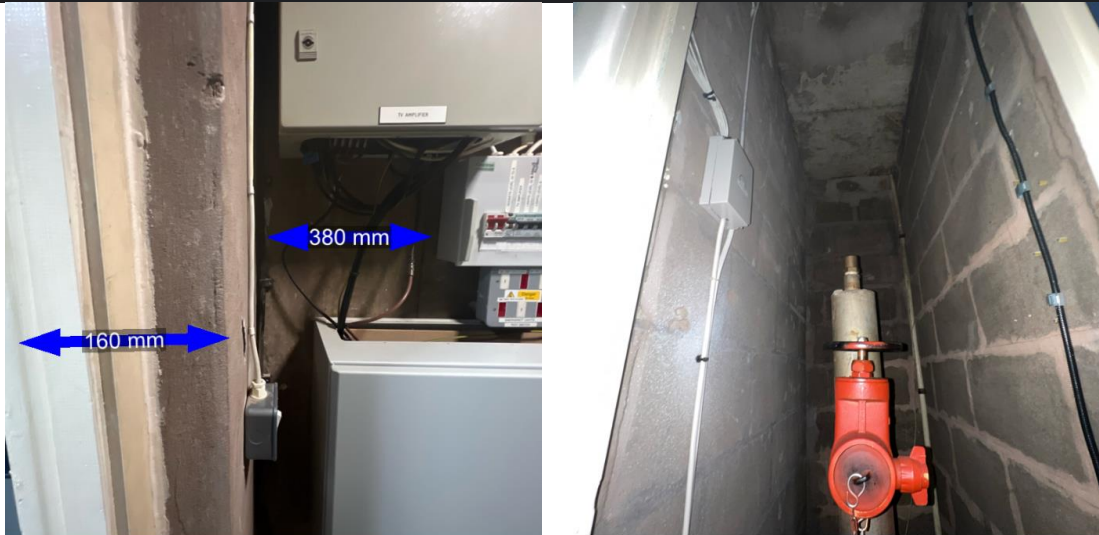
Figure 12 and 13: Vertical RC Elements

The interior of the stair core walls were checked and were plumb and in line with observations made to the exterior – no significant signs of leaning or movement noted. There is a vertical crack (BRE Category 1 crack) noted to finishes in staircase between main stair wall and external wall joint. The vertical crack was noted in the staircase to the finishes noted on most levels. Cracking is likely to indicate some thermal movement and does not appear to be structurally significant in its current state. The crack is advised to be monitored and checked in future inspections.

The typical RC wall was noted to be 160mm thick, a cover test is required to check the resistance of the concrete section in the event of a fire.

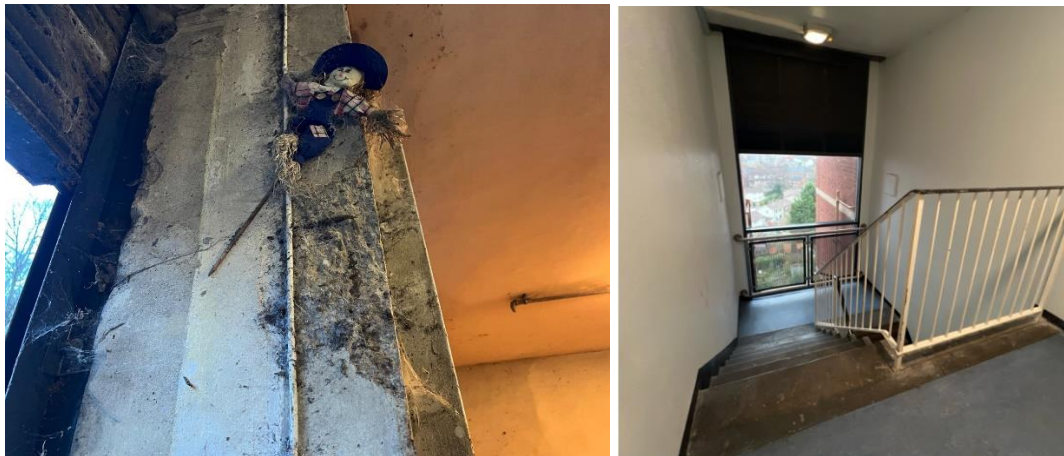
Figure 14 and 15: Localised area of spalling and Staircase

There was a localised area of spalling noted to an RC section at ground level within the bin store. This is to be fixed by a specialists concrete repair contractor by breaking back to the steel bar, cleaning with a wire brush, a protective layer applied and then covered with a repair mortar, to specialist installers specification.

| Ref no | Observations | Risk Rating | Mitigation | Timescale |
|---|---|---|---|---|
| Hams 002/2024 | Localised concrete repair to bin store where spalling noted. | Low / Medium | Engage a qualified specialist contractor to complete the repair | Within next 12 months |

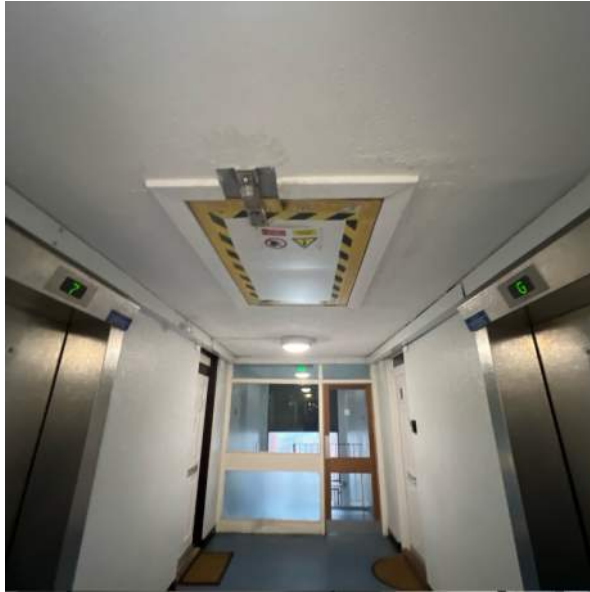
## Main Roof

Comments: Unable to access roof/open hatch during inspection.

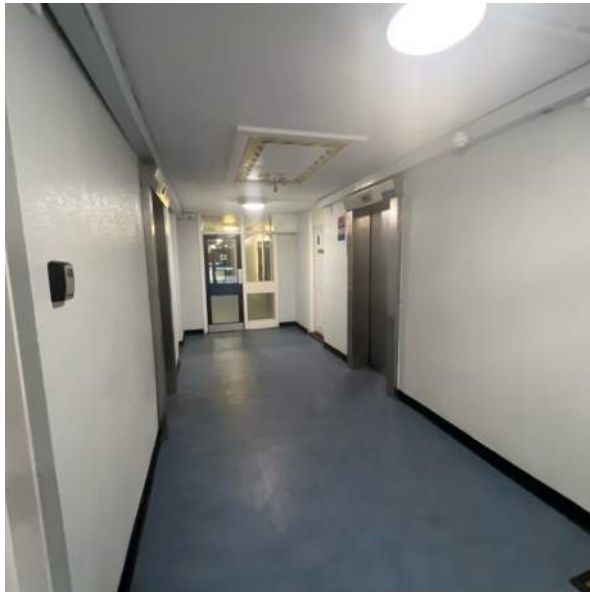
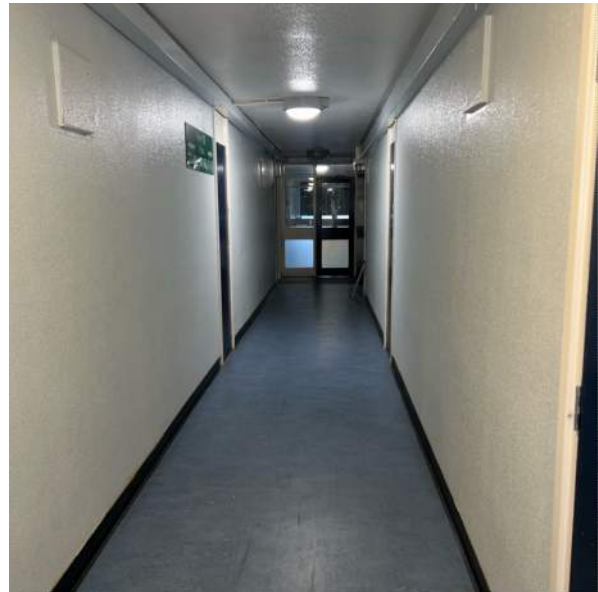
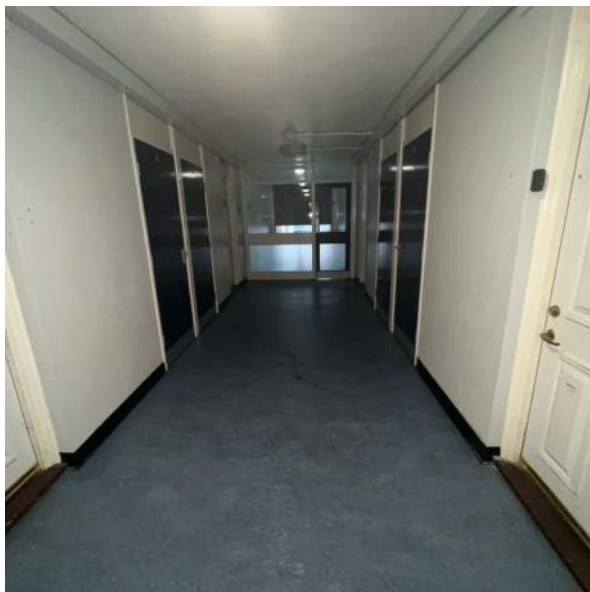
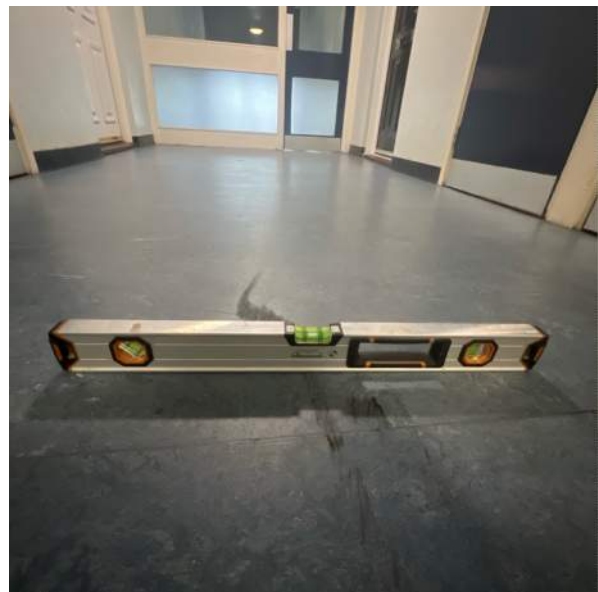
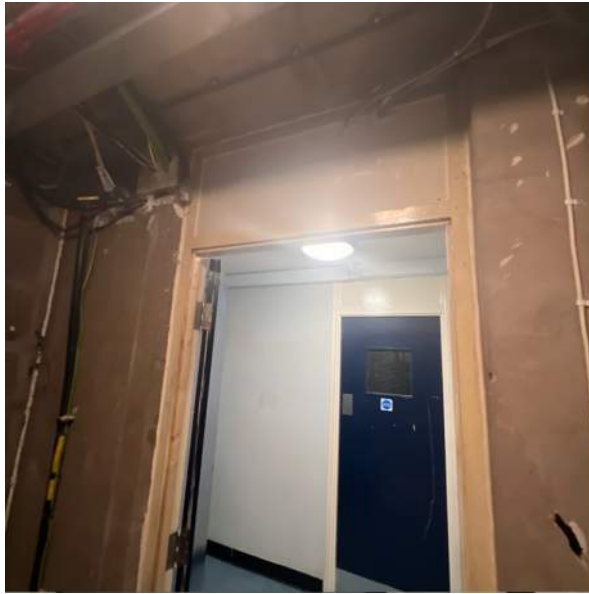
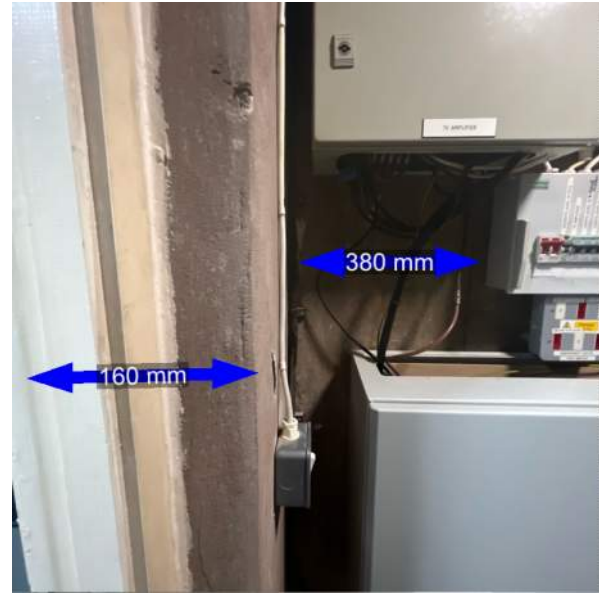
## 10th Floor Hallway

Comments: No jams or distortions noted to hallway doors to indicate any serviceability issues. Generally walls covered with finishes in hallway, likely to consist a mixture of concrete shear walls, embedded columns and masonry infill walls. Limited structure exposed. Concrete column/walls noted in electrical cupboard. Masonry block infill (non-load bearing) walls noted in riser cupboard.

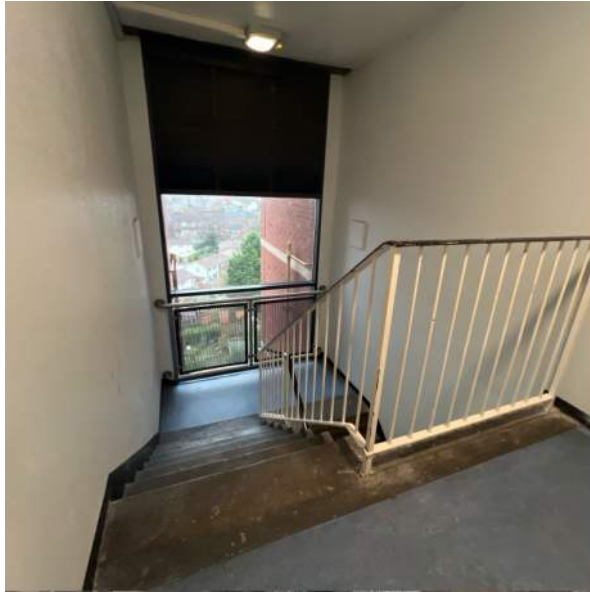
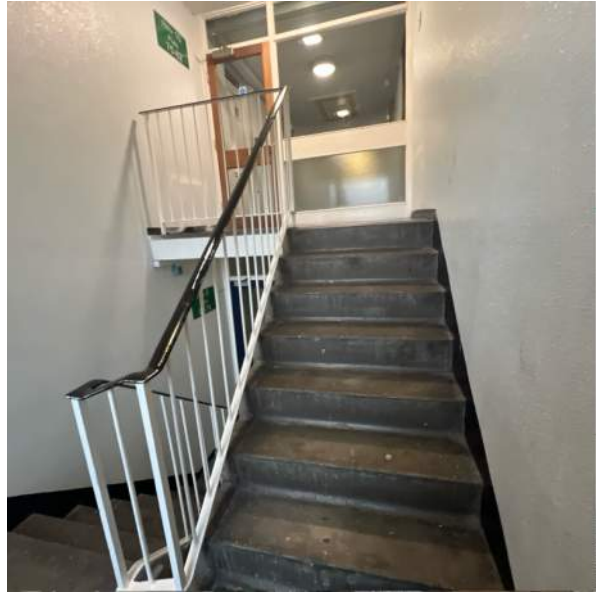
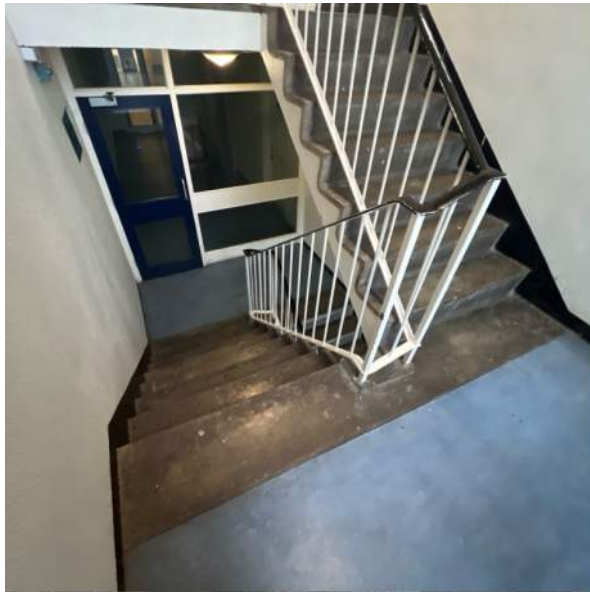
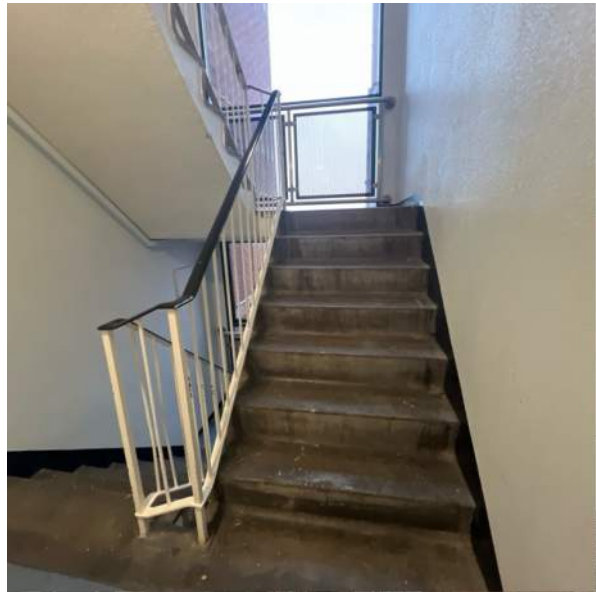
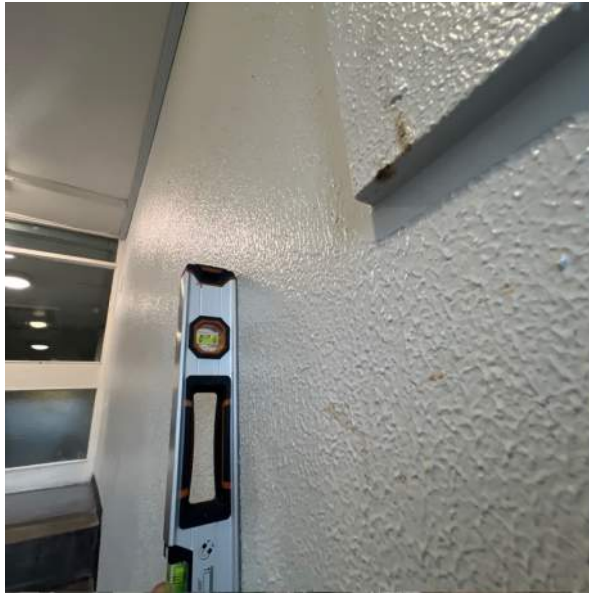
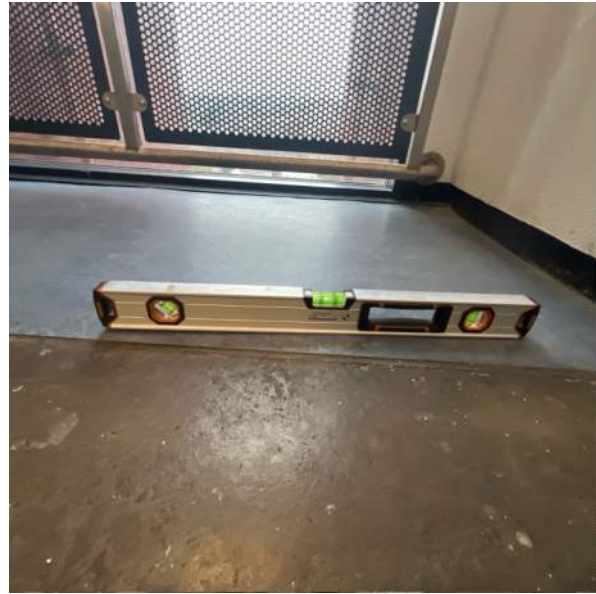
## 10th Floor Staircases

Comments: Insitu concrete stairs with steel hand railing fixed to stairs. Walls and floors appear to be fairly level. Locally sloping stair platform however this does not appear to be structural.  
Stair walls covered with finishes however these would likely form the main concrete shear core walls.

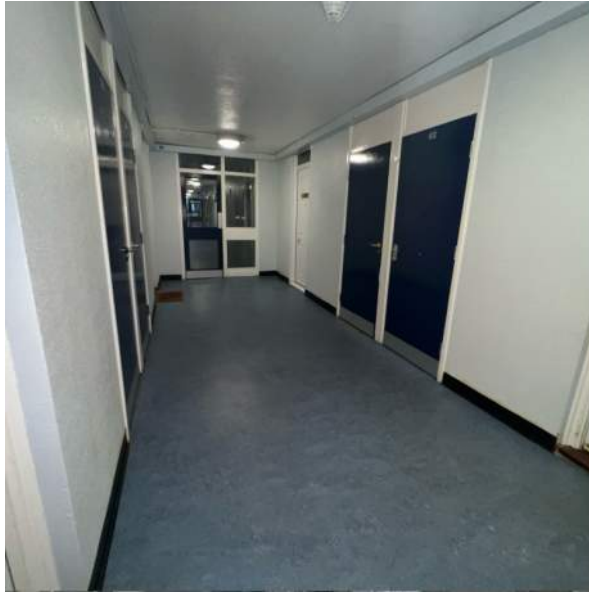
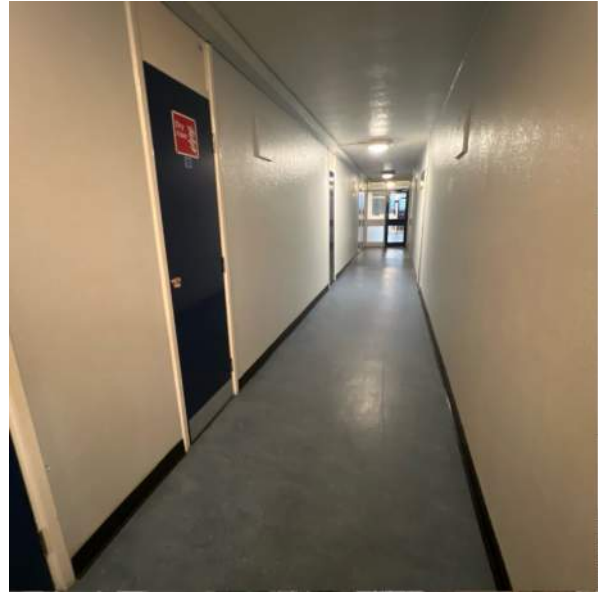
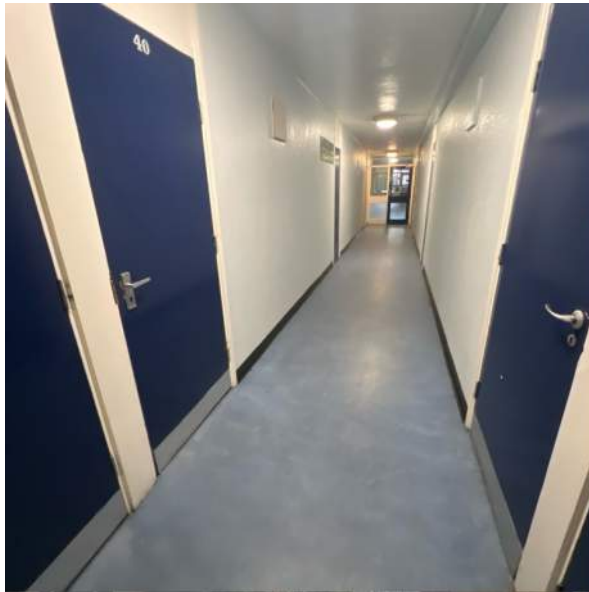
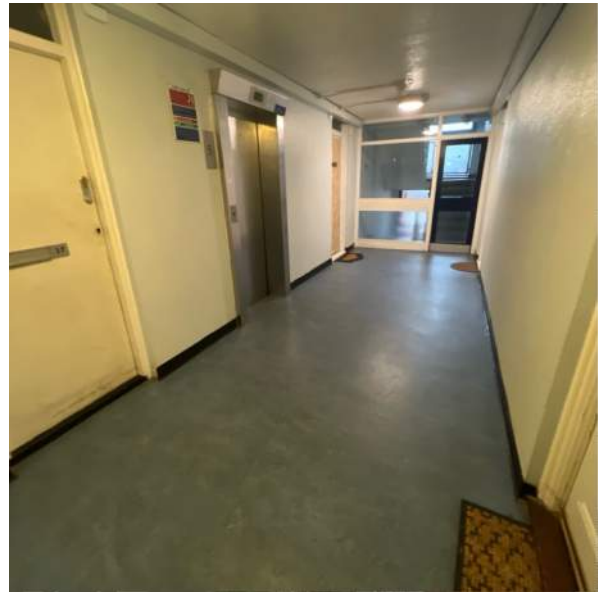
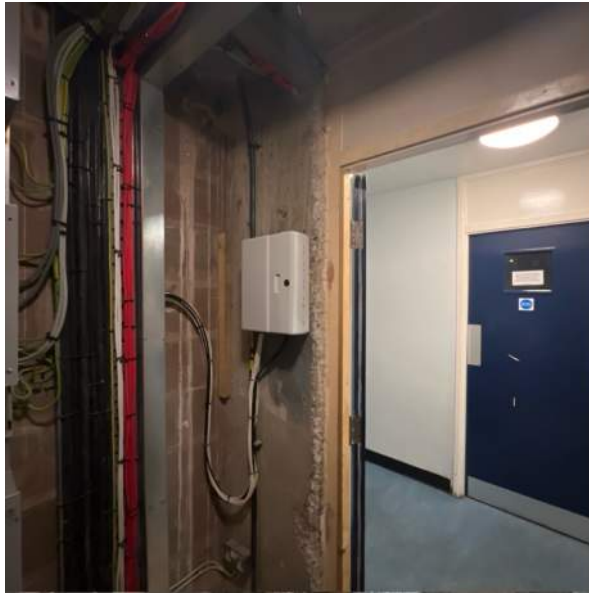
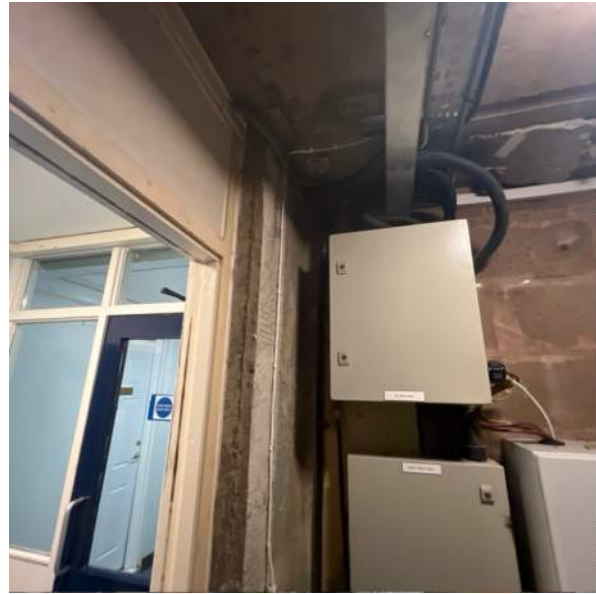
## 5th Floor Hallway

Comments: No jams or distortions noted to hallway doors to indicate any serviceability issues. Generally walls covered with finishes in hallway, likely to consist a mixture of concrete shear walls, embedded columns and masonry infill walls. Limited structure exposed. Concrete column/walls noted in electrical cupboard. Masonry block infill (non-load bearing) walls noted in riser cupboard.

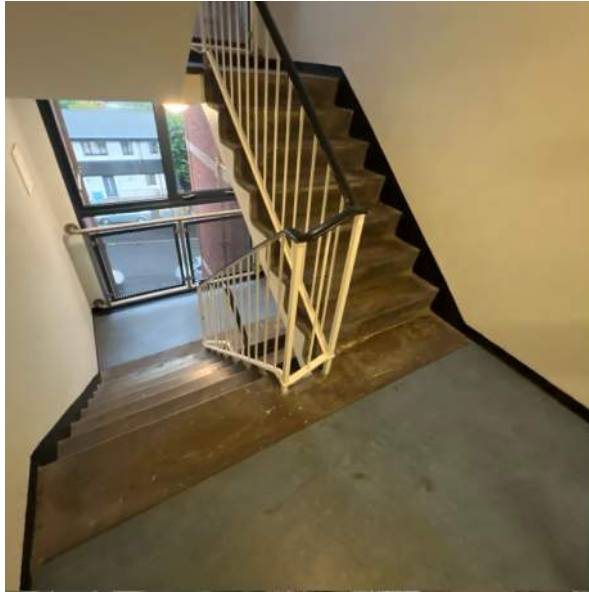
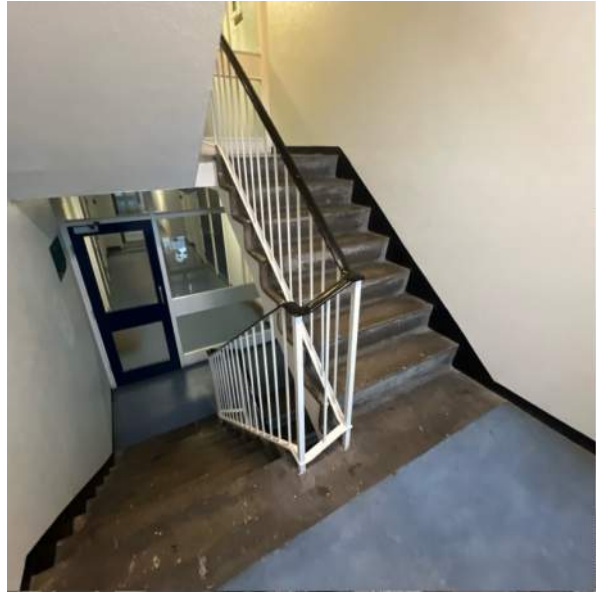
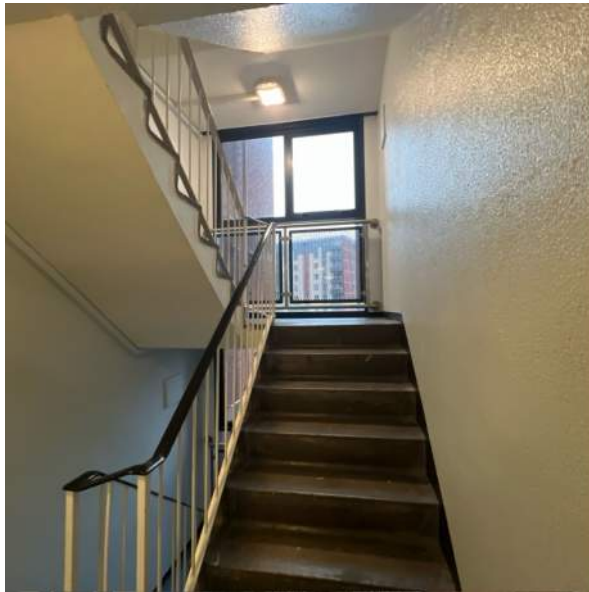
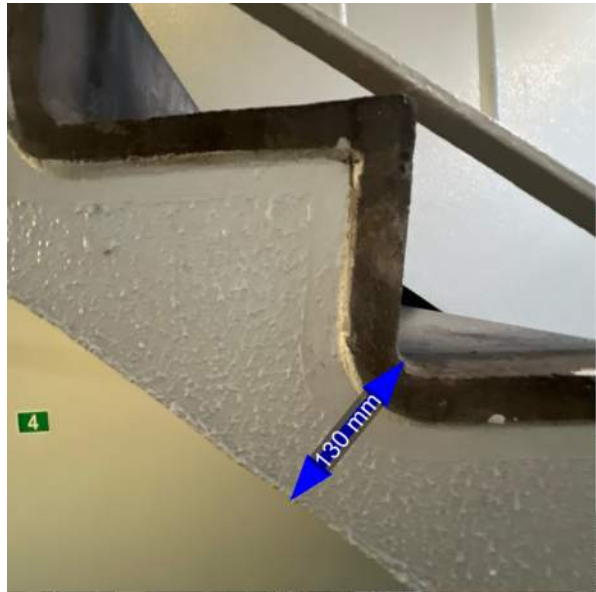
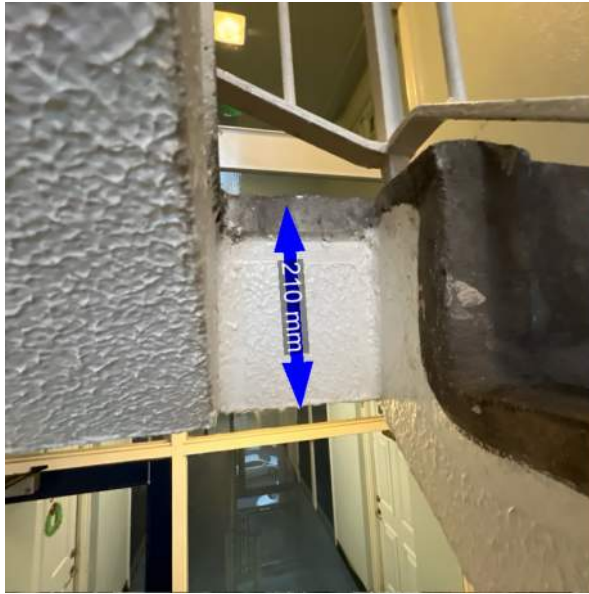
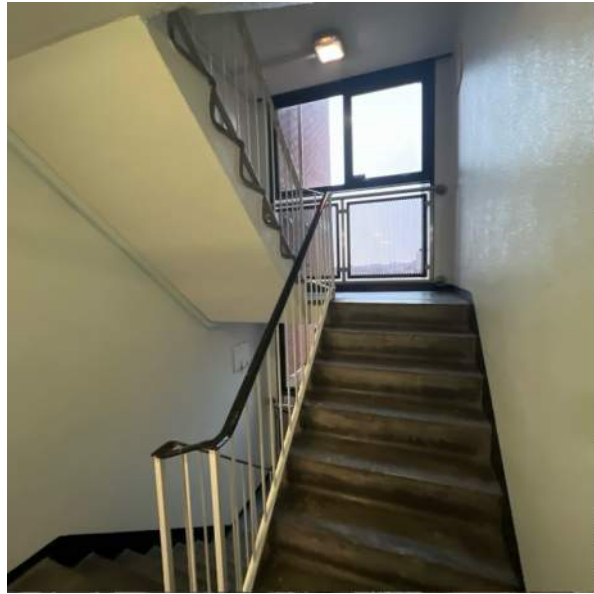
## 5th Floor Staircases

Insitu concrete stairs with steel hand railing fixed to stairs. Walls and floors appear to be fairly level.

Stair walls covered with finishes however these would likely form the main concrete shear core walls.

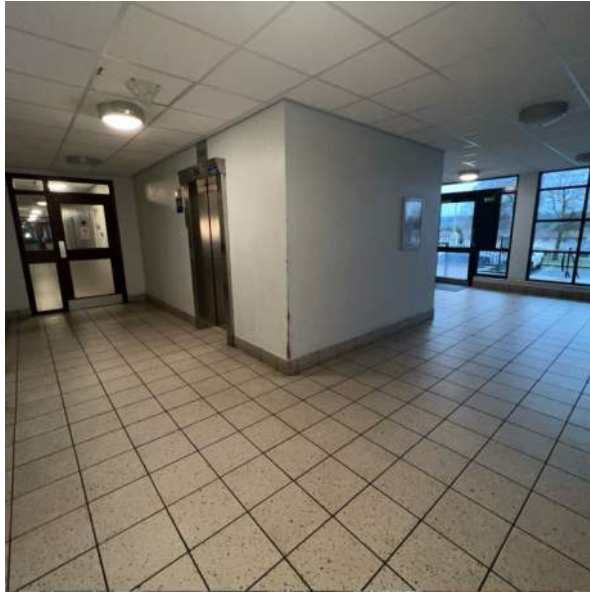
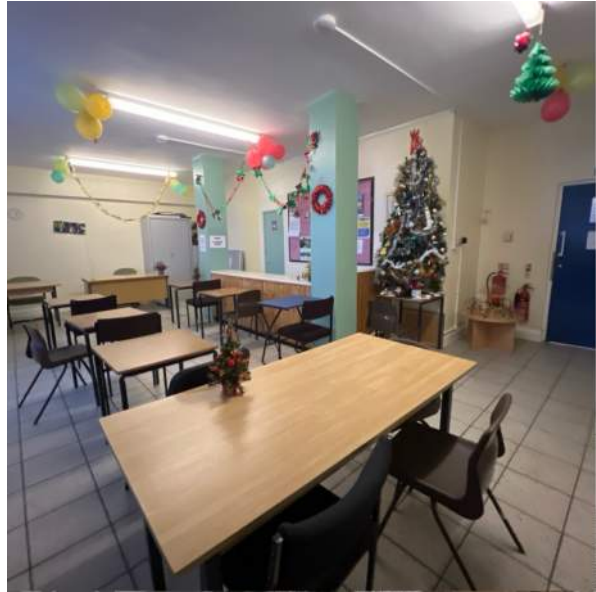
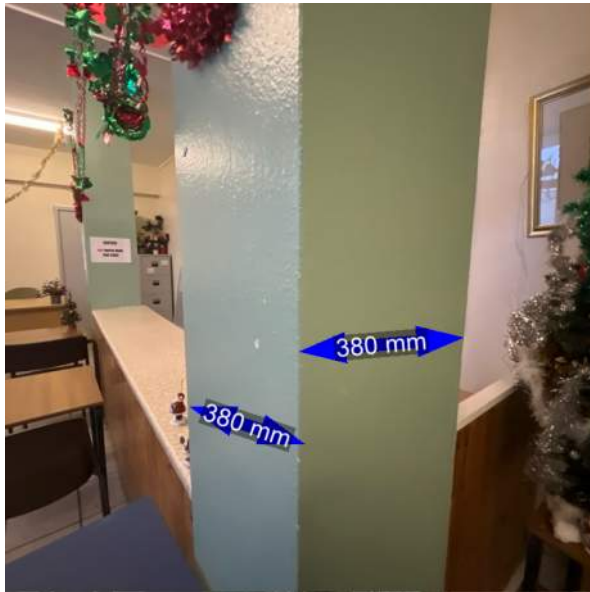
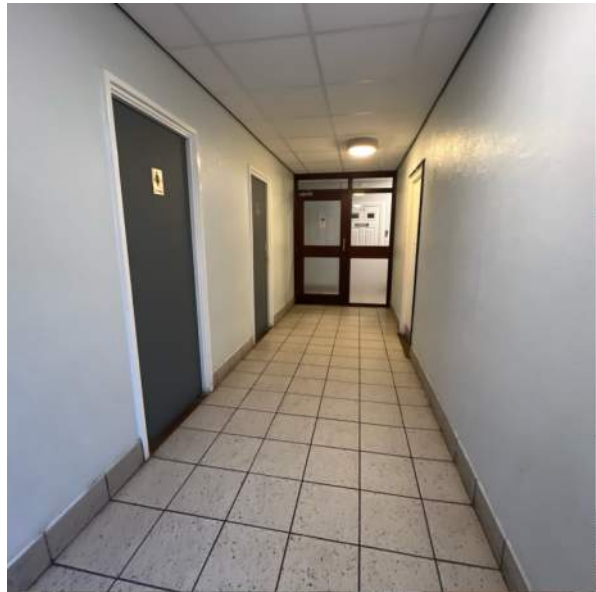
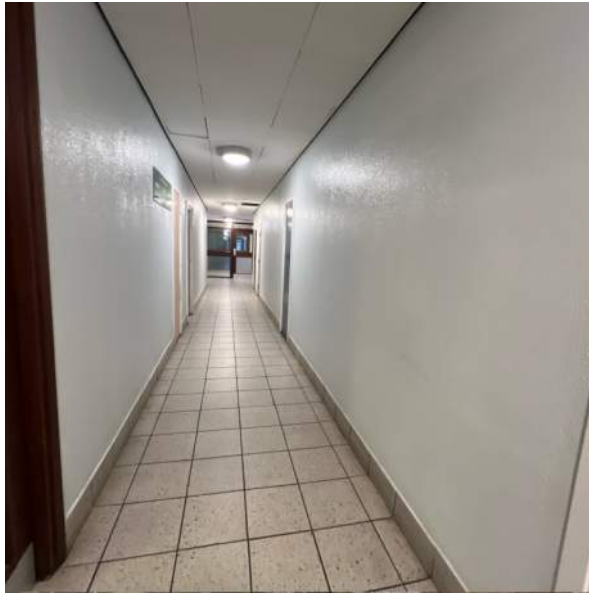
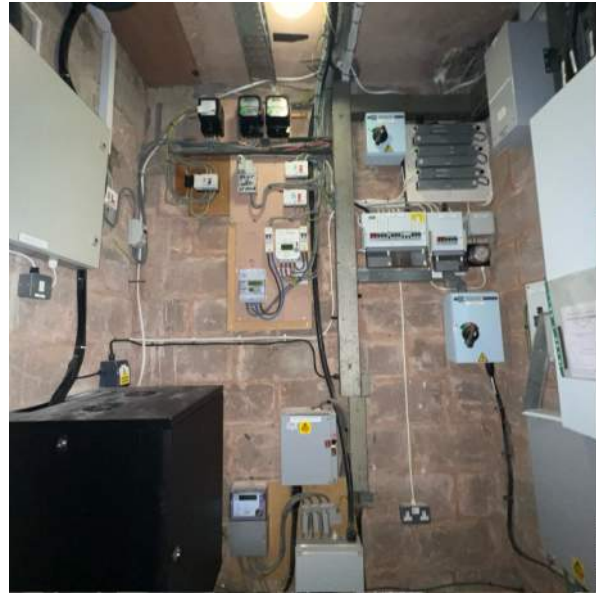
## Ground Floor Hallway

Comments: No jams or distortions noted to hallway doors to indicate any serviceability issues. Generally walls covered with finishes in hallway, likely to consist a mixture of concrete shear walls, embedded columns and block infill walls. Limited structure exposed. RC columns noted in community room.

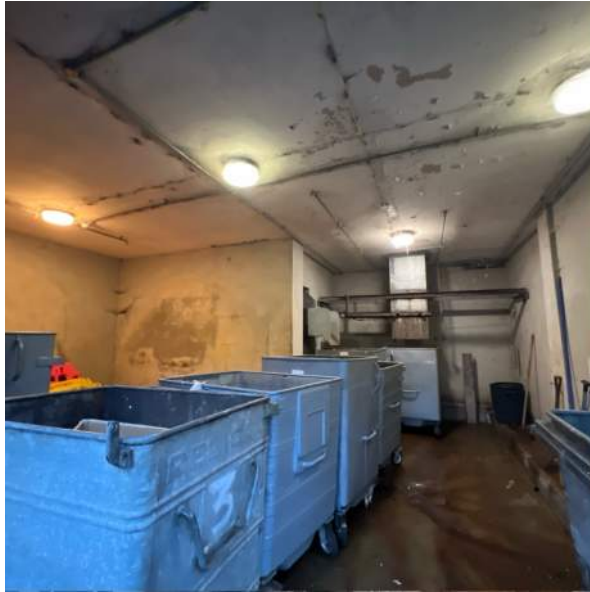
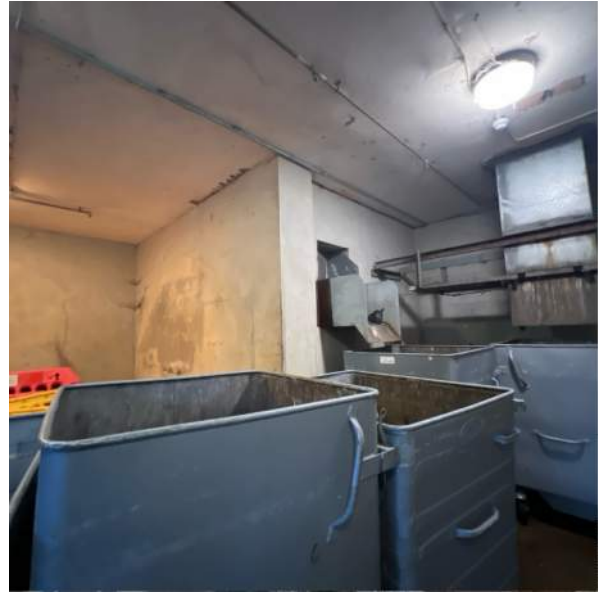
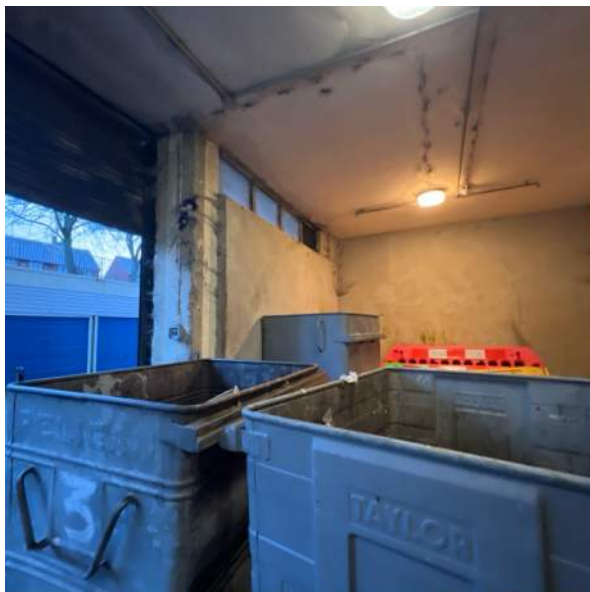
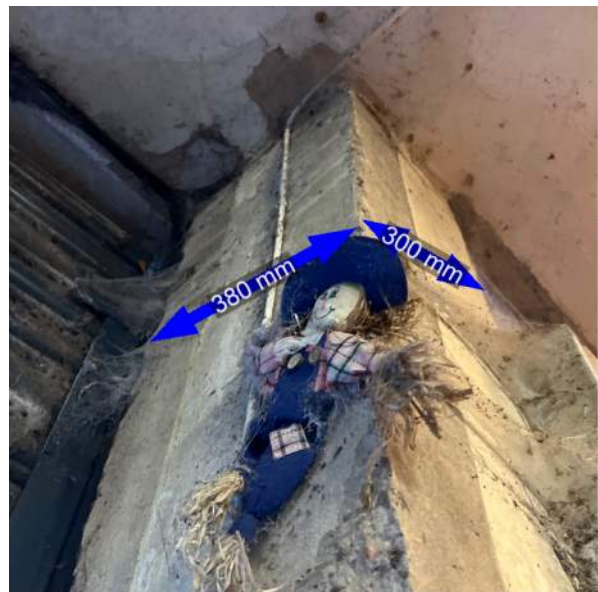
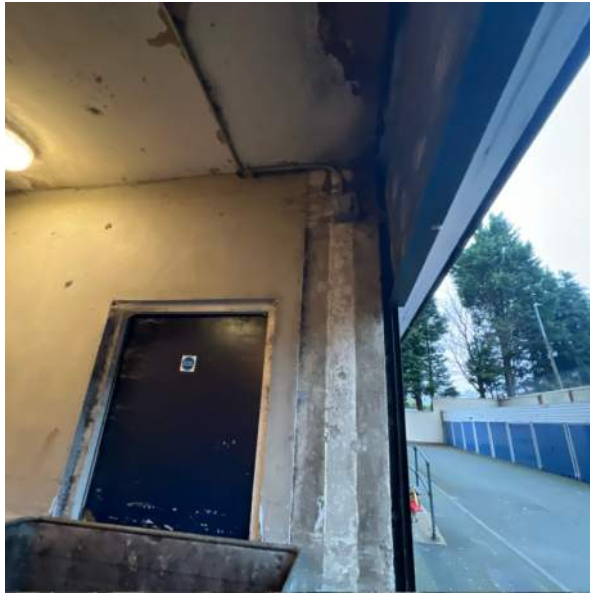
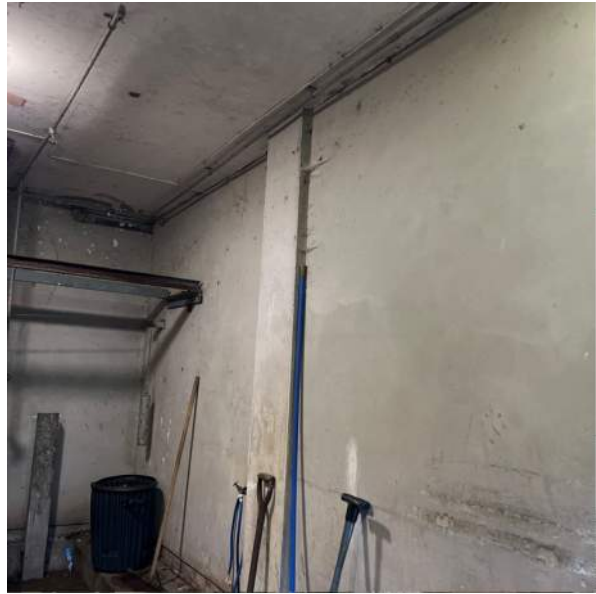
## Binstore

RC shear walls noted. Perimeter columns measure to be approx. 380x300mm.

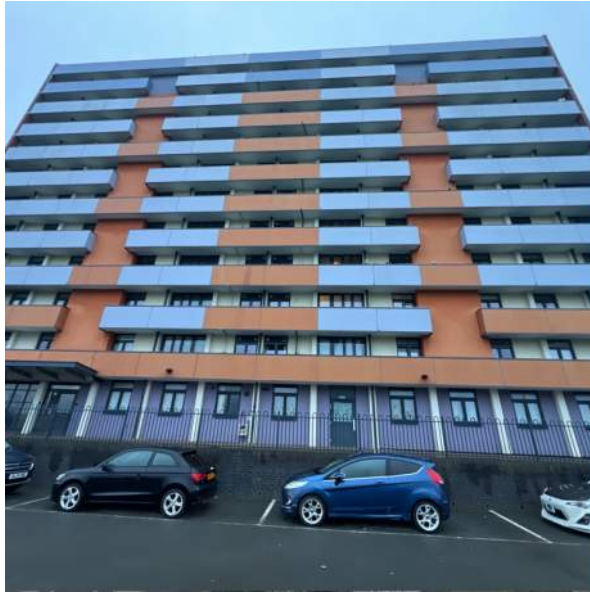
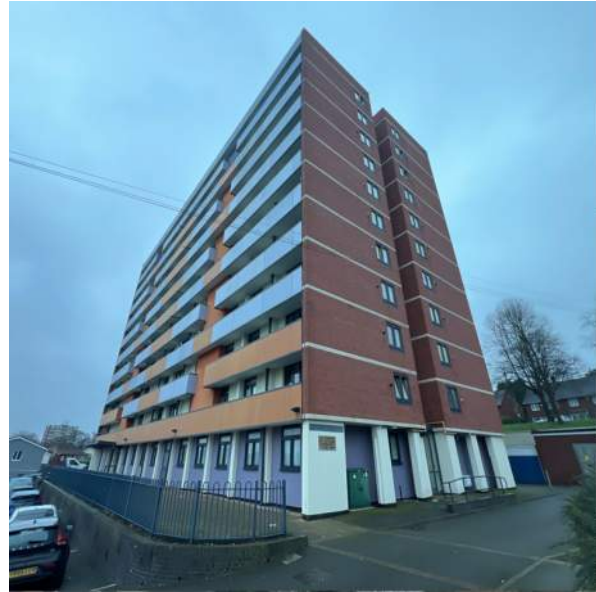
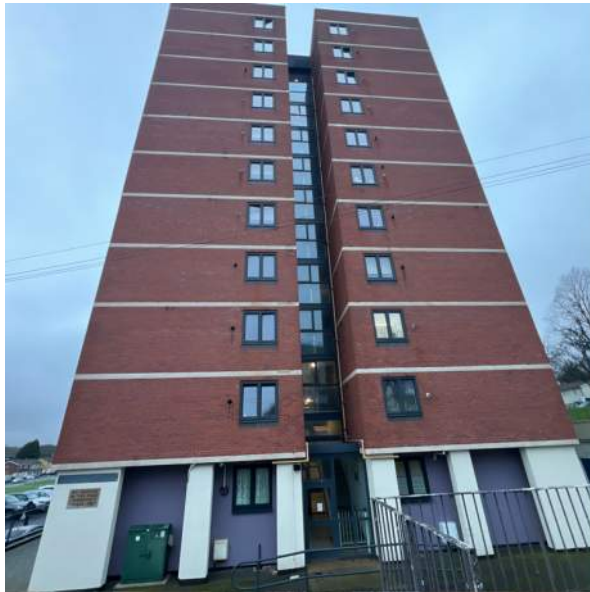
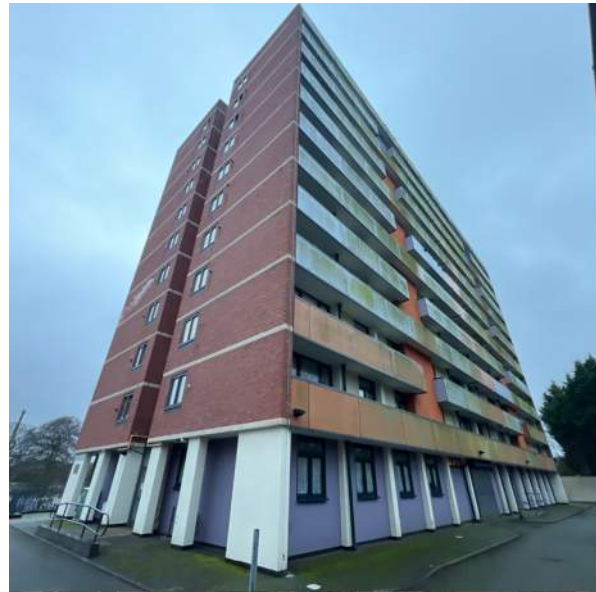
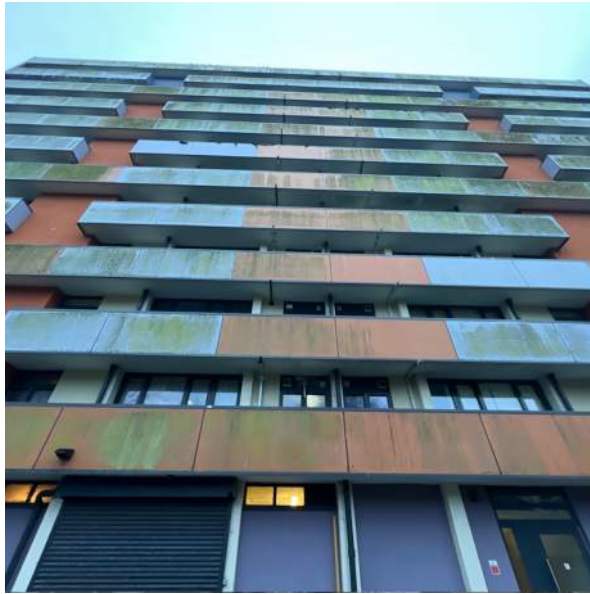
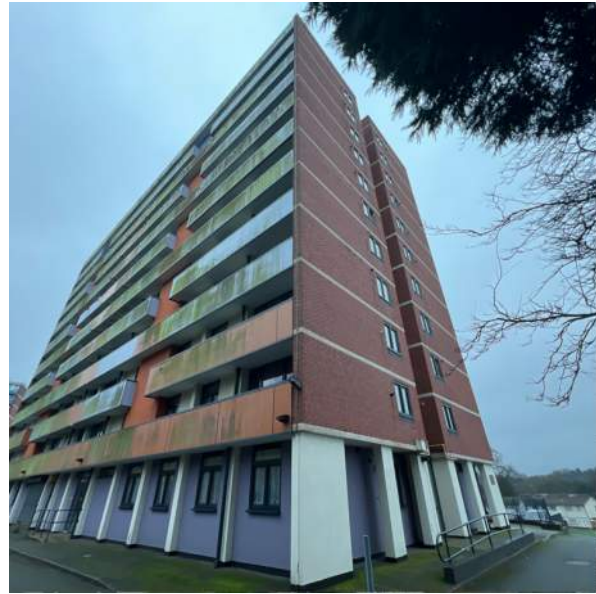
## Elevations

Comments: Rendered facade to front and rear elevations. Brickwork to side elevations. Balconies noted at each level, cladded.
