VISUAL STRUCTURAL APPRAISAL

1-73 Harry Price House

Hartlebury Rd  
Oldbury  
B69 1EQ

12<sup>th</sup> November 2024

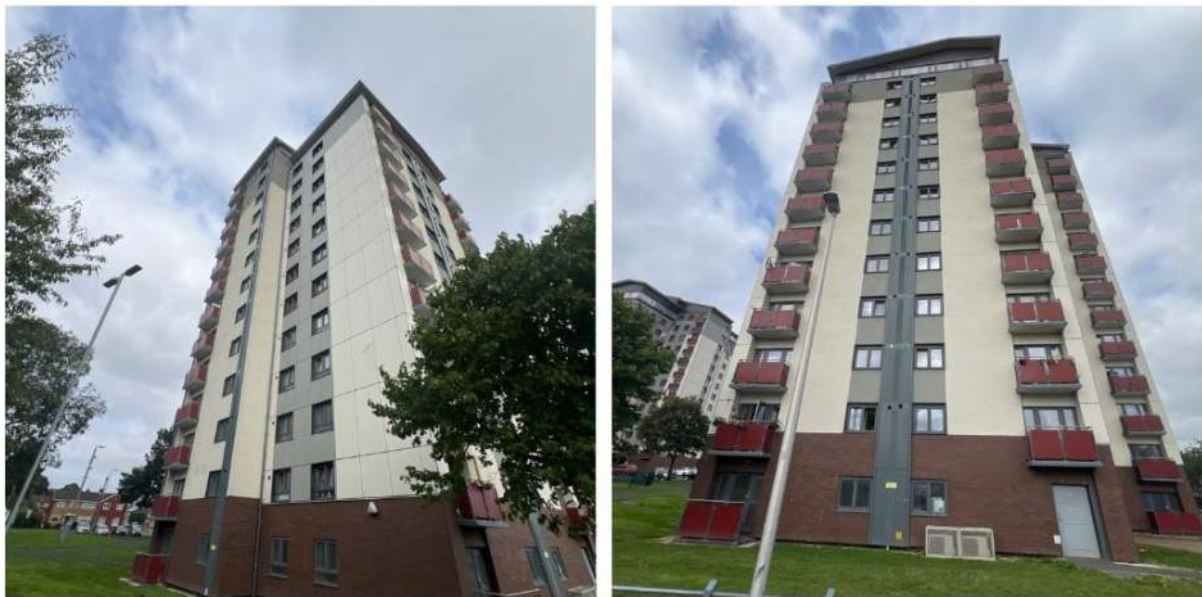
Figure 9 and 10: Building Elevations

The exterior elevations were generally in ok condition and no significant structural defects were noted to the cladding panels. There were no significant cracks or tell-tale signs of any significant structural movement noted at the time of our inspection.

The exterior panels were noted to be plumb with no signs of significant bowing, bulging or leaning noted to the panels indicating failed fixings however their presence and condition cannot be confirmed.

There are balconies at each level which are formed of cantilevered RC slabs tied into the main frame, likely cast monolithically with the primary RC frame.

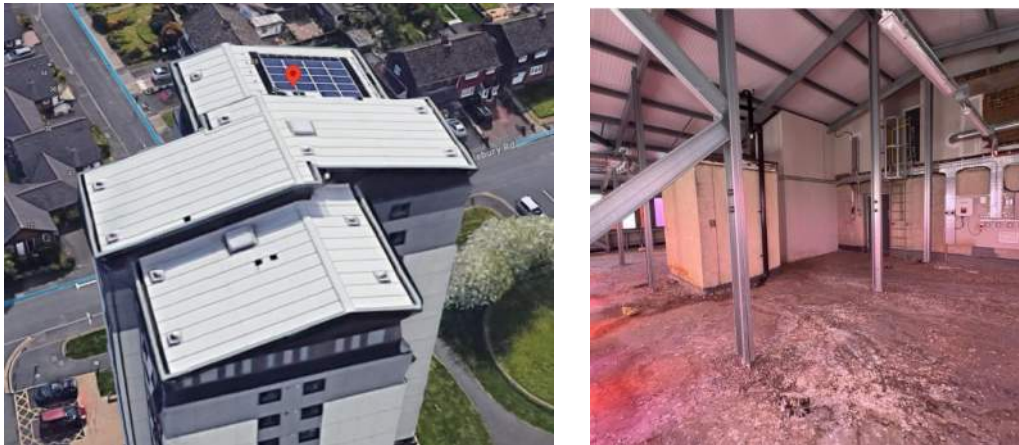
Figure 11 and 12: Roof Level

There were no tell-tale signs of any significant structural movement noted at the time of our inspection. The exterior walls were noted to be plumb with no signs of significant bowing, bulging or leaning noted to the masonry walls.

The roof has subsequently been covered with a new waterproofing covering formed of a steel frame installed to the existing roof which supports pitched corrugated sheets. This roof is not insulated and therefore acts purely as a weather barrier. The fire protection of the steel is unclear as the beams do not appear to be protected. Details of this frame should be requested from the contractor who completed the works in 2018.

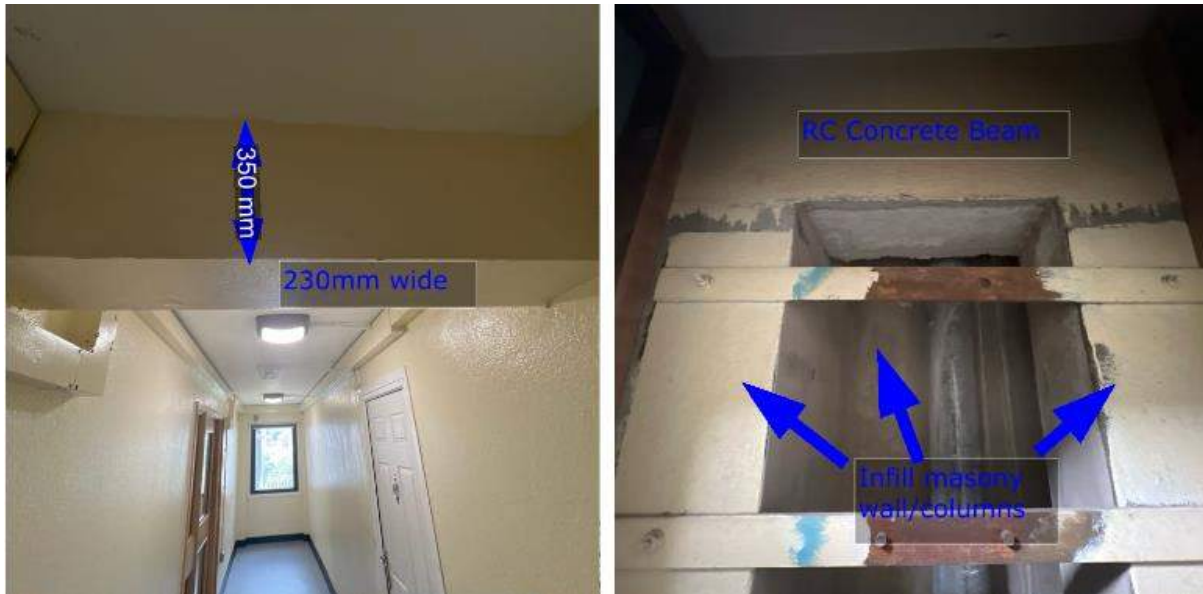
Figure 13 and 14: RC Structure

The interior of the stair core walls were checked and were plumb and in line with observations made to the exterior – no significant signs of leaning or movement noted. The concrete appeared in fair condition with few BRE category 1 cracks but no structurally significant defects were noted.

The shear walls around stair core appeared to be 240mm including finishes, therefore ~200mm RC wall. Ther beams are measured with 350mm downstand including finishes. A cover test is required to check the resistance of the concrete section in the event of a fire.

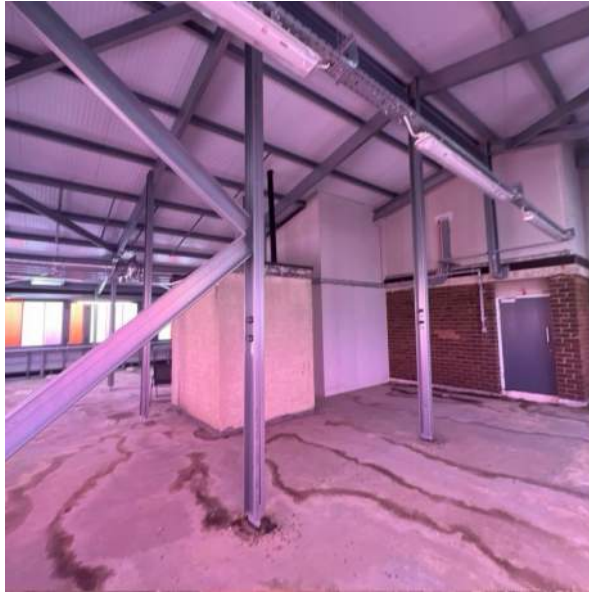
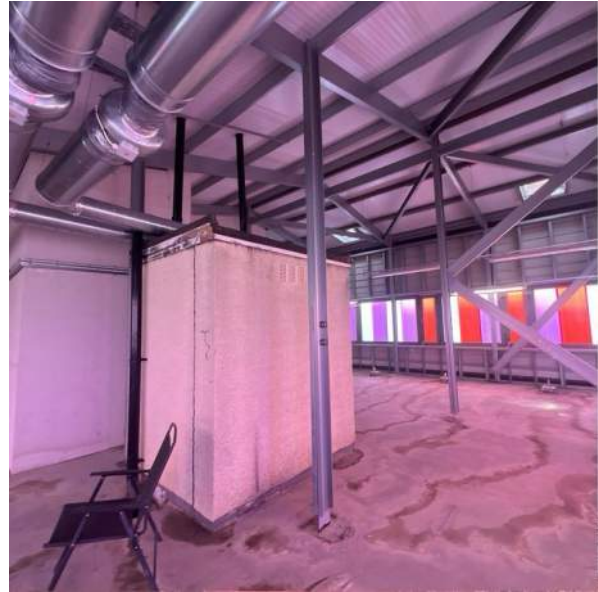
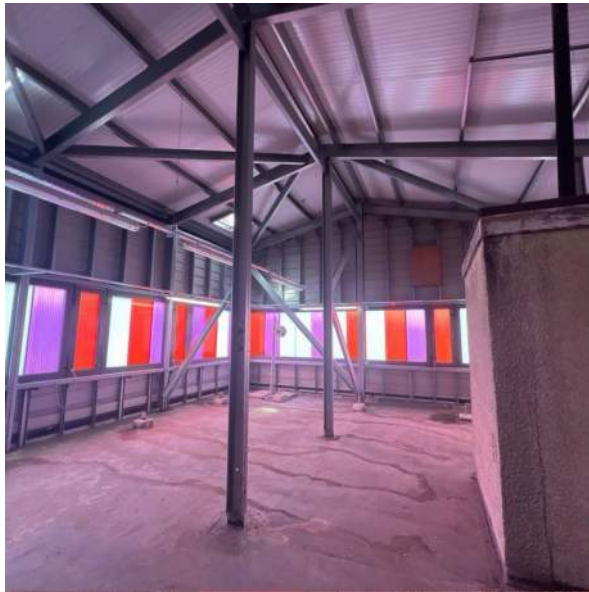
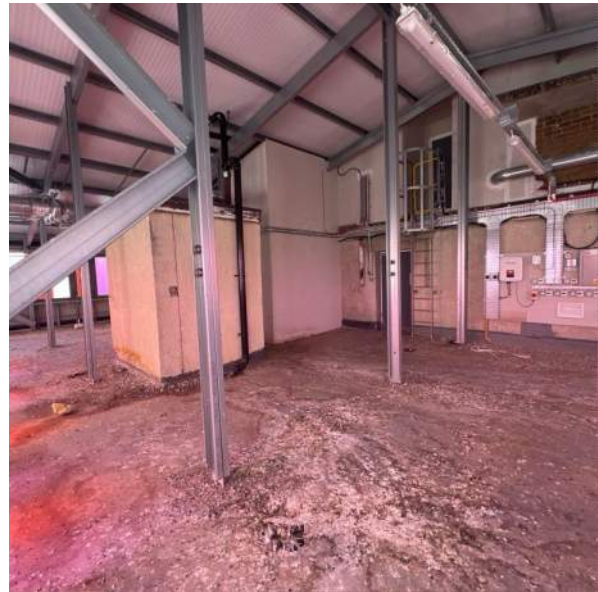
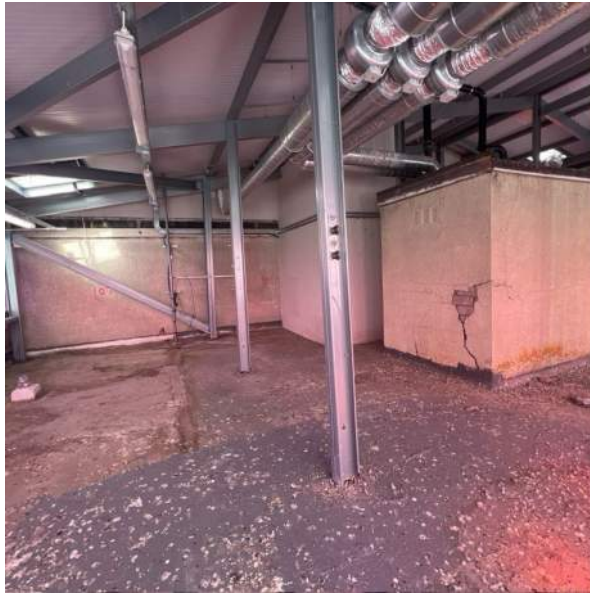
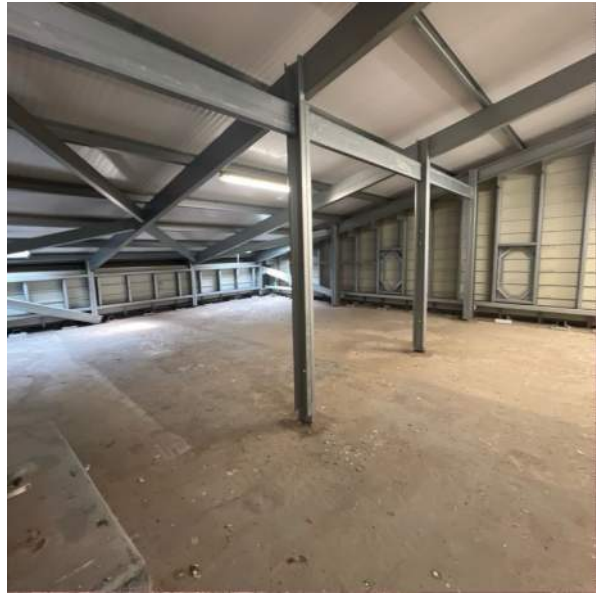
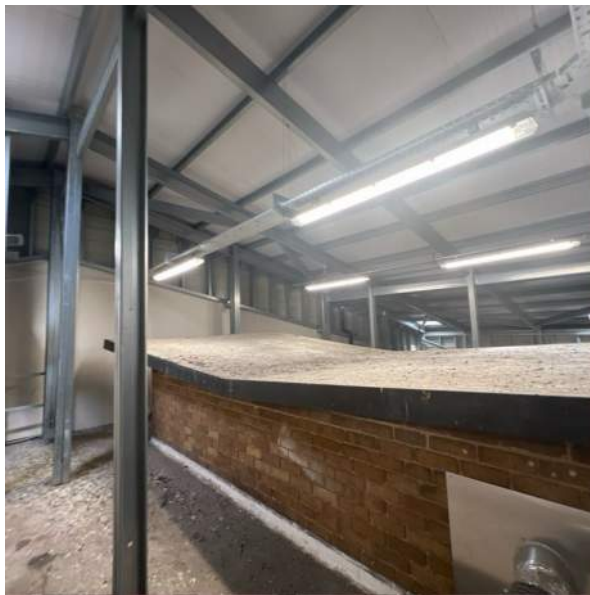
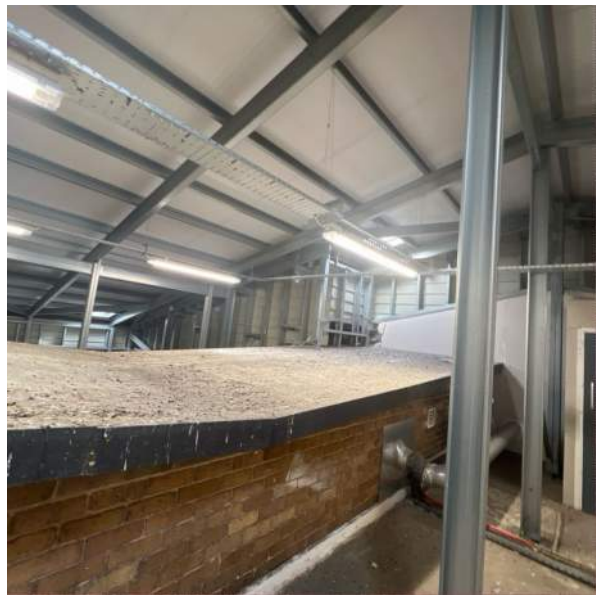
## Main Roof

Comments: Roof structure consists of a lower and higher section and is formed of a concrete slab with a Lightweight SFS (appear to be cold rolled) frame with a pitched roof fixed on to main roof structure. Frame columns fixed to perimeter of roof.

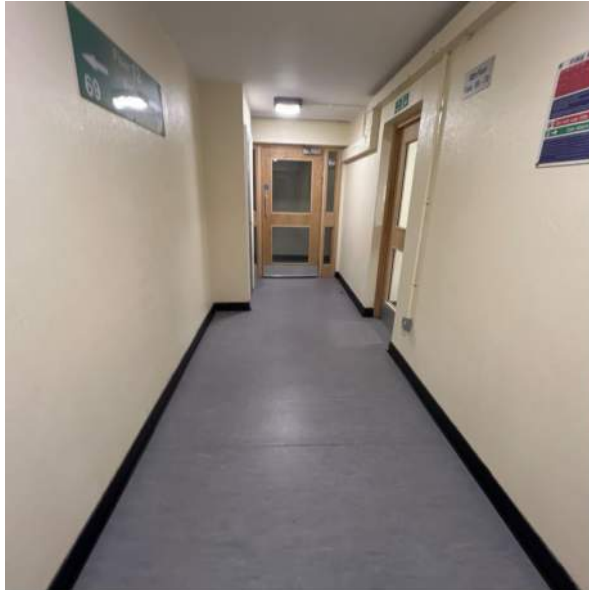
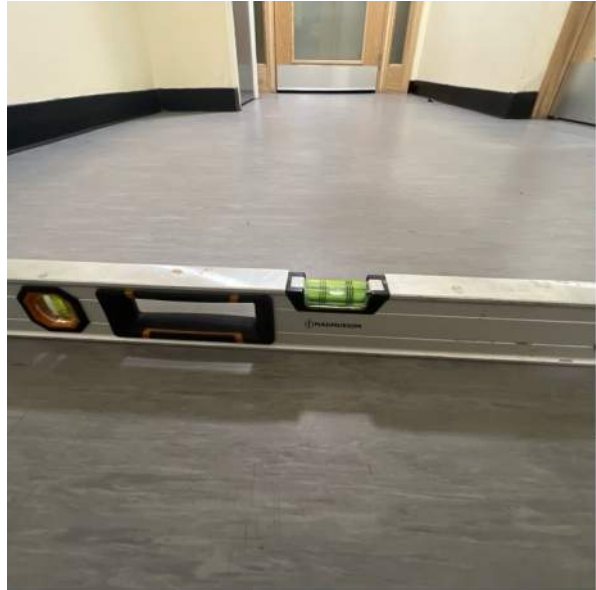
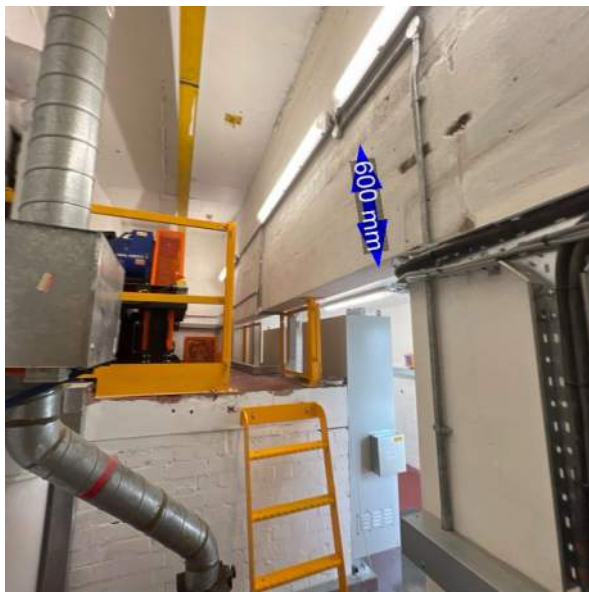
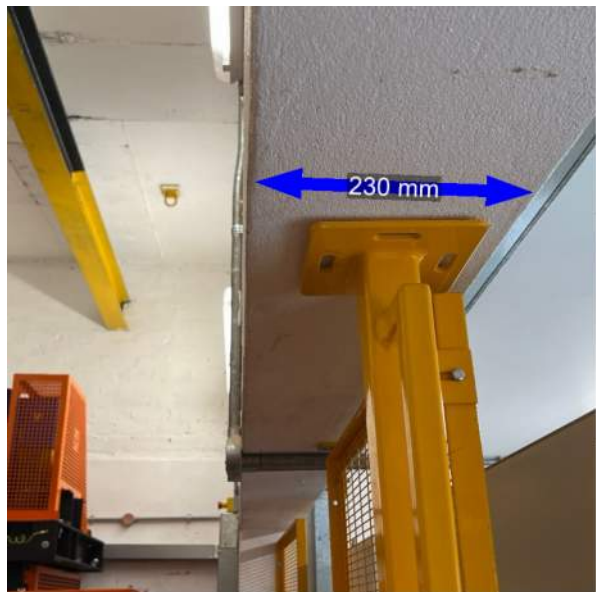
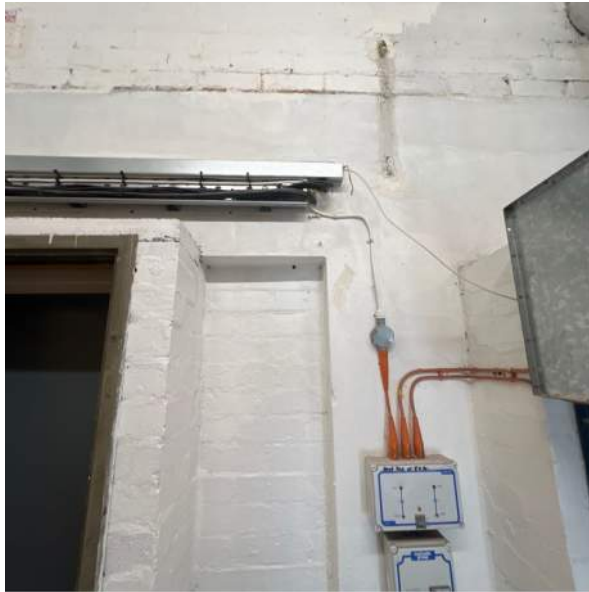
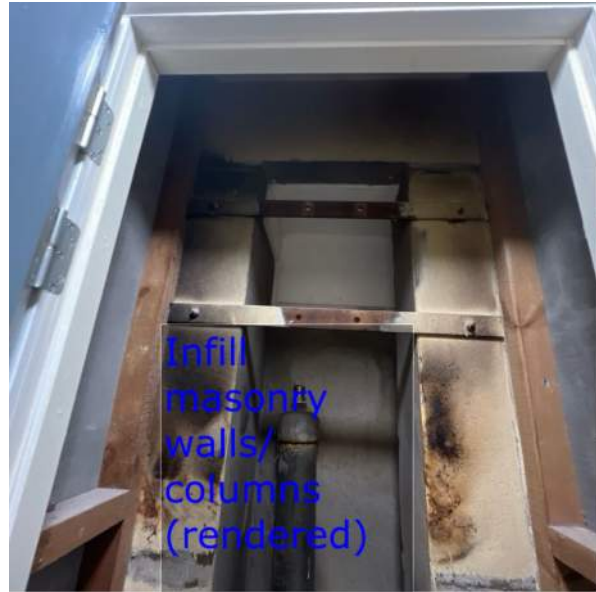
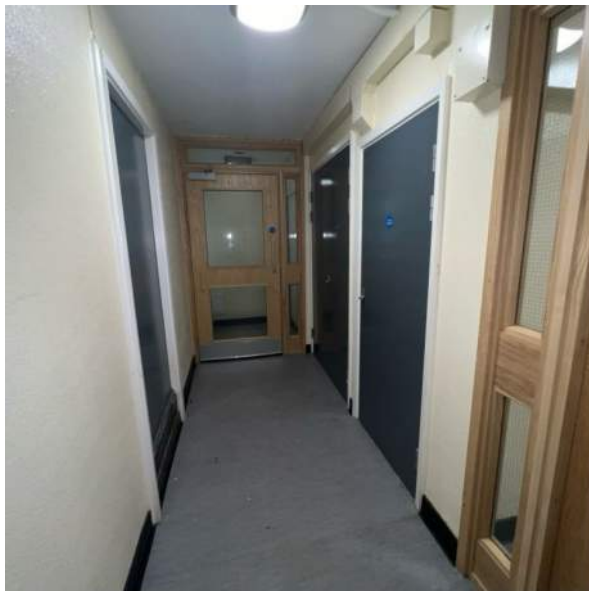
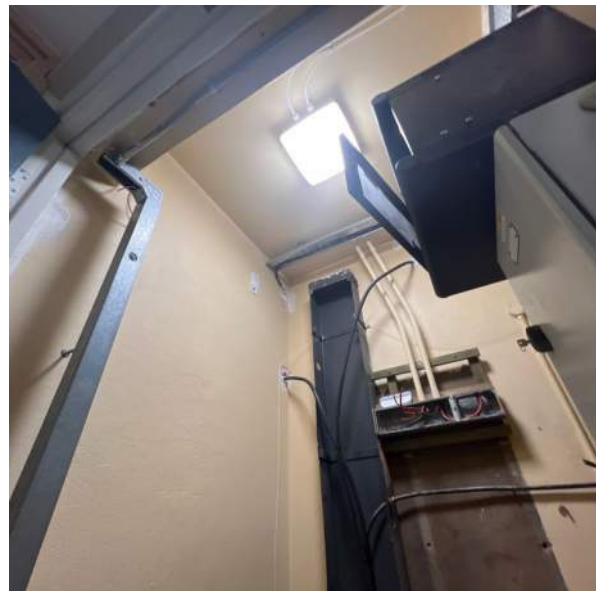
## 12th Floor Hallway

Comments: No jams or distortions noted to hallway doors to indicate any serviceability issues. Generally walls covered with finishes in hallway, likely to consist a mixture of concrete shear walls and embedded columns with internal partition walls. Visible concrete elements (RC Beams and Columns) noted via lift room. Some infill (non-load bearing) masonry noted, some of which are rendered.

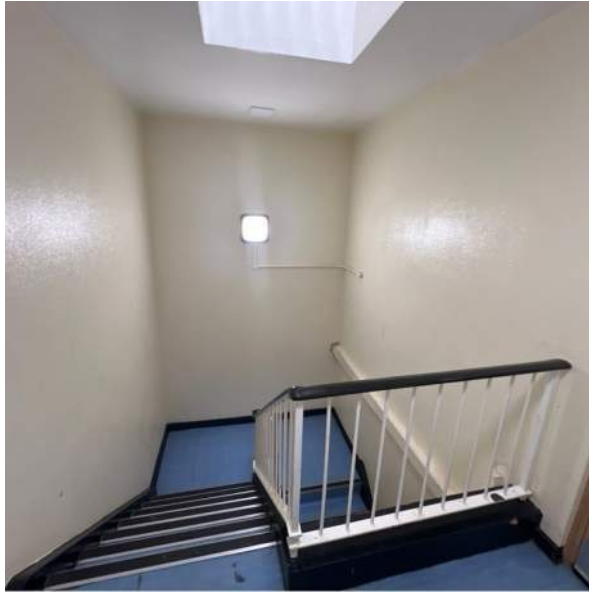
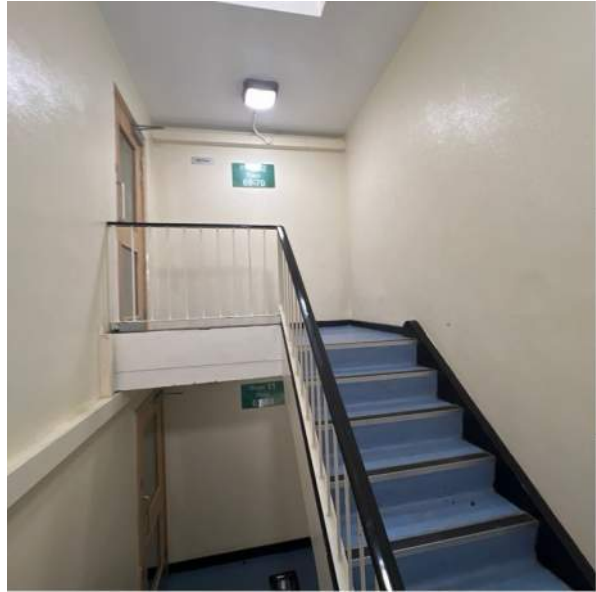
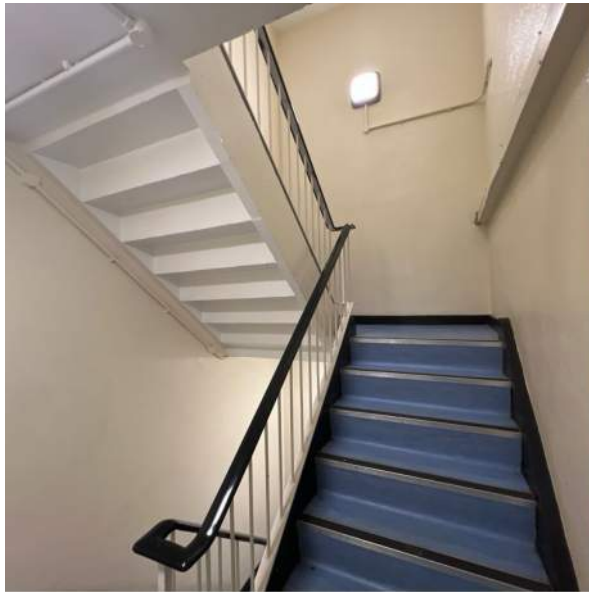
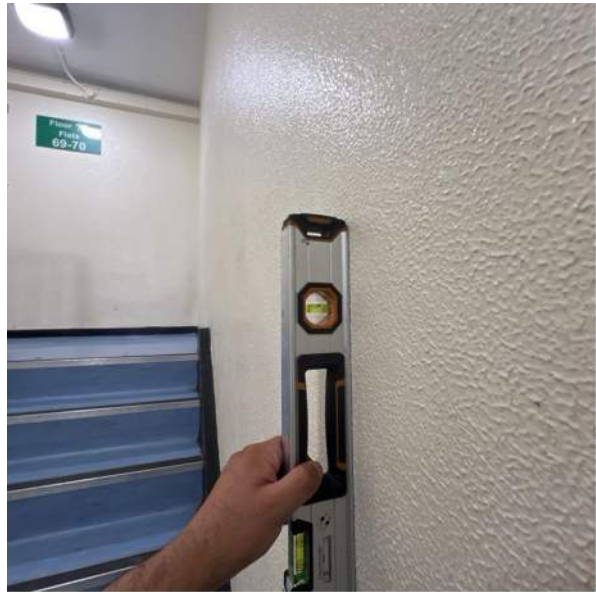
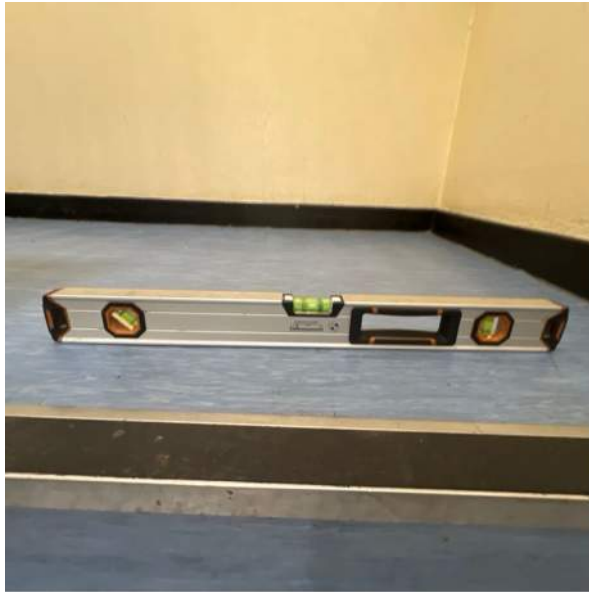
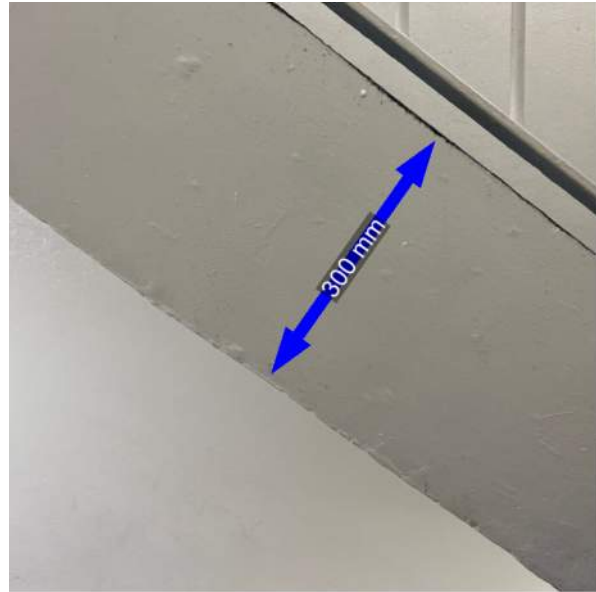
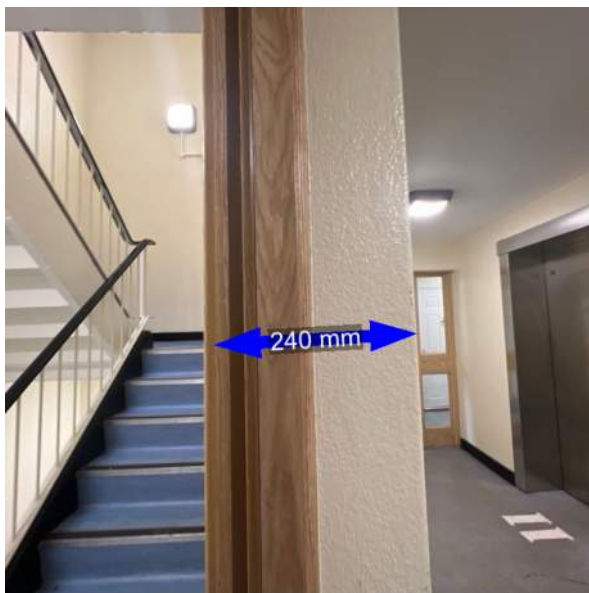
## 12th Floor Staircase

In situ concrete stairs with steel hand railing fixed to stairs. Walls and floors appear to be fairly level.

Staircase/hallway wall measured to be approx. 240mm thick.

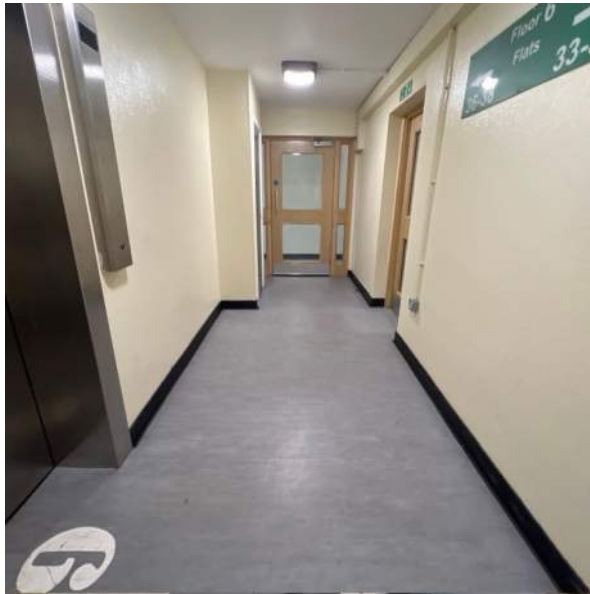
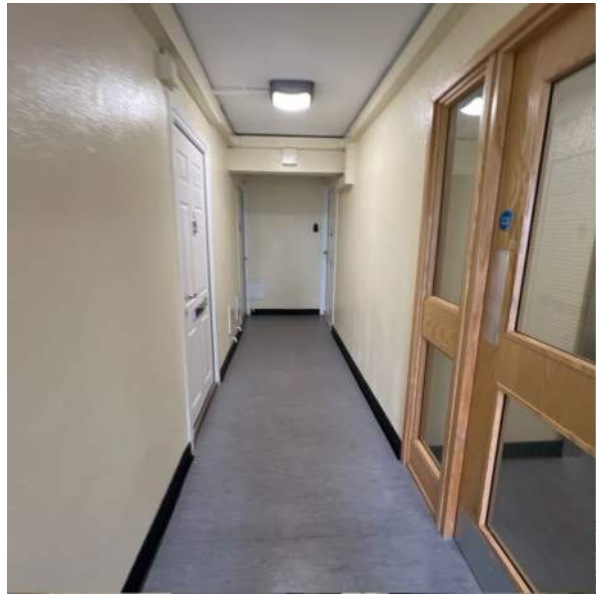
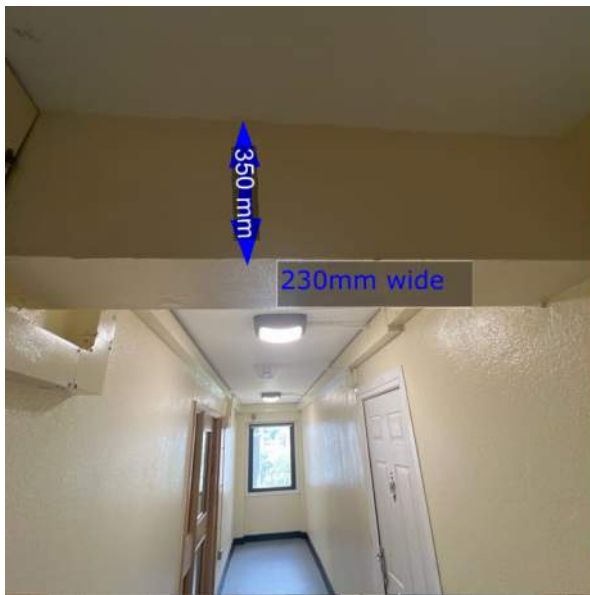
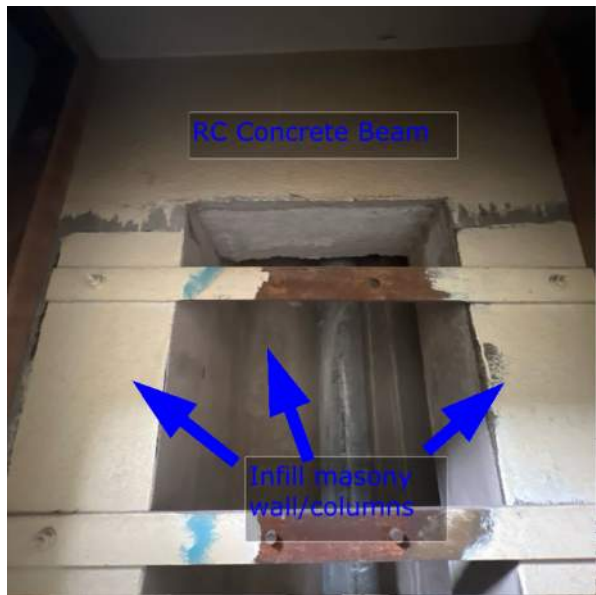
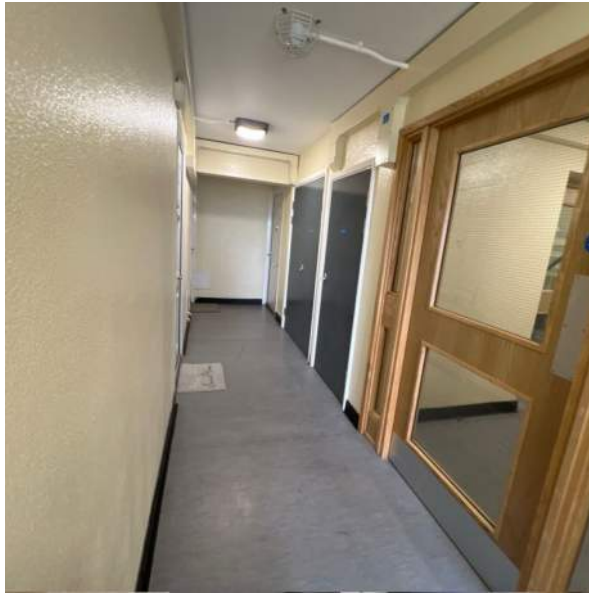
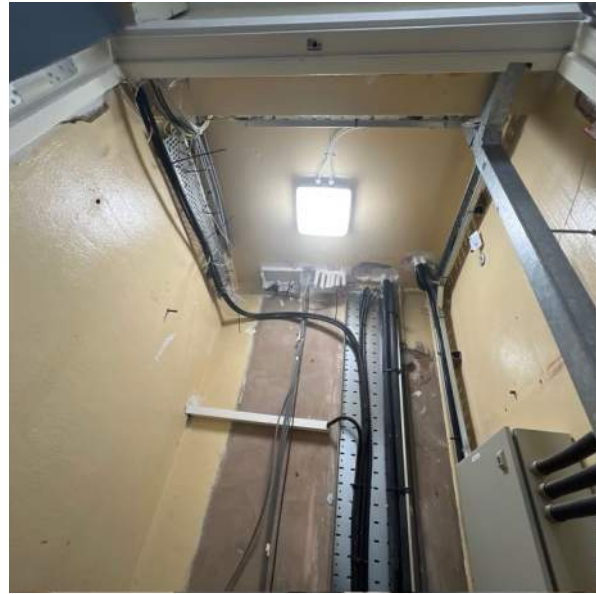
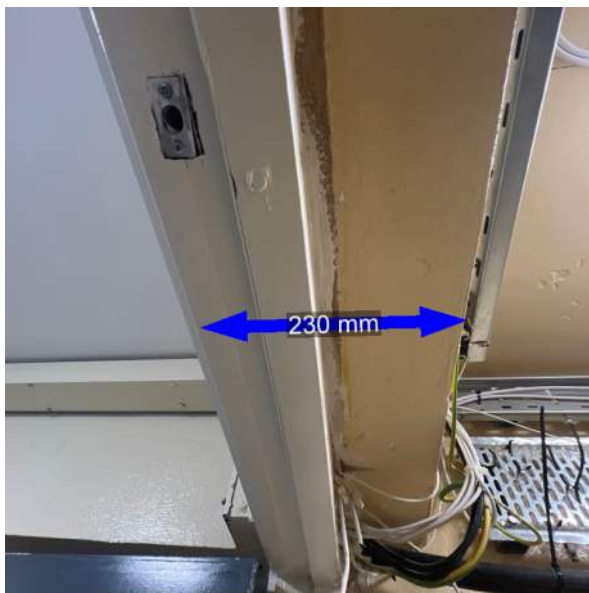
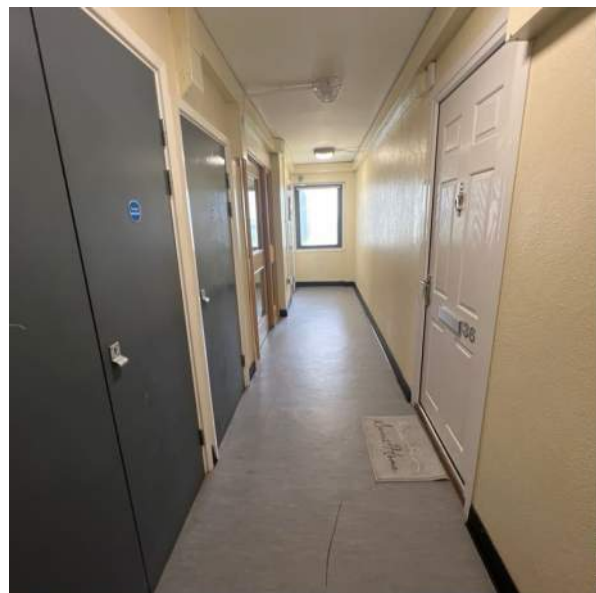
## 6th Floor Hallway

No jams or distortions noted to hallway doors to indicate any serviceability issues. Generally walls covered with finishes in hallway, likely to consist a mixture of concrete shear walls and embedded columns with internal partition walls. Possible concrete walls noted via riser cupboard. Some infill (non-load bearing) masonry noted some of which are rendered.

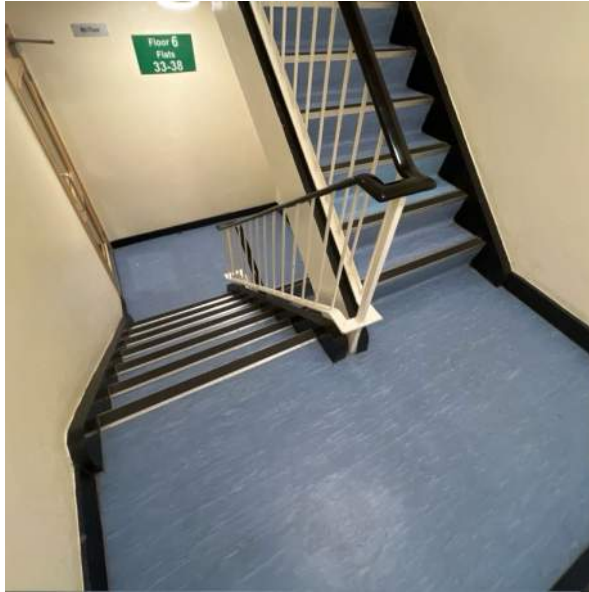
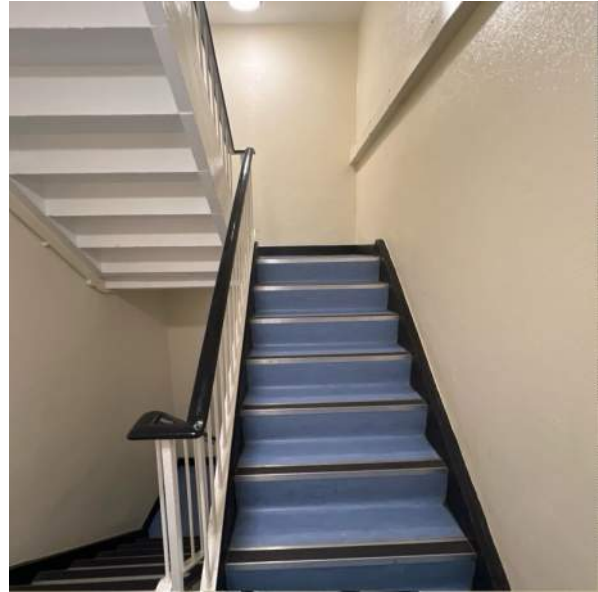
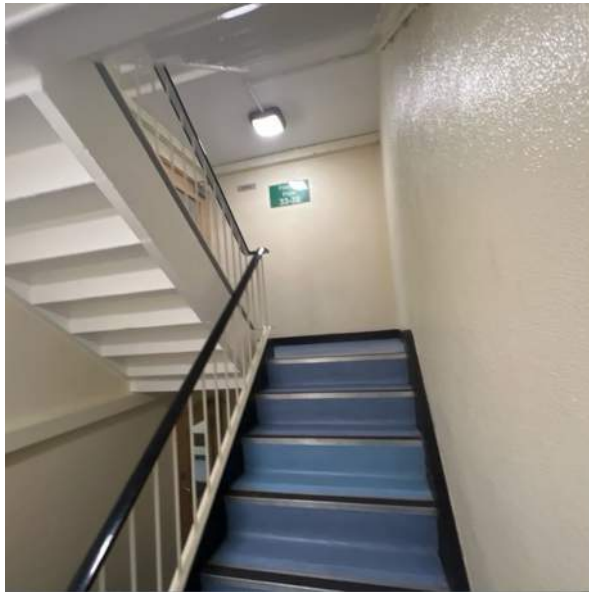
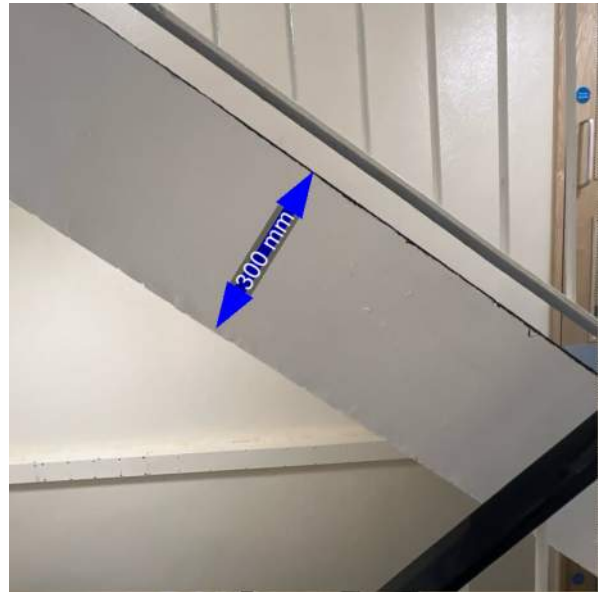
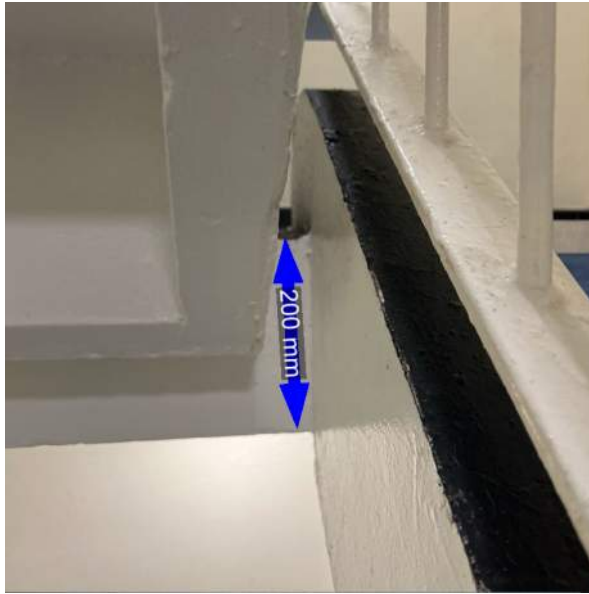
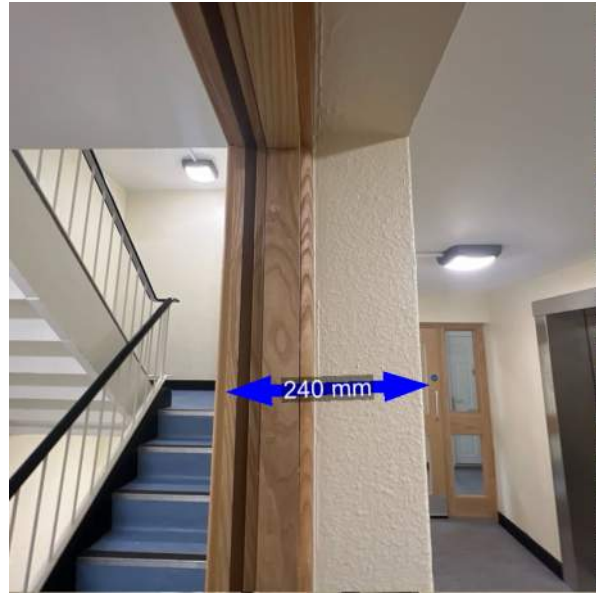
## 6th Floor Staircase

In situ concrete stairs with steel hand railing fixed to stairs. Walls and floors appear to be fairly level.

Staircase/hallway wall measured to be approx. 240mm thick.

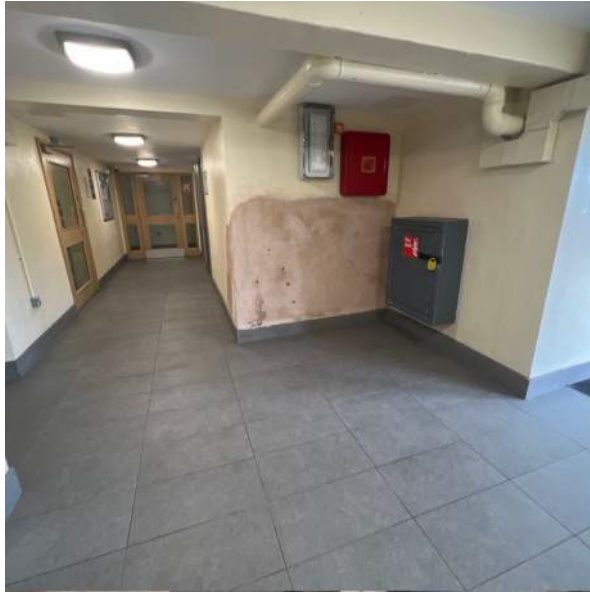
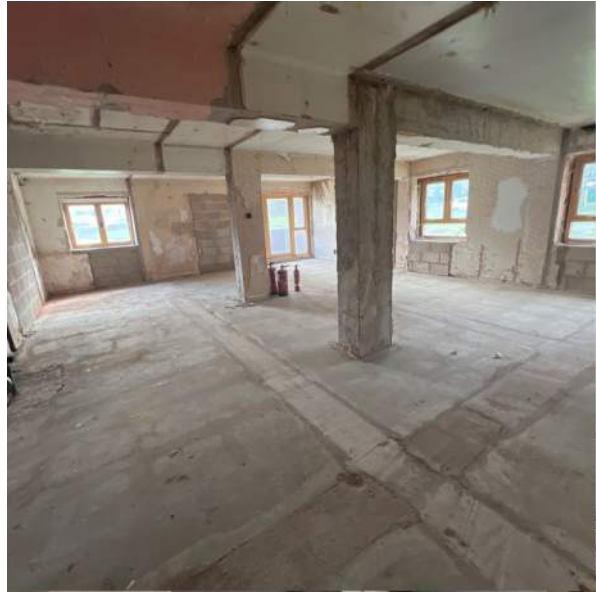
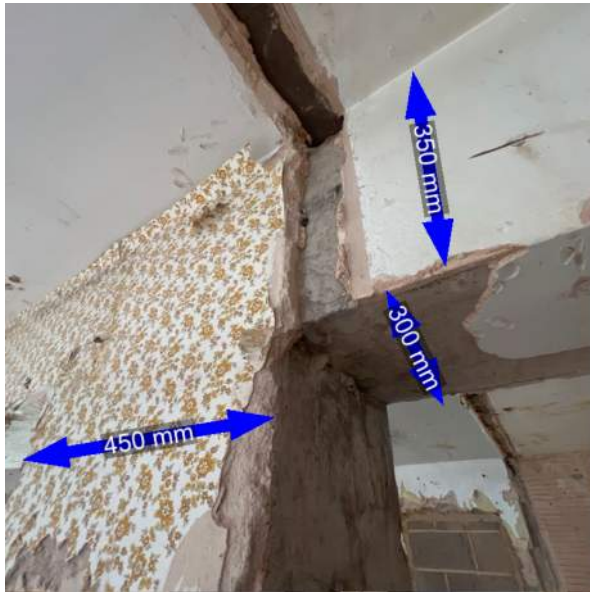
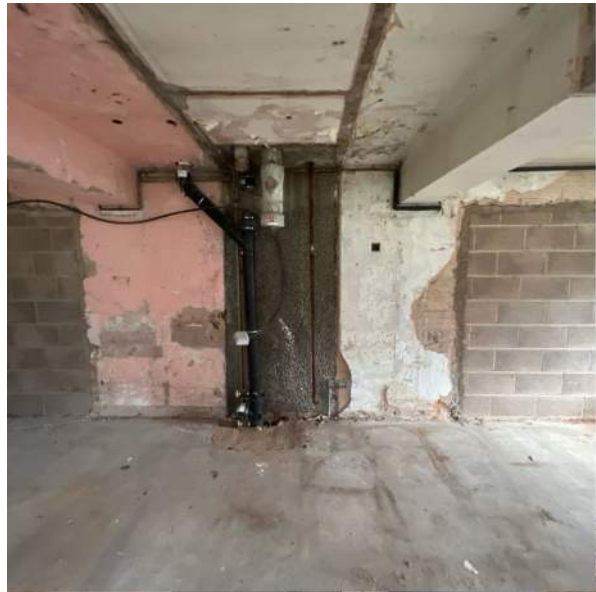
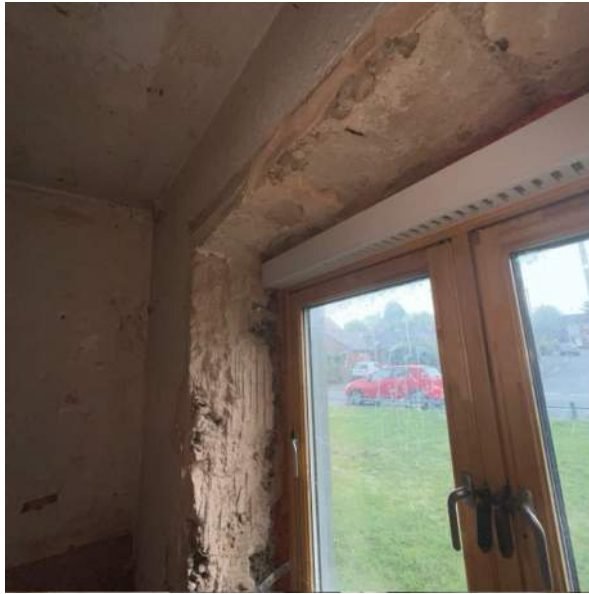
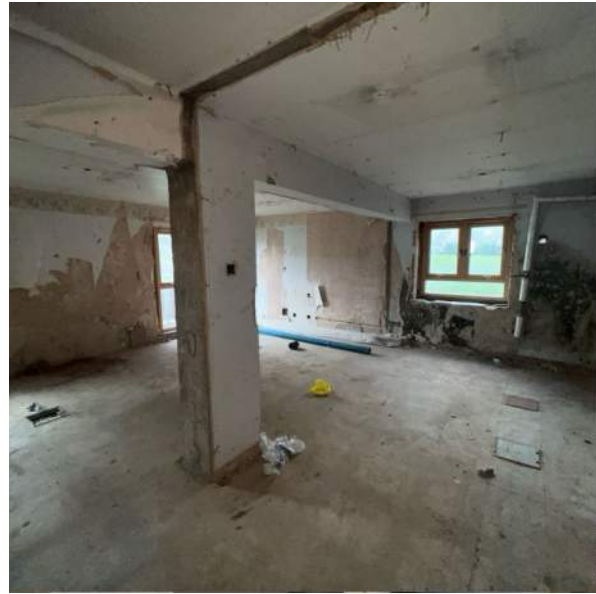
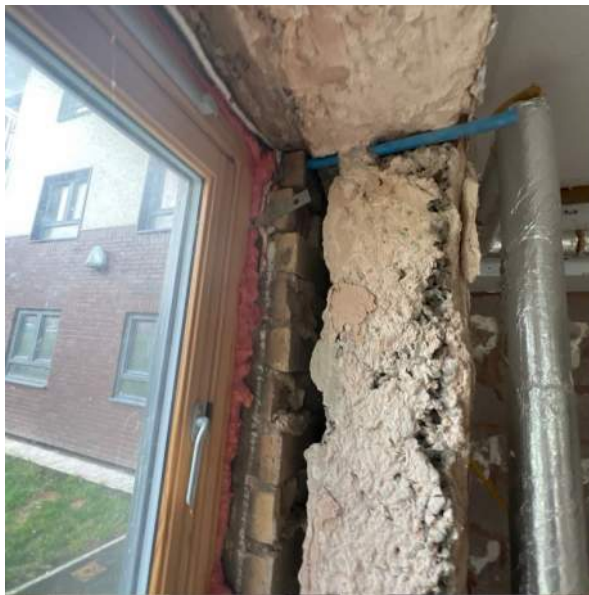
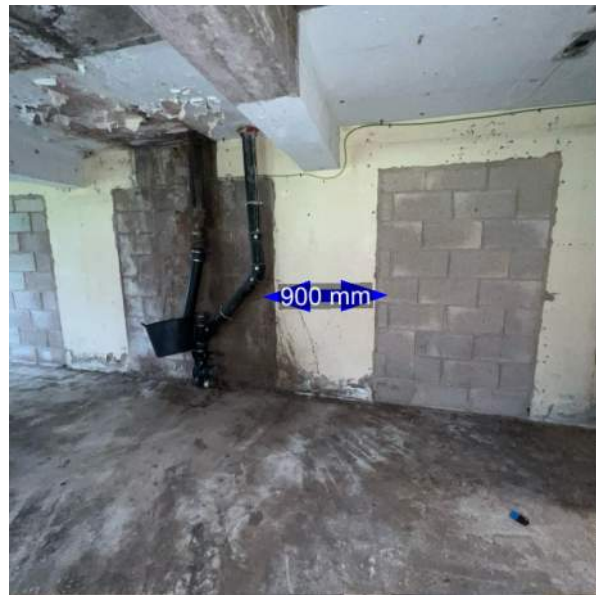
## Ground Floor Hallway

No jams or distortions noted to hallway doors to indicate any serviceability issues. Generally walls covered with finishes in hallway, likely to consist a mixture of concrete shear walls and embedded columns with internal partition walls. Concrete frame consisting of RC columns, Shear Walls and RC Beams noted in visible areas of ground floor rooms. Infill (non-load bearing) walls noted. Perimeter walls noted to have RC columns/walls and No-fines concrete infill walls.

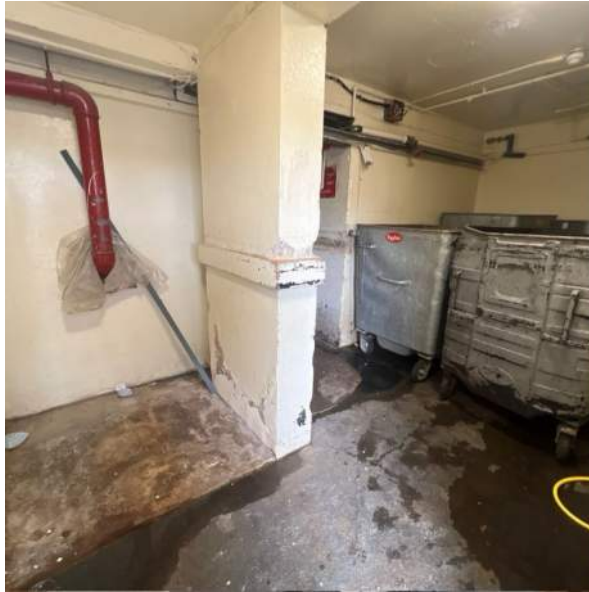
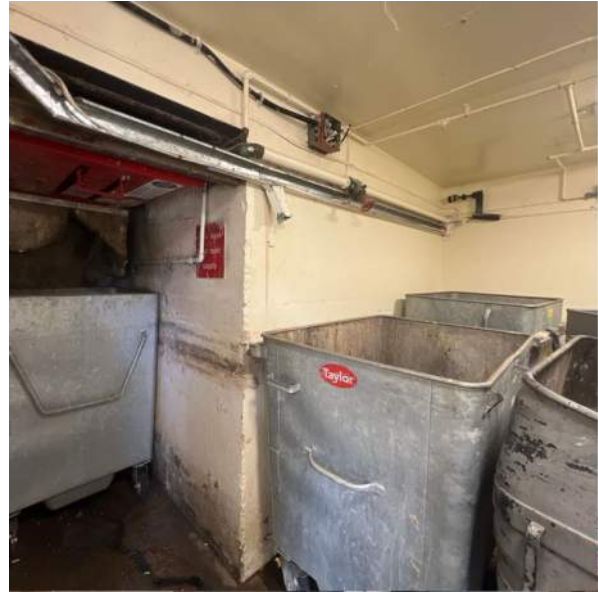
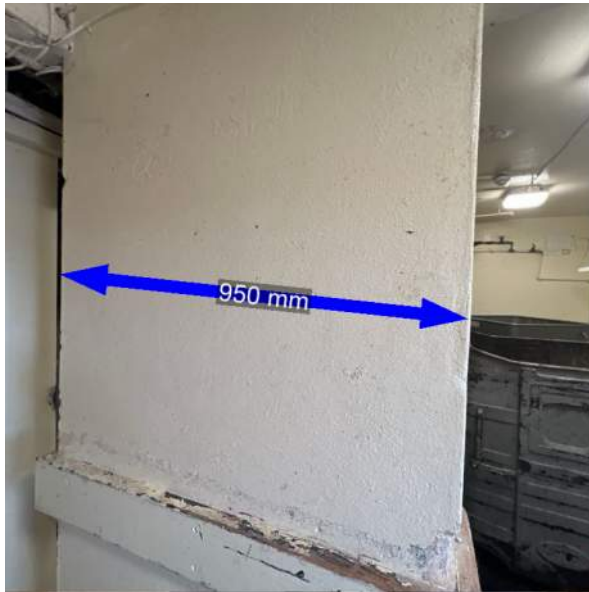
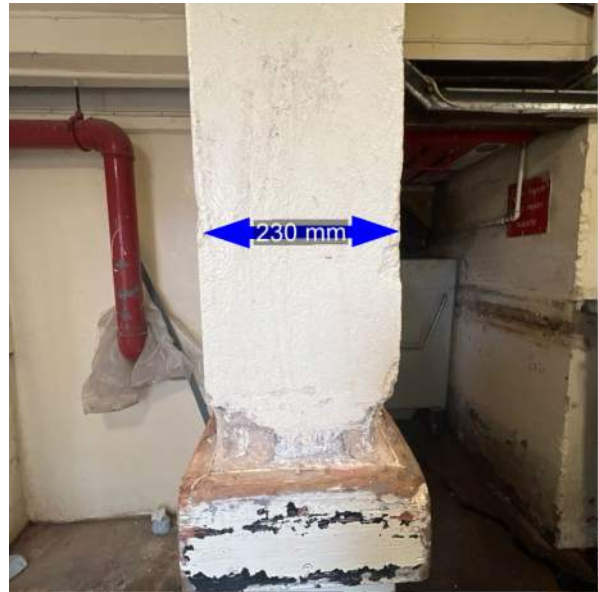
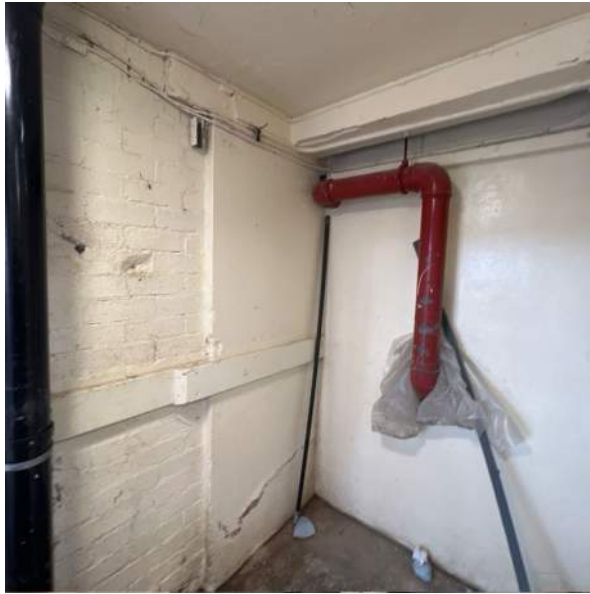
## Bin Store

Comments: RC shear walls, columns and beams noted.  
Infill (non-load bearings) masonry walls noted.
