VISUAL STRUCTURAL APPRAISAL

1-73 Harry Price House

Hartlebury Rd  
Oldbury  
B69 1EQ

12<sup>th</sup> November 2024

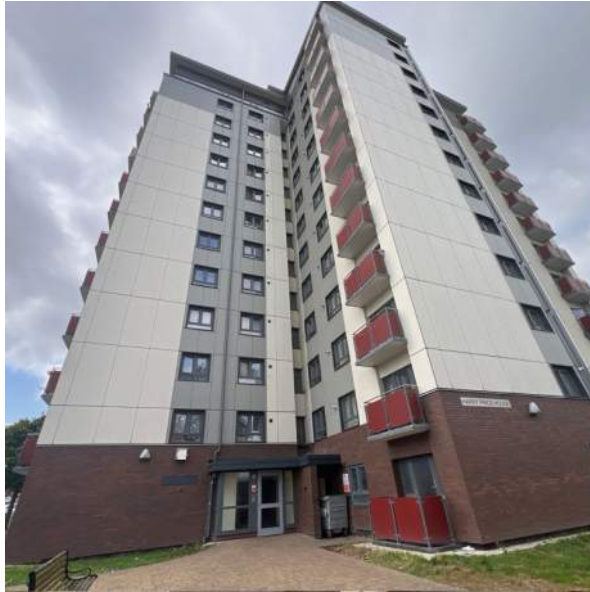
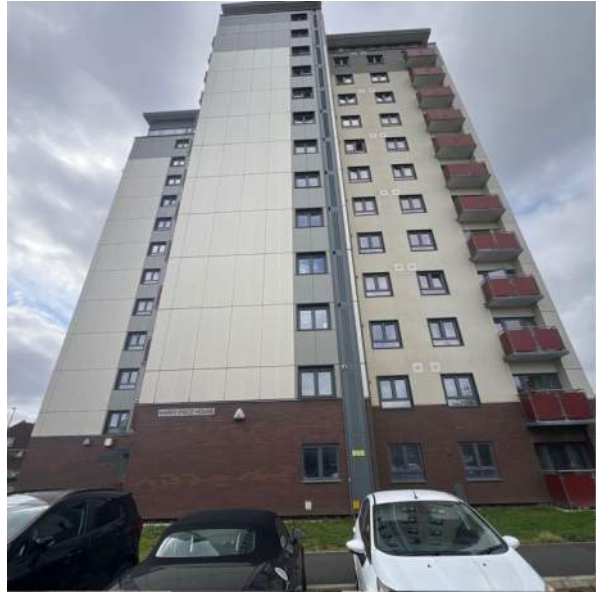
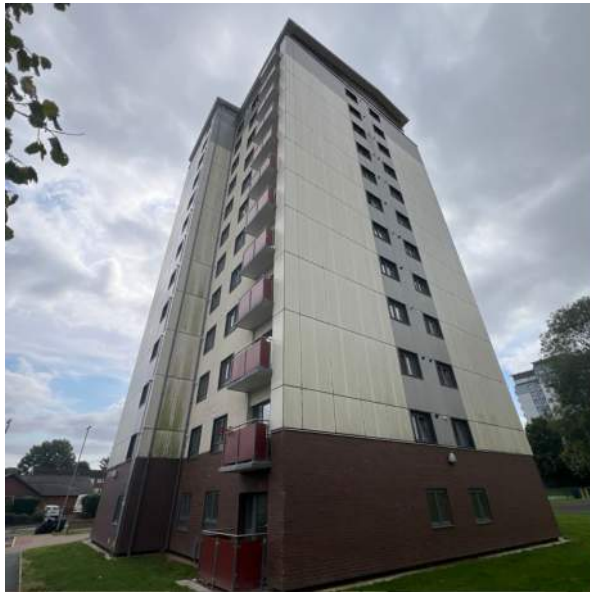
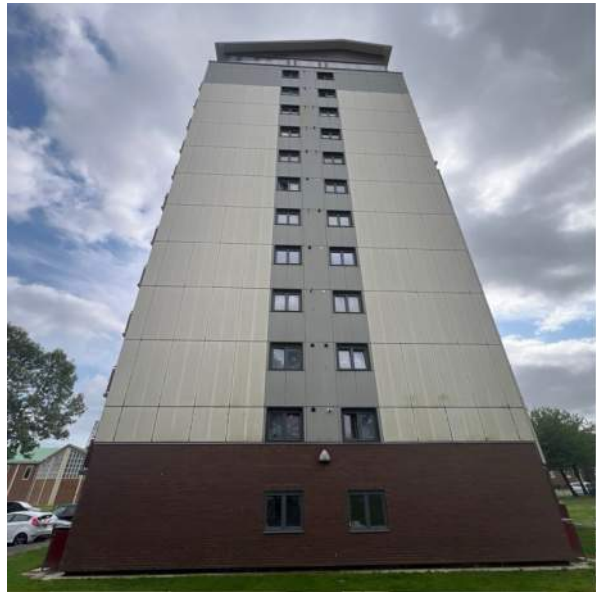
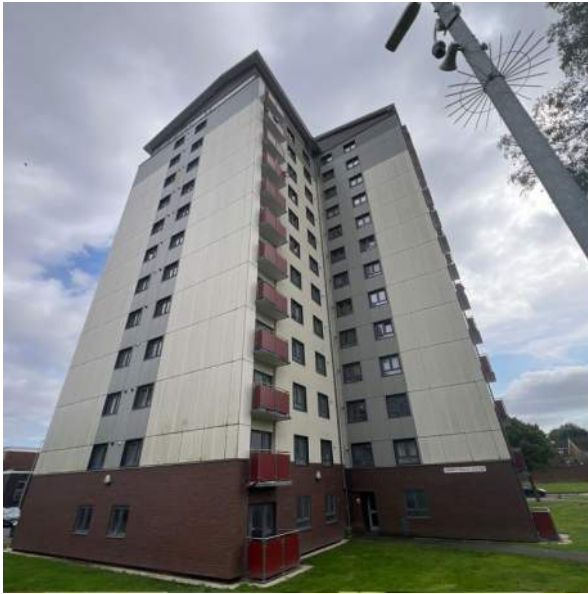
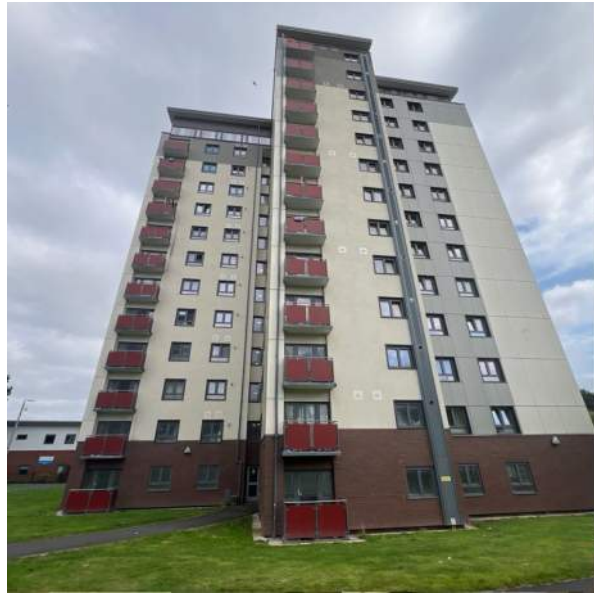
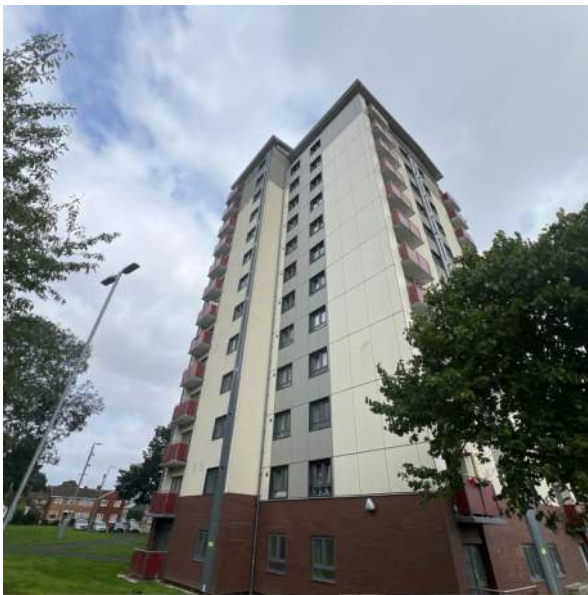
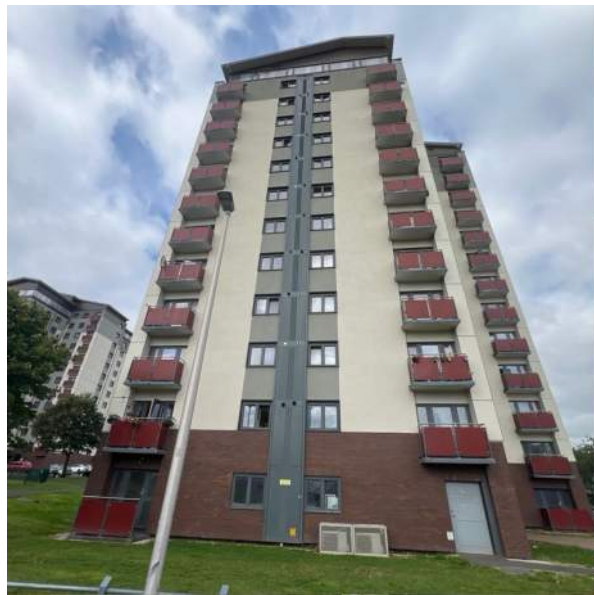
## Elevations

External ground floor level consists of brick work.  
Remaining floors noted to have a cladded facade to exterior. Balconies noted.  
Some staining noted to cladding.

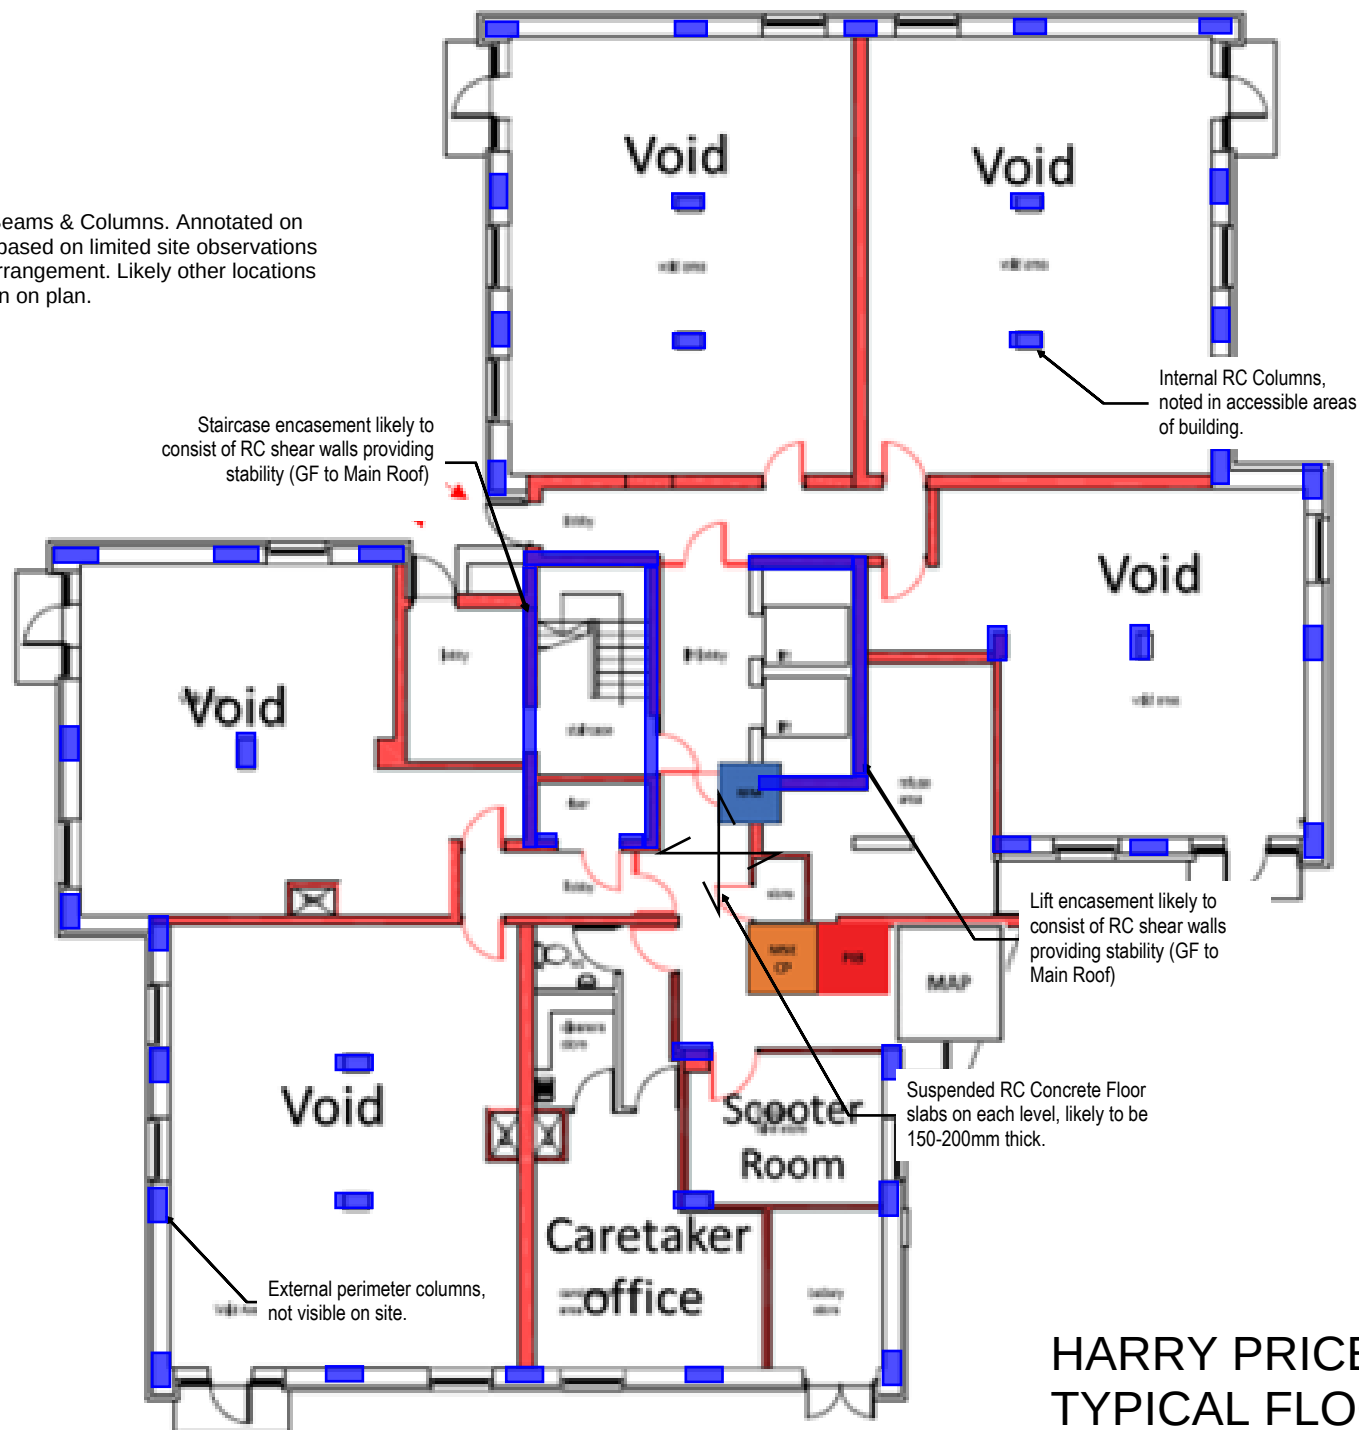
HARRY PRICE HOUSE  
TYPICAL FLOOR LAYOUT

RC Shear/Core Walls, Beams & Columns. Annotated on plan shown indicatively based on limited site observations and general floor plan arrangement. Likely other locations present where not shown on plan.
