**FIRNTEC**  
BUILDING COMPLIANCE

VISUAL STRUCTURAL APPRAISAL

Heronville House  
Sedgeley Road East  
Tipton  
DY4 7TX

24<sup>th</sup> June 2025

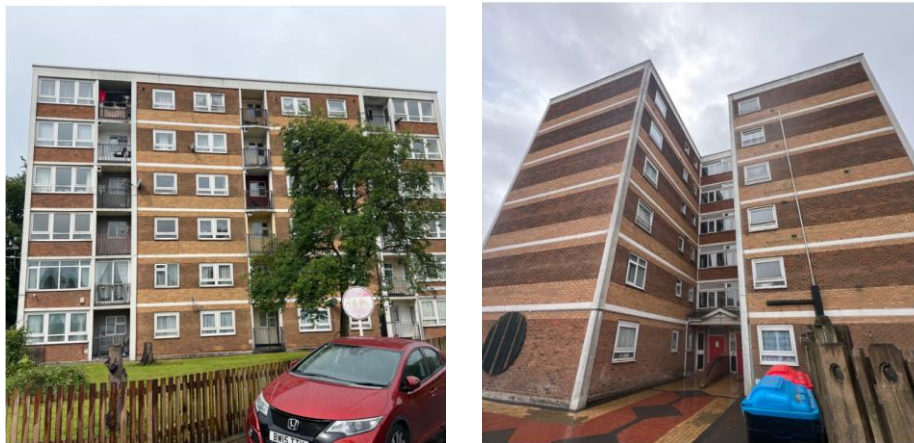
Figure 9 and 10: Building Elevations

The exterior elevations were generally in ok condition and no significant structural defects were noted to the infill panels. There were no significant cracks or tell-tale signs of any significant structural movement noted at the time of our inspection.

The exterior panels were noted to be plumb with no signs of significant bowing, bulging or leaning noted to the panels indicating failed fixings however their presence and condition cannot be confirmed.

There are inset balconies at each level to the long elevation which are formed of RC slabs tied into the main frame. The balconies would benefit from a refurbishment with widespread failed coatings throughout. The exposed slabs should be checked for internal corrosion potential at the benchmark inspections.

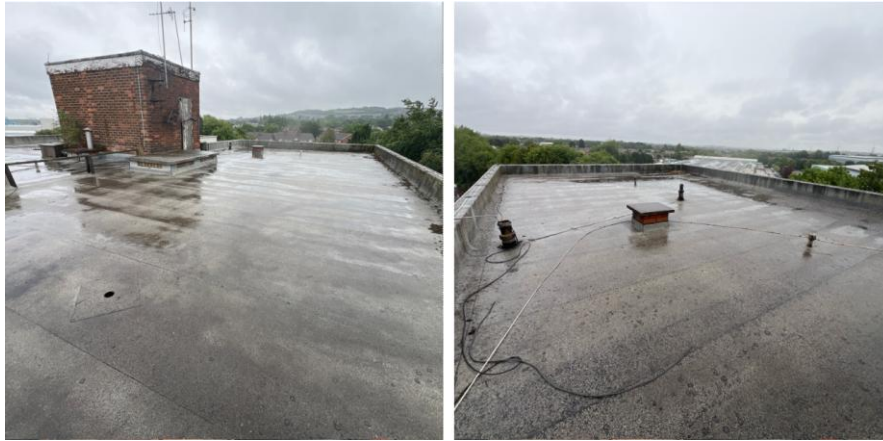
Figure 11 and 12: Roof Level

The flat roof structure is a reinforced concrete cast slab. There is an enclosure which partially covers the roof area which covers the access stairs. The enclosure would benefit from a refurbishment, the timber fascia should be replaced.

There were no tell-tale signs of any significant structural movement noted at the time of our inspection.

The roof has a felted waterproofing system. The exact build-up of the roof finishes were not accessible at the time of inspection. It is recommended an intrusive survey of the roof finishes is completed by a specialist surveyor to assess the condition of the roof covering although they were noted in good condition with no known water ingress issues and therefore a low risk element.

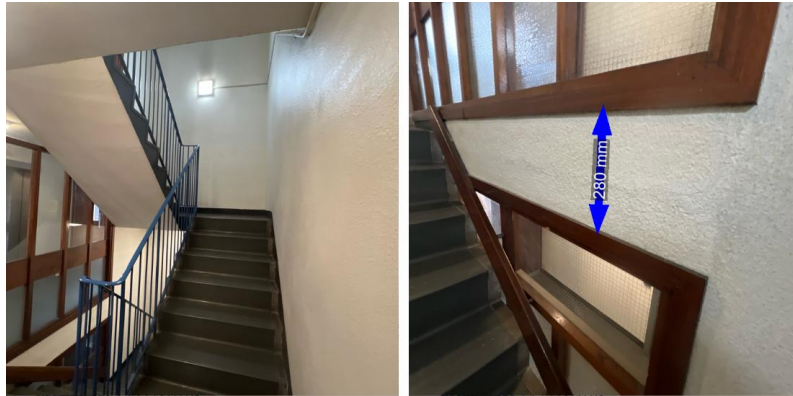
Figure 14 and 15: Slab edge and stair stringer

The interior of the stair core walls were checked and were plumb and in line with observations made to the exterior – no significant signs of leaning or movement noted. The concrete appeared in fair condition with few BRE category 1 cracks but no structurally significant defects were noted.

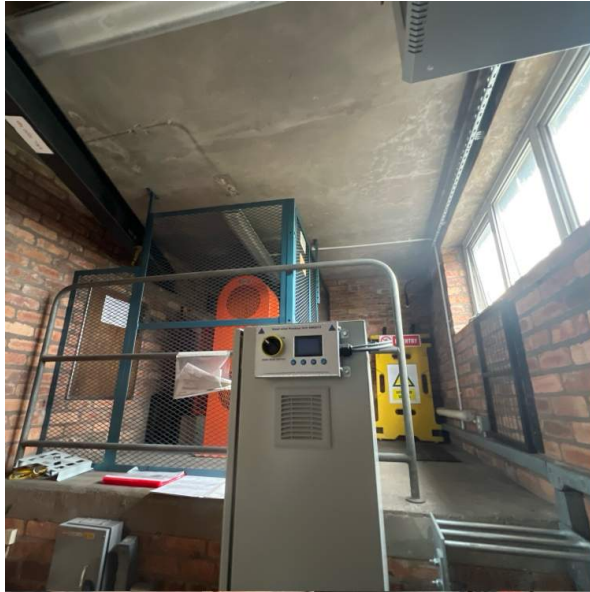
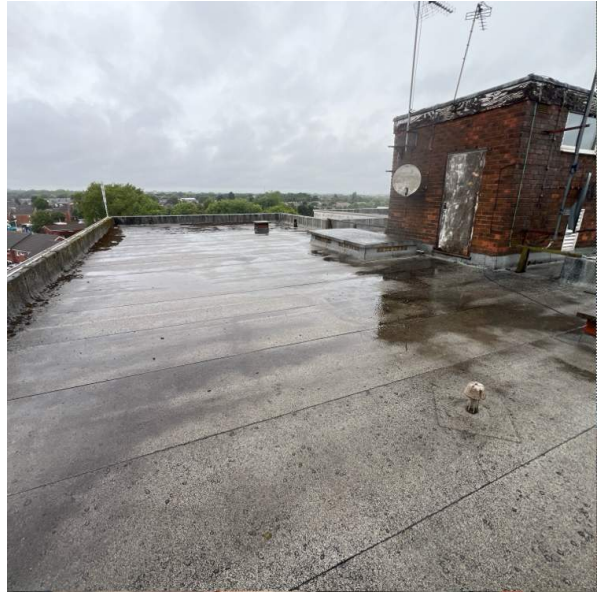
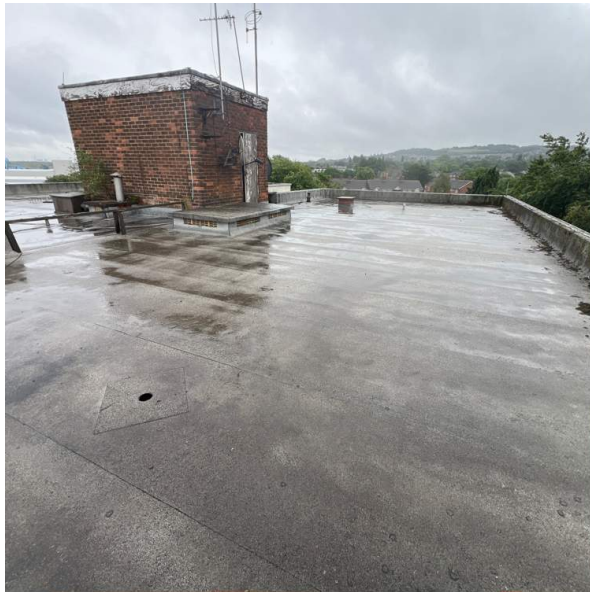
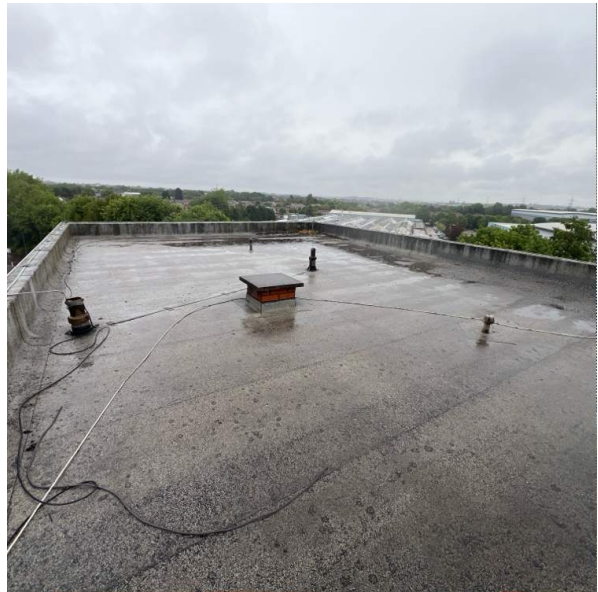
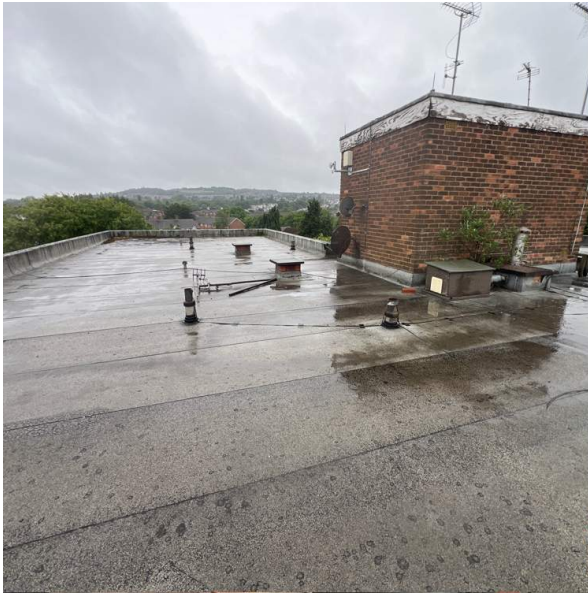
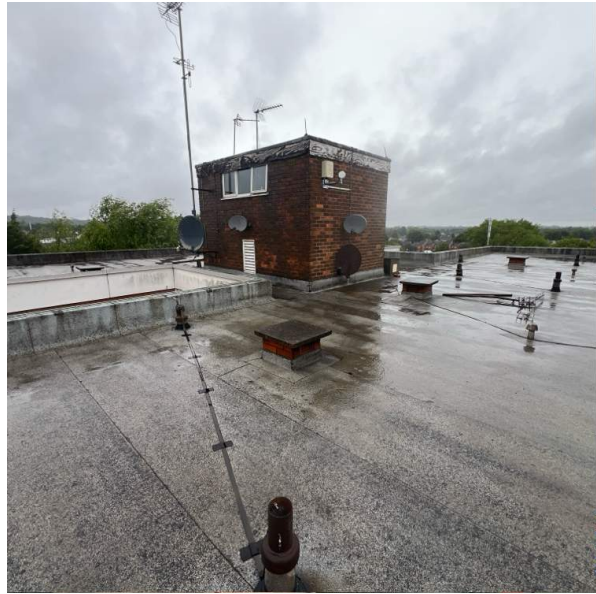
## Main Roof

Comments: Flat roof, RC concrete slab with insulated PIR board and felt coverings.

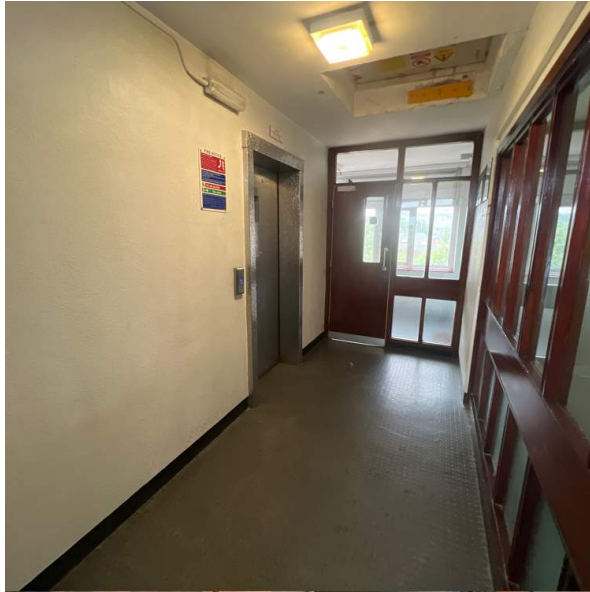
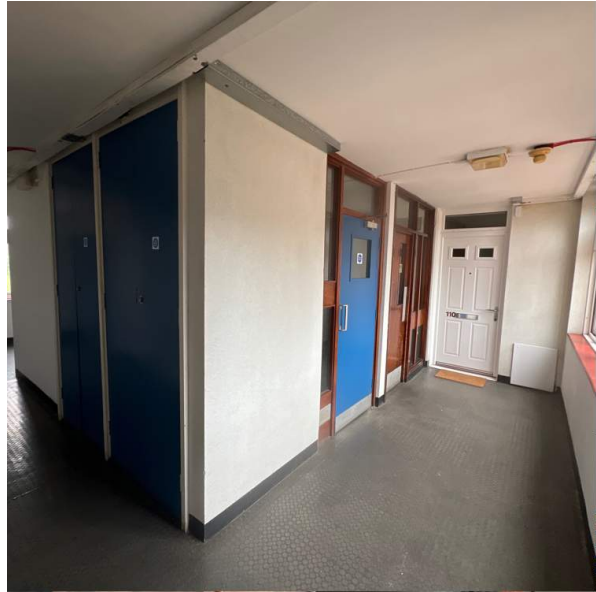
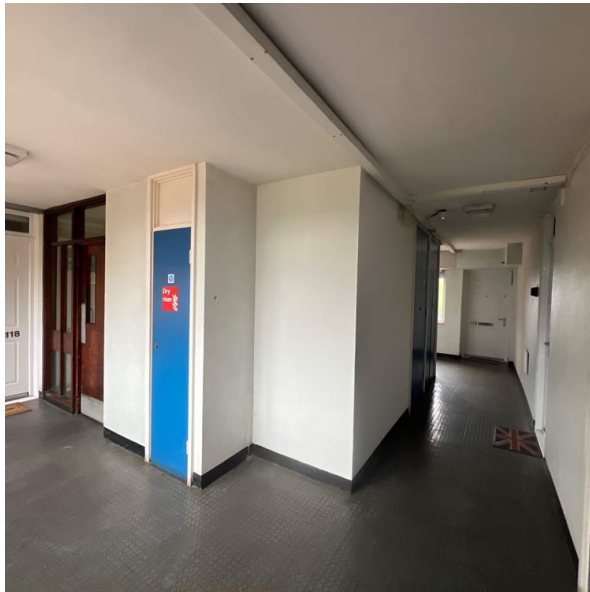
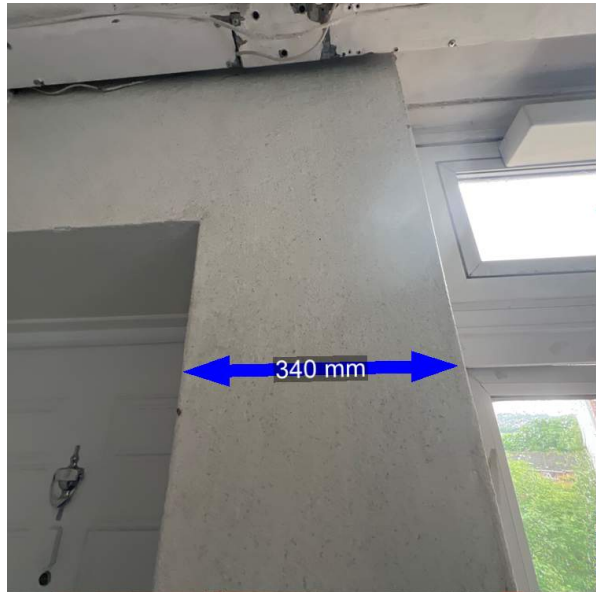
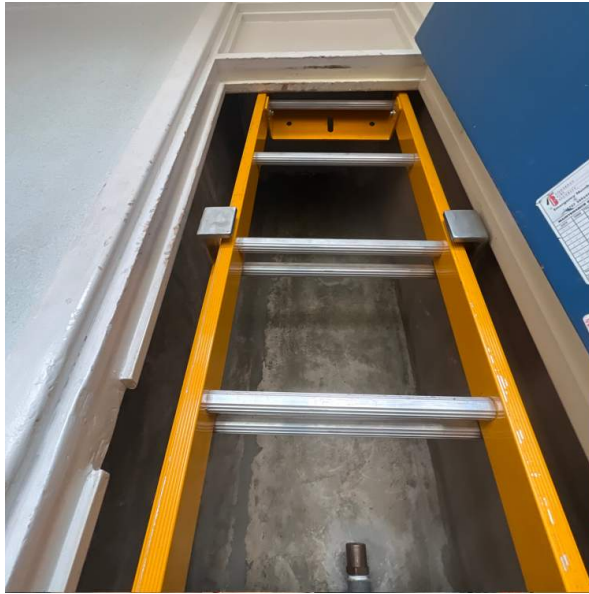
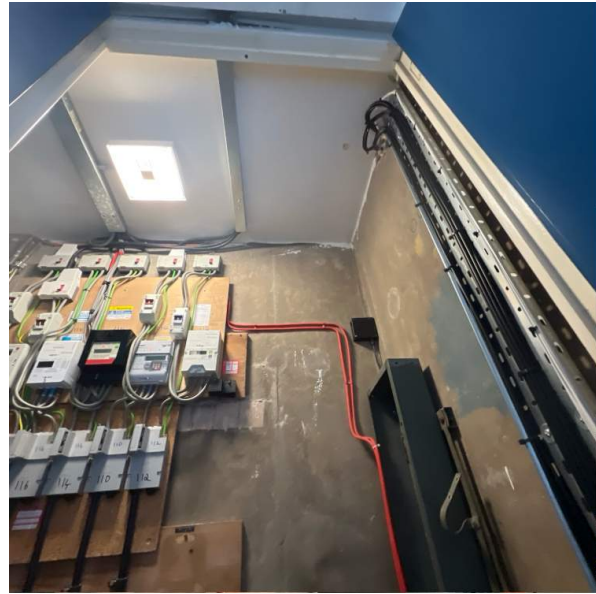
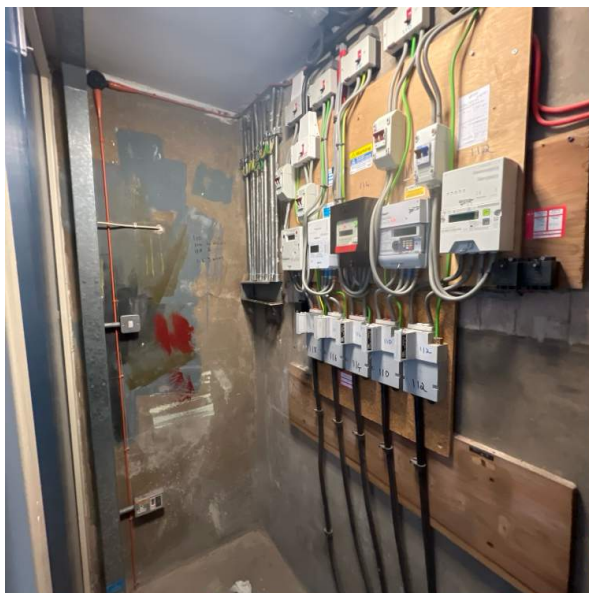
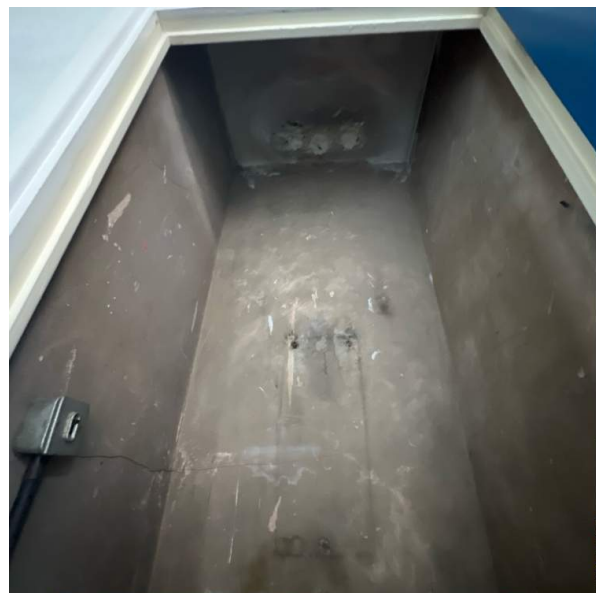
## 5th Floor Hallway

Comments: No jams or distortions noted to hallway doors to indicate any serviceability issues. Generally walls covered with finishes in hallway, likely to consist a mixture of concrete shear walls, embedded columns and masonry infill walls. Limited structure exposed. Concrete structure and rendered infill masonry (non-load bearing) walls noted in riser cupboards. Some superficial/non-structural cracks to finishes.

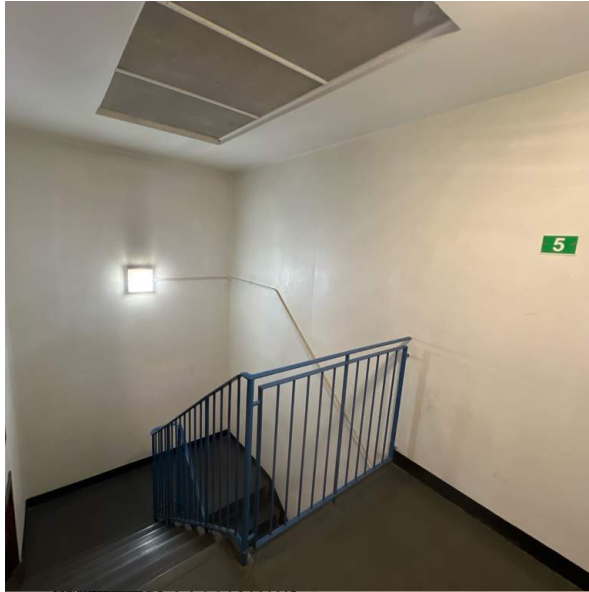
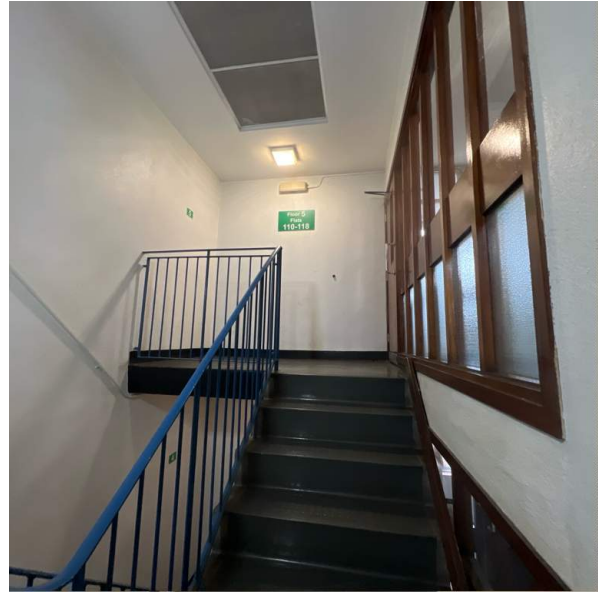
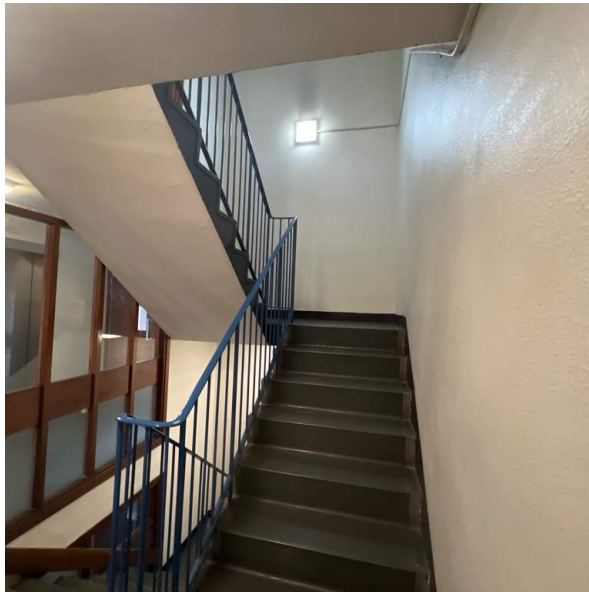
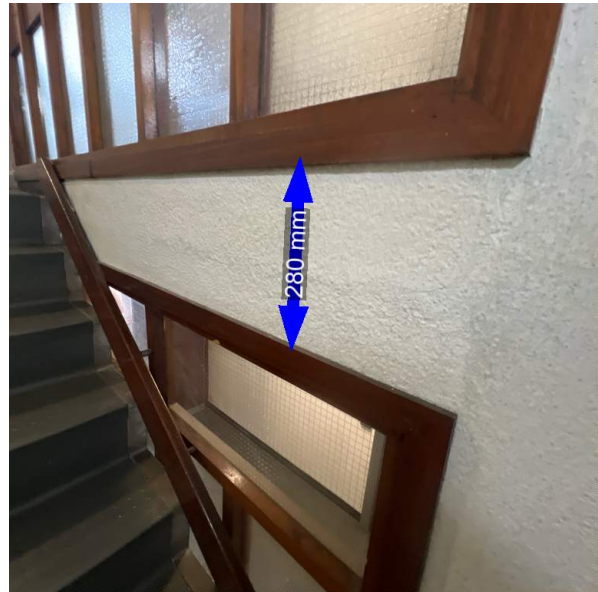
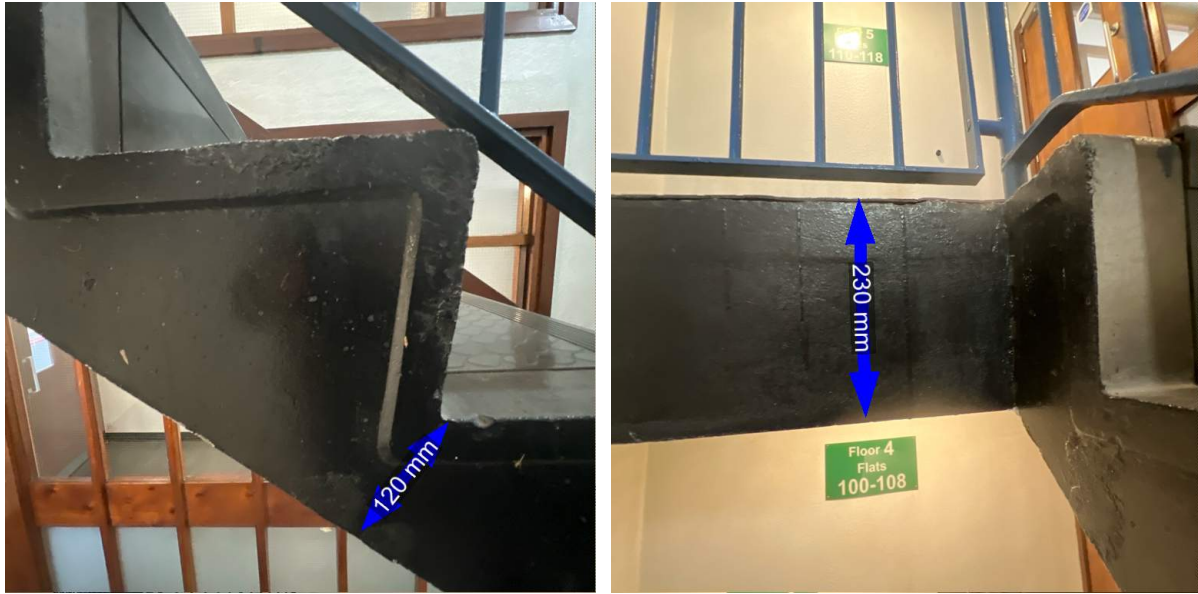
## 5th Floor Staircases

Comments: Insitu concrete stairs with steel hand railing fixed to stairs. Walls and floors appear to be fairly level.  
Stair walls covered with finishes however these would likely form the main concrete shear core walls. One side of staircase wall consists of an RC concrete beam and infill partition/glazing.

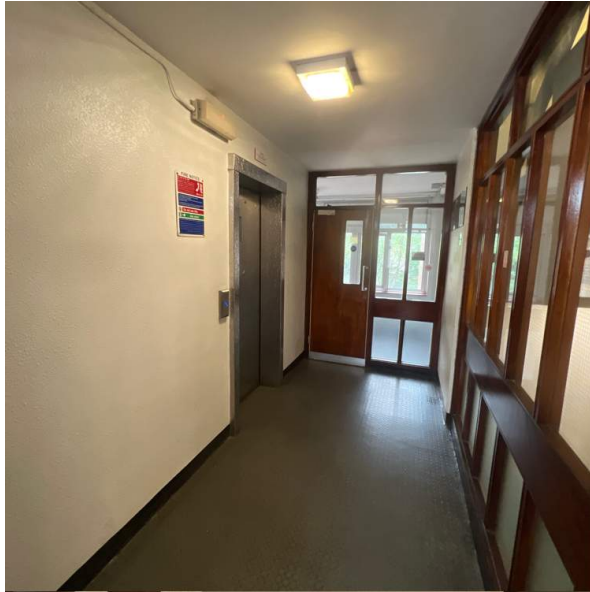
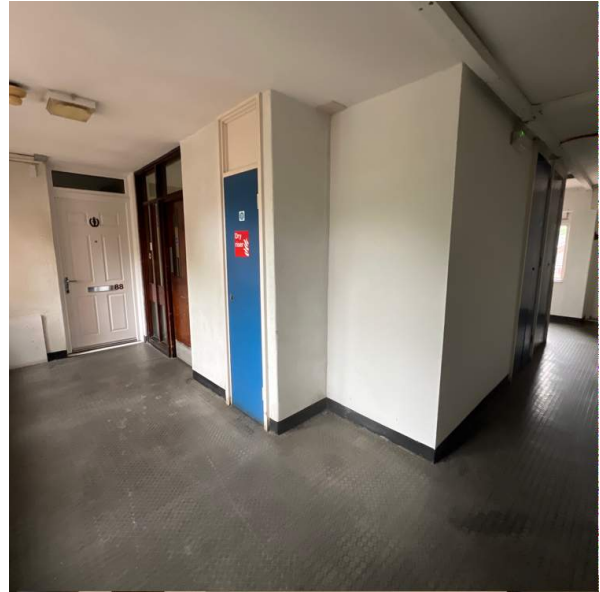
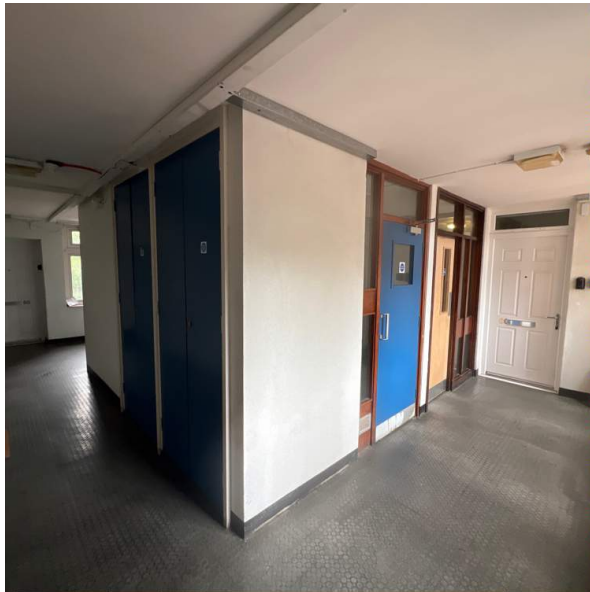
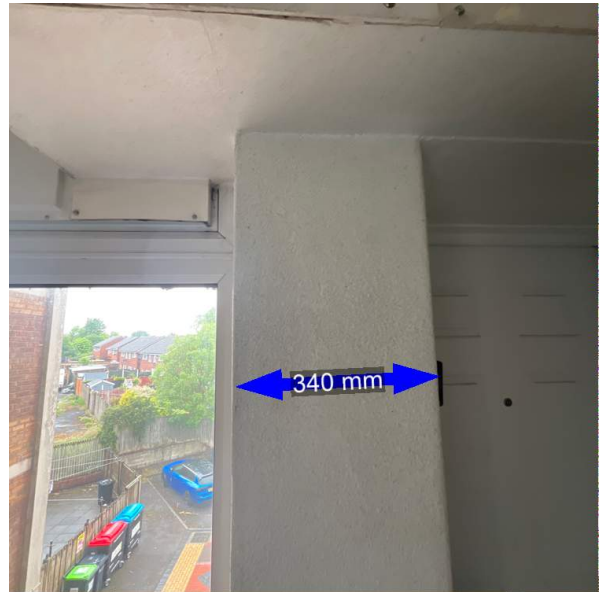
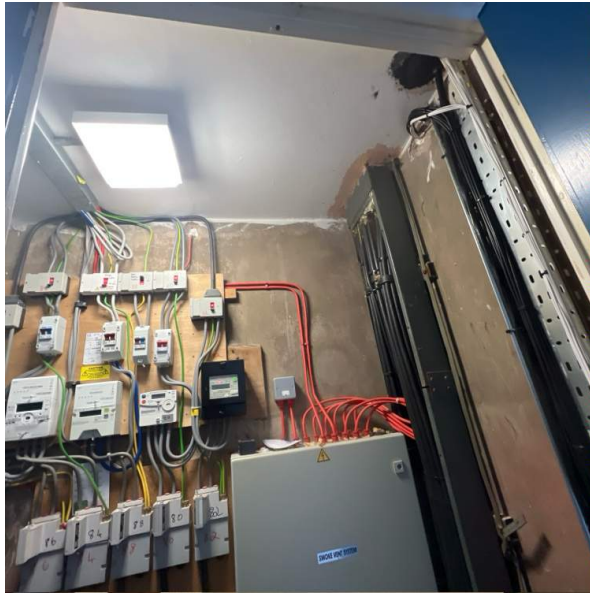
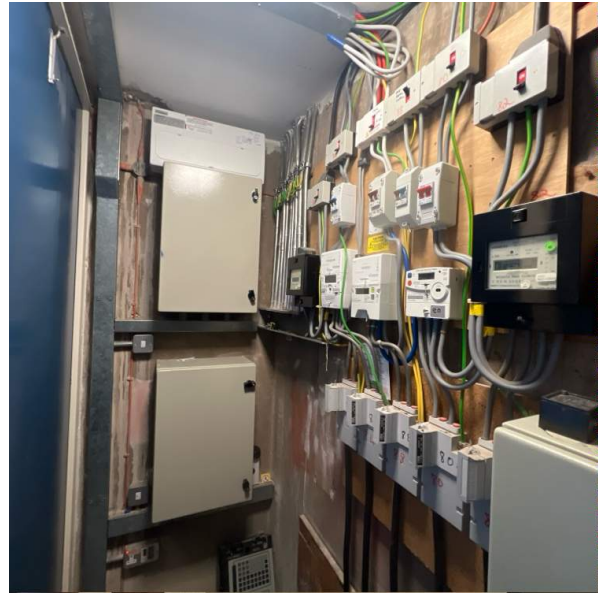
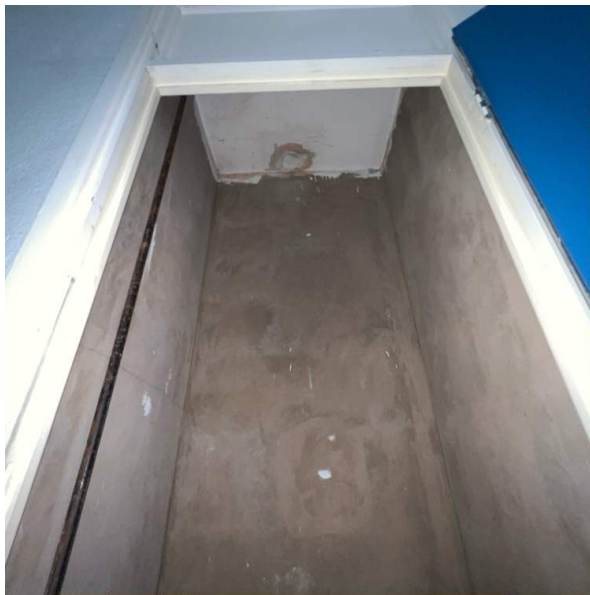
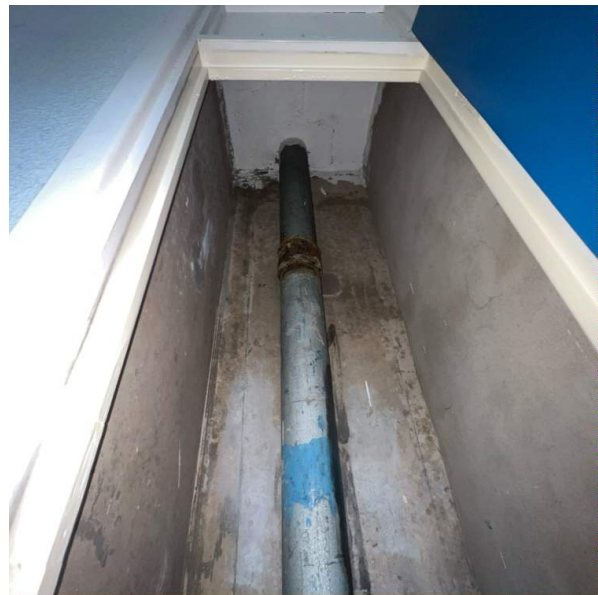
## 2nd Floor Hallway

Comments: No jams or distortions noted to hallway doors to indicate any serviceability issues. Generally walls covered with finishes in hallway, likely to consist a mixture of concrete shear walls, embedded columns and masonry infill walls. Limited structure exposed. Concrete structure and rendered infill masonry (non-load bearing) walls noted in riser cupboards.

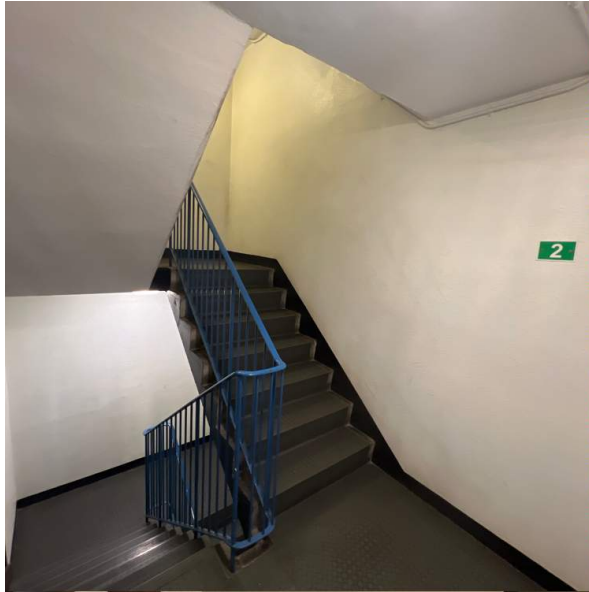
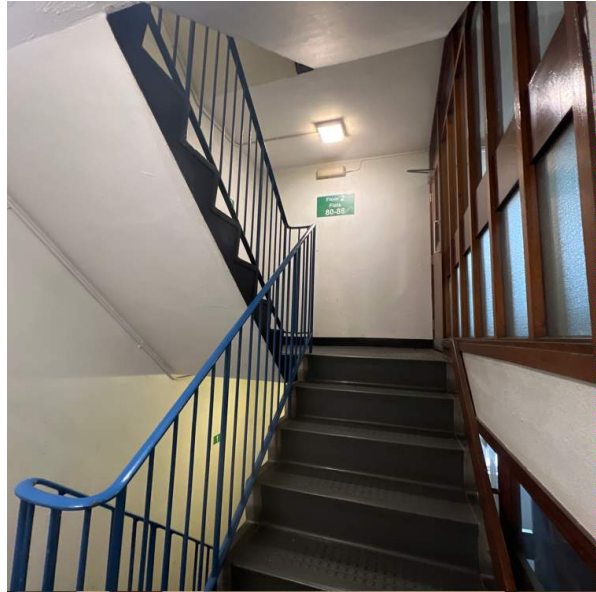
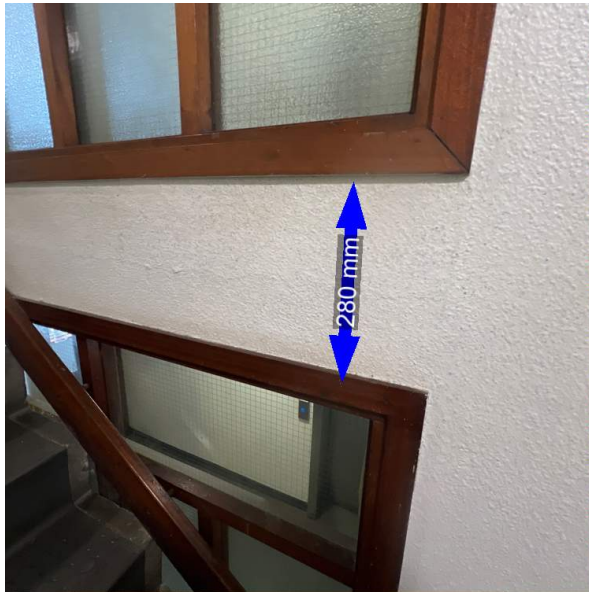
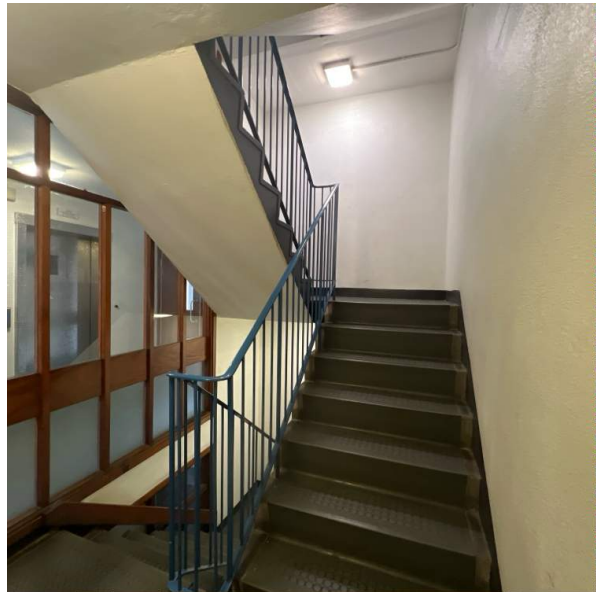
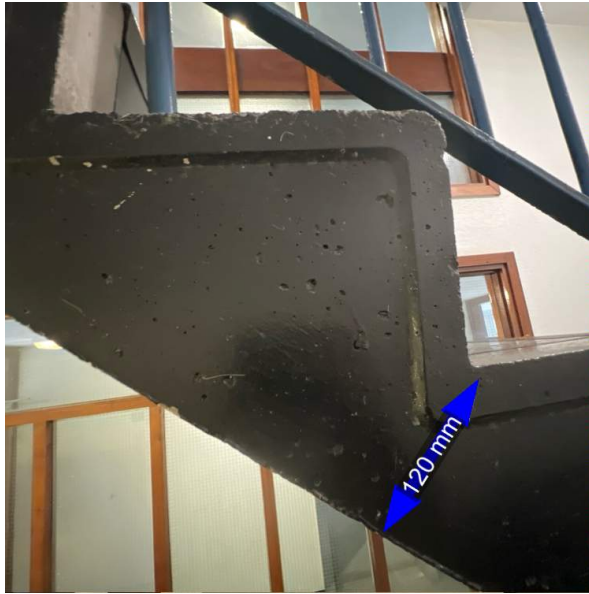
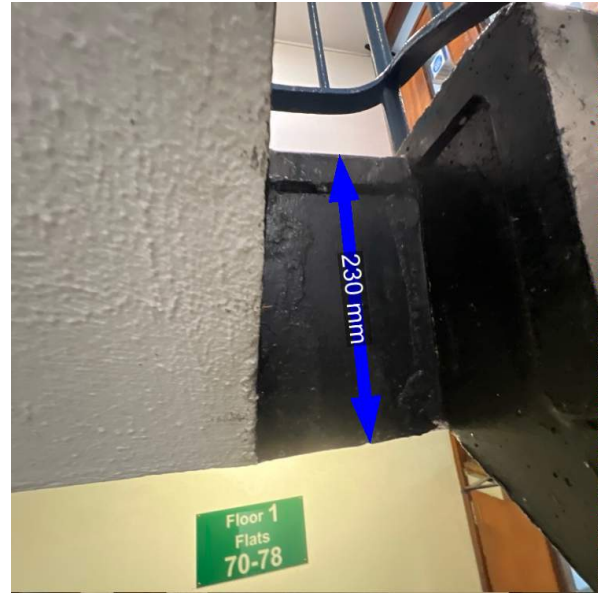
## 2nd Floor Staircases

Comments: Insitu concrete stairs with steel hand railing fixed to stairs. Walls and floors appear to be fairly level.  
Stair walls covered with finishes however these would likely form the main concrete shear core walls. One side of staircase wall consists of an RC concrete beam and infill partition/glazing.

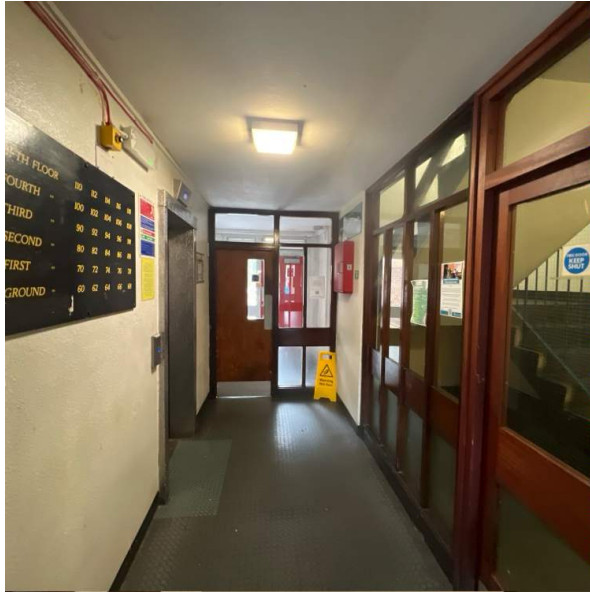
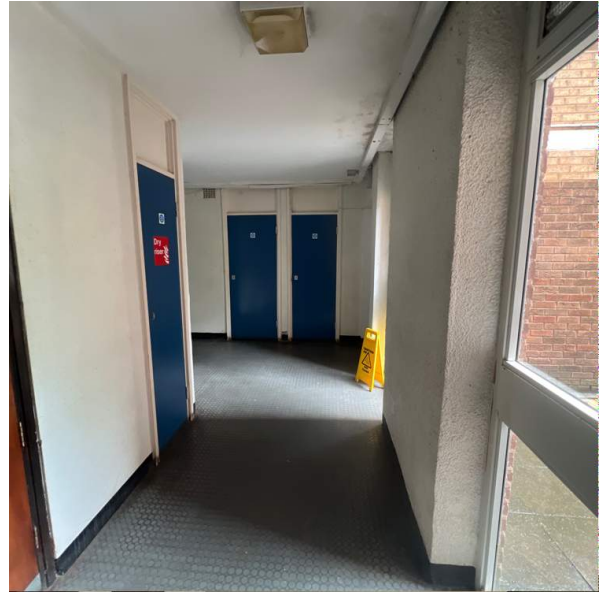
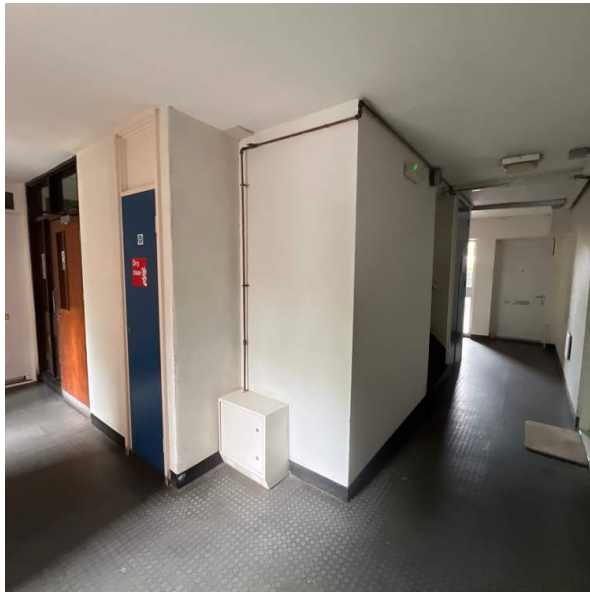
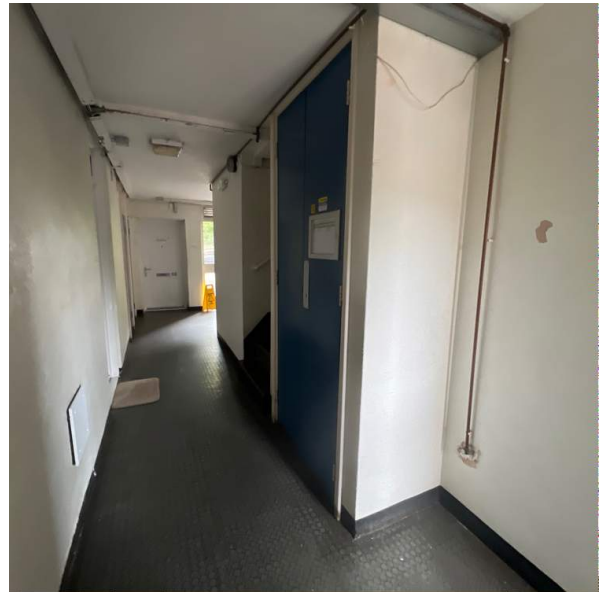
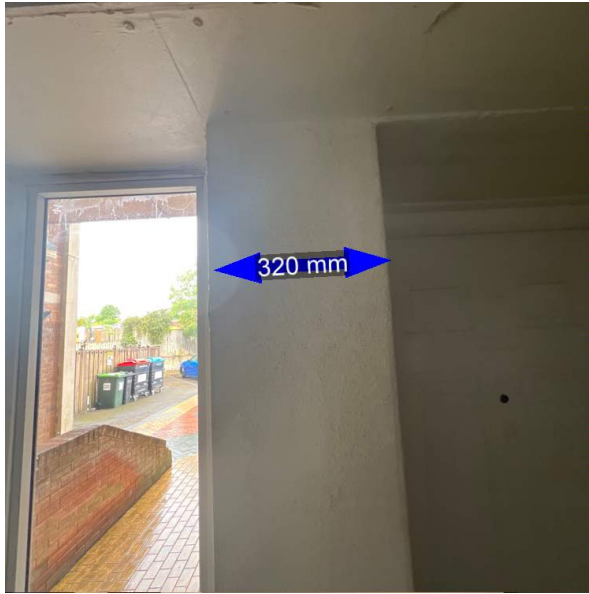
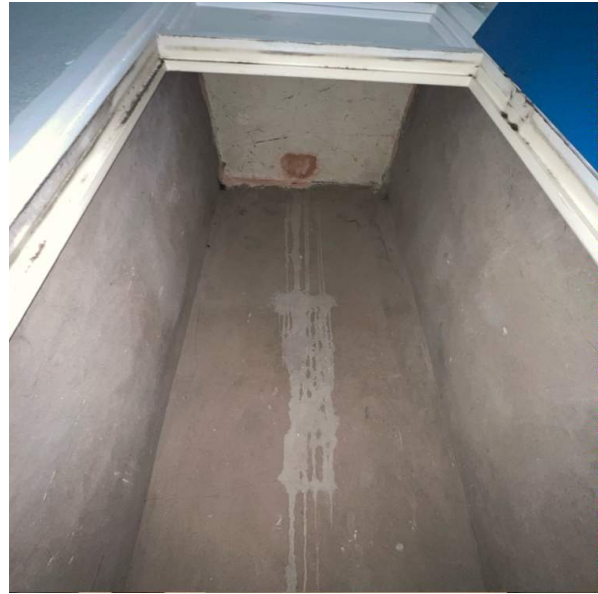
## Ground Floor Hallway

Comments: No jams or distortions noted to hallway doors to indicate any serviceability issues. Generally walls covered with finishes in hallway, likely to consist a mixture of concrete shear walls, embedded columns and masonry infill walls. Limited structure exposed. Concrete structure and rendered infill masonry (non-load bearing) walls noted in riser cupboards.

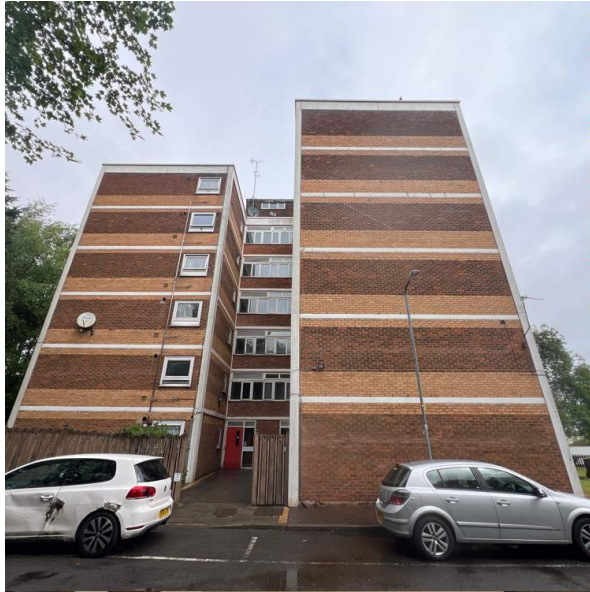
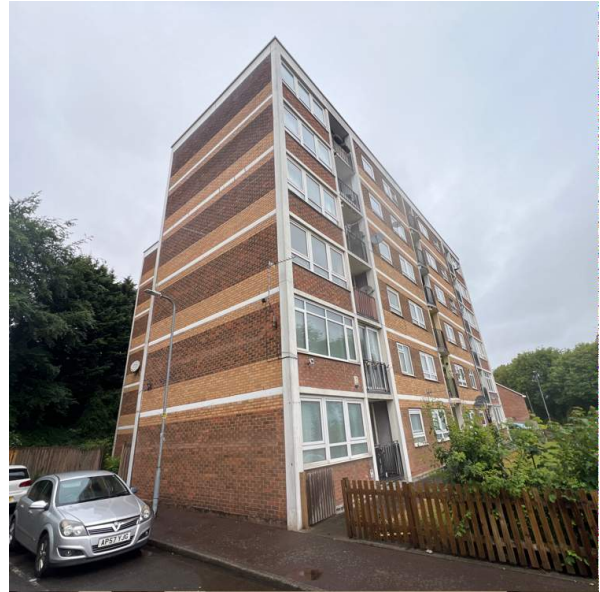
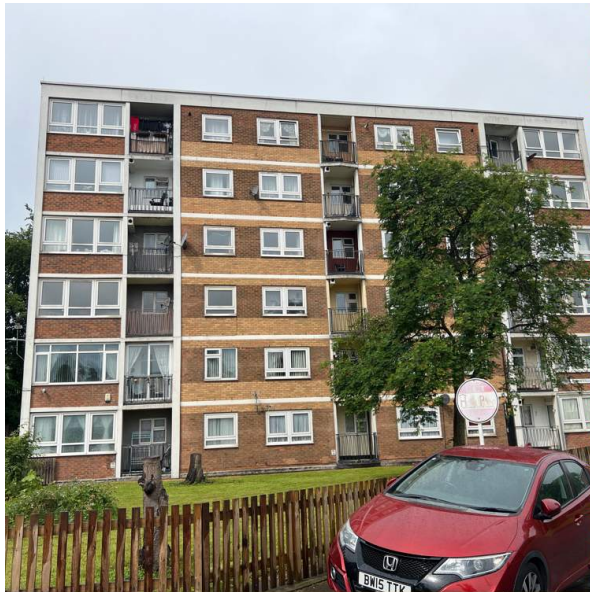
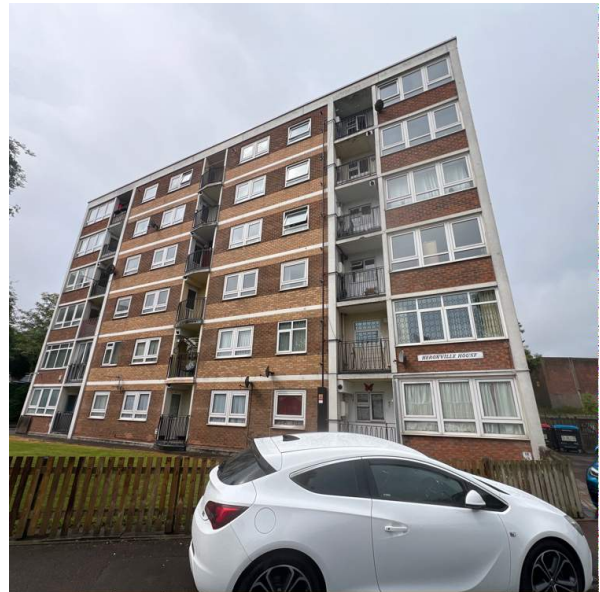
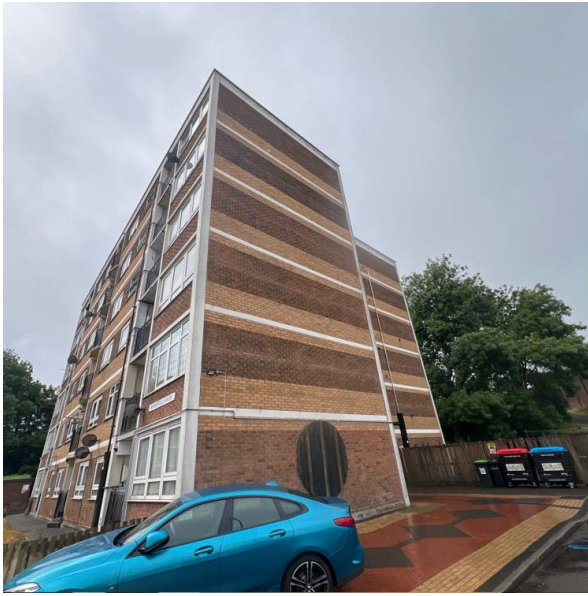
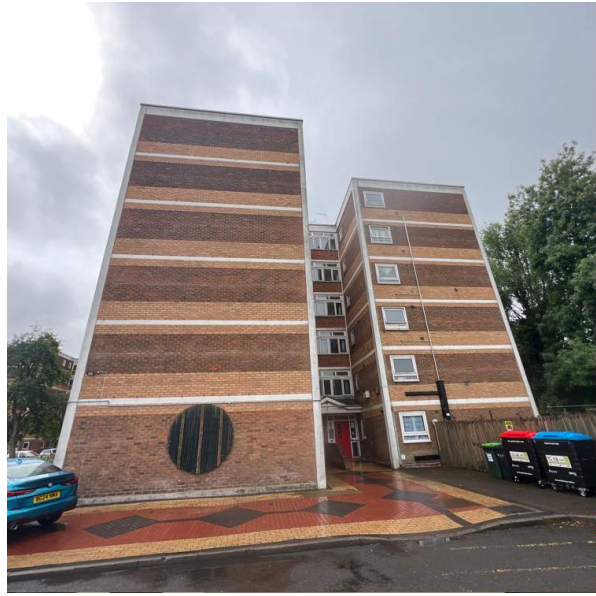
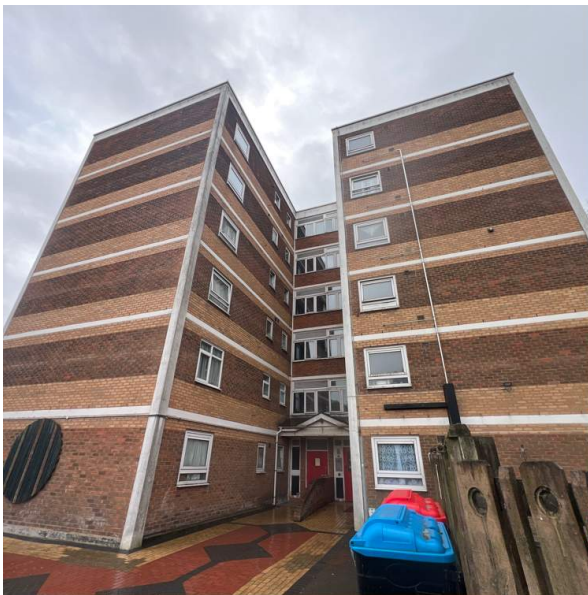
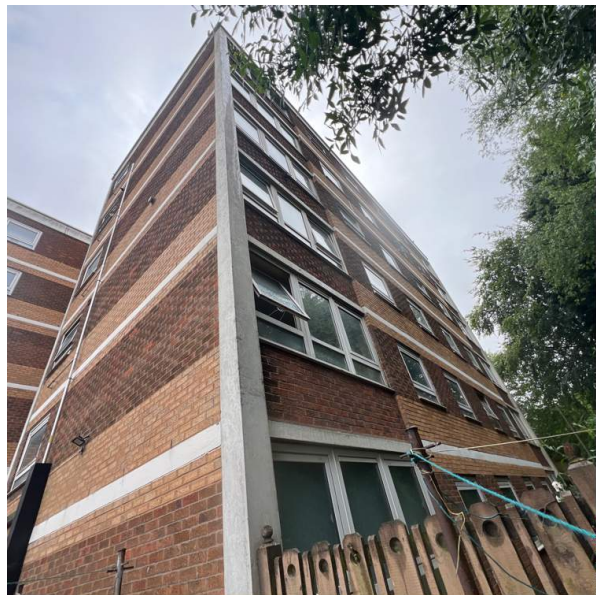
## Elevations

Comments: External facade consists of brick work to all elevations GF to top floor.  
Elevations generally in fair condition.  
RC columns forming part of main structural elements noted to perimeter of building.
